**SAN JOAQUIN SOLAR 1 & 2 HYBRID
PROJECT
12-AFC-08**

**Supplemental Information
In Response To Cure Data Request Set #4**

San Joaquin Solar 1 & 2 Hybrid Project
Supplemental Information
In Response to CURE Data Request Set #4
08-AFC-12

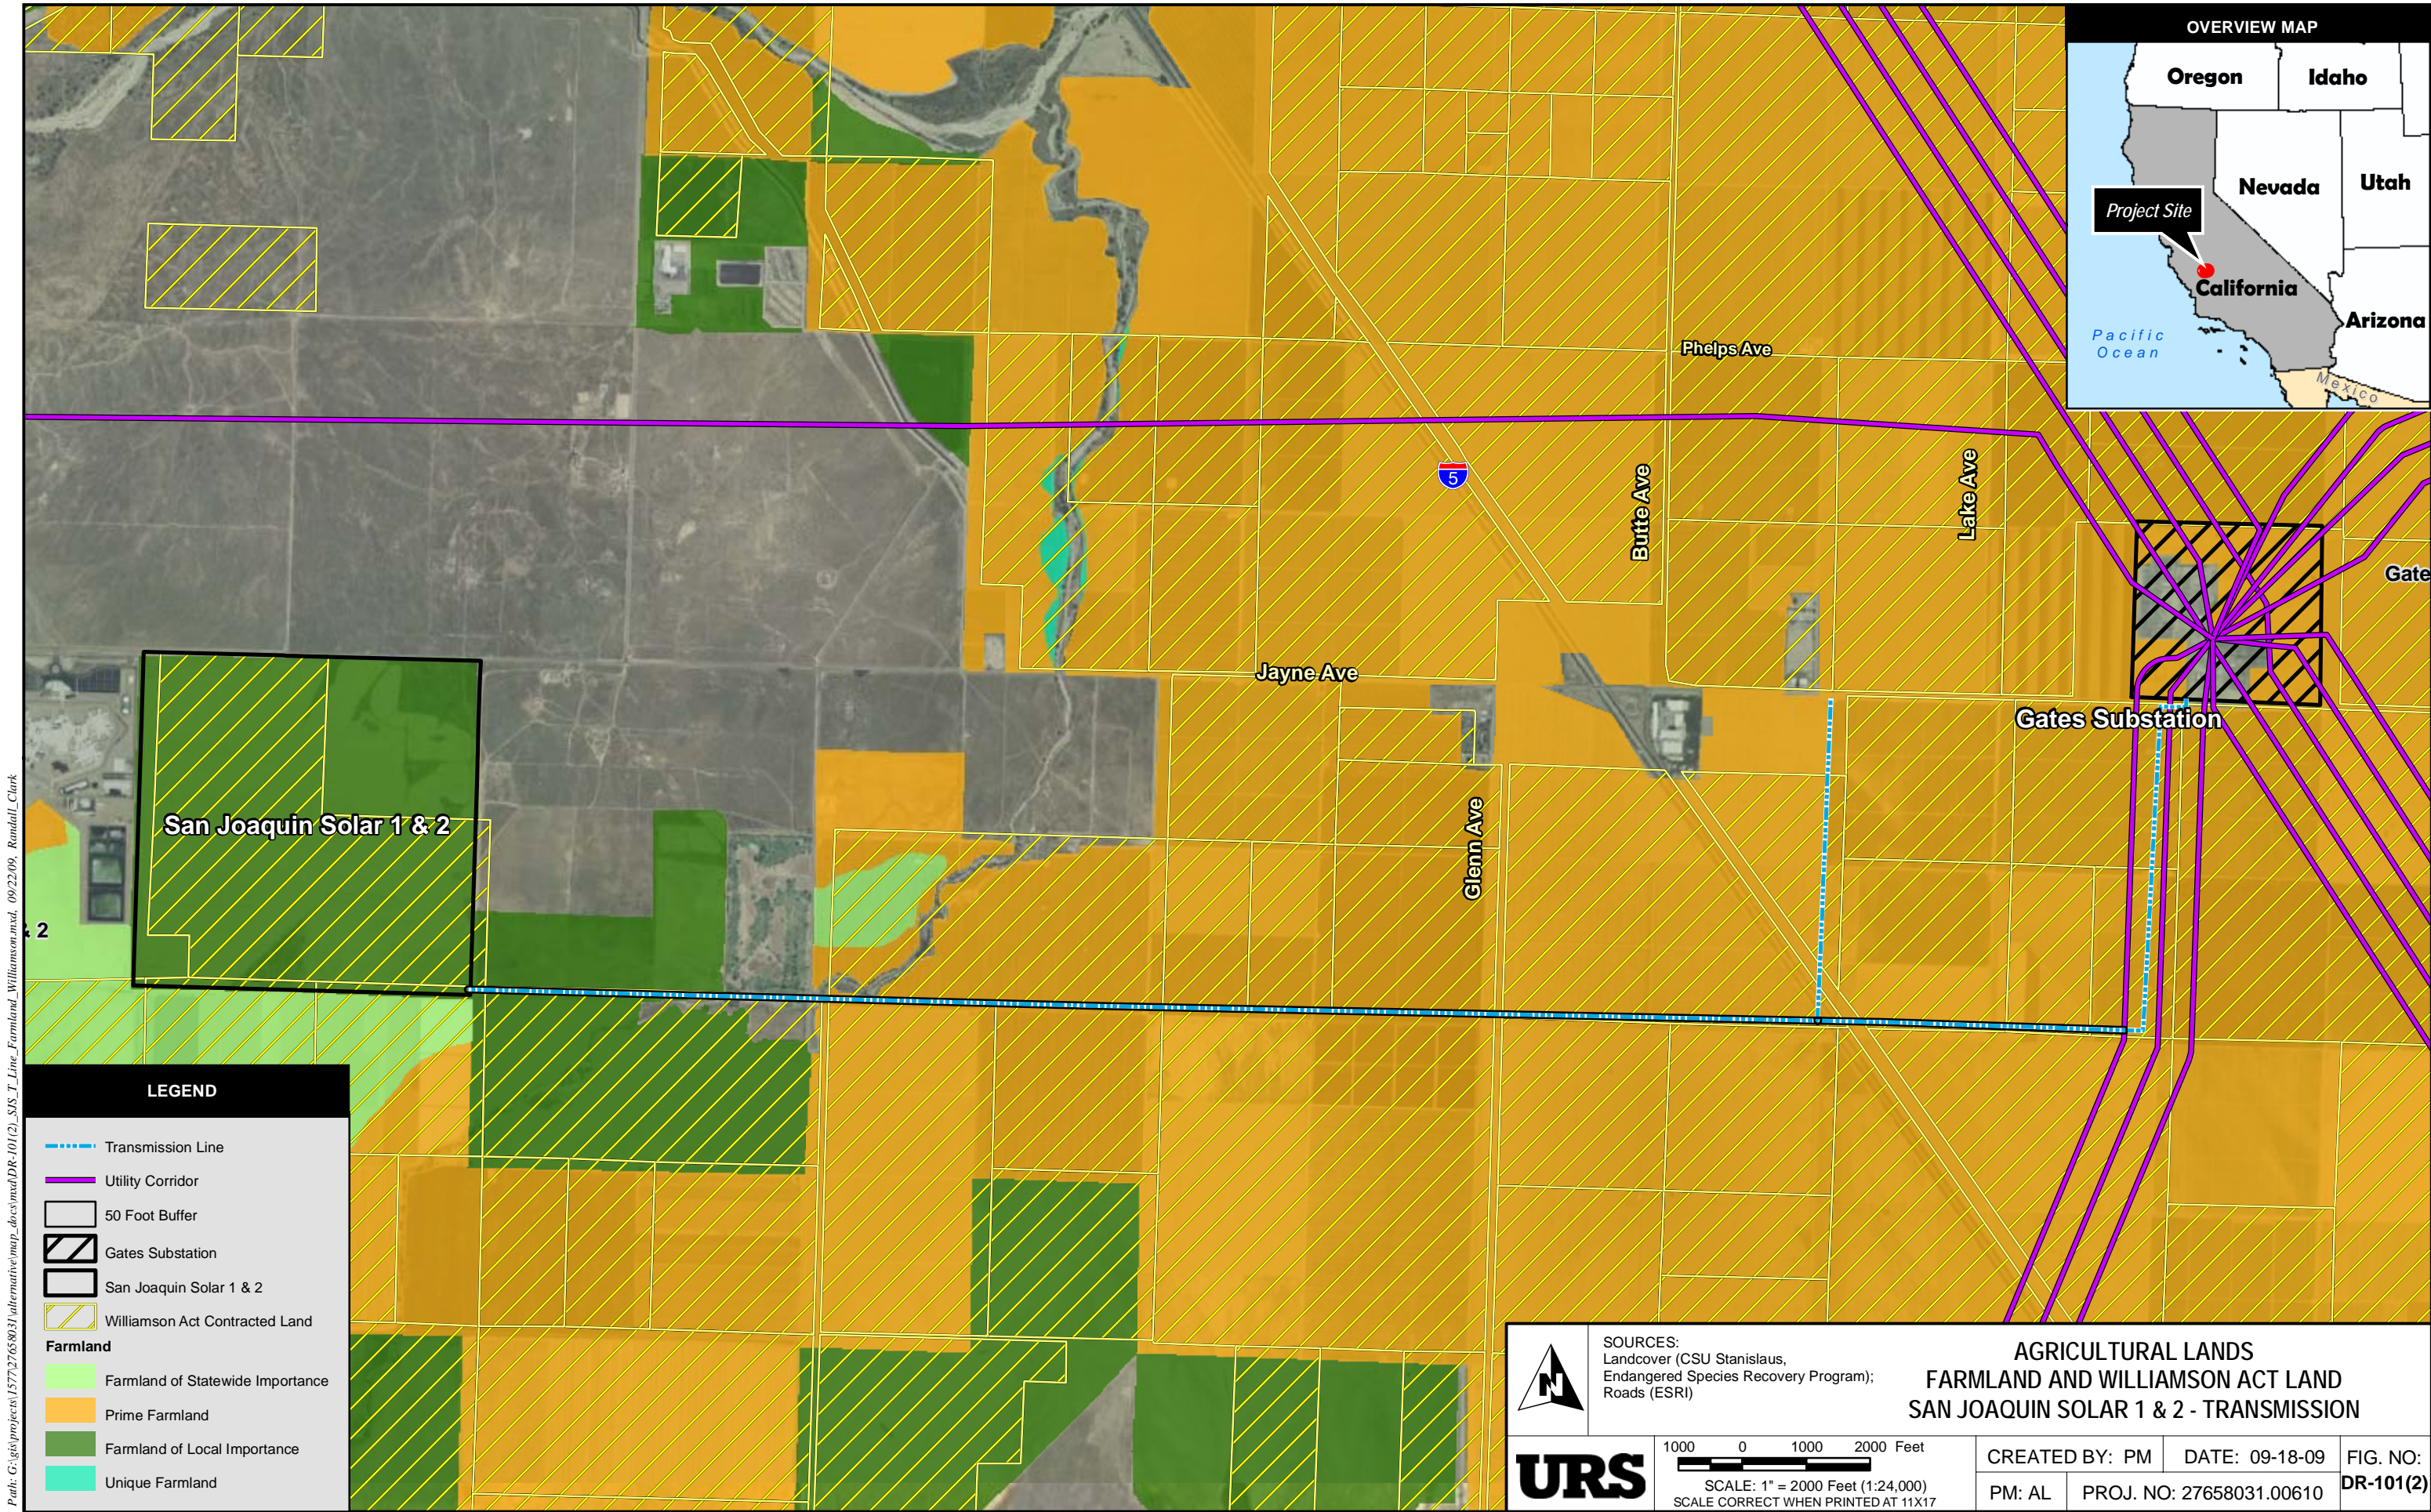
Response: Majority means more than 50%. As shown in Figure DR-103 less than one mile of the approximate 6 mile transmission line route is not comprised of orchards and row crops.

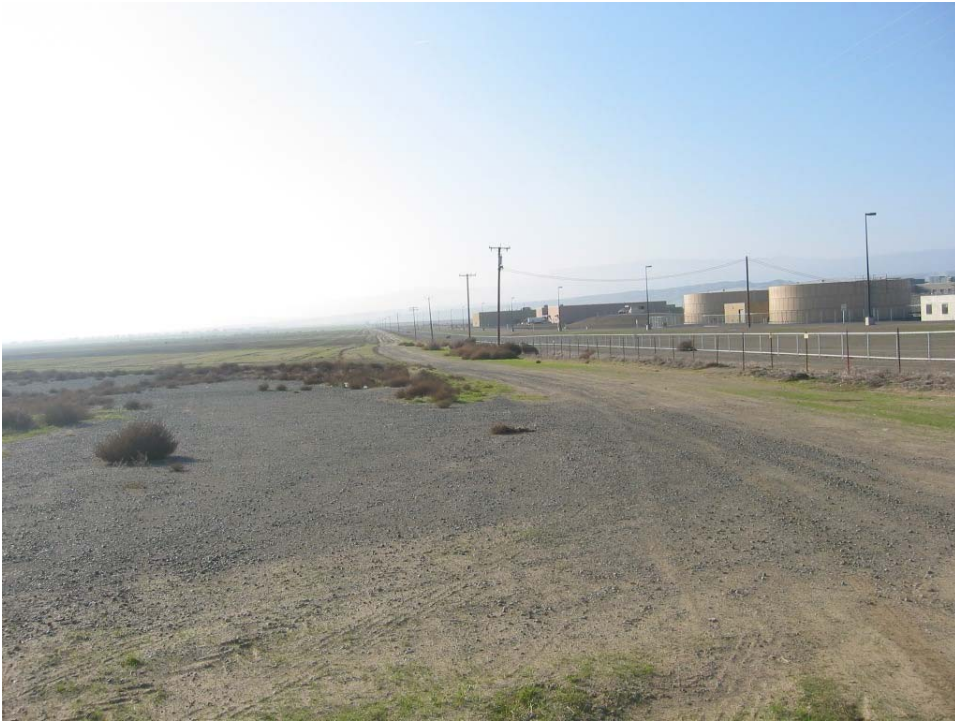
Photograph #1

View of the SJS 1&2 Project Site from northwest corner south along western edge. Coalinga State Hospital and Prison are located adjacent to the SJS Site.

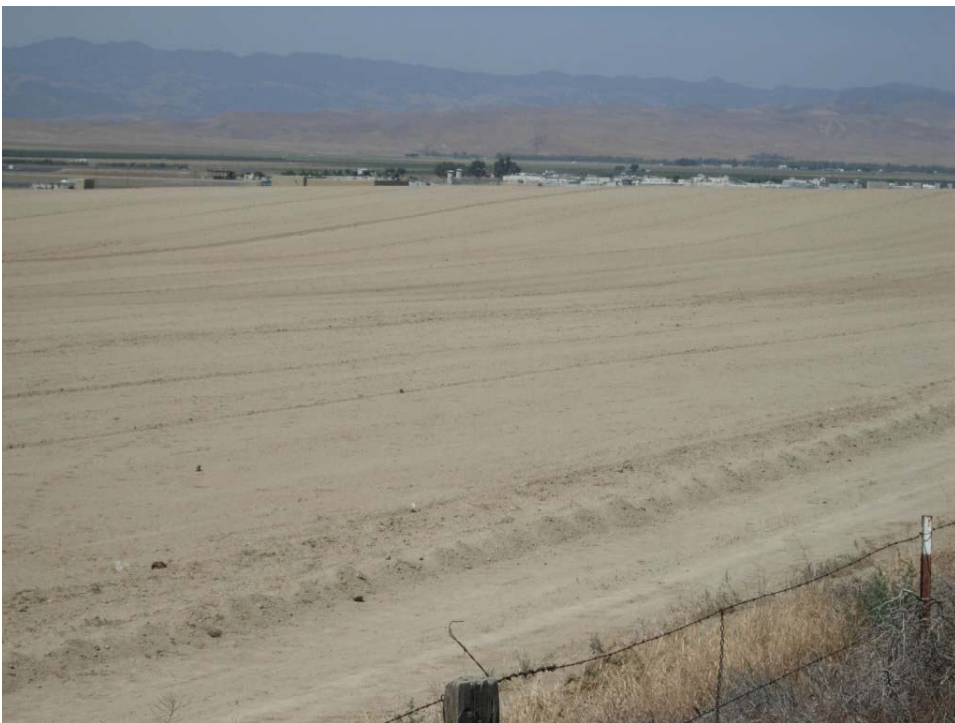
Photograph #2

View of the SJS 1&2 Project site from Jayne Avenue. View is from north to southwest.

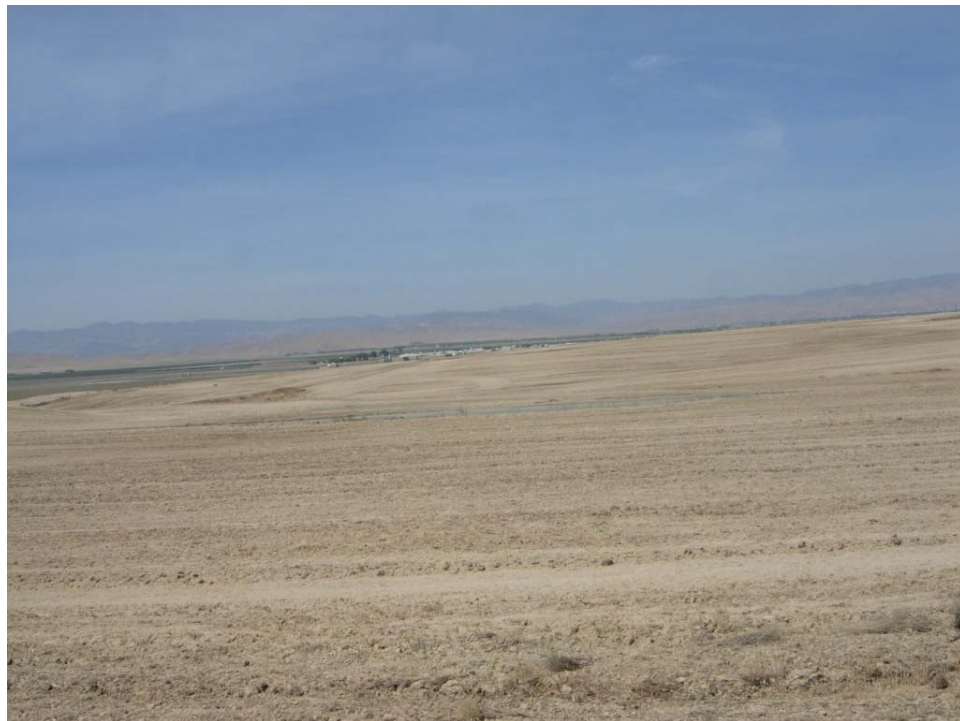
Photograph #3

View of the SJS 1&2 Project site from west end of the site. The west side of the site is entirely cleared of vegetation and prepared for seeding at the time of this photograph (May, 2008). Site does not support suitable habitat for BNLL.

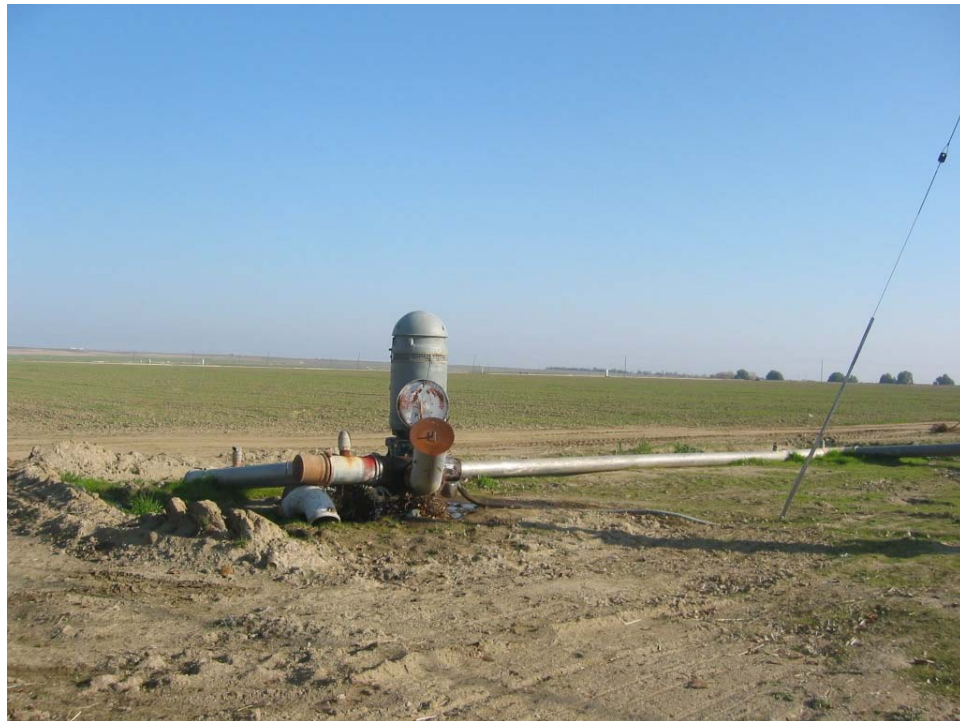
Photograph #4

View of the SJS 1&2 Project site from the southwest corner, looking to the northeast. Note existing crops across the southern portion of the site and water pump in the foreground.

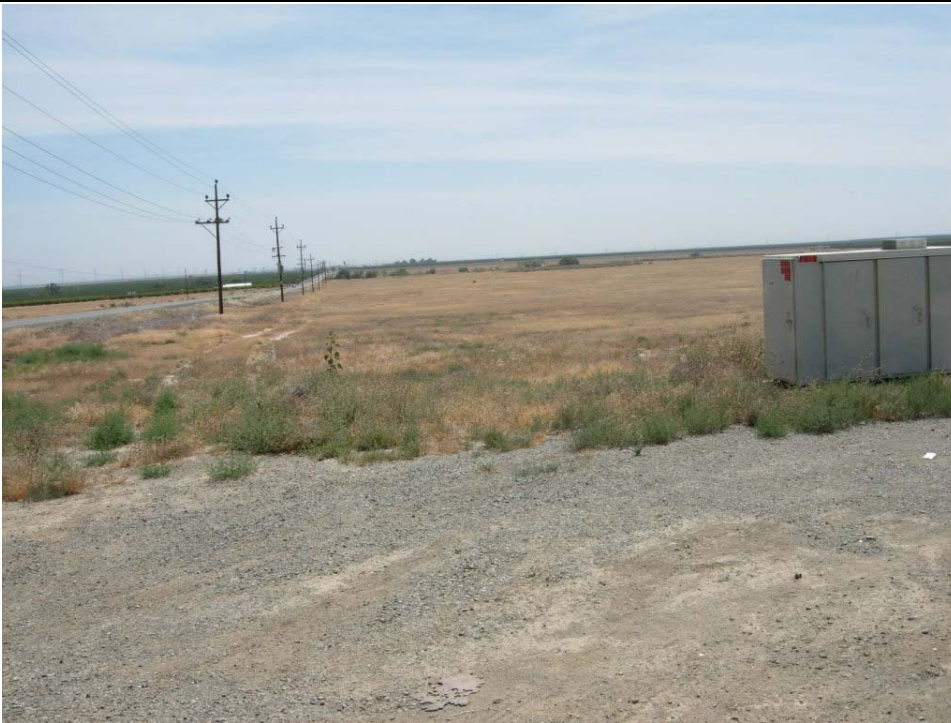
Photograph #5

View of the SJS 1&2 Project site from the northeast corner to the east at the disturbed non-native grassland and saltbush scrub habitat along the transmission line corridor on the south side of Jayne Avenue.

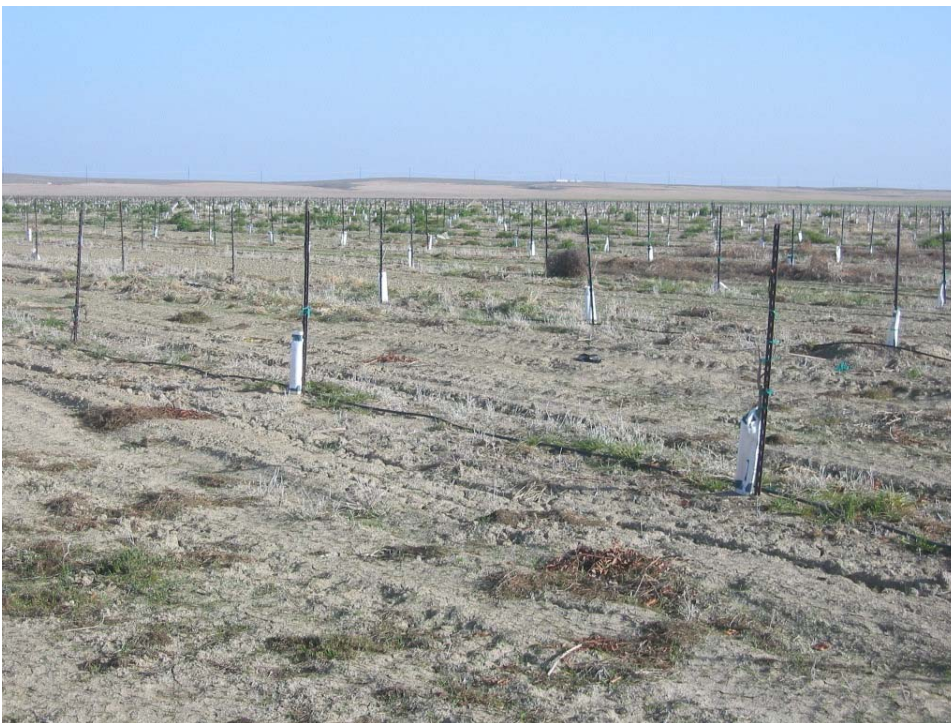
Photograph #6

View of the SJS 1&2 Project site from west toward the east at row crops. Shows lack of suitable habitat for BNLL.

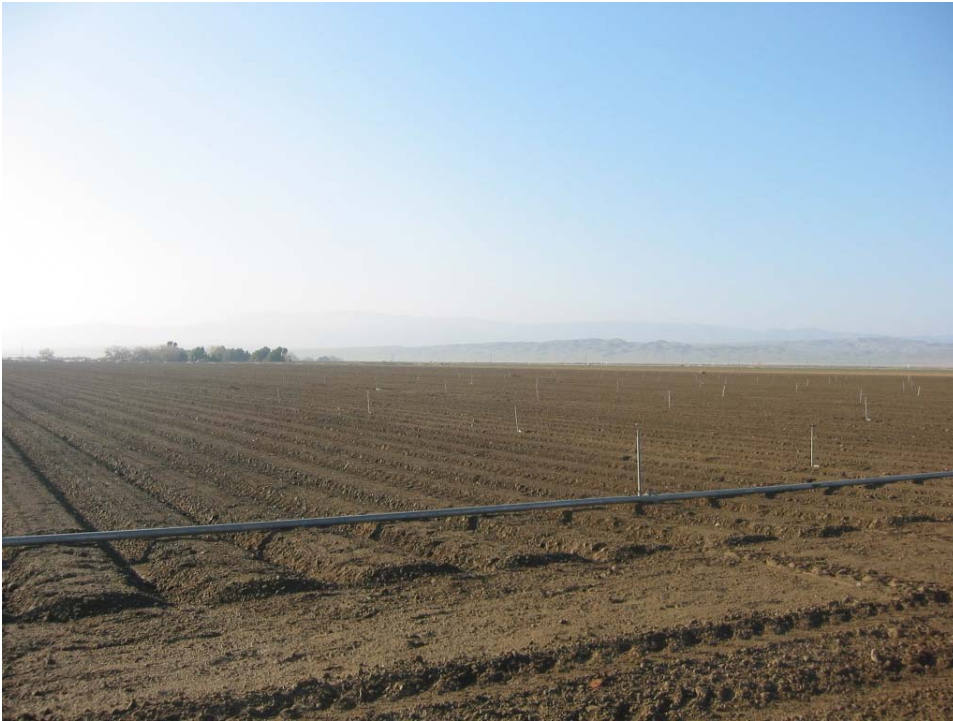
Photograph #7

View of the SJS 1&2 Project site from west toward the east of soils prepared for row crops.

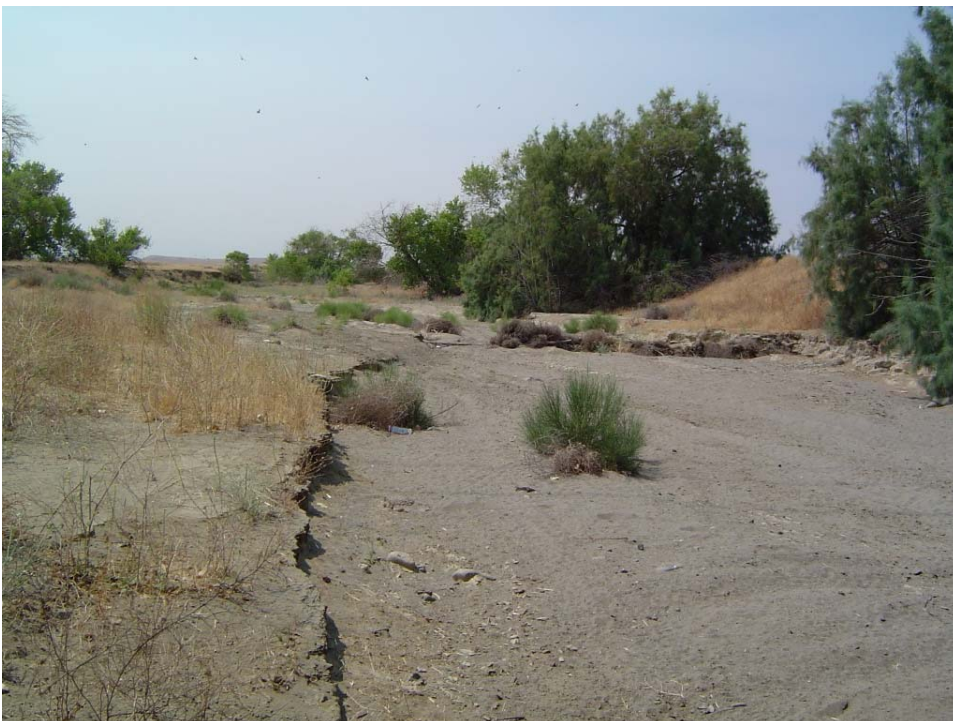
Photograph #8

View of Zapato Chino Creek where it crosses the SJS 1&2 transmission line corridor. This view is to the south of Jayne Avenue. The banks are dominated by tamarisk, with individual cottonwood trees and non-native grasses.
