Re: Response to Comments on the Hydrogen Energy California Wetland Delineation

This letter is provided on behalf of Hydrogen Energy California, LLC (HECA) to respond to your comments transmitted via e-mail on May 9, 2013. Responses to each comment are provided below and in the enclosed attachments.

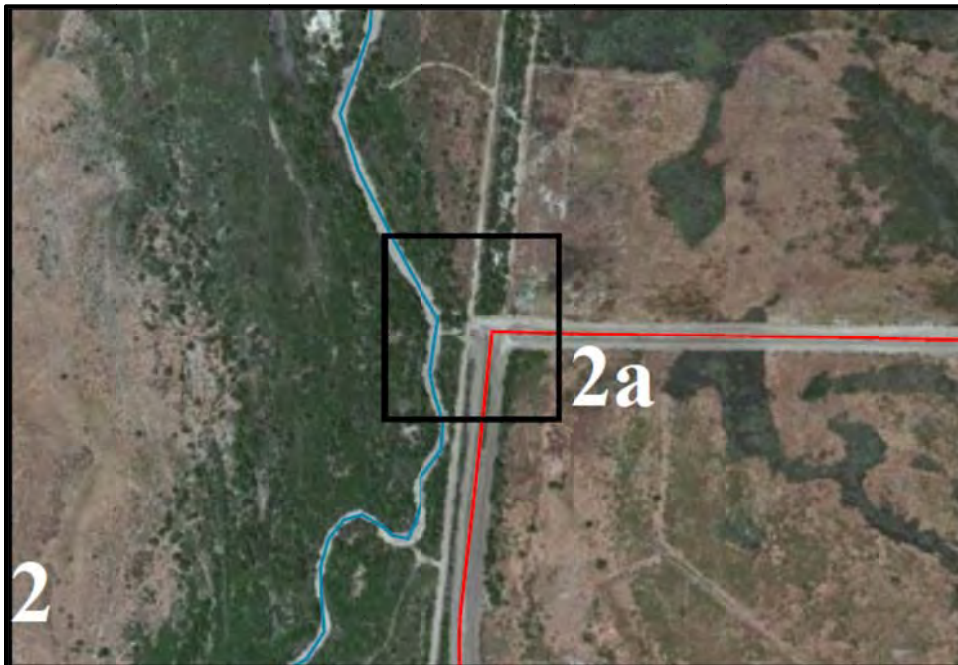
**Photo 1.** The location of the historic connection between the Kern River Flood Control Channel and the West Side Canal.

According to the BVWSD, the potential connection identified by the USACE is an unused culvert with a slide gate structure that was constructed in the 1970s by a third party. At this location, the bed of the KRFCC lies at a higher elevation than the invert of the WSC. The slide gate controls movement of water through a culvert between the KRFCC and an impoundment adjacent to the WSC that is separated from the WSC by an earthen berm (Photos 2&3). Existing BVWSD employees do not recall this connection being utilized to divert water to or from the KRFCC. It should also be noted that the former connection point is the terminus of the WSC. Water flowing northward in the WSC is routed easterly through two culverts into a ditch known as the Cross Canal.

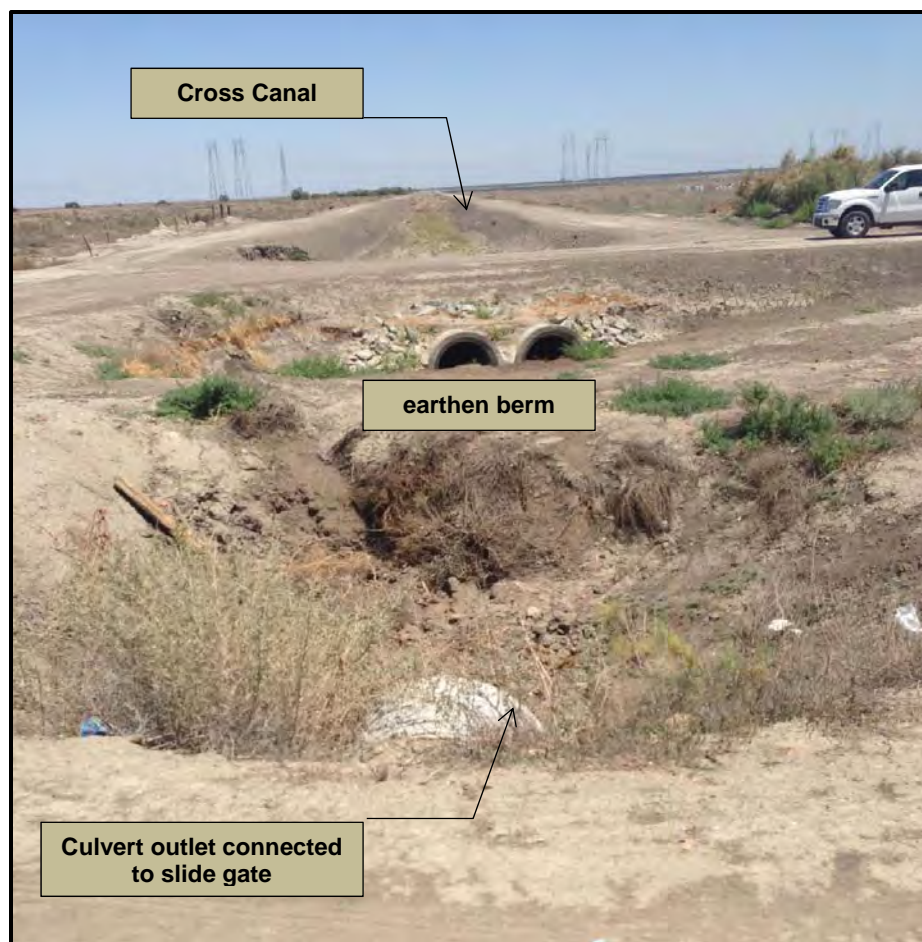
**Photo 2.** Looking east from the Kern River Flood Control Channel slide gate culvert. Note the earthen berm that separates the culvert outlet and the West Side Canal (located on the far-side of the earthen dam). The two culverts in the center of the picture connect the West Side Canal to the Cross Canal.

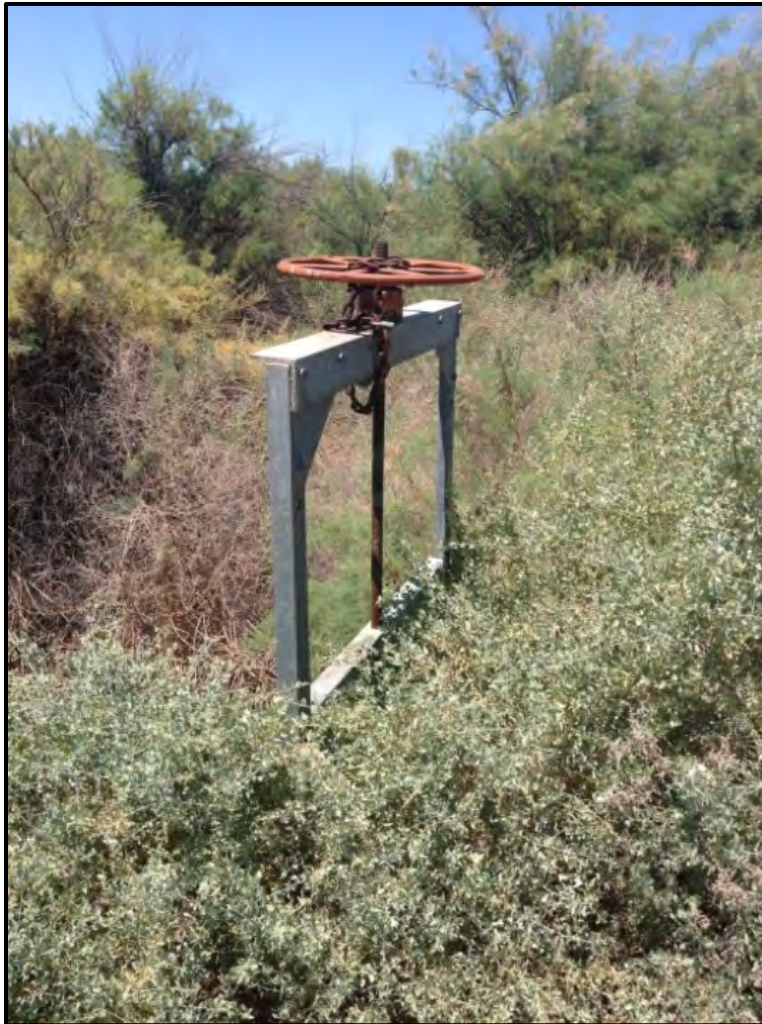
**Photo 3.** Looking north at the slide gate that controls diversion of water from the Kern River Flood Control Channel to the West Side Canal/Cross Canal location shown in Photo 2.

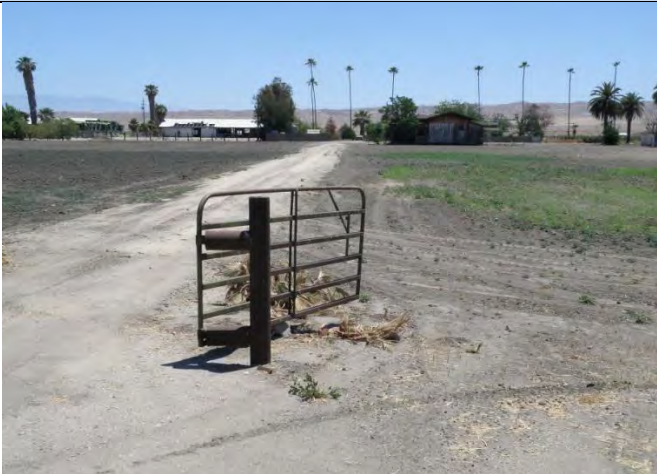
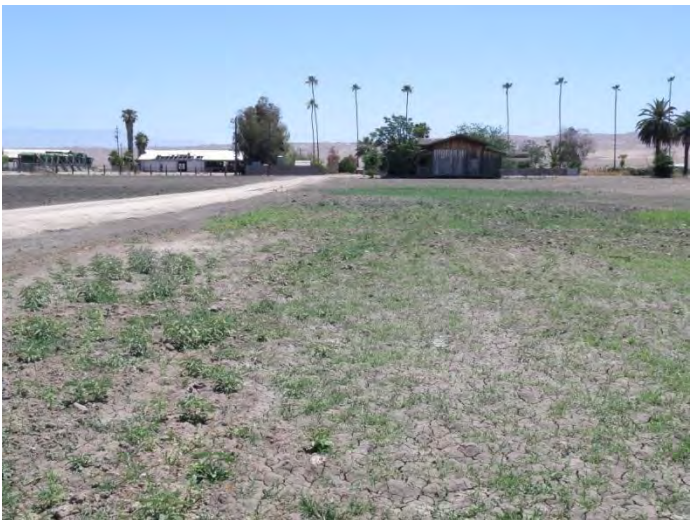
16/25	146	This location is a cultivated field. No wetland indicators were observed during multiple site visits, including the May 30, 2013 field visit.

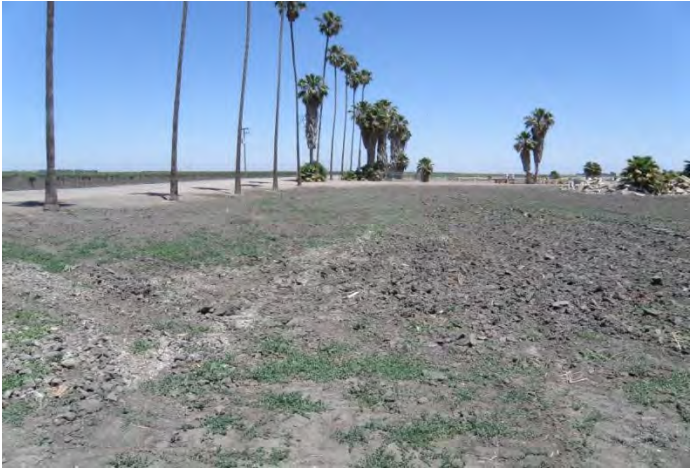
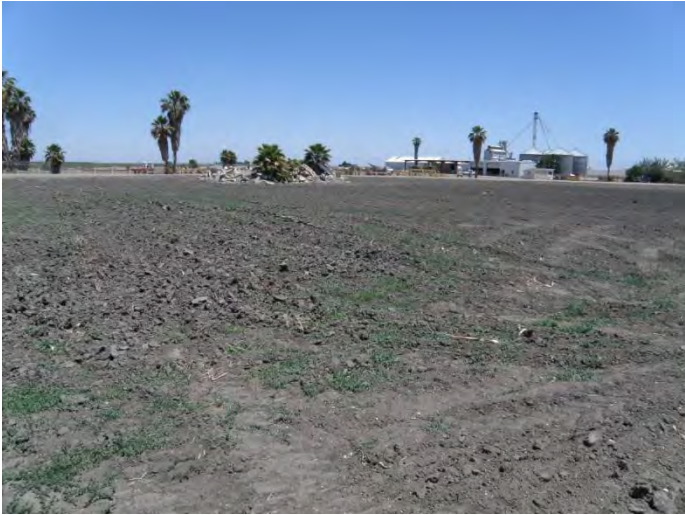
16/25	147	<p>This location is a cultivated field. No wetland indicators were observed during multiple site visits, including the May 30, 2013 field visit.</p>

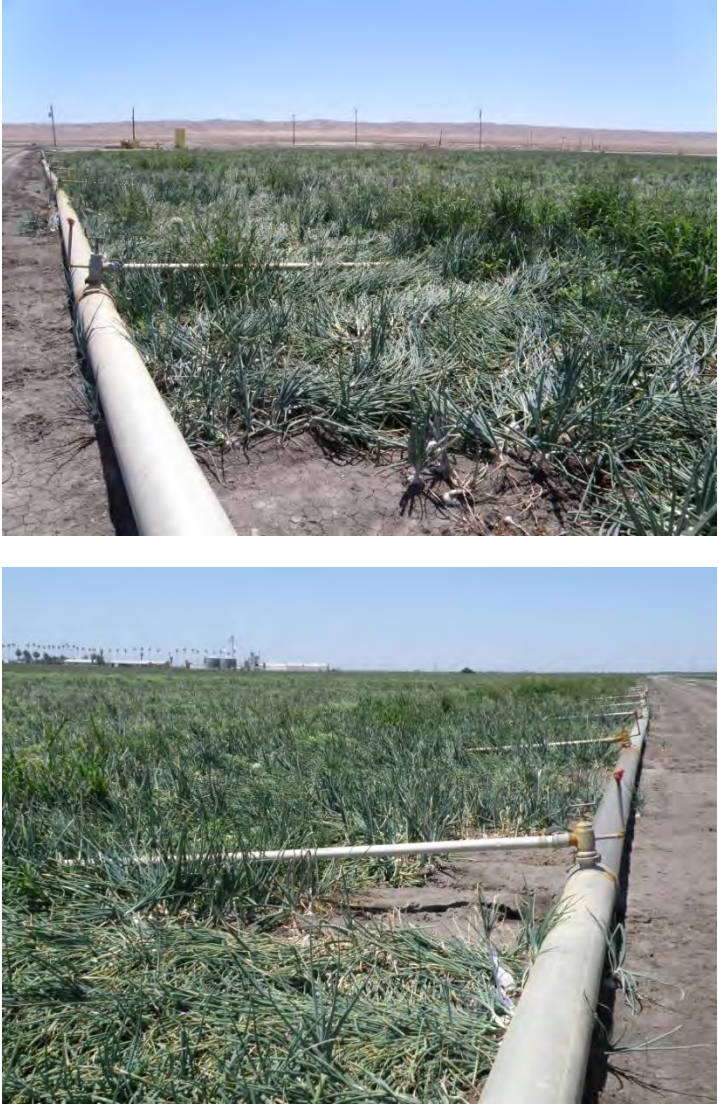
24	149	<p>This area lies within a leveled and cultivated field. No wetland indicators were observed during multiple site visits. The field is currently cultivated for onion production.</p>

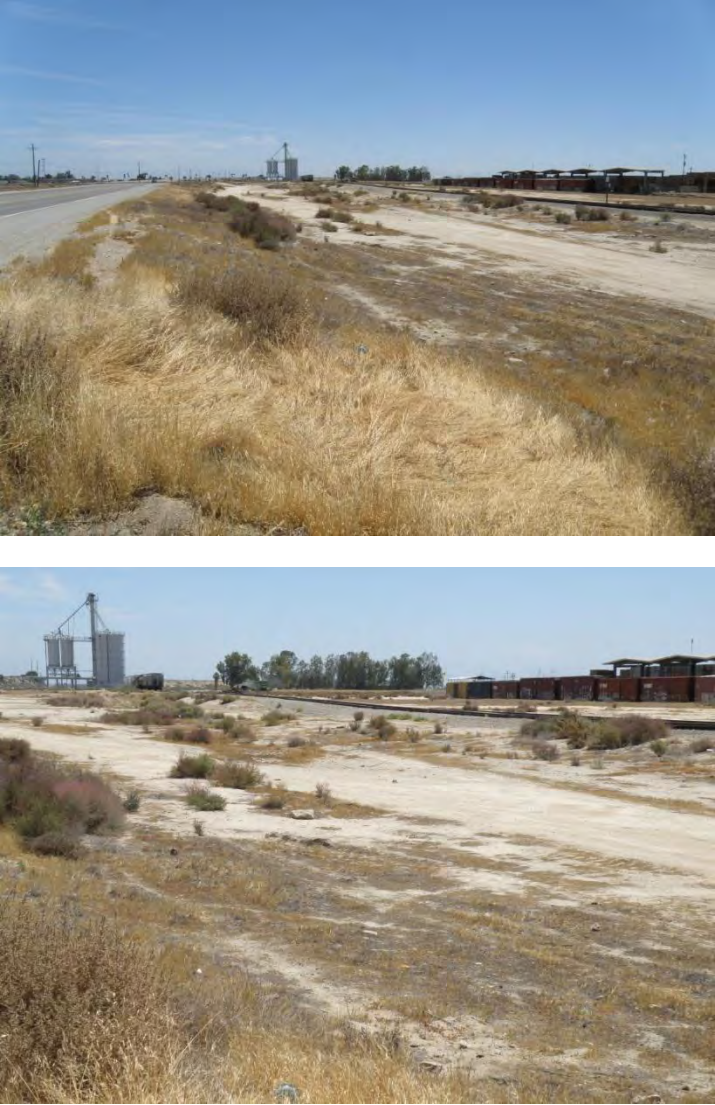
34	108	<p>No evidence of hydrology was observed at the locations identified as #108-110. This entire area south of State Route 58 and north of the railroad embankment was delineated after a significant precipitation event. All areas with ponding, saturation, or surface cracks were delineated. No vegetation was seen in any of the WUS features (one vegetated area was delineated as WL 1). All other vegetation in the areas was upland alkali scrub.</p>

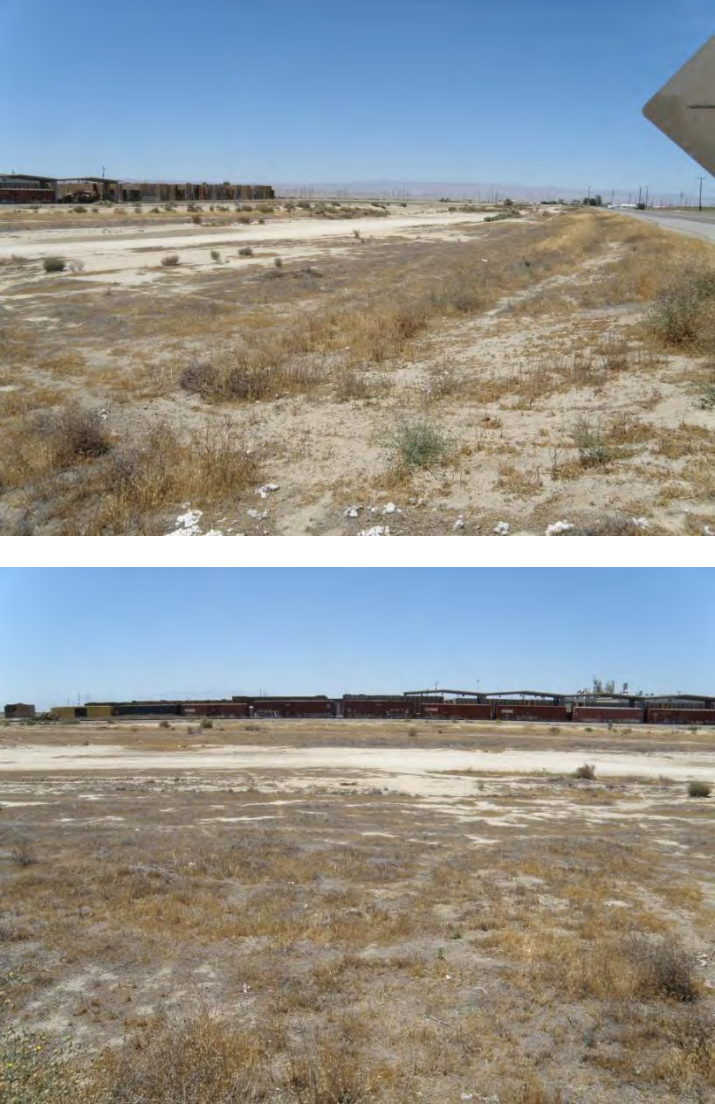
34	109	<p>This entire area south of State Route 58 and north of the railroad embankment was delineated after a significant precipitation event. All areas with ponding, saturation, or surface cracks were delineated. No evidence of hydrology was observed at the locations identified as #108-110</p>

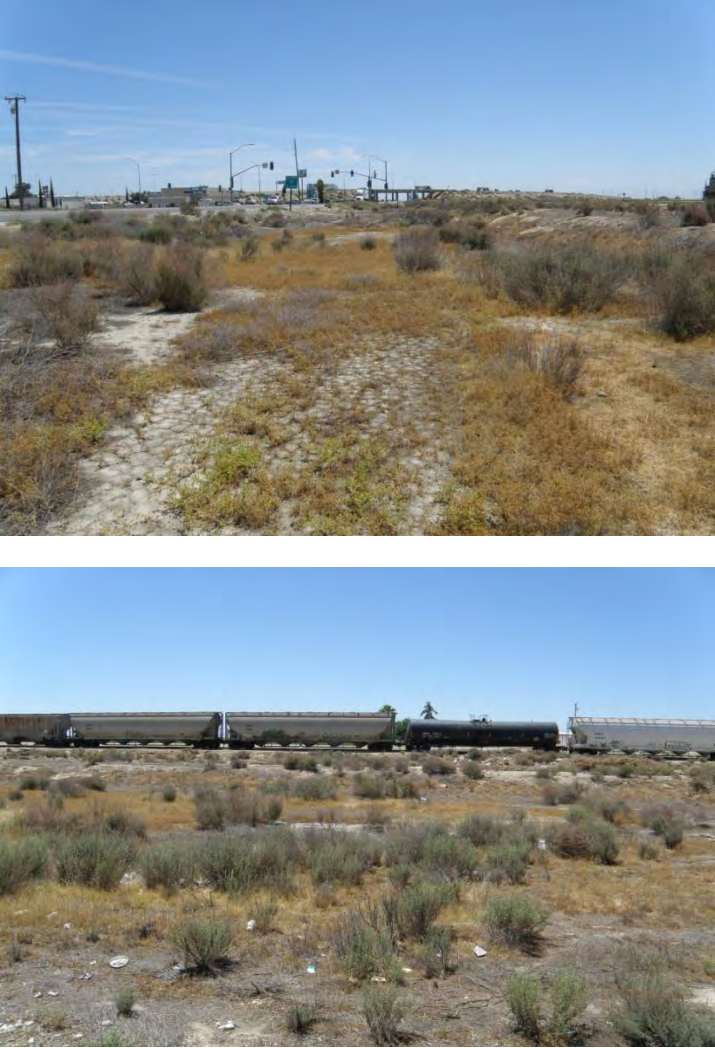
35	117	<p>These locations were surveyed after a significant precipitation event. All areas with ponding, saturation, or surface cracks were delineated. No evidence of hydrology was observed at locations 116 or 117.</p>

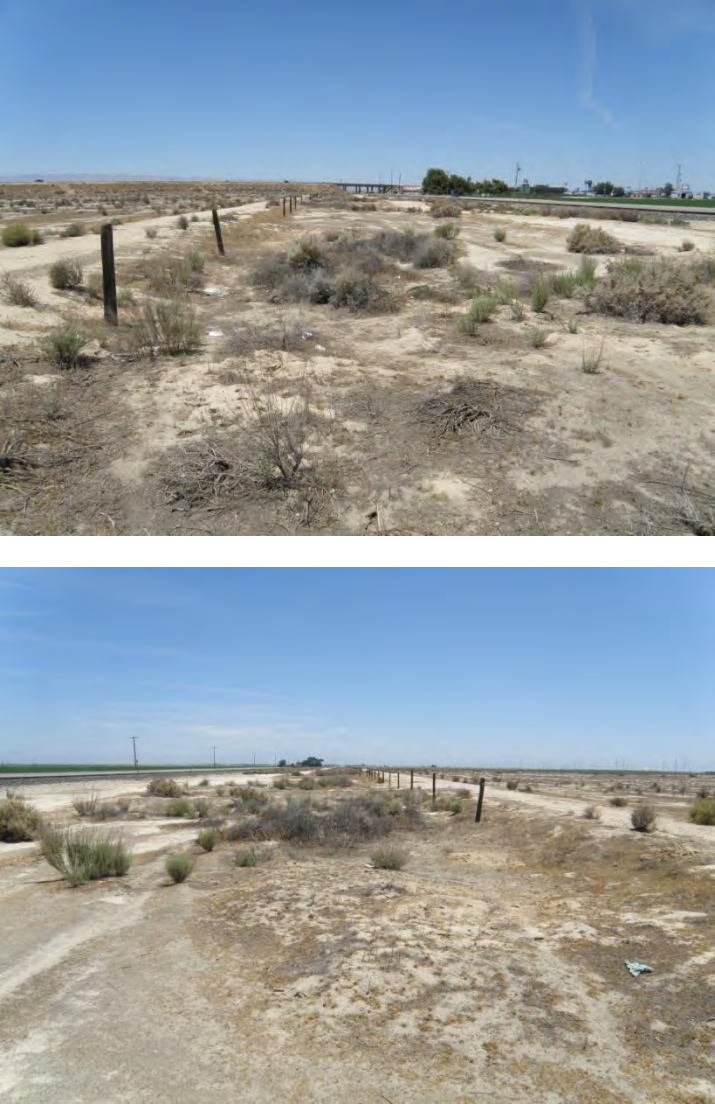
35	129	<p>This location was delineated after a significant precipitation event. All areas with ponding, saturation, or surface cracks were delineated. No evidence of hydrology (e.g. surface cracking) was observed at this location on May 30, 2013.</p>

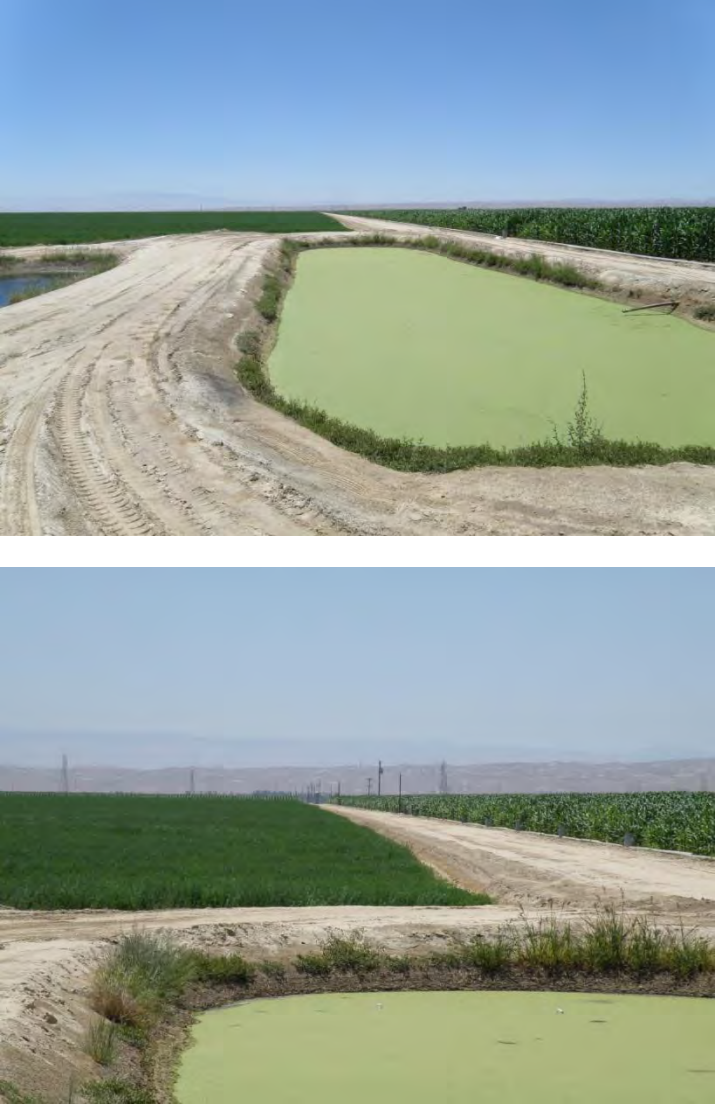
<p>The top photograph shows a dirt road with tire tracks curving around a bright green pond. The background features a flat landscape with green crops under a clear blue sky. The bottom photograph shows a similar scene from a different angle, with the dirt road and green pond in the foreground and a line of green crops in the middle ground. In the far distance, there are low hills and utility poles under a hazy sky.</p>	38	137 and 139	<p>This location is a leveled agricultural field currently used to cultivate alfalfa. This field is located in an area of historic alkali scrub/sink habitat that has subsequently been extirpated – aerial signatures may be based on high soil sodicity. No wetland indicators were observed during multiple site visits.</p>

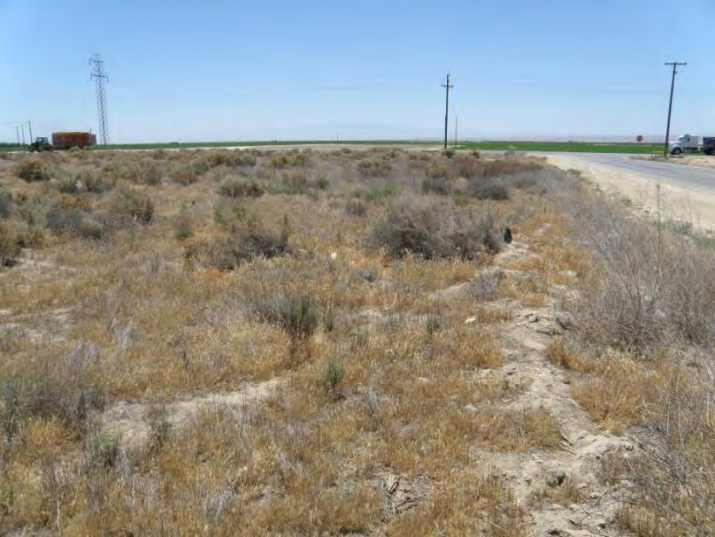
41	86	<p>Parcel with alkali scrub vegetation community, dominated by <i>Atriplex</i> and <i>Bromus</i>. DP 86 lies in a topographically elevated position relative to the rest of the undeveloped parcel.</p>

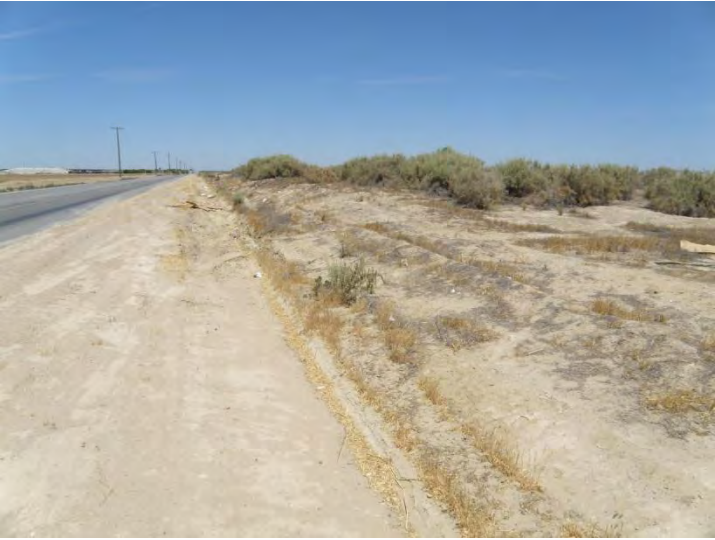
41	90 and 92	<p>This location is a topographic high area within a parcel dominated by alkali scrub vegetation. No evidence of wetland hydrology or wetland vegetation is present at this location because it is well-drained upland habitat.</p> <p>Vegetation observed on May 30, 2013 included <i>Atriplex</i> and <i>Bromus</i>.</p>

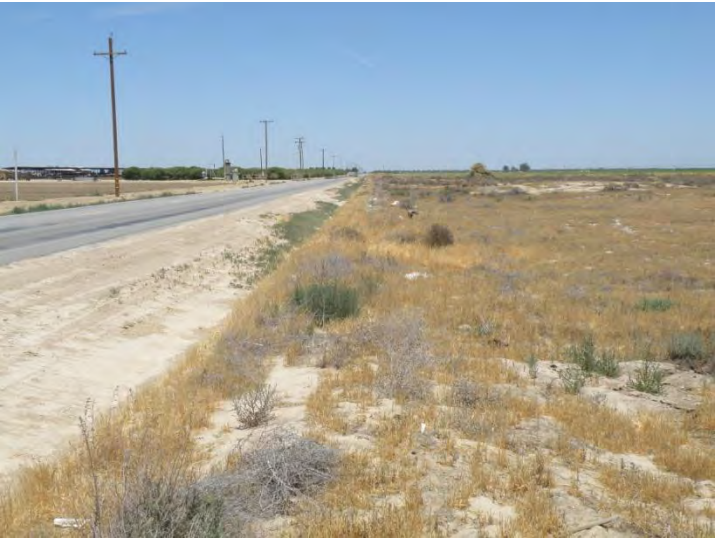
42	95	<p>This feature is not connected to any drainage features and would not be considered a tributary to a traditionally navigable waterway.</p> <p>This location is a topographic depression that may occasionally exhibit surficial ponding or episaturation when local precipitation is substantial. However, standing water or saturated soils were not observed at this location in 2011 and 2012 delineations, or during the May 30, 2013 site visit. The surrounding parcel includes alkali scrub/sink vegetation community as well as hydric vegetation in some alkali depressions. The soils are considered problematic because of the high alkalinity content, and no redoximorphic features were observed.</p>

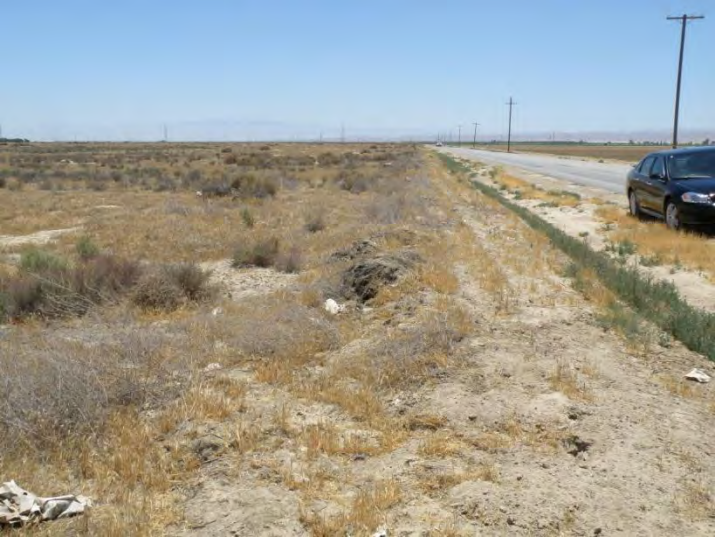
42	163	<p>Parcel with alkali scrub/sink vegetation community. This location is a topographic high area within a parcel dominated by alkali scrub vegetation (<i>Bromus sp.</i> and <i>Atriplex sp.</i> understory). No evidence of wetland hydrology or wetland vegetation is present at this location because it is well-drained upland habitat.</p>

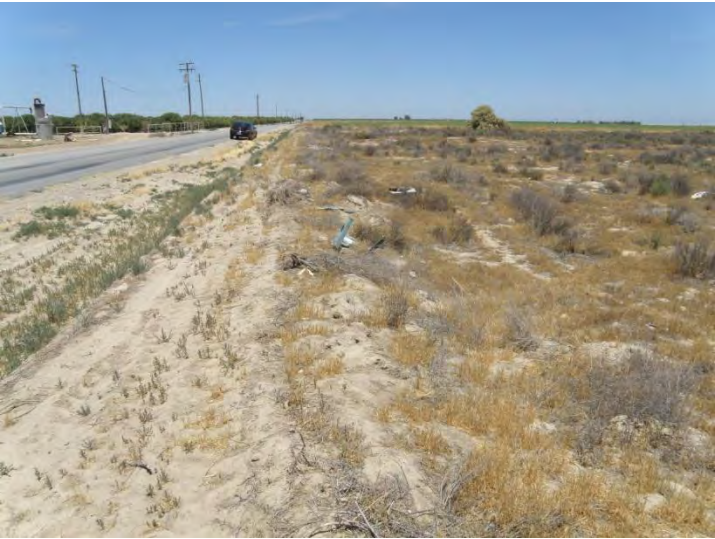
42	165	<p>Parcel with alkali scrub/sink vegetation community. Topographically lower area dominated by <i>Bromus sp.</i>, <i>Atriplex sp.</i>, and <i>Erodium cicutarium</i>. No evidence of wetland hydrology visible during the 2011 and 2012 delineations, or during the 5/30/13 site visit.</p>

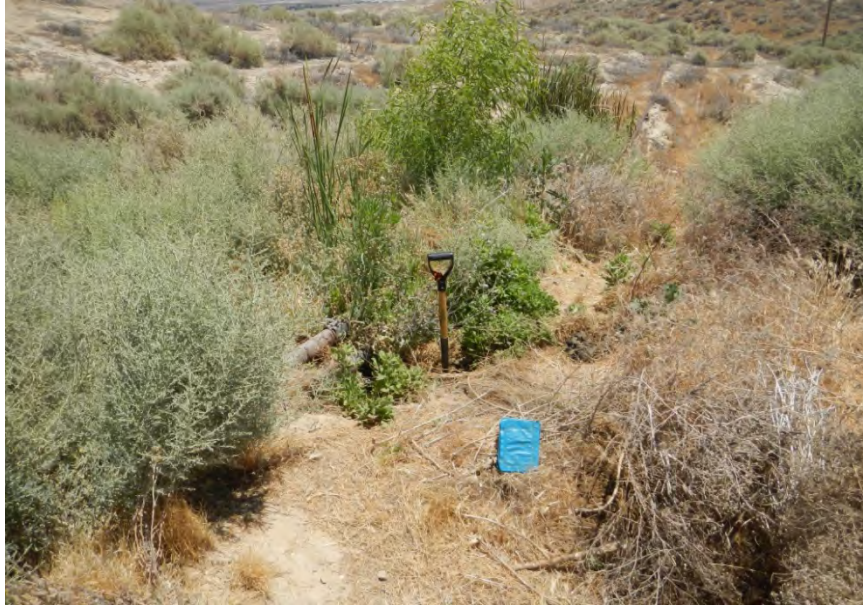
Representative photograph showing the location of **DP 150**, facing east. This feature is an artificial wetland induced by leaky water pipes. Upland and wetland data points (DP150c and DP150d) were taken to document existing conditions and determine the wetland boundary; the Munsell fieldbook marks the upland position and the shovel marks the location of the wetland test pit.

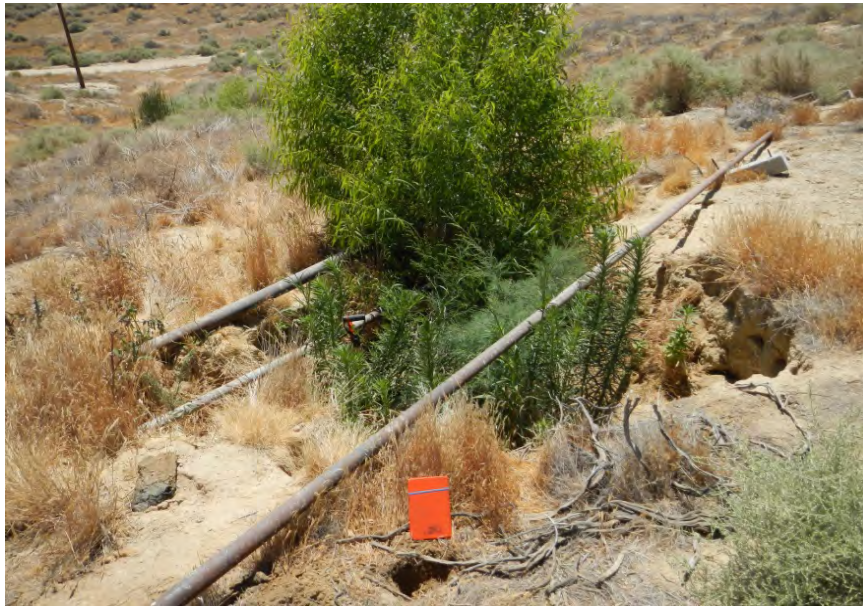
Representative photograph showing the location of **DP 150**, facing southeast. This feature is an artificial wetland induced by leaky water pipes. Upland and wetland data points (DP150a and DP150b) were taken to document existing conditions and determine the wetland boundary; the orange fieldbook marks the upland position and the shovel (left-center of photograph) marks the location of the wetland test pit.

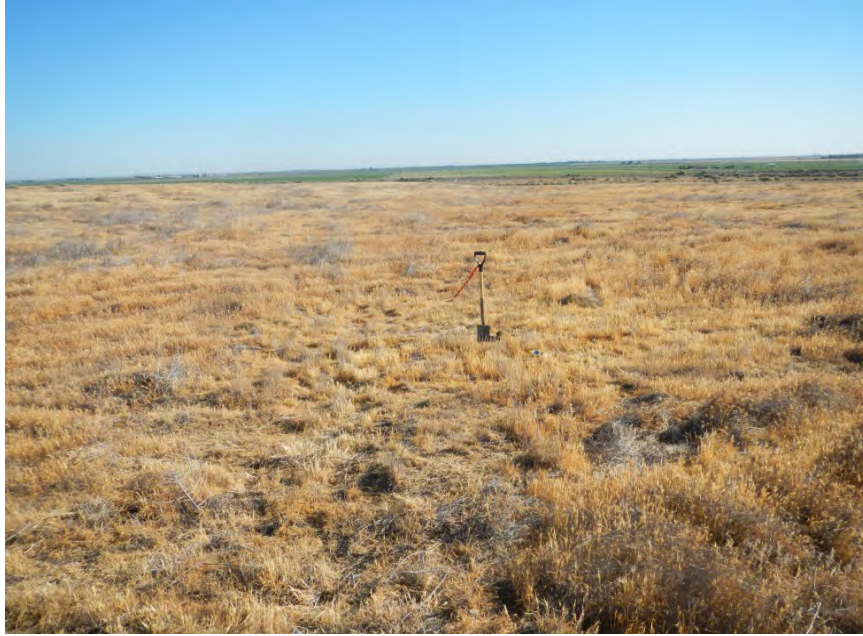
Representative photograph showing location of **DP 151**, facing northeast. Shovel marks the location of descriptive DP151. Feature is a shallow basin that has a prevalence of hydrophytic vegetation (i.e., dominance exhibited by *Hordeum marinum* – FAC) and presence of hydrologic indicators (i.e., sediment deposits and saturation visible on aerial imagery), but lacks hydric soil indicators.

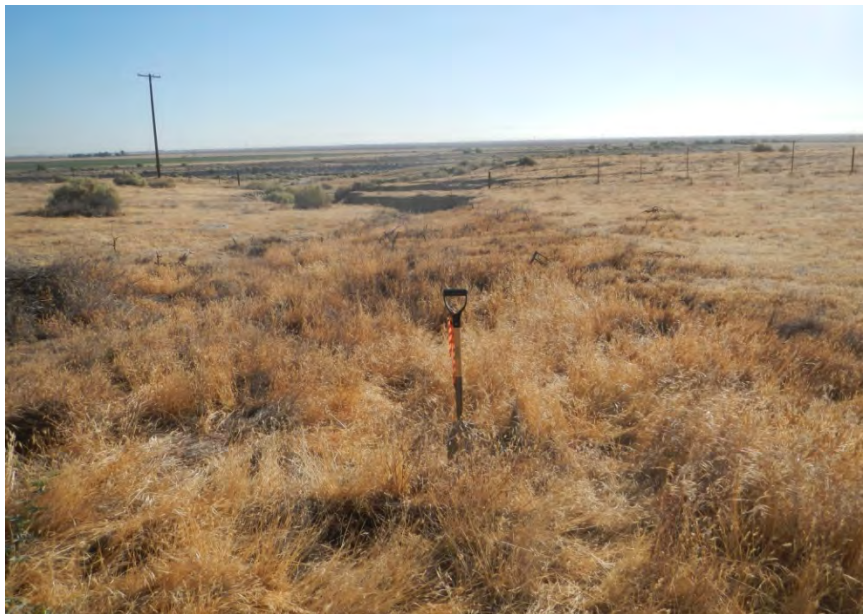
Representative photograph showing location of **DP 152**, facing east. Sample area consists of low-gradient swale transitioning to a gully with numerous deeply incised nickpoints.

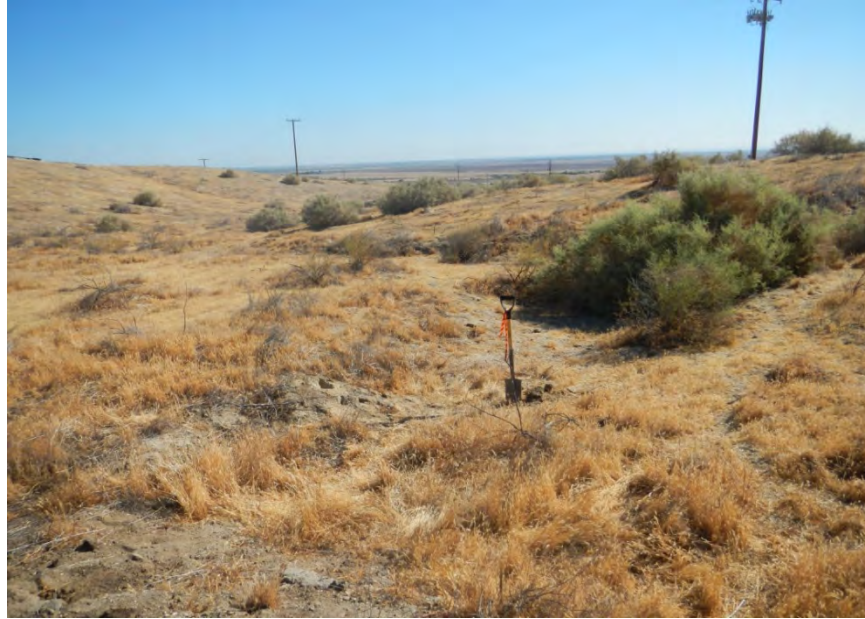
Representative photograph showing the location of **DP 153**, facing northeast and downslope. This low-gradient swale lacks hydrophytic vegetation, and hydric soil indicators. Only a single secondary hydrologic indicator (i.e., drainage pattern) was evident at this location.

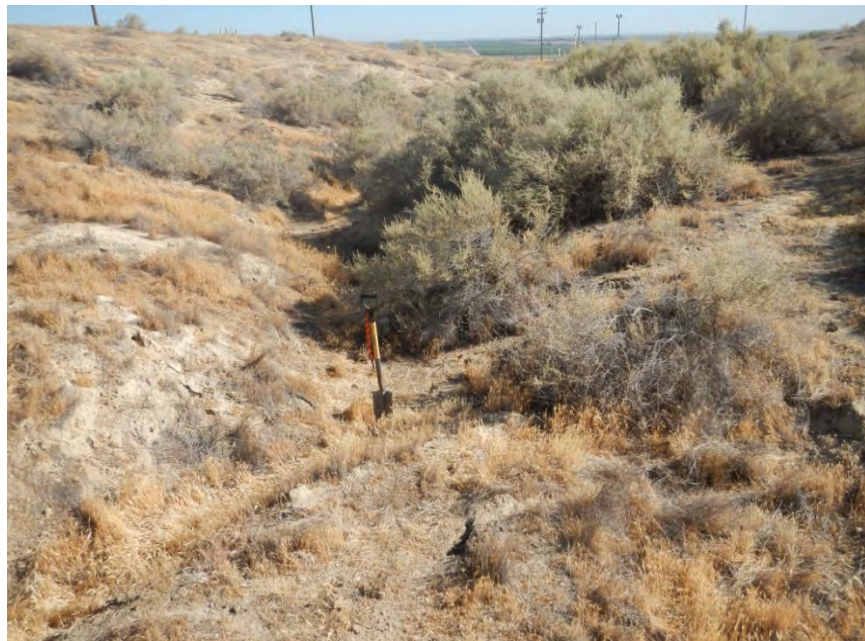
Representative photograph showing the location of **DP 154**, facing northeast/downslope. This mapped feature is a low-gradient ephemeral drainage that has a defined bed and bank, but is hydrologically truncated downslope by historic cut and fill grading activities associated with oil production infrastructure.

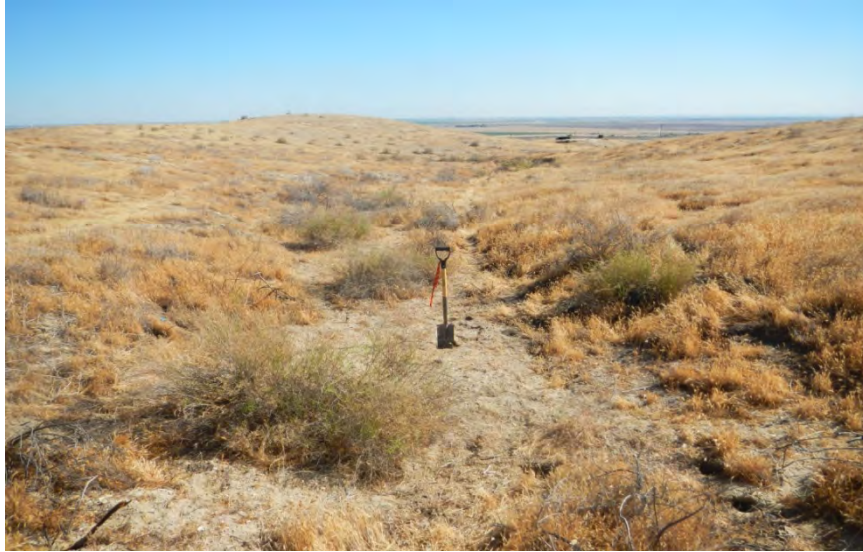
Representative photograph showing the location of **DP 155**, facing northeast and downslope. This low-gradient ephemeral drainage exhibits a bed and bank, intermittent scour, and change in average sediment textures.

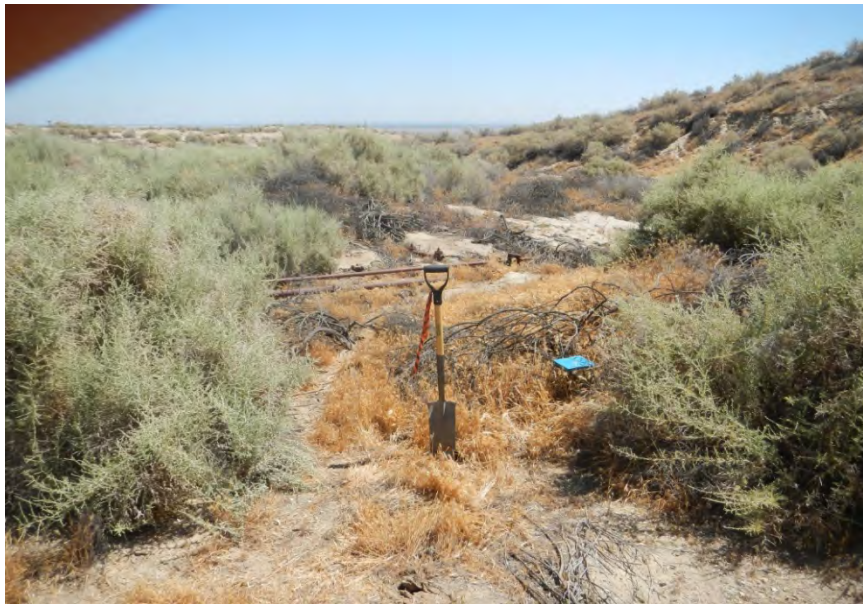
Representative photograph showing the location of **DP 156**, facing northeast. This low-gradient swale lacks hydrophytic vegetation or hydric soil indicators. Only a single secondary hydrologic indicator (i.e., drainage pattern) was evident at this feature.

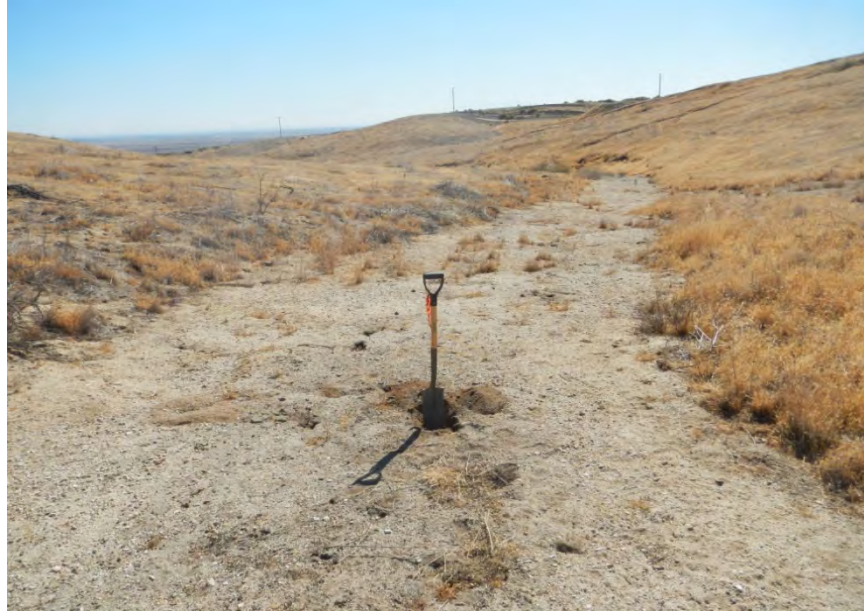
Representative photograph showing the location of **DP 157**, facing northeast and downslope. This low-gradient swale lacks hydrophytic vegetation or hydric soil indicators. Only a single secondary hydrologic indicator (i.e., drainage pattern) was evident at this location.
