Covered conductor system solution to minimize risk of fire ignition

Market Ready Covered Conductor Research and Development Project

Final Report *for*

Document Reference	GR7272-ER-05-P
Date	28th September 2017
Revision	1.1

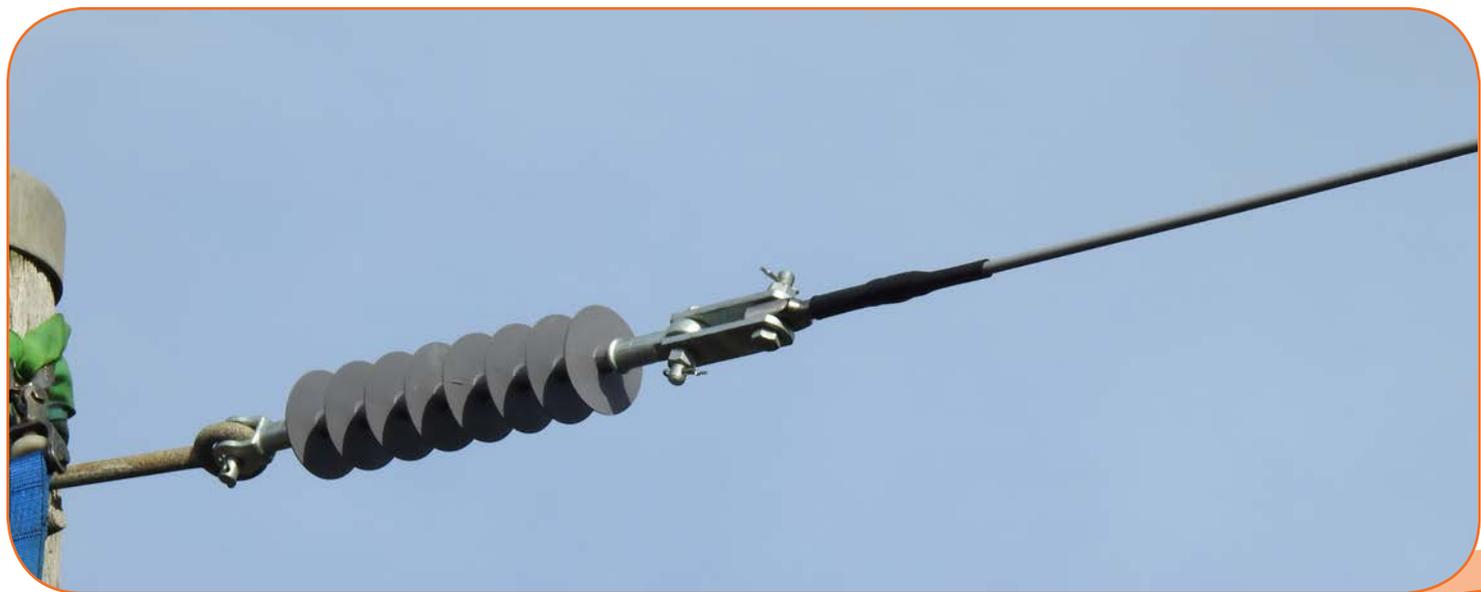
Figure 6: Installed ACS covered conductor on SWER asset

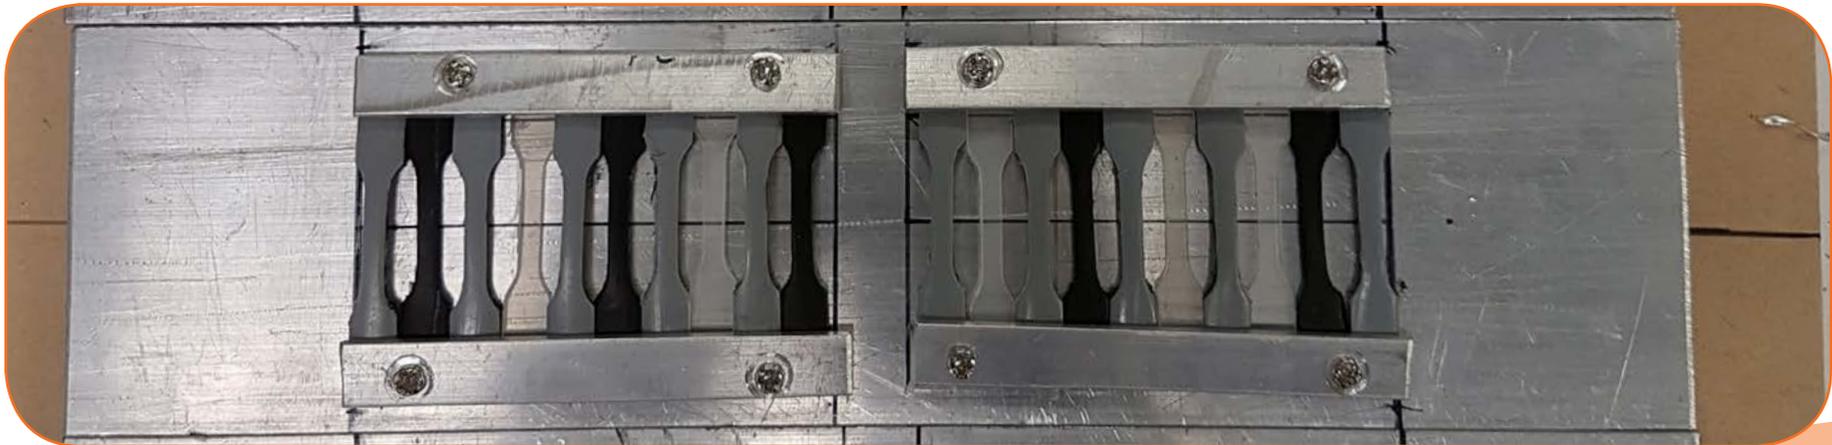
Figure 17: UV Testing Specimen Plate

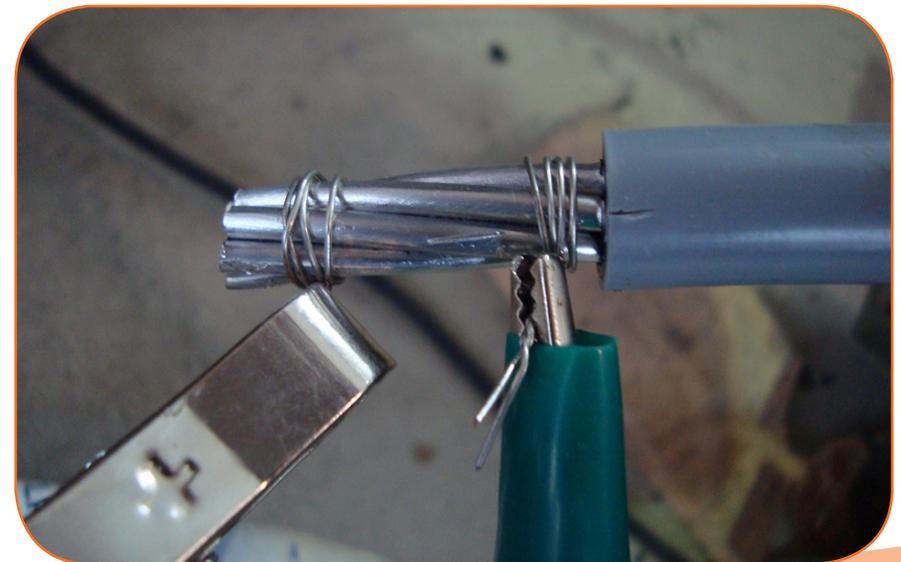
Figure 18: Interstrand Conductivity Test Setup

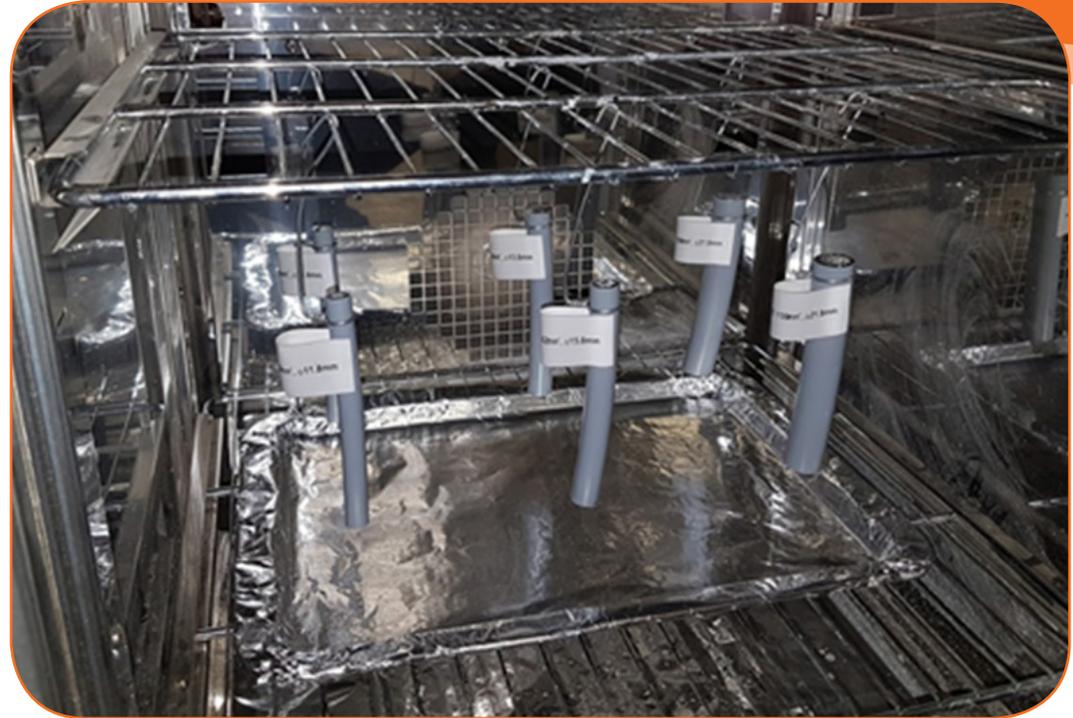
Figure 22: Dripping Test Setup

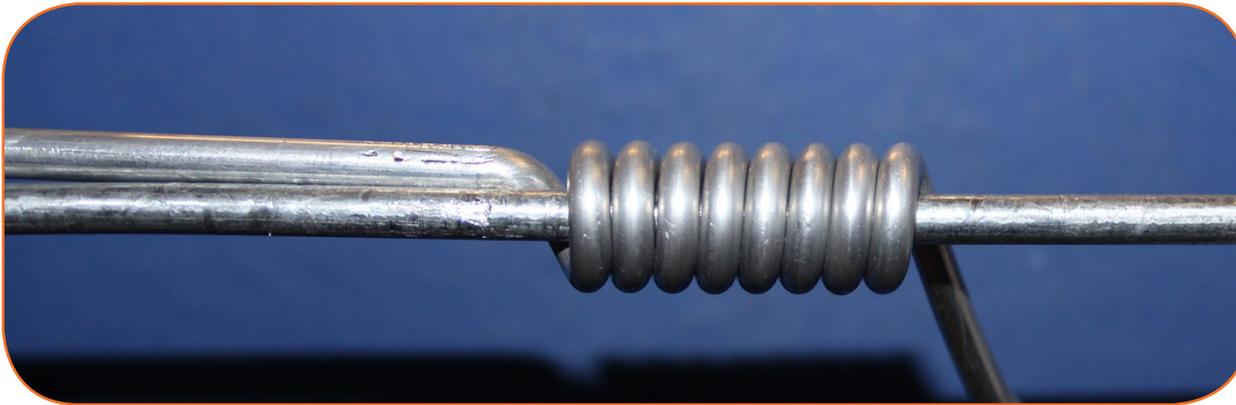
Each test specimen was wrapped around a wire of its own diameter to form a close helix of eight turns. Following this, the strands are inspected for any surface fractures. Strands also may not break during testing.

Figure 24: Strand Wrapping Test Example

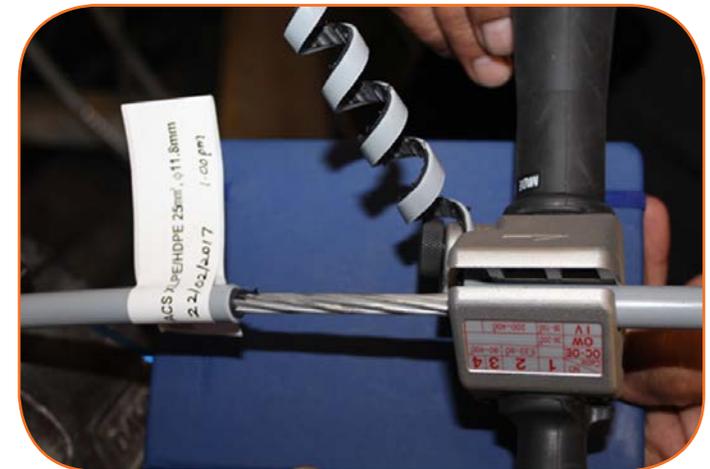
As per the requirements of AS/NZS 3675-2002 Appendix F, at the completion of the removal of the covering, the surface of the exposed conductor was examined and noted for any water blocking material remaining within or on the wires of the conductor.

Figure 25: Stripping Test Example

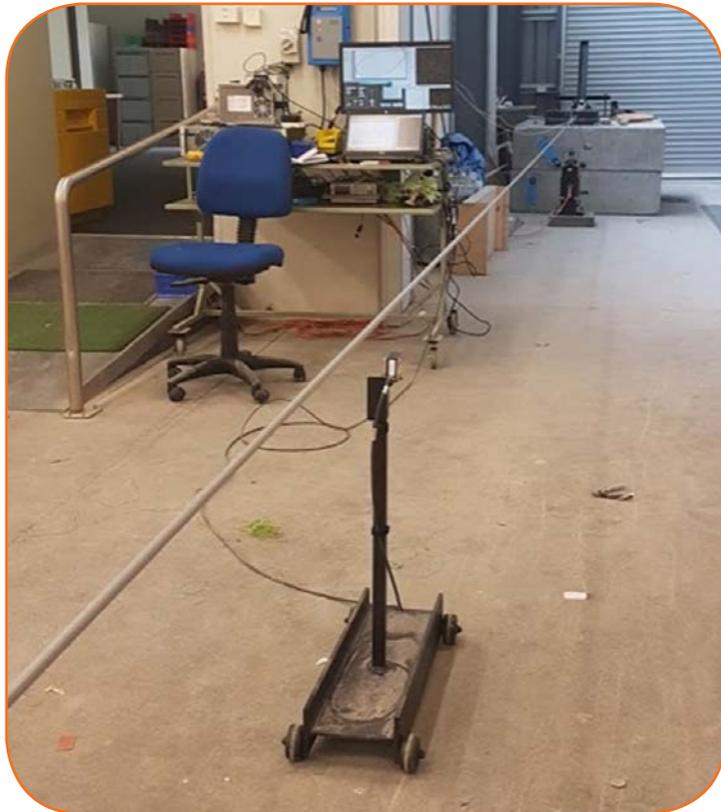
A schematic diagram of the test bed is shown below, as well as the actual test setup, in the following figures. The supports, fixtures and instruments are chosen to meet the requirements of the standards.

Figure 27: Test Span for Conductor Self-damping Testing

Figure 26: Test span for conductor self-damping measurement

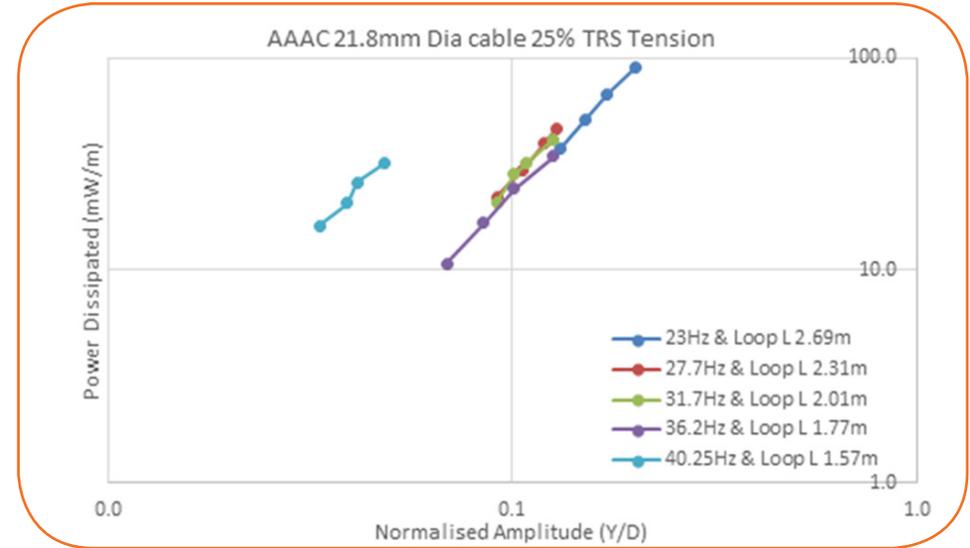
Following capture of all required data, an analysis is undertaken to determine the self-dampening characteristics of the conductors under test. From this analysis the following results were obtained:

Figure 28: 7/2.12 ACS Vibration Testing Result at 15% UTS Tension

Figure 29: 7/2.12 ACS Vibration Testing Result at 20% UTS Tension

Figure 30: 7/2.12 ACS Vibration Testing Result at 25% UTS Tension

Figure 31: 19/3.37 AAC Vibration Testing Result at 15% UTS Tension

Figure 32: 19/3.37 AAAC Vibration Testing Result at 20% UTS Tension

Figure 33: 19/3.37 AAAC Vibration Testing Result at 25% UTS Tension

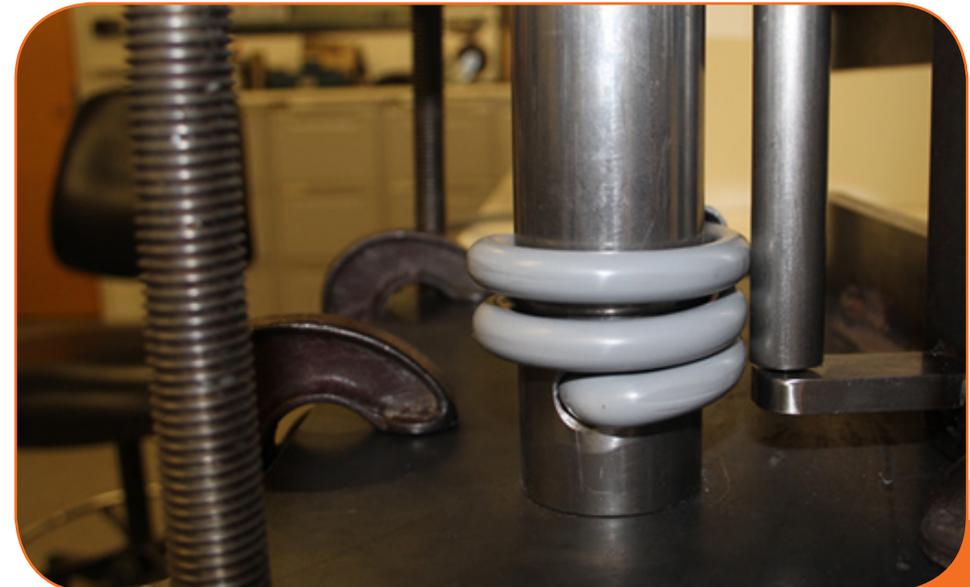
Following the requirements of AS/NZS 3675-2002 Section 2.3 the sample of 7/2.12 ACS covered conductor was bent around a mandrel of approximately 55mm diameter (4.7x conductor diameter), after the conductor and apparatus were cooled in a Refrigerator (at approx. 4°C) for a period of 16 hours. Following this, the sample was inspected for cracks in the covering material.

Figure 34: Bending Test at Low Temperature Example

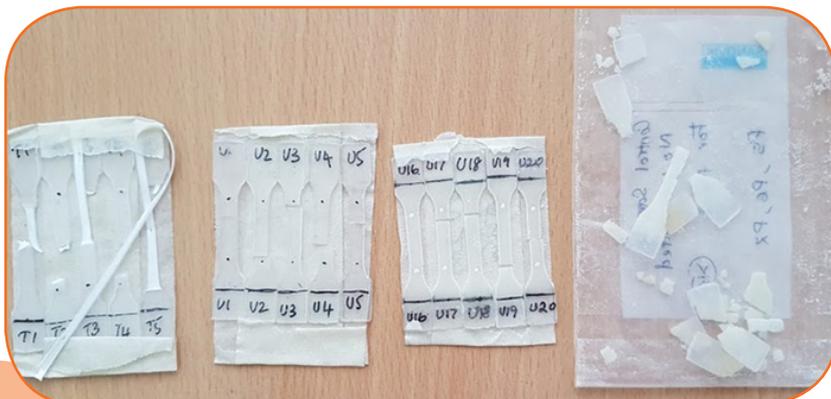
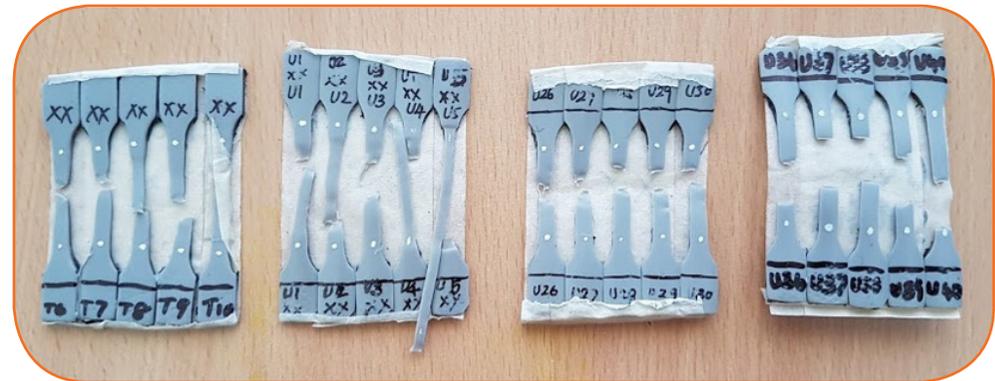
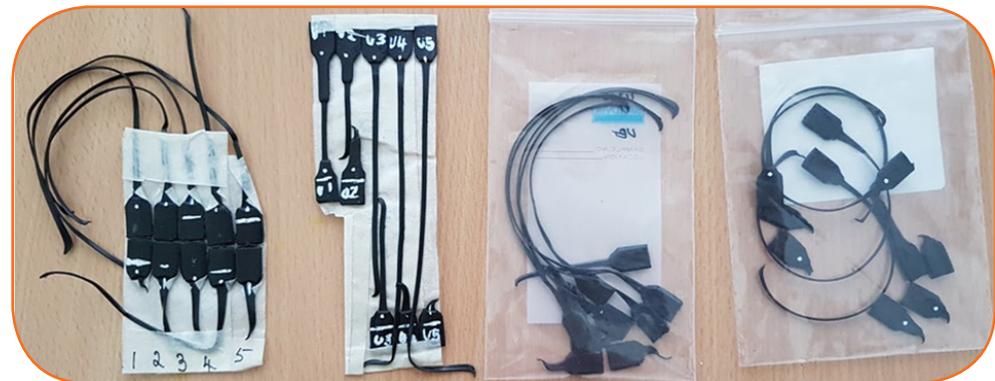
The UV testing was conducted as described in the ASTM G154 – Cycle 4. Accelerated test of UV-A radiation for 2000 hours (84 days) using UVA-340 lamps with 1.55W/m²/nm irradiance based on a cycle of 8 hours UV exposure at 70C black panel temp and 4 hours condensation at 50C black panel temperature. This was agreed through consultation with the project group and an external materials testing expert considering the time limitations on completing this testing.

Figure 43: Non-UV treated ABS Material* - Photo order: Intact sample, 100hrs UV, 200hrs UV & 500hr

Figure 40: HDPE/XLPE Covered Conductor sample- Photo order: Intact sample, 336hrs aging test, 100hrs UV, 200hrs UV & 500hrs UV

Figure 41: XLPE/XLPE Covered Conductor sample- Photo order: Intact sample, 100hrs UV, 200hrs UV & 500hrs UV

Figure 42: United Energy Cable sample- Photo order: Intact sample, 100hrs UV, 200hrs UV & 500hrs UV

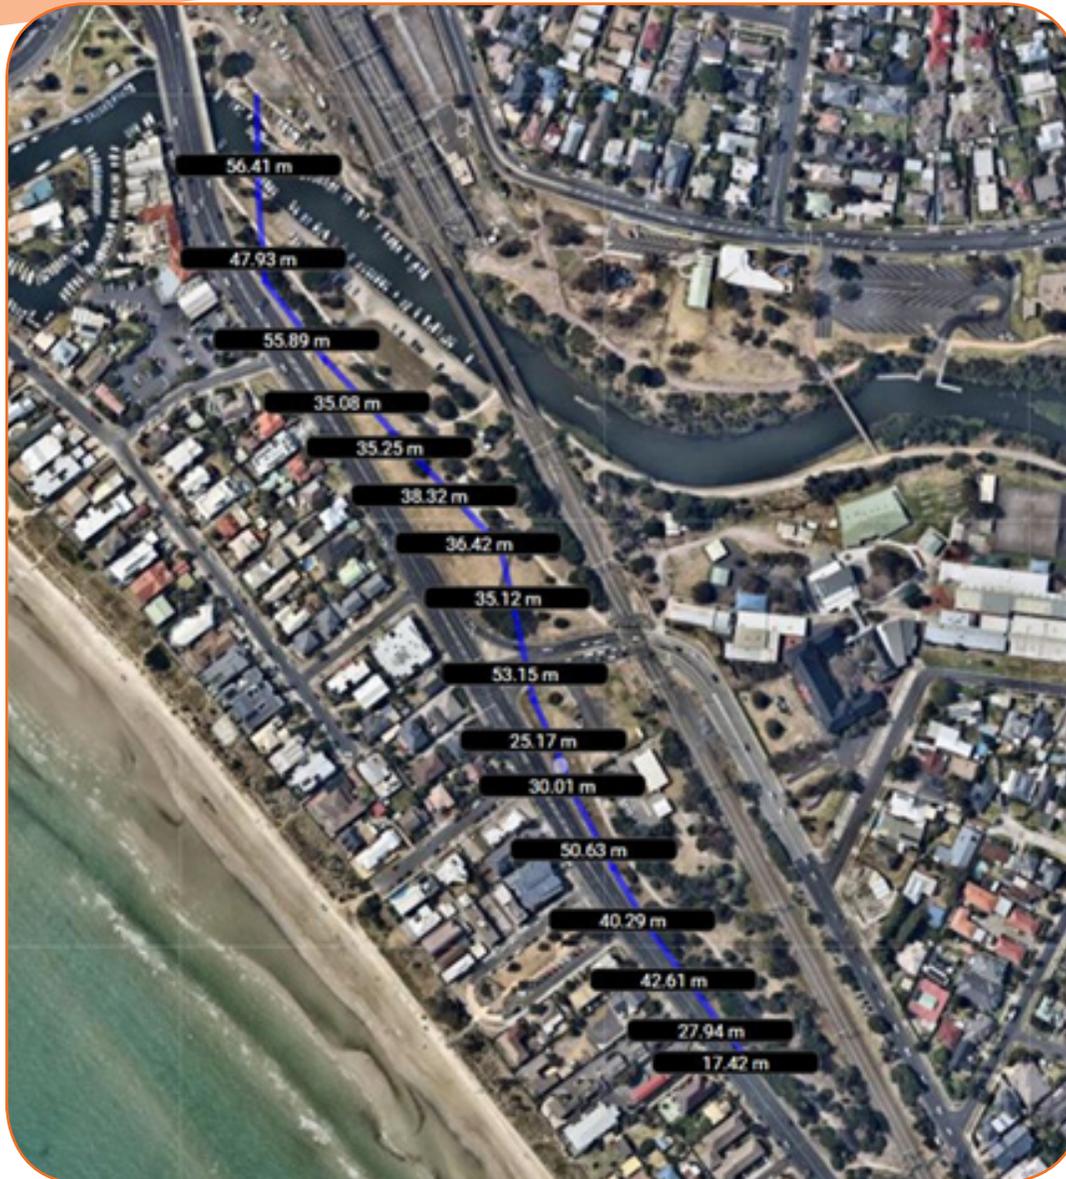
Figure 55: Mordialloc Trial Section Route

Mordialloc – this section is a bay-side location (feeder MC01) also susceptible to salt spray and has been chosen to allow for evaluation of the safety impacts of covered conductor in an exposed urban environment using a fully proven, in service covered conductor system. This is also an area with a high fault frequency and high fault current, and will allow for evaluation of the covered conductor system under electrical stress conditions.
