## **Facility Closure Plan**

# **Rice Solar Energy Project**

(09-AFC-10C)

Revision 1.0

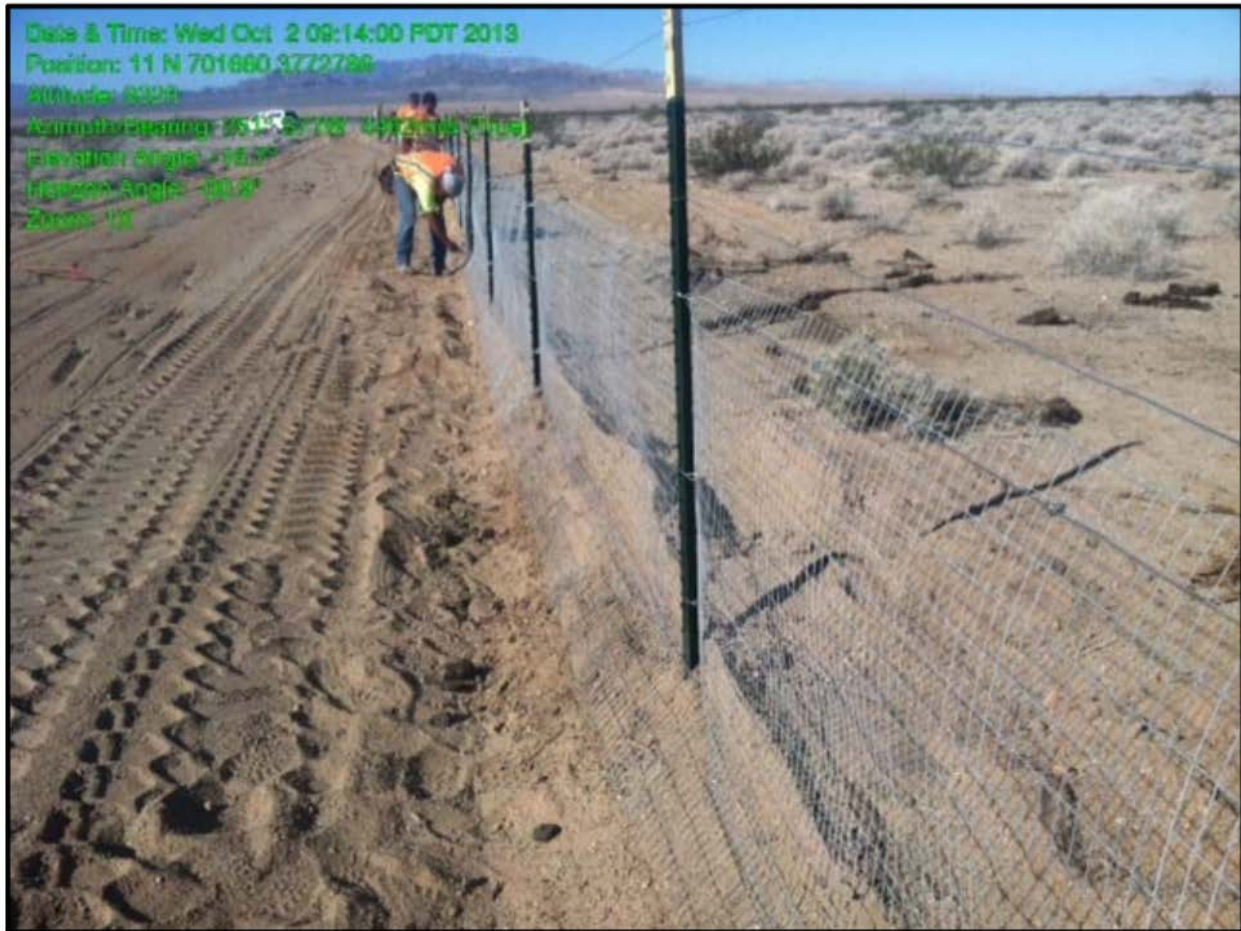
*Figure 2 - Desert Tortoise Fence with Backfill*

Construction of the desert tortoise fence commenced on September 3, 2013. This work required the use of a grader to clear an 18-foot wide alignment and cut a v-ditch one-foot below existing grade along the proposed desert tortoise fence centerline. Following excavation of the v-ditch, the Contractor began installation of t-posts at 10-foot offsets; these posts were installed 18 inches below the bottom of the

v-ditch. As the posts were installed, the Contractor (Crown Fence) began securing the desert tortoise fence fabric to the posts with metal hog rings. Finally, the v-ditches were backfilled and compacted to match existing elevations and provide the requisite 12-inch embedment depth below finished grade. The 18-foot wide alignment adjacent to the desert tortoise fence effectively served as an access road to construct the fence and move construction equipment and personnel through the site. This road remains as the only visible evidence of construction.

Plans for the construction of this fence are provided as **Appendix A**. Additionally, the fence can be seen after backfill in **Figure 2** below.

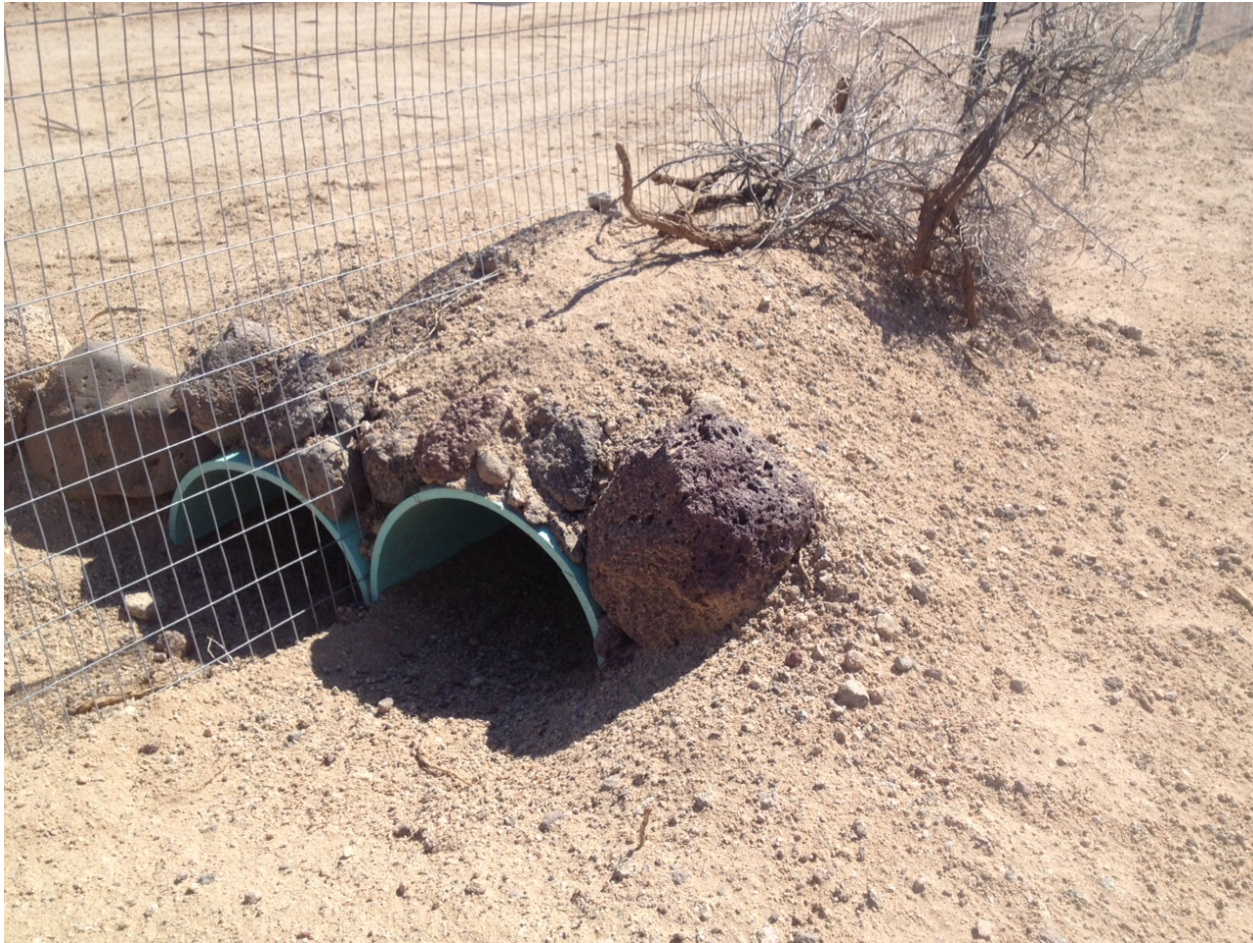
*Figure 3 - Desert Tortoise Shade Structure*

Though not required by the RSEP permit conditions, the Project Owner agreed with a recommendation by the Designated Biologist to install temporary desert tortoise shelter sites along the project perimeter fence line. These structures consisted of 36" lengths of 12" PVC pipe sections cut longitudinally, which were installed at strategic locations (i.e. angle, trap or confusion points) and 280-meter intervals on both sides of the fence. See **Figure 3** below for an image of these desert tortoise shelter sites.

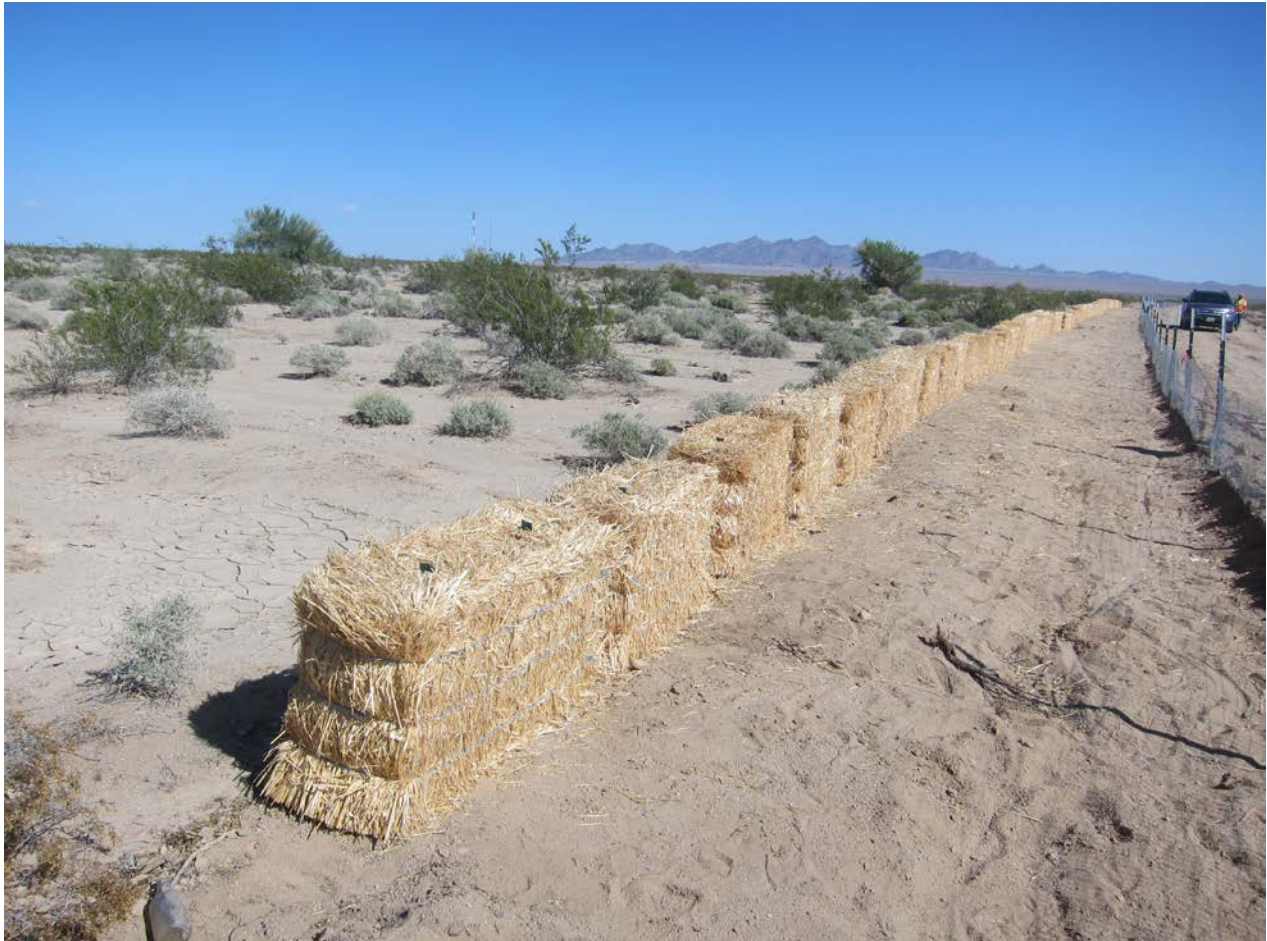
*Figure 4 - Stormwater BMPs installed along NE portion of fence*

In addition to the work described above, it was determined that erosion control measures known as Best Management Practices (BMPs) were required across the eastern wash which intersects the perimeter fenceline on the northeastern side of the site. A total of 75 straw bales (288 linear feet) were placed side by side, with a small gap between them in order to convey stormwater flows but reduce water velocity and collect transported debris before it comes into contact with the fence. The bales were placed 8 feet upstream of the fence and anchored into the ground with steel rebar. These BMPs are depicted in **Figure 4**.

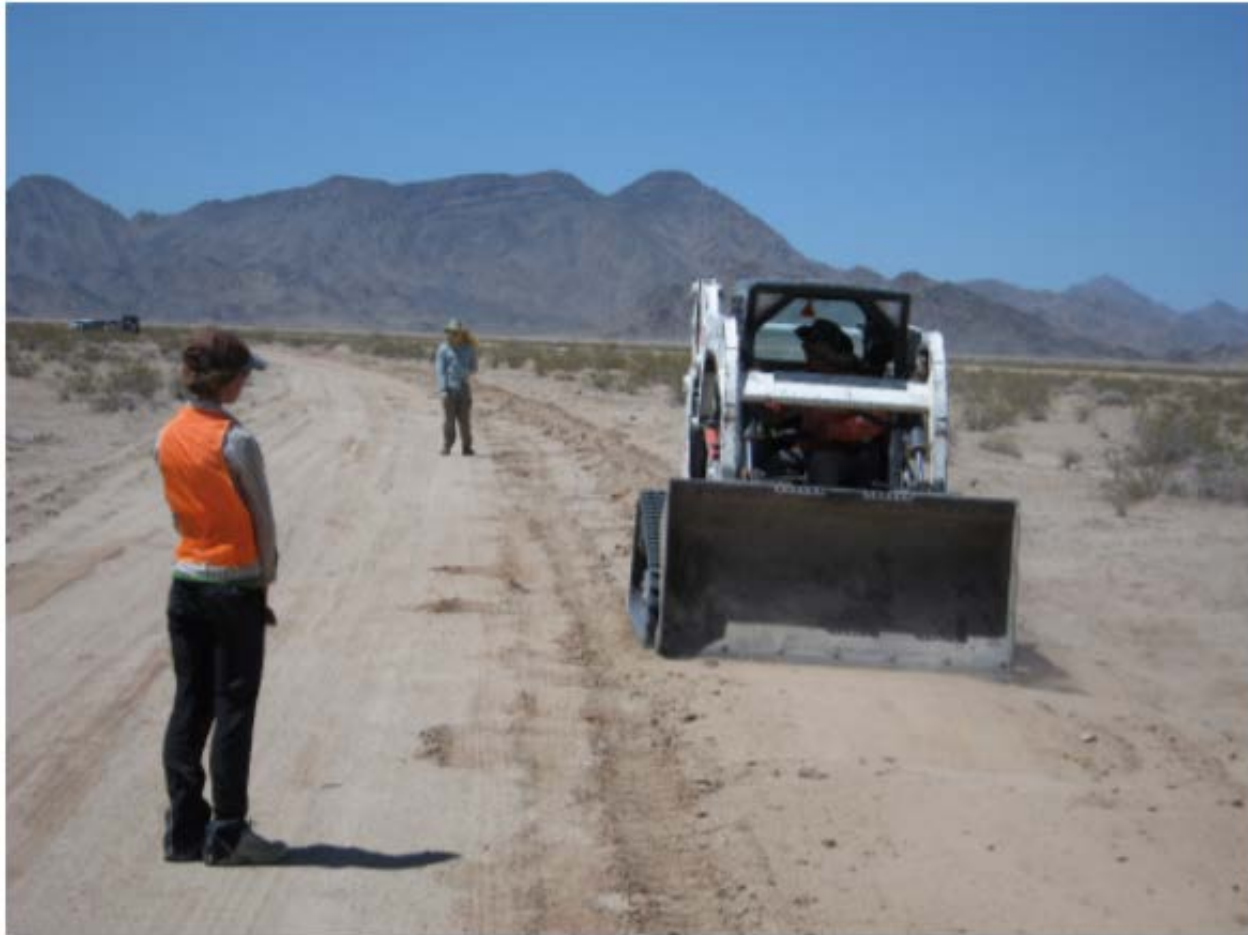
*Figure 5 - Grade Restoration after Fence Removal*

These removal activities commenced on June 9, 2014 as described in MCR No. 10. The work included removing the t-posts, which resulted in soil disturbance up to one-foot in depth. The tortoise fence was rolled up as well so it could be easily moved offsite for recycling. This was performed utilizing a special attachment on the “Bobcat” machinery. The Bobcat was subsequently used with a different attachment to grade and flatten these disturbed areas following the completion of fence removal. This resulted in restoration of the site to an even, natural surface. See **Figure 5** below for illustration.

The desert tortoise fence and access road was a temporarily disturbed area, which triggers this COC. However, the grades have been restored to pre-project grades as shown in **Figure 5** and **Appendix B**. Further, nearly five-years of naturally occurring processes have resulted in a natural revegetation of the temporarily disturbed areas. As articulated below, the landowner is not requesting any additional improvements at this time, nor are they requesting compensation for the temporary impacts.

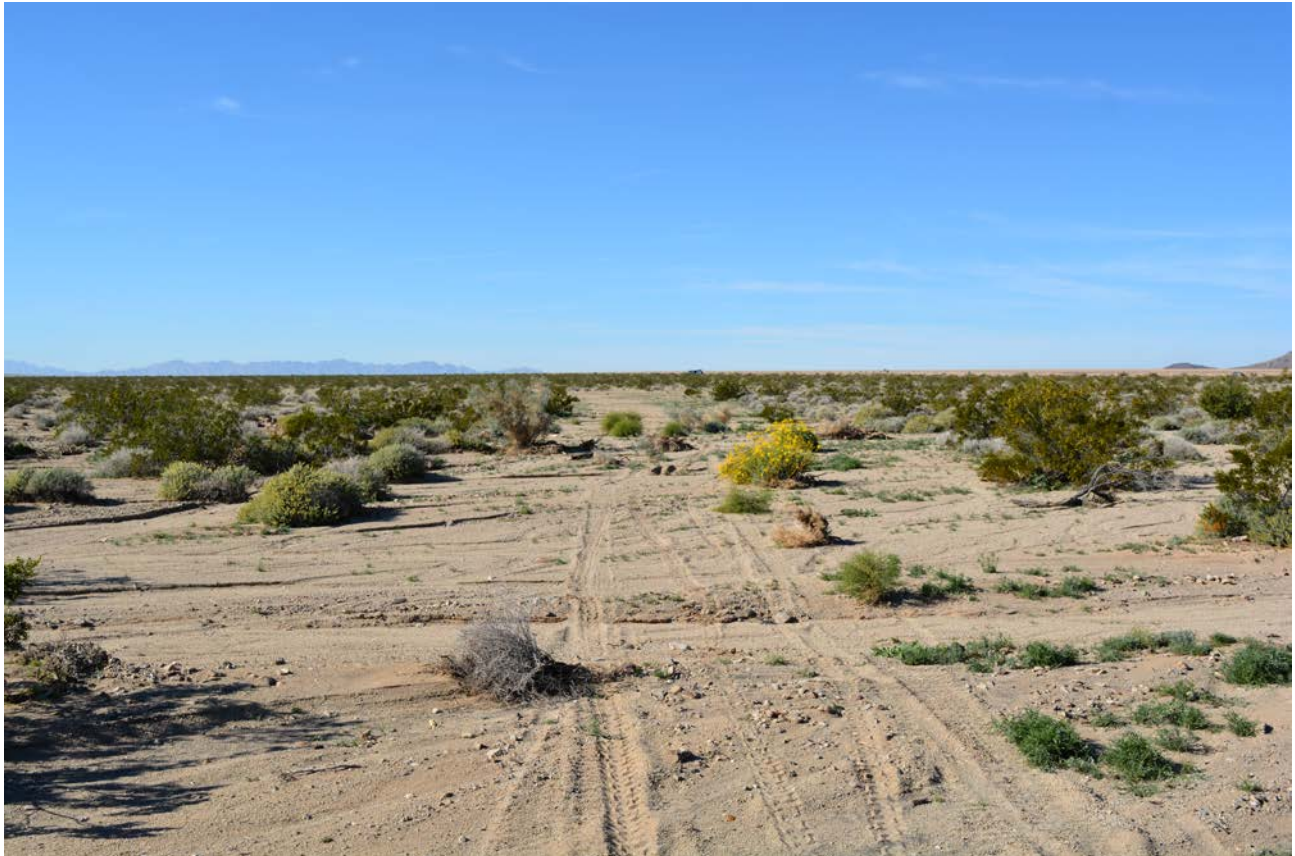
Figure 6 - Desert Tortoise Fence Access Road at BMP Location

In addition to the photographs shown in **Appendix B**, which were taken with an emphasis in consistency, certain portions of the desert tortoise fence access road are barely recognizable. This is clearly evidenced in **Figure 6** below, taken in December of 2018 in the location where the stormwater BMPs were once sited.
