<b>Docket Number:</b>	19-SPPE-03
<b>Project Title:</b>	Sequoia Data Center
<b>TN #:</b>	229419-3
<b>Document Title:</b>	Appendices A-N - part 2
<b>Description:</b>	N/A
<b>Filer:</b>	Patty Paul
<b>Organization:</b>	C1-Santa Clara, LLC
<b>Submitter Role:</b>	Applicant
<b>Submission Date:</b>	8/14/2019 2:25:14 PM
<b>Docketed Date:</b>	8/14/2019

**APPENDIX B**  
**BAAQMD STATIONARY SOURCE**  
**INQUIRY FORM**

# CyrusOne Santa Clara 1 Data Center

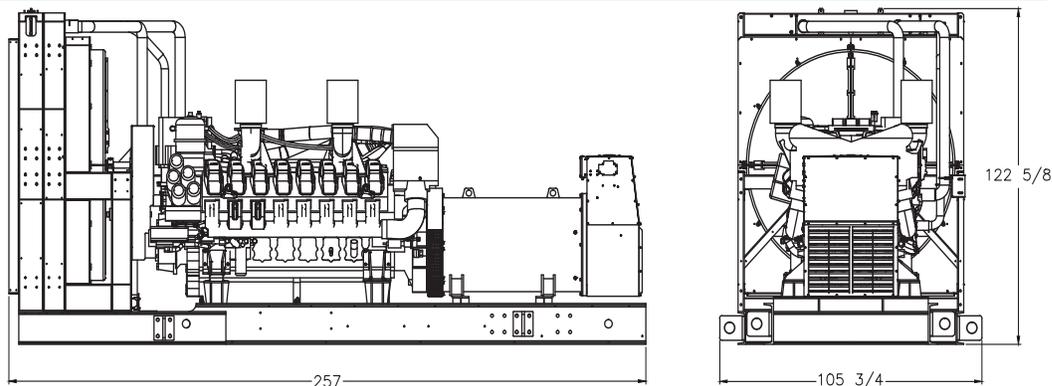
Drawing above for illustration purposes only, based on standard open power 480 volt generator set. Lengths may vary with other voltages. Do not use for installation design. See website for unit specific template drawings.

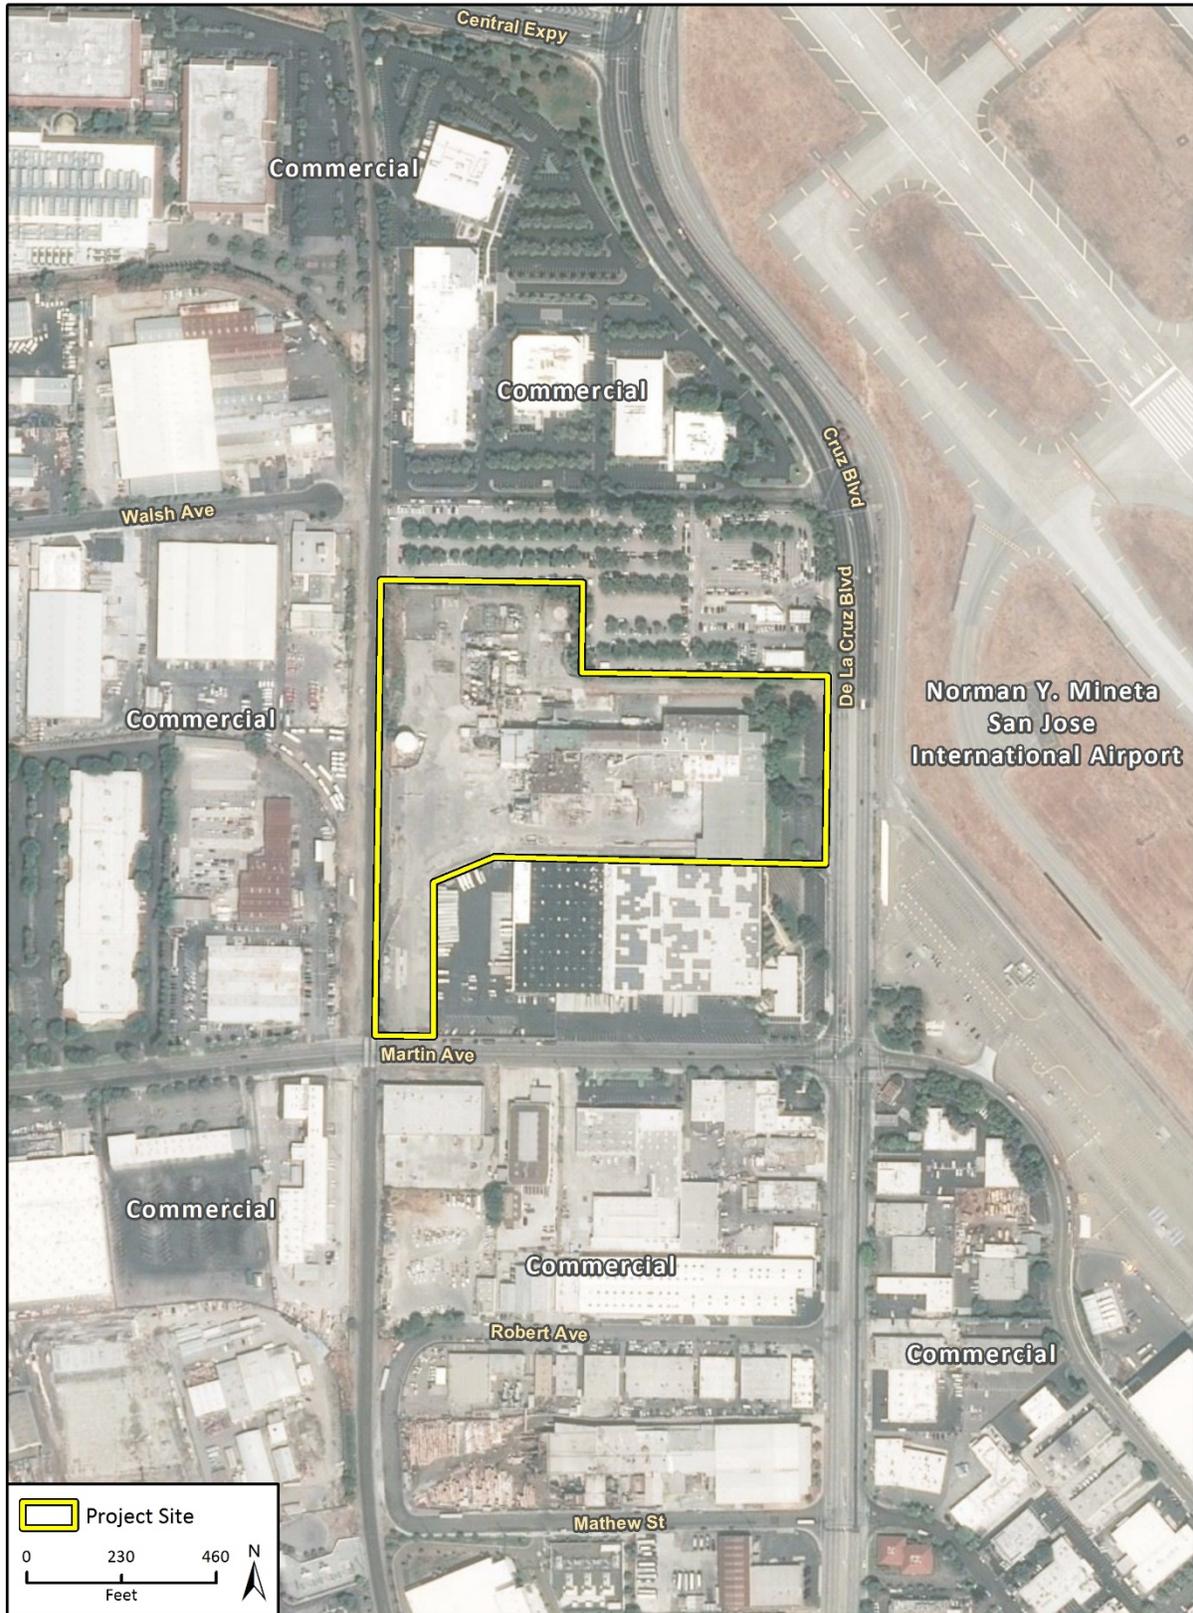
Figure 2 Project Site Location

The approximately 15-acre project site is located at 2600 De La Cruz Boulevard in the City of Santa Clara in Santa Clara County (Assessor Parcel Number 230-03-99). The project site is located at the northwest corner of De La Cruz Boulevard and Martin Avenue and is bound by De La Cruz Boulevard to the east, Marin Avenue to the south, railroad tracks to the west, and commercial development to the north. The Norman Y. Mineta San Jose International Airport is located east of the project site across De La Cruz Boulevard. The project site has a land use designation and zoning of Heavy Industrial. The project site also contains a surface parking lot that is accessible via De La Cruz Boulevard. Figure 1 shows the project site’s regional location, and Figure 2 shows an aerial view of the project site and surrounding area.

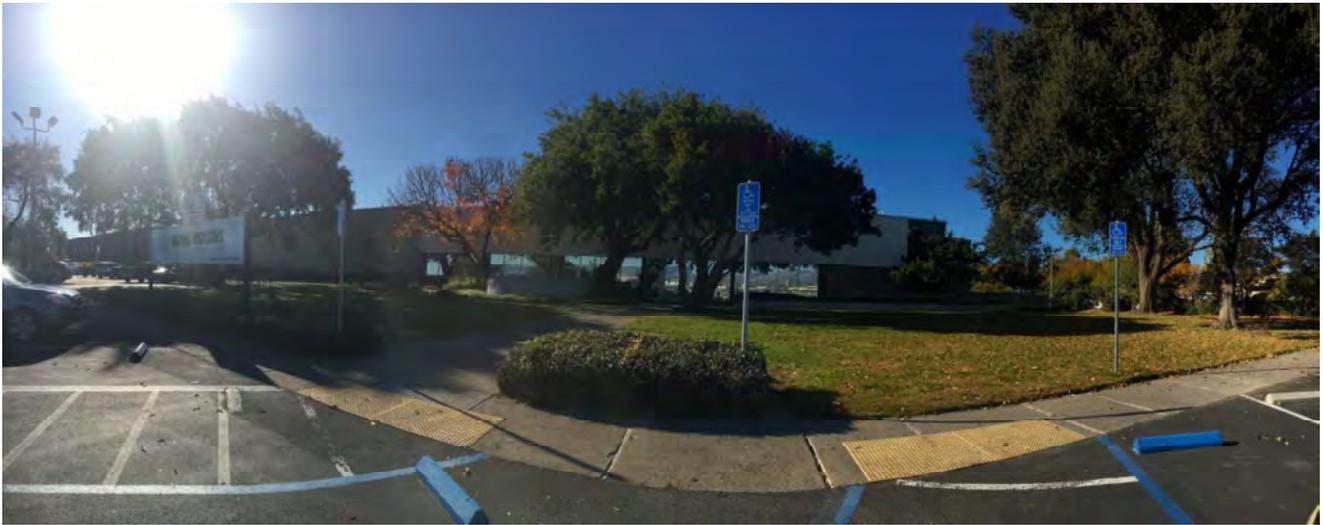
Photo 1: The site, facing west towards the eastern entrance/offices from along the eastern paved parking lot along De La Cruz Boulevard.

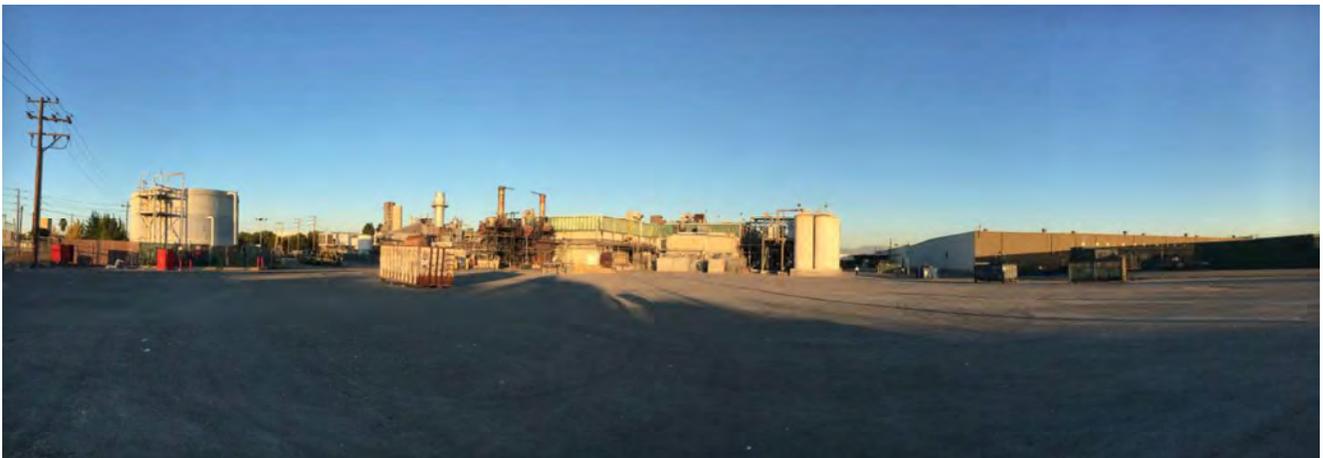
Photo 2: The site, facing east towards the mill complex (center to left), former off-site folding carton plant (2500 De La Cruz)(right), and western paved storage yard (bottom entirety).

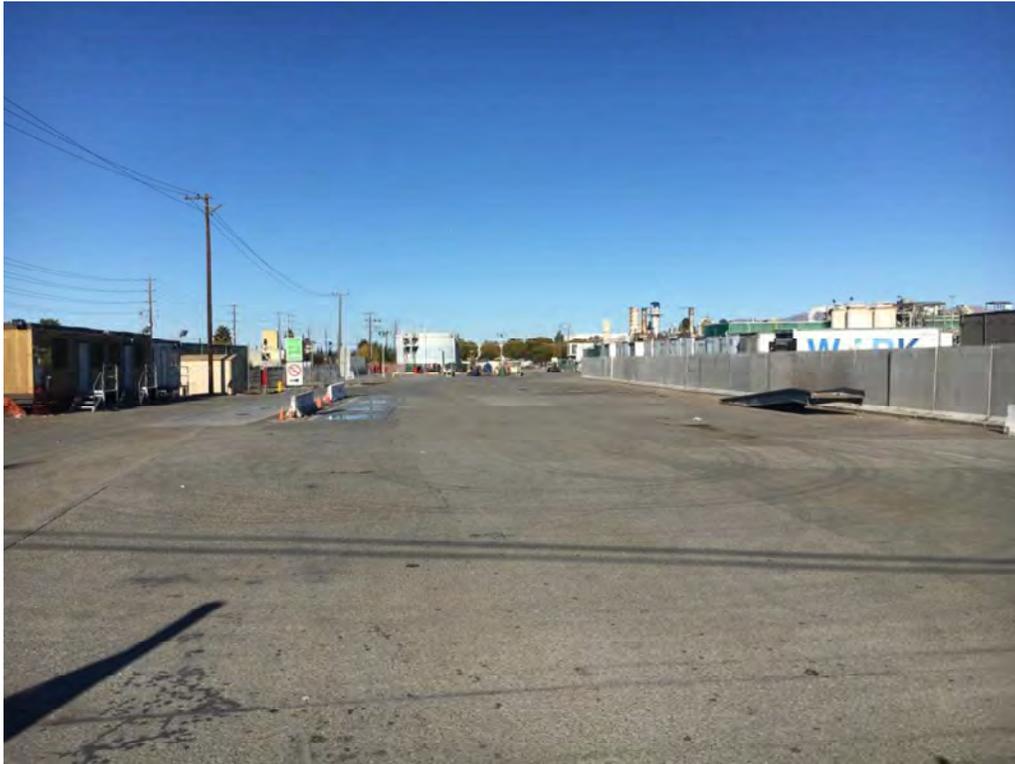
Photo 3: The site, facing north from Martin Avenue towards southwestern shipping/receiving yard. The truck scale (center-left) and scale house (left) are visible, as is 2500 De La Cruz Blvd (right).

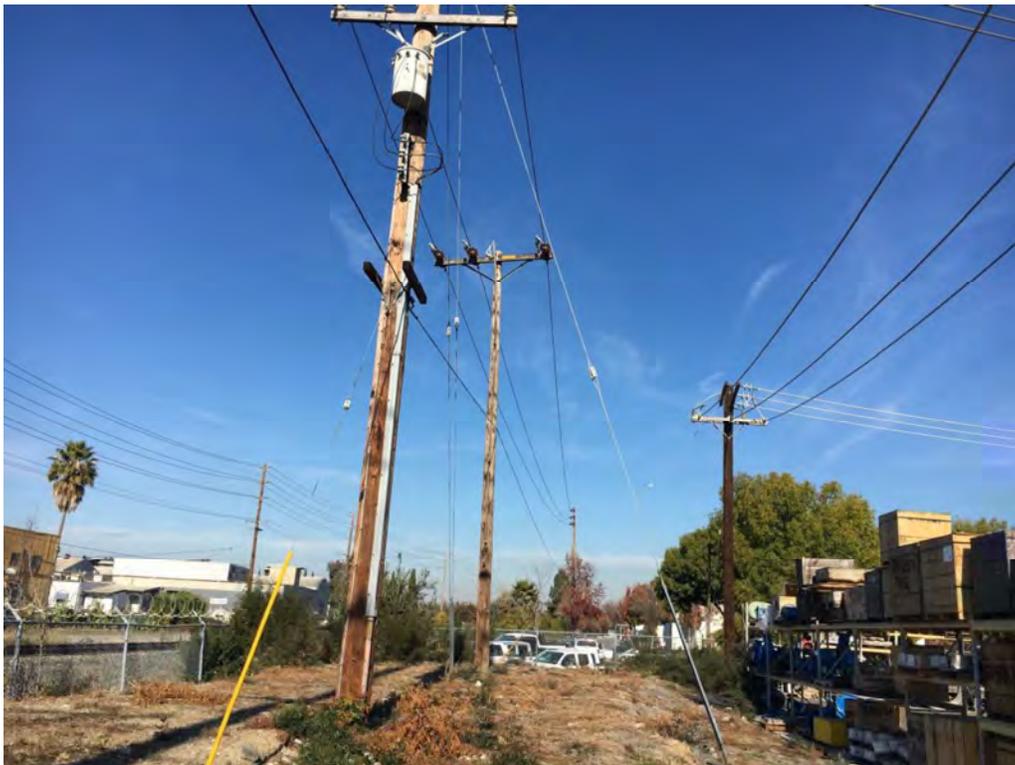
Photo 4: The site, facing the northwestern-most corner along rail way. One pole-mounted transformer is visible at top-center. Distressed vegetation is visible along the northwestern surfaces.

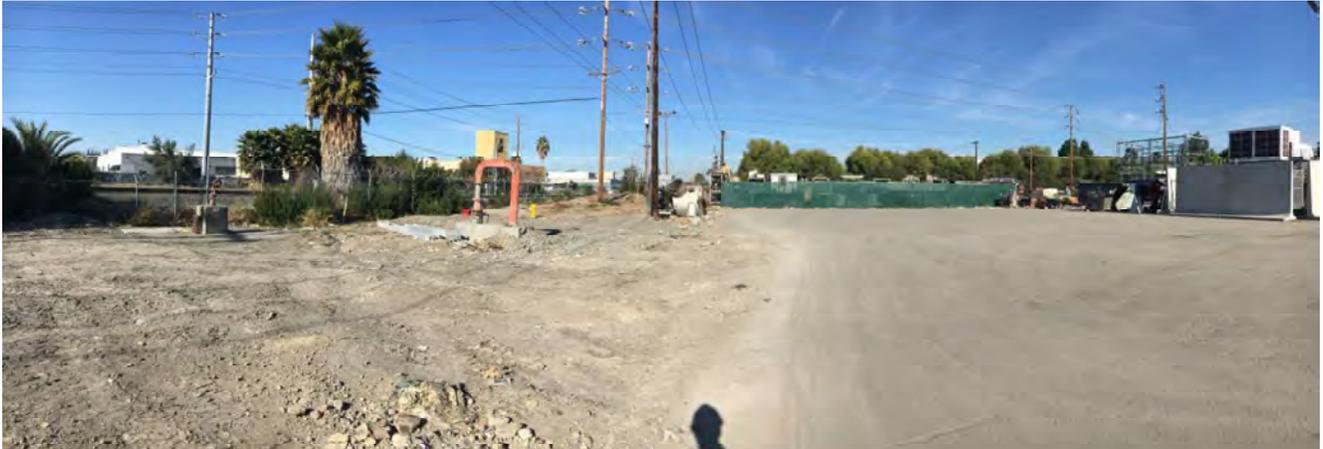
Photo 5: The site, facing northwest. The northwestern former stock paper storage yard with unpaved areas (left) and paved areas (right) are visible. An equipment storage yard is visible at center.

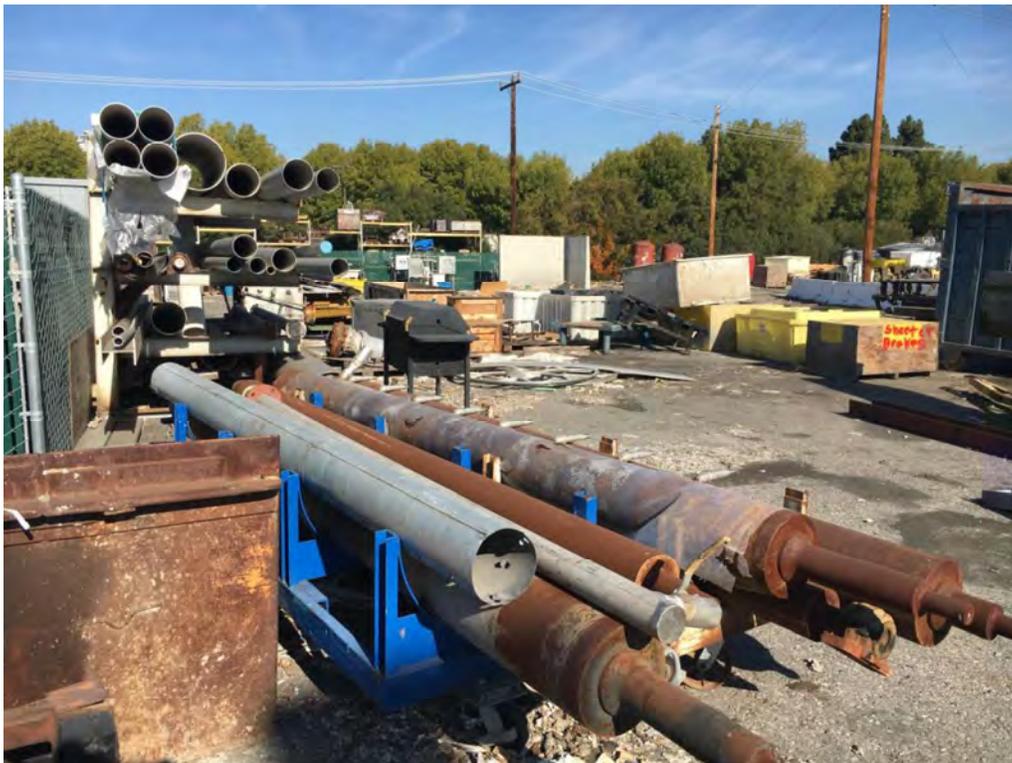
Photo 6: The site, facing north towards the equipment storage yard. Minor staining/saturated ground surfaces are present along the interior (right) areas of the yard.

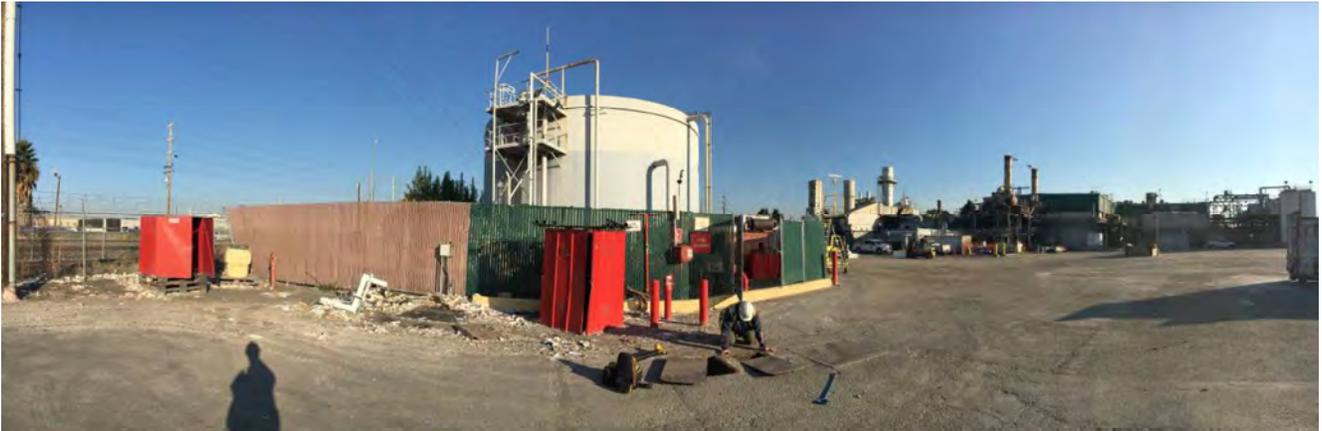
Photo 7: The site, facing north towards the 400,000 gallon well water storage tank within bermed and fenced area. In addition, the former chemical tote storage area is visible along the fence line.

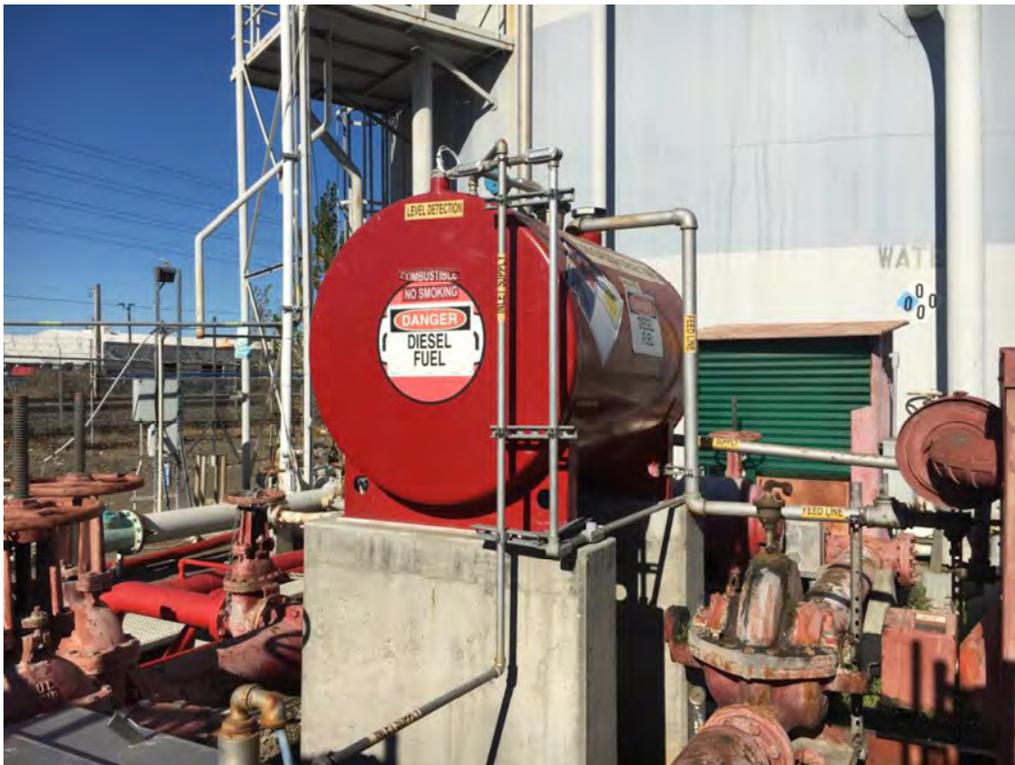
Photo 8: The site, facing northwest towards 300 gallon diesel AST above bermed containment, south of water AST.

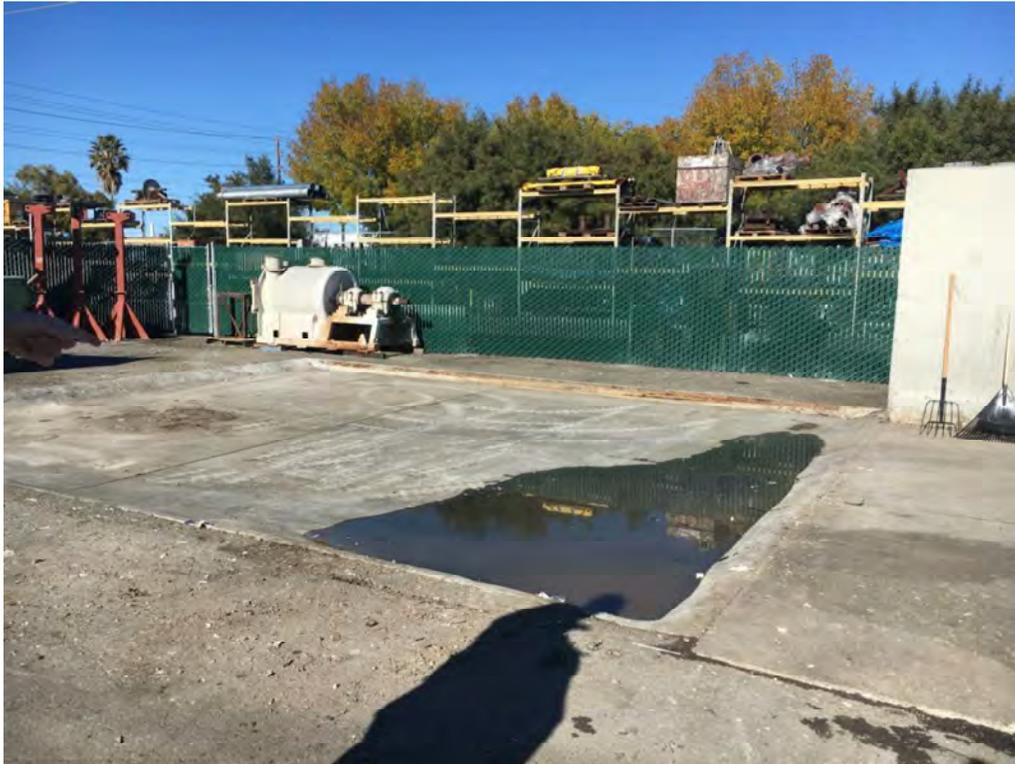
Photo 9: The site, facing northwest towards the northwestern sub-grade paved trash washing area with southeastern sump. The northern site property fence line is visible beyond at center.

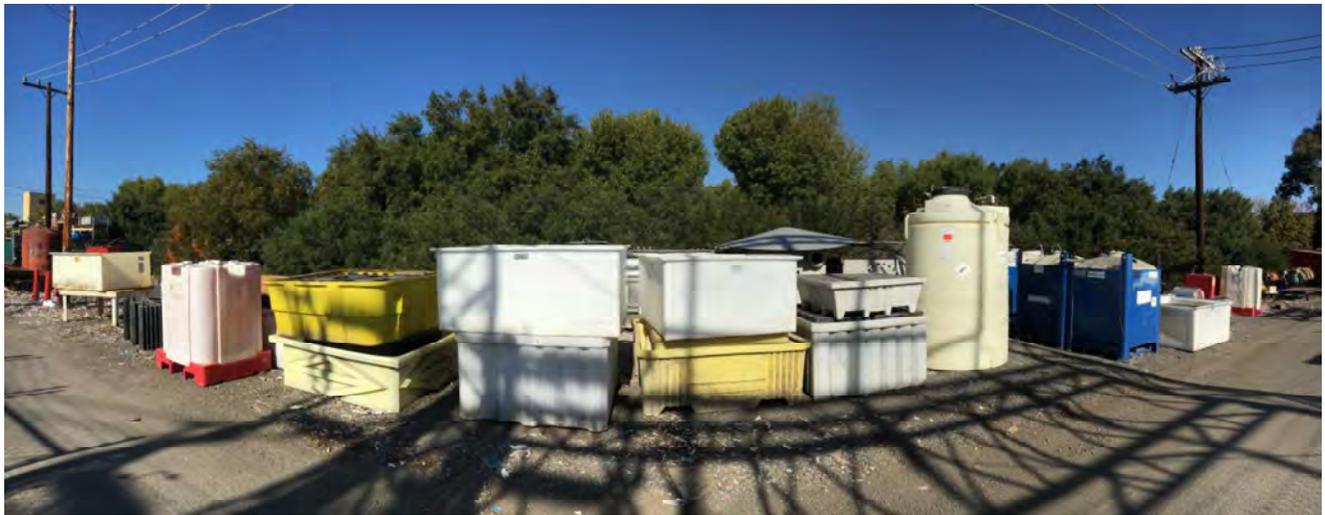
Photo 10: The site, facing north along the northern property line. Empty container/tote/tank storage is visible on bare ground/gravel covered area.

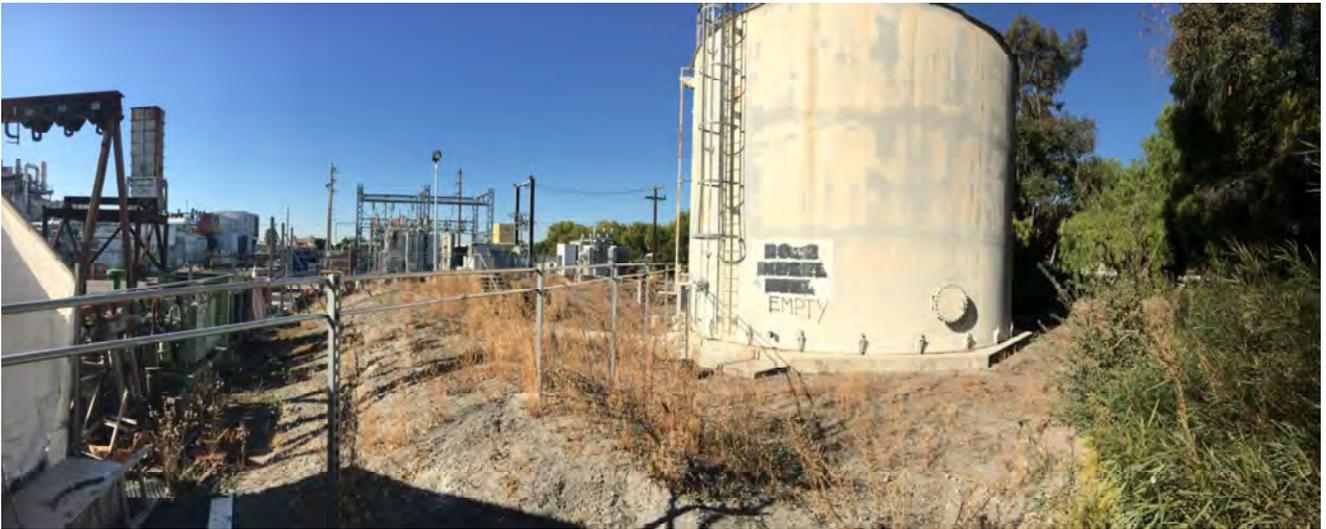
Photo 11: The site, facing northwest towards the 126,000 gallon former fuel AST within clay-bermed area with 136,000 gallon capacity. Backup chemical storage areas are visible beyond at center-left.

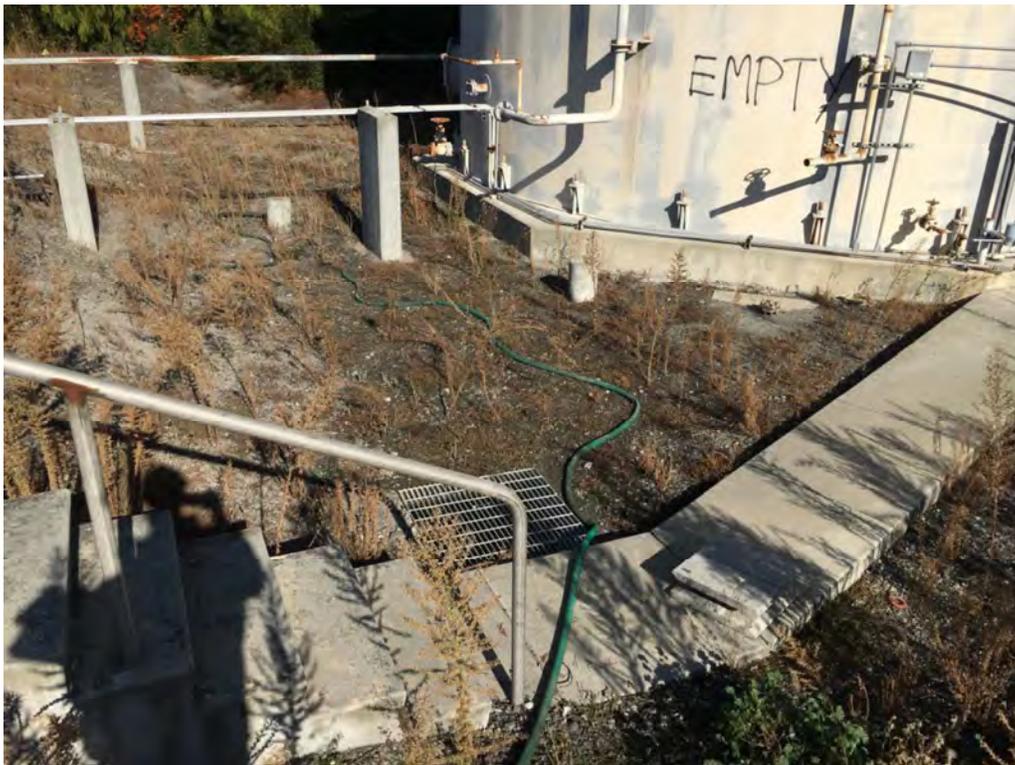
Photo 12: The site, facing north towards the fuel AST bermed area, with interior sump located at its southwestern corner (center).

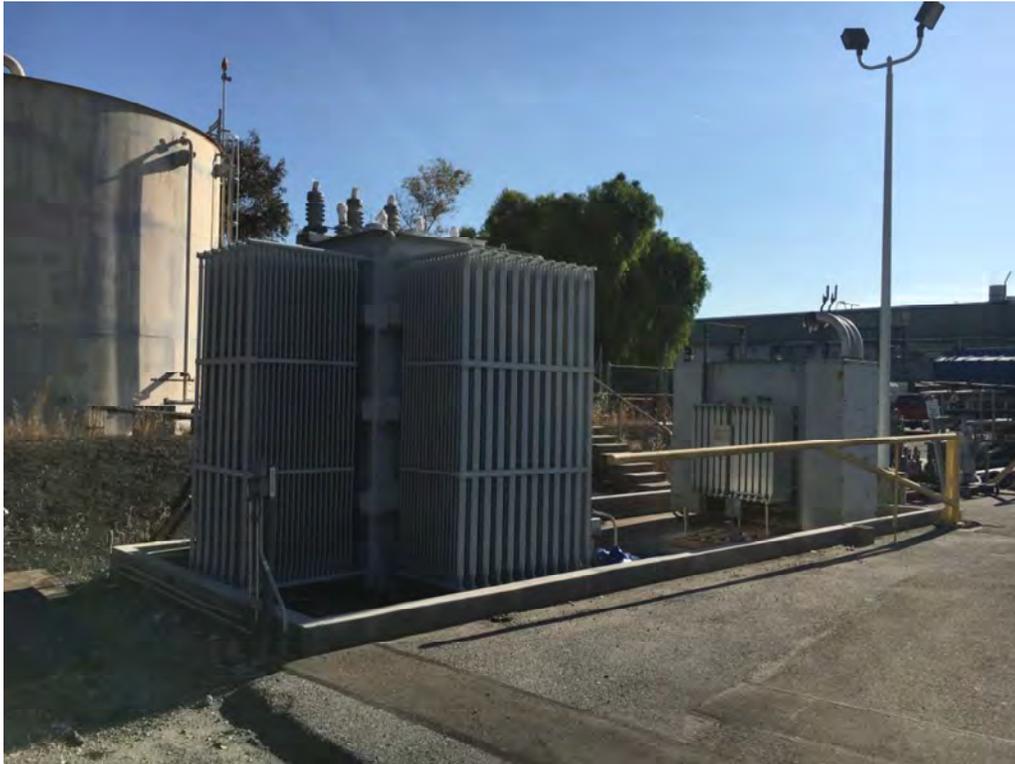
Photo 13: The site, facing southeast towards a bermed former fueling area, now utilized for backup storage of unused transformer units.

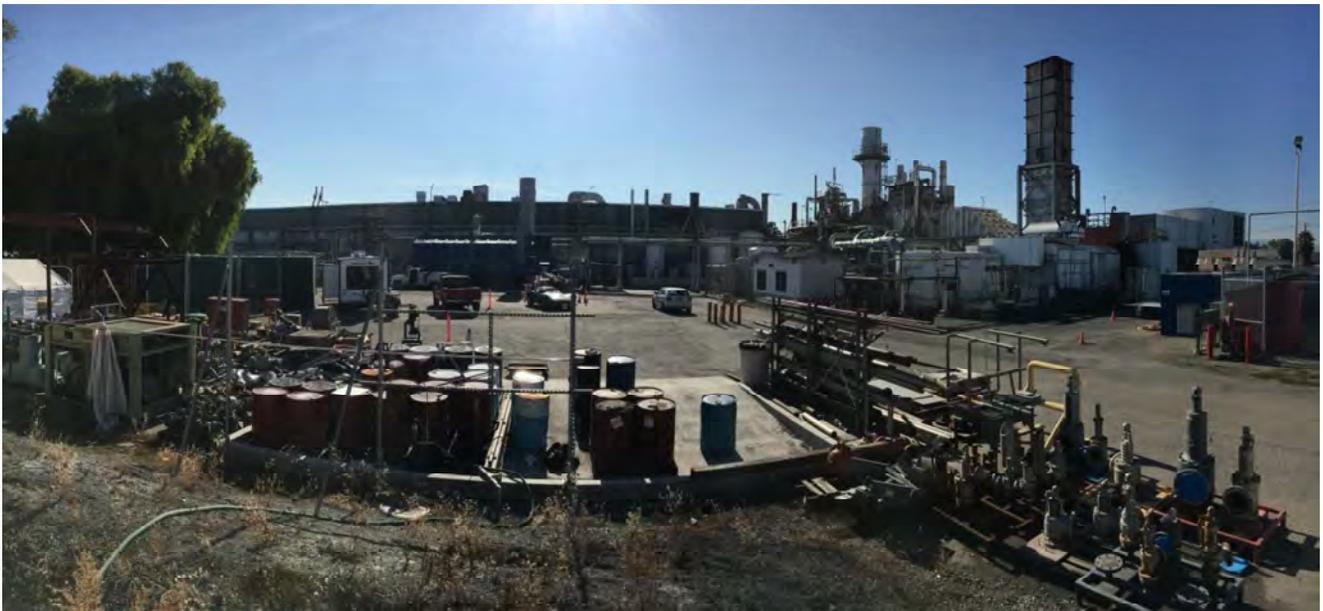
Photo 14: The site, facing south towards the mill building (center), cogeneration plant (right) and backup chemical storage containment at bottom-center. Sumps are located within the sub-grade area.

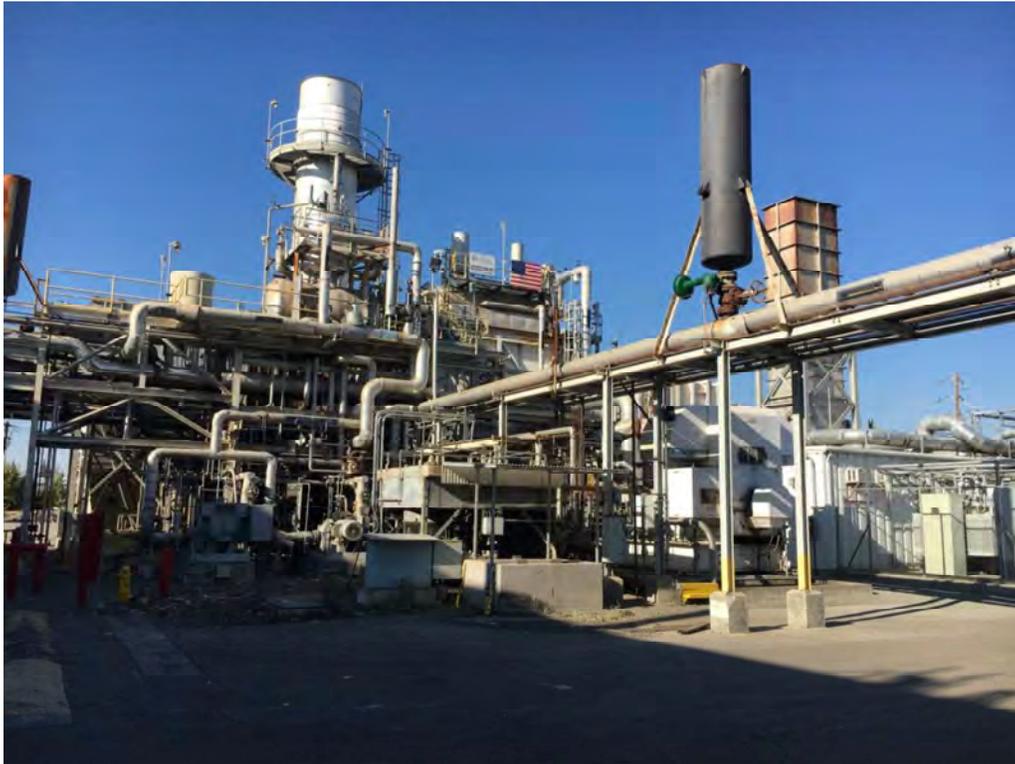
Photo 15: The site, facing northwest towards the southeast corner of the cogeneration plant.

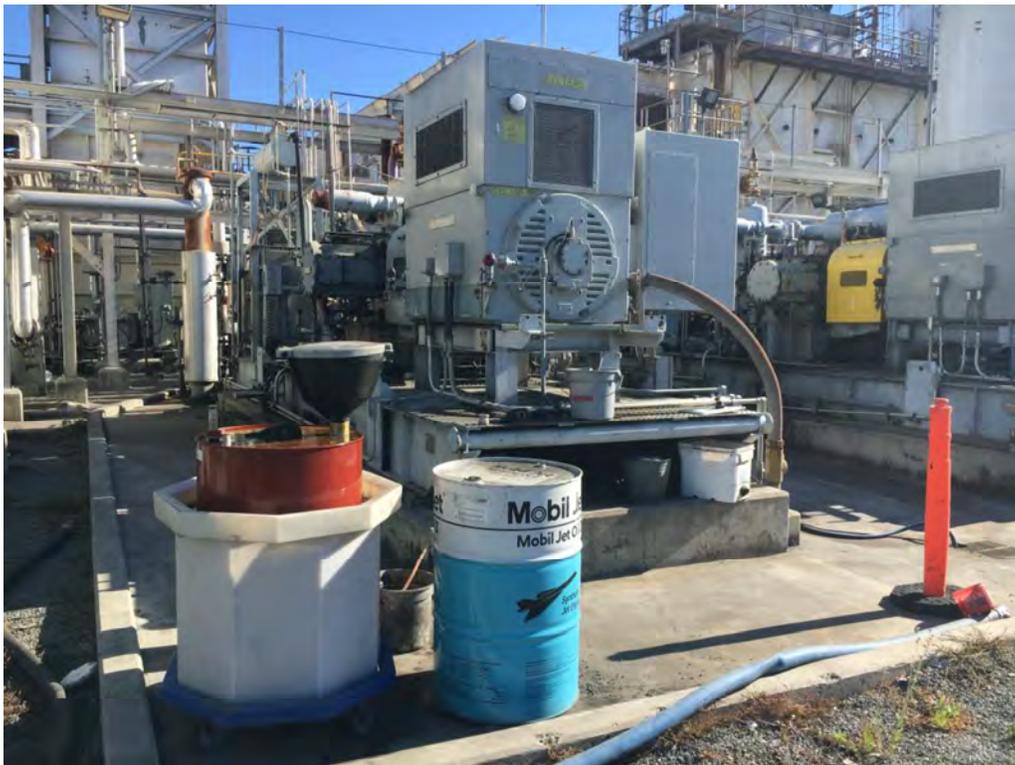
Photo 16: The site, facing east towards the northwestern corner of the cogeneration plant. Generators with gas compressor and petroleum product (jet fuel/petroleum) secondary containment are visible at center.

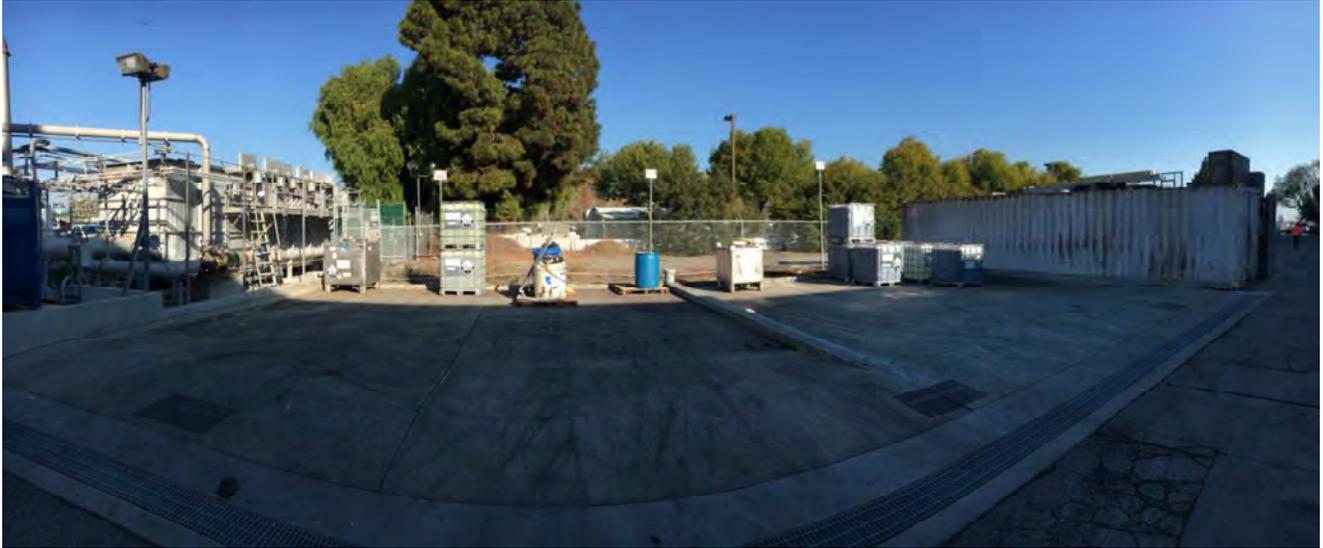
Photo 17: The site, facing north towards the northeastern chemical storage area, former location of chemical totes and containers for water treatment and cogeneration plant chemicals.

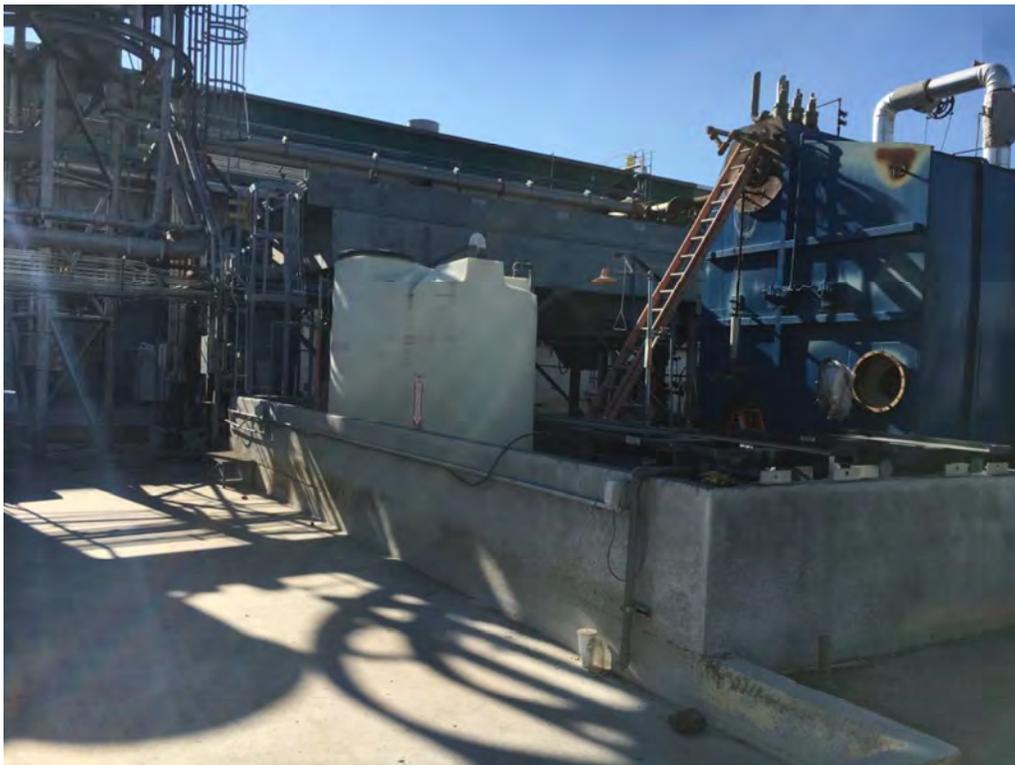
Photo 18: The site, facing south towards the northeastern cogeneration plant chemical storage area #2 within concrete bermed containment.

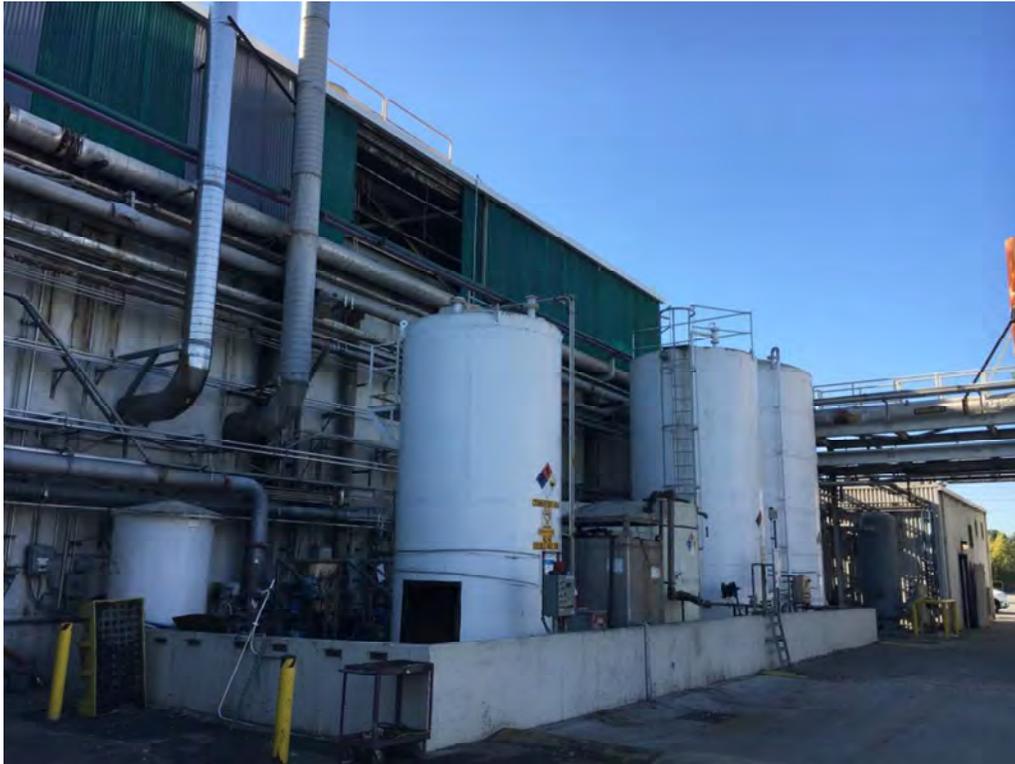
Photo 19: The site, facing southwest towards the wet end chemical storage tank farm at mill northwest corner, with 4,000 to 20,000 gallon tanks for bulk storage of water treatment chemicals, within berm containment.

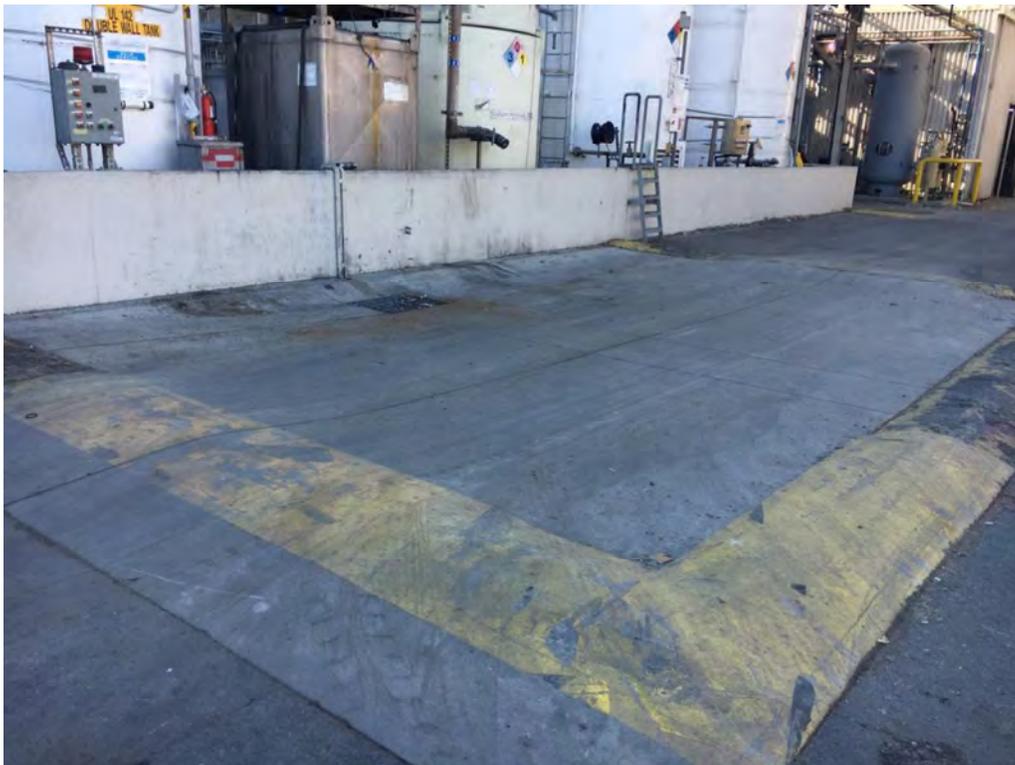
Photo 20: The site, facing southwest towards the wet end tank farm unloading area within bermed pad with bottom sump (water pumped back into mill reservoirs).

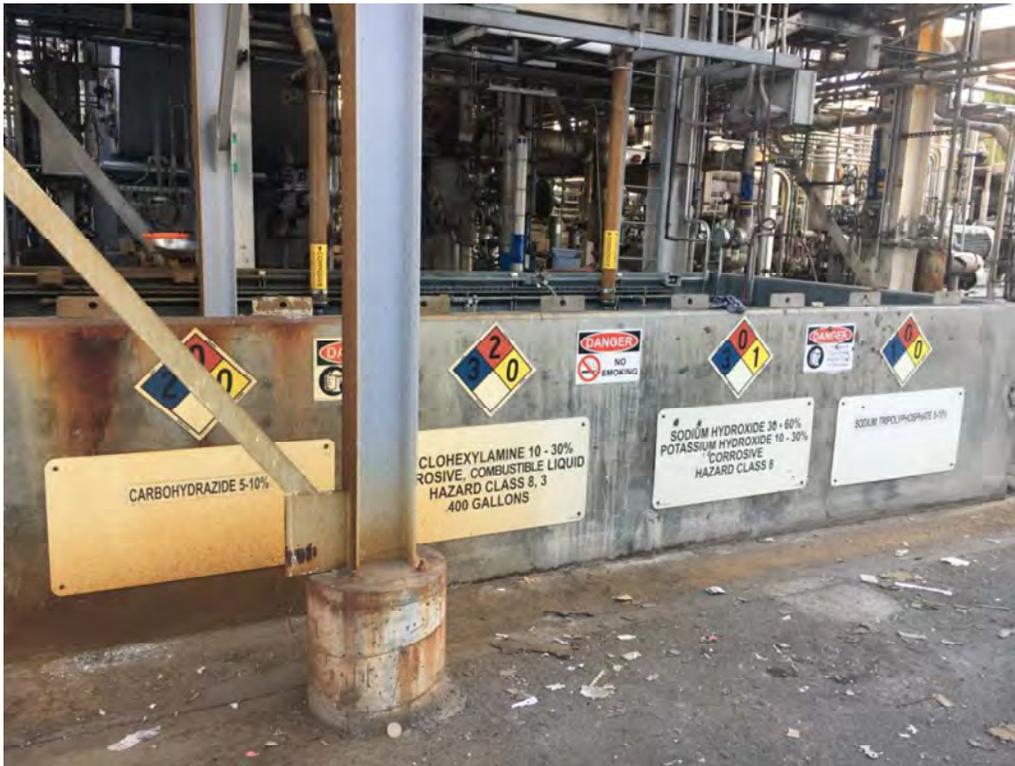
Photo 21: The site, facing north towards the cogeneration plant chemical storage area #1 within concrete berm containment.

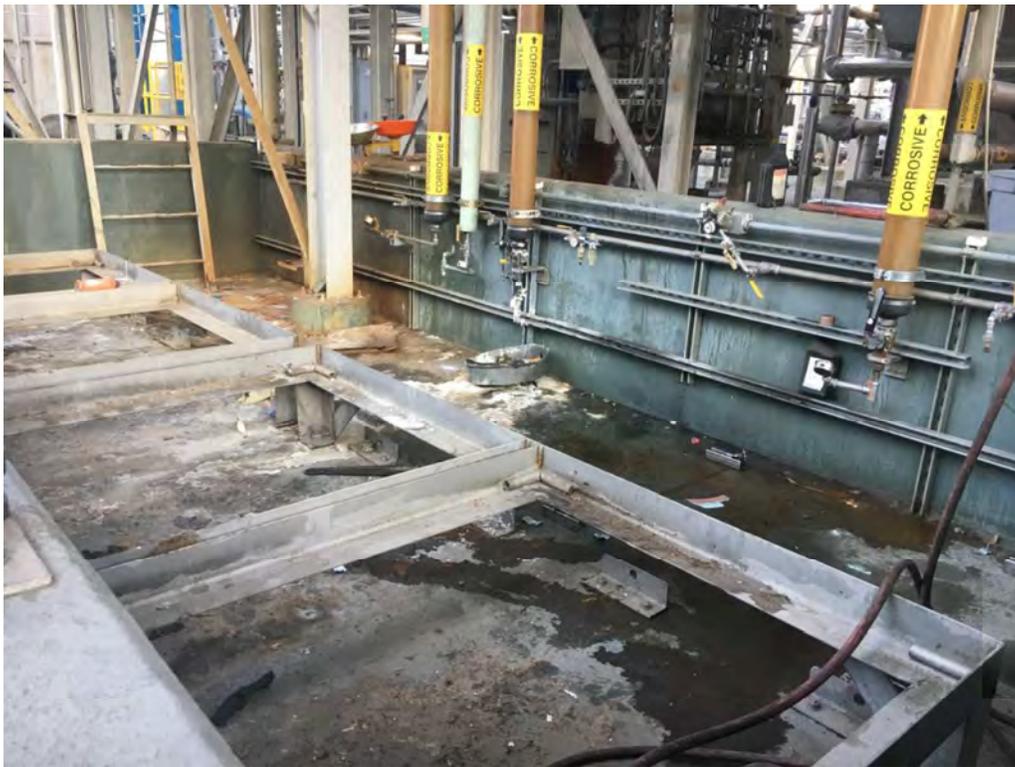
Photo 22: The site, facing northwest within the cogeneration chemical storage area #1 concrete berm containment.

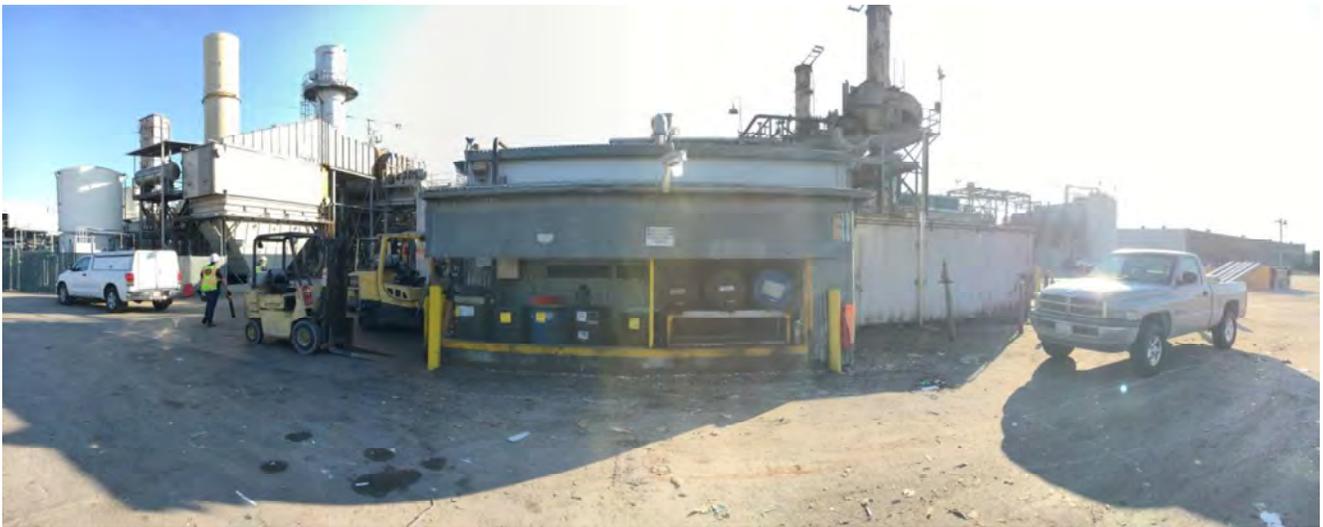
Photo 23: The site, facing east towards the maintenance oil/lubricant storage shed at northwestern corner of the mill, adjacent to compressor shed. Drum storage is within secondary containment.

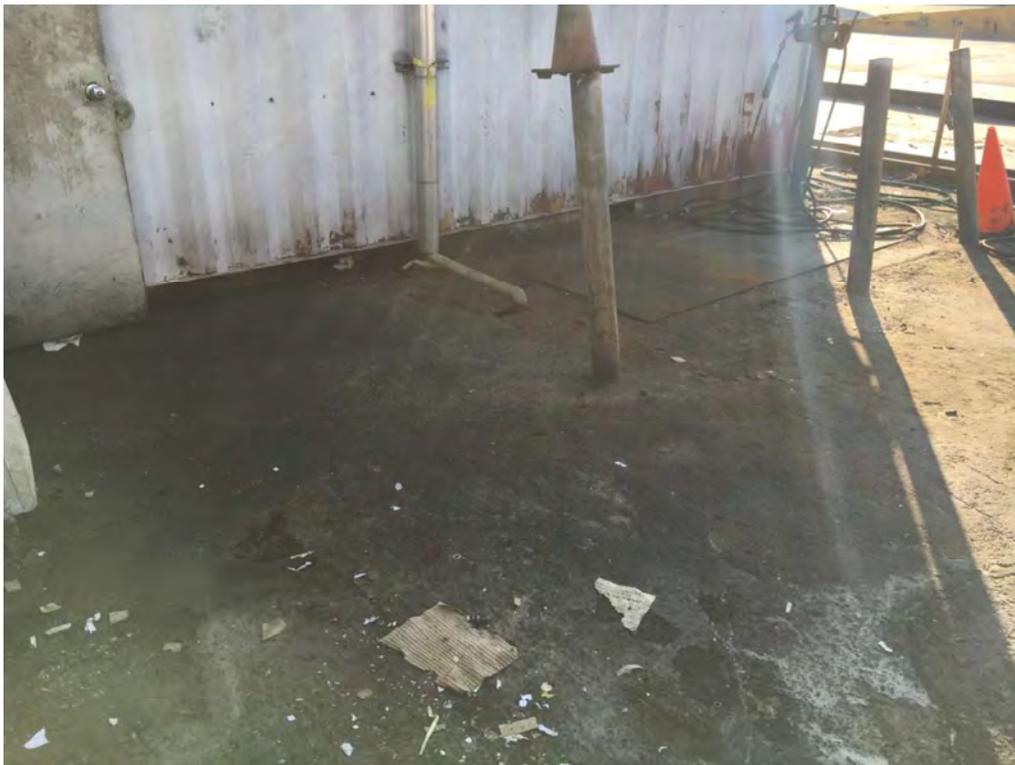
Photo 24: The site, facing southeast towards access grate (center-right) for 2,000 gallon oil-water clarifier system adjacent to the north of (and connected via underground piping to) sub-grade forklift maintenance wash pad.

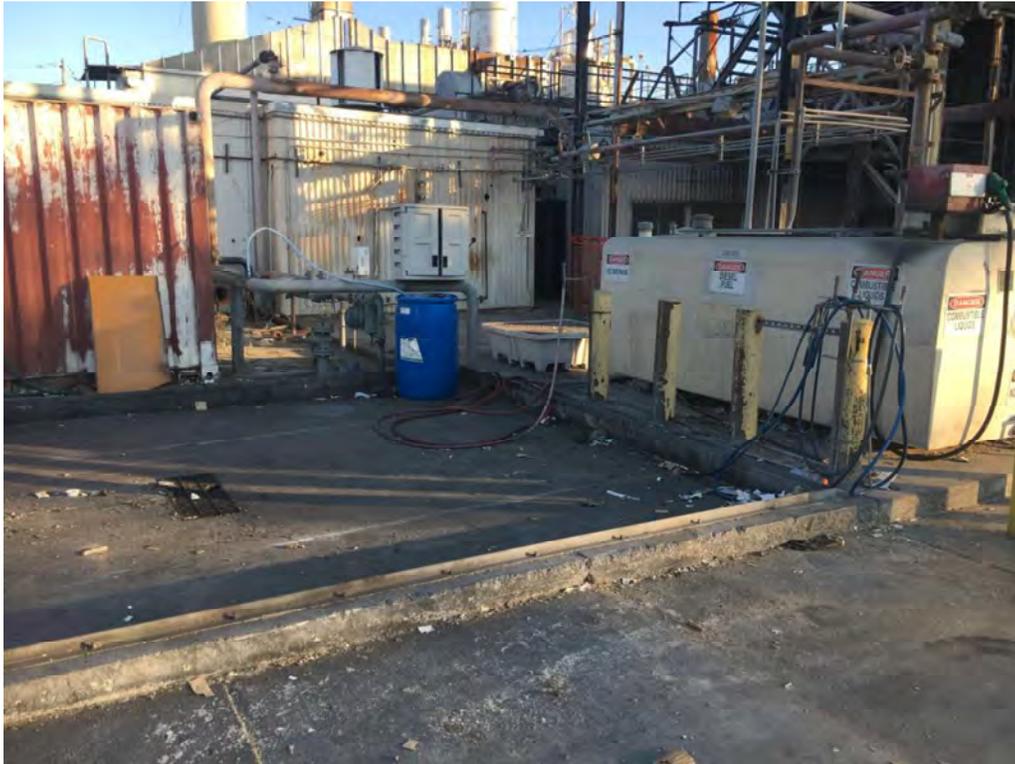
Photo 25: The site, facing northeast towards forklift maintenance shed (left) and compressor storage shed (center), as well as 1,000 gallon double-contained diesel tank for forklifts (right), and forklift maintenance wash pad (bottom).

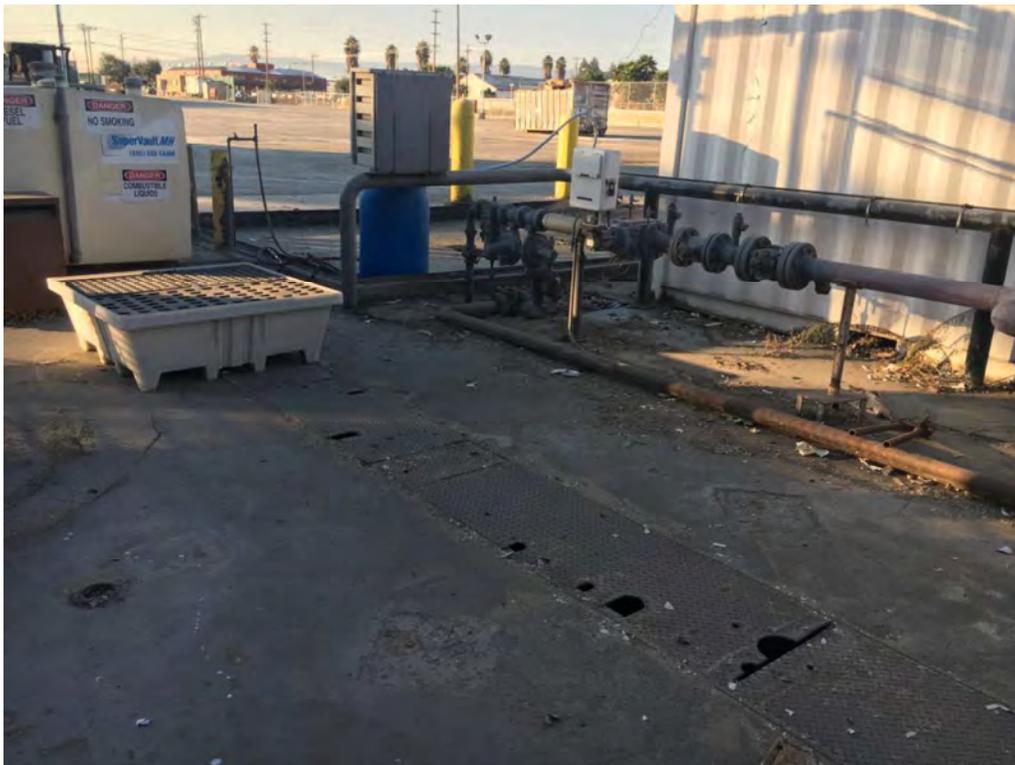
Photo 26: The site, facing southwest towards the forklift wash pad, with sanitary sewer line center to bottom right.
