<b>Docket Number:</b>	19-SPPE-03
<b>Project Title:</b>	Sequoia Data Center
<b>TN #:</b>	229419-3
<b>Document Title:</b>	Appendices A-N - part 2
<b>Description:</b>	N/A
<b>Filer:</b>	Patty Paul
<b>Organization:</b>	C1-Santa Clara, LLC
<b>Submitter Role:</b>	Applicant
<b>Submission Date:</b>	8/14/2019 2:25:14 PM
<b>Docketed Date:</b>	8/14/2019

**APPENDIX B**  
**BAAQMD STATIONARY SOURCE**  
**INQUIRY FORM**

# CyrusOne Santa Clara 1 Data Center

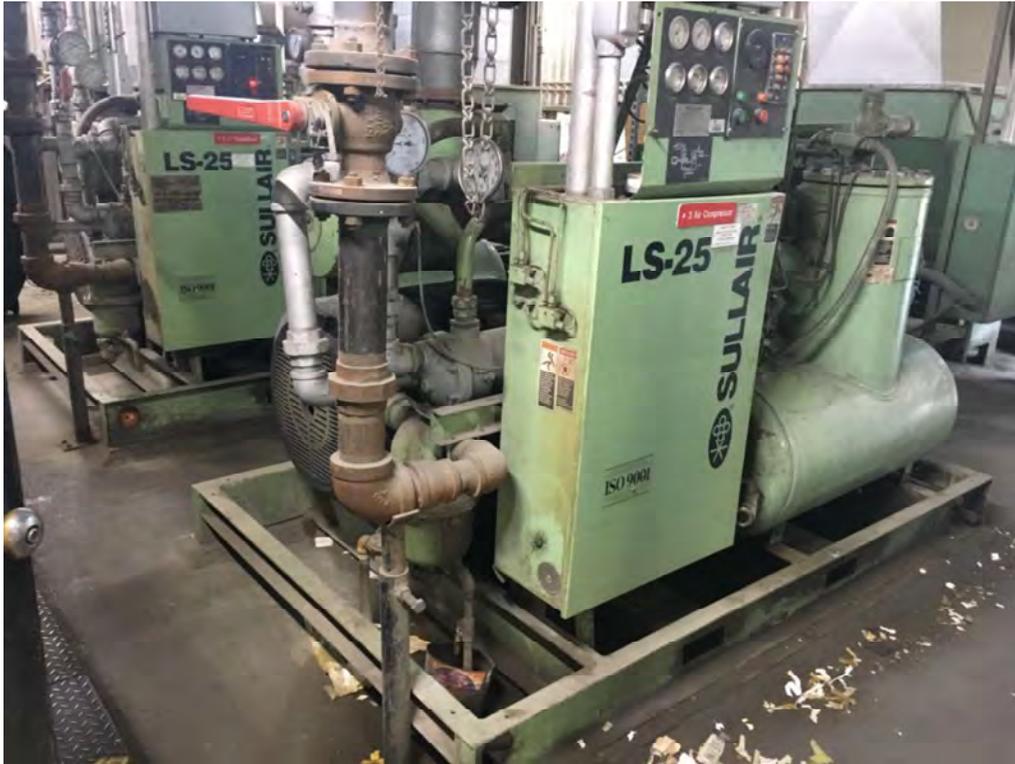
Photo 27: The site, facing east towards air compressors within the air compressor shed, with drip pans on far underside of units.

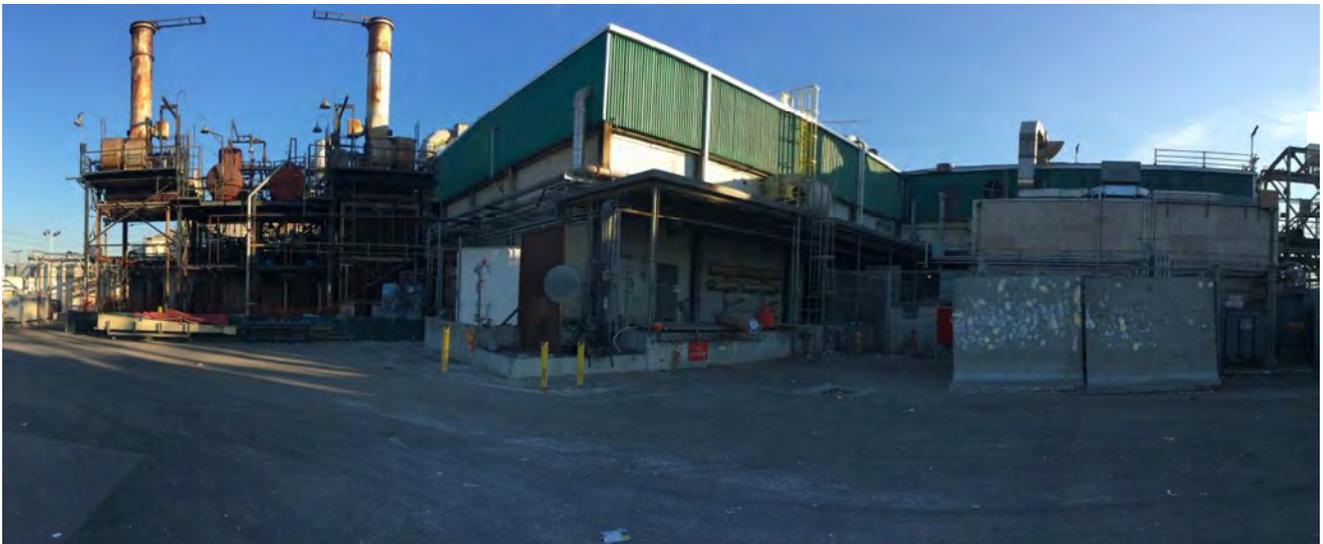
Photo 28: The site, facing northeast towards southwest corner of mill building. Abandoned boiler units are visible at left (location of former 25,000 gallon USTs). A loading dock area, previous location of chemical tote storage is visible at center. The main transformer yard is visible at right.

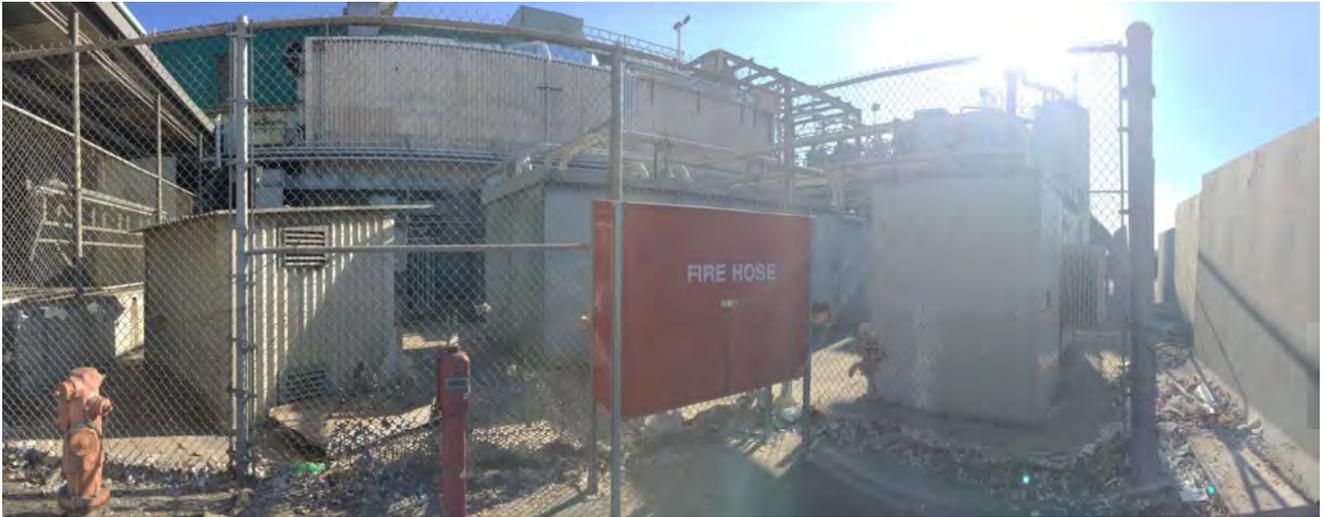
Photo 29: The site, facing east towards the southwestern main transformer yard, where approximately ten pad-mounted transformers are located.

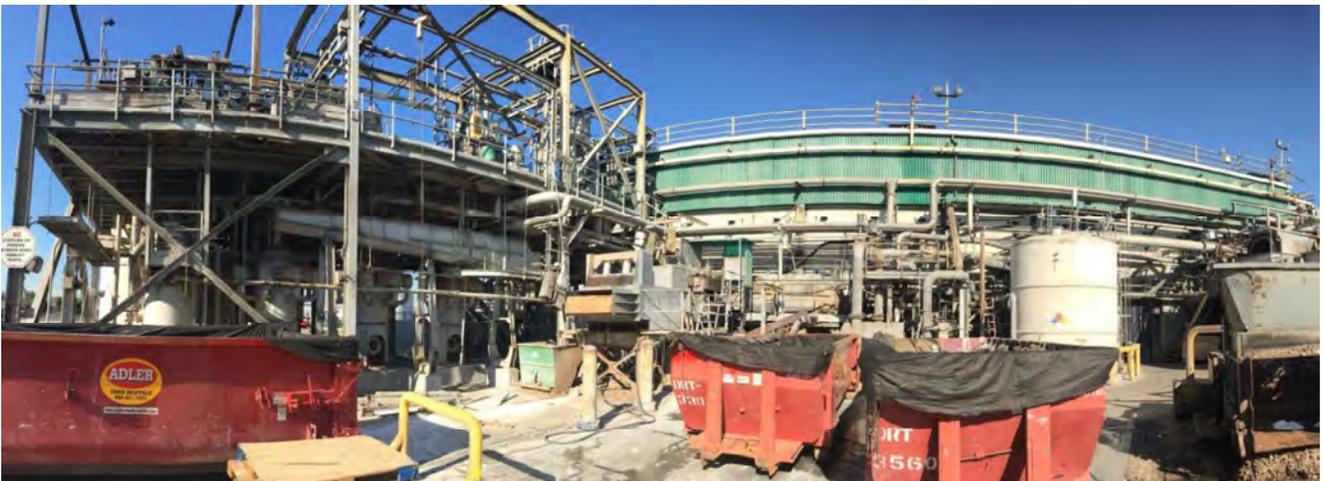
Photo 30: The site, facing northwest along the northwestern corner of the central mill courtyard. The two-story "Top Liner" de-inking and water treatment are visible from west (left) to east (right).

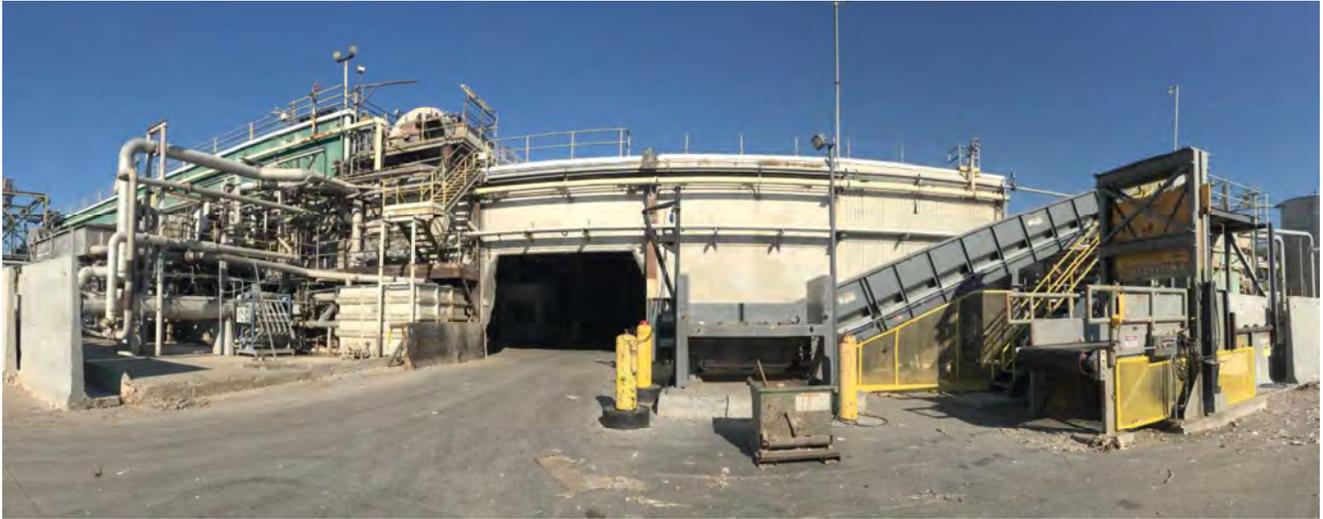
Photo 31: The site, facing north along the northern courtyard edge at southwestern stock paper preparation loading area (center). The "wet strength" pulper system (within sub-grade concrete berm containment) is visible at right.

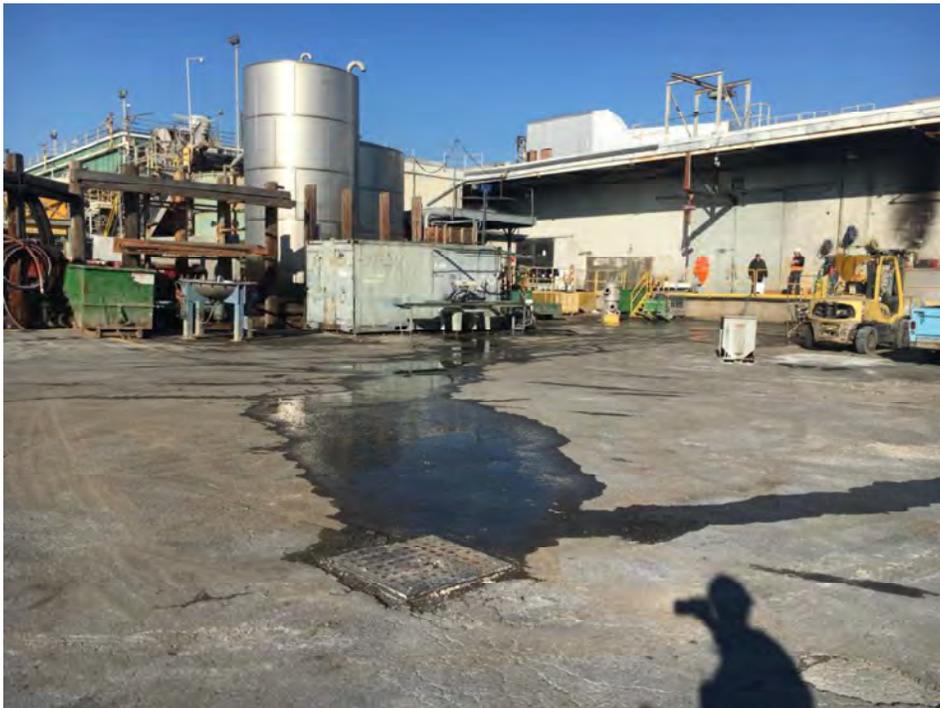
Photo 32: The site, facing northwest towards northwestern corner of courtyard (along loading dock). A storm drain is visible at center (with butterfly valve). A wash pad for equipment/vehicles is visible along the center.

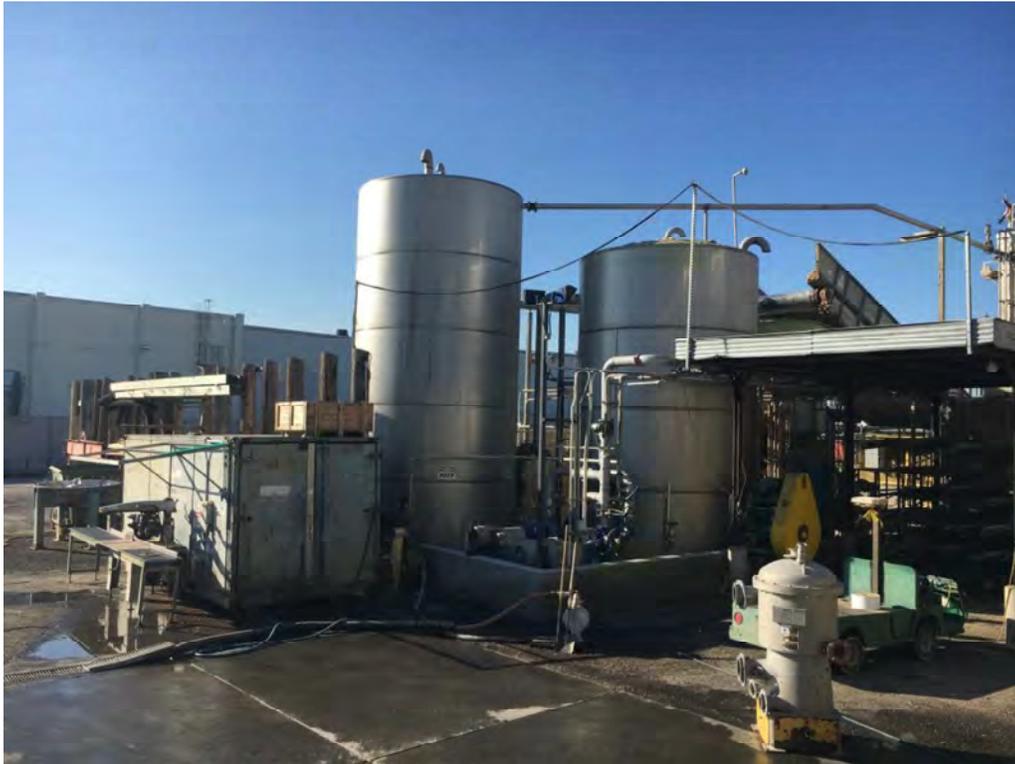
Photo 33: The site, facing southwest towards the interior courtyard area, with northeastern corner of "wet strength" pulping equipment at center. Hazardous waste/materials storage platform is beyond to the right.

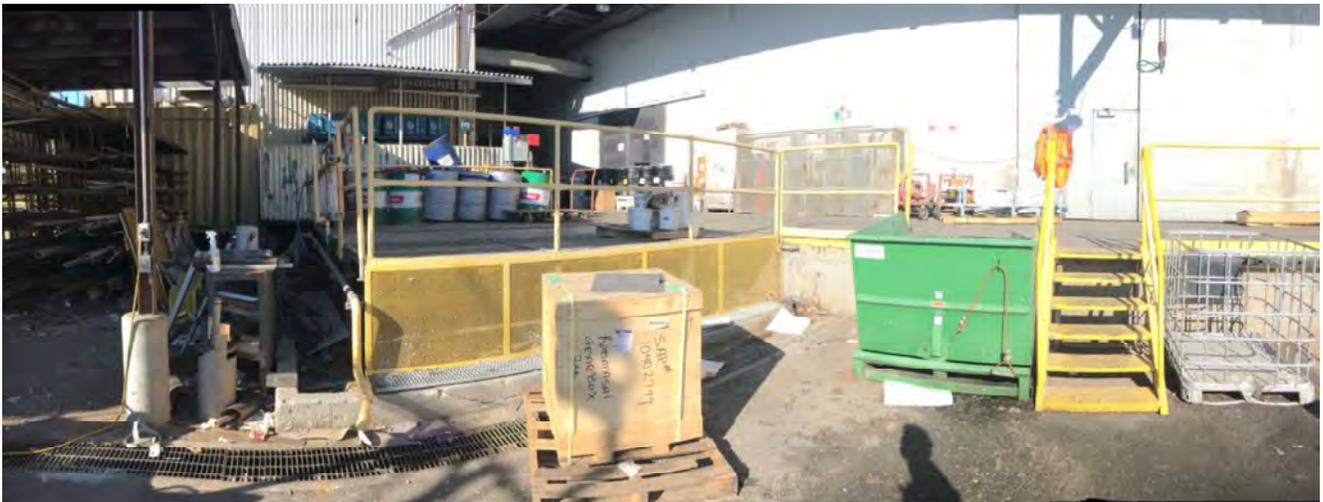
Photo 34: The site, facing northwest towards hazardous materials/waste storage platform, above concrete berm with interior sump. Surrounding trenches drain to the facility process water reservoirs (inside). Dry storage of metal parts/pipes is visible at left.

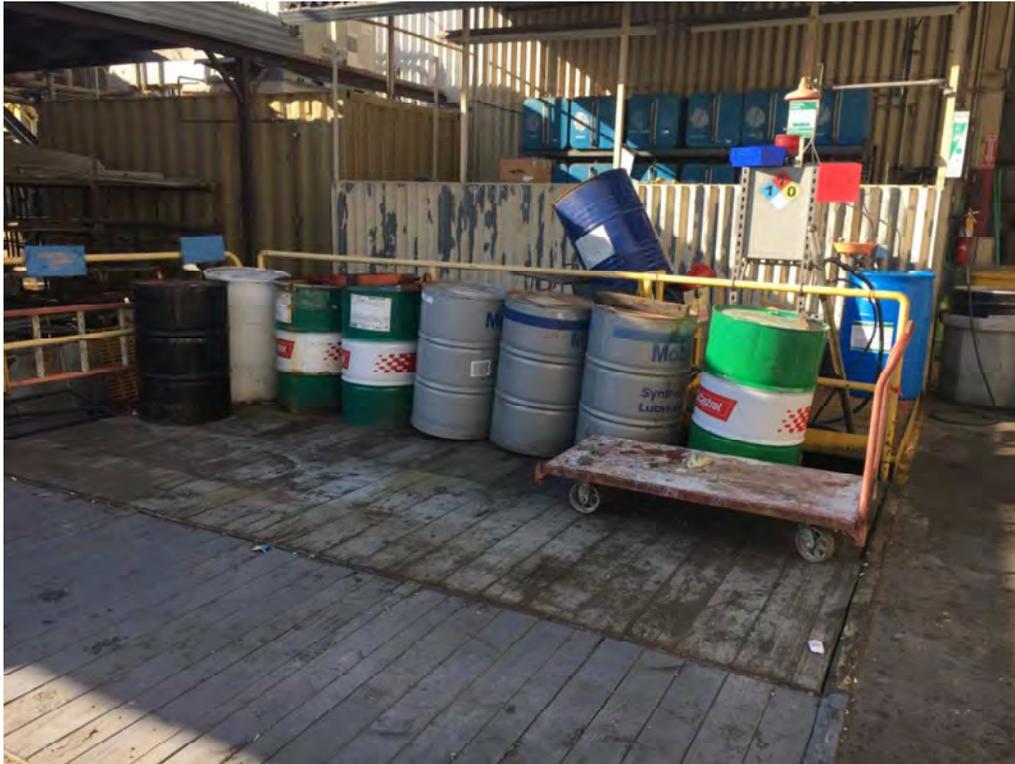
Photo 35: The site, facing southwest at the hazardous materials/waste storage platform, with used petroleum product (oil/lubricant) and solvent storage above concrete containment.

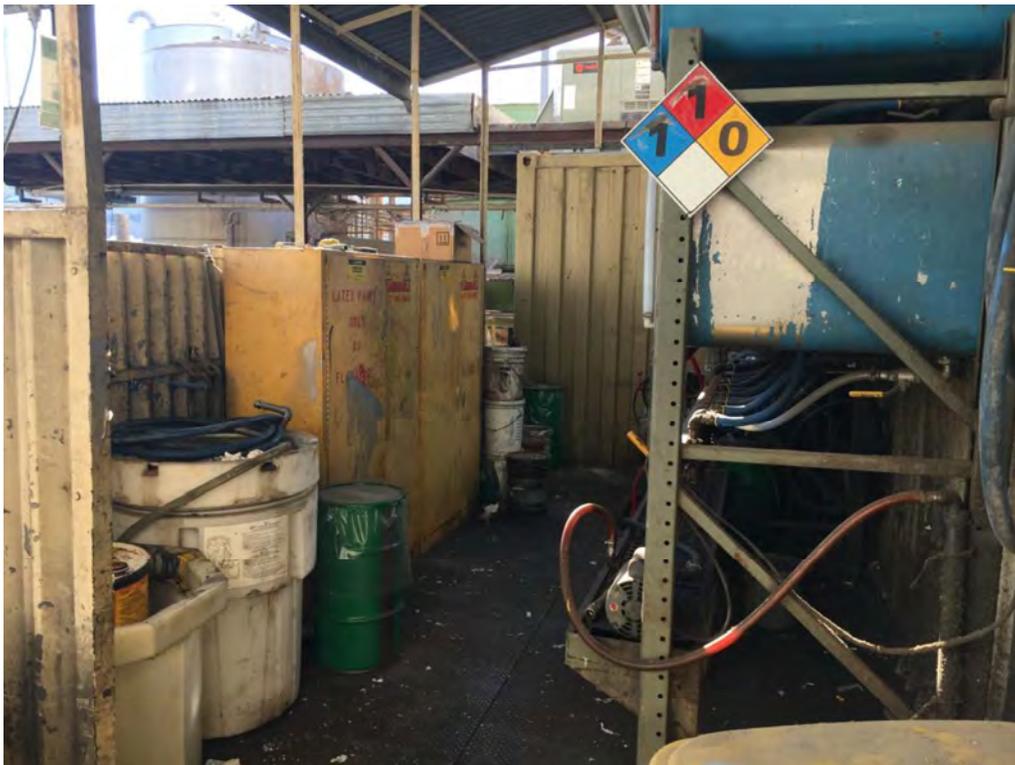
Photo 36: The site, facing south within the "lubricant shed" adjacent to hazardous materials platform, and also above concrete containment. Flammable materials cabinets and additional wastes were stored here.

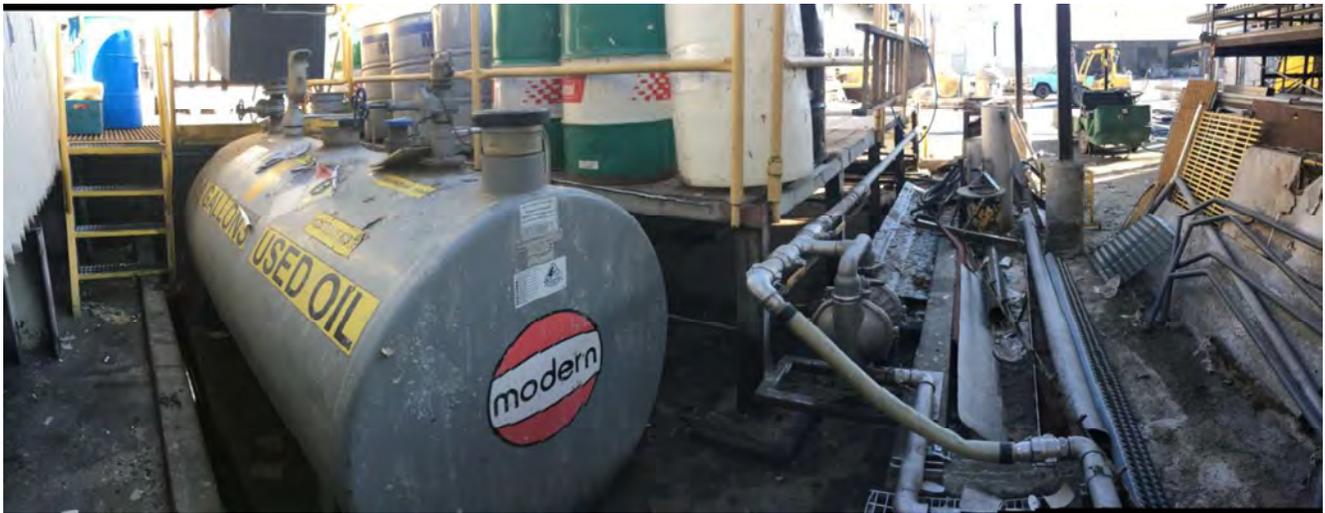
Photo 37: The site, facing northeast in the hazardous materials/waste storage area. A lubricant shed is along the left, and the hazardous materials platform is beyond at center-right, with 700 gallon used oil tank visible at center, within bermed area.

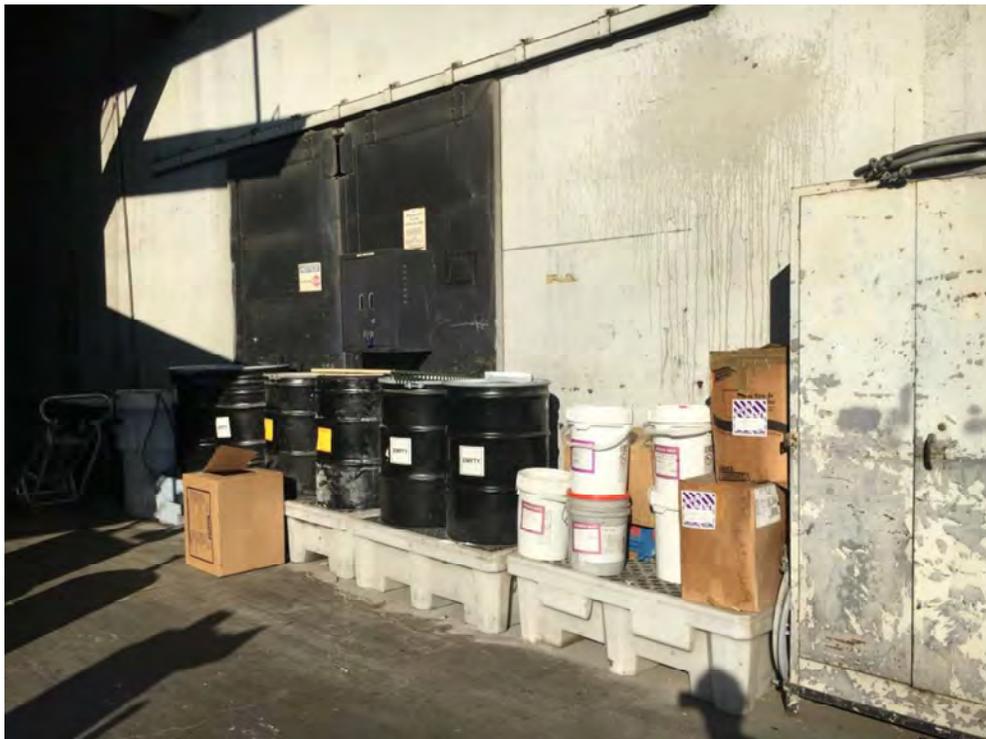
Photo 38: The site, facing northwest along the southern edge of mill building loading dock, with additional hazardous materials/waste drums (including universal wastes) on plastic secondary containment.

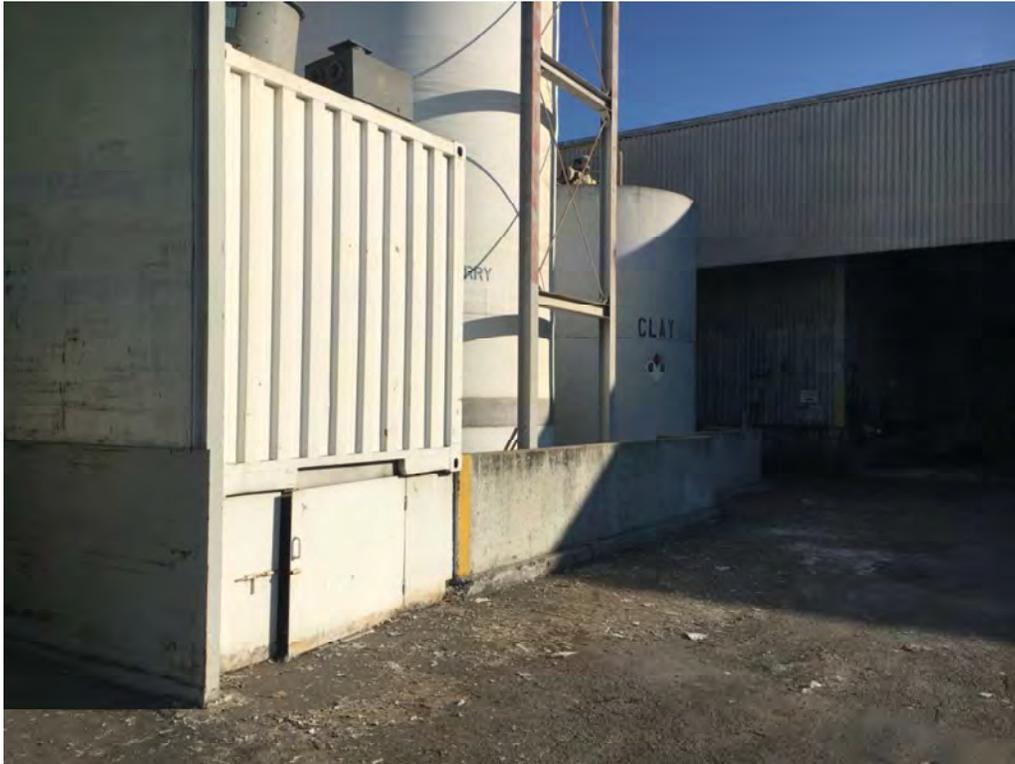
Photo 39: The site, facing northeast towards the coating bulk (clay) storage tank farm within concrete bermed secondary containment.

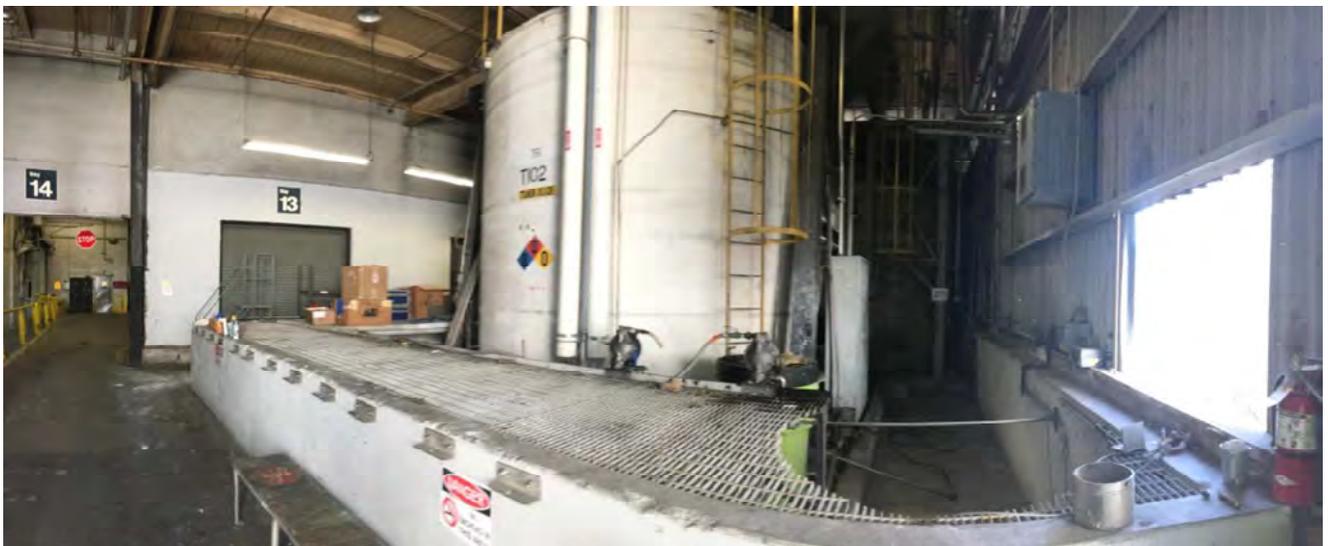
Photo 40: The site, facing southeast towards the interior bulk coating (latex) material storage area within secondary containment.

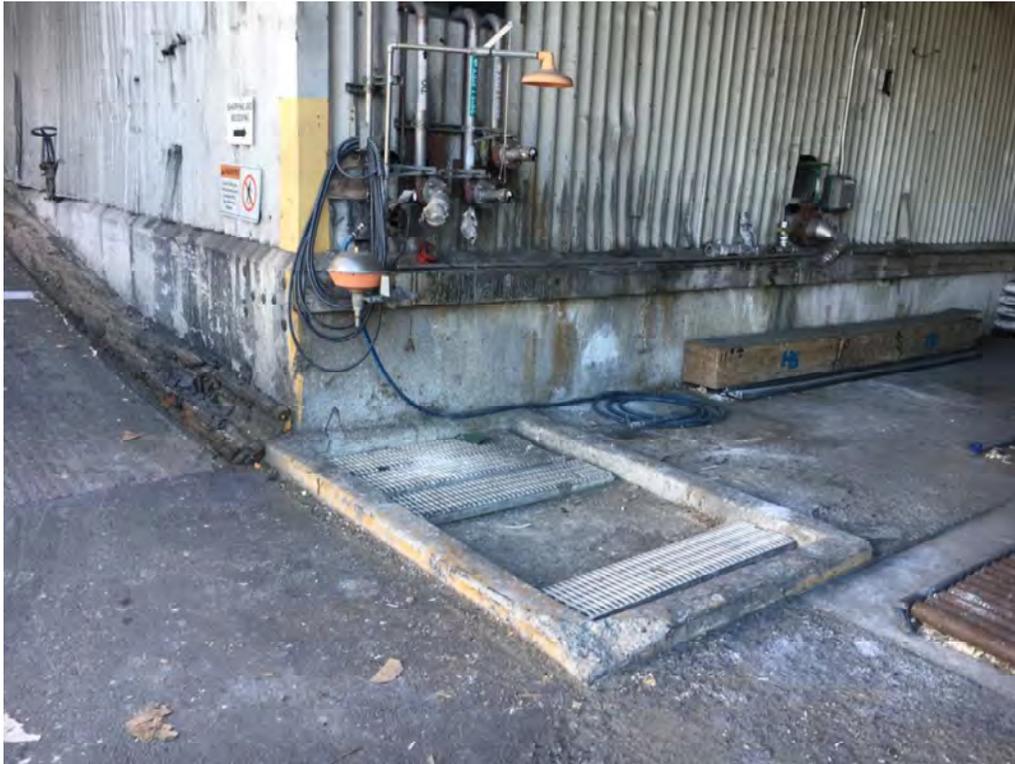
Photo 41: The site, facing northeast towards the interior coating materials fill port within small bermed area. The sanitary sewer sampling point (POTW-1) is located within the canopy covered loading dock area to the right.

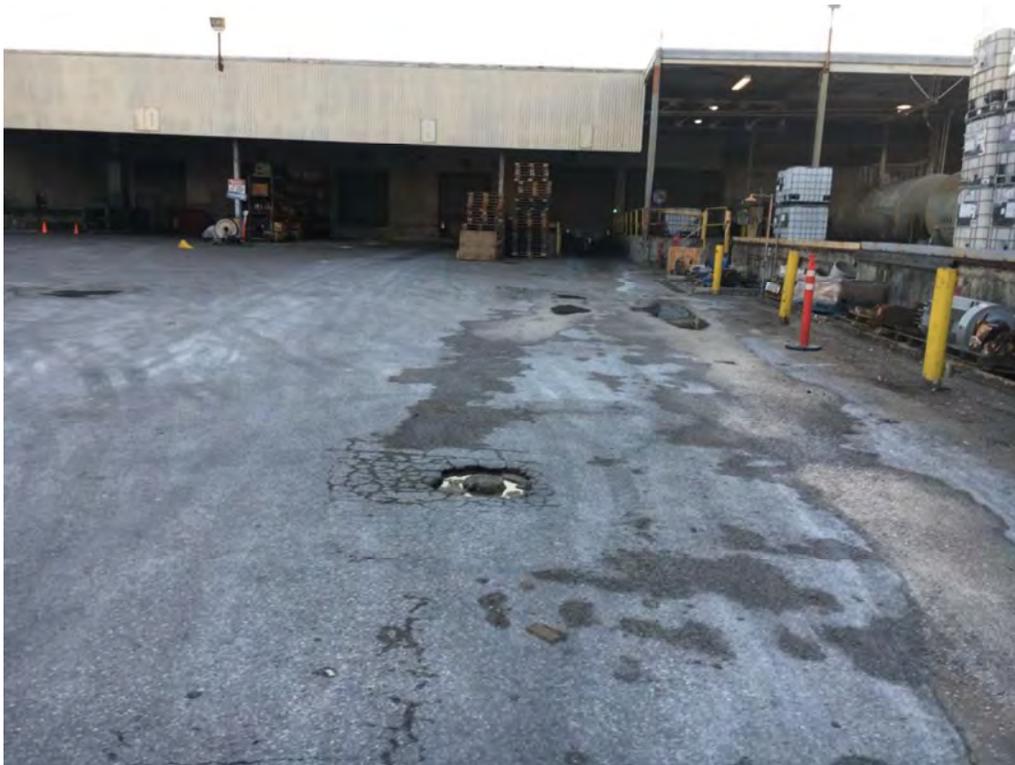
Photo 42: The site, facing east towards southeastern corner of central courtyard area. Abandoned former monitoring well locations are visible at center and beyond: the locations of former solvent and diesel USTs. A former gasoline UST is closed in place here.

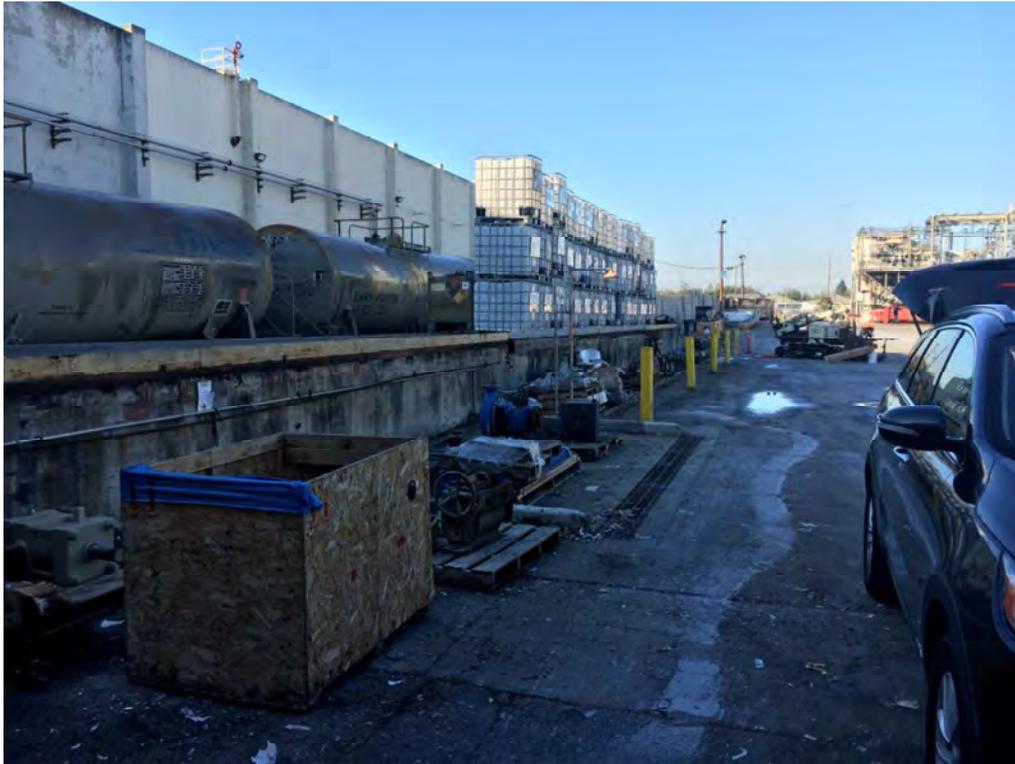
Photo 43: The site, facing southwest towards the southern extent of the central courtyard. An unloading platform extends along the southern portion of the courtyard, with empty tote storage visible at center-right, and the rail spur beyond to the left.

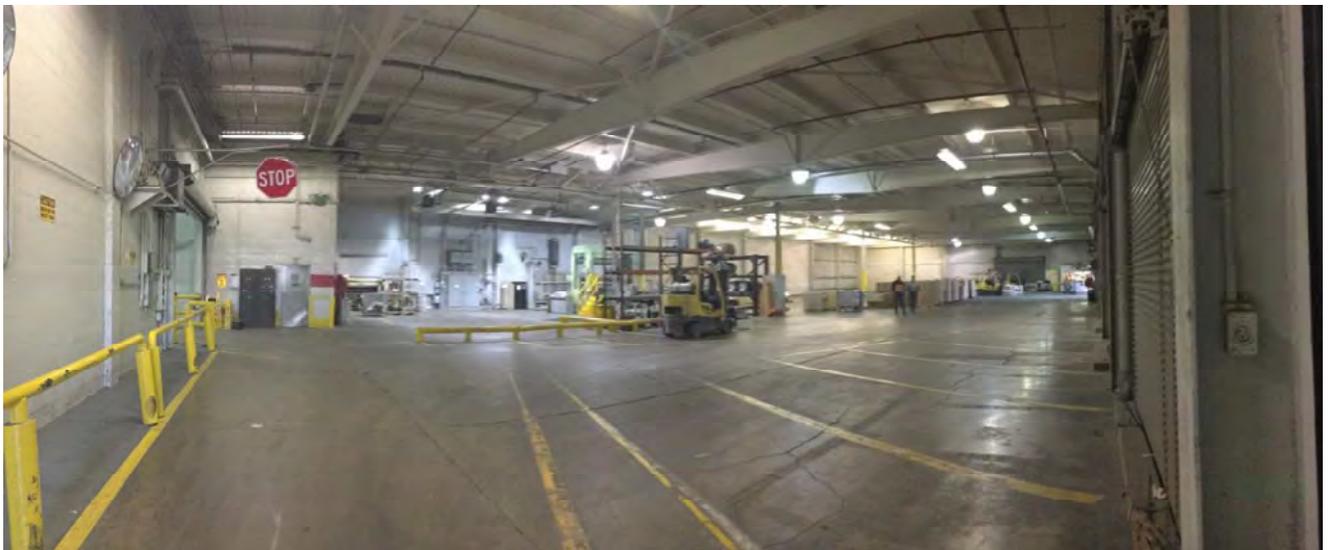
Photo 44: The site, facing southeast within the southeastern storage warehouse area (connecting the subject facility to 2500 De La Cruz) to the south (at right).

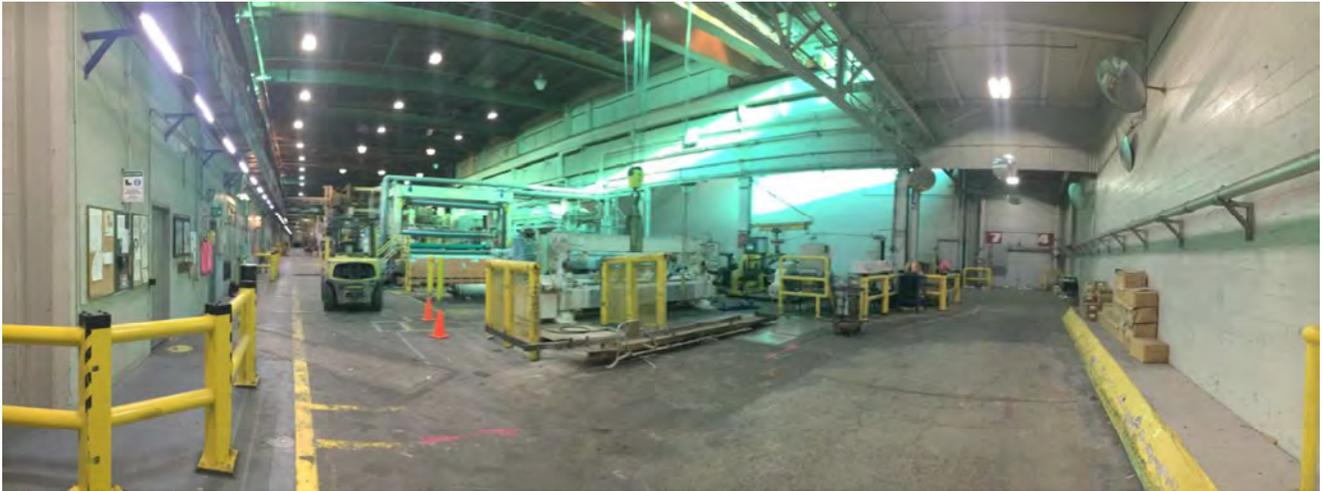
Photo 45: The site, facing northwest along the "dry" end of the process line, right sub-grade scale visible at center-right. The former sheeter room is visible beyond at center.

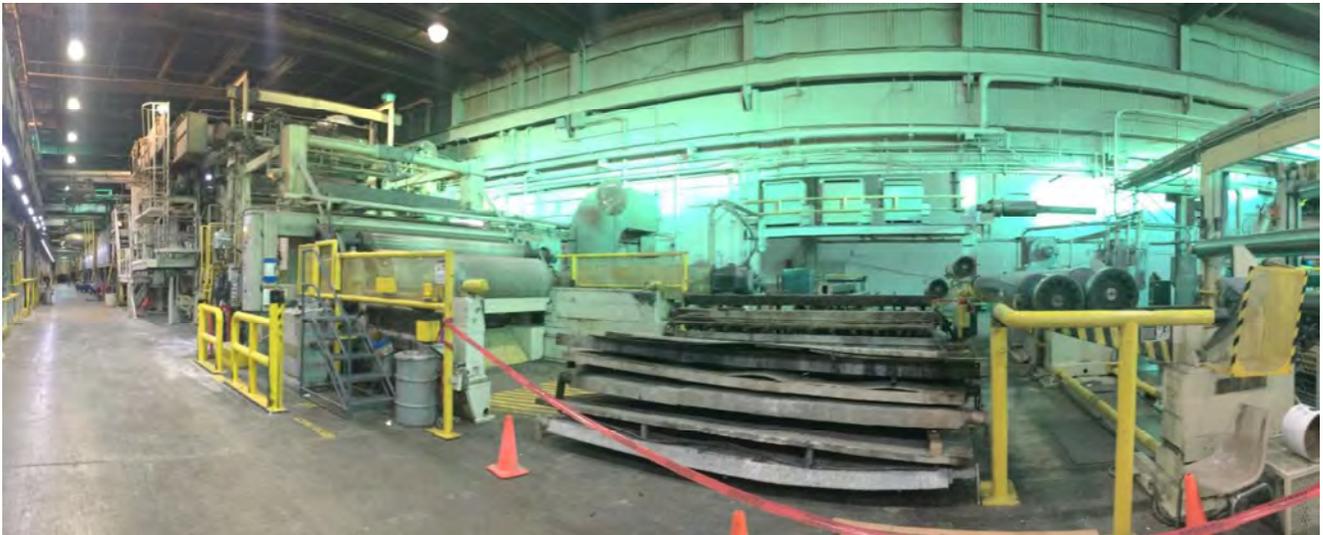
Photo 46: The site, facing northwest along the "dry" end of the process line, with dryer calendar stacks visible at left.

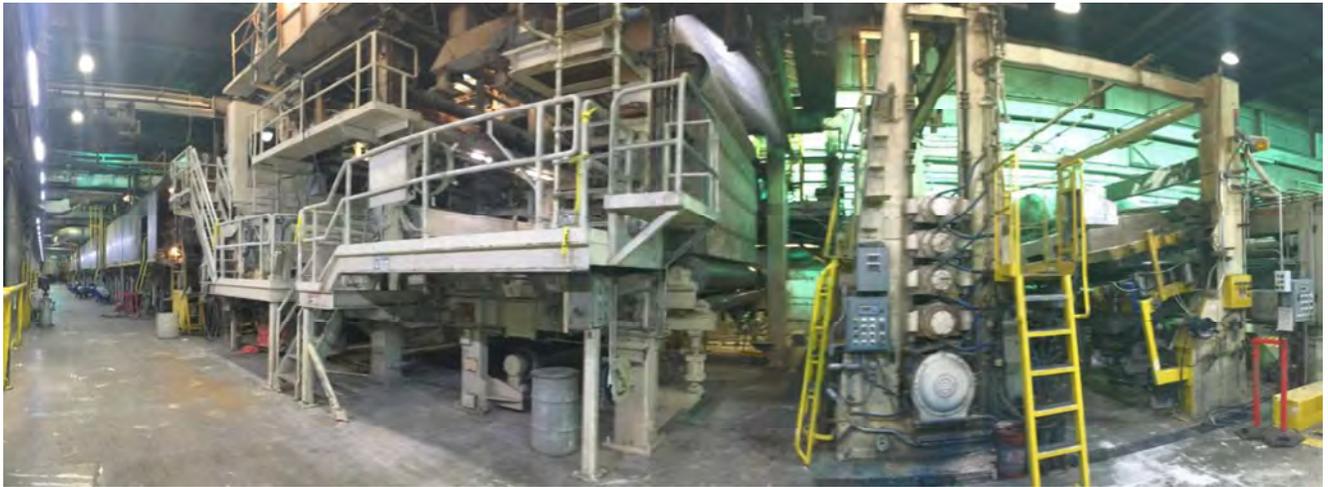
Photo 47: The site, facing northwest along the “dry” end of the process line. Scanning for product quality assurance takes place along the right.

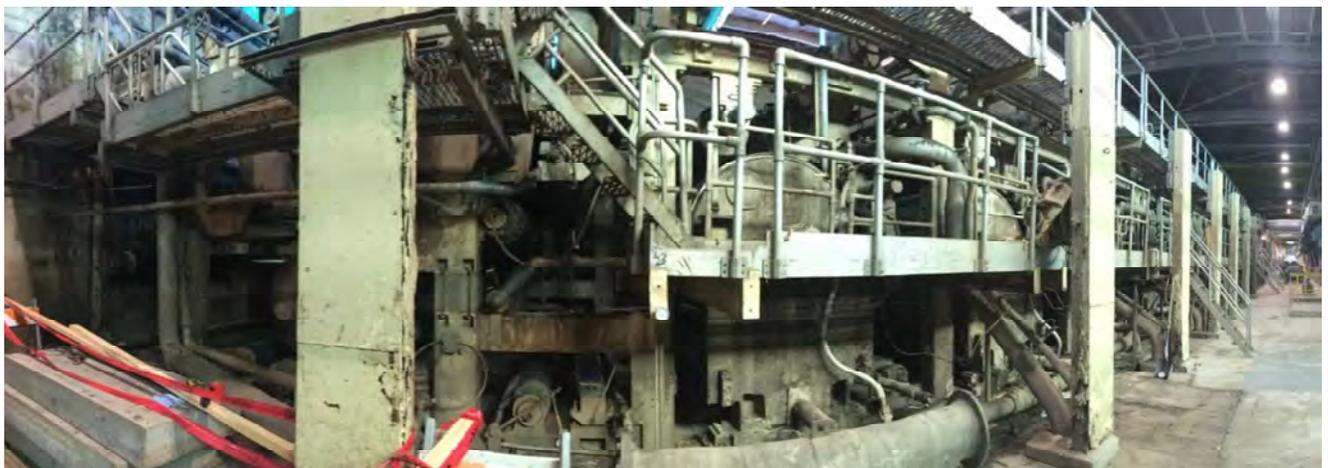
Photo 48: The site, facing north along the western-most extent of the “wet” end of the process line, where process water is utilized to form pulp webs along felt fabric.

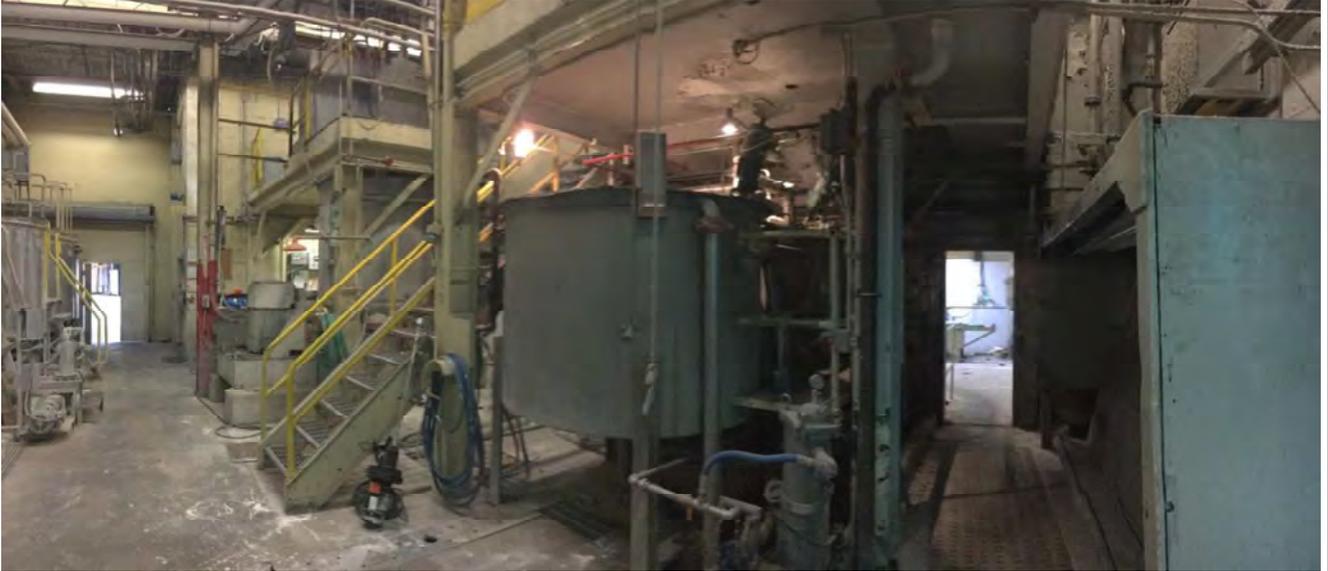
Photo 49: The site, facing southwest within the coating mixing room, with several aboveground vat vessels utilized to mix clay, latex, and other pigments and additives as coating/sealant for use at the "dry" end of process line.

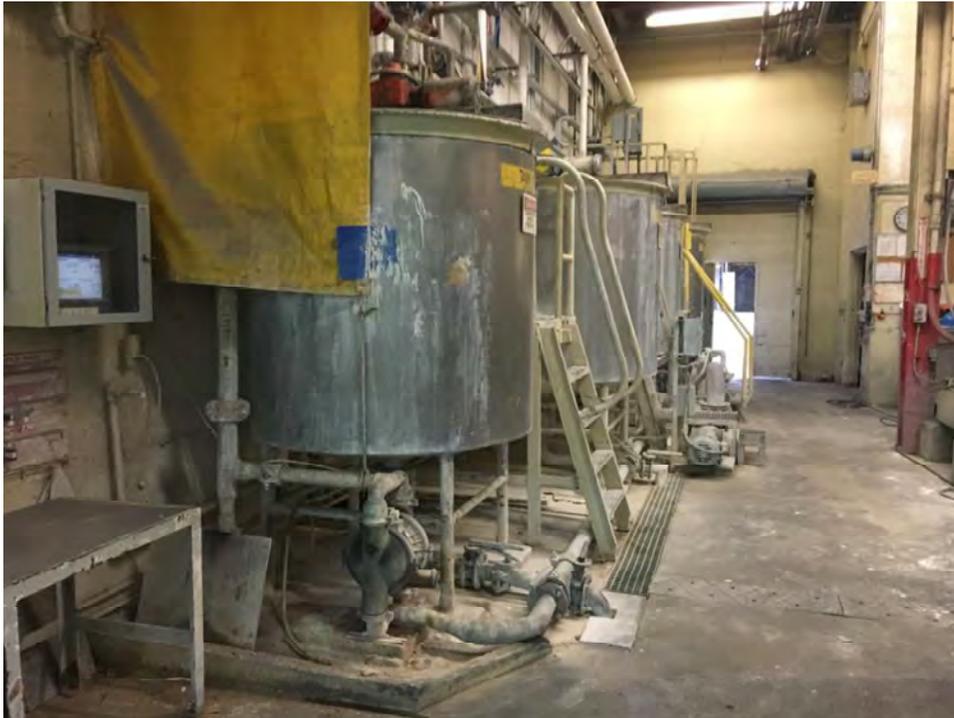
Photo 50: The site, facing south within the coating mixing room, with additional aboveground vessels for mixing coating materials.

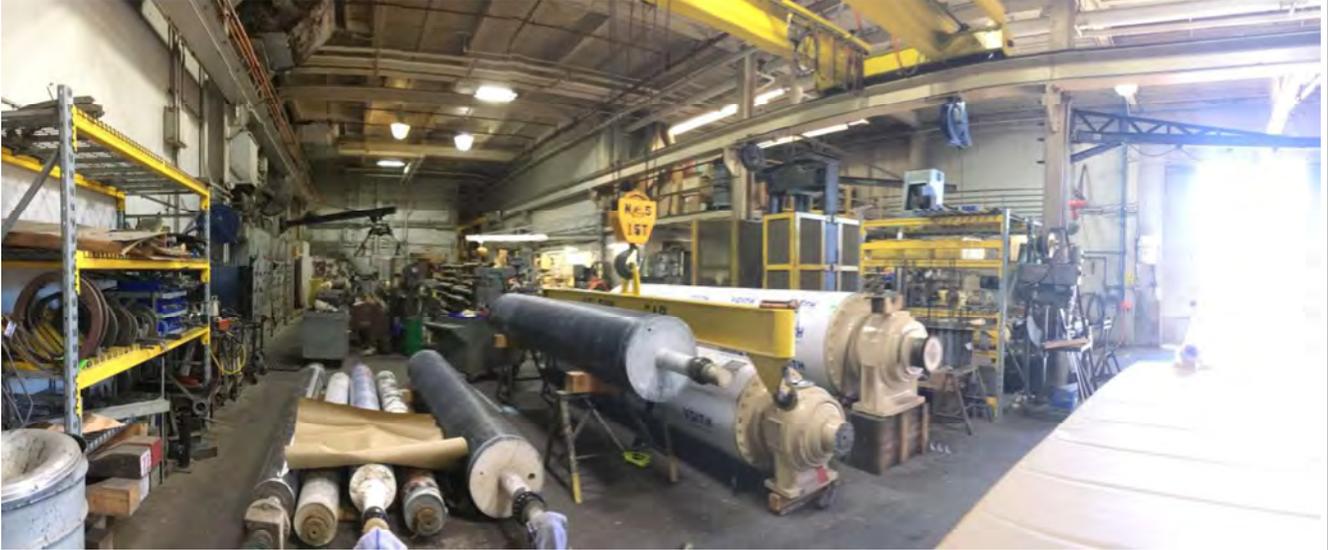
Photo 51: The site, facing southeast within the southern maintenance room, where machining and parts cleaning takes place.

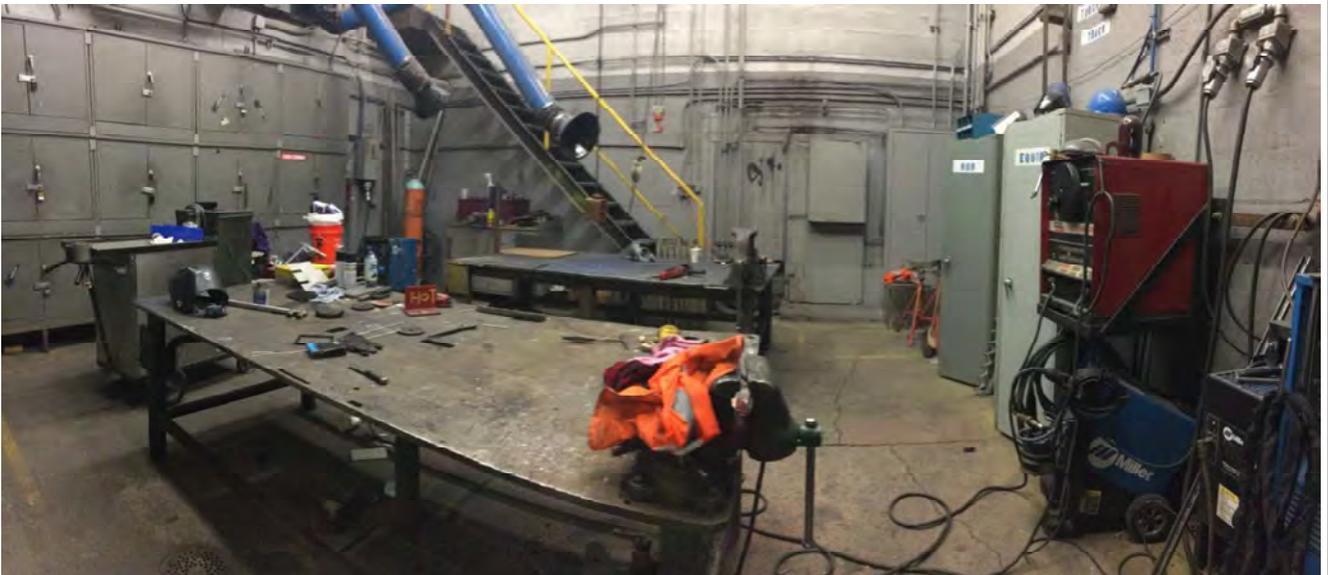
Photo 52: The site, facing east within the eastern welding room (adjacent to maintenance room). Compressed gases are utilized here.

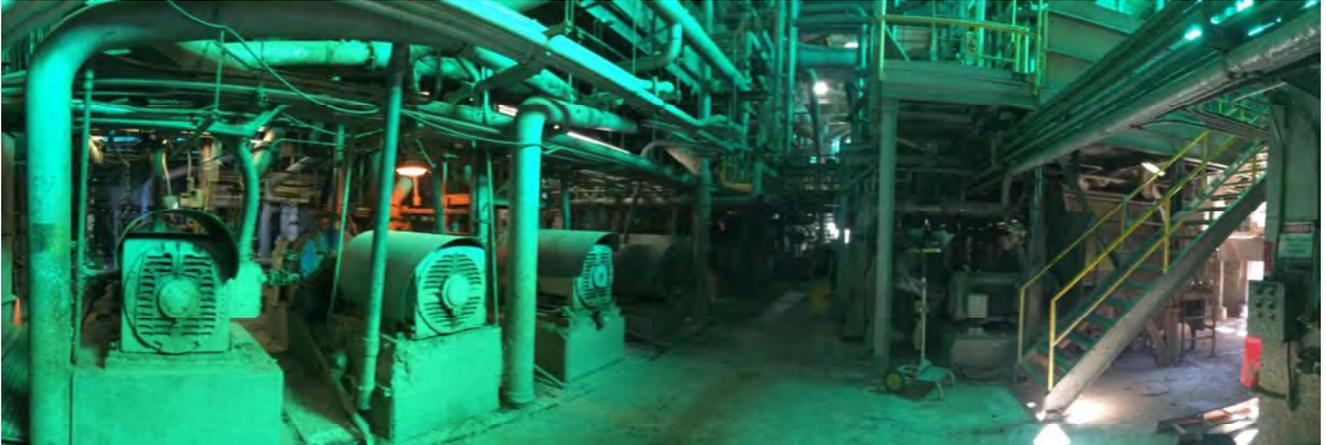
Photo 53: The site, facing northeast from along the southwestern interior corner of the mill building, within the fiber treatment area. The former dye room is visible along the right extent.

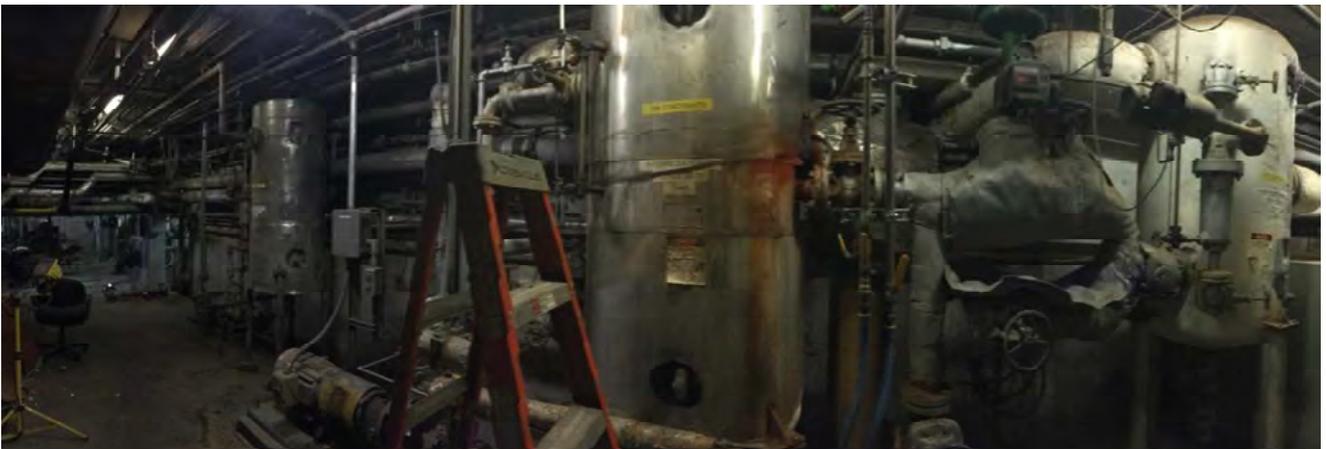
Photo 54: The site, within the basement area beneath the "wet" end. Several condensate tanks are stored within this area.

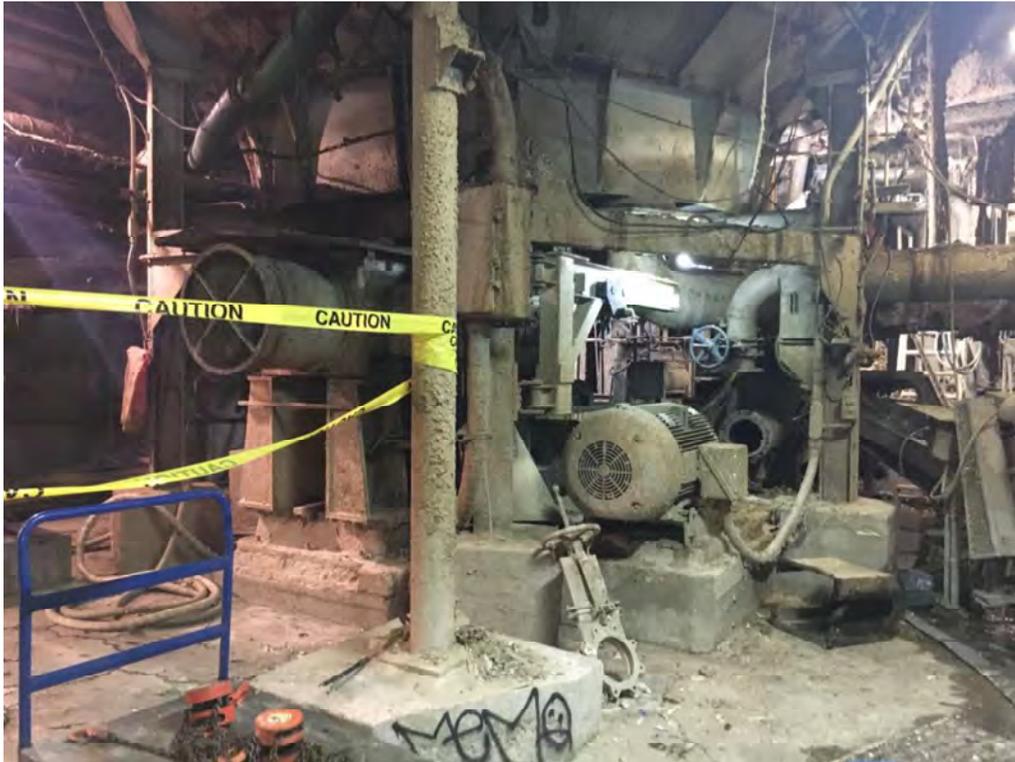
Photo 55: The site, facing southeast within the below-ground basement area. One of three interior pulper vessels (this is the filler pulper) with sub-grade containment (bottom-center) are located in this region of the basement. Oil reservoirs are located along the sides of each pulper.

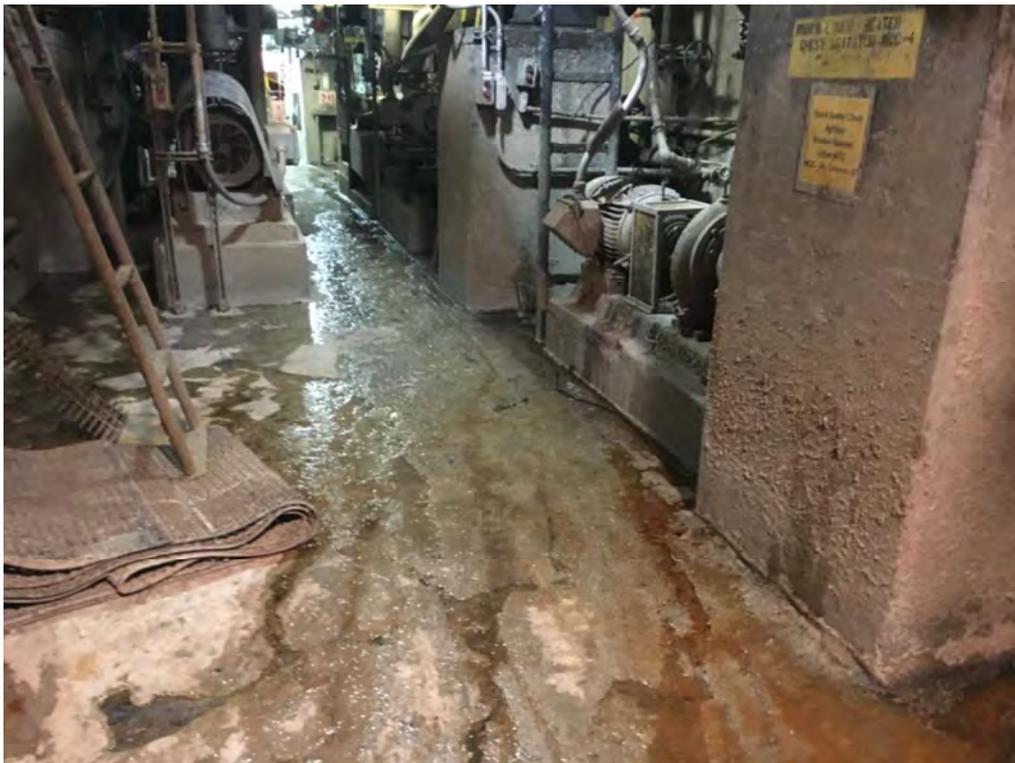
Photo 56: The site, facing northwest within the below-ground basement area. Groundwater intrusion is visible in this area.
