<b>Docket Number:</b>	19-SPPE-03
<b>Project Title:</b>	Sequoia Data Center
<b>TN #:</b>	229419-3
<b>Document Title:</b>	Appendices A-N - part 2
<b>Description:</b>	N/A
<b>Filer:</b>	Patty Paul
<b>Organization:</b>	C1-Santa Clara, LLC
<b>Submitter Role:</b>	Applicant
<b>Submission Date:</b>	8/14/2019 2:25:14 PM
<b>Docketed Date:</b>	8/14/2019

**APPENDIX B**  
**BAAQMD STATIONARY SOURCE**  
**INQUIRY FORM**

# CyrusOne Santa Clara 1 Data Center

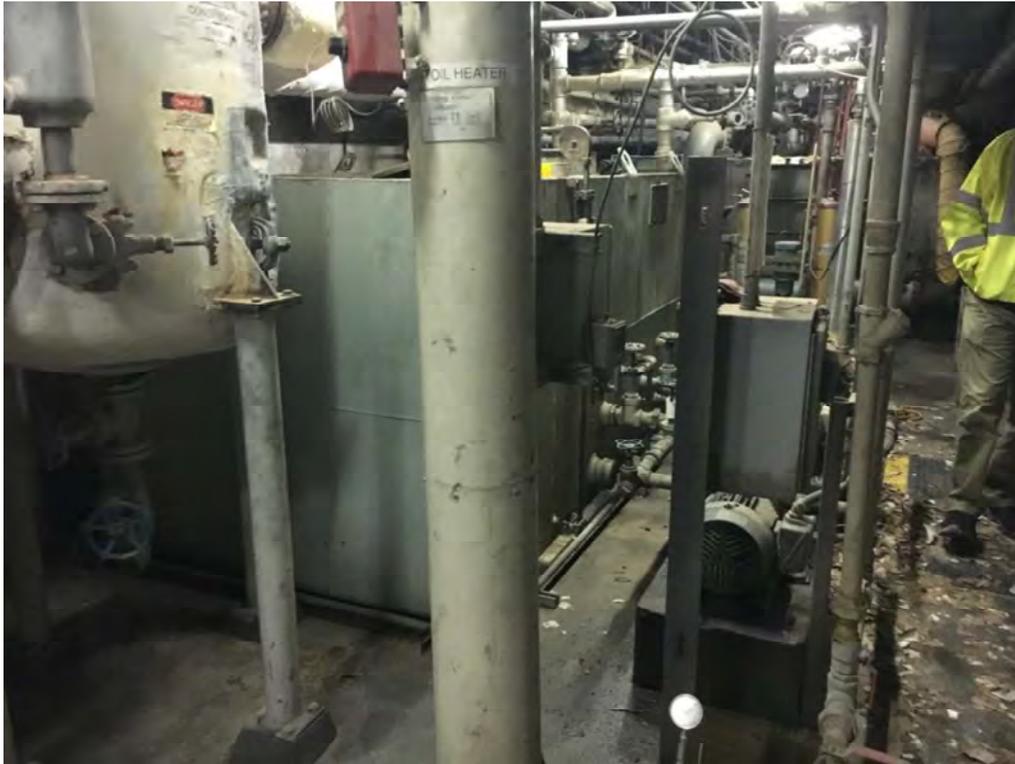
Photo 57: The site, facing northeast within the below-ground "basement" area. The 1,500 gallon "Bowser" AST for petroleum oil/lubricant storage for the process line is located here.

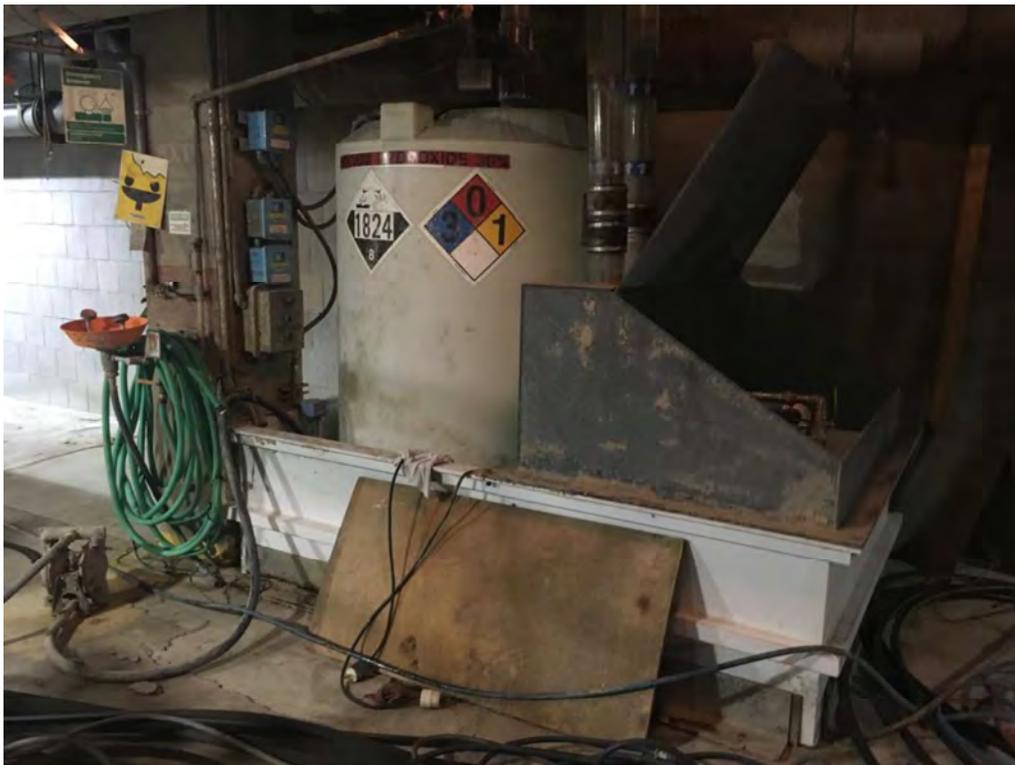
Photo 58: The site, facing northwest within the below-ground basement area. A 400 gallon aboveground container is located here within secondary containment for sodium hydroxide, conveyed here from the northwestern exterior tank farm.
