DOCKETED	
Docket Number:	16-AFC-01C
Project Title:	Stanton Energy Reliability Center - Compliance
TN #:	229492-9
Document Title:	Stanton Energy Reliability Center Monthly Compliance Report No. 5 Part 2
Description:	N/A
Filer:	Cenne Jackson
Organization:	California Energy Commission
Submitter Role:	Commission Staff
Submission Date:	8/20/2019 10:06:38 AM
Docketed Date:	8/20/2019

Subject Stanton Energy Reliability Center (16-AFC-1C)
Cultural Resources Monthly Compliance Report
June 2019

Monthly Report of Paleontological Resources Monitoring Activities for the Stanton Energy Reliability Center

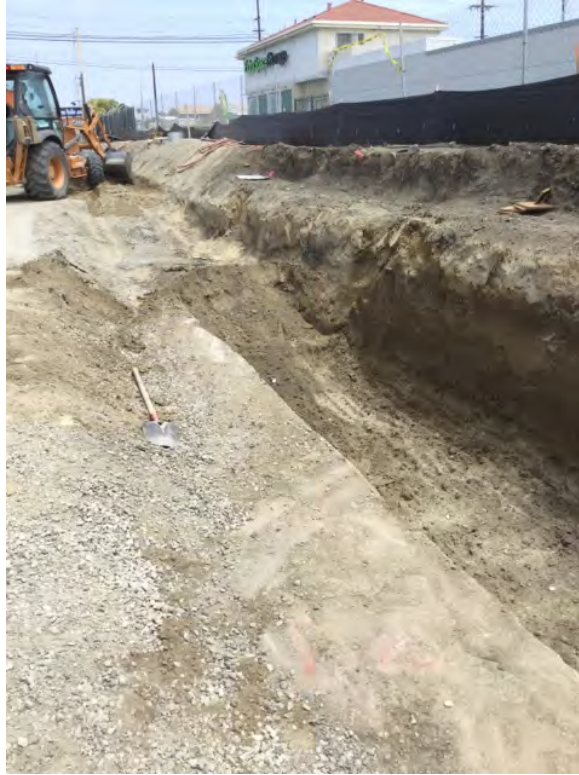
6/3/2019 1:43:20 PM

Parcel 1 excavations were within a poorly-indurated, fine/moderately-sorted, sub-rounded, light gray to buff fine-med sand (quartz-rich) with orange/beige laminae staining already exposed as excavations began at ~5'bgs.

66kv trench east end

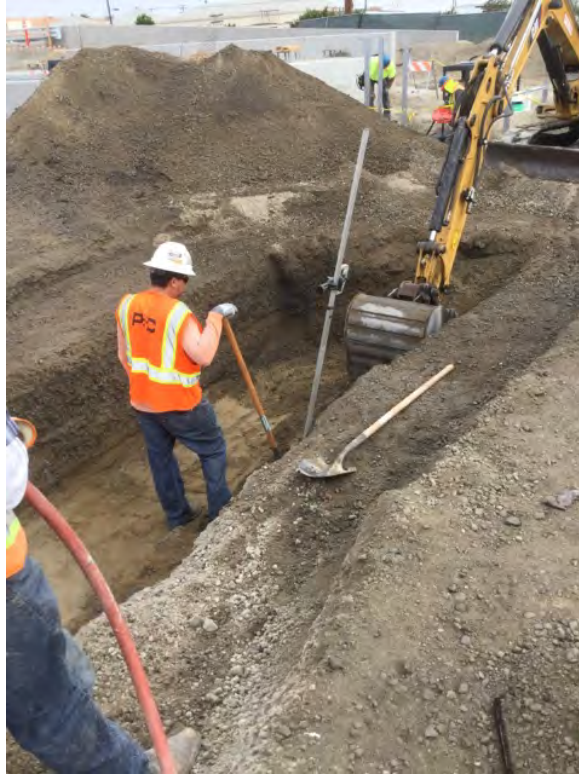
6/12/2019 8:00:51 AM

Excavation of a duct bank lateral off of the 66kv, going north

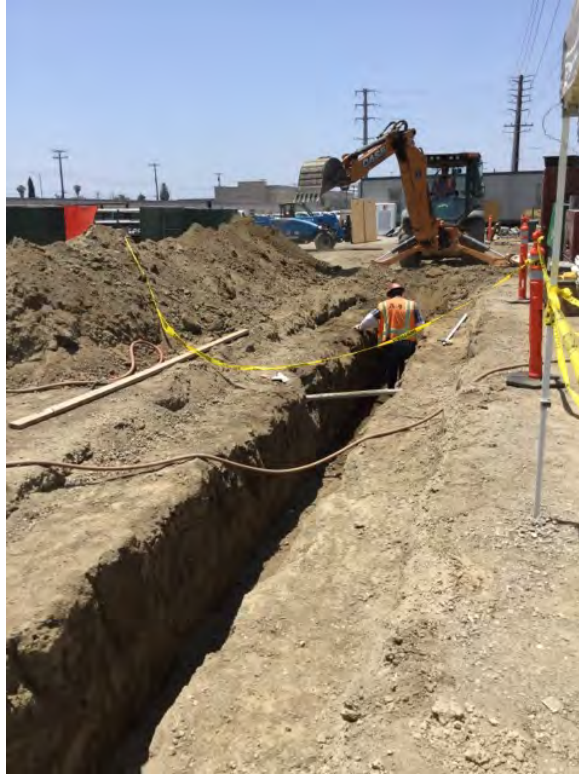
6/19/2019 12:52:48 PM

Fire protection line running west, close to ARB trailers

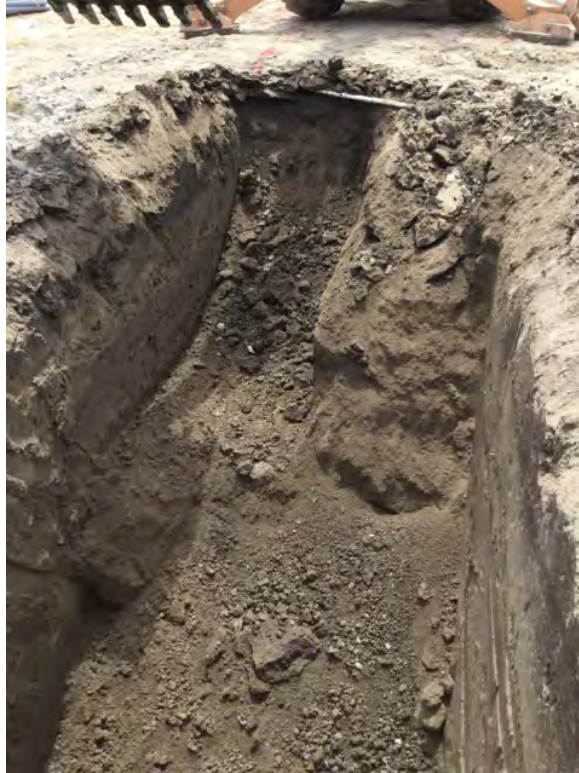
6/24/2019 1:57:44 PM

Excavation showed top layer of disturbed dark brown sandy loam roughly 2' thick, followed by a poorly-indurated, fine/moderately-sorted, sub-rounded, light gray to buff fine-med sand (quartz-rich) with orange/beige laminae staining.

View of the 66kv trench location closer to dale ave at ~13' depth

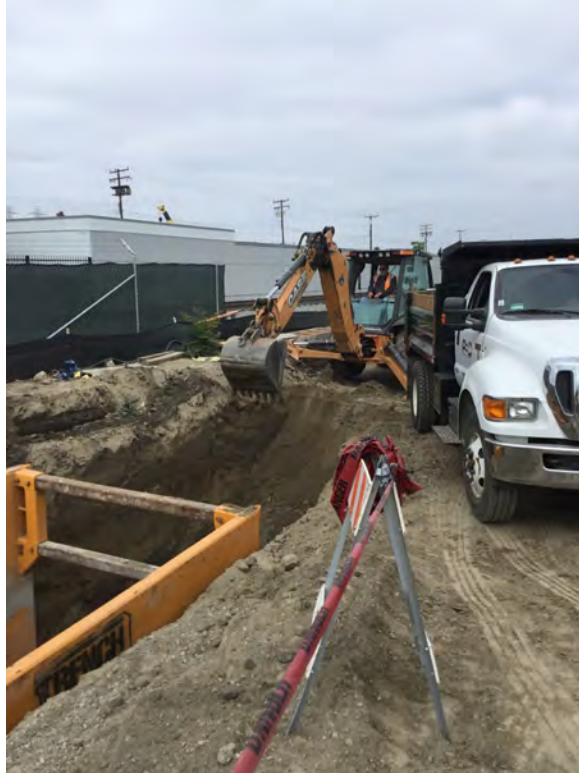
6/28/2019 9:17:02 AM

Excavation in parcel 1 66kv Duct bank
