Genesis Solar Energy Project

Summary Report for Botanical Conservation Measures Year 2020

**GENESIS SOLAR ENERGY PROJECT
SUMMARY REPORT FOR BOTANICAL CONSERVATION MEASURES
YEAR 2020**

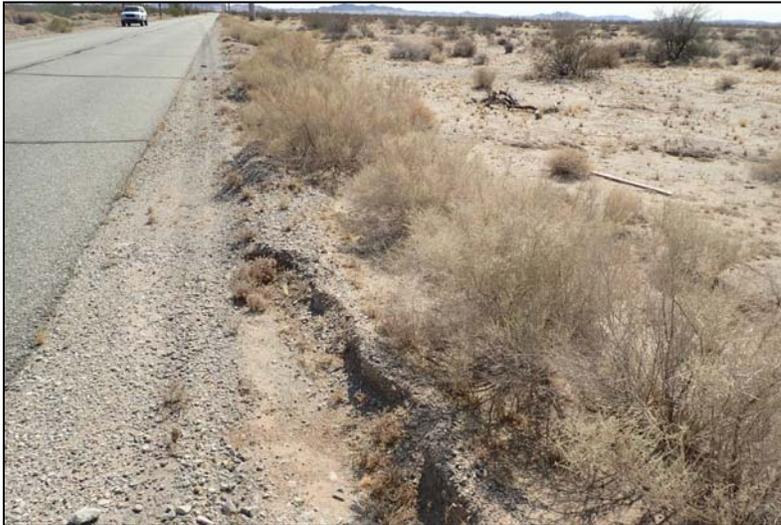
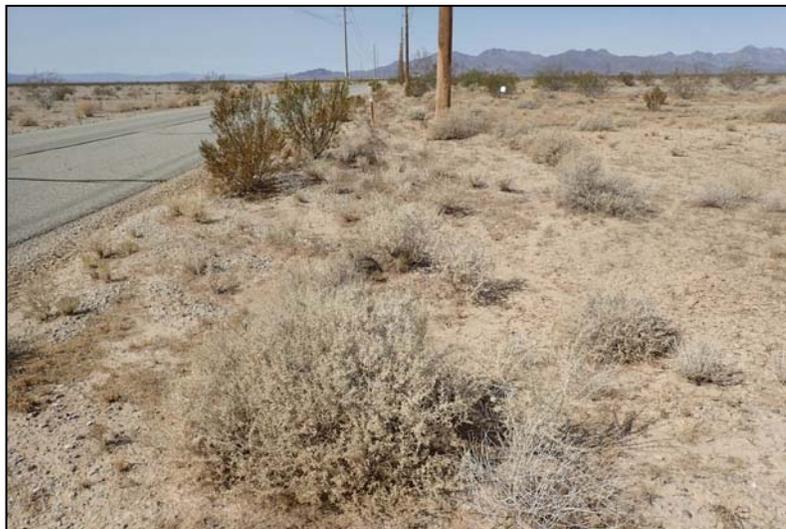
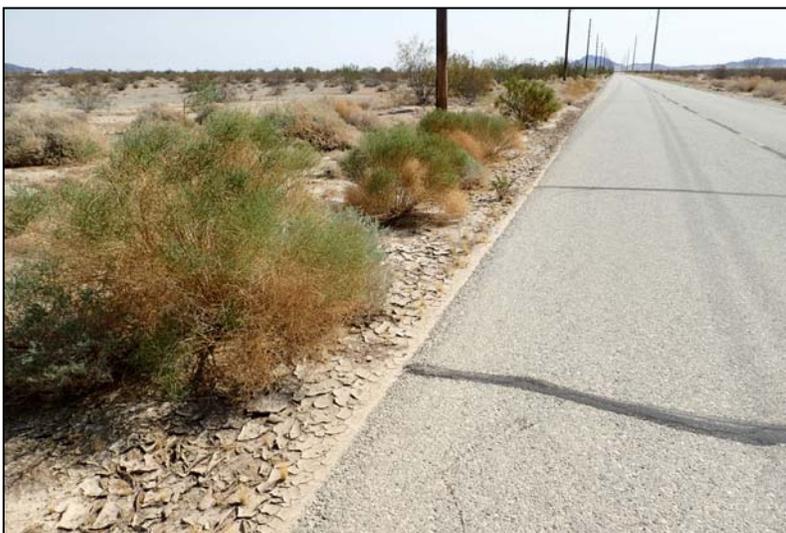
In Year 6 after active restoration, shrub and bunch grass regrowth is robust on the restored road shoulders and substantially greater than in the surrounding native habitat (Figure 1), consistent with earlier observations and measurements⁹. Plant density is not only much greater on the shoulders than in the surrounding native habitat, but individuals are robust - creosote bush (*Larrea tridentata*)

Figure 1. Examples of the high growth in aggressively created berms and swales from Fall 2013 and Spring 2014 restoration

is often over a meter tall. This indicates that revegetation success has proceeded beyond mere germination; growth is also well supported.

The site has experienced substantial drought since restoration began in Fall 2013. Three of seven winters have been dry and four summers have had either no rain, or only minor and patchy rainfall. Despite this, the combined restoration approaches of aggressive surface re-contouring to capture seed, sediment, and water, and to a lesser extent active seeding (on the southern shoulder), have successfully resulted in robust germination (initial recruitment) and continued growth toward a mature, functioning community. Soil functioning, water capture and seed capture appear to be sufficient to support continued passive restoration of the road shoulders. No additional efforts are currently recommended.
