Docket Number:	07-AFC-06C
Project Title:	Carlsbad Energy Center - Compliance
TN #:	237842
Document Title:	Monthly Compliance Report- April 2021
Description:	Demolition of Encina Demolition - Monthly Compliance Report for April 2021.
Filer:	Anwar Ali
Organization:	Carlsbad Energy Center LLC
Submitter Role:	Applicant
Submission Date:	5/18/2021 3:47:30 PM
Docketed Date:	5/18/2021

**RE: AMENDED CARLSBAD ENERGY CENTER PROJECT, DOCKET NO. 07-AFC-06C, DEMOLITION OF ENCINA POWER STATION
CONDITION OF CERTIFICATION, COM-6
APRIL 2021, MONTHLY COMPLIANCE REPORT**

April 2021

***Submitted by: Cabrillo Power I LLC
Date Submitted: 05-14-2021***

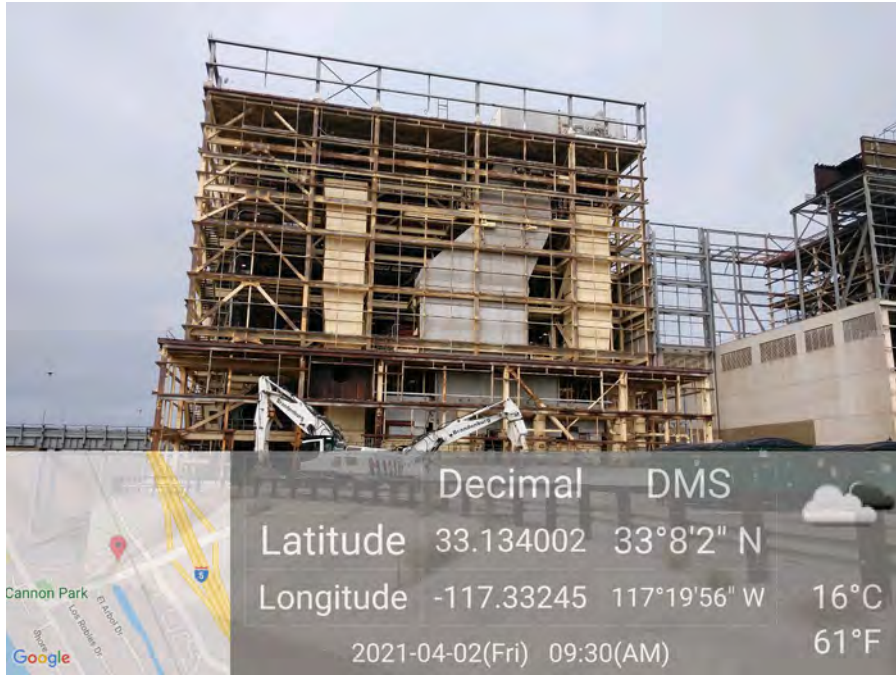
Photo 1

Location	EPS site	Description	Overview of demolition activities within the site.
----------	----------	-------------	--

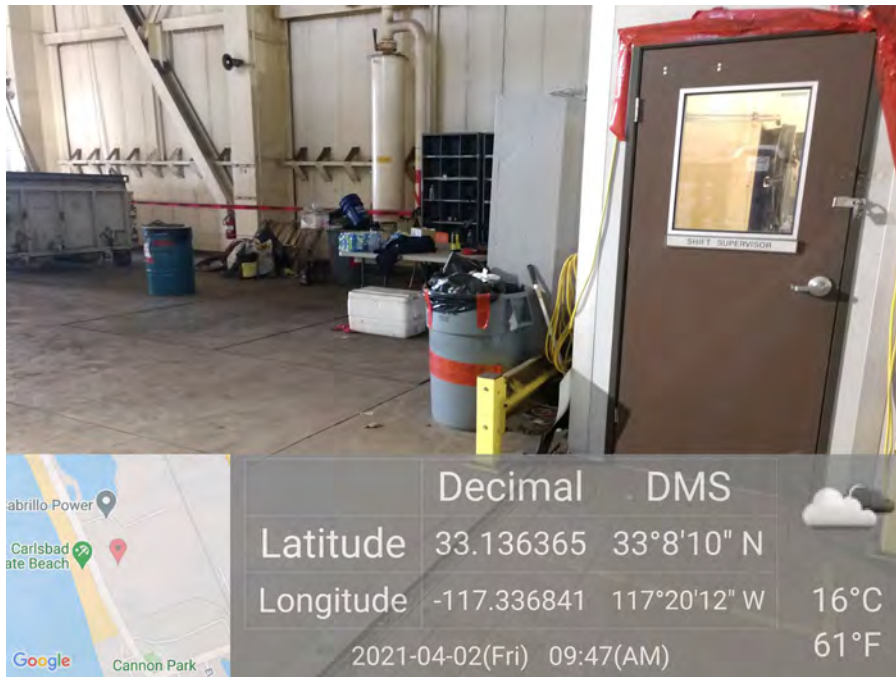
Photo 2

Location	EPS site	Description	An uncovered trash receptacles was observed.
----------	----------	-------------	--

Items Requiring Action/Follow-up					
<ul style="list-style-type: none"> • A request was submitted to the contractor to conduct litter removal and to cover all trash receptacles. 					
Wildlife Species Observed					
<p>American bushtit (<i>Psaltiriparus minimus</i>), American crow, American peregrine falcon, Anna's hummingbird (<i>Calypte anna</i>), black phoebe (<i>Sayornis nigricans</i>), California brown pelican, common raven (<i>Corvus corax</i>), common yellowthroat (<i>Geothlypis trichas</i>), double-crested cormorant, European starling, Heermann's gull (<i>Larus heermanni</i>), house finch, hmourning dove, royal tern (<i>Thalasseus maximus</i>), song sparrow (<i>Melospiza melodia</i>), western fence lizard (<i>Sceloporus occidentalis</i>), western gull (<i>Larus occidentalis</i>), and white-crowned sparrow (<i>Zonotrichia leucophrys</i>).</p>

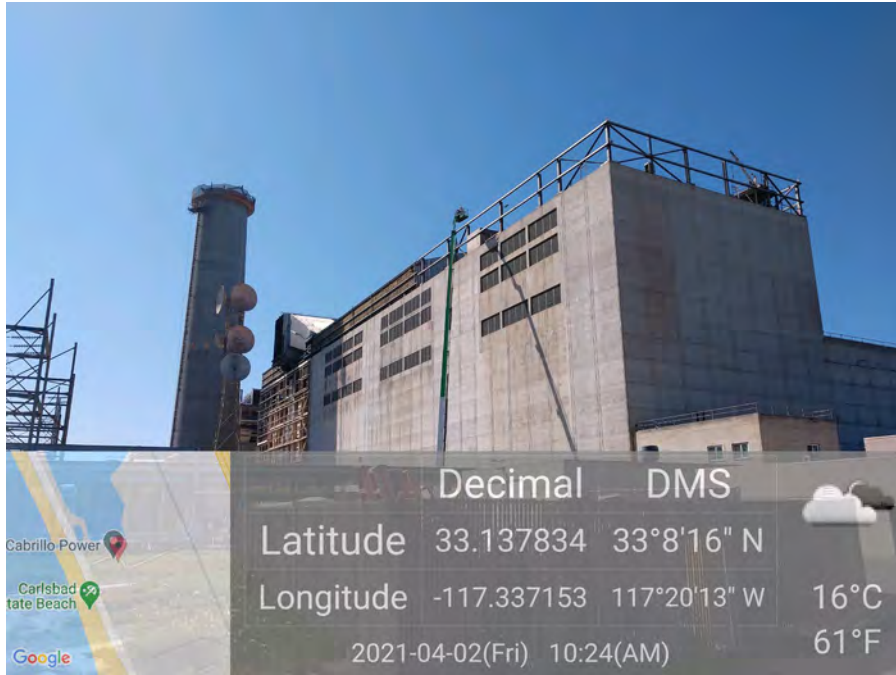
Photo 3

Location	EPS site	Description	House finch activity was observed in the louvers.
----------	----------	-------------	---

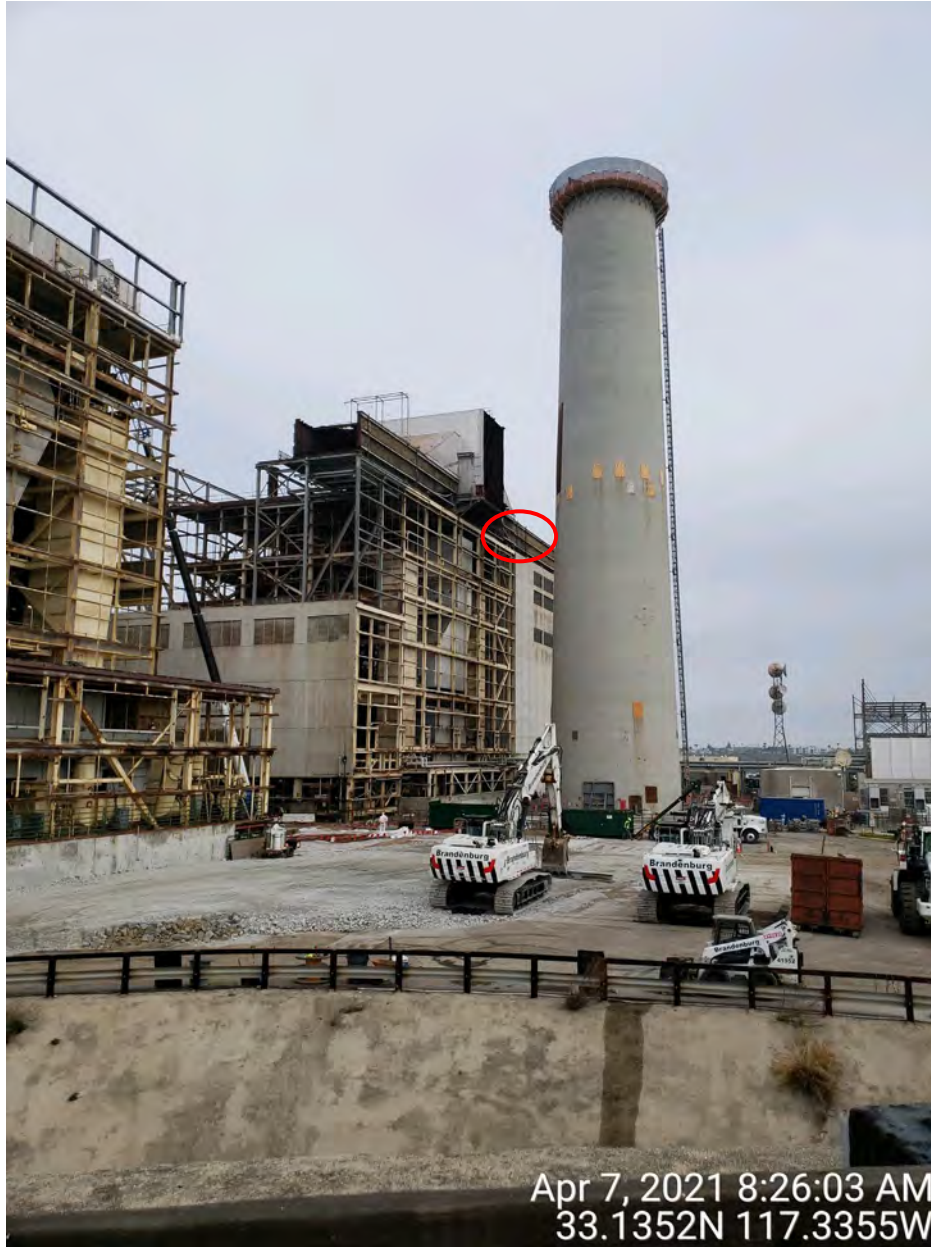
Photo 1

Location	33.1352N, 117.3355W Facing north	Description	Location of the peregrine falcon nest on the eastern side of the EPS from the observation location in the Laydown Yard.
-----------------	-------------------------------------	--------------------	---

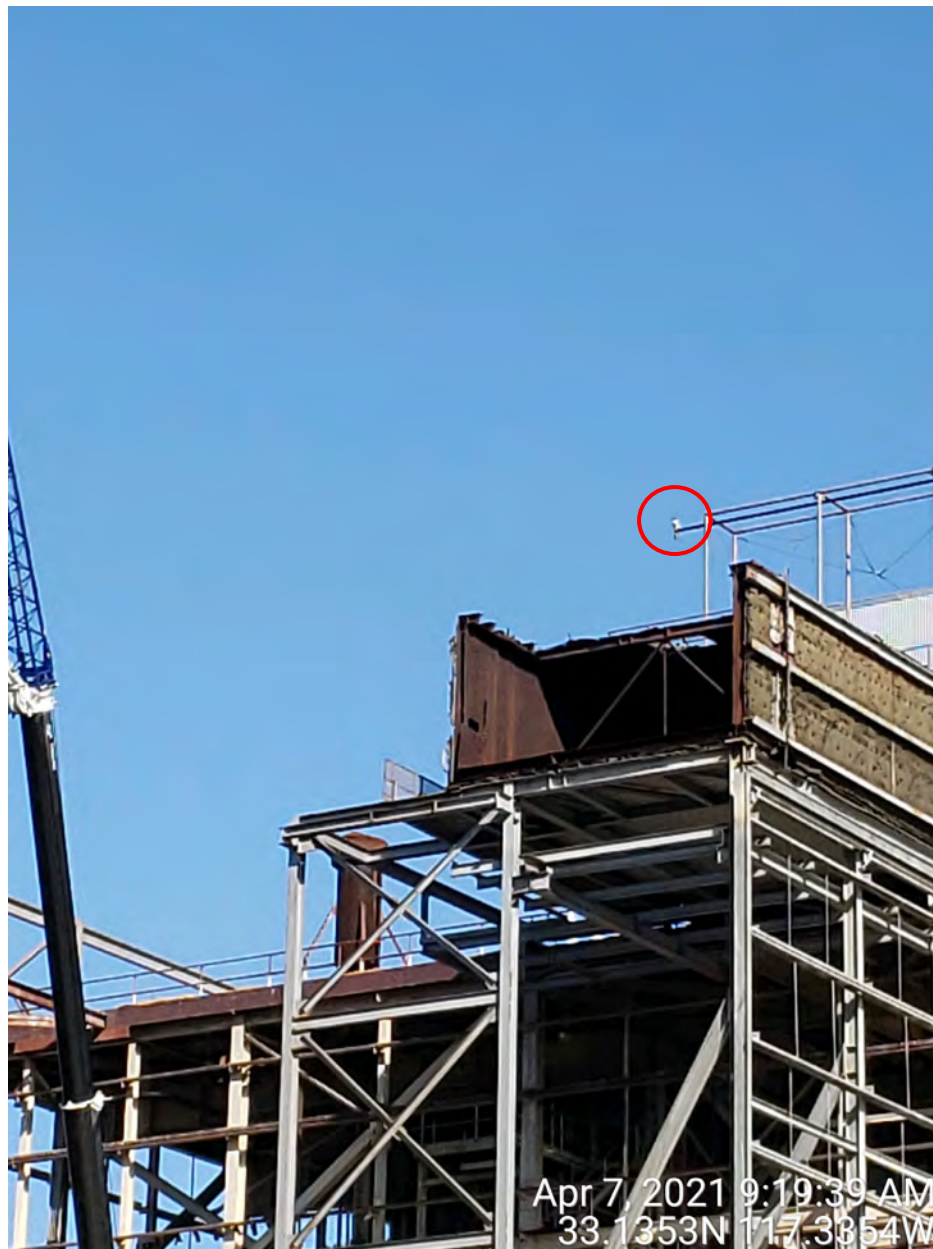
Photo 2

Location	33.1353N, 117.3354W Facing northwest	Description	Non-incubating peregrine falcon adult observed perched on top of the EPS near active crane activities.
-----------------	---	--------------------	--

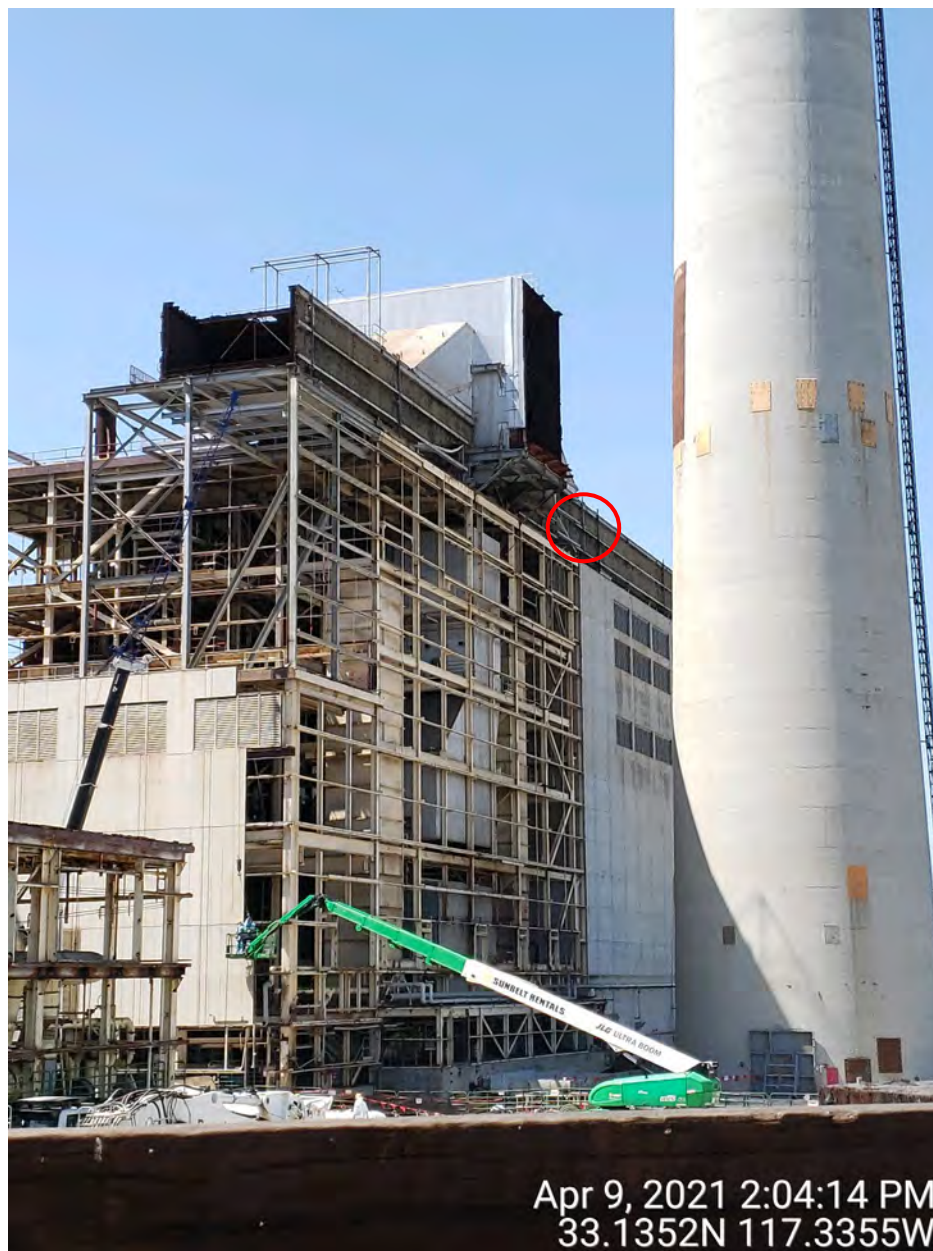
Photo 2

Location	33.1352N, 117.3355W Facing northwest	Description	Both peregrine falcon adults at the nest, with the non-incubating adult perched on the nest ledge next to the incubating adult.
-----------------	---	--------------------	---

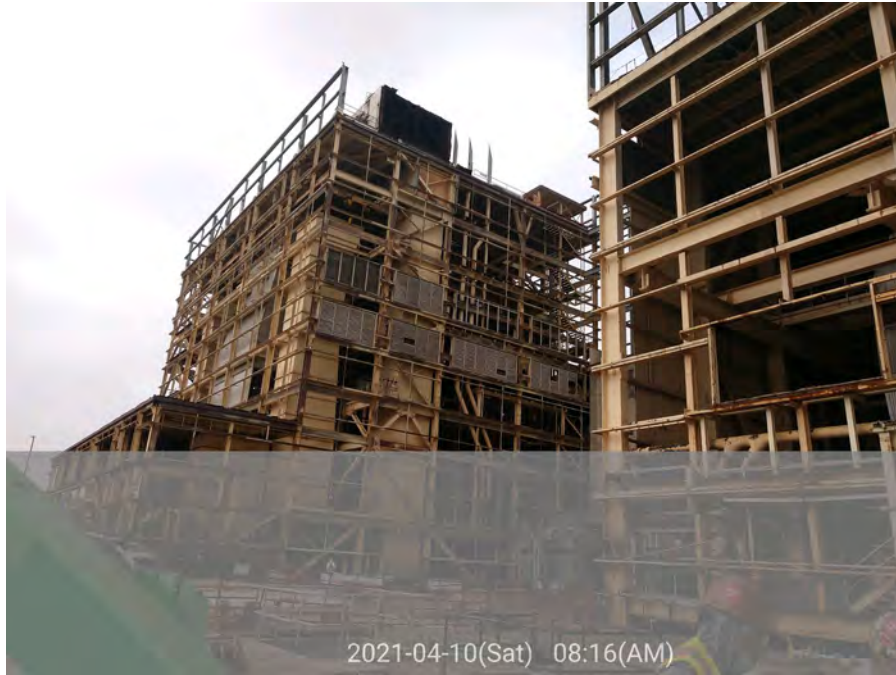
Photo 1

Location	EPS site	Description	House finches were observed flying into the louvers.
-----------------	----------	--------------------	--

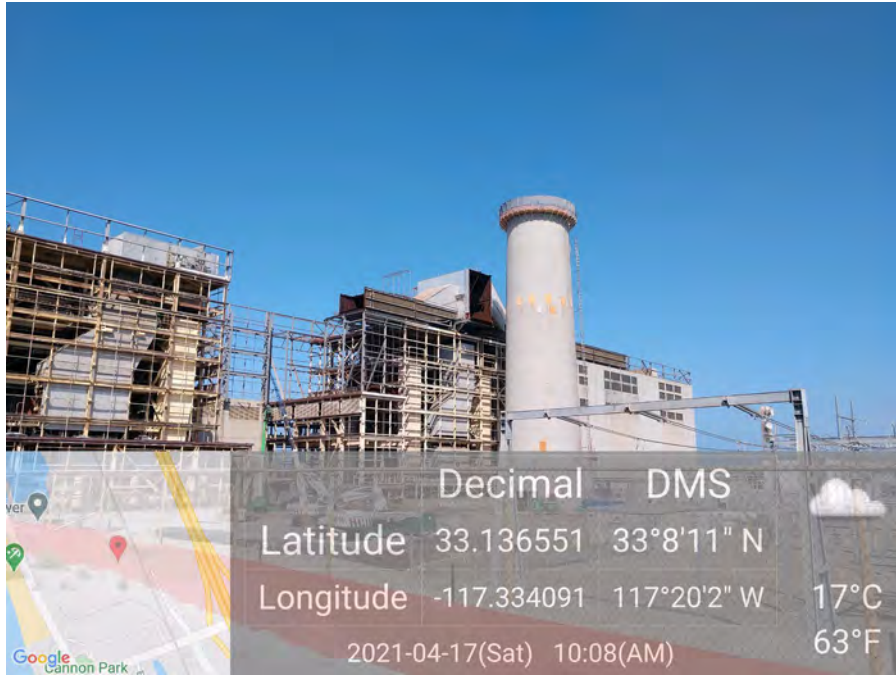
Photo 1

Location	EPS site	Description	An American peregrine falcon was observed.
----------	----------	-------------	--

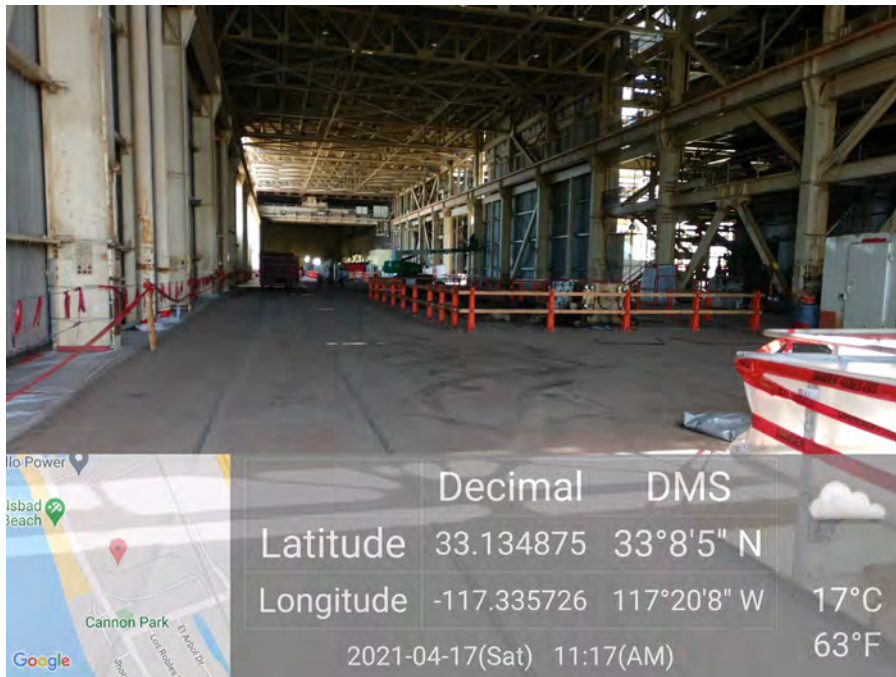
Photo 2

Location	EPS site	Description	Overview of the EPS building.
----------	----------	-------------	-------------------------------

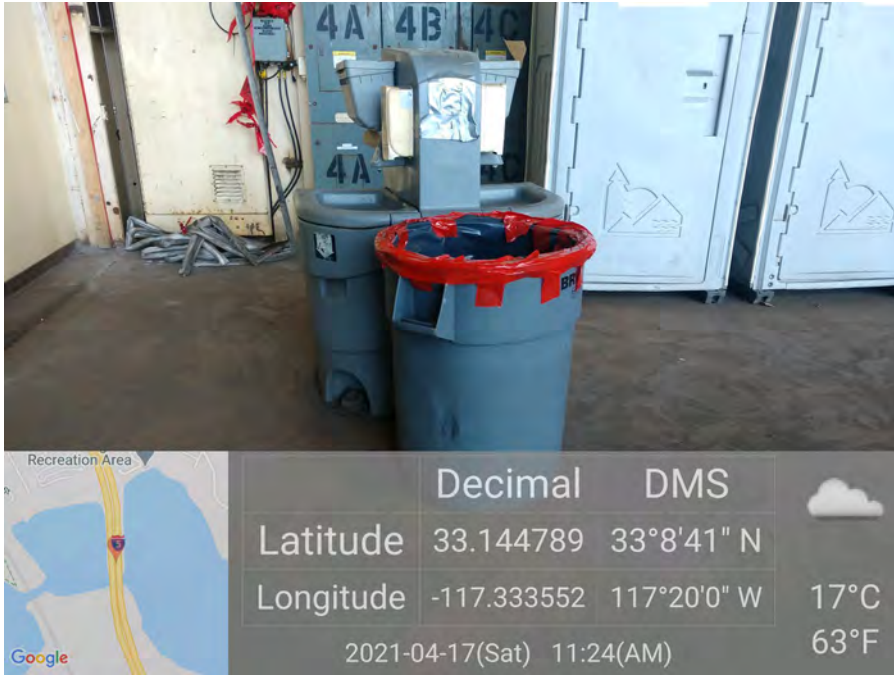
Photo 3

Location	EPS site	Description	An uncovered trash can was observed.
----------	----------	-------------	--------------------------------------

Items Requiring Action/Follow-up					
<ul style="list-style-type: none"> A request was submitted to the contractor to conduct litter removal and to cover all trash receptacles. 					
Wildlife Species Observed					
<p>American bushtit (<i>Psaltiriparus minimus</i>), American crow, American kestrel (<i>Falco sparverius</i>), American peregrine falcon, Anna's hummingbird (<i>Calypste anna</i>), black phoebe (<i>Sayornis nigricans</i>), California brown pelican, common raven (<i>Corvus corax</i>), double-crested cormorant, European starling, house finch, lesser goldfinch (<i>Spinus psaltria</i>), mourning dove, Say's phoebe (<i>Sayornis saya</i>), song sparrow (<i>Melospiza melodia</i>), western fence lizard (<i>Sceloporus occidentalis</i>), western gull (<i>Larus occidentalis</i>), white-crowned sparrow (<i>Zonotrichia leucophrys</i>).</p>

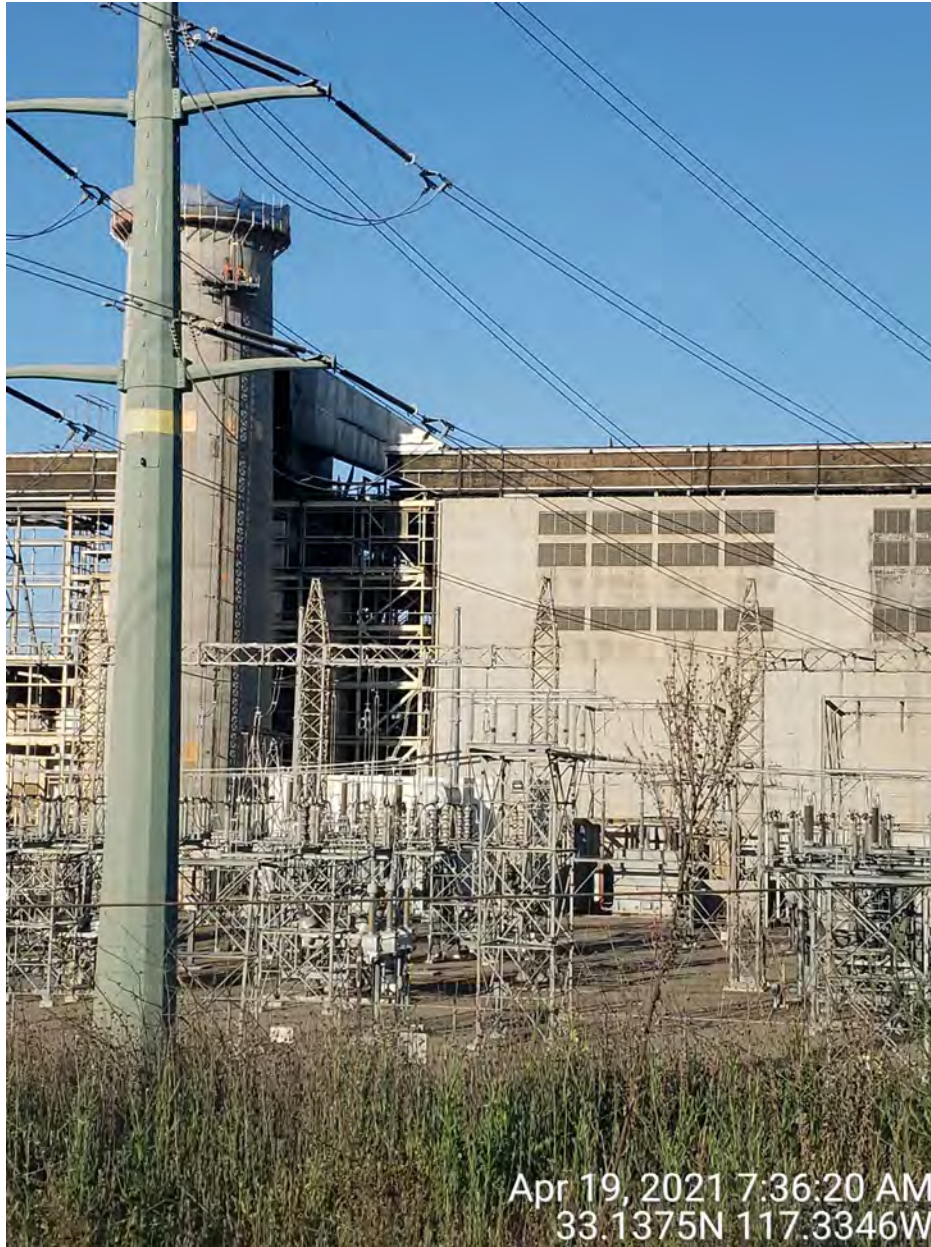
Photo 1

Location	33.1375N, 117.3346W Facing west	Description	View of peregrine falcon nesting area and Encina stack demolition area at the beginning of 4/19/21.
----------	------------------------------------	-------------	---

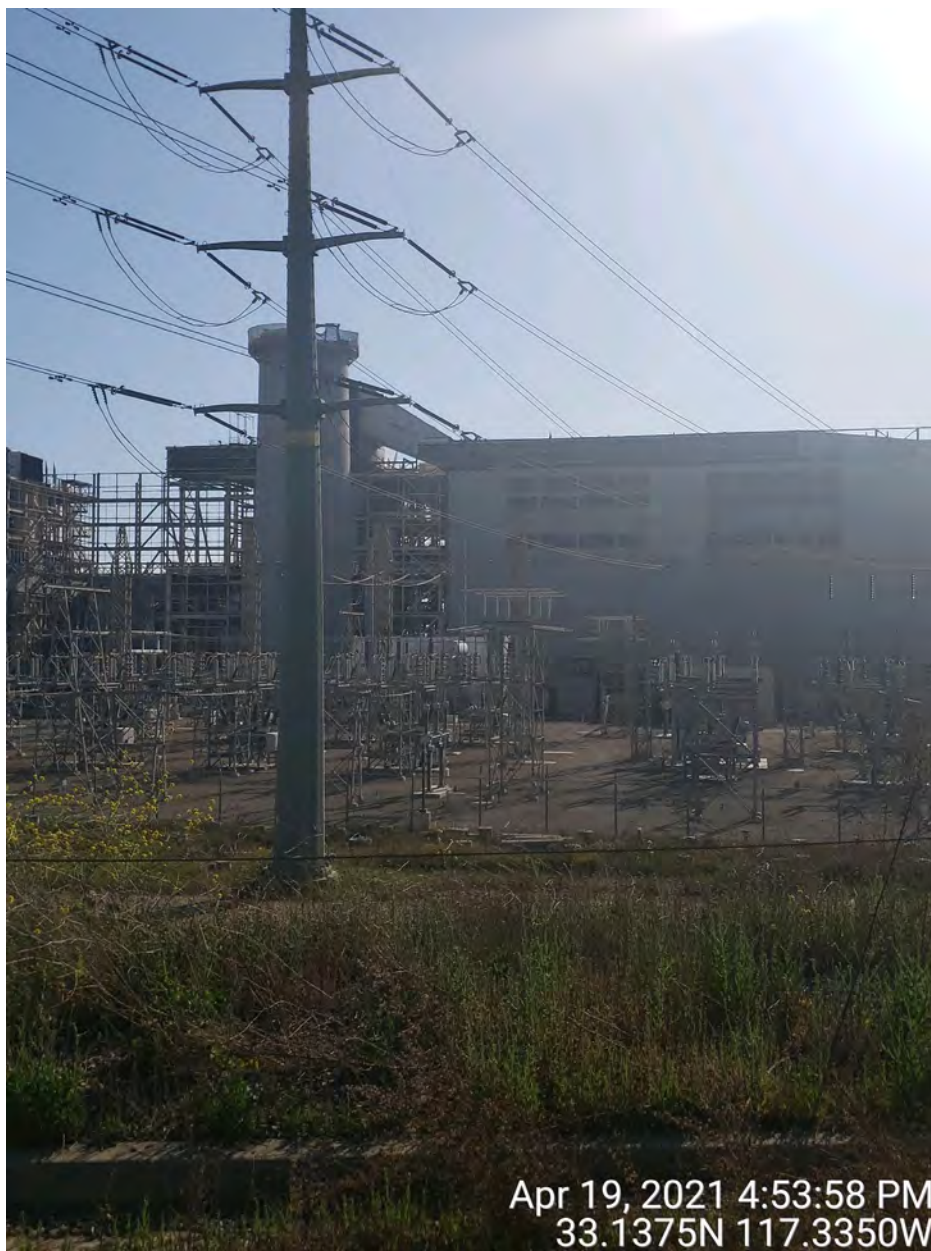
Photo 2

Location	33.1375N, 117.3350W Facing west	Description	View of peregrine falcon nesting area and Encina stack demolition area at the end of 4/19/21.
-----------------	------------------------------------	--------------------	---

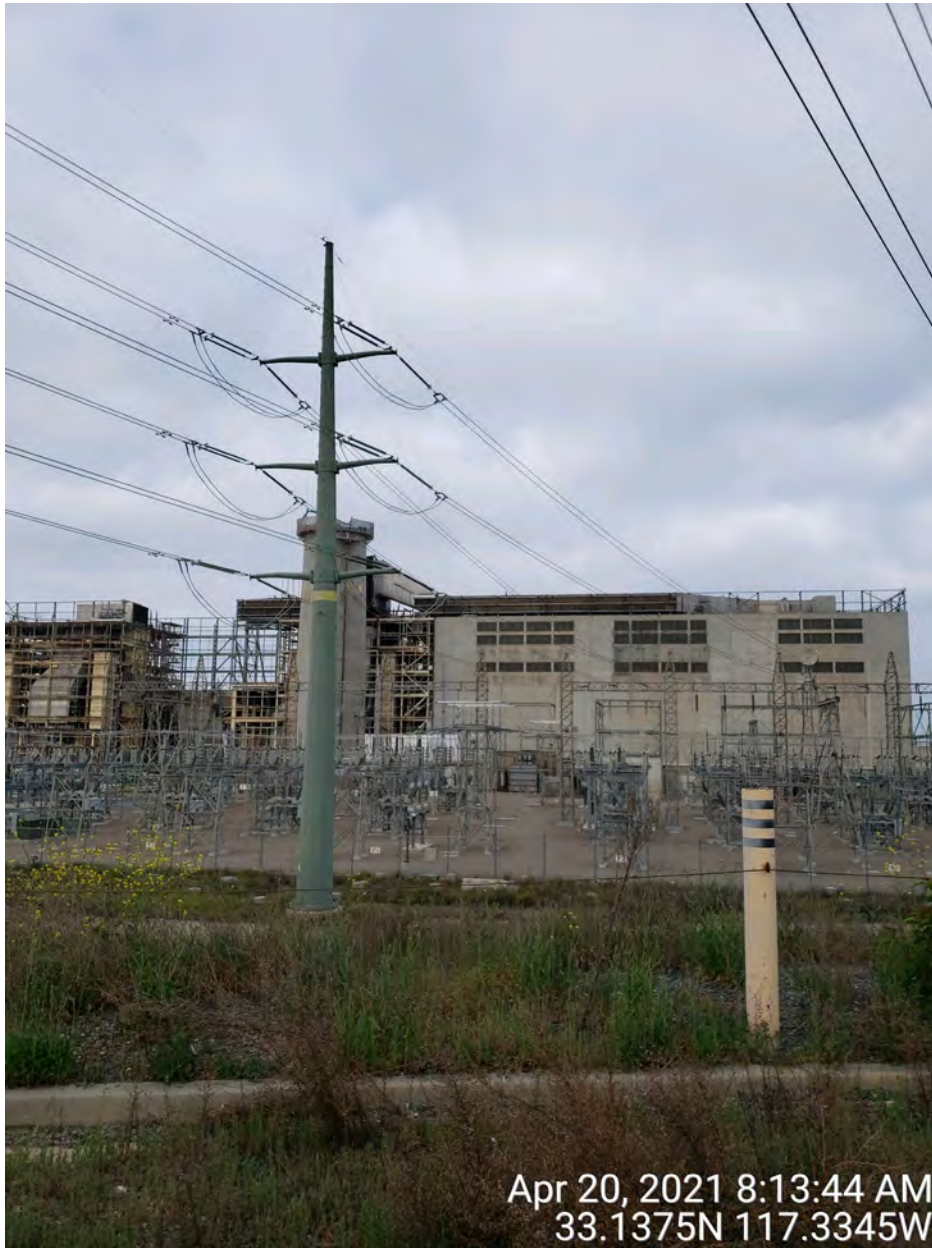
Photo 1

Location	33.1375N, 117.3345W Facing west	Description	View of peregrine falcon nesting area and Encina stack demolition area at the beginning of 4/20/21.
----------	------------------------------------	-------------	---

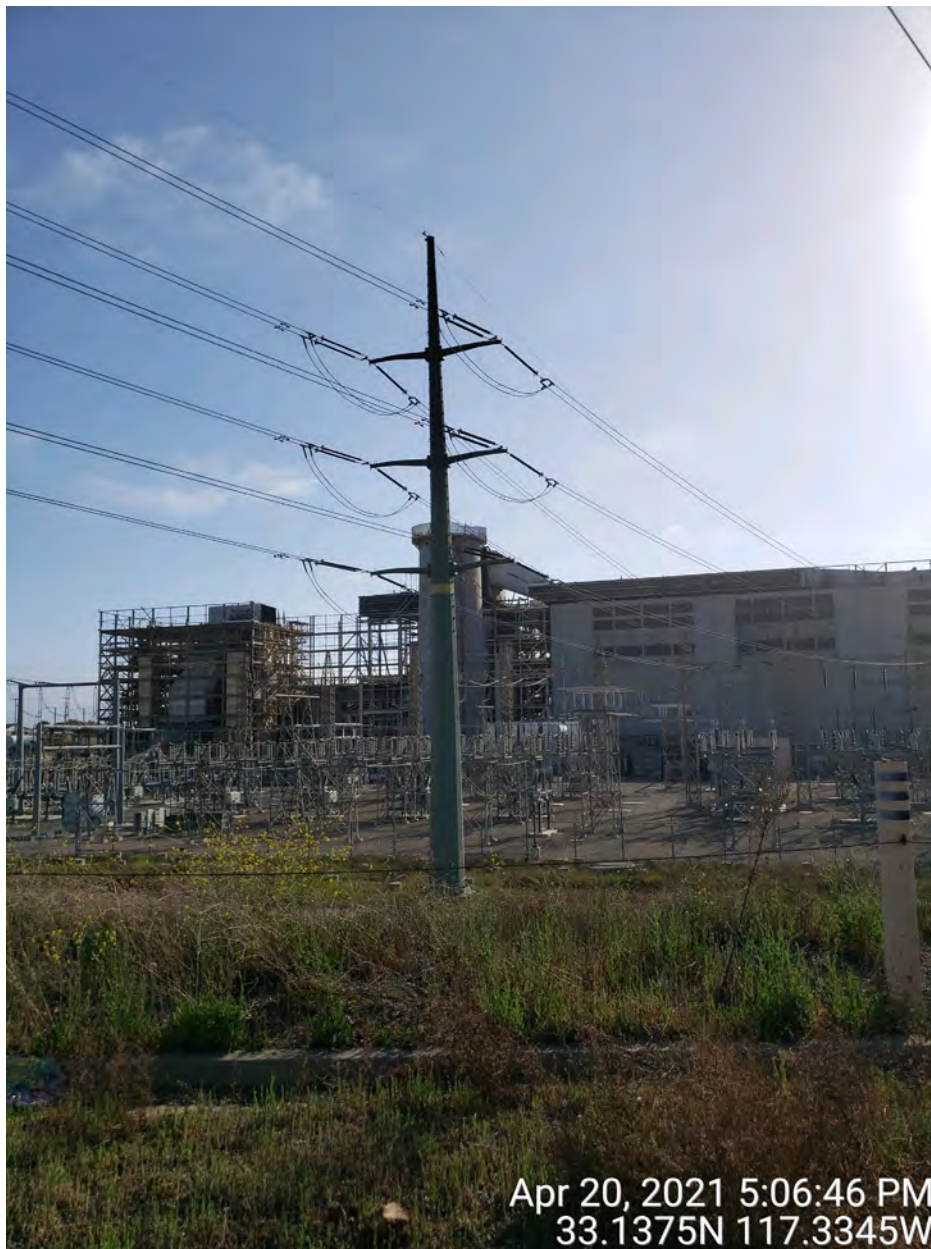
Photo 2

Location	33.1375N, 117.3345W Facing west	Description	View of peregrine falcon nesting area and Encina stack demolition area at the end of 4/20/21.
-----------------	------------------------------------	--------------------	---

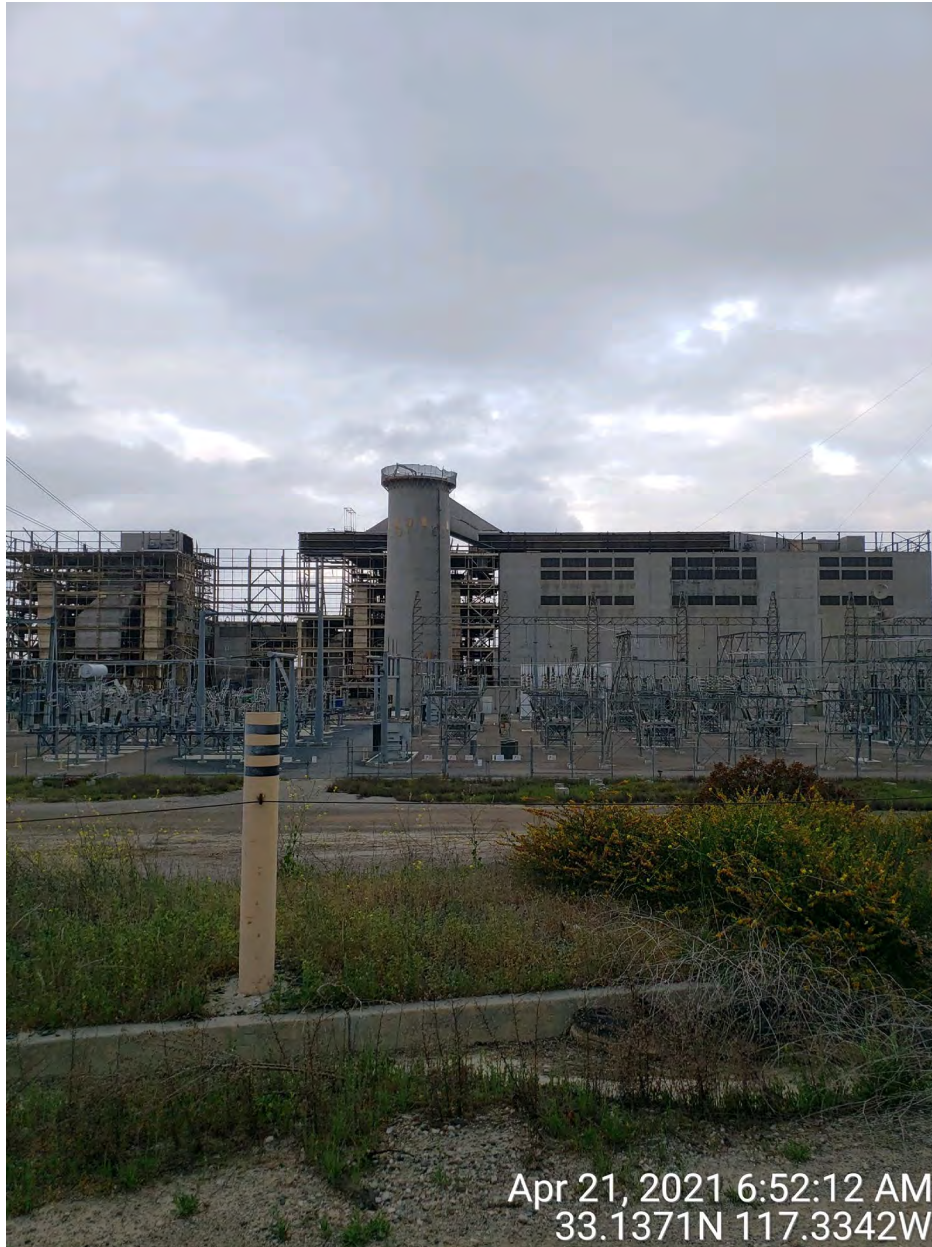
Photo 1

Location	33.1371N, 117.3342W Facing west	Description	View of peregrine falcon nesting area and Encina stack demolition area at the beginning of 4/21/21.
-----------------	------------------------------------	--------------------	---

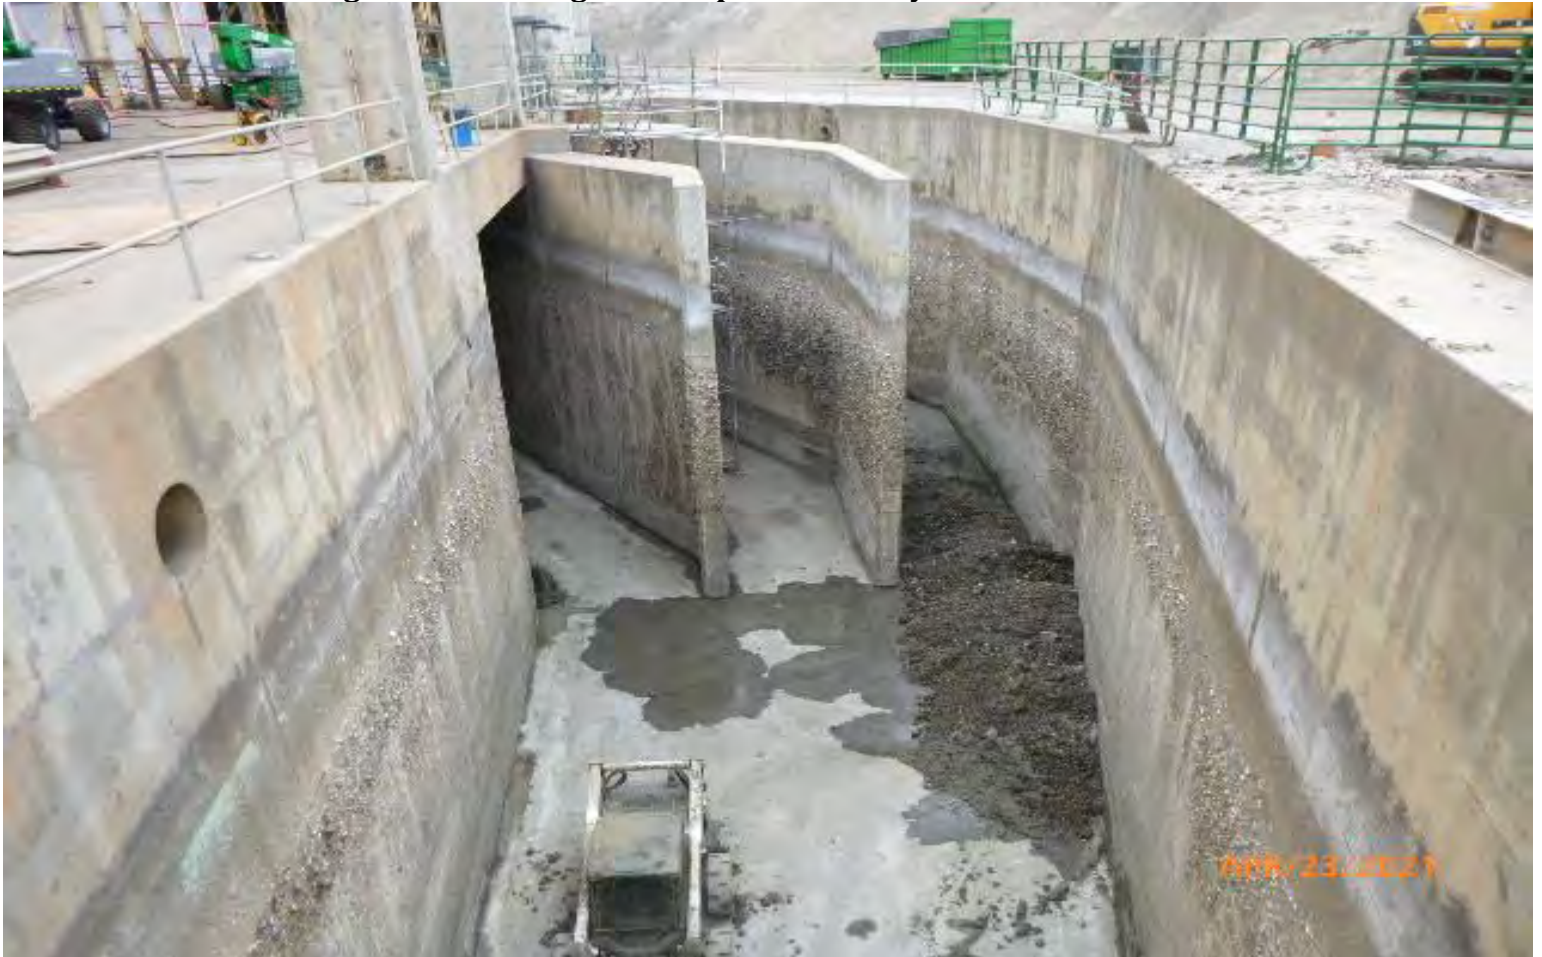
Photo #1: Water Cooling channels being cleaned prior to slurry backfill

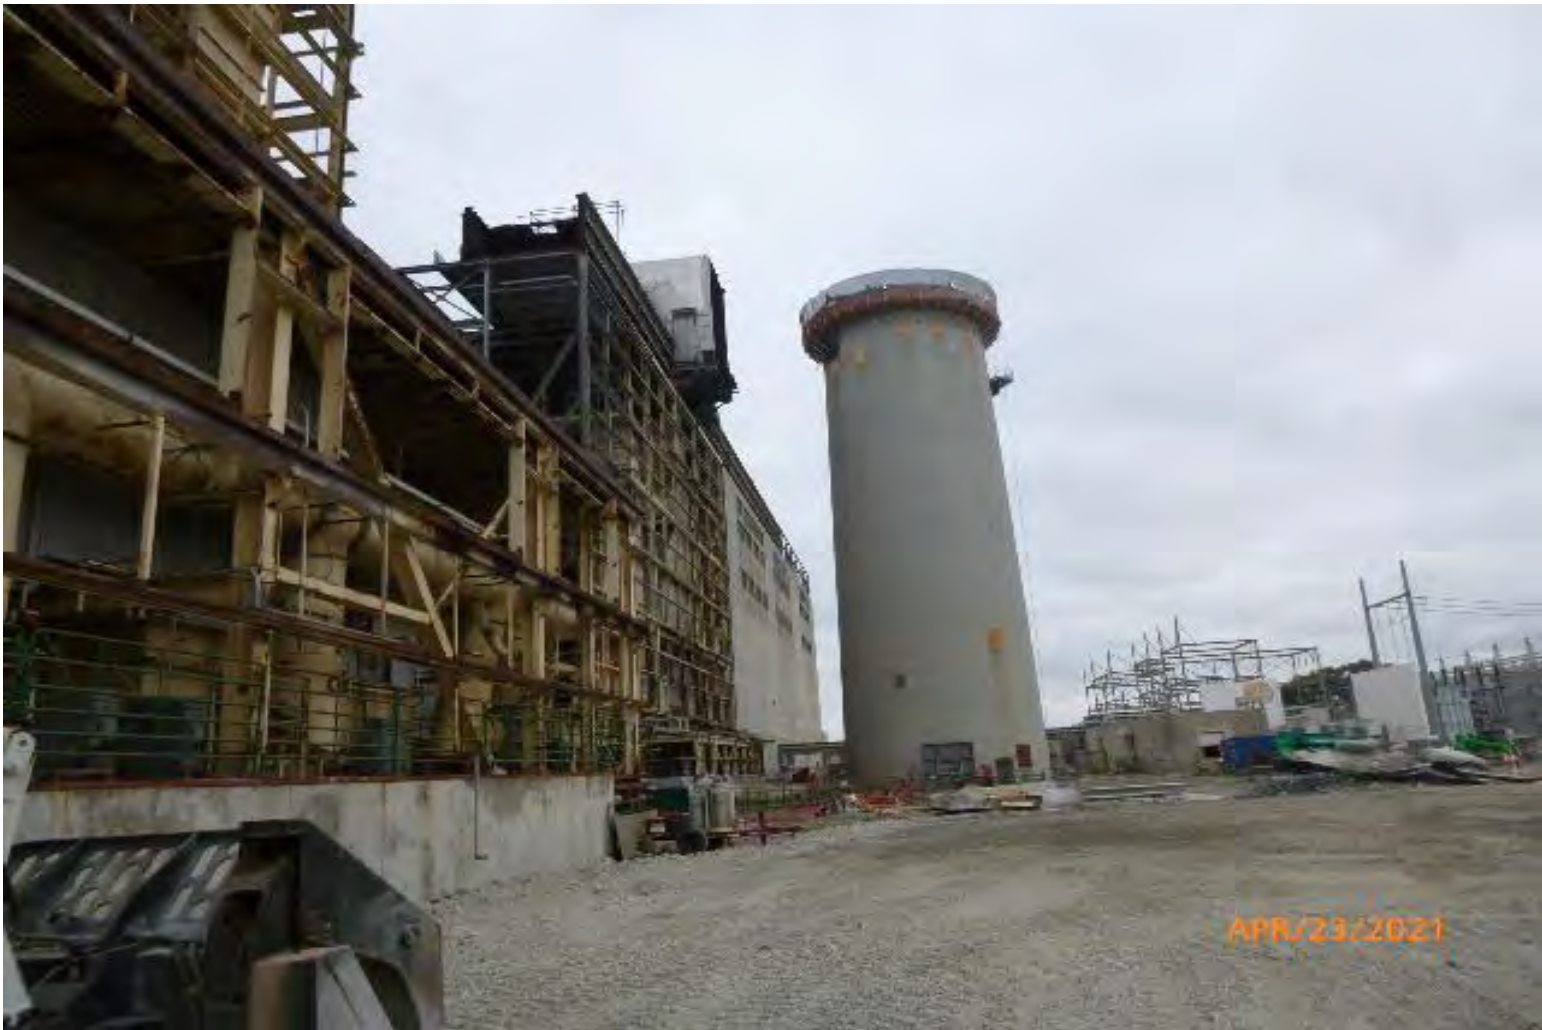
Photo #2: Stack Demo at this time down to approx. 250'

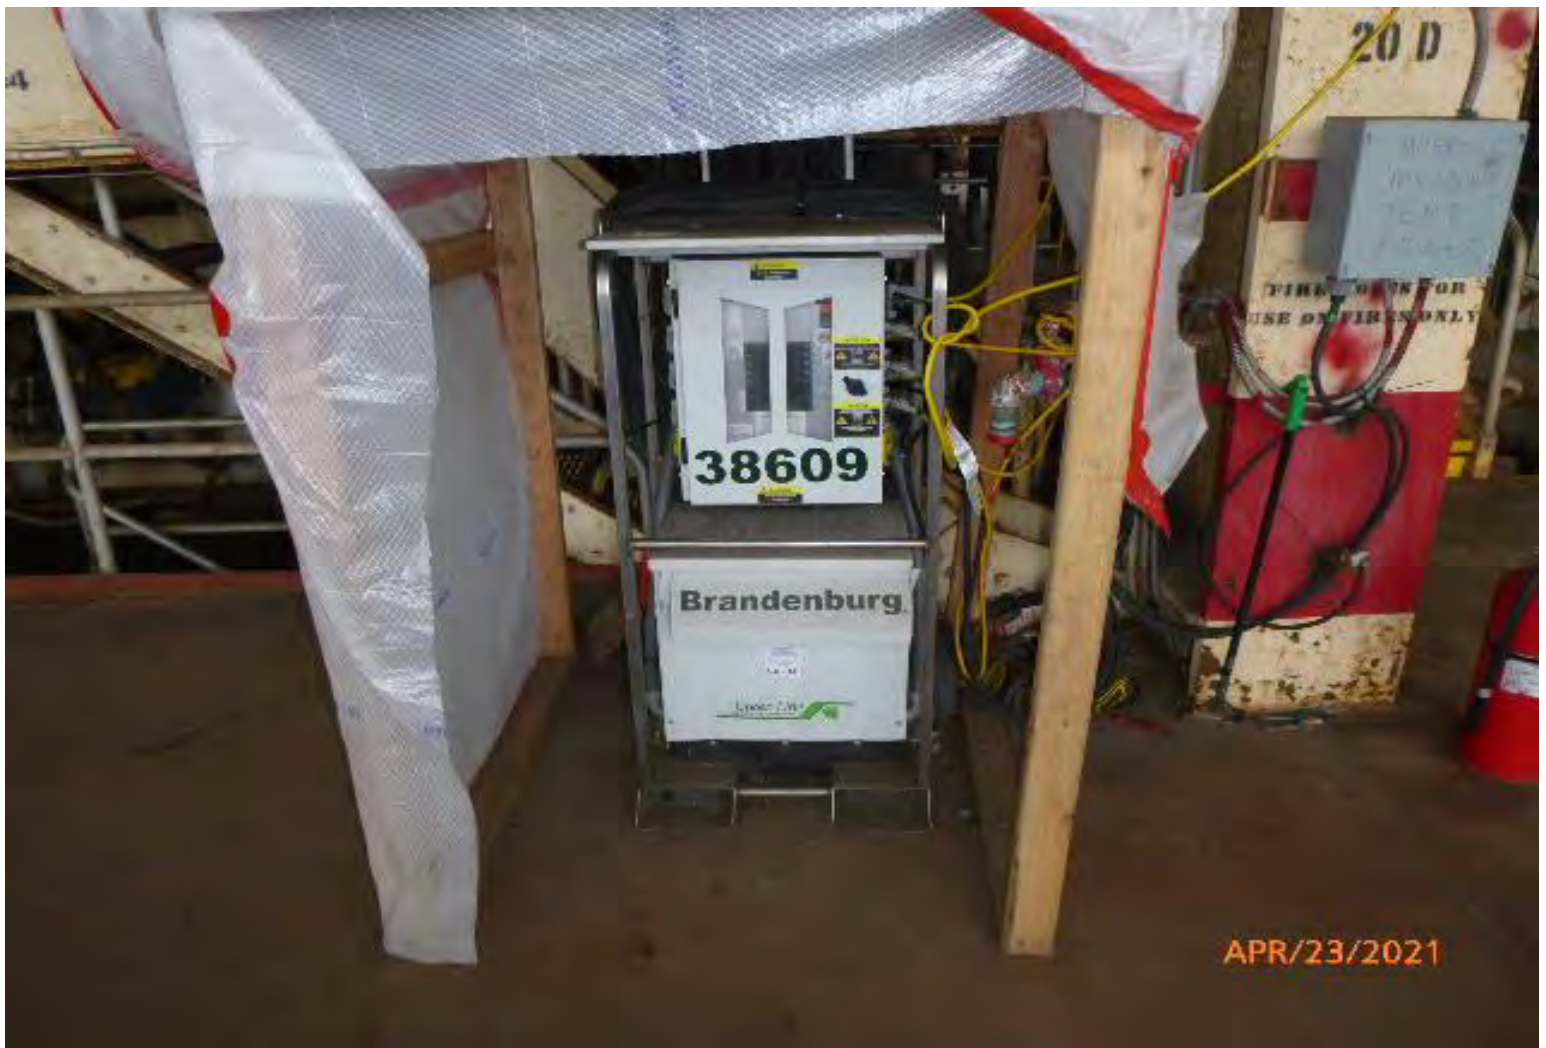
Photo #3: Typical Temporary Power Distribution Unit note extension cords used extensively

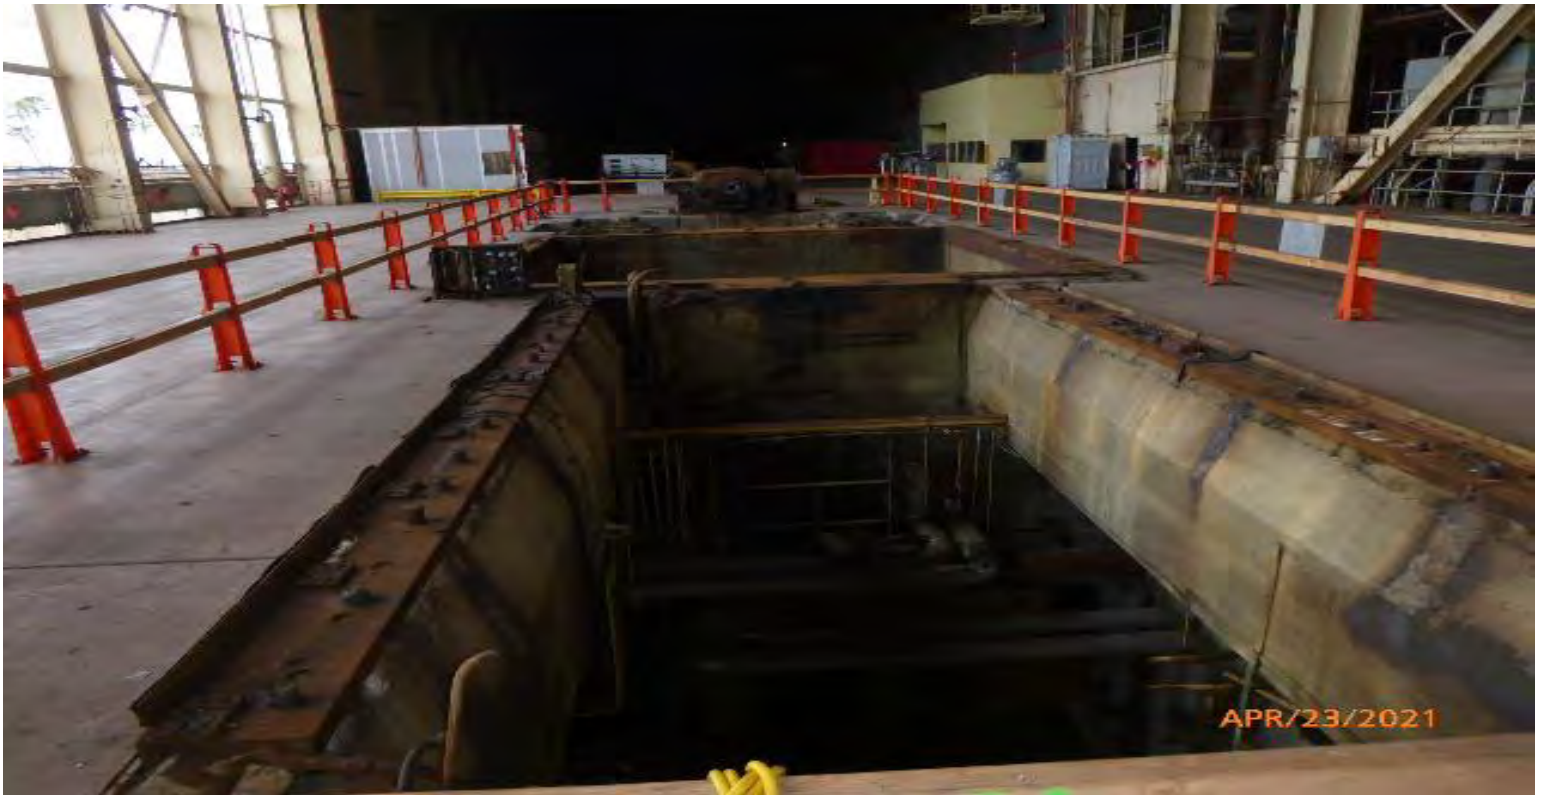
Photo #4: Turbine Removed typical #1 - #5

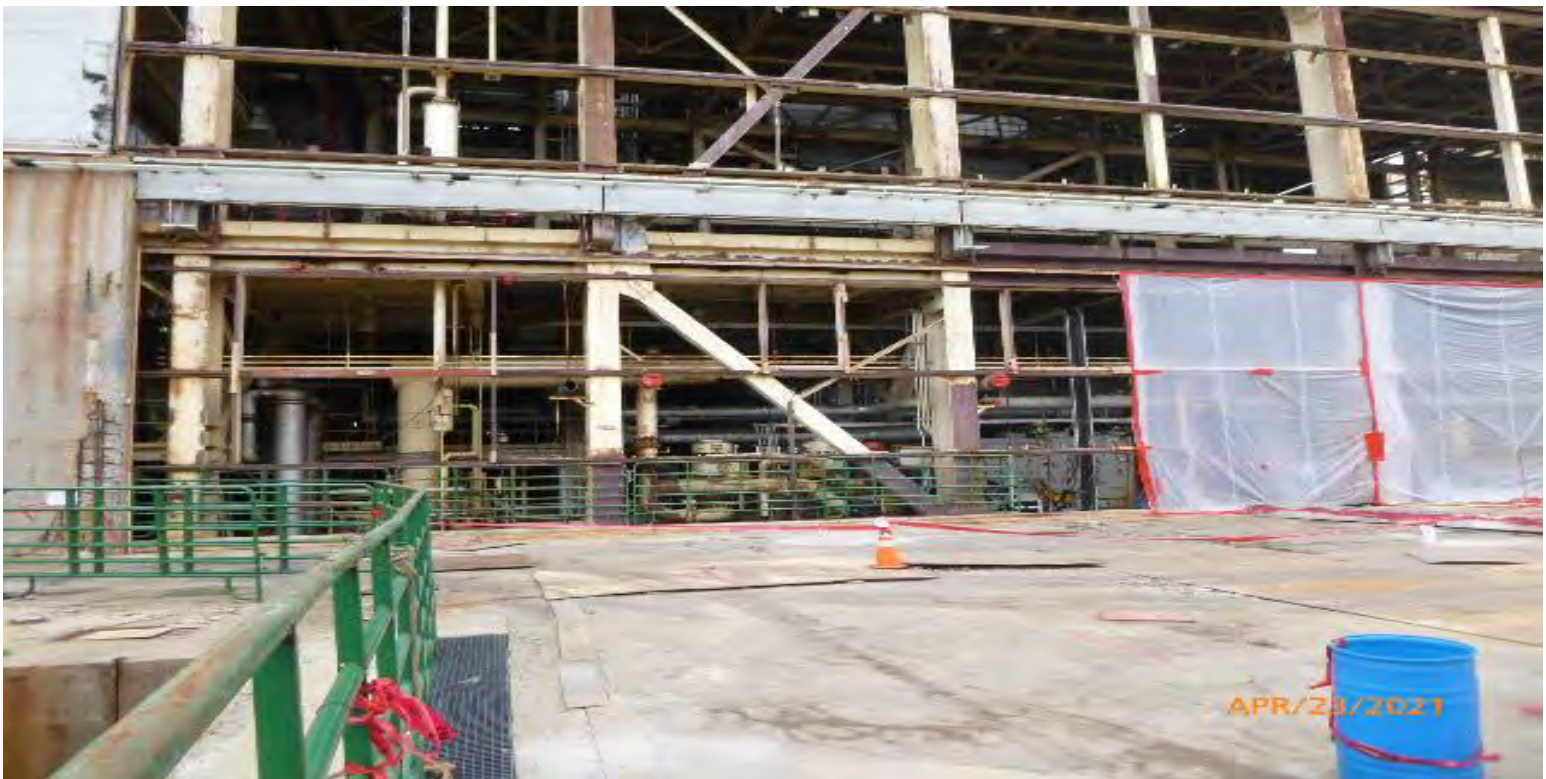
Photo #5: West Cooling level plastic protection as cleaning is performed
