Docket Number:	07-AFC-06C
Project Title:	Carlsbad Energy Center - Compliance
TN #:	237842
Document Title:	Monthly Compliance Report- April 2021
Description:	Demolition of Encina Demolition - Monthly Compliance Report for April 2021.
Filer:	Anwar Ali
Organization:	Carlsbad Energy Center LLC
Submitter Role:	Applicant
Submission Date:	5/18/2021 3:47:30 PM
Docketed Date:	5/18/2021

**RE: AMENDED CARLSBAD ENERGY CENTER PROJECT, DOCKET NO. 07-AFC-06C, DEMOLITION OF ENCINA POWER STATION
CONDITION OF CERTIFICATION, COM-6
APRIL 2021, MONTHLY COMPLIANCE REPORT**

April 2021

***Submitted by: Cabrillo Power I LLC
Date Submitted: 05-14-2021***

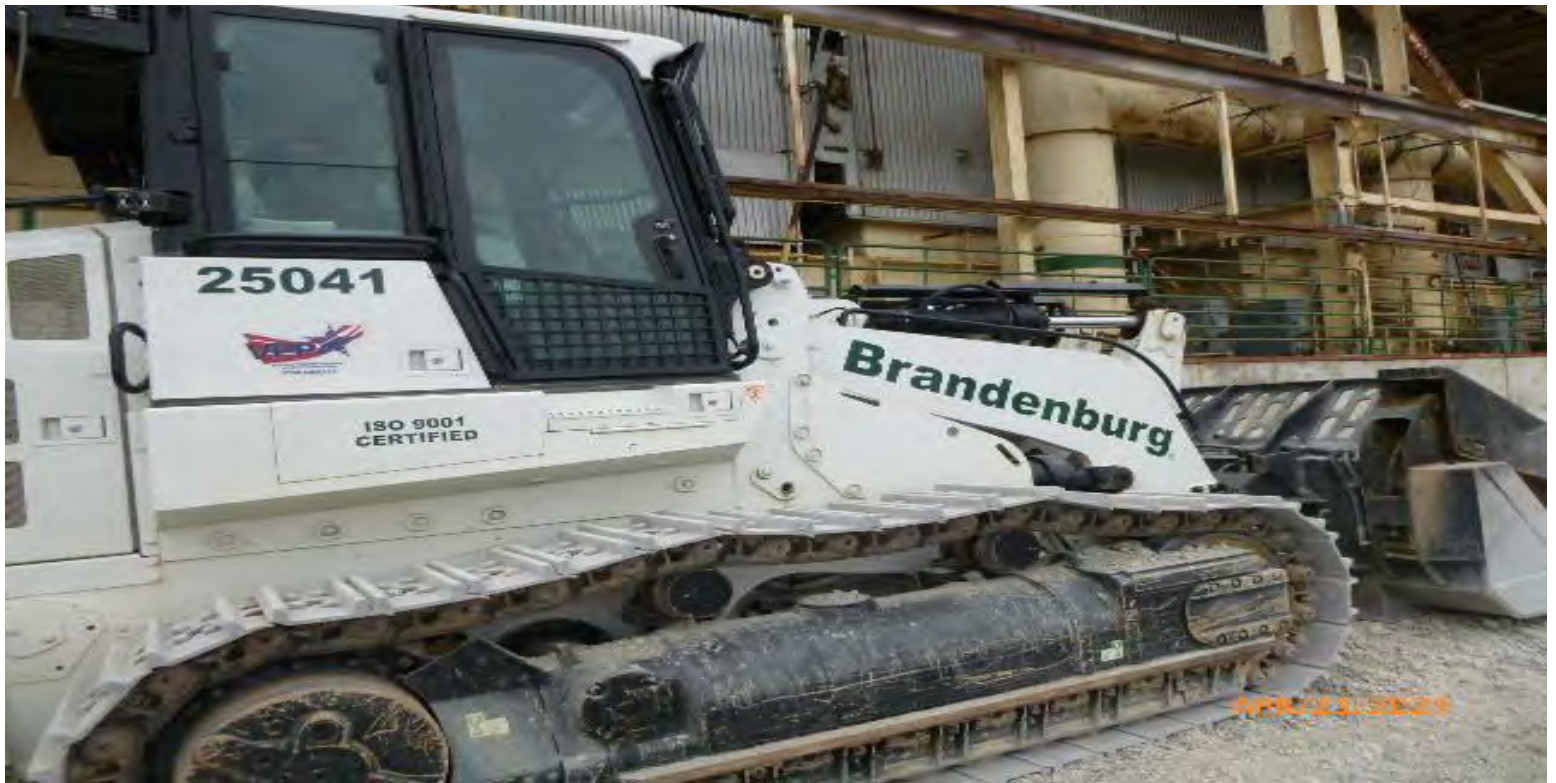
Photo #6: Equipment used to off load concrete demo spoils from stack

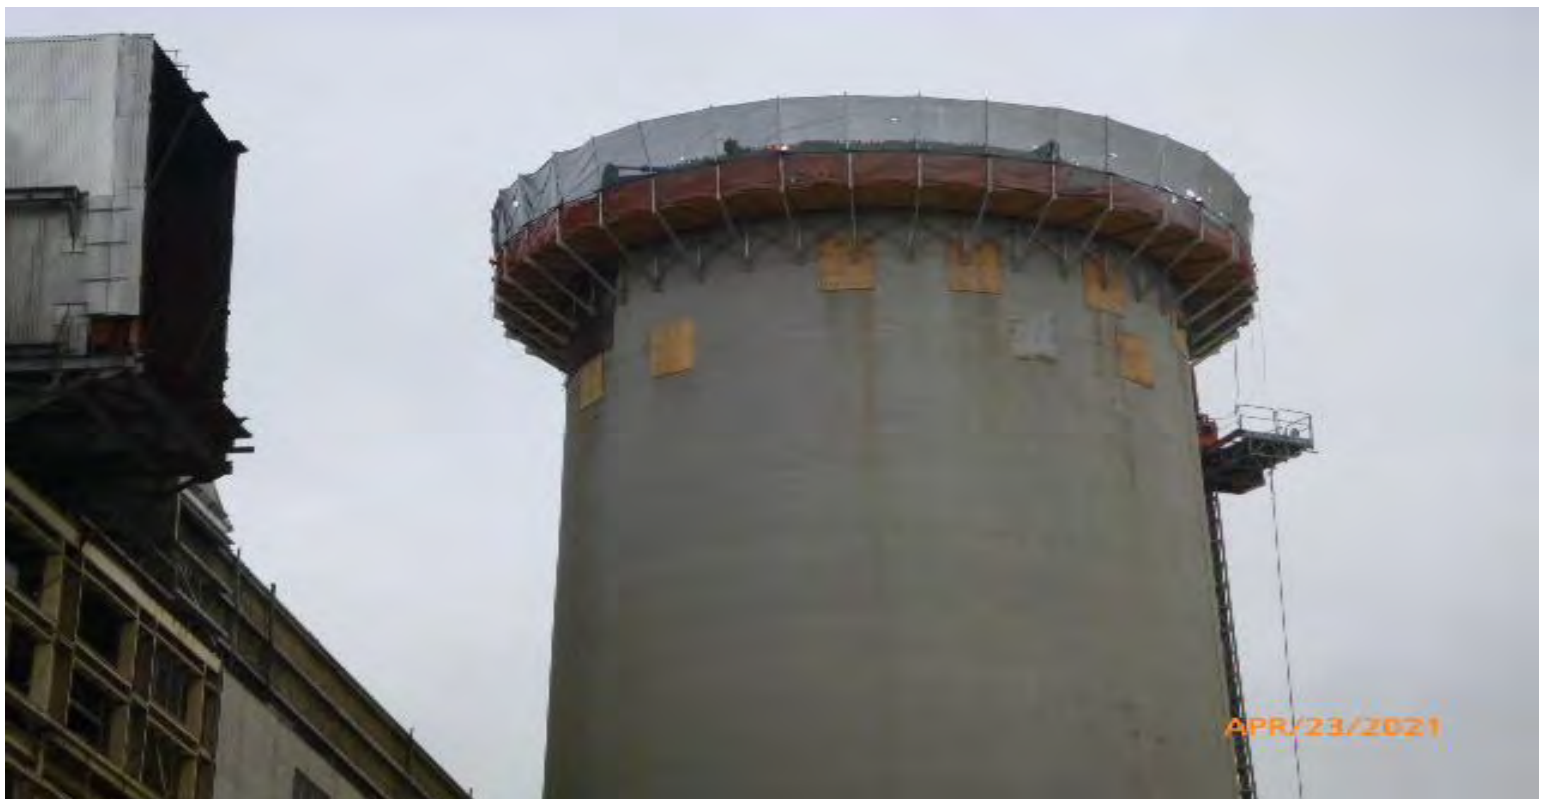
Photo #7: Stack at current level

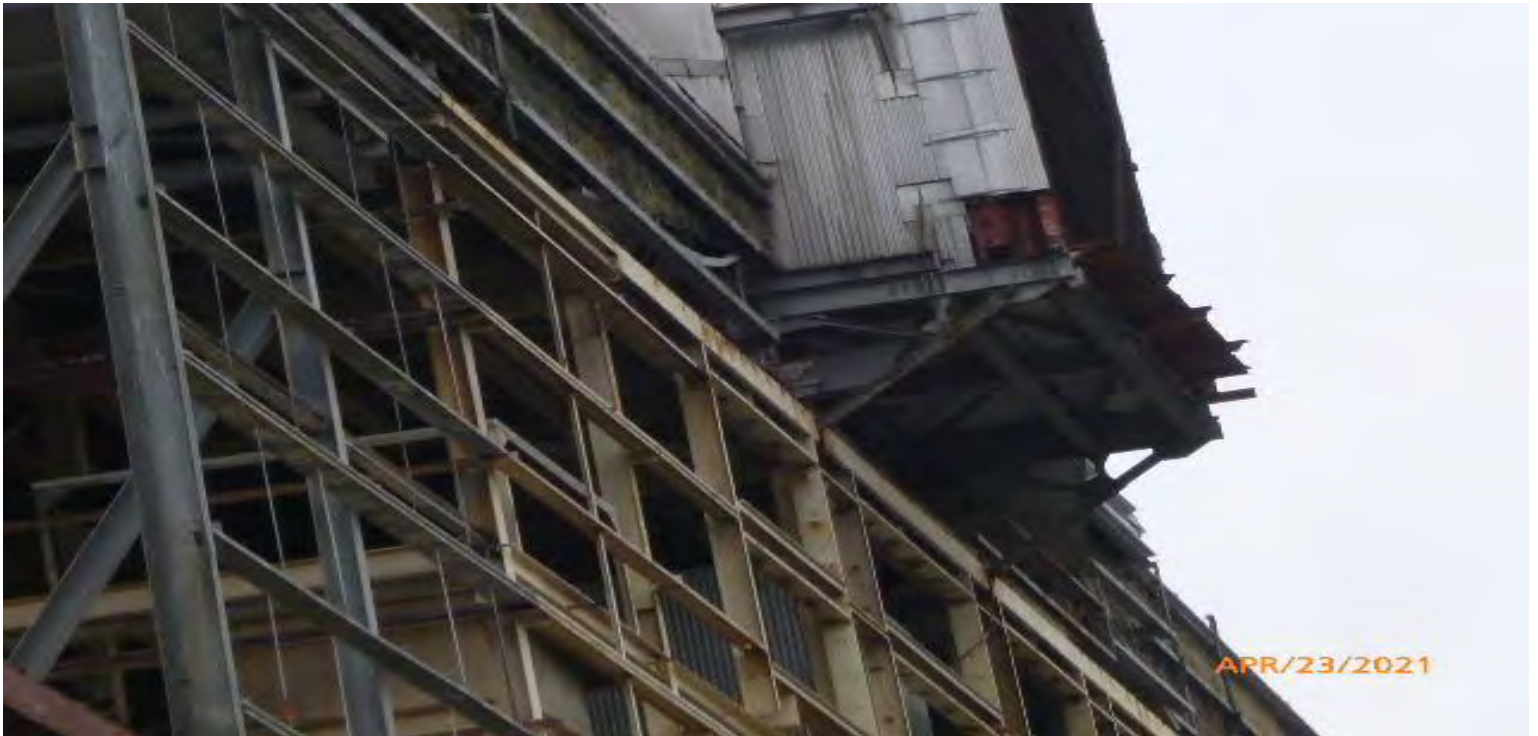
Photo #8: Falcon Nest location at structure overhang on east wall

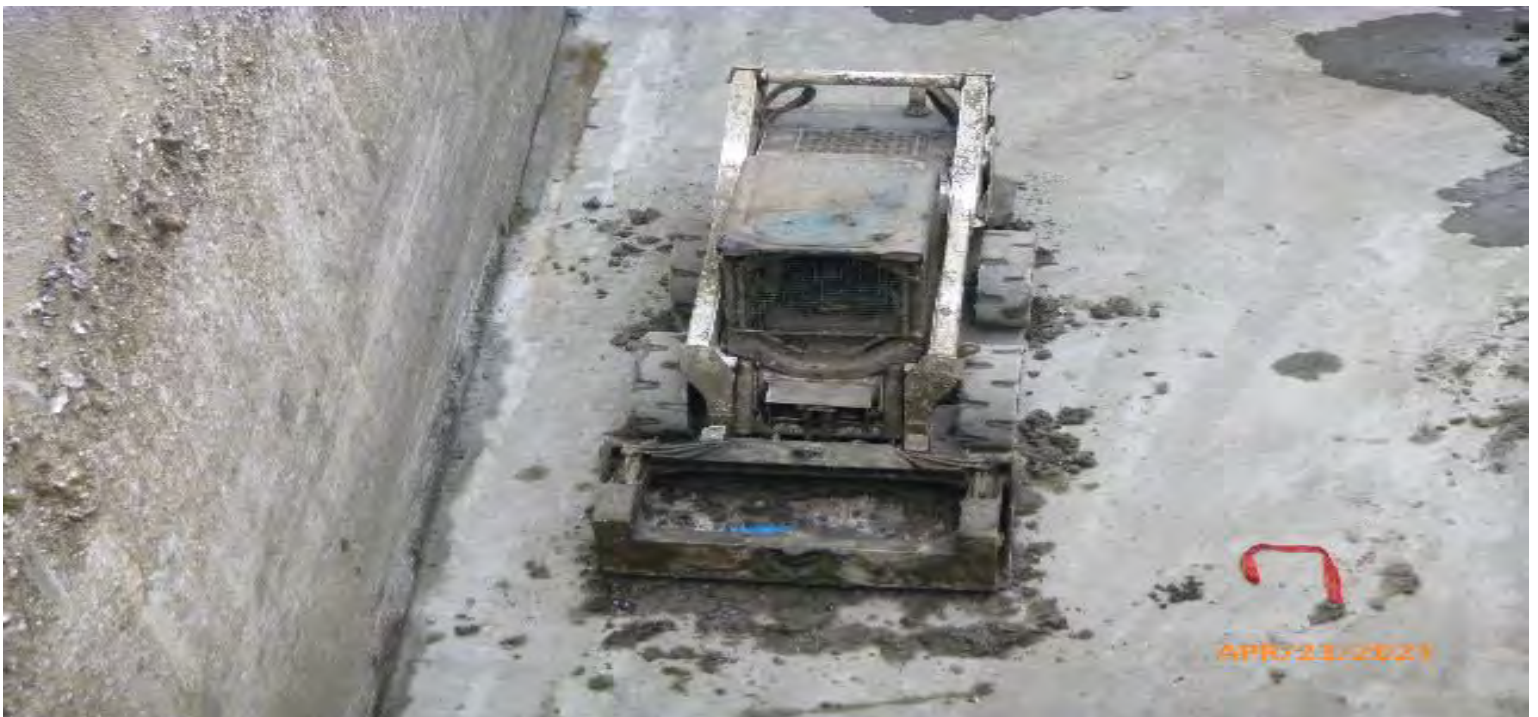
Photo #9: Equipment used to clean waterways at cooling channels

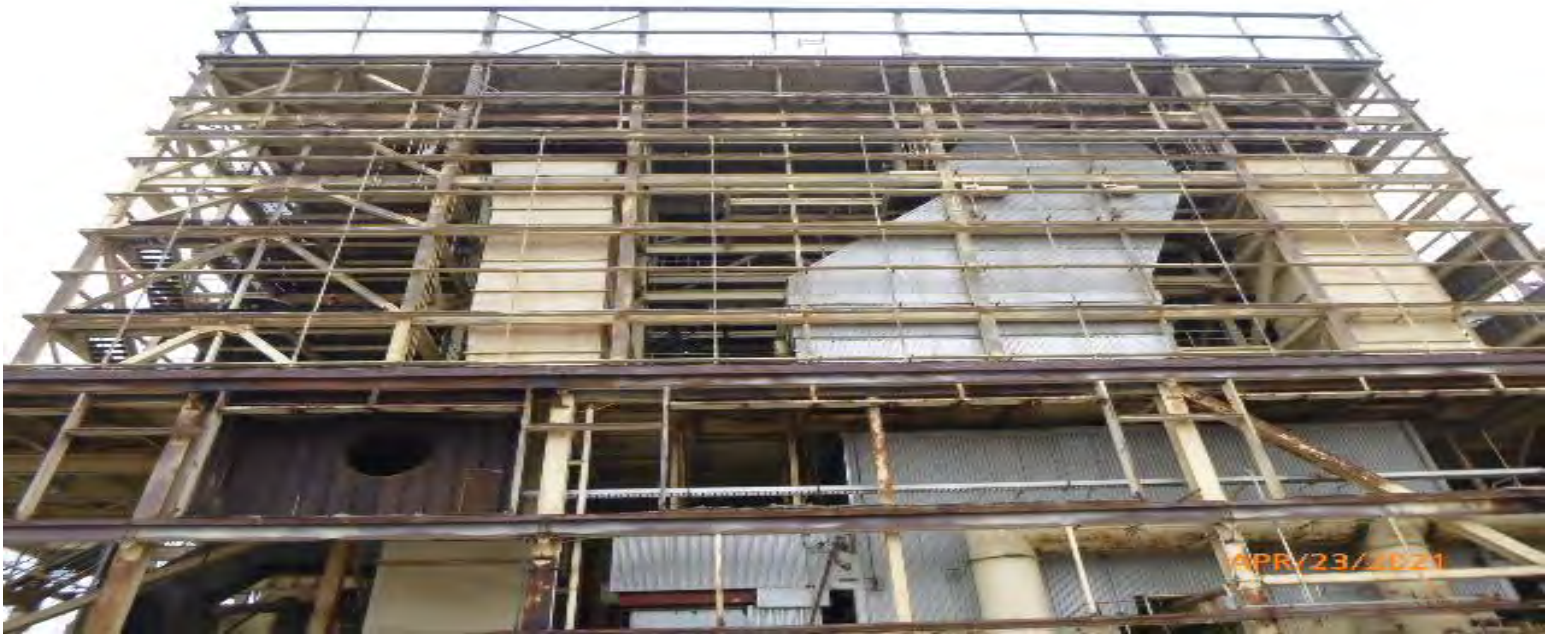
Photo #10: South wall transite panels removed

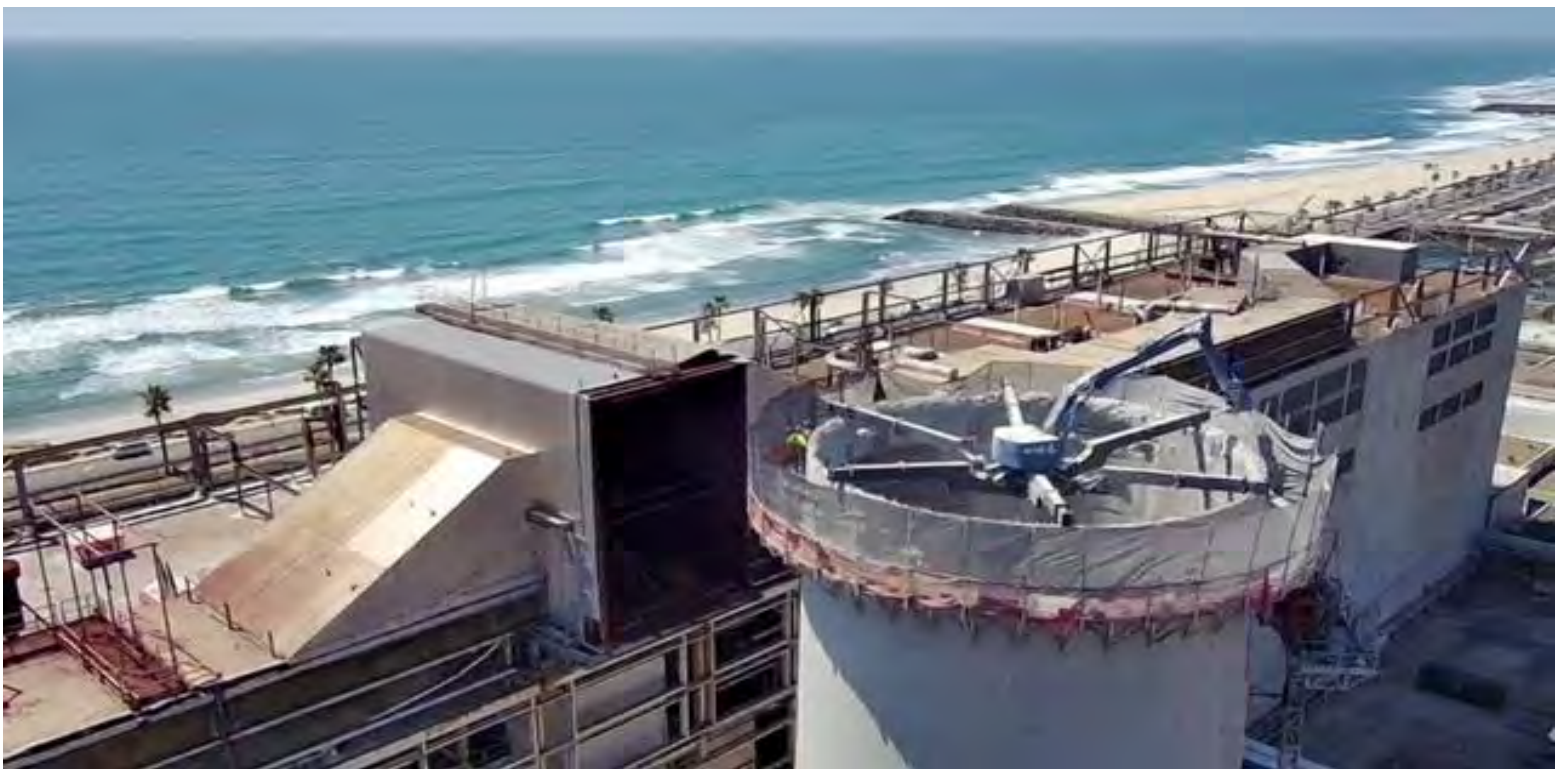
Photo #11: Pullman's Spider at top of stack demo in progress

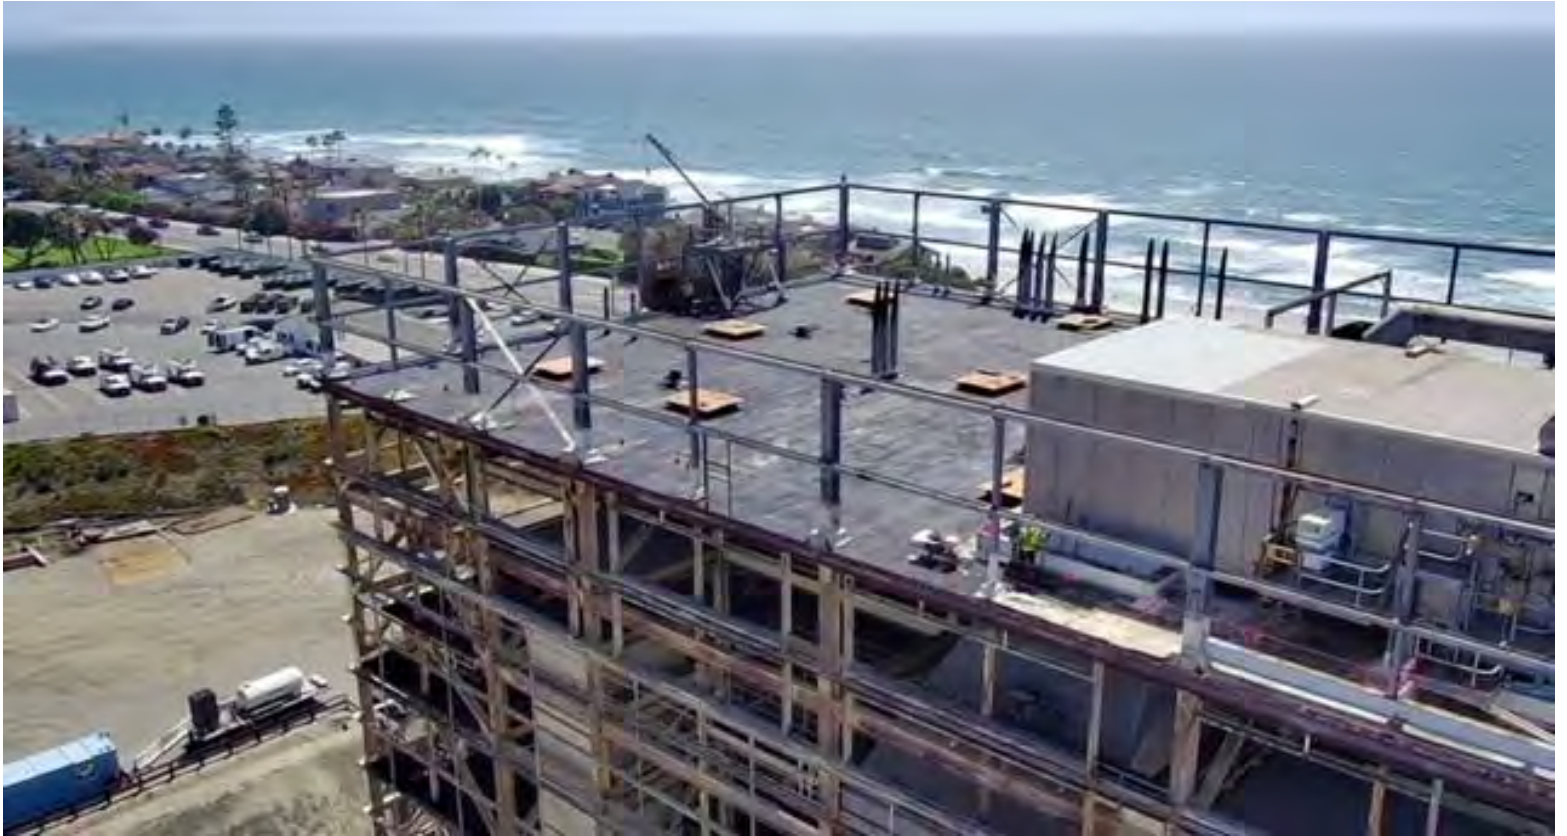
Photo #12:Roof at South end of building all transite removed at this location
