**on Errata Diablo Canyon Power Plant (part 2 of 2)**

# DIABLO CANYON POWER PLANT HISTORICAL SITE ASSESSMENT REPORT

JUNE 2018

Prepared for  
**Pacific Gas & Electric Company**

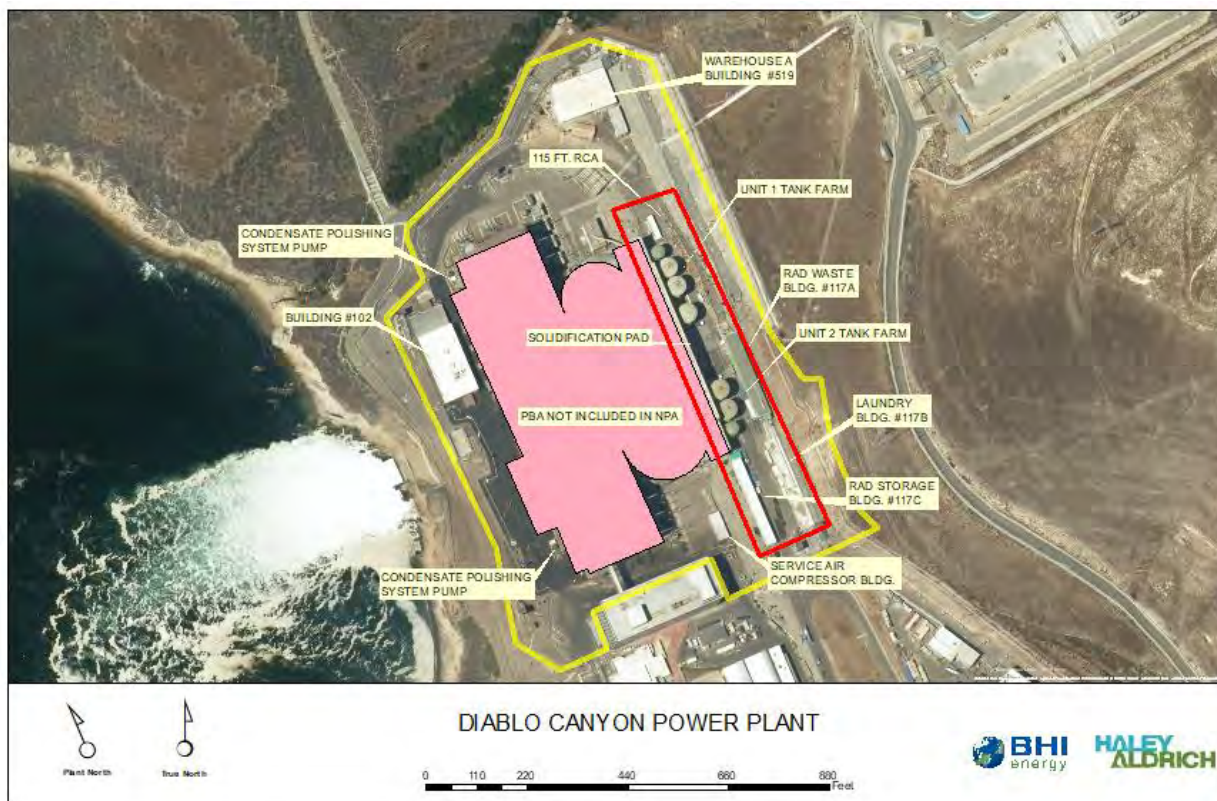
**Figure 5.5-1. Structures and Areas within the NPA**

The NPA contains the Make-Up Water tanks, Fire Water tank, Radwaste buildings, Solidification Pad, Transformers, Service Air Compressors, several smaller shops, a warehouse, and office space for plant support activities. Laydown, staging, and temporary storage areas have been routinely established in the NPA to support plant outage activities.

Figure 5.5-1 shows the general orientation of NPA as well as major plant structures included in the area.

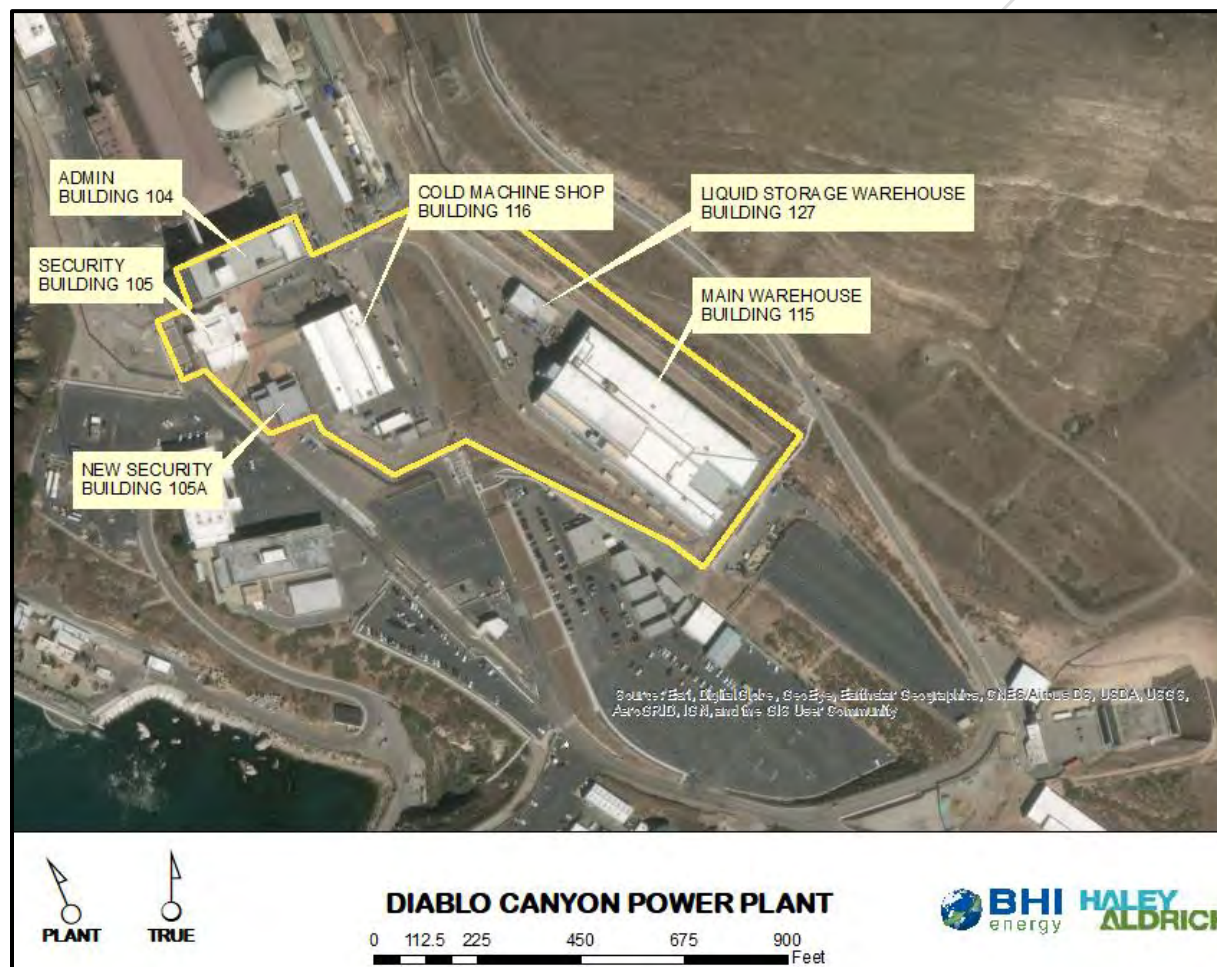
Figure 5.6-1. Structures and Areas within the SPA

All buildings in the SPA area are located close to the plant vent stacks where tritium and C-14 are/have been released. Condensate from air conditioning units associated with all the buildings in the area discharge directly to the ground. Radionuclides (tritium and C-14) entrained in the condensate would have been released to the ground.

The SPA is bounded to the north by the North Protected Area and to the east, west, and south by the South Owner Controlled Area.
