DOCKETED	
Docket Number:	23-AFC-01
Project Title:	Morton Bay Geothermal Project (MBGP)
TN #:	249725
Document Title:	Morton Bay Geothermal Project AFC Volume 2 Appendix 5-2 Biological Resources
Description:	N/A
Filer:	Jerry Salamy
Organization:	Jacobs
Submitter Role:	Applicant Consultant
Submission Date:	4/18/2023 10:56:22 AM
Docketed Date:	4/18/2023

Appendix 5.2C Figure 1 Overview
Aquatic Resource Delineation Results
Morton Bay Geothermal Project
Imperial County, California

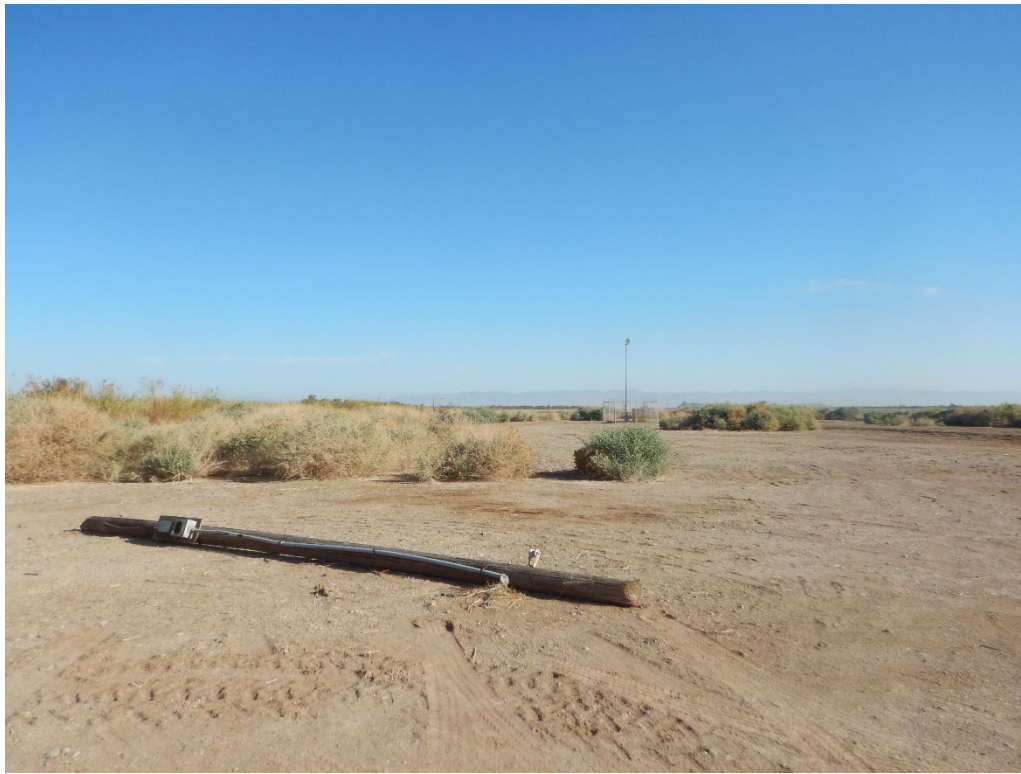
Photo 1: View to the north at **Sample Point 1**. Photo shows an area mapped by National Wetland Inventory (NWI) as a seasonally flooded palustrine excavation with unconsolidated shore (PUSC_x), but no wetland indicators are present.

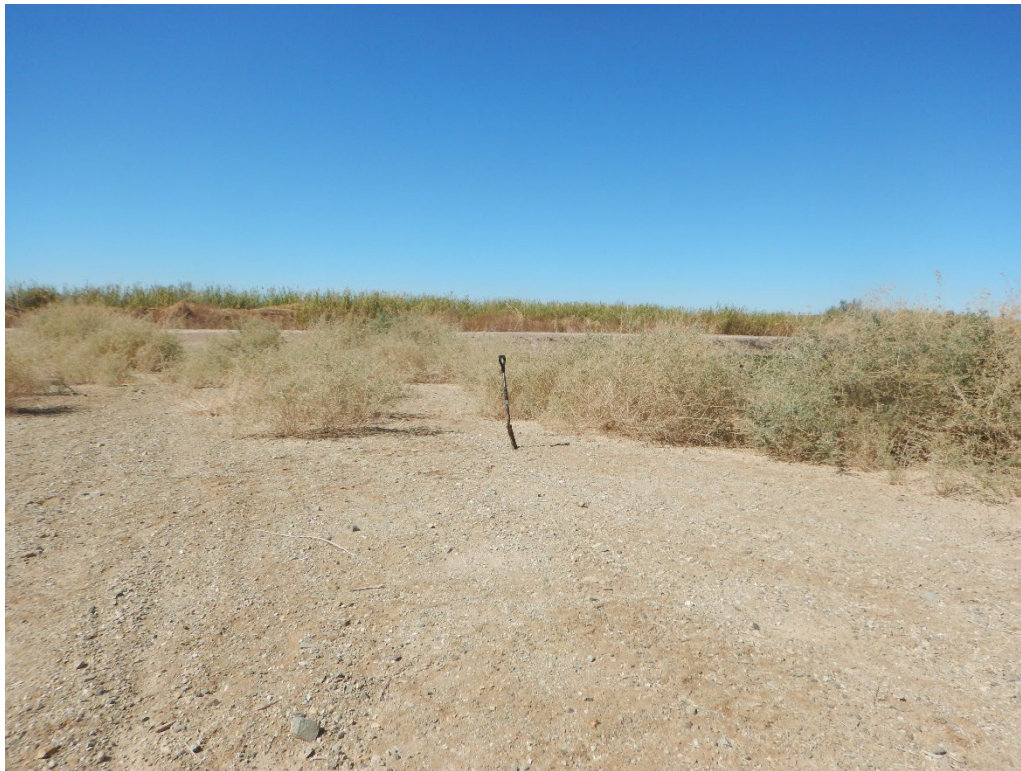
Photo 2: View to the west at **Sample Point 2**. Photo shows an area mapped by NWI as PUSC_x, but no wetland indicators are present.

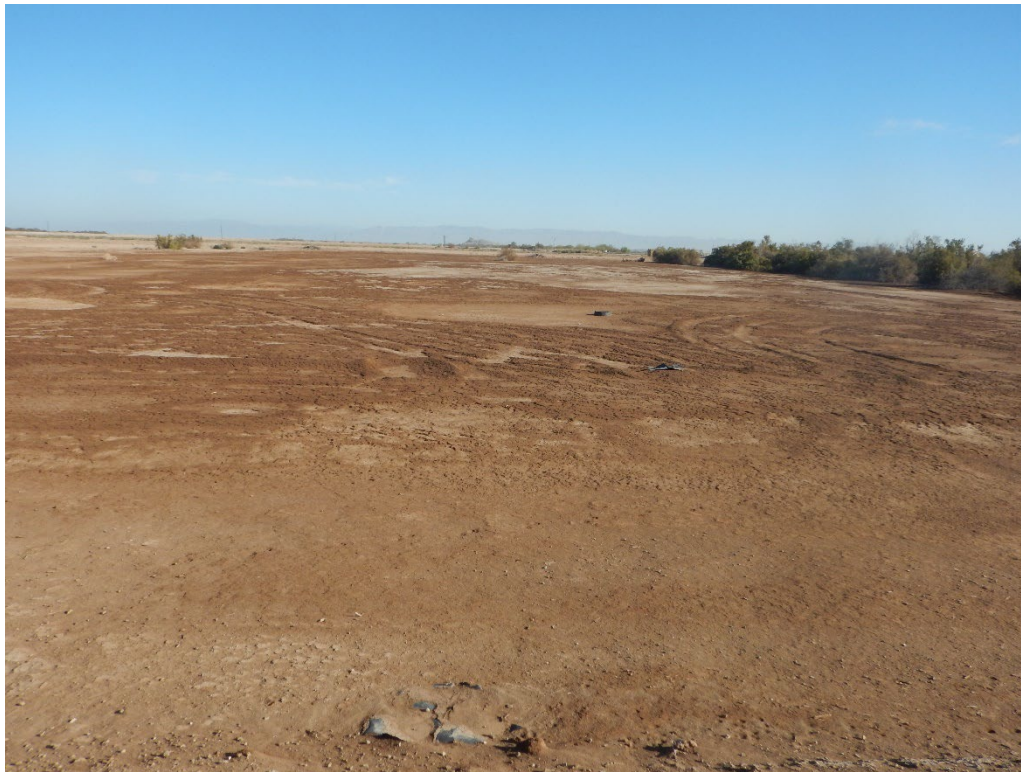
Photo 3: View to the north at **Sample Point 3**. Photo shows an area mapped by NWI as PUSC_x, but no wetland indicators are present.

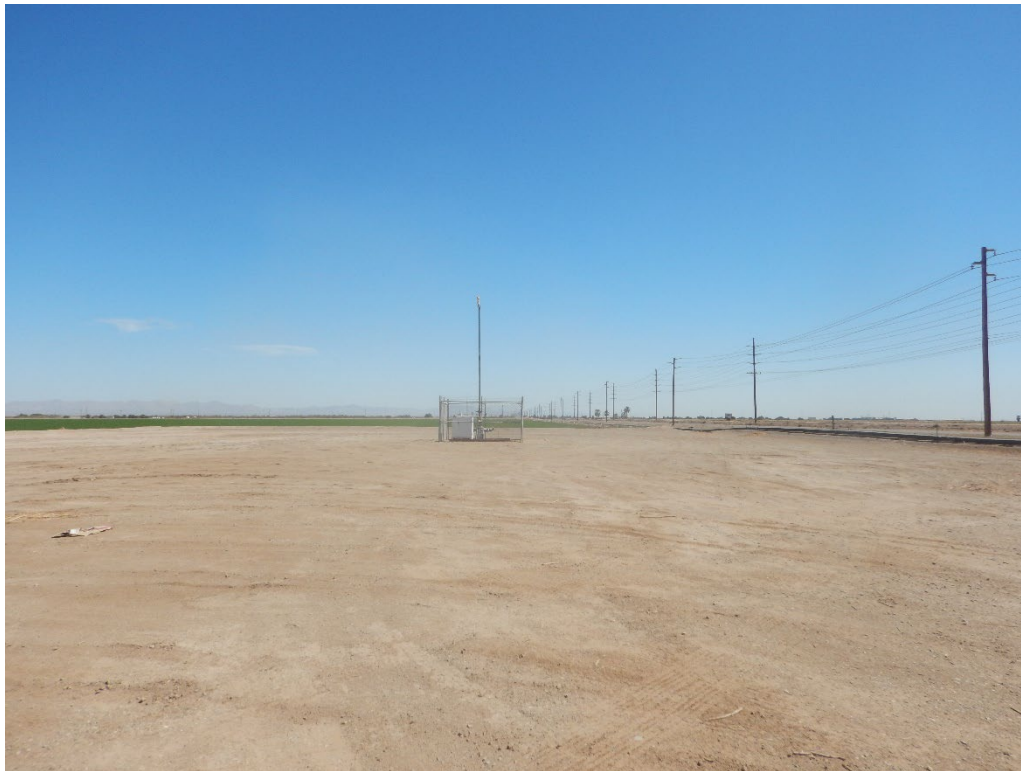
Photo 4: View to the east at **Sample Point 4**. Photo shows an area mapped by NWI as PUSC_x, but no wetland indicators are present.

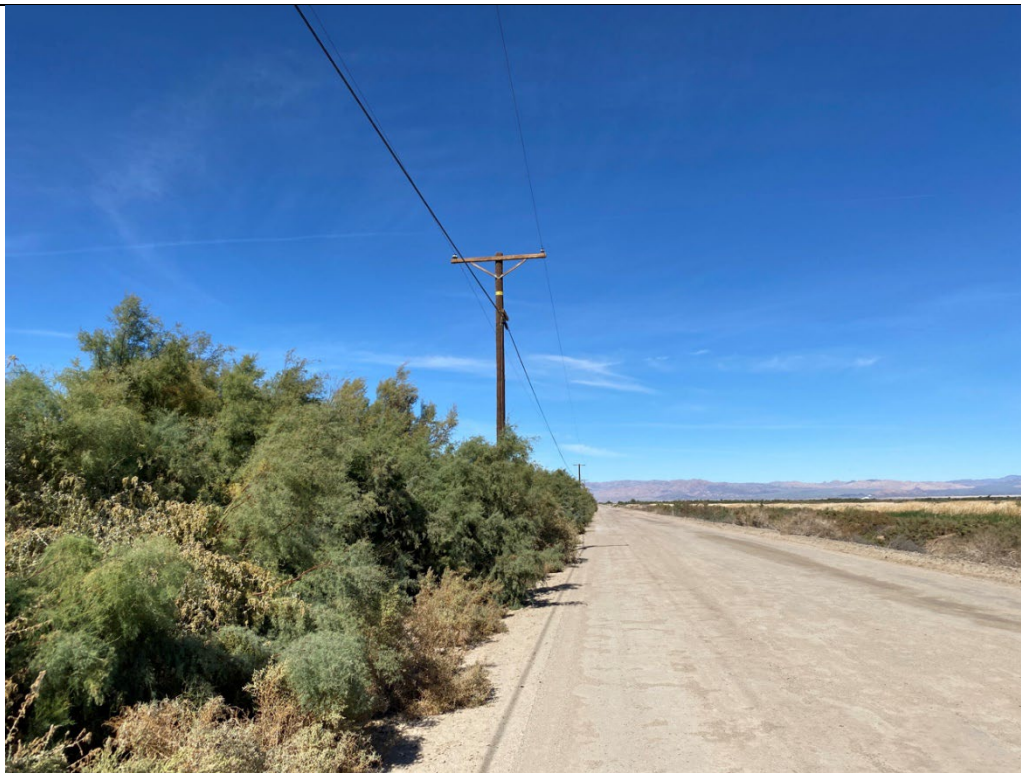
Photo 5A: View to the north at **Sample Point 5**. Photo shows an area mapped by NWI as palustrine scrub-shrub (PSS) and by National Hydrography Dataset (NHD) as an intermittent lake/pond, but no hydrology indicators are present.

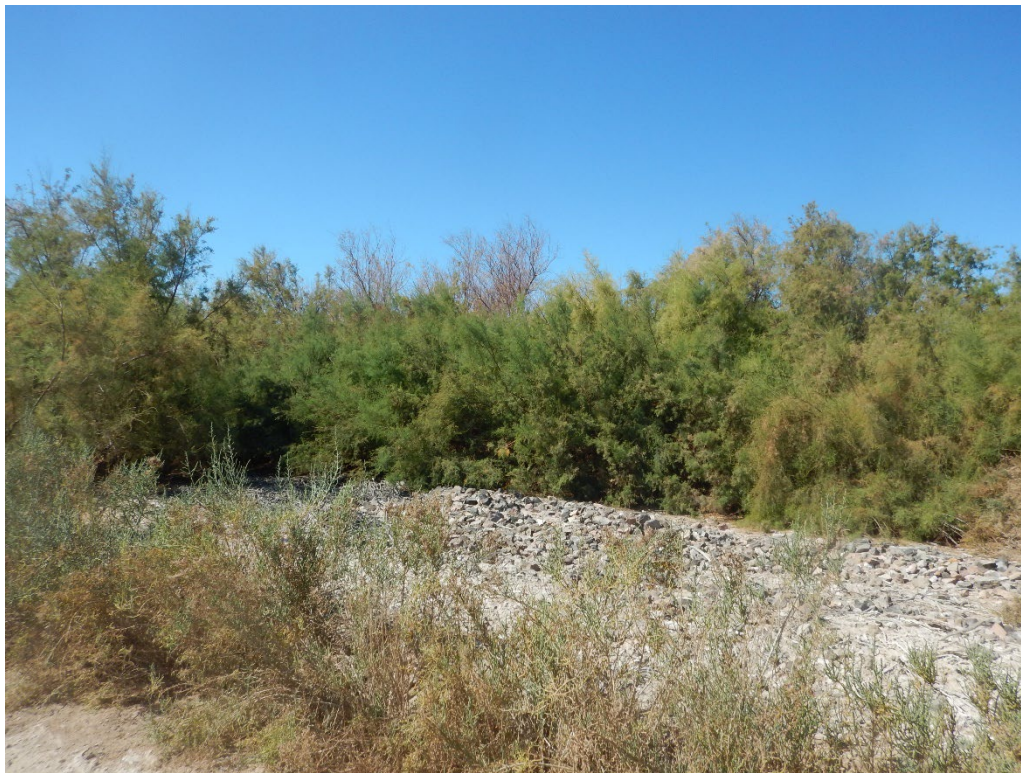
Photo 5B: View to the southwest at **Sample Point 5**. Photo shows an area mapped by NWI as PSS and by NHD as an intermittent lake/pond, but no hydrology indicators are present.

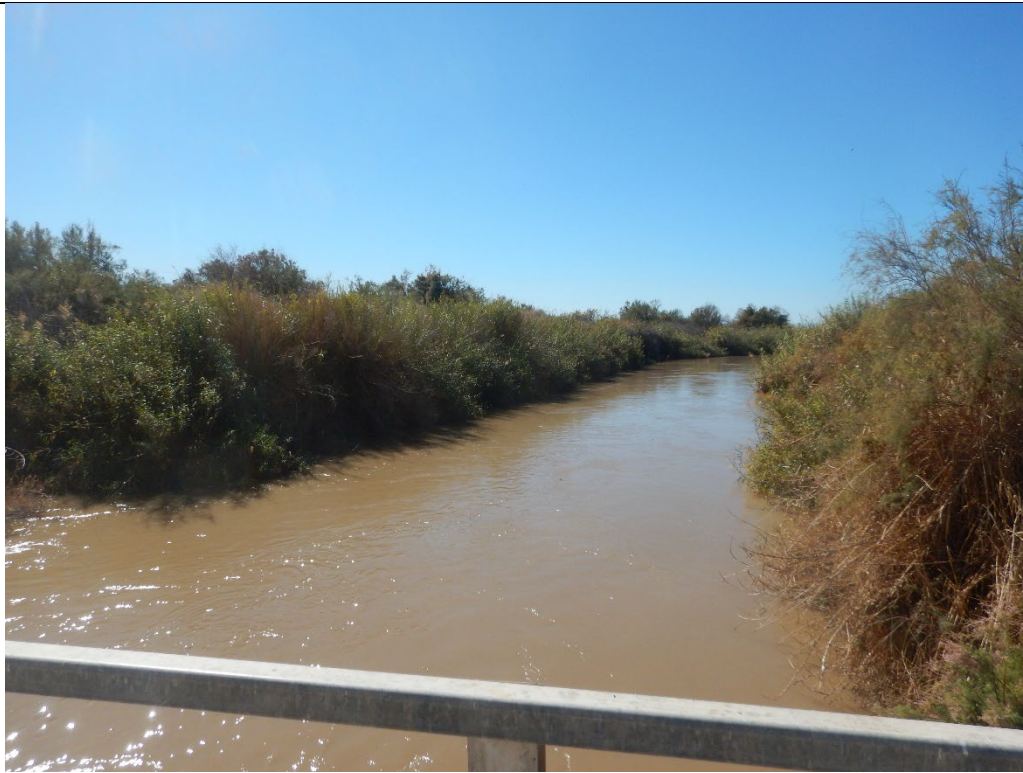
Photo 6A: View to the northwest at **Sample Point 6**. Photo shows the NHD- and NWI-mapped perennial stream **PS-1, Alamo River**, flowing southeast to northwest towards the Salton Sea, with fringe palustrine emergent wetland PEM-1.

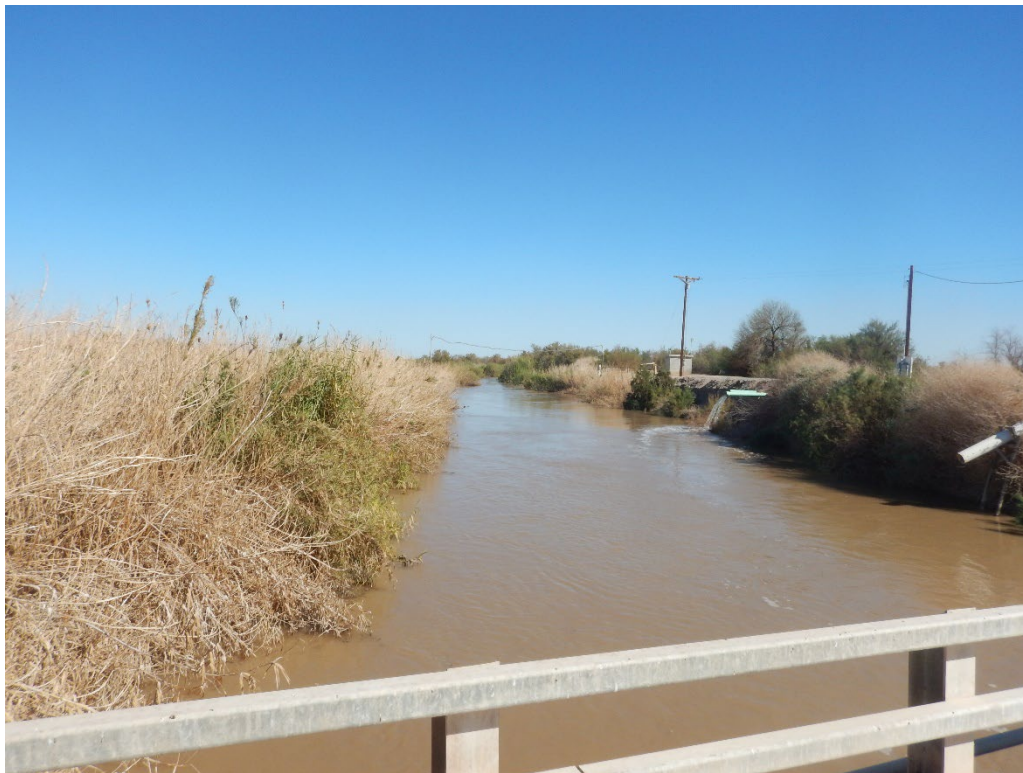
Photo 6B: View to the southeast at **Sample Point 6**. Photo shows the NHD- and NWI-mapped perennial stream **PS-1, Alamo River**, flowing southeast to northwest towards the Salton Sea, with fringe palustrine emergent wetland PEM-1.

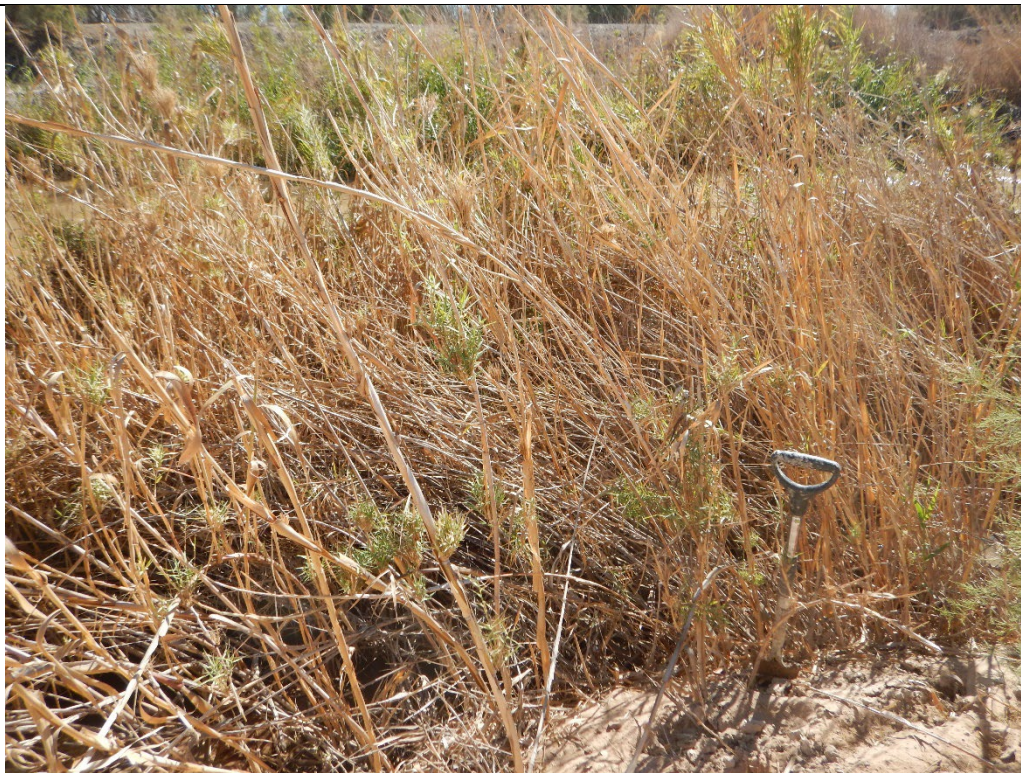
Photo 7: View to the south at **Sample Point 7**. Photo shows fringe palustrine emergent wetland **PEM-1** on the banks of PS-1 Alamo River.

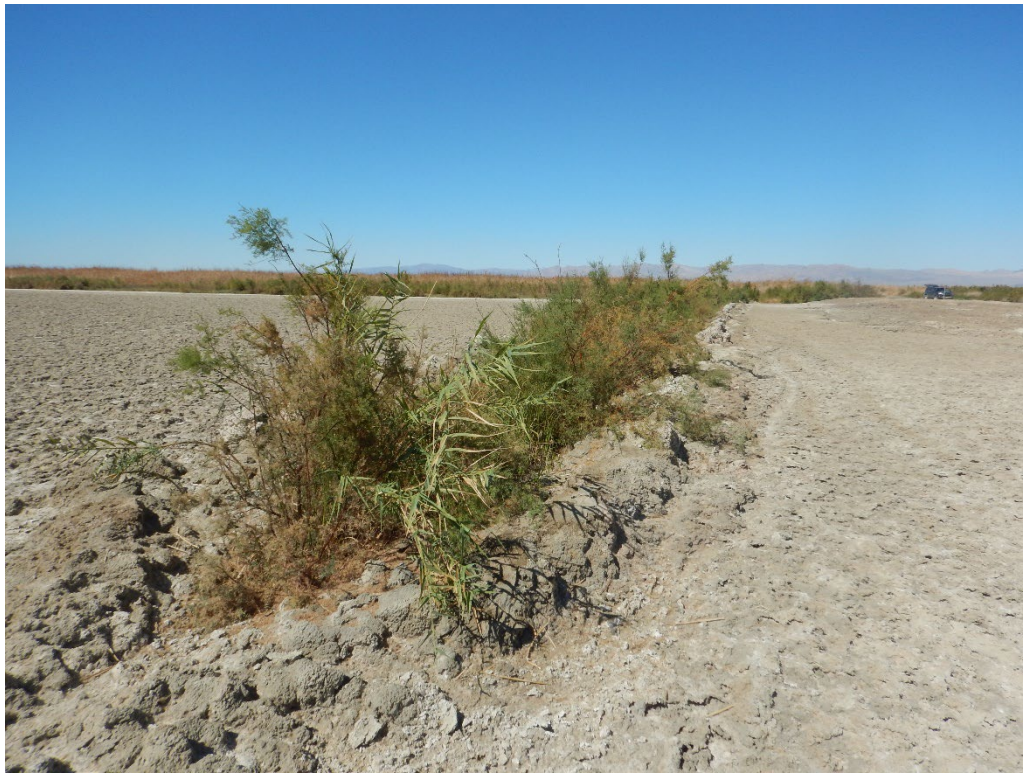
Photo 9: View to the northwest at **Sample Point 9**. The photo shows fringe/depressional palustrine scrub-shrub wetland **PSS-1** on Morton Bay.

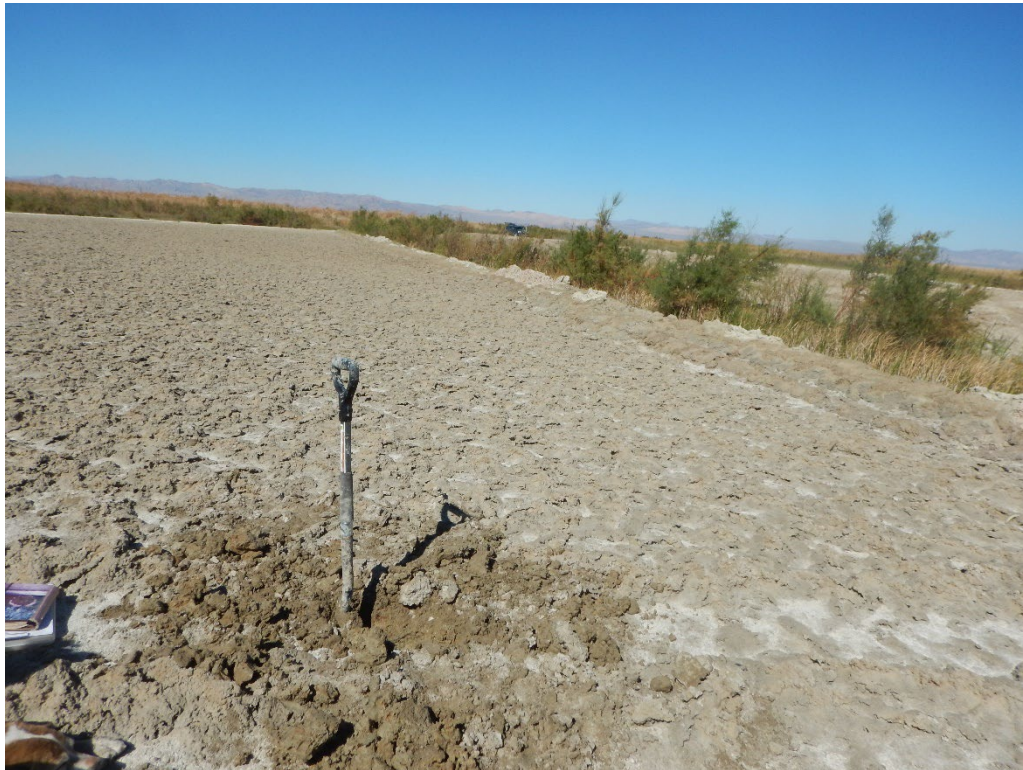
Photo 10A: View to the north at **Sample Point 10**. The photo shows palustrine seasonally flooded salt flat **PUBC-1A** abutting **PSS-1** and Morton Bay.

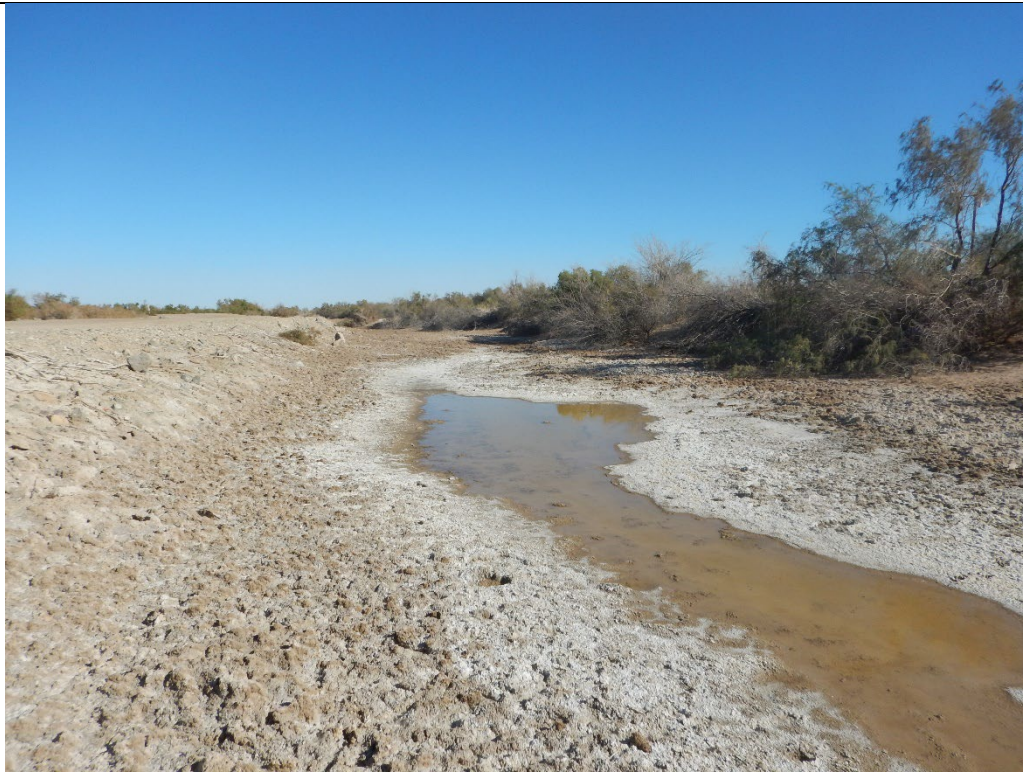
Photo 10B: View to the southeast of **PUBC-1B** separated by a road from PSS-2.

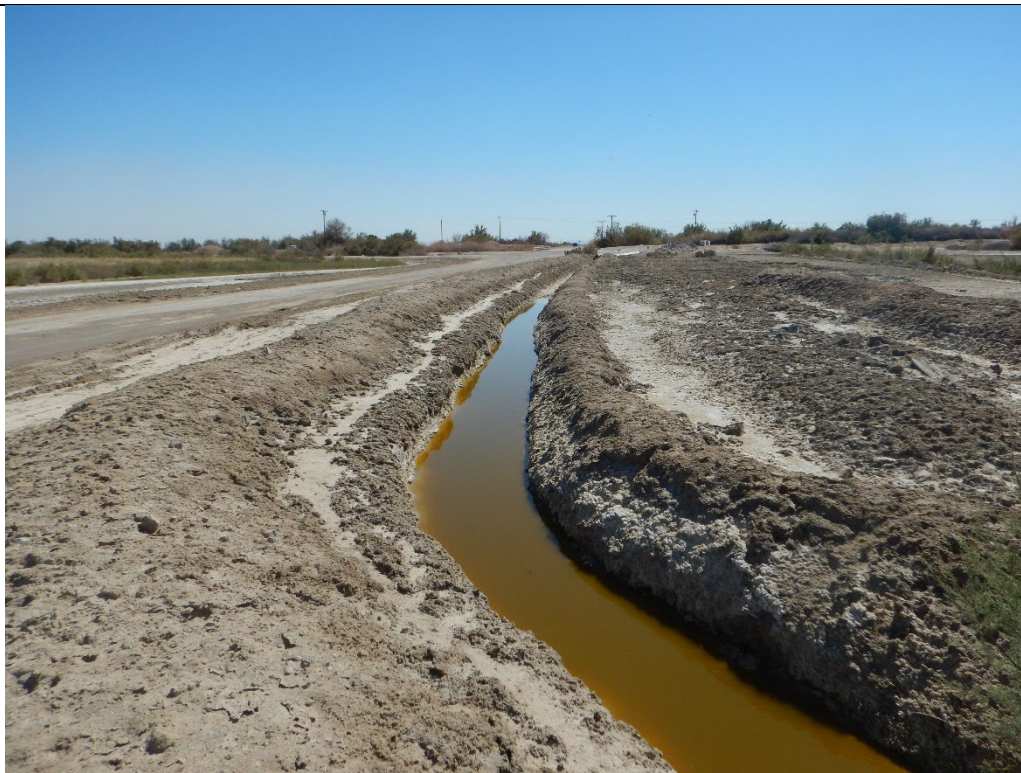
Photo 12: View to the south at **Sample Point 12**. Photo shows **Ditch-1**, a manmade drainage leading from PUBC-1A to Morton Bay.

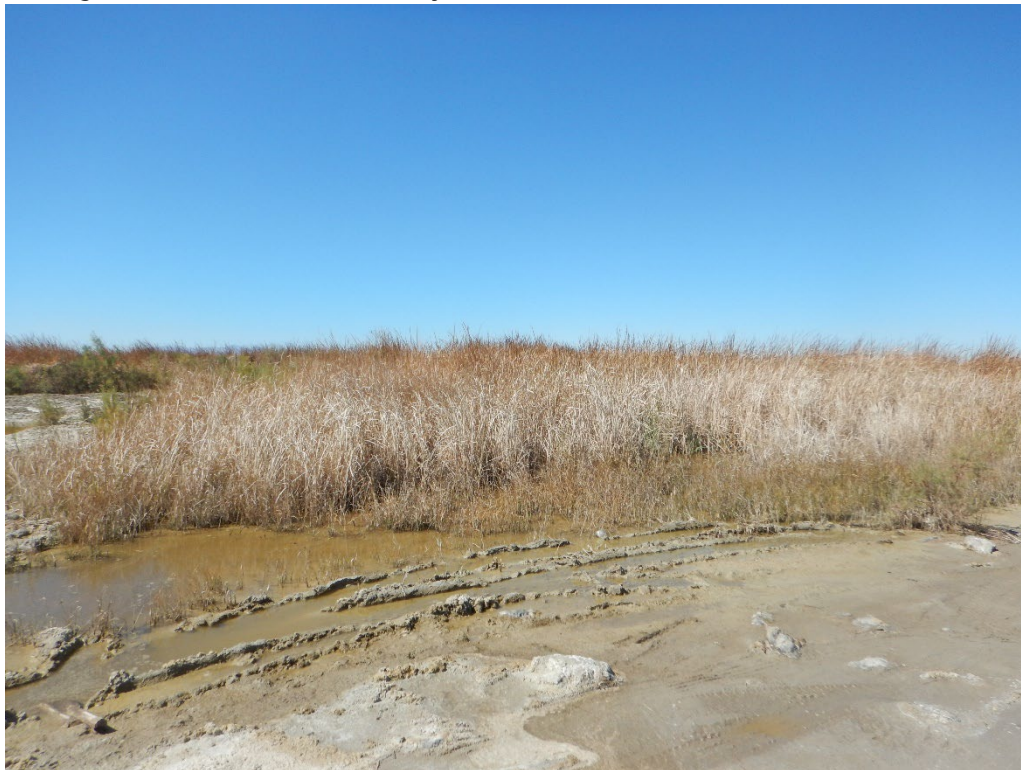
Photo 13A: View to the northwest at **Sample Point 13**. Photo shows fringe palustrine emergent wetland **PEM-2A** on Morton Bay.

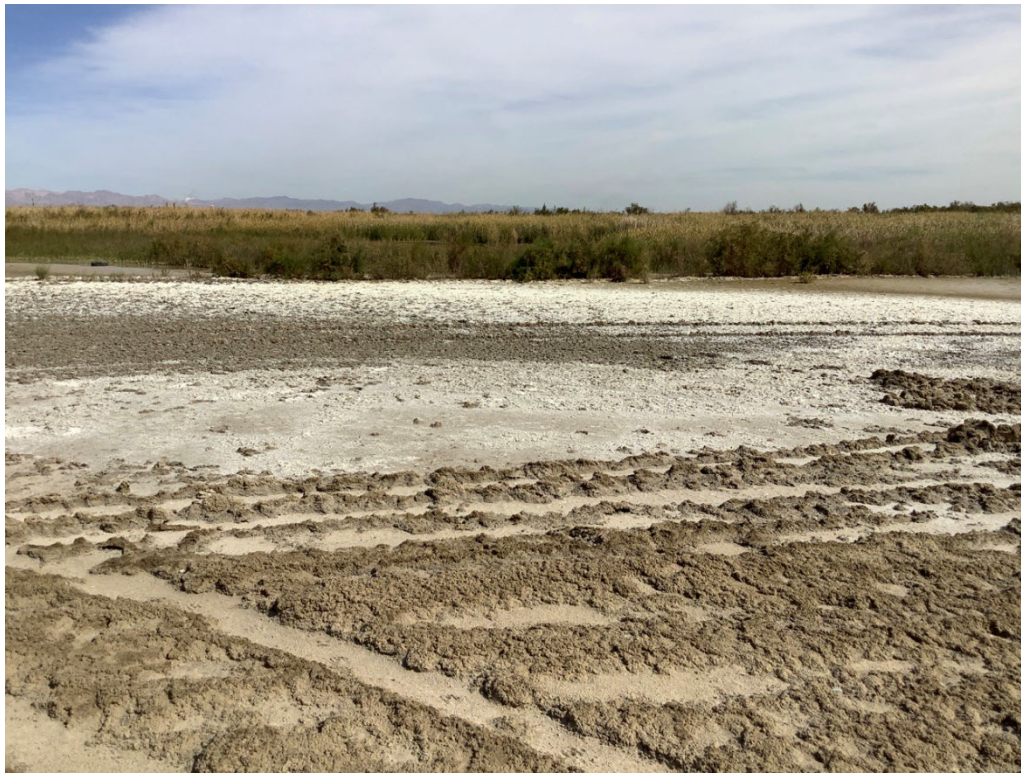
Photo 13B: View to the east at **Sample Point 13**. Photo shows fringe palustrine emergent wetland **PEM-2B** (background) and **PUBC-1A** (foreground).

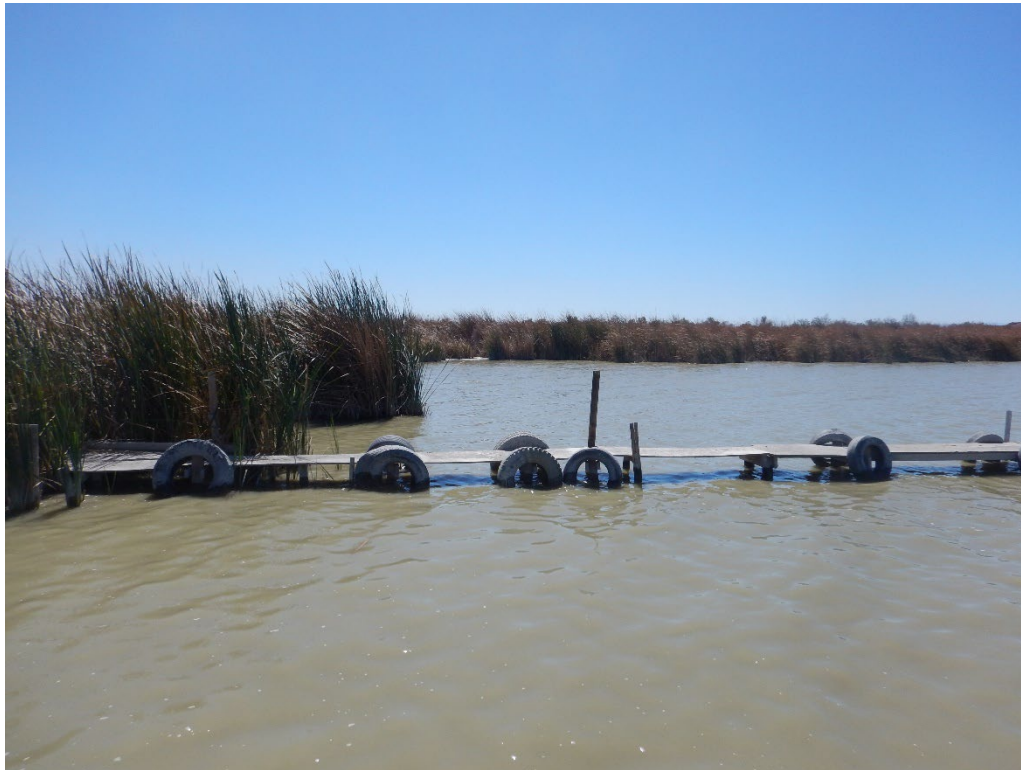
Photo 14: View to the south at **Sample Point 14**. The photo shows NWI-mapped **L1UBH-1**, **Morton Bay**.

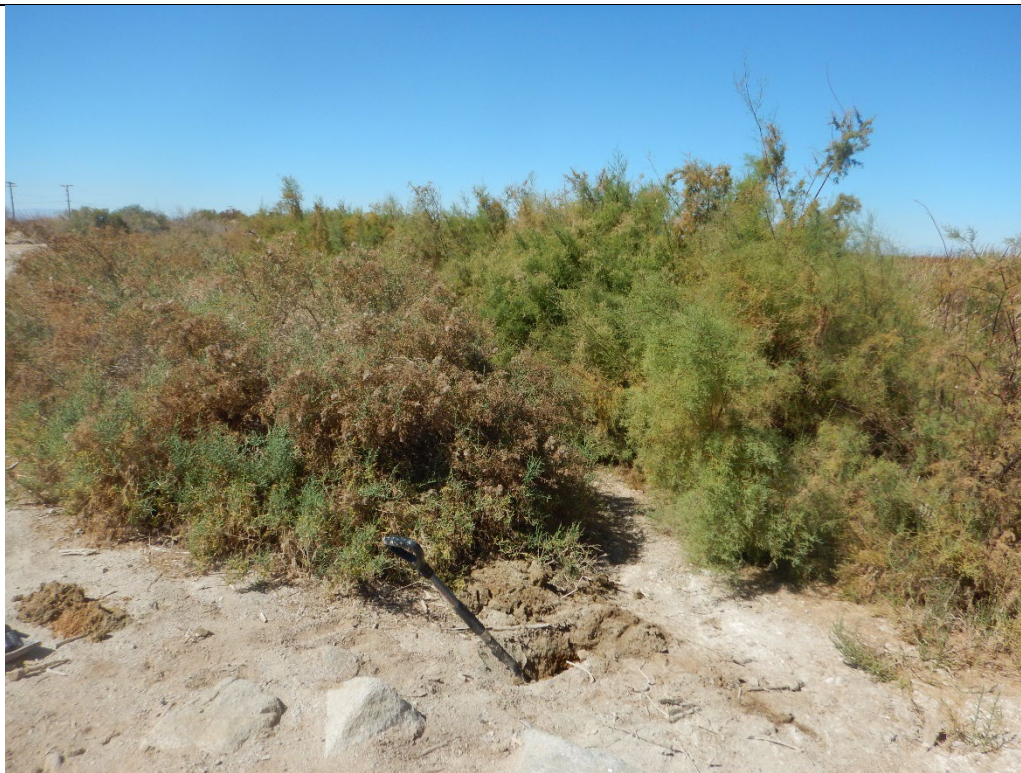
Photo 15A: View to the west at **Sample Point 15**. The photo shows fringe palustrine scrub-shrub wetland **PSS-2A** on **L1UBH-1**, Morton Bay.

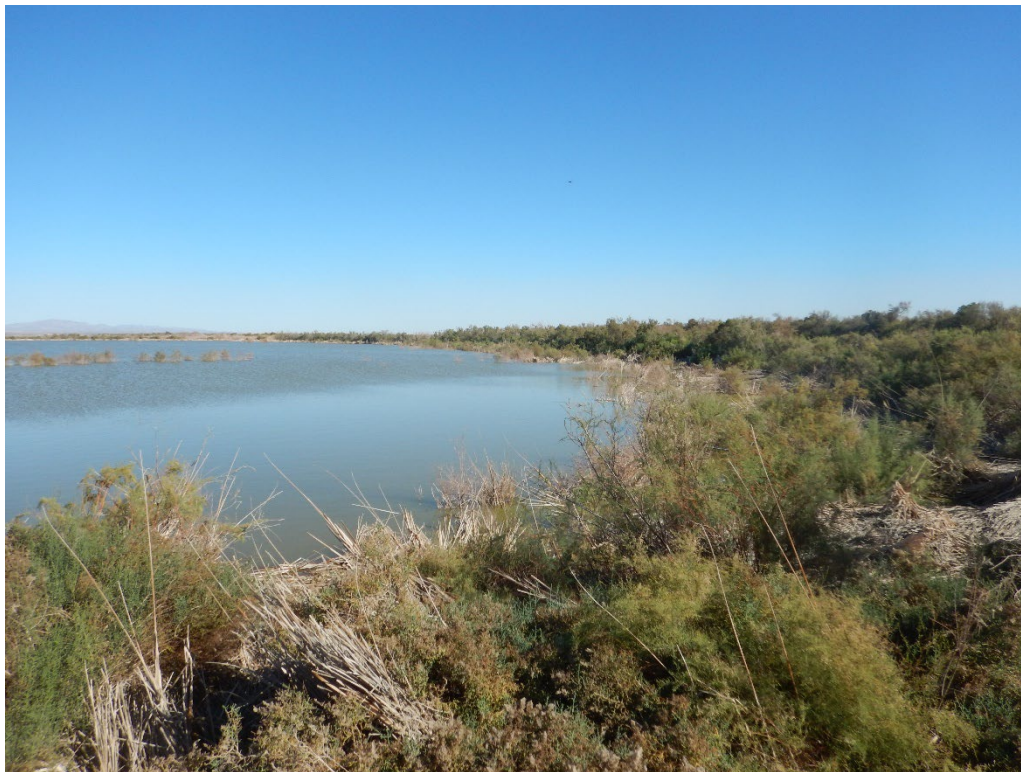
Photo 15B/17/18: View to the east of palustrine scrub shrub **PSS-2B**, riparian fringe (**Sample Point 17**), and **L1UBHx-1** (**Sample Point 18**).

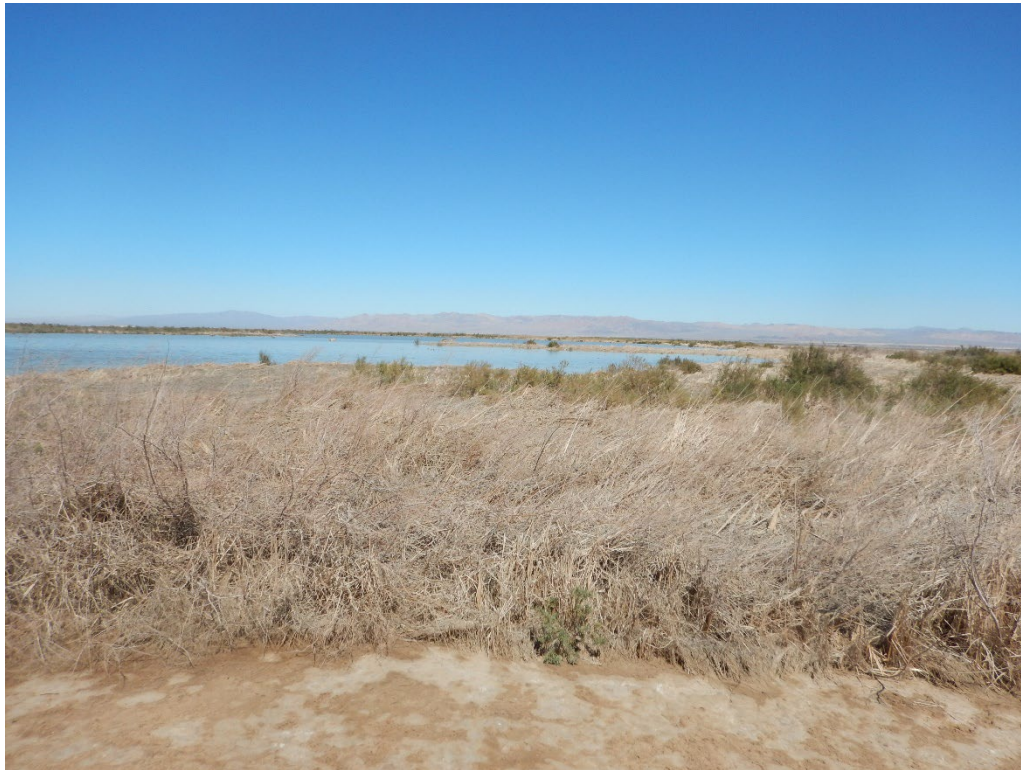
Photo 17B: View to the north of riparian area along L1UBHx-1.

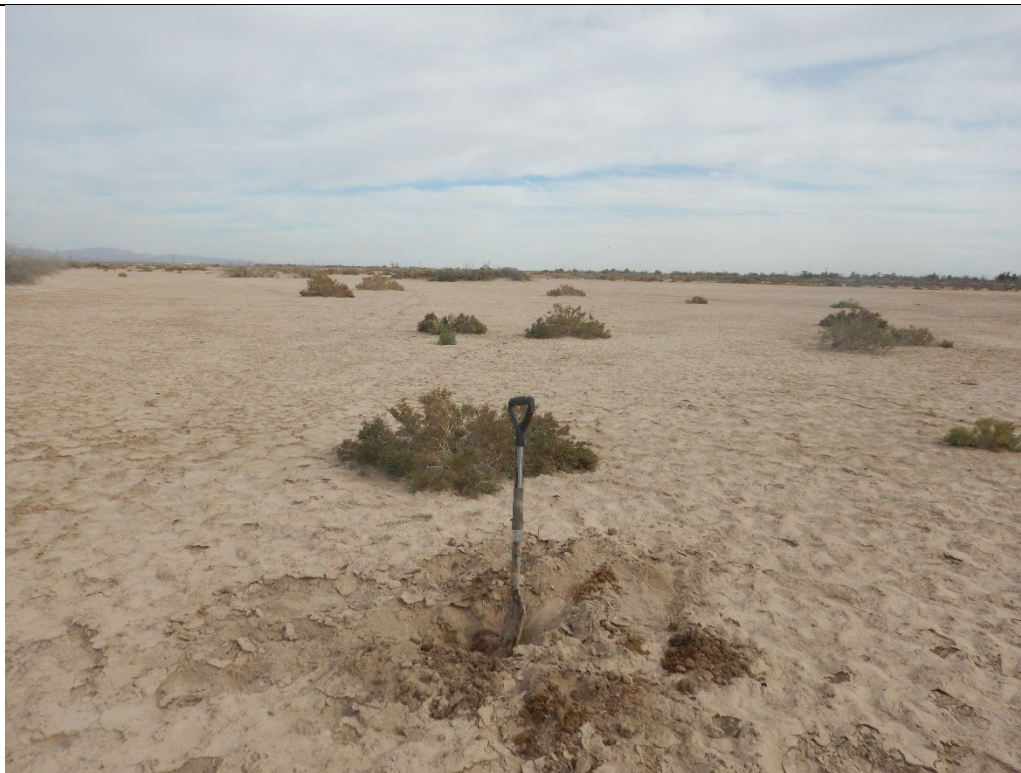
Photo 19A: View to the southeast at **Sample Point 19**. The area is NWI-mapped as PUSC_x and NHD-mapped as an intermittent reservoir. Surface soil cracks and hydric soils are likely relictual.

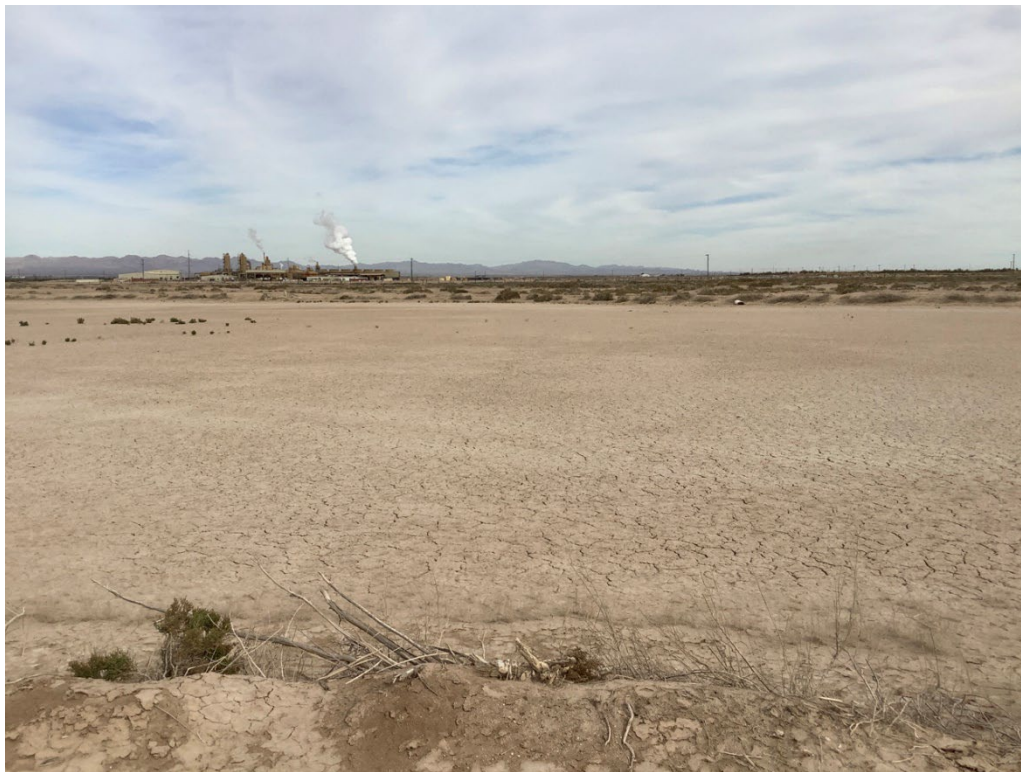
Photo 19B: View to the east of abandoned industrial pond mapped by NWI as PUSC_x and by NHD as an intermittent reservoir. Surface soil cracks and hydric soils are likely relictual.

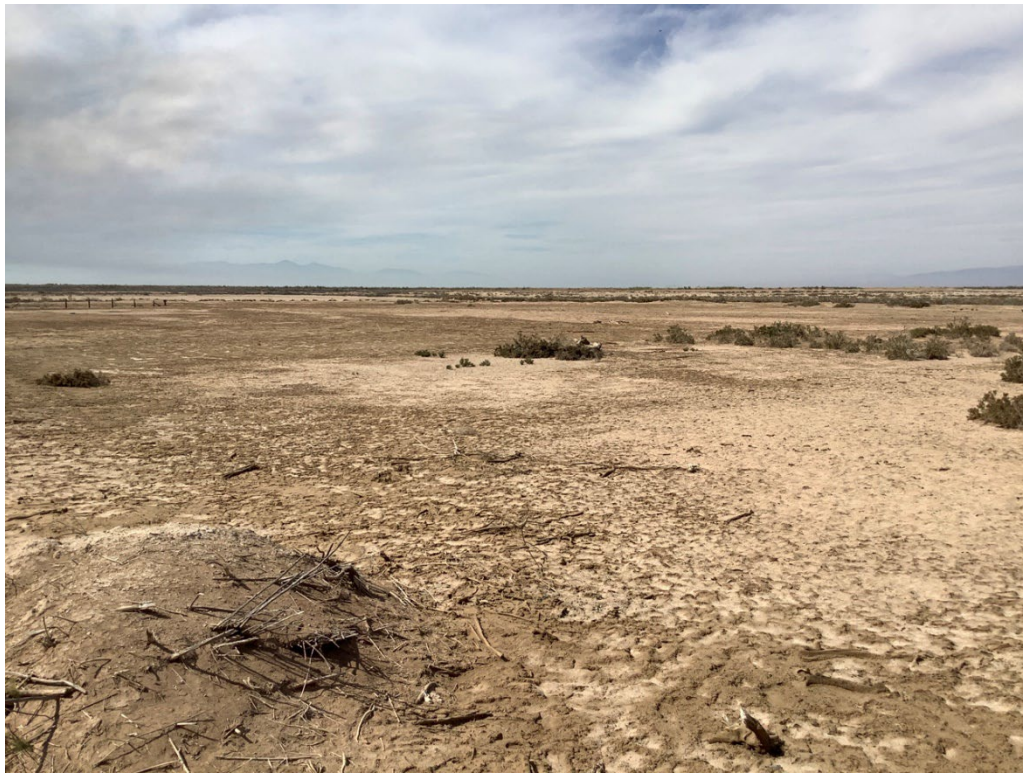
Photo 19C: View to the northwest of an abandoned industrial pond mapped by NWI as PUSC_x and by NHD as an intermittent reservoir. Surface soil cracks and hydric soils are likely relictual.

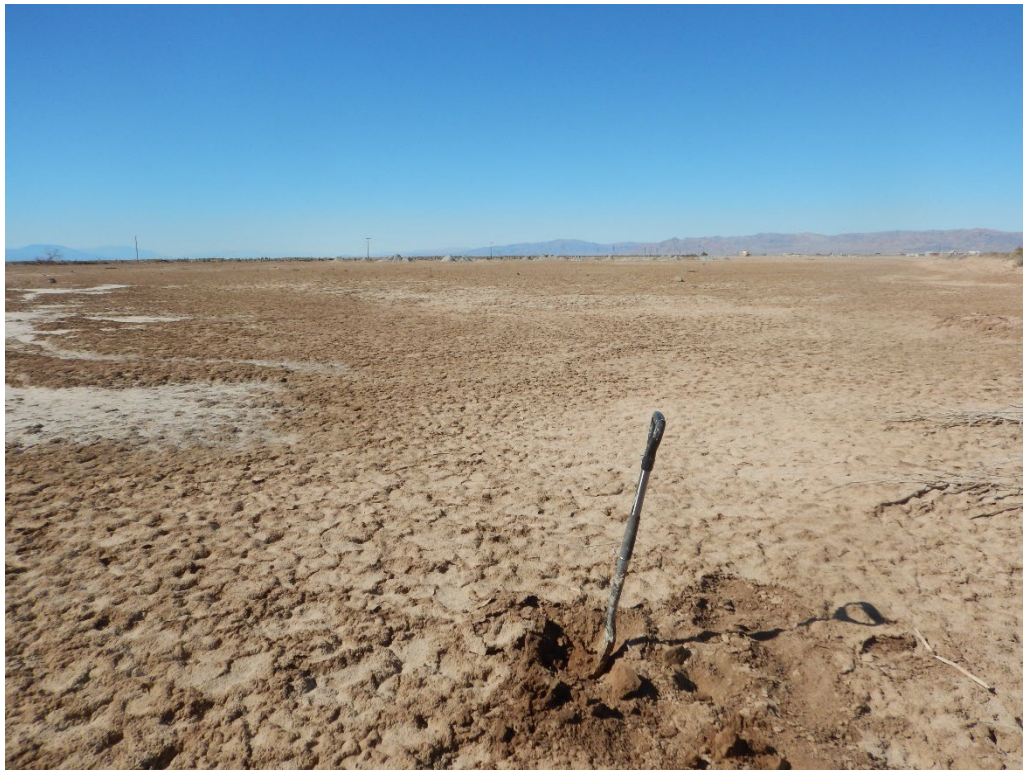
Photo 20A: View to the northwest of an abandoned industrial pond mapped by NHD as an intermittent reservoir, but lacking hydric soil indicators. Surface soil cracks are likely relictual from historical hydrologic regime.

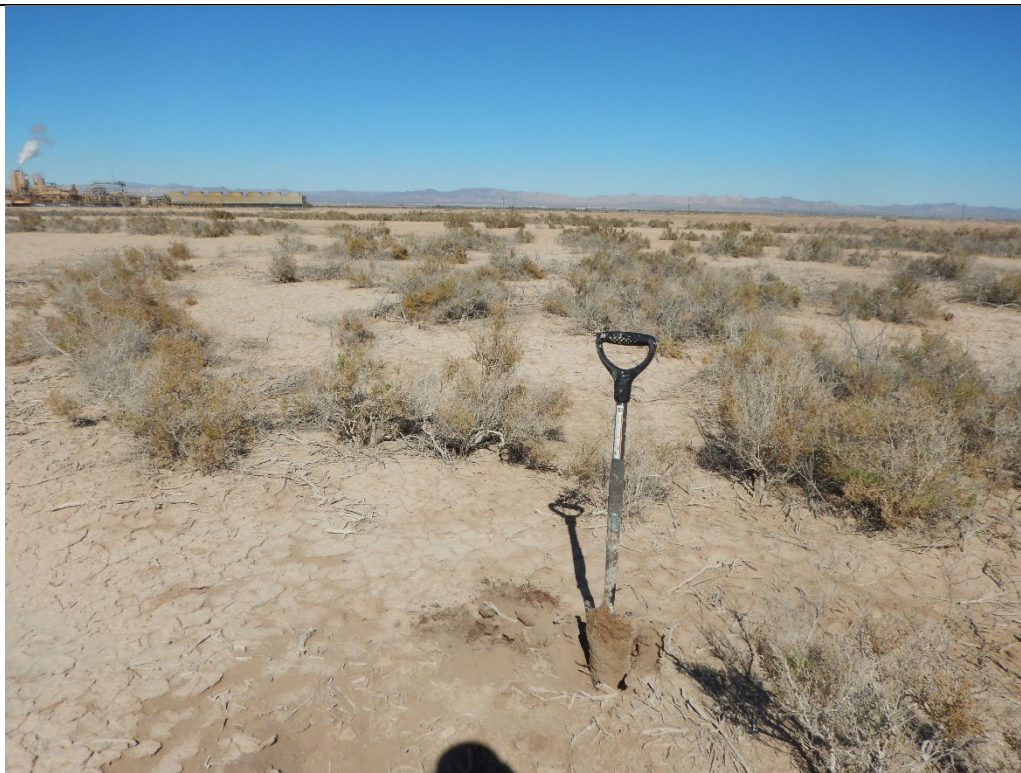
Photo 20B: View to the northeast at **Sample Point 20**. The area is NWI-mapped as PUSC_x and NHD-mapped as an intermittent reservoir, but no hydric soil indicators are present. Surface soil cracks are likely relictual from historical hydrologic regime.

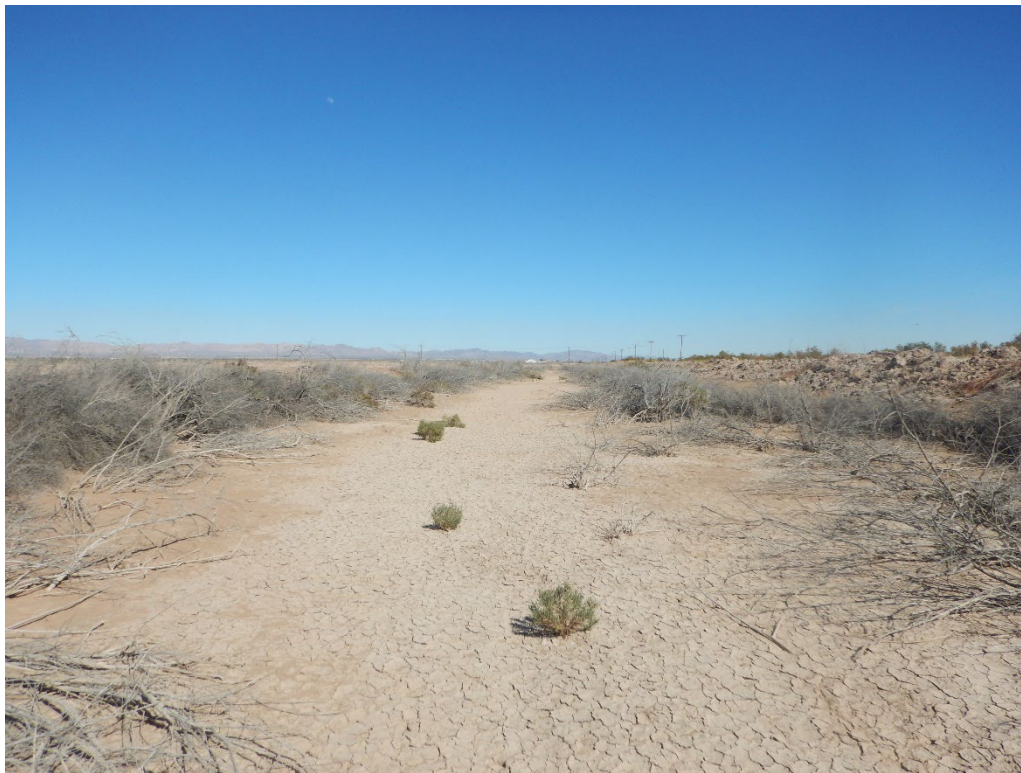
Photo 20C: View to the east of an abandoned industrial pond. The area is NWI-mapped as PUSC_x and NHD-mapped as an intermittent reservoir, but no hydric soil indicators are present. Surface soil cracks are likely relictual from historical hydrologic regime.

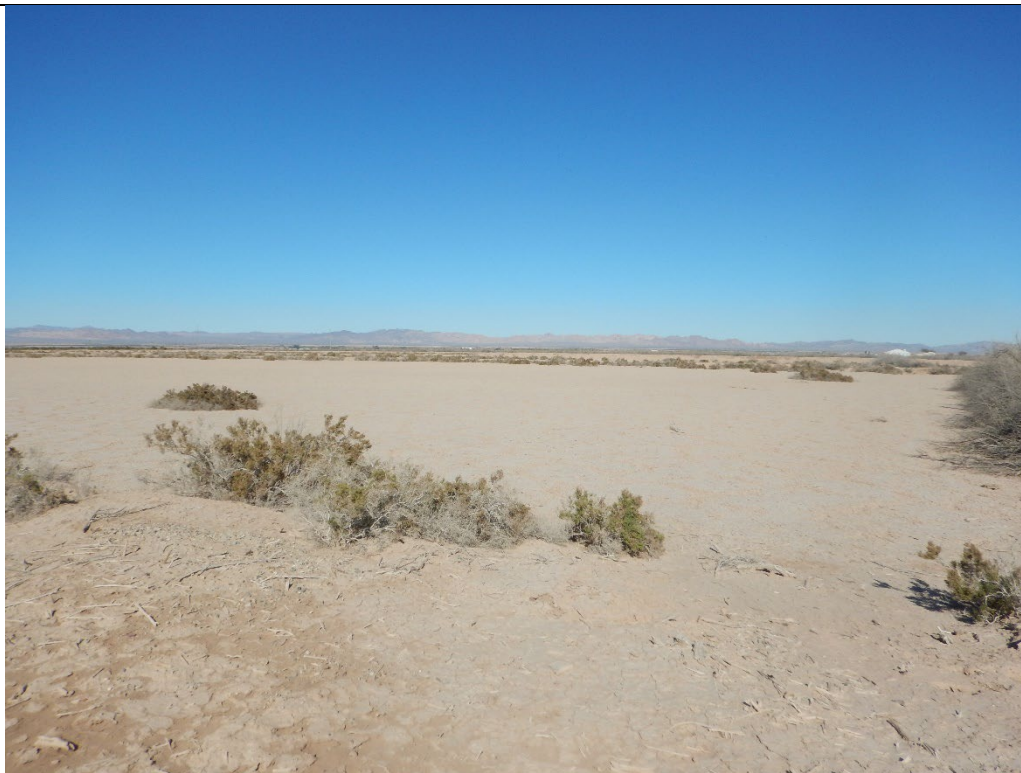
Photo 20D: View to the northeast of an abandoned industrial pond. The area is NWI-mapped as PUSC_x and NHD-mapped as an intermittent reservoir, but no hydric soil indicators are present. Surface soil cracks are likely relictual from historical hydrologic regime.

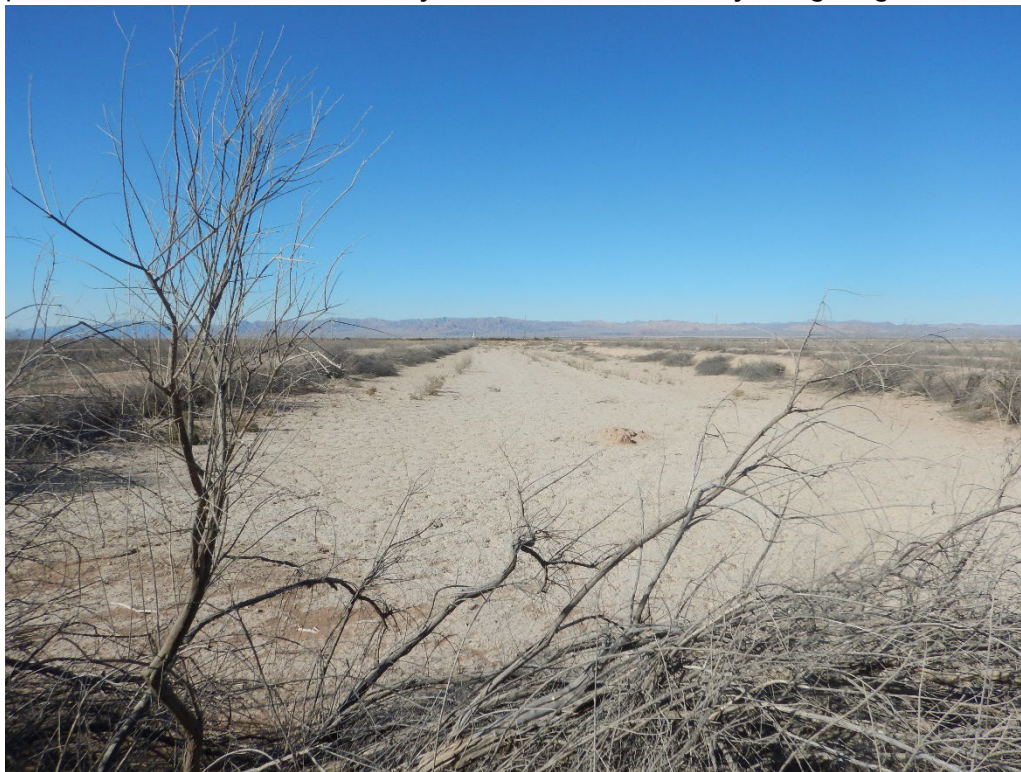
Photo 20E: View to the north of an abandoned industrial pond. The area is NWI-mapped as PUSC_x and NHD-mapped as an intermittent reservoir, but no hydric soil indicators are present. Surface soil cracks are likely relictual from historical hydrologic regime.
