DOCKETED	
Docket Number:	23-AFC-01
Project Title:	Morton Bay Geothermal Project (MBGP)
TN #:	249725
Document Title:	Morton Bay Geothermal Project AFC Volume 2 Appendix 5-2 Biological Resources
Description:	N/A
Filer:	Jerry Salamy
Organization:	Jacobs
Submitter Role:	Applicant Consultant
Submission Date:	4/18/2023 10:56:22 AM
Docketed Date:	4/18/2023

Appendix 5.2C Figure 1 Overview
Aquatic Resource Delineation Results
Morton Bay Geothermal Project
Imperial County, California

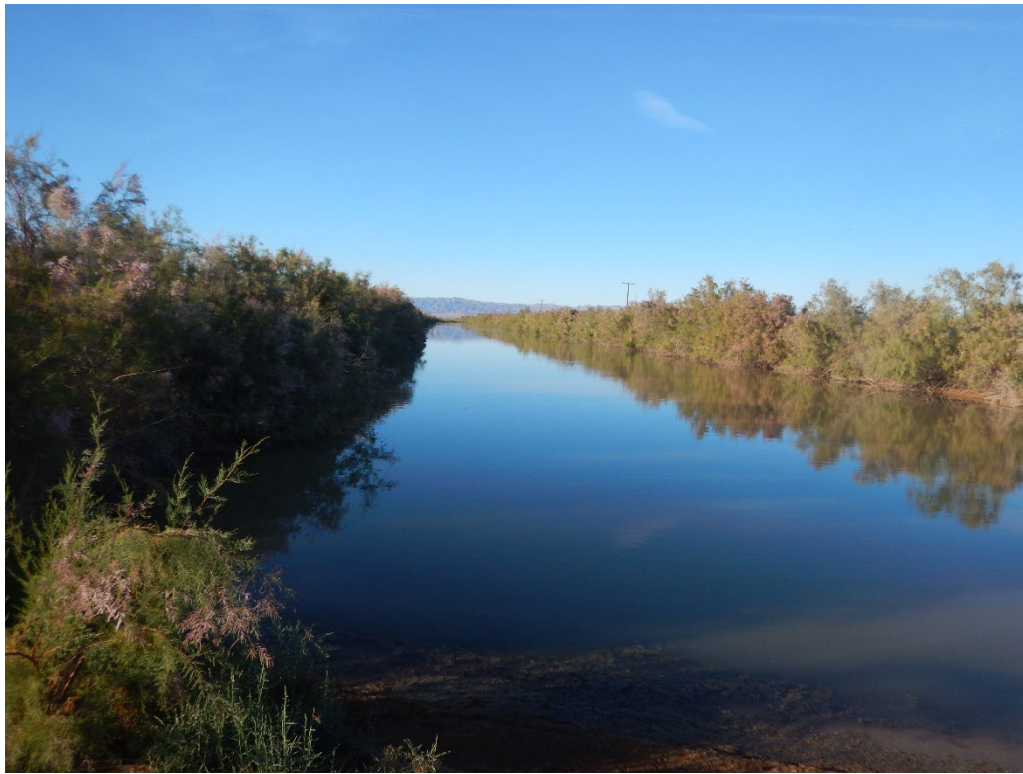
Photo 21: View to the north at **Sample Point 21**. Photo shows NWI-mapped semipermanently flooded palustrine excavation **PUBFx-1** with fringe riparian area.

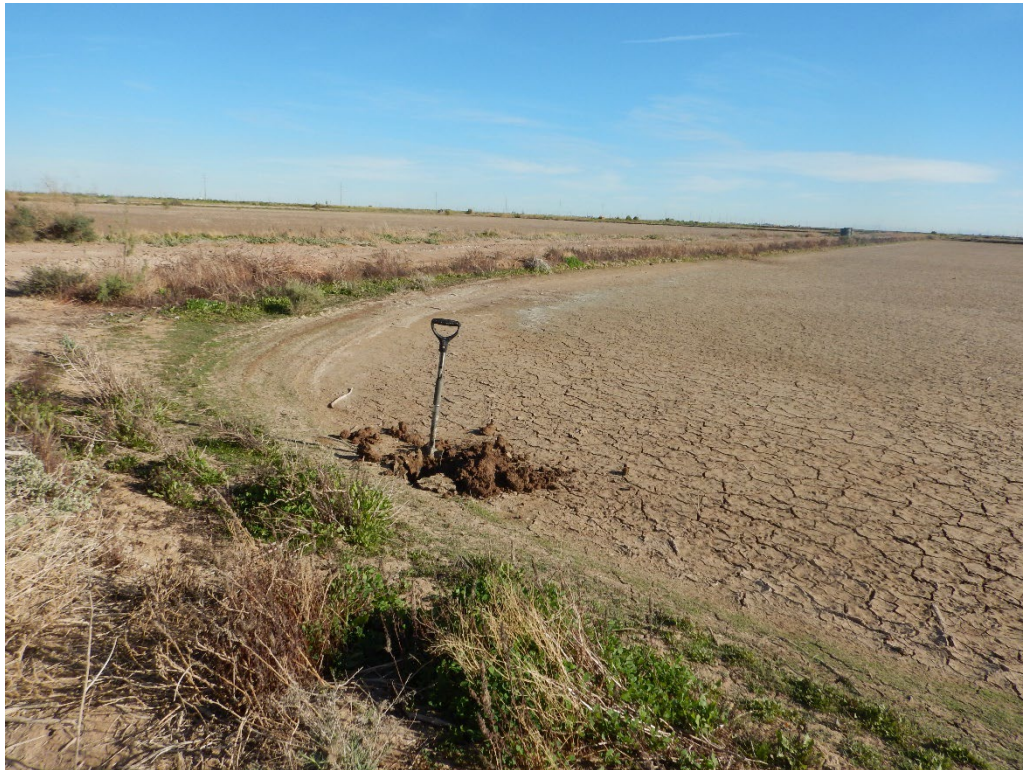
Photo 22: View to the southeast at **Sample Point 22**. Photo shows area mapped by NWI as a seasonally flooded palustrine excavation and by NHD as an intermittent reservoir. This area is managed for waterfowl hunting and lacks hydric soil indicators.

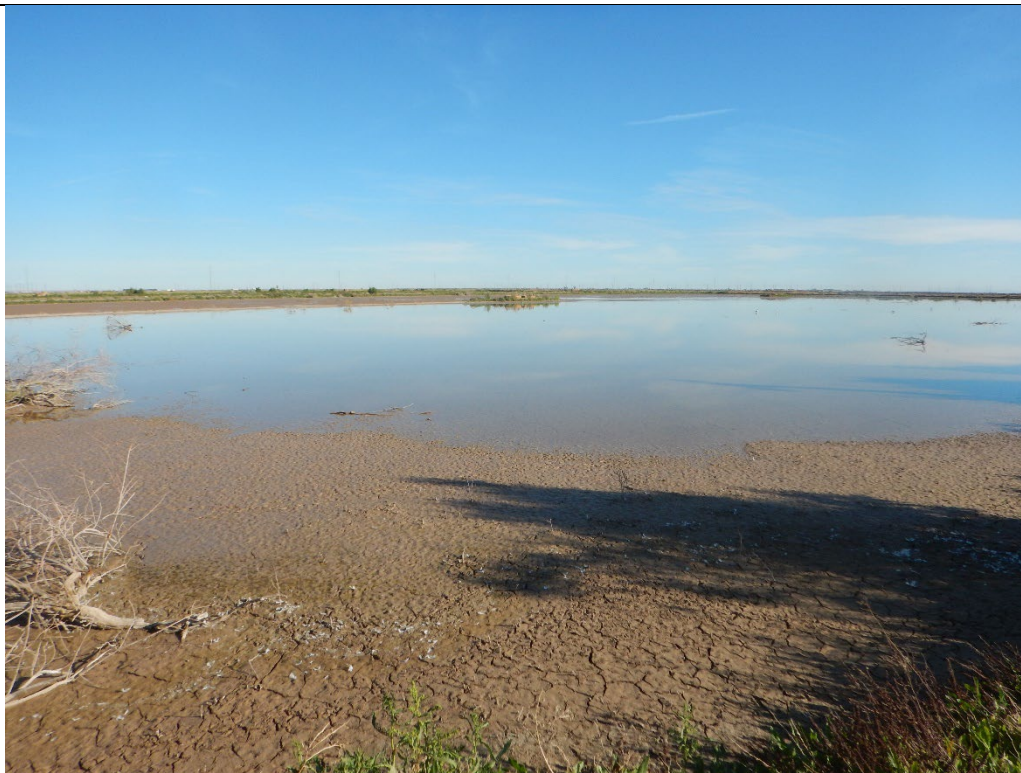
Photo 23: View to the southeast at **Sample Point 23**. Photo shows area mapped by NWI as a seasonally flooded palustrine excavation and by NHD as an intermittent reservoir. This area is managed for waterfowl hunting and lacks hydric soil indicators.

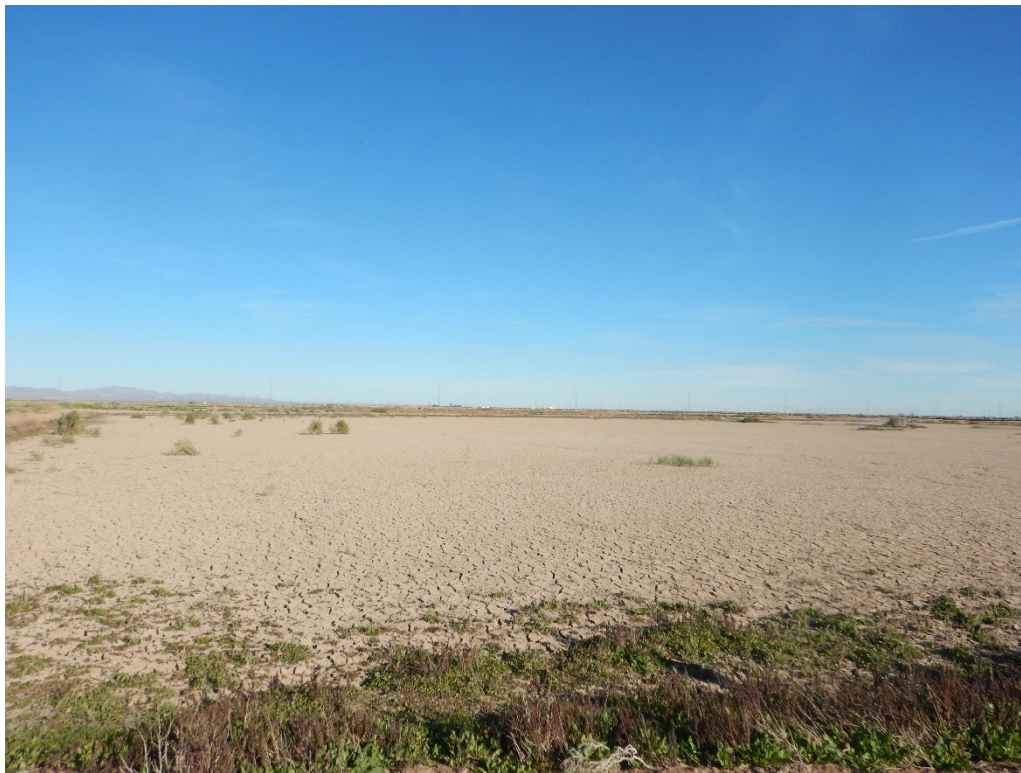
Photo 24: View to the southeast at **Sample Point 24**. Photo shows area mapped by NWI as a seasonally flooded palustrine excavation and by NHD as an intermittent reservoir. This area is managed for waterfowl hunting and lacks hydric soil indicators.

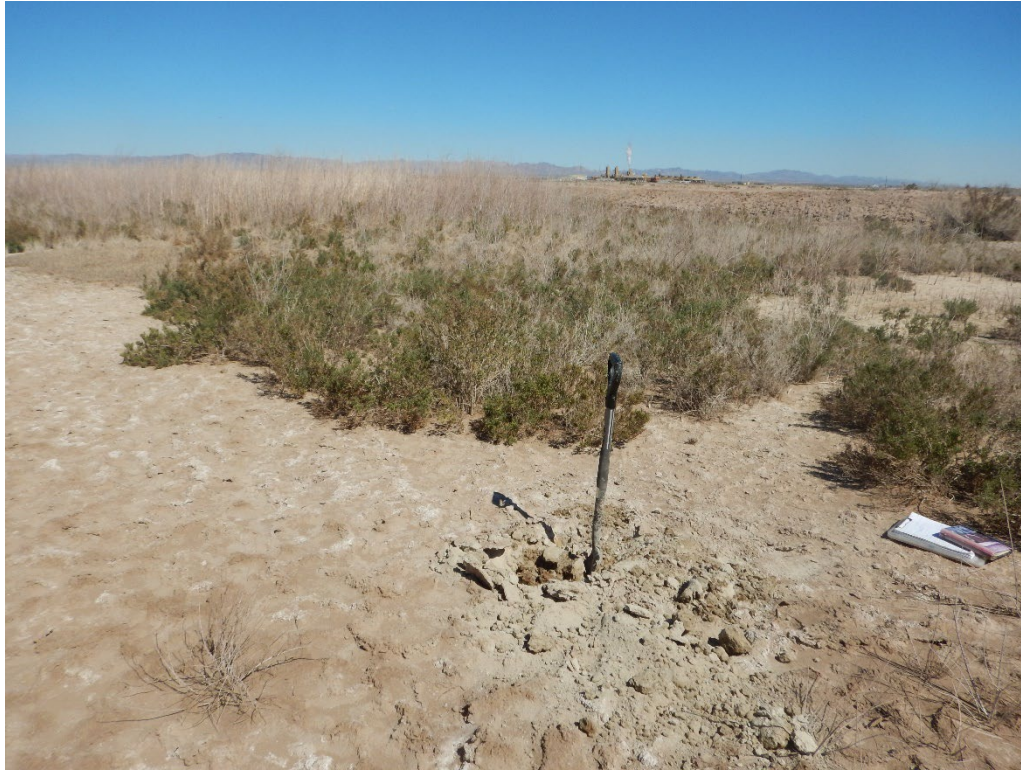
Photo 25A: View to the east at **Sample Point 25**. The photo shows an area previously qualifying as a wetland, but construction of the O-N Drain Connector in 2019 severed hydrologic connectivity.

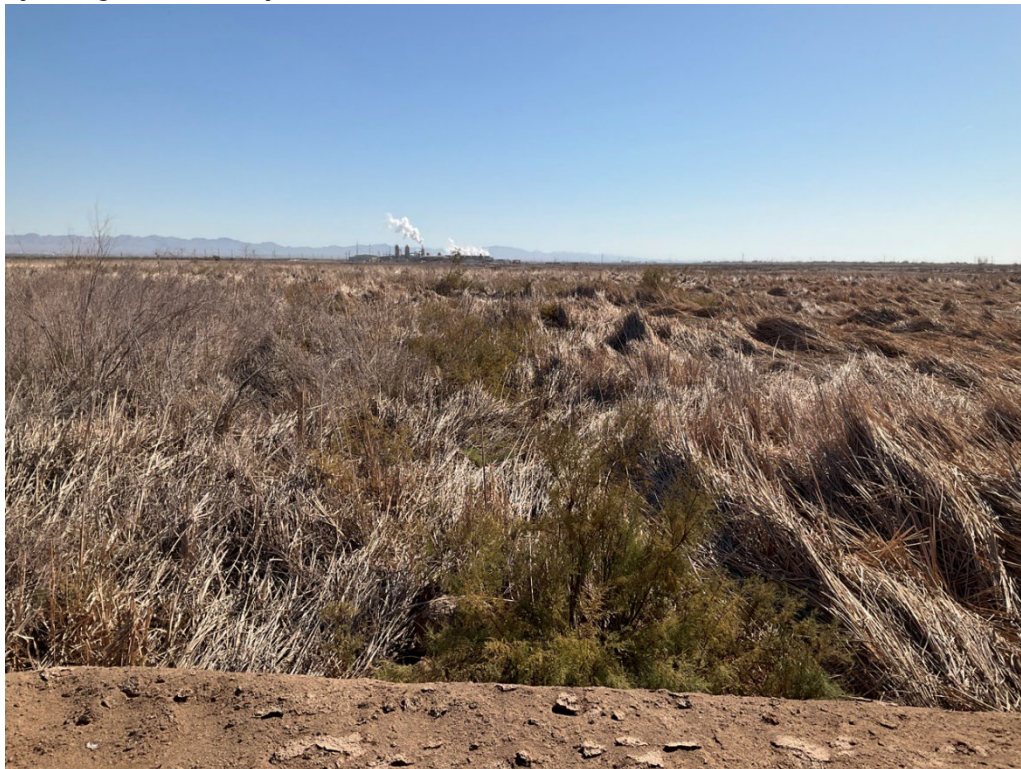
Photo 25B: View to the east of area previously qualifying as a wetland, but construction of the O-N Drain Connector in 2019 severed hydrologic connectivity.

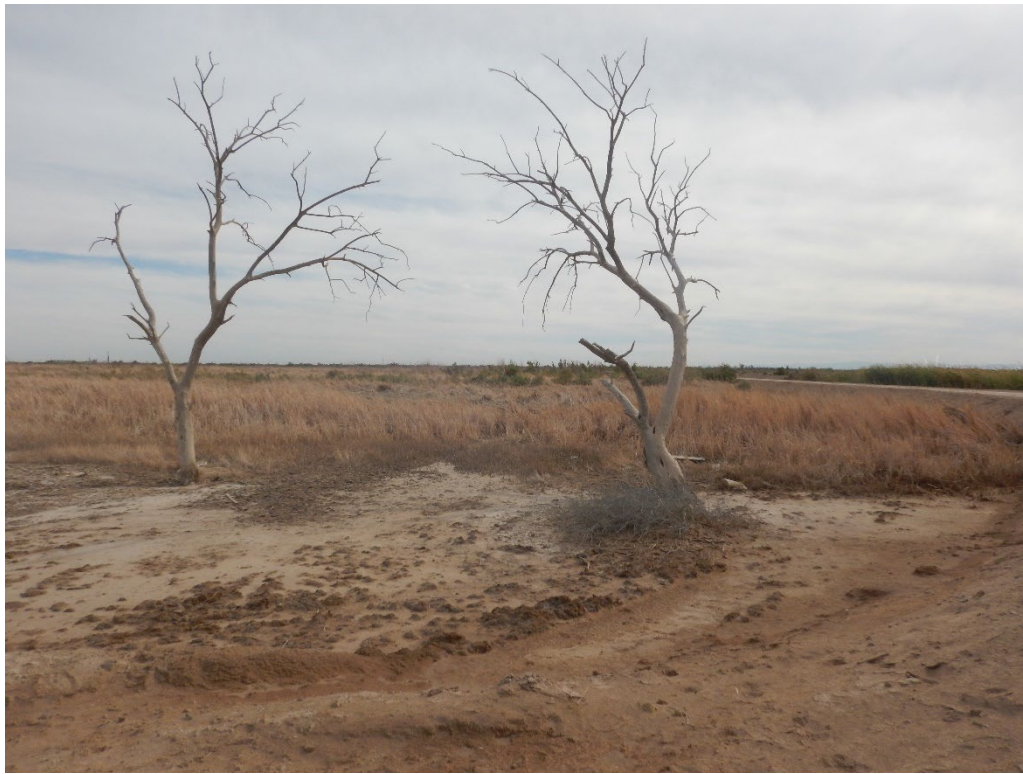
Photo 25C: View to the south of area previously qualifying as a wetland, but construction of the O-N Drain Connector in 2019 severed hydrologic connectivity.

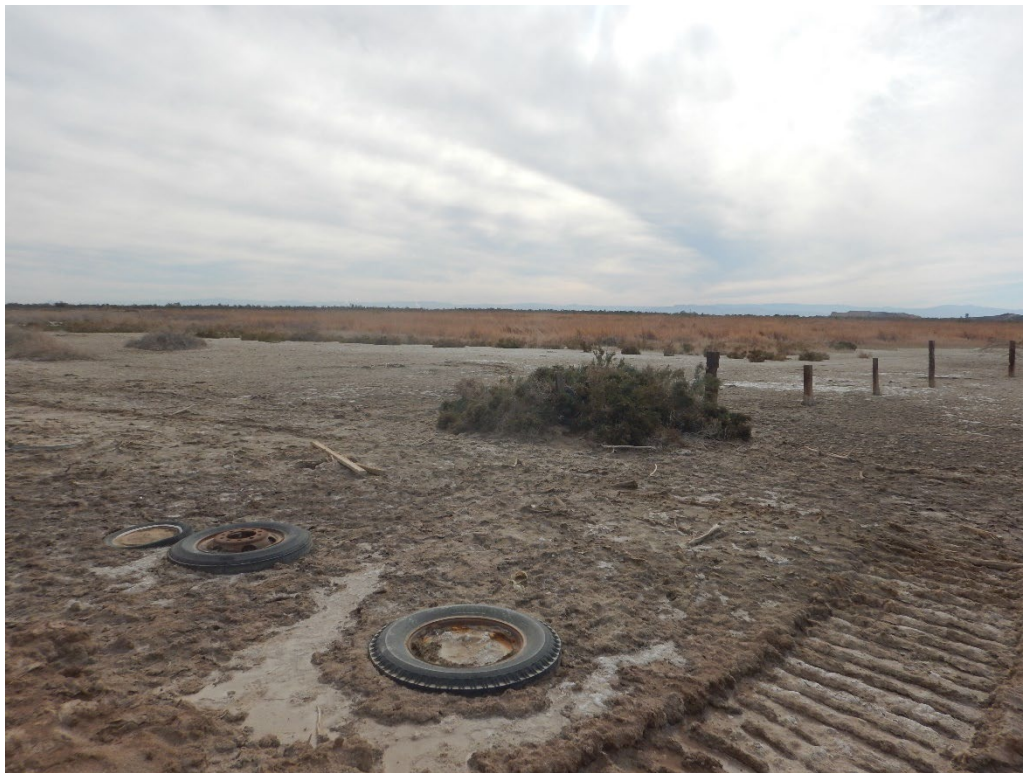
Photo 25D: View to the southwest of area previously qualifying as a wetland, but construction of the O-N Drain Connector in 2019 severed hydrologic connectivity.

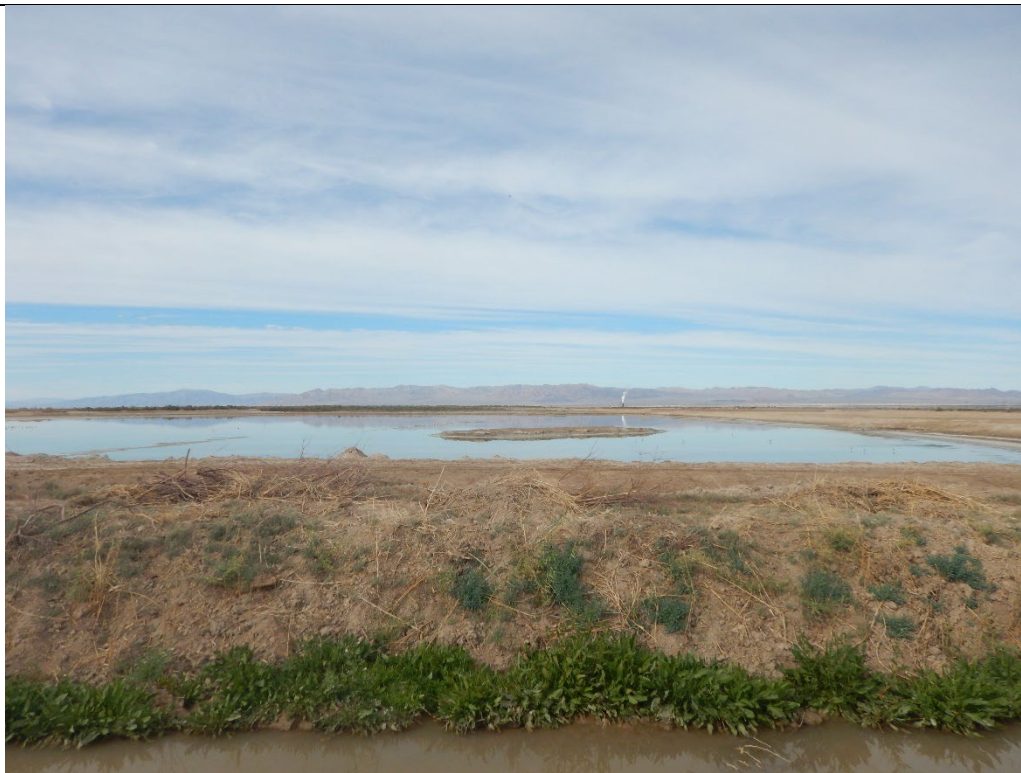
Photo 26: View to the north at **Sample Point 26**. The photo shows NWI-mapped semipermanently flooded palustrine excavation **PUBFx-2** (background).

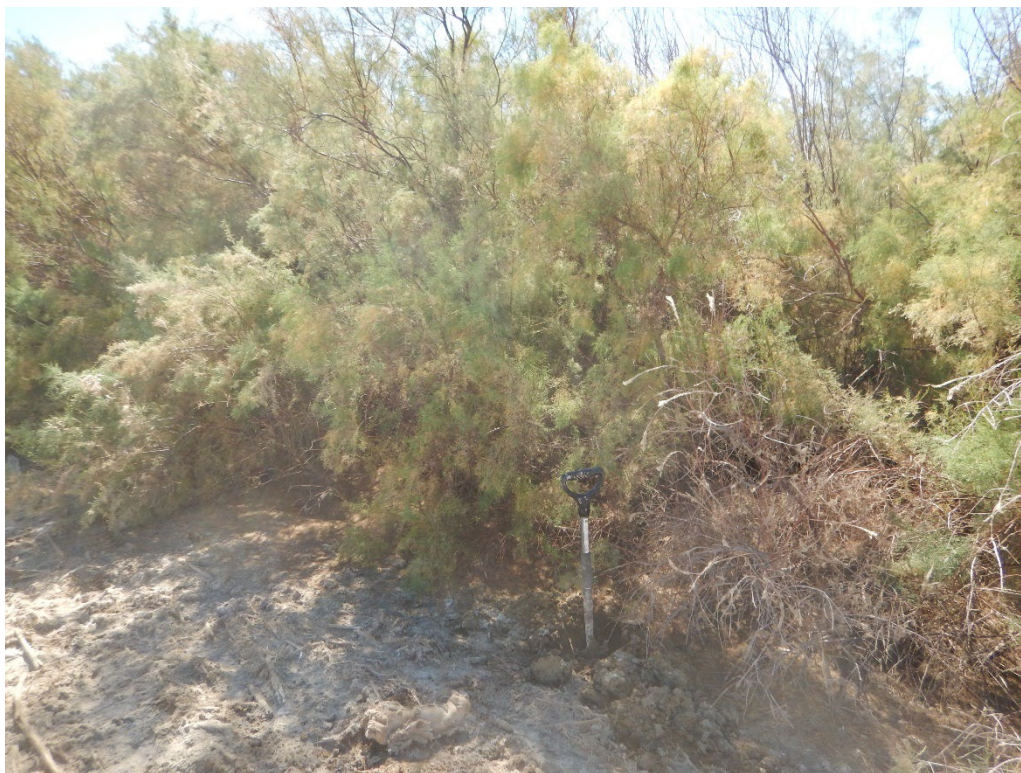
Photo 27A: View to the southwest at **Sample Point 27**. The photo shows depressional palustrine scrub-shrub wetland **PSS-3** in area mapped by NWI as L2USCx/L2UBFx.

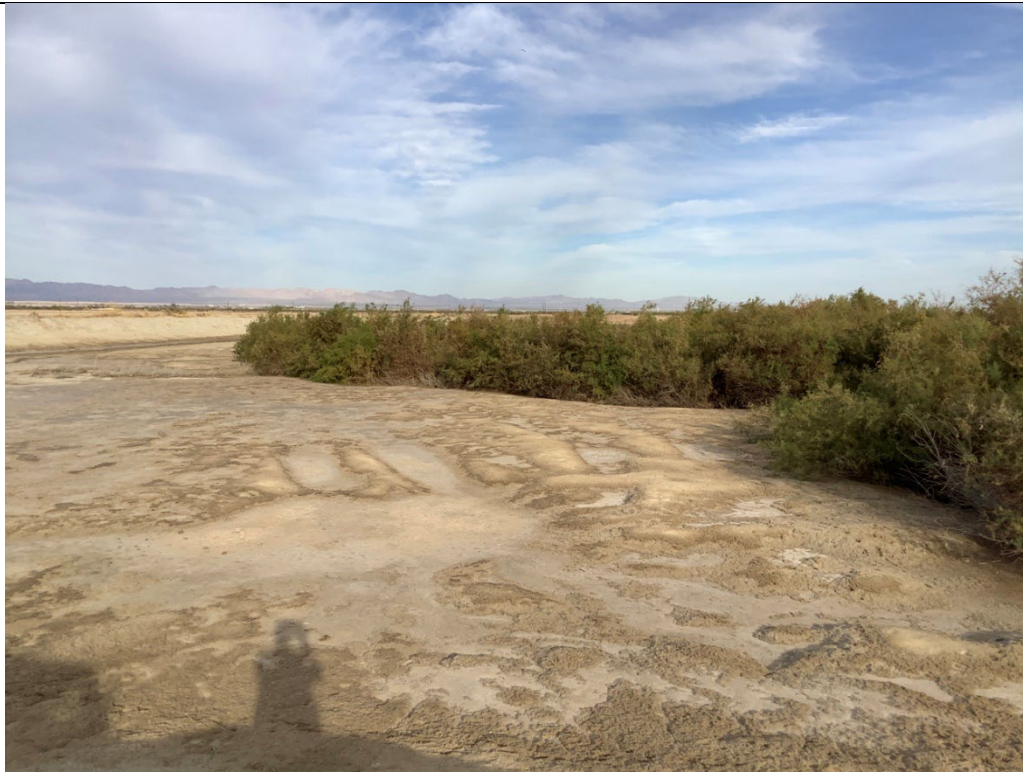
Photo 27B: View to the east of depressional palustrine scrub-shrub wetland **PSS-3** in area mapped by NWI as L2USCx/L2UBFx .

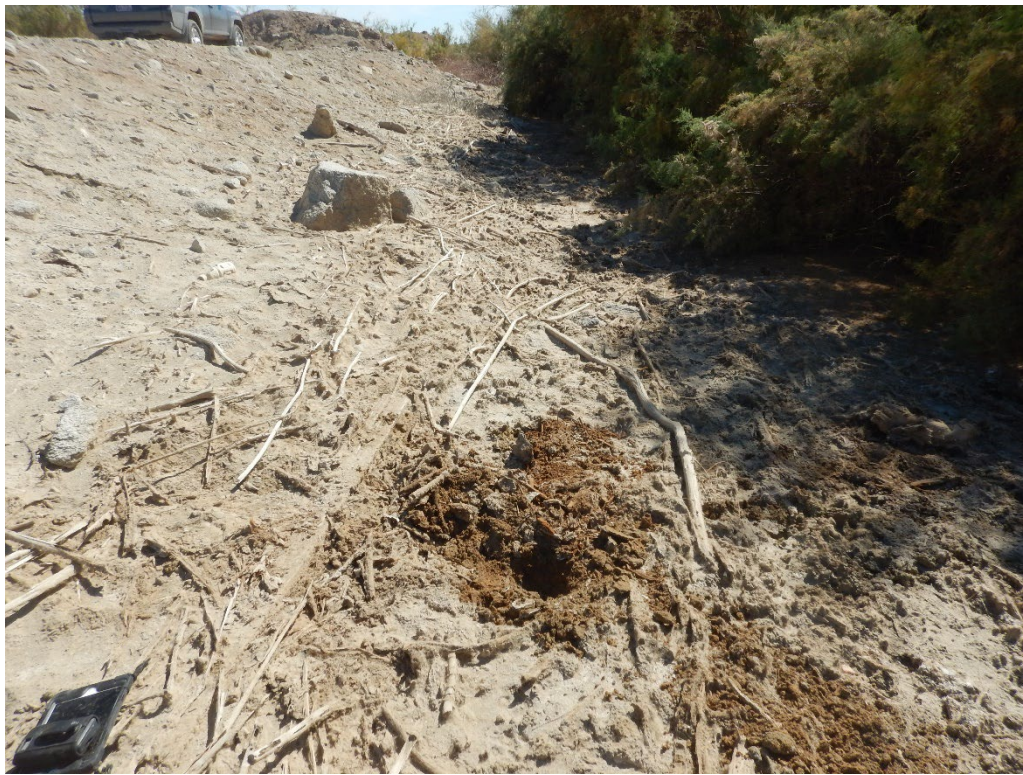
Photo 28: View to the south at **Sample Point 28**. Photo shows the paired upland point for Sample Point 27.

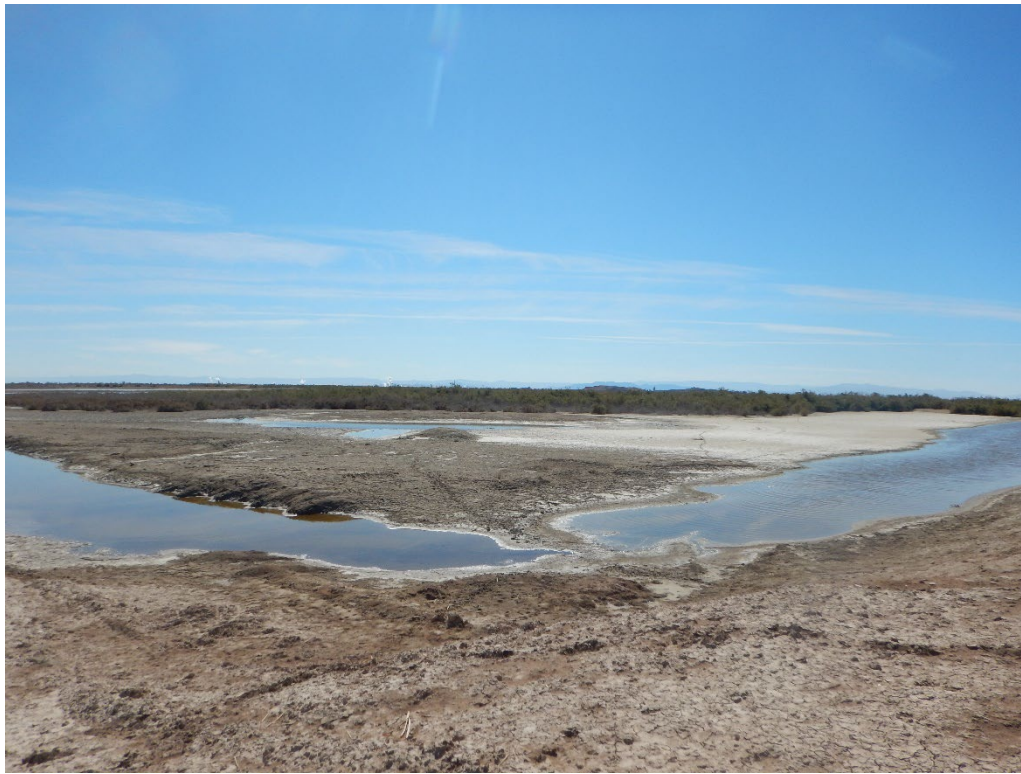
Photo 29: View to the southwest at **Sample Point 29**. The photo shows palustrine seasonally flooded salt flat **PUBC-2**. The area is NWI-mapped as L2USC_x, but surface water lacks sufficient coverage and depth.

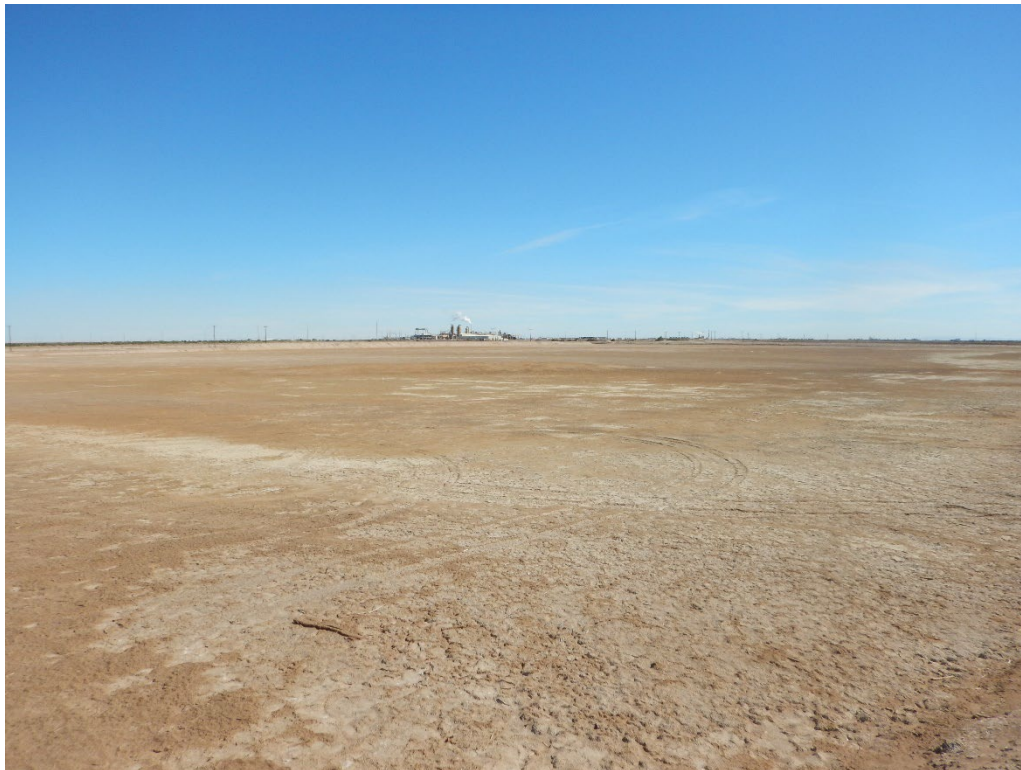
Photo 30: View to the southeast at **Sample Point 30**. Photo shows an area mapped by NWI as L2USC_x and by NHD as an intermittent reservoir, but no indicators are present.
