Biological Resources Assessment

# Darden Clean Energy Project

Aquatic Resources Representative Photographs

Delineation Data Sheet

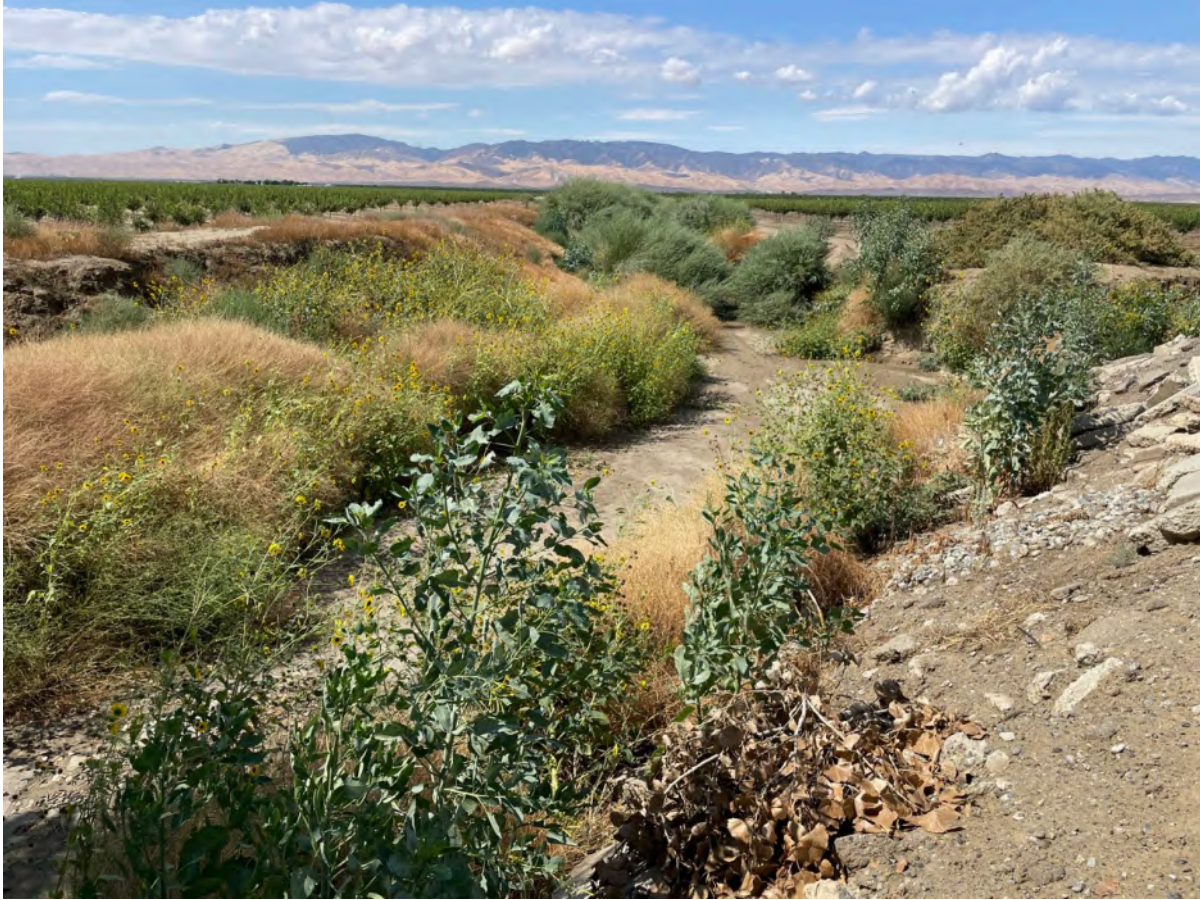
**Photograph 1.** View southwest, Cantua Creek, Photo Point 6. The creek here is channelized between levees as it enters the gen-tie line ROW buffer area. Dominant hydrophytic vegetation in the channel is sandbar willow (*Salix exigua*) (FACW). Other vegetation on the banks includes annual sunflower (*Helianthus annuus*) (FACU), big saltbush (*Atriplex lentiformis*) (FACU), Russian thistle (*Salsola tragus*) (FACU), and tree tobacco (*Nicotiana glauca*) (FAC).

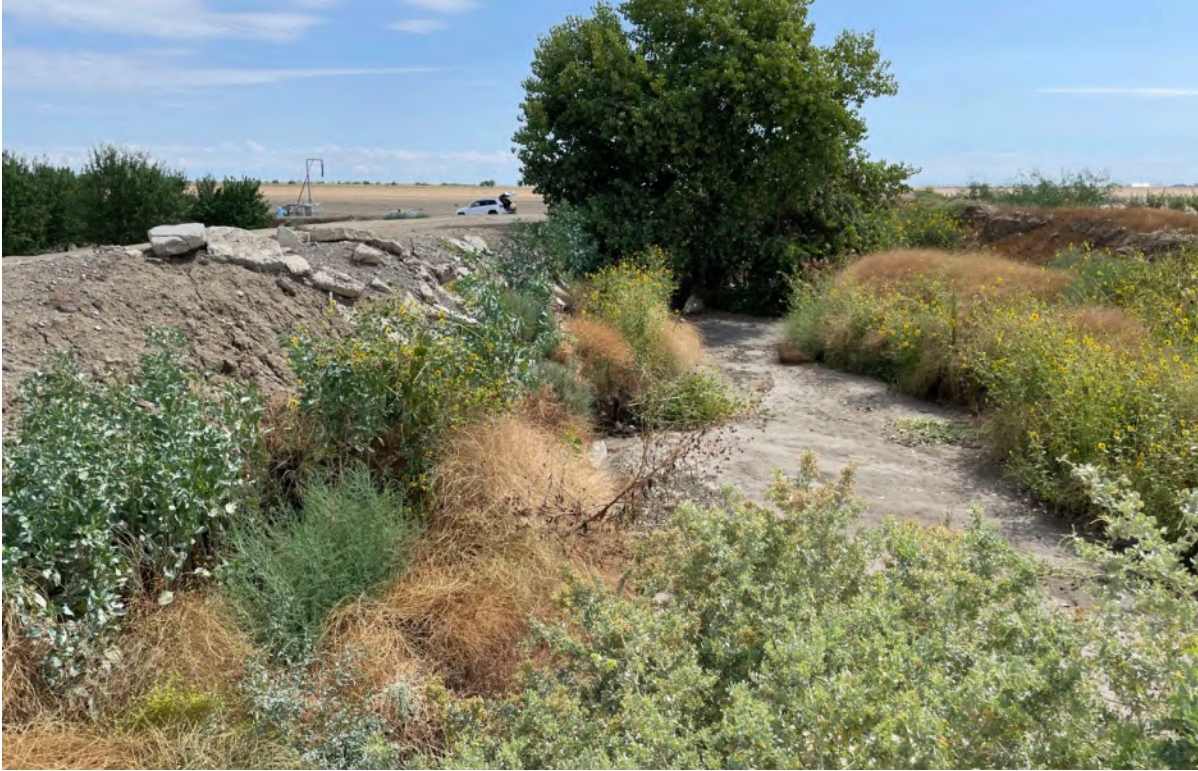
**Photograph 2.** View east of Cantua Creek, on the south edge of the gen-tie line ROW buffer, Photo Point 4. The tree is a Fremont cottonwood (*Populus fremontii* subsp. *fremontii*) (FAC). An OHWM data sheet was prepared for Cantua Creek in the approximate location of this photograph and is attached in Appendix J.

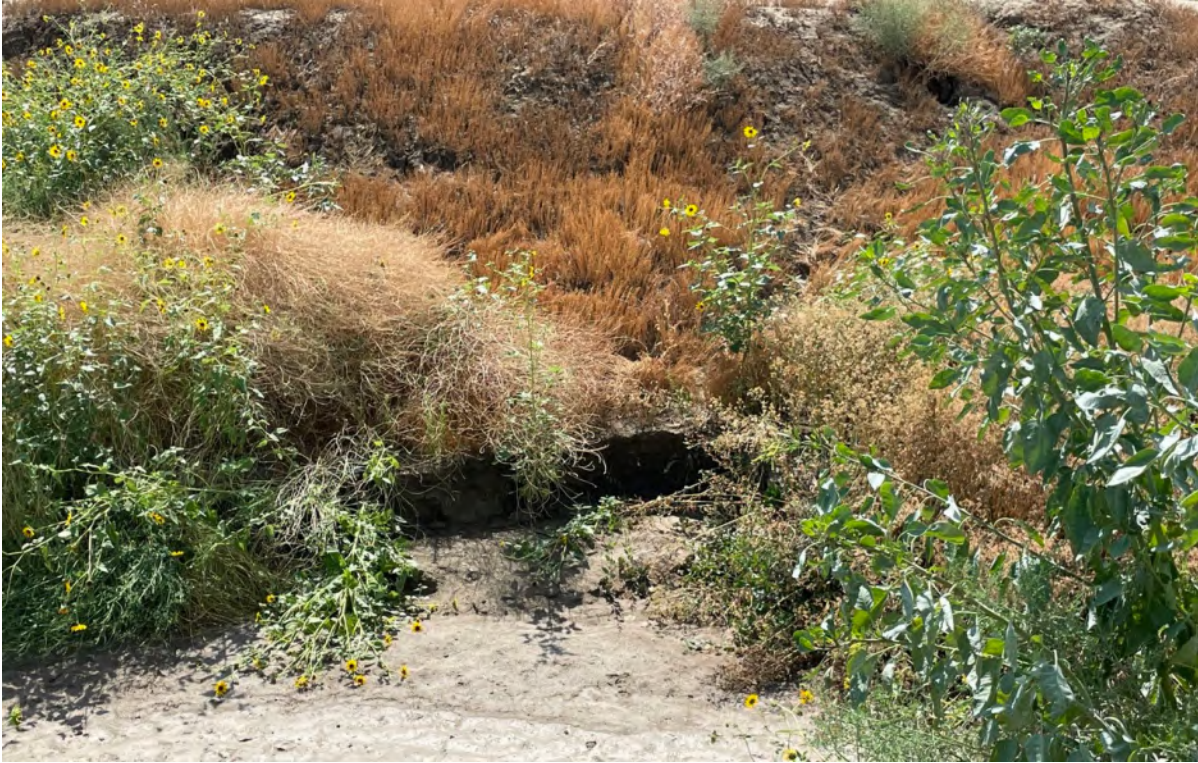
**Photograph 3.** View south, Cantua Creek, Photo Point 5. Evidence of shelving indicating the OHWM. Other indicators include break in slope, scour, and sediment sorting.

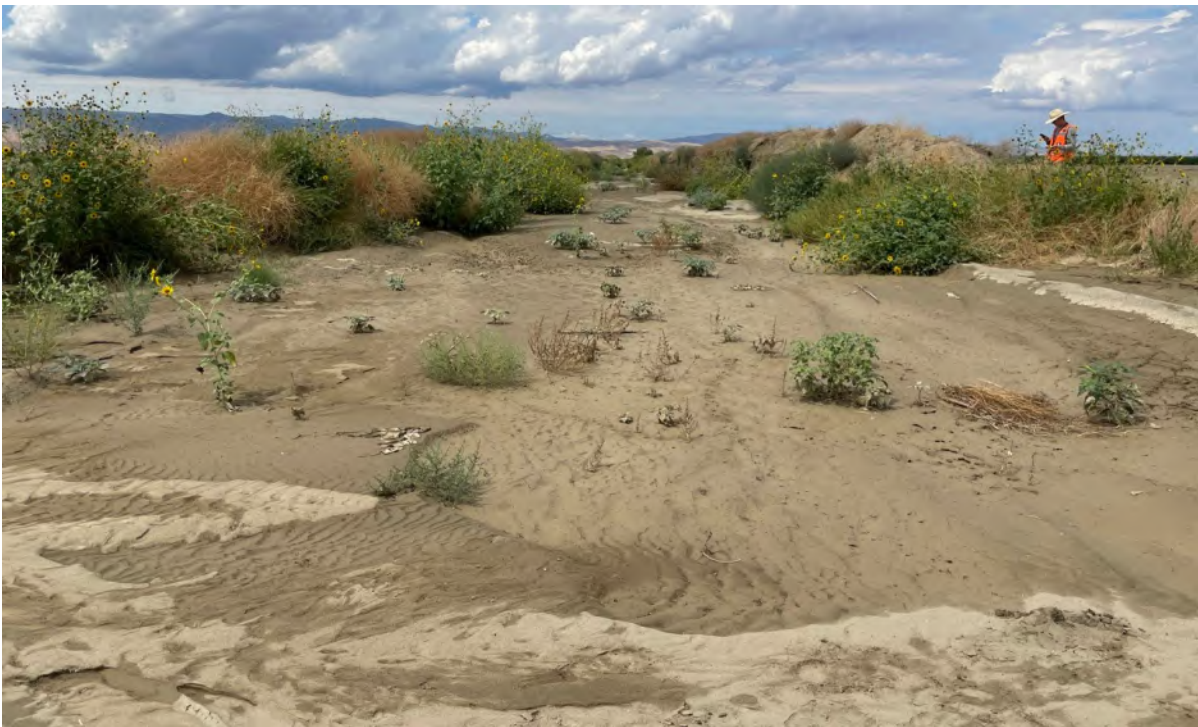
**Photograph 4.** View west near the terminus of Cantua Creek, Photo Point 7. Here the creek bed meets the level of both adjacent fields, flow sinks into the ground, and the levees abruptly end.

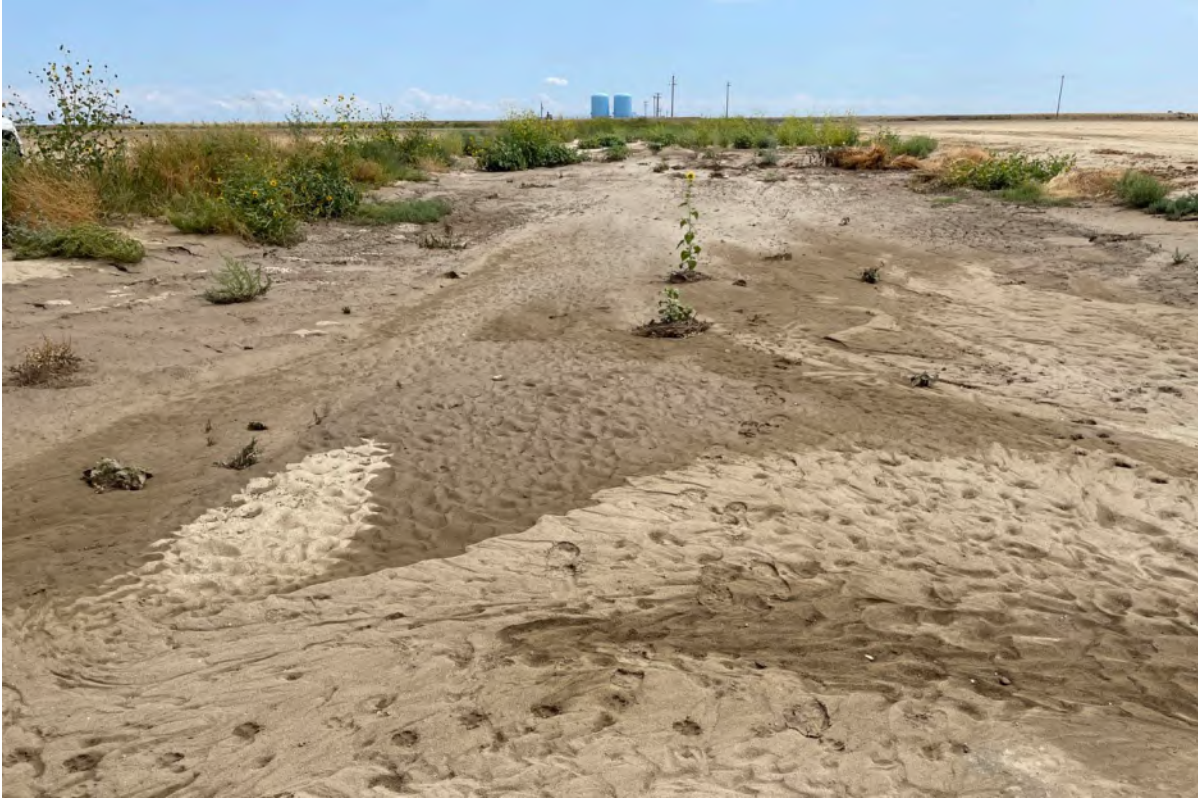
**Photograph 5.** View east near the terminus of Cantua Creek, Photo Point 8. The line of vegetation in the center is primarily annual sunflower and Russian thistle and indicators of an OHWM as seen in Photos 1-3 are absent. The levee of the California Aqueduct is visible in the distance.

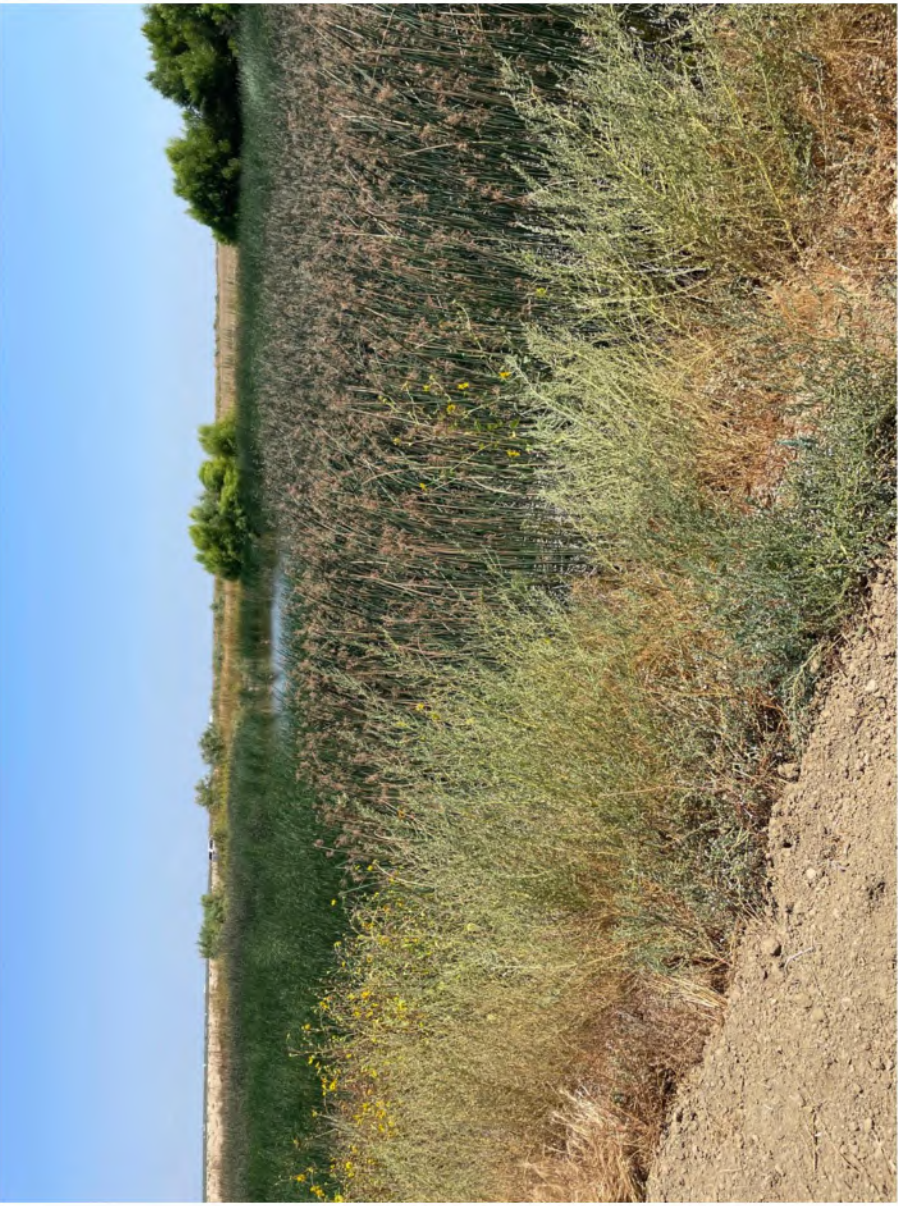
**Photograph 6.** View northeast, Basin 12, Photo Point 17. This basin is dominated by tule and cattails, with Goodding's willow (*Salix gooddingii*) (FACW) on the banks. Paired Wetland Sample Point Data Sheets SP1 (wetland) and SP2 (upland) were completed to characterize the vegetation at this basin and are attached in Appendix J. Soil pits were not dug due to inaccessible steep slopes; standing water and an abrupt change from hydrophytic to non-hydrophytic vegetation was observed. Adjacent to the west and connected via an under-road culvert is Basin 13, with a long and narrow L-shape and containing much the same vegetation. Both basins meet the three-parameter definition of a wetland with hydrophytic vegetation, presumed hydric soils, and hydrology. However, the basins are excavated in uplands and used and maintained for agricultural operations. Therefore, these basins are considered non-jurisdictional as isolated, manmade excavated features used for agriculture.

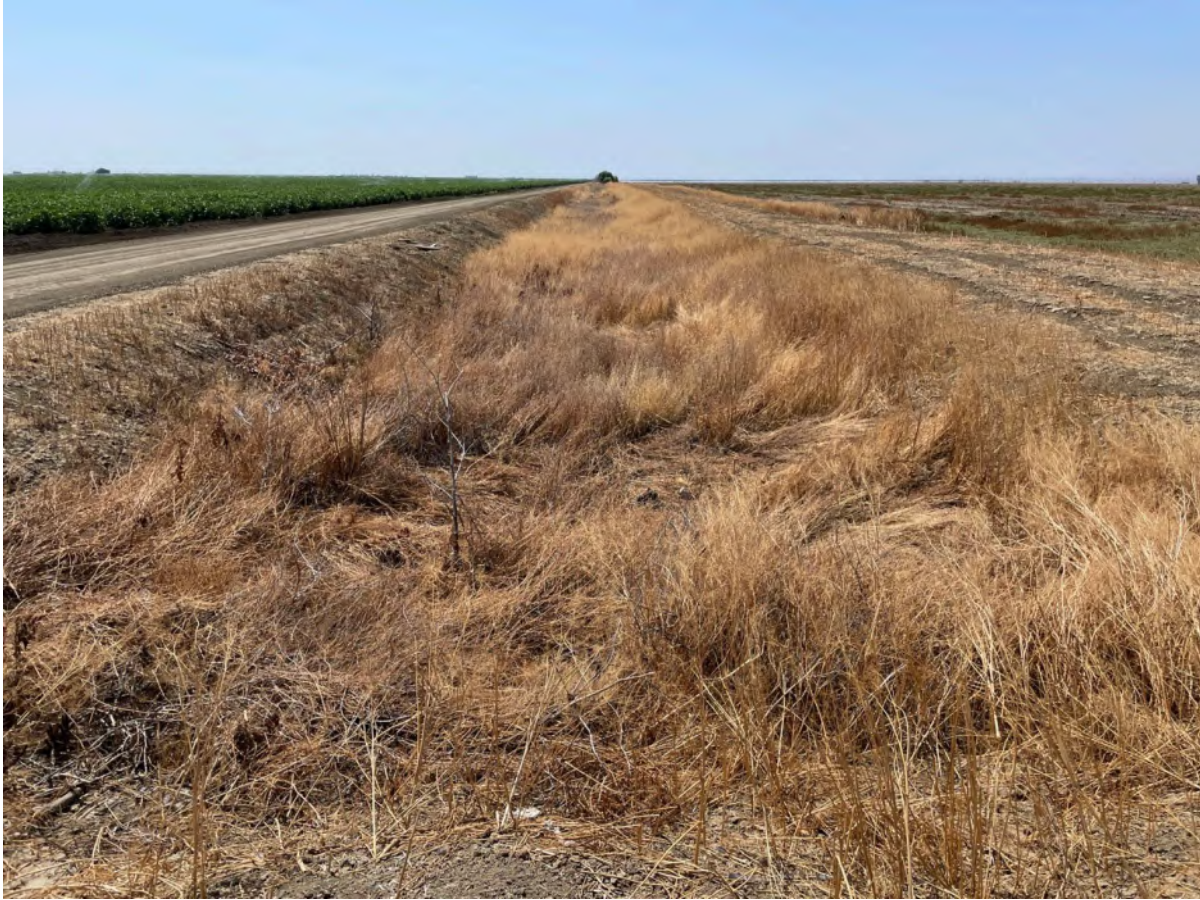
**Photograph 7.** View south, from north end of Basin 15, Photo Point 18. At this end, the basin was dry during the August survey and contained evidence of non-hydrophytic vegetation, though progressing south there appears to be a gradient of decreasing elevation where water remains longer, with evidence of dried hydrophytic vegetation such as curly dock (*Rumex crispus*) (FAC), small areas that were still saturated or had standing water with live curly dock and (*Polygonum* sp.), and a pool of standing water at the far end with several large Goodding's willows, seen in the distance in the photo. Evidence of a culvert connecting to Basin 16 to the south was not detectable and the basins show no evidence of flow. The NWI shows this basin, Basin 16, and Basin 17 (at the south end of Basin 16 and running east-west) as part of an extensive system to the east of the JSA and has these features mapped as R4SBc. However, there is no evidence these are channelized historically natural streams, no evidence they are connected, and no evidence of flow. While fallow at the time of the delineation site visit in August 2023, at the time of the reconnaissance site visit in December of 2022, the ditch and field seen on the right in the photo were barren dirt, with the exception of the Goodding's willows. As part of agricultural operations, these basins are considered non-jurisdictional.

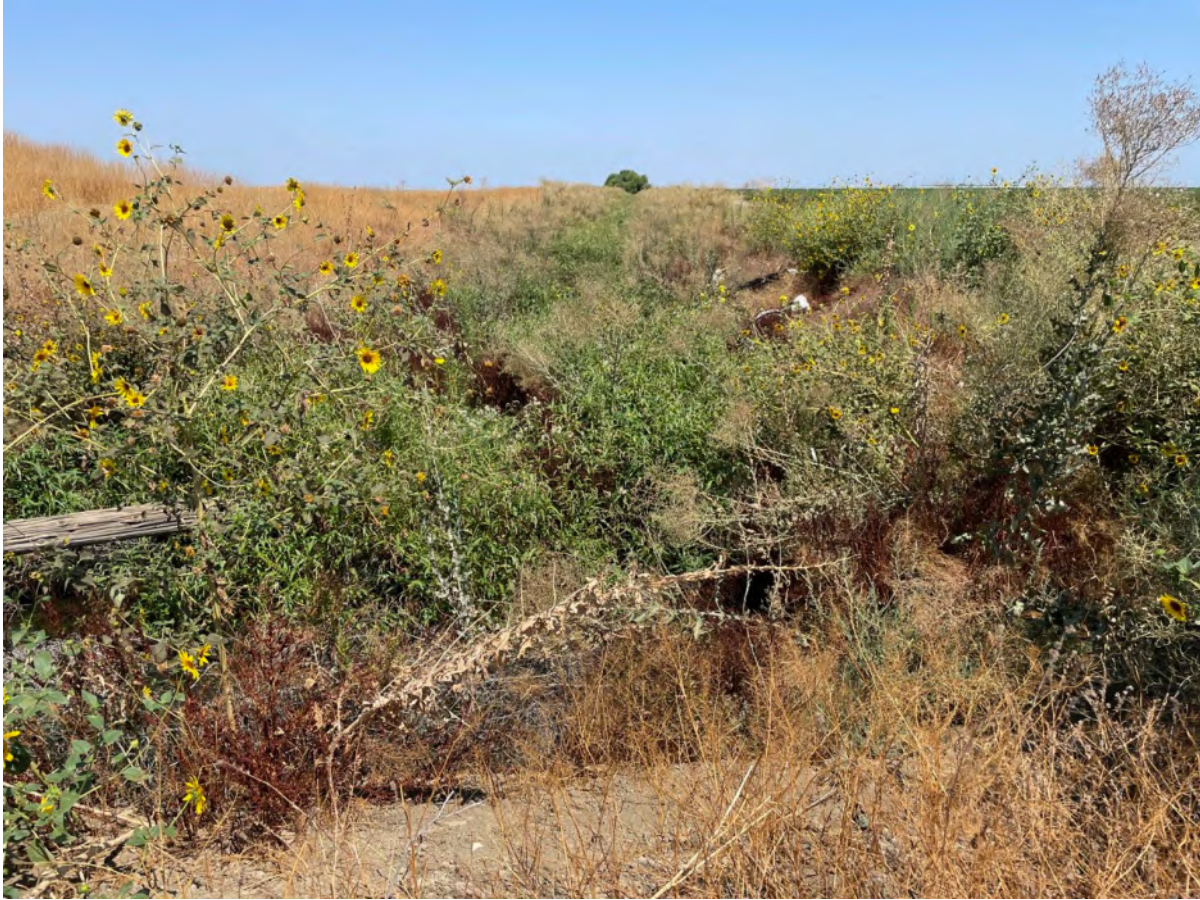
**Photograph 8.** View north, from south end of Basin 16, Photo Point 19. Water was still present over a greater distance of this basin than Basin 16 with standing water in much of the south end. There is a small group of Goodding's willow near the center. This basin is in line with Basin 15 in Photograph 7; however, no culvert was detected and no connection could be established. As noted above, these basins were barren of vegetation in December of 2022, with the exception of the Goodding's willows. Basins 15, 16, and 17 are considered non-jurisdictional as they are for agricultural purposes.

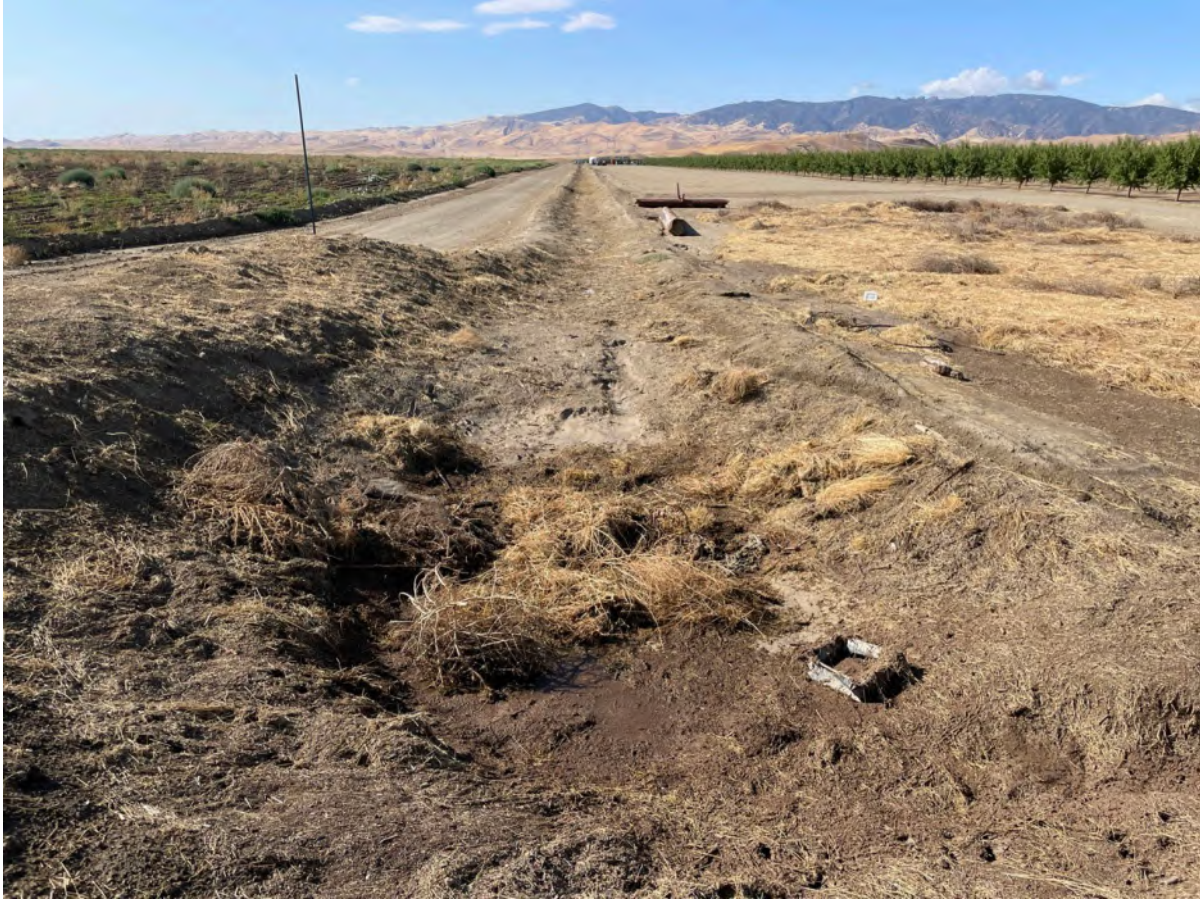
**Photograph 9.** View south, AD-1, Photo Point 1. Typical of larger, primarily u-shape agricultural ditches with natural line on bank and slight erosion creating slope break where water enters the ditch. Average OHWM width is 8 feet. Ditch is non-jurisdictional as it is for agricultural purposes. An OHWM data sheet was prepared for this feature in the approximate location of center of this photograph and is attached in Appendix J.

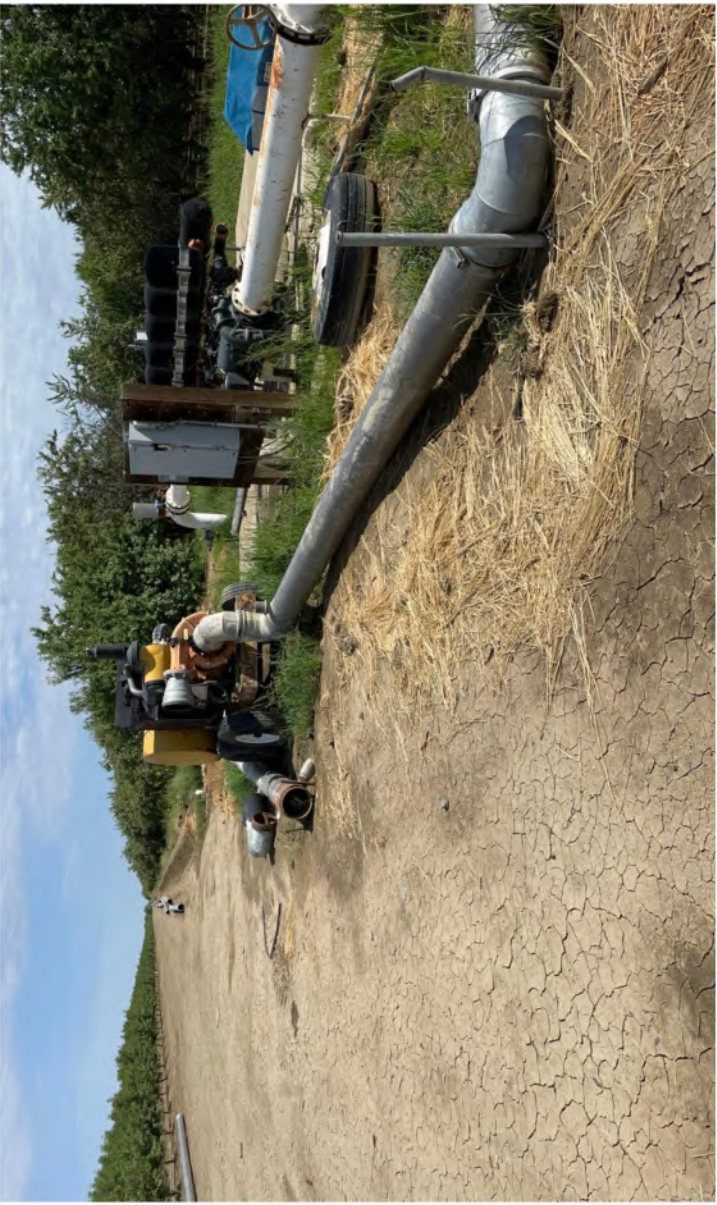
**Photograph 10.** View North, AD-4, Photo Point 3. Top left of photo shows typical of v-ditch created to hold irrigation pipes. Average width at top is 3 feet. Many additional ditches of this type were not mapped as they are not intended to convey or hold water directly. They are frequently created and destroyed, do not meet the definition of waters, and would be non-jurisdictional as they are used for agricultural purposes.

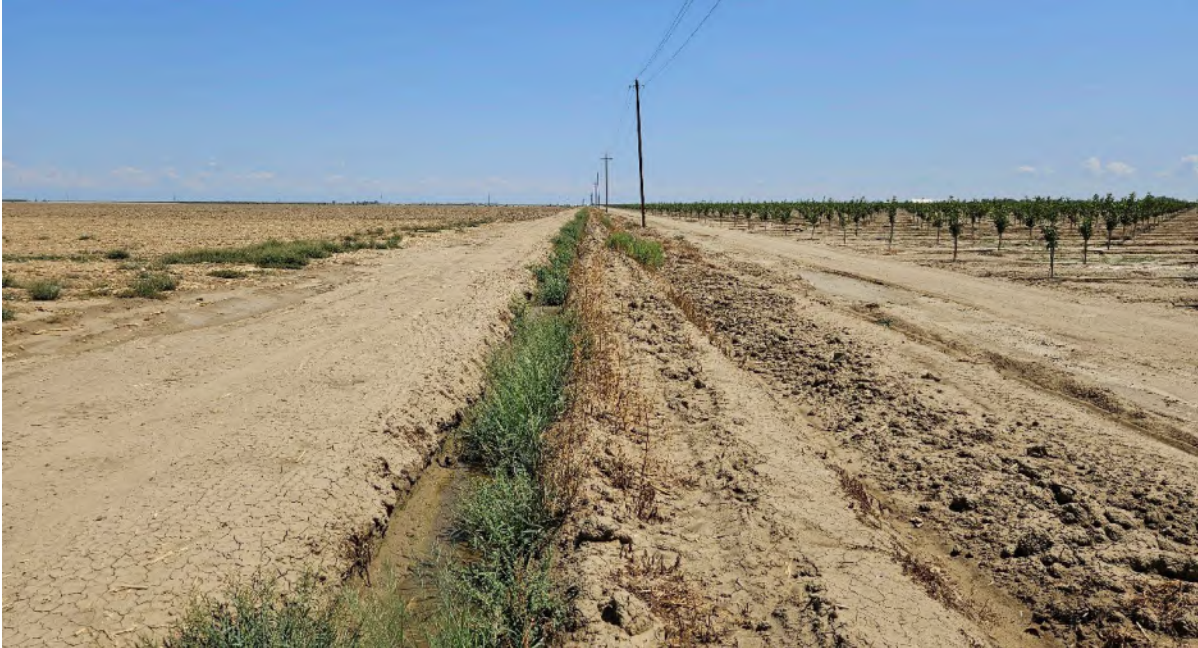
**Photograph 11.** View east, AD-5, Photo Point 9. AD-5 is typical of trapezoidal ditches throughout the Project site. The average OHWM width is 3 feet, often widening somewhat at culverted crossings. By design the ditch has a bed and banks, other indicators include break in slope and natural line on bank. In some reaches the ditch is vegetated, here with Russian thistle and further west includes bearded sprangletop (*Leptochloa fusca* subsp. *fascicularis*) (NL) and other non-hydrophytic vegetation. This ditch was being actively maintained during the survey by a crew removing vegetation further to the east.

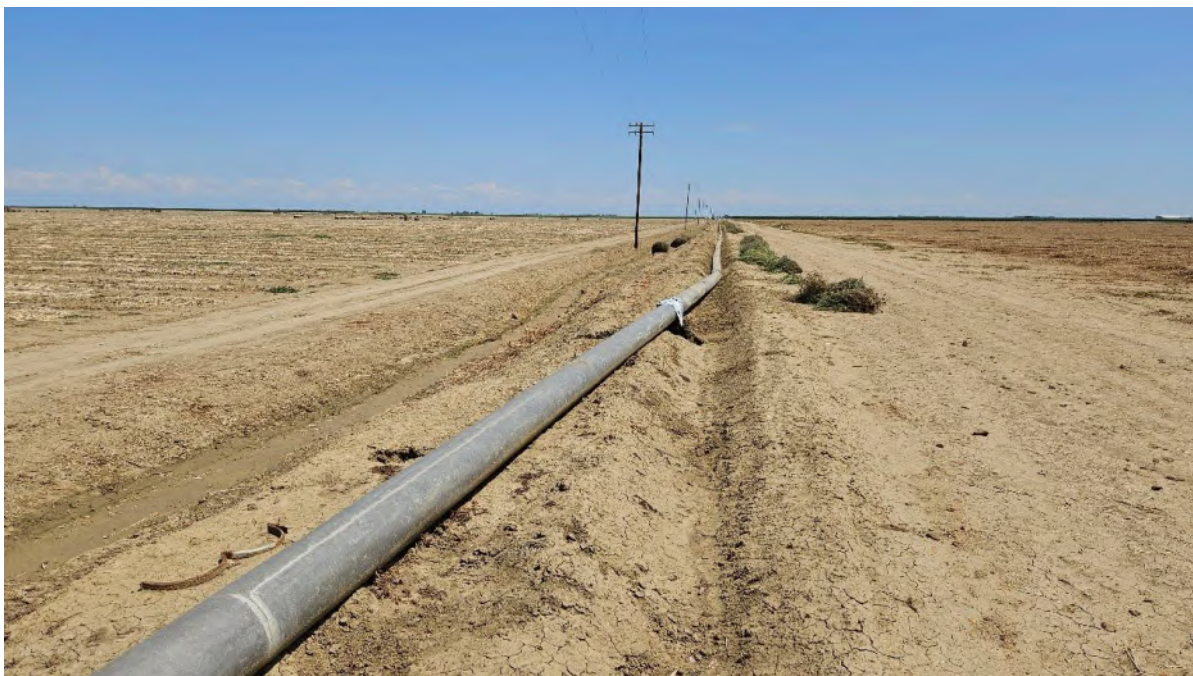
**Photograph 12.** View east, AD-5, Photo Point 10. AD-5 is on the left in the photo, parallel on the right is a pipe v-ditch with Russian thistle that has been removed to lay the pipe.

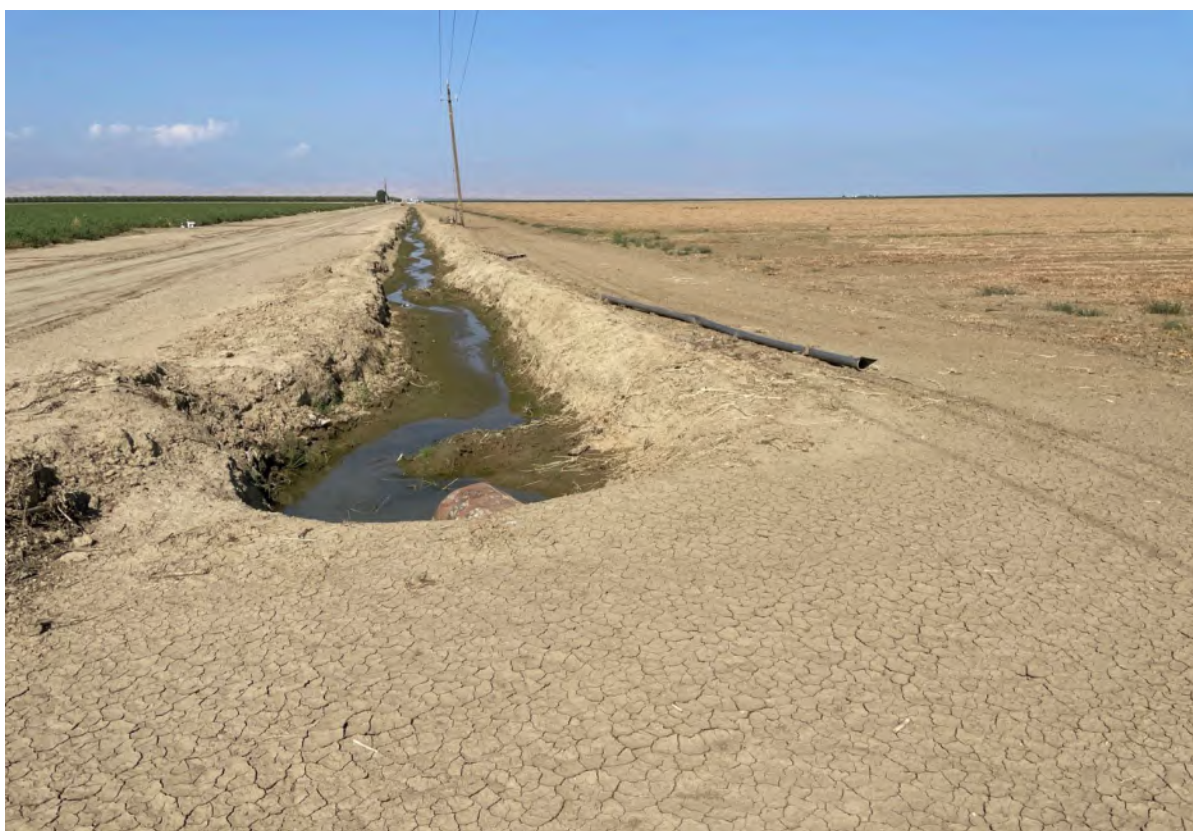
**Photograph 13.** View west, AD-5, Photo Point 12. View of typical culvert crossing of ditch AD-5. Average size of culverts is 30-inches.

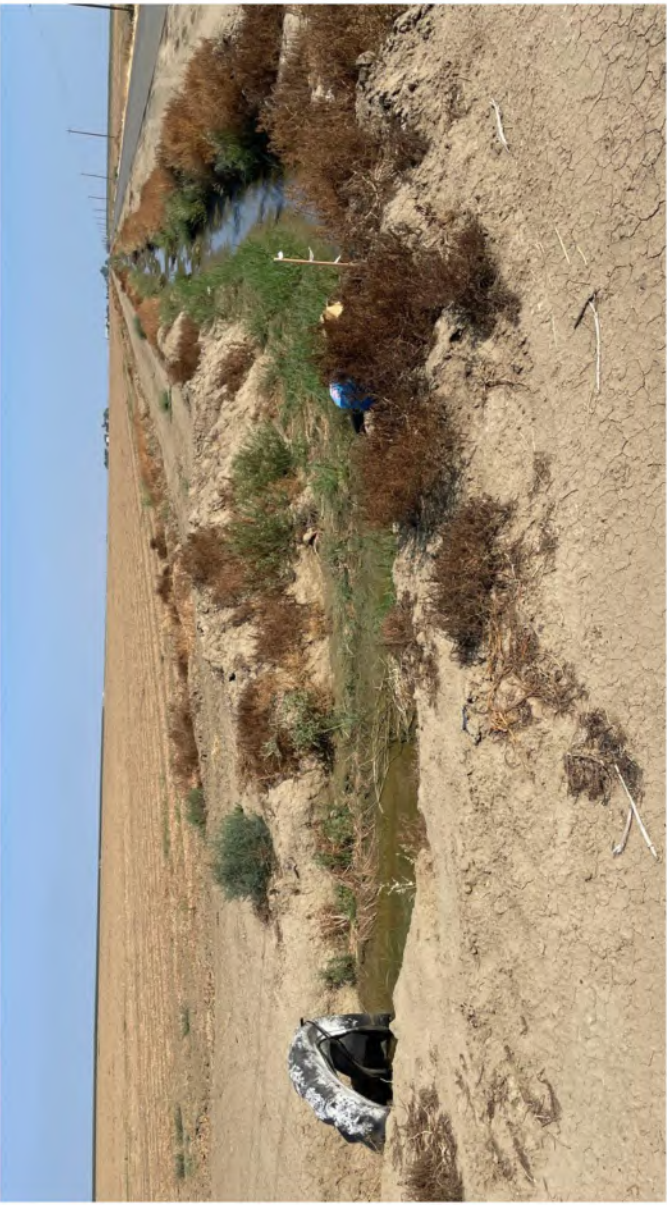
**Photograph 14.** View north, AD-6, Photo Point 11. View at the intersection of West Harlan Avenue and South Sonoma Avenue. AD-6 has an average width of 5 feet and is connected to AD-5 through the culvert seen on the left. This section is also generally trapezoidal in shape, and a slope break can be seen on the bank near the center of the photo. Vegetation is Russian thistle and bearded sprangletop. AD-6 continues north along South Sonoma Avenue, within the 250 foot buffer of the Project site. AD-6 flows through a culvert into canal AC-1 approximately 0.5 miles north. AC-1 averages 40 feet in width and is connected on the north to AC-2, averaging 65 feet in width, which runs offsite. While supporting vegetation occasionally, these ditches and canals are maintained regularly and generally kept free of vegetation. An OHWM data sheet was prepared for this feature in the approximate location of the upper right of this photograph and is attached in Appendix J.

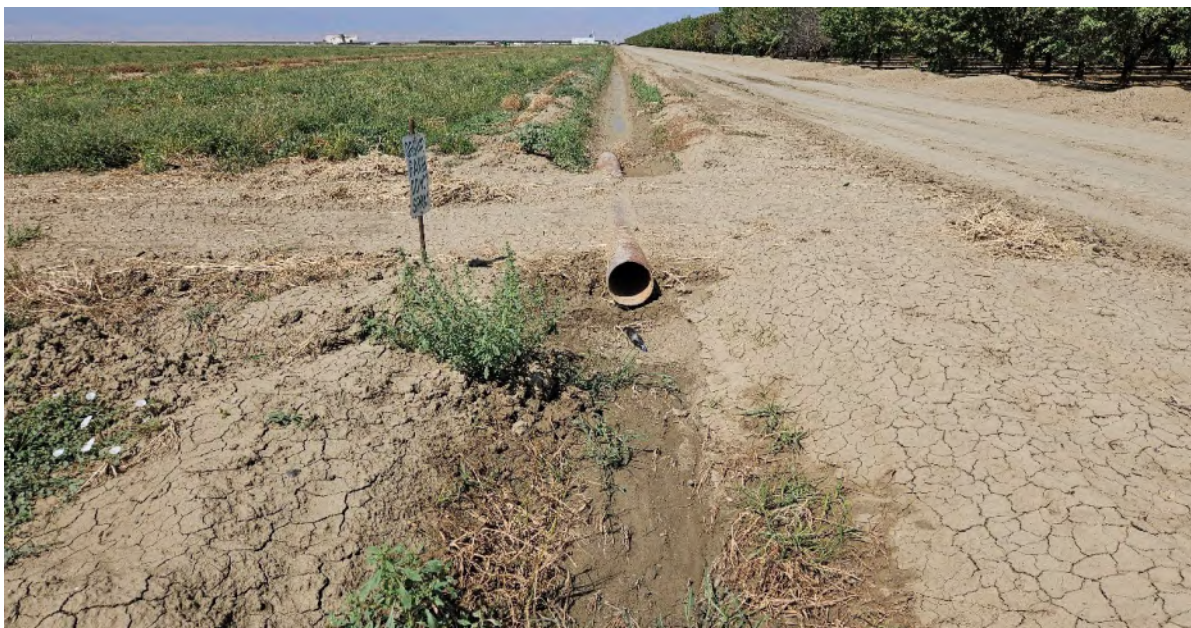
**Photograph 15.** View west, AD-8, Photo Point 16. Typical of small u-shaped ditches throughout the site. Average OHWM width is 2 feet. Non-jurisdictional as it is used for agricultural purposes.

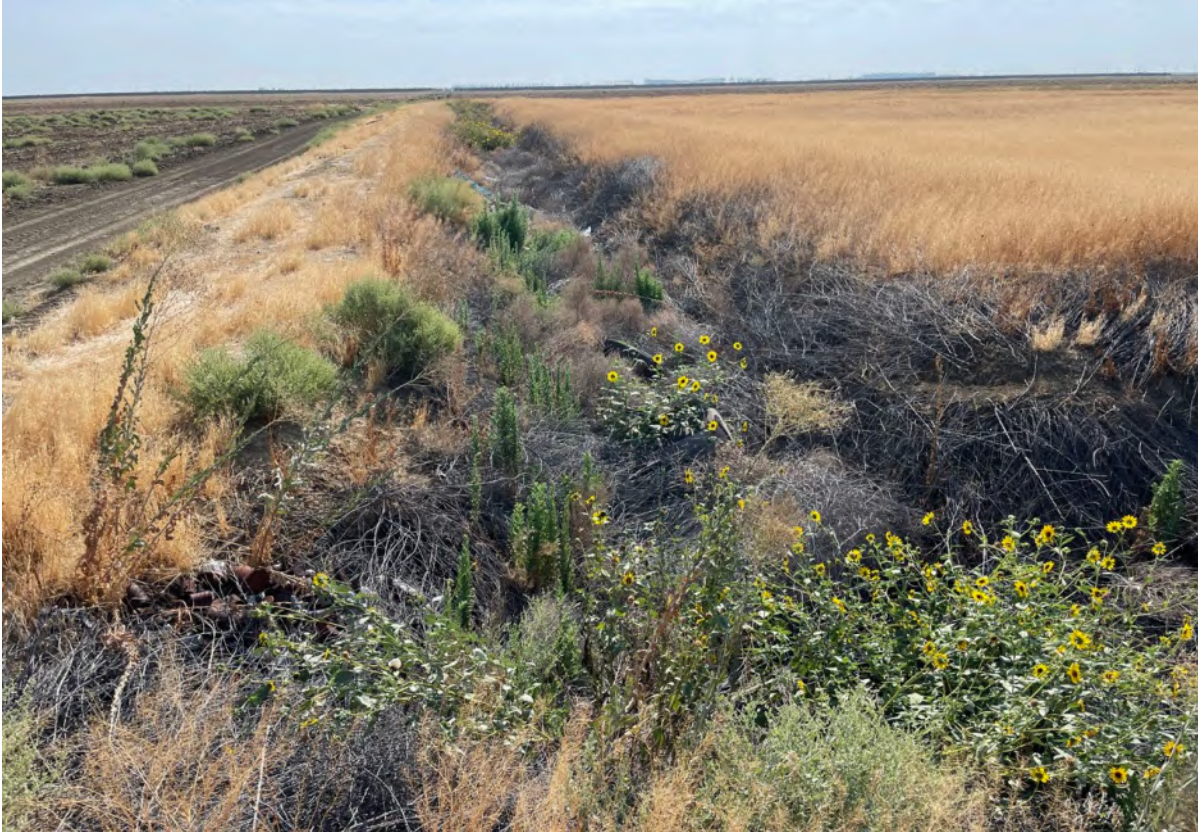
**Photograph 16.** View east, AD-17, Photo Point 20. Ditch not currently in use for agriculture. The average width is 5 feet, approximately 80% vegetated though much of it is dead; All vegetation present is upland, primarily telegraph weed (*Heterotheca grandiflora*) (NL), annual sunflower, prickly lettuce (*Lactuca seriola*) (FACU), and big saltbush. No current hydrology and does not meet the definition of a wetland; non-jurisdictional. An OHWM data sheet was prepared for this feature in the approximate location of the upper center of this photograph and is attached in Appendix J.

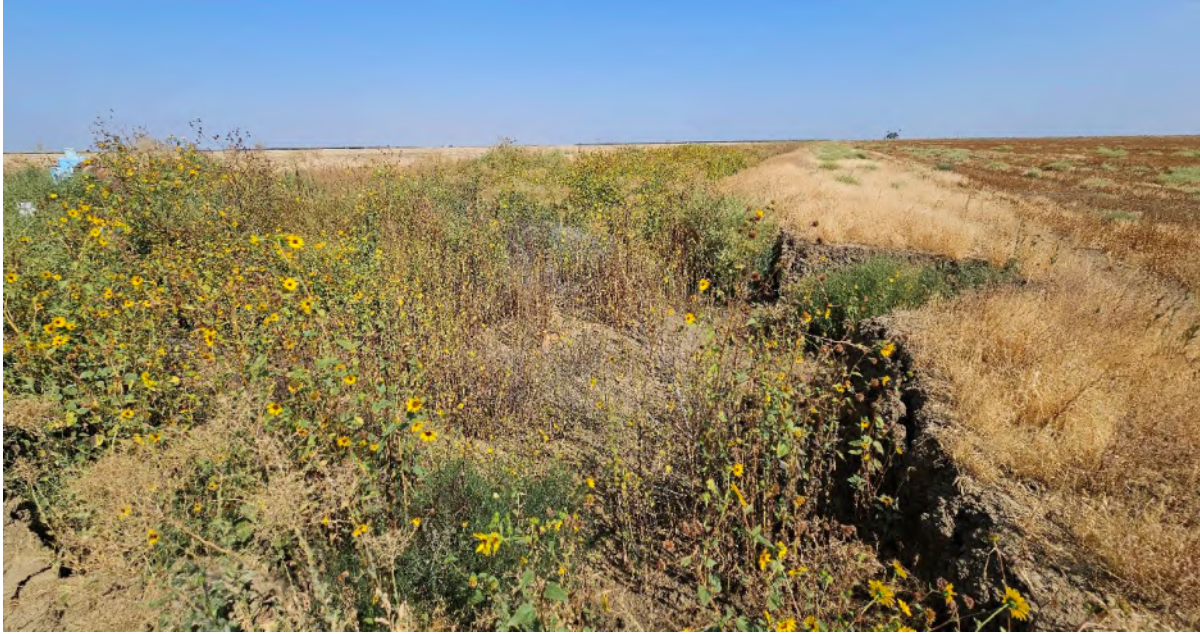
**Photograph 17.** View north, AD-10, Photo Point 15. Large ditch not currently in use. Average width is 15 feet, dominated by annual sunflower and prickly lettuce. No current hydrology and does not meet the definition of a wetland; non-jurisdictional.

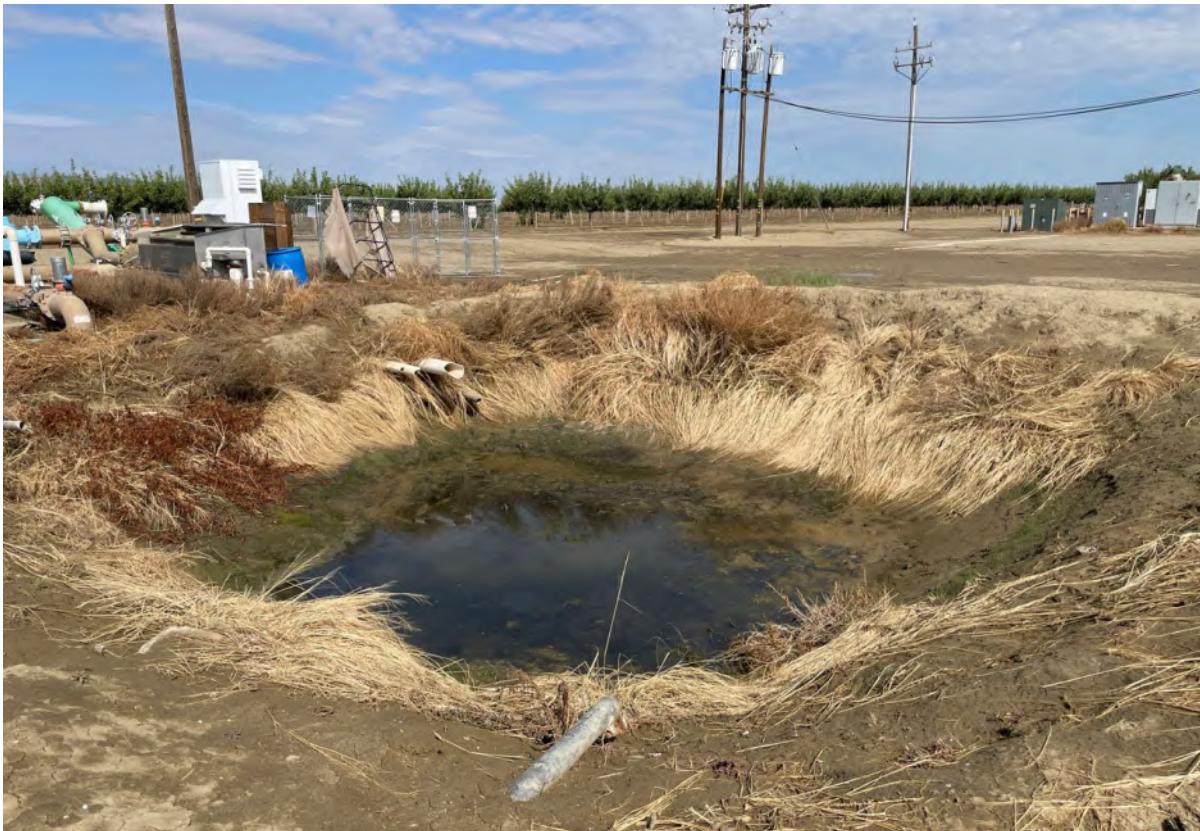
**Photograph 18.** View northwest, Basin 2, Photo Point 2. Typical small basin for agriculture, non-jurisdictional. Vegetation surrounding the basin is nonnative annual grass.

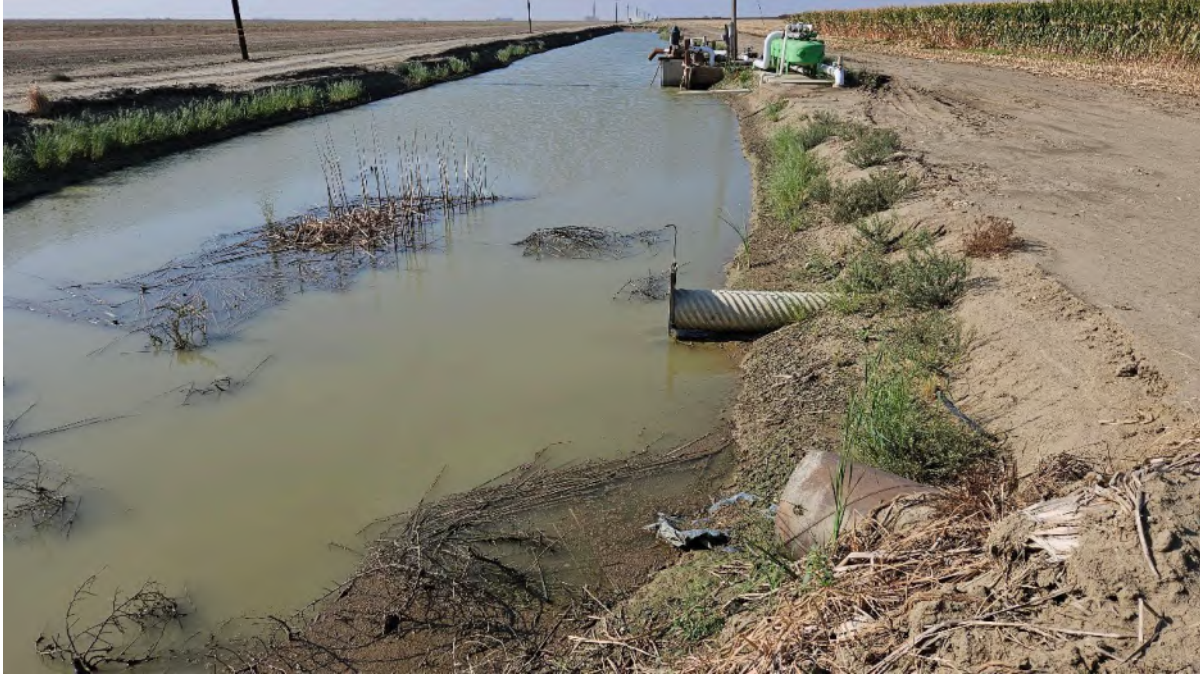
**Photograph 19.** View south, Basin 8, Photo Point 13. Typical larger basin in active use, average OHWM width is 45 feet, generally unvegetated.

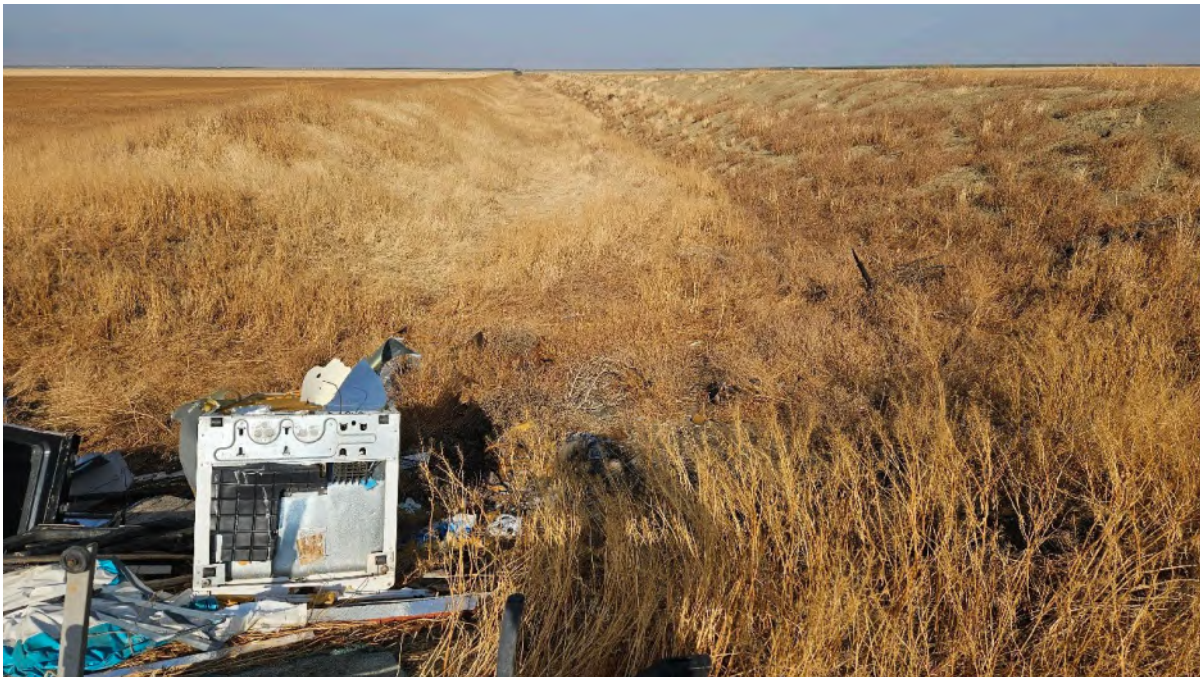
**Photograph 20.** View south, Basin 9, Photo Point 14. Typical large basin not currently in use for agriculture. Average width is 30 ft, covered by nonnative annual grasses; this basin was unvegetated during the December 2022 reconnaissance survey. Other vegetation in similar basins include prickly lettuce and annual sunflower. No current hydrology and does not meet the definition of a wetland; non-jurisdictional.

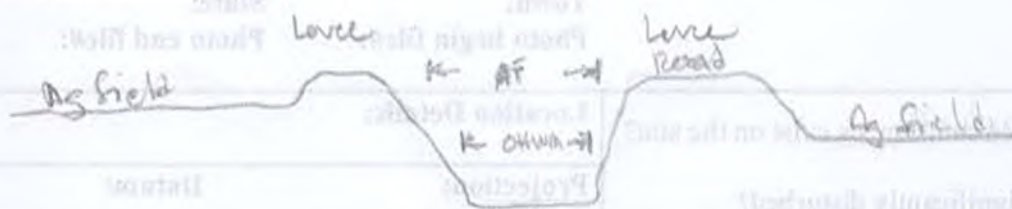
### Cross section drawing:

| <input type="checkbox"/> Change in average sediment texture | <input checked="" type="checkbox"/> Break in bank slope |
| <input type="checkbox"/> Change in vegetation species | <input checked="" type="checkbox"/> Other: <u>Shelving</u> |
| <input checked="" type="checkbox"/> Change in vegetation cover | <input type="checkbox"/> Other: _____ |

Cambria Creek is mapped in NWI as intermittent. Here on the site it is channelized between levees. Natural course appears to have been north into what is now an ag field. Sink is indicated in NHD and it does disappear into valley floor at east end of levees.

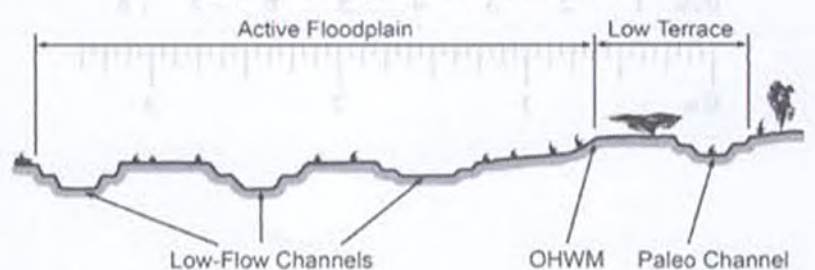
<b>Procedure for identifying and characterizing the floodplain units to assist in identifying the OHWM:</b> <ol style="list-style-type: none"> <li>1. Walk the channel and floodplain within the study area to get an impression of the geomorphology and vegetation present at the site.</li> <li>2. Select a representative cross section across the channel. Draw the cross section and label the floodplain units.</li> <li>3. Determine a point on the cross section that is characteristic of one of the hydrogeomorphic floodplain units.           <ol style="list-style-type: none"> <li>a) Record the floodplain unit and GPS position.</li> <li>b) Describe the sediment texture (using the Wentworth class size) and the vegetation characteristics of the floodplain unit.</li> <li>c) Identify any indicators present at the location.</li> </ol> </li> <li>4. Repeat for other points in different hydrogeomorphic floodplain units across the cross section.</li> <li>5. Identify the OHWM and record the indicators. Record the OHWM position via:           <table style="width: 100%;"> <tr> <td><input type="checkbox"/> Mapping on aerial photograph</td> <td><input type="checkbox"/> GPS</td> </tr> <tr> <td><input checked="" type="checkbox"/> Digitized on computer</td> <td><input type="checkbox"/> Other:</td> </tr> </table> </li> </ol>		<input type="checkbox"/> Mapping on aerial photograph	<input type="checkbox"/> GPS	<input checked="" type="checkbox"/> Digitized on computer	<input type="checkbox"/> Other:
