| <b>DOCKETED</b> | |
|---|---|
| <b>Project Title:</b> | Willow Rock Energy Storage Center |
| <b>Document Title:</b> | Willow Rock Energy Storage Center Supplemental AFC Volume II - Appendix 54A - Part VI |

## **APPENDIX J**

### **BEFORE AND AFTER PHOTOGRAPHS OF SLAKE DURABILITY TEST SPECIMENS**

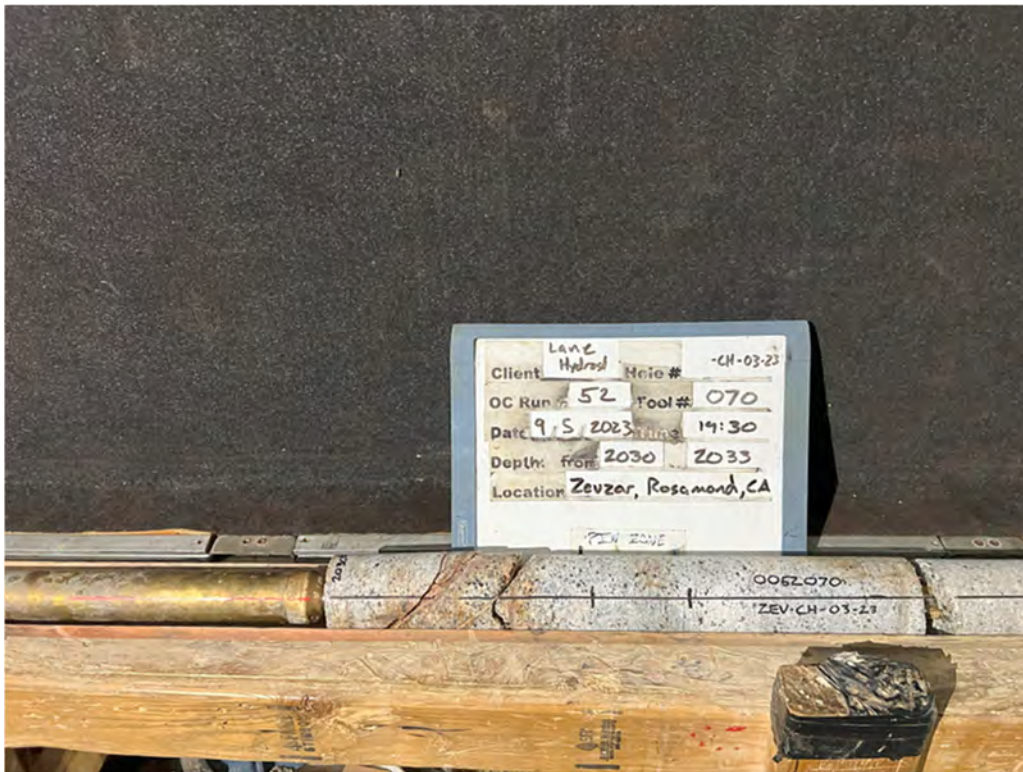
**Figure 2. Photograph of Recovered Core from Overcore 0052-070**

Stress testing in core hole ZEV-CH-03-23 began on September 4, 2023, at a depth of 2027.4 ft. A total of four tests were attempted in the core hole to a depth of 2037.0 ft. A summary of the overcoring test attempts is given in Table 1. Two tests were successful: overcores 0052-70 and 0054-70. When possible, the recovered cores for each test were photographed to document rock type and condition, particularly cores that contained fractures which may have influenced the overcore data. Photographs of the recovered core for the two successful tests, including the relative location of the measurement pins are shown in Figures 2 and 3.
