Updated Built Environment Inventory and Evaluation Report

Compass Energy Storage Project

Orange County, California

NOVEMBER 2024

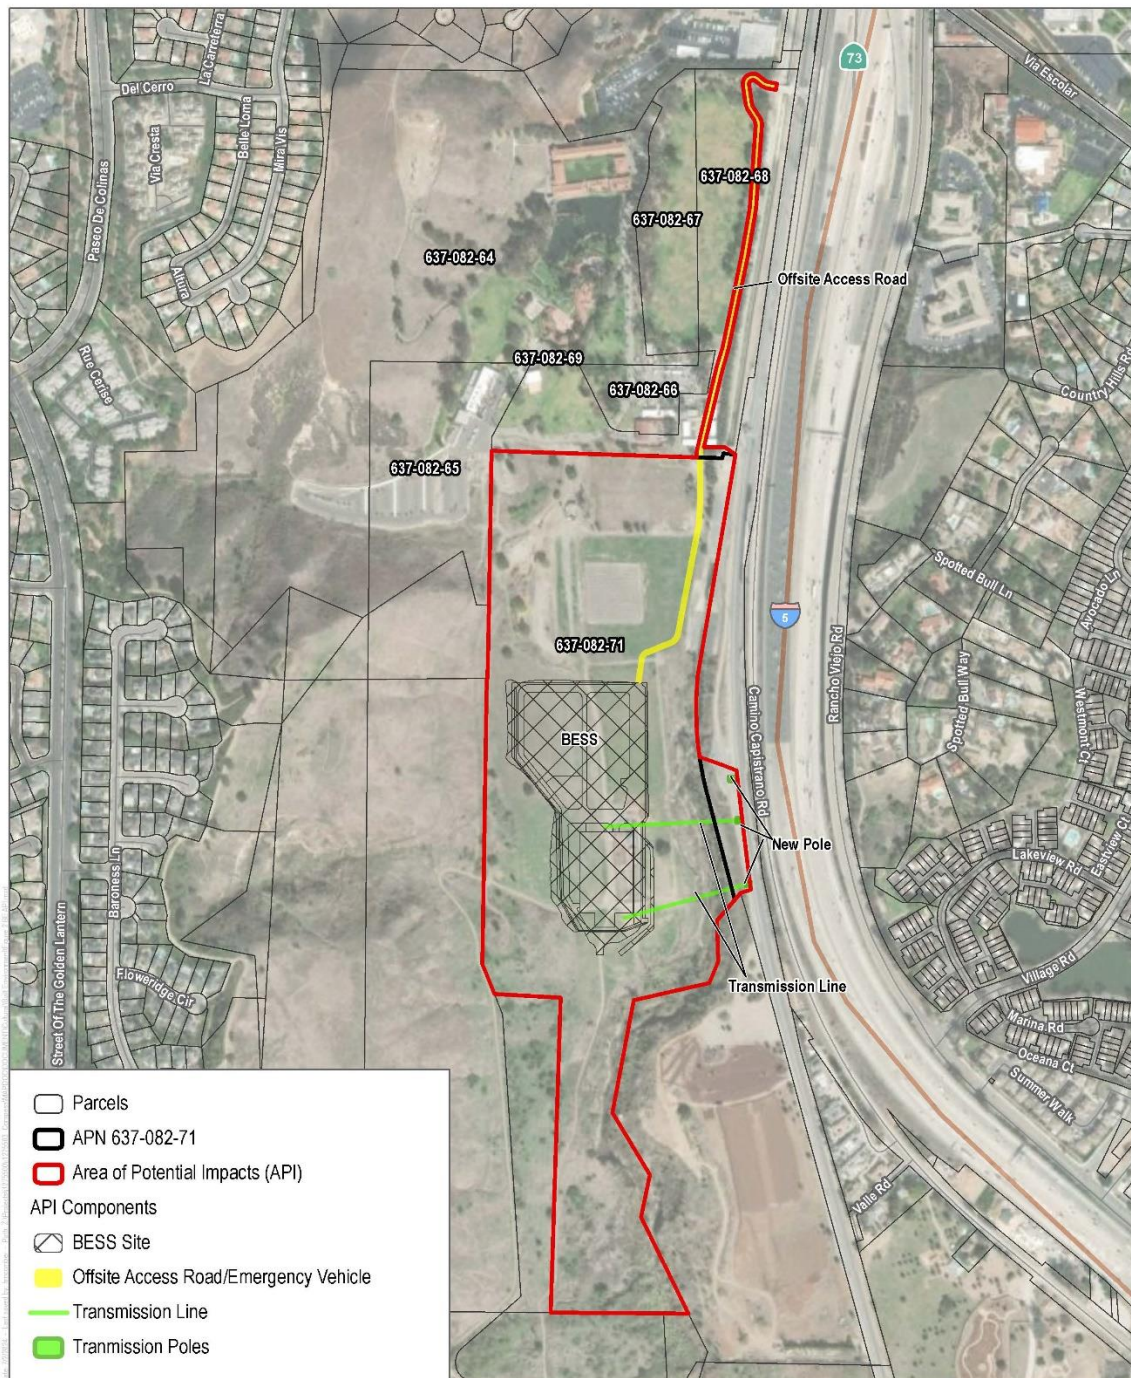
FIGURE 2
Built Environment Area of Potential Impact
Compass Energy Storage Project

SOURCE: Maxar 2022; Orange County 2023

Visual impacts on the Metro Line (former railroad line) and the Camino Capistrano would be the only potential consideration that the project could have on these linear features. However, the setting for both these linear features is already compromised by I-5, the construction of twentieth century buildings and transmission lines in their immediate vicinity. The setting for both these linear features is already compromised by I-5, the construction of twentieth century buildings and transmission lines, and modern structures related to the operation of Metrolink, all of which are in the immediate vicinity of these two linear features. The setting changes are further compounded by the changes to design, materials, workmanship, feeling, and association that these resources would need to retain to be considered eligible for the NRHP or the CRHR. The Oso Flood Control Channel was constructed in 1985 and is less than 45 years old. Therefore, these three linear features are excluded from the API.

Finally, since there are no reasonably foreseeable project activities that would occur later in time or that would be farther removed in distance that could indirectly affect historical resources, the API contains no geographic areas under consideration for indirect effects.

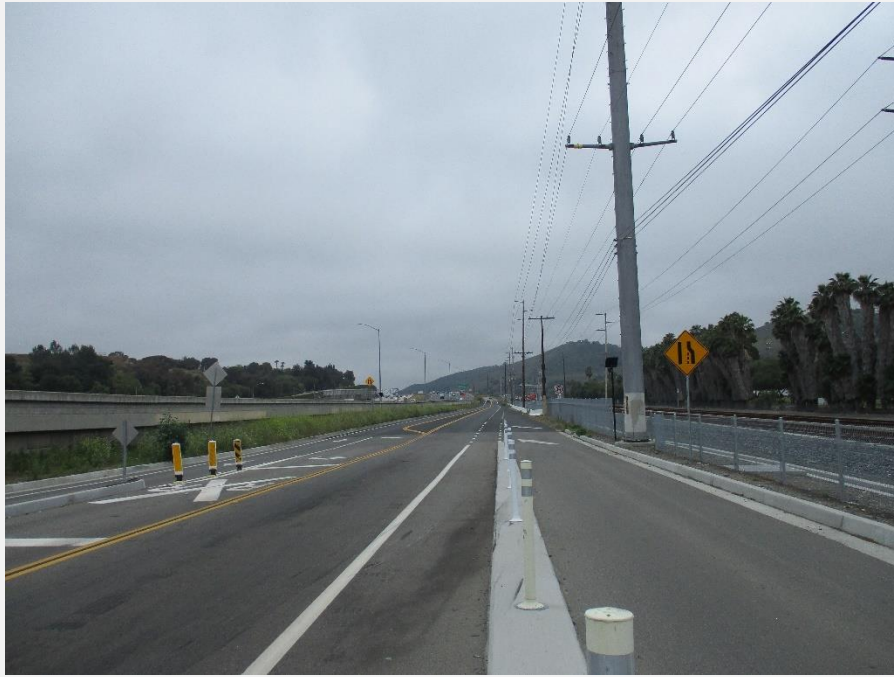
This segment of Camino Capistrano is approximately 0.70-miles long (Exhibit 1). The road has two concrete lanes with bike lanes on either side. The road measures approximately 23.5 feet wide. A merge lane, concrete curbs and metal guard rails were added at various times. The road is flanked by Interstate 5 to the east and a transmission line and MetroLink tracks to the west.

Exhibit 1. Map ID 1. Camino Capistrano segment, camera facing south.

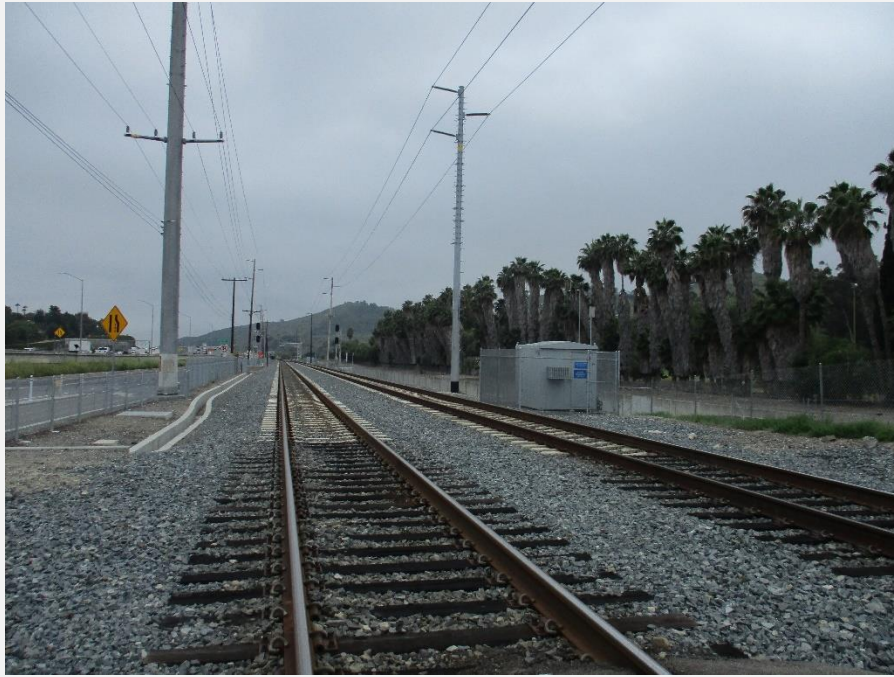
Various segments of this railroad have been recorded throughout California. The portion in this project area was previously recorded in 2018 by HDR. The description remains valid with the only noted change is most of the wood ties over the ballast have been replaced since 2018 (Exhibit 2).

Exhibit 2. Map ID 2. Metrolink alignment, camera facing south.

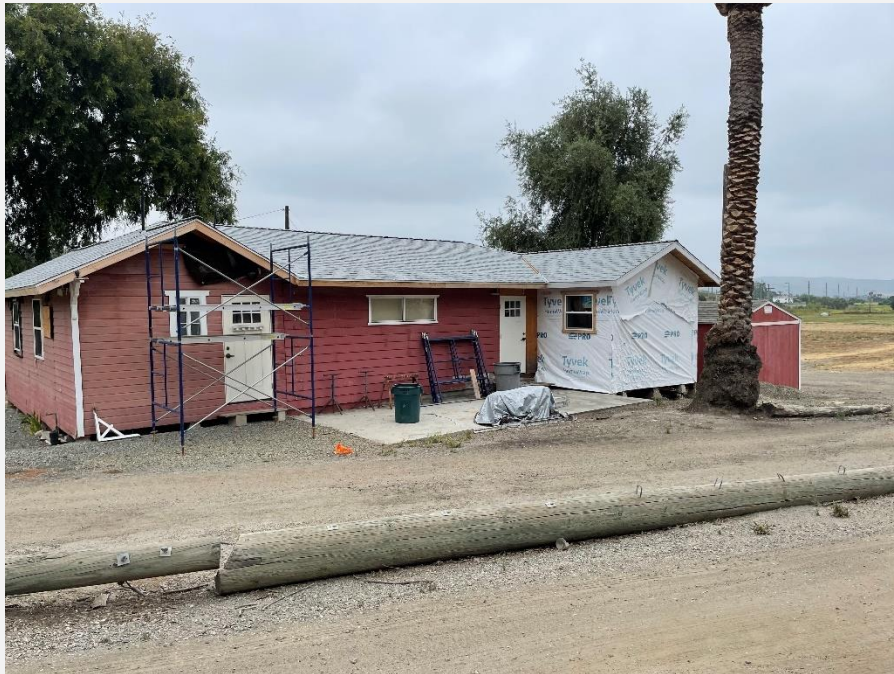
of recordation, it was undergoing extensive alterations that included replacing windows and siding. No other changes were noted since the building was recorded in 2001. A modern era small shed is located southwest of the building. South of the building is empty acreage where citrus trees were historically. There is also a modern-era small farm. What are now used as hiking/walking/horse trails were historically unimproved dirt roads associated with the property when it was a working citrus ranch. All vestiges of the citrus ranch were removed post-2001.

Exhibit 3. Map ID 3. Last remaining building of the Bathgate Ranch, camera facing southeast.

Materials are the physical elements that were combined to form the Bathgate Ranch during its construction. The materials associated with the subject building include wood sheathing and wood framed windows. At the time of Dudek's recordation, the extant building was undergoing alterations, including replacement siding and windows. The roof also appears to have been redone at an unknown date. The modern vinyl replacement windows and new siding have introduced new materials to a building constructed in the 1920s. These alterations have a cumulative effect and has resulted in a loss of integrity of materials.

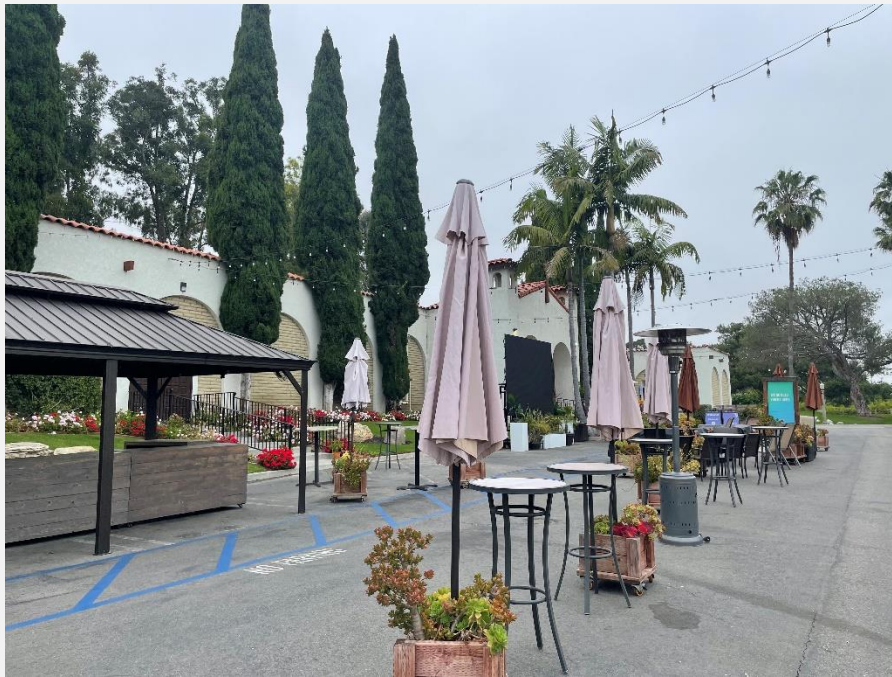
The Saddleback Church Rancho Capistrano Main Office building was constructed in c. 1972 (Exhibit 5) (NETR 2024). This Spanish Revival style building has an asymmetrical footprint with two projecting wings, one in the center of the main façade and one on the east side of the main façade. All walls are stucco clad. On the south elevation, there is a gabled projecting element. The roof is flat, except for the front gabled projecting wing in the center of the façade and the side gabled projecting element on the south elevation. There is a slight parapet on the primary façade and along the north and south sides of the roof, adorned with rounded tile. The remainder of the roof is of corrugated metal. The primary façade has an arcaded portico, and the gabled roof is flanked square towers on either side. The east and north facades have slightly recessed arcaded walls infilled with brick. Fenestration includes modern vinyl replacement windows, glazed metal doors, or paneled wood double doors. The entrances are accessible by concrete or tile stairs with iron railings.

Exhibit 5. Map ID 5. Main Office Building, camera facing north.

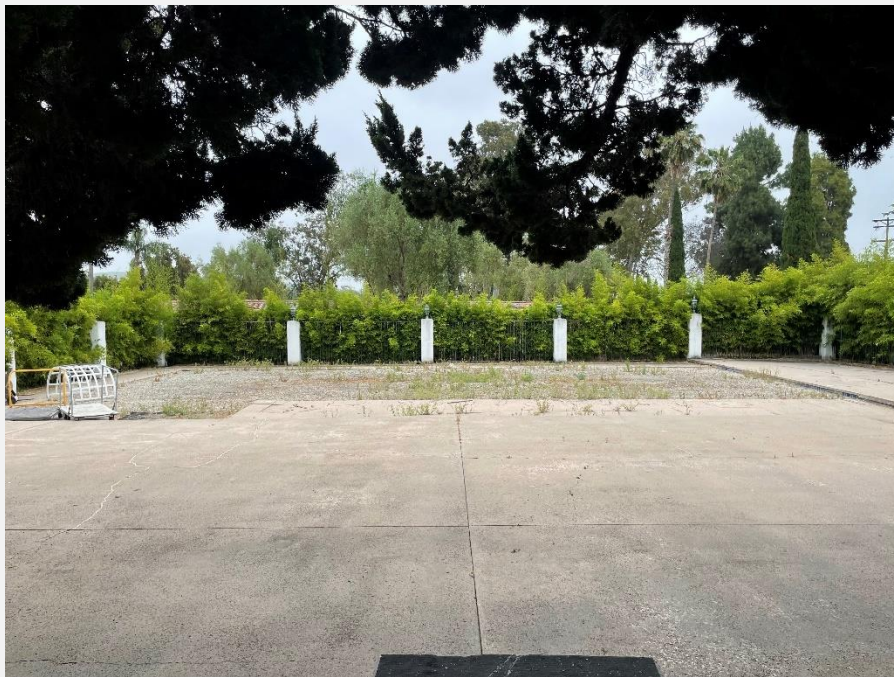
Map ID 6 is an infilled pool constructed in c. 1941 (Exhibit 6). The pool measures approximately 55' by 25' and was infilled in c. 2012 (NETR 2024). It is partially surrounded by a concrete patio and a pool deck. The infilled pool and patio are fenced in by a wrought iron fence with concrete pillars topped with lights. Mature and overgrown bushes are evident at the fence line.

Exhibit 6. Map ID 6. Infilled swimming pool, camera facing east.

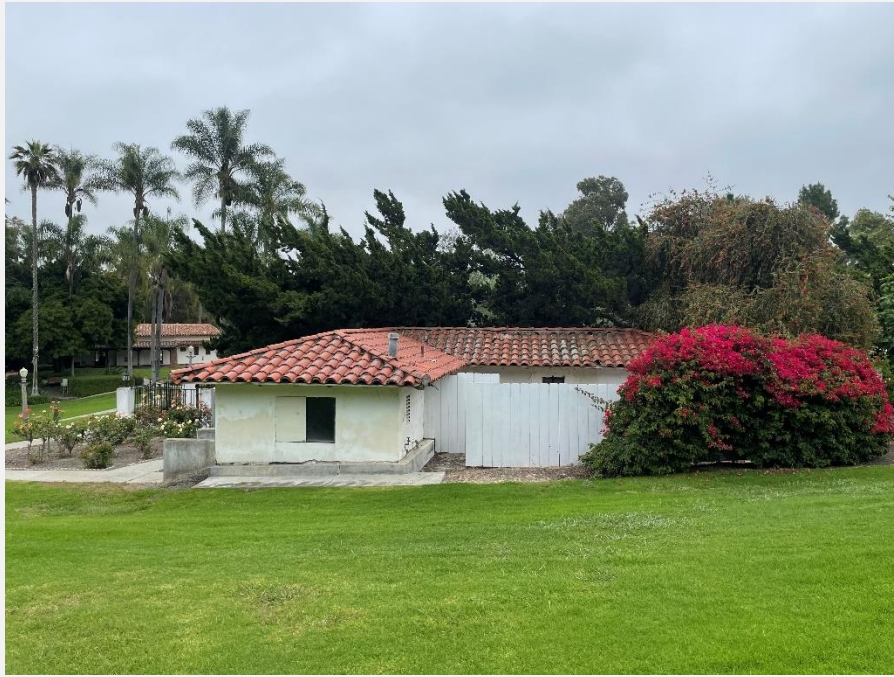
Map ID 7 is a pool house constructed in c. 1941 (Exhibit 7). The pool house was built in the Spanish Revival style with a hipped roof clad in rounded tiles and has exposed rafters. It has an L-shaped footprint and is set on a concrete foundation. Fenestration includes single-hung horizontal pane windows, large, fixed windows, and wood paneled doors. A wrought iron fence extends along the northwest elevation of the property. The main entrance is located on the east elevation and consisted of a recessed entryway with four wood paneled doors and tiled flooring. Other elements include exposed wood rafters and decorative latticework flanking the windows on the east façade and louvered grates.

Exhibit 7. Map ID 7. Pool House, camera facing east.

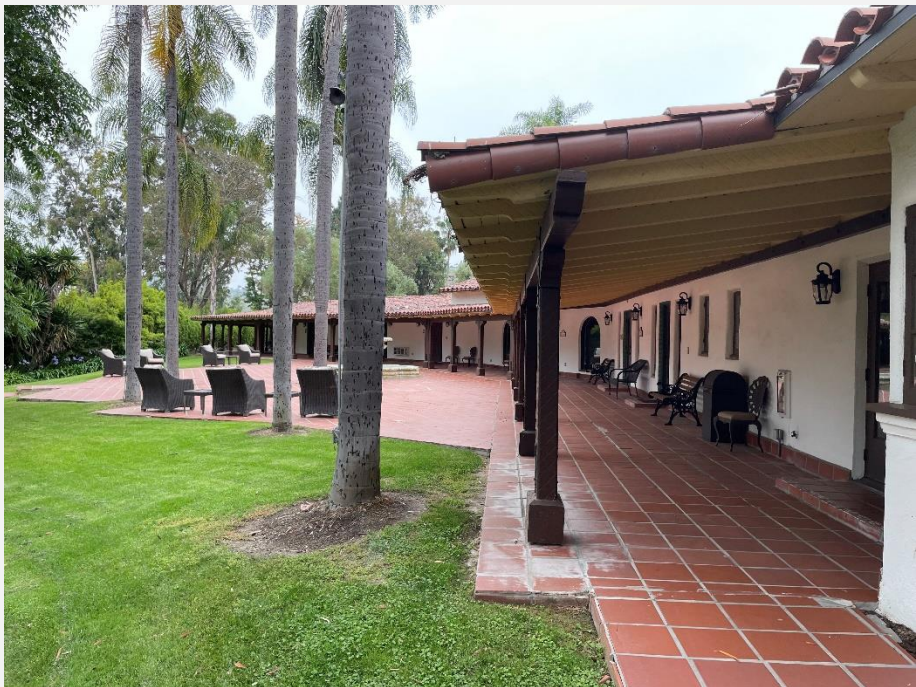
The former ranch residence was constructed in 1937 in the Spanish Revival style (Exhibit 8). The original residence had a crescent-shaped footprint and was side gabled with a clerestory in the middle of the building. The low-pitched roof was of round tiles and the walls were clad in stucco. On the west elevation, a wide overhang extends from the roofline, supported by wood posts flanked by brick columns at either side. Sometime between 1952 and 1963, a circular courtyard was constructed to the northeast of the original residence (NETR 2024). Between 1980 and 1985, additions to the residence were constructed, as well as two patios, each with a fountain (NETR 2024). The building additions were all single-story, in the same Spanish Revival style. Fenestration on the original residence include solid wood plank and paneled doors, large round arch windows, and wood frame casement windows. On the additions, there are glazed wooden single and double doors with sidelites, and full-length fixed windows. Other details include decorative stained-glass windows, tile-roofed chimney tops, and arcaded walkways.

Exhibit 8. Map ID 8. Petitfils Ranch residence, camera facing southwest.

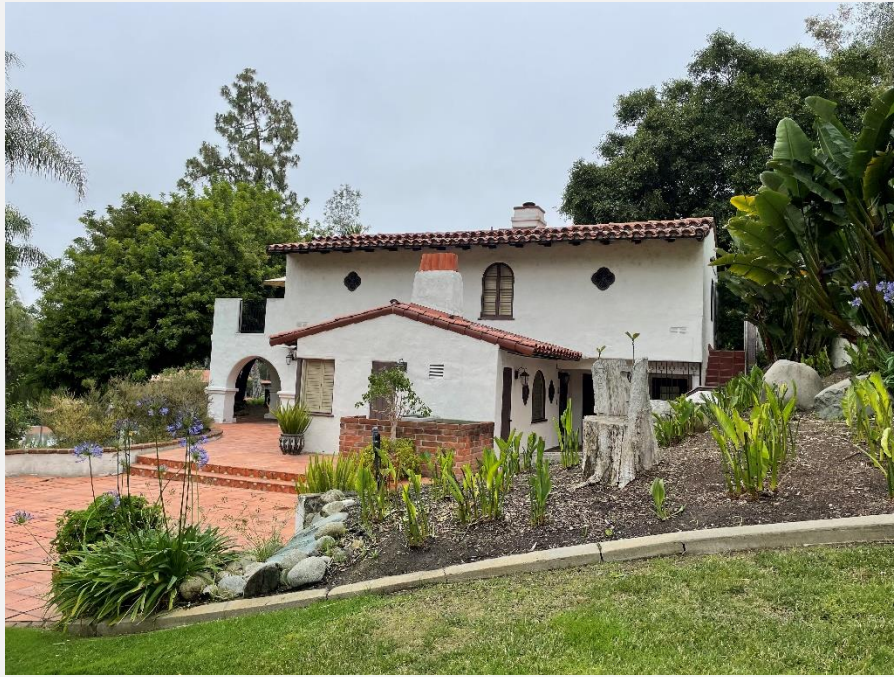
This building was built c. 1967 in the Spanish Revival style (Exhibit 9). It has a low pitched roof with exposed rafters and walls clad in stucco. The residence consists of a two-story side gabled main block with a single-story, front gabled projecting wing. A tile-roofed chimney is situated on the single-story wing. There is an arcaded walkway on the west side of the façade at ground level that extends along the west elevation, and a second arcaded walkway on the north elevation at the second story level. On the east side of the main façade is a recessed entryway and walled entry courtyard. The second story level is accessible by an exterior staircase on the east elevation and a separate, unattached staircase on the northwest elevation. The west elevation also features a balcony with iron railing. Fenestration includes wood plank and paneled doors, modern sliding glass doors, wood casement windows, round arched windows, double pane replacement windows, and decorative stained glass windows.

Exhibit 9. Map ID 9. Loughridge Ranch Residence, camera facing east.

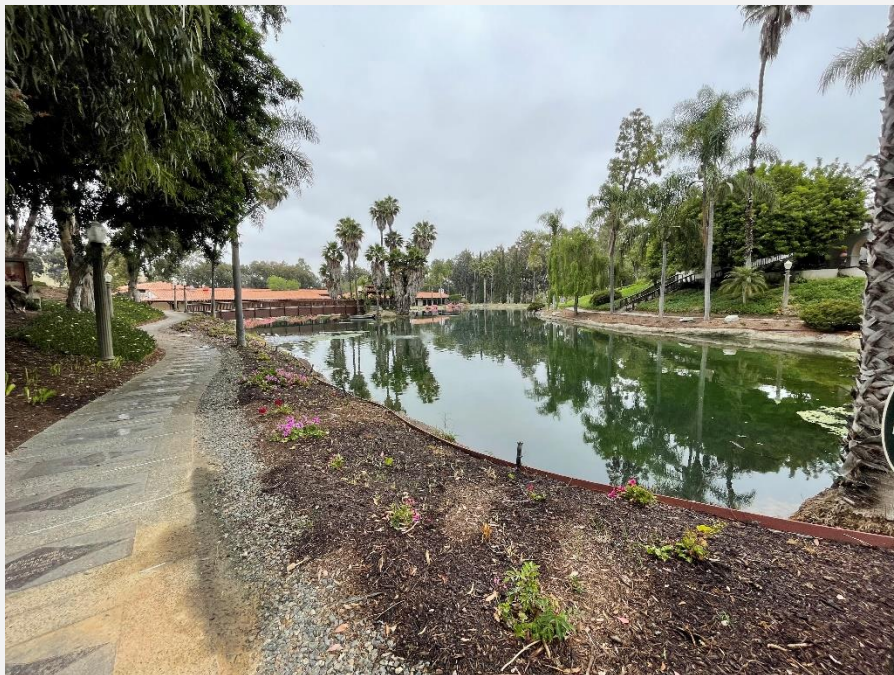
Map ID 10 is a manmade lake constructed in c. 1963 (Photos 1-3). The lake encompasses approximately 1.23 acres and has an irregular shape. A footbridge measuring approximately 65 feet extends across the lake to a gazebo and vegetation. It is surrounded by landscaping and a walking path.

Exhibit 10. Map ID 10. Lake and paths, camera facing northwest.

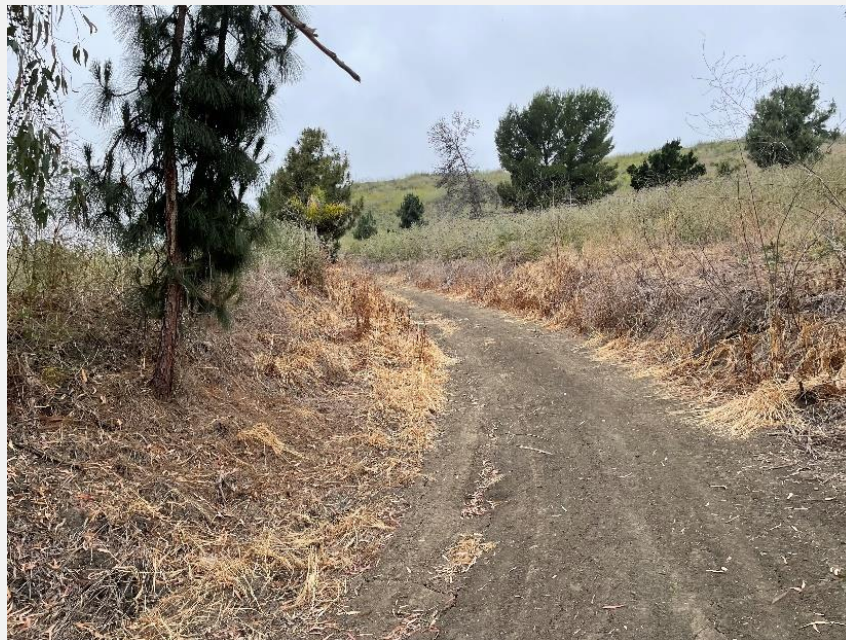
Map ID 11 is approximately 0.5 mile of the Bluff Trail that crosses a portion of the parcel. It varies in width from 1-3 feet (Exhibit 11). Historically it was an unimproved dirt road.

Exhibit 11. Map ID 11. Trail, camera facing northwest.

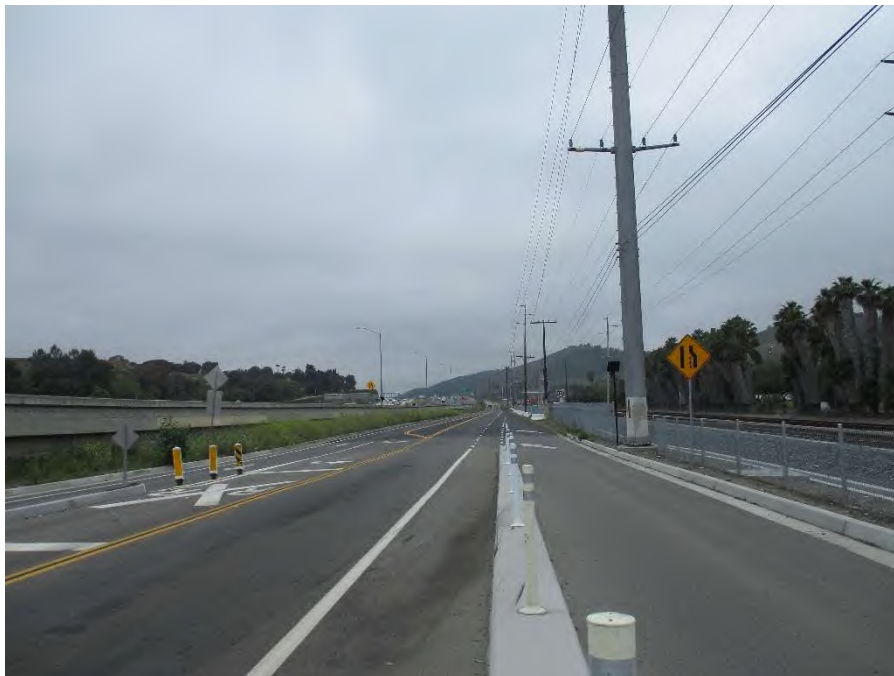
P5b. Description of Photo: (View, date, accession #) Photo 1, Camino Capistrano, looking south, June 11, 2024

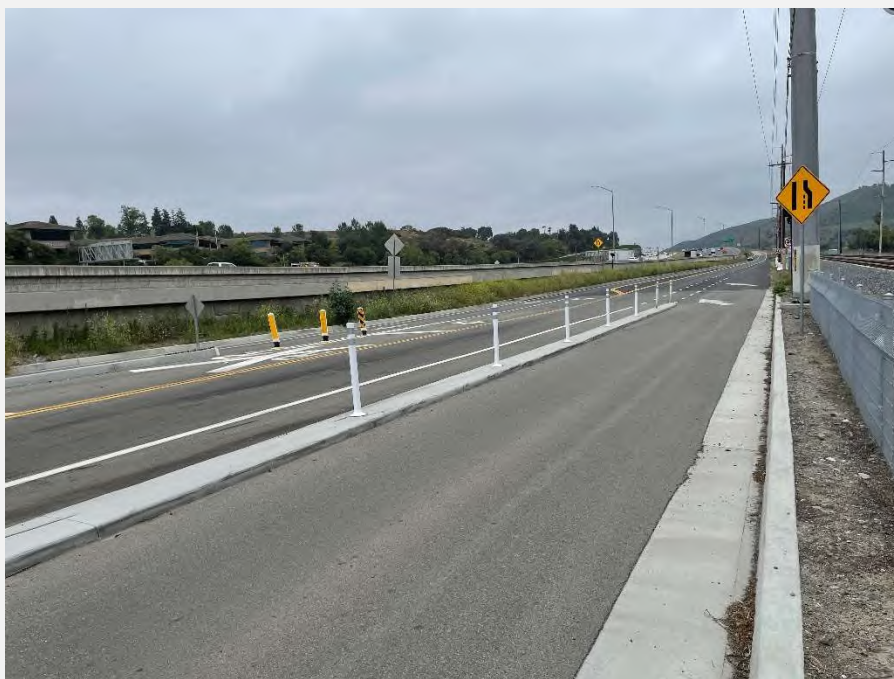
Photo 2. Camino Capistrano, looking south. Shows merge lanes, turn lanes, Interstate 5.

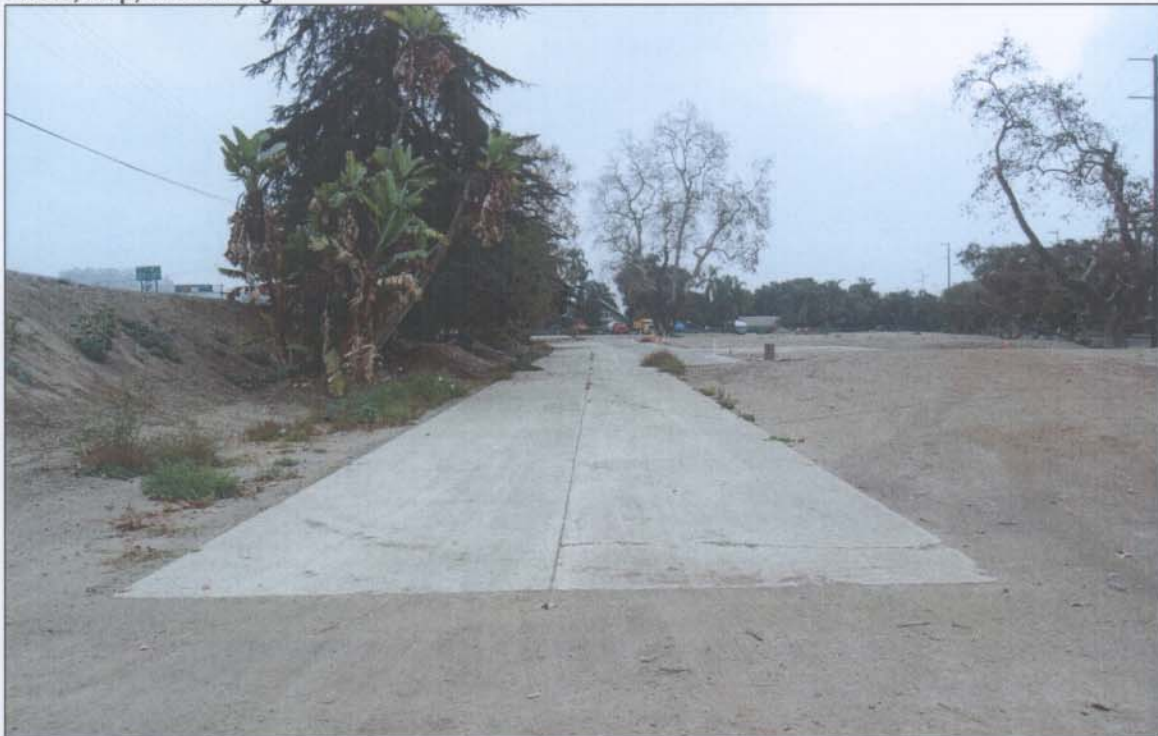
L7. Integrity Considerations: Integrity is good across length of segment.

L8b. Description of Photo, Map, or Drawing: Segment 1, North end view south (SJC-RJC-01-dm-041)

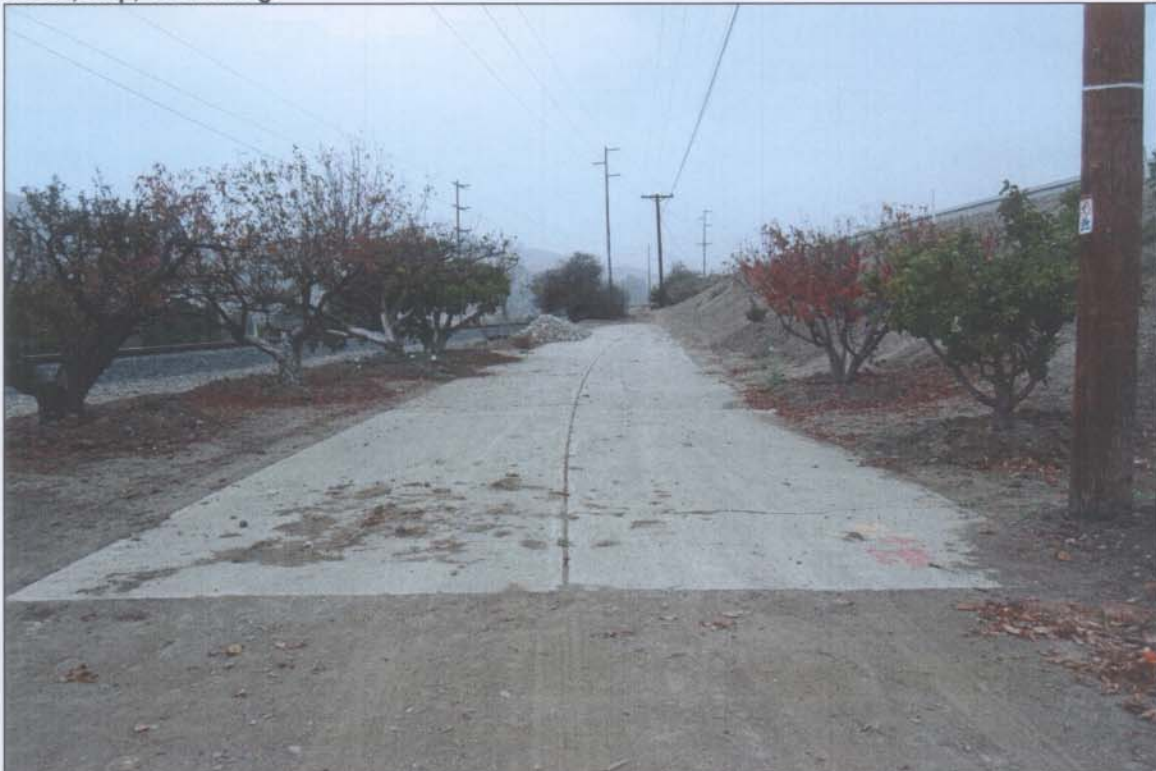
L7. **Integrity Considerations:** Integrity is good across length of segment.

L8b. **Description of Photo, Map, or Drawing:** Segment 2, south end view north (SJC-RJC-01-dm-036).

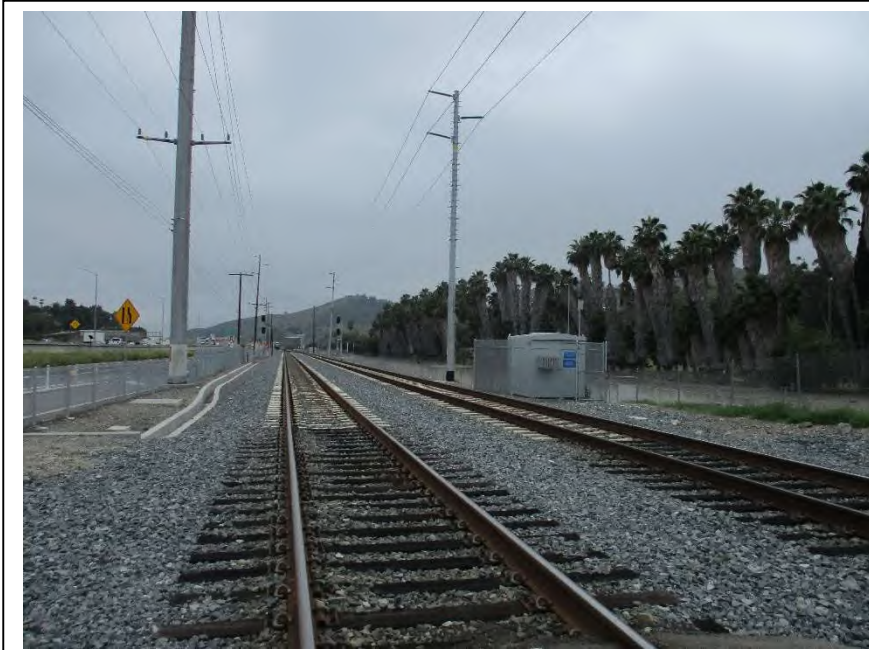
***P3a. Description:** Various segments of this railroad have been recorded throughout California. The portion in this project area was previously recorded in 2018 by HDR. The description remains valid with the only noted change is most of the wood ties over the ballast have been replaced since 2018 (**Photo 1 and 2**).

P5b. Description of Photo: (View, date, accession #) Photo 1, Tracks, looking south, June 11, 2024

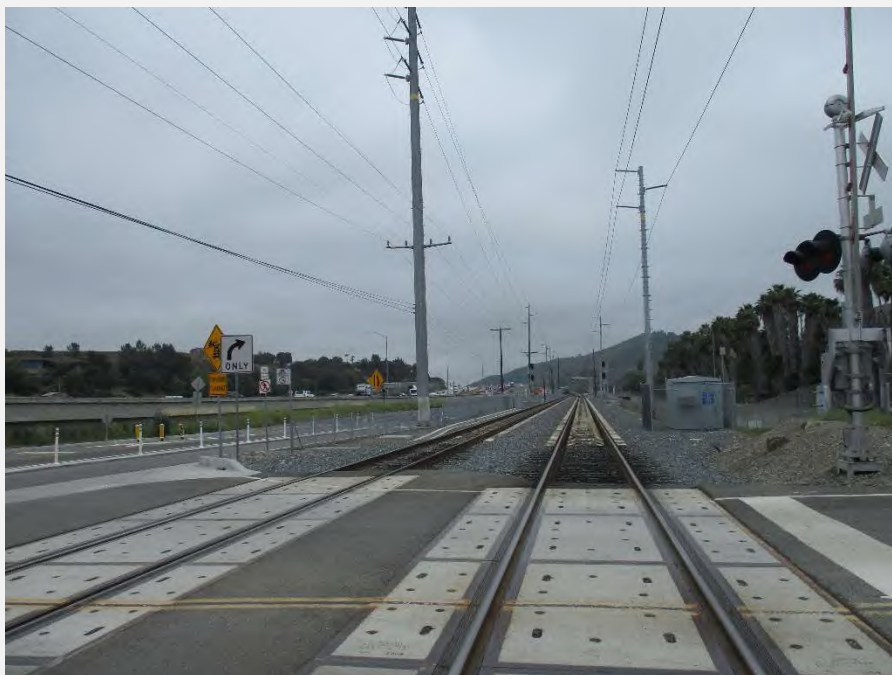
Photo 2. Railroad tracks and modern safety crossing structure, looking south.
