| <b>Document Title:</b> | Los Esteros Critical Energy Facility (03-AFC-02C) Petition for Modification Tanager Battery Energy Storage System Project |

RE: Los Esteros Critical Energy Facility (03-AFC-02C)  
Petition for Modification: Tanager Battery Energy Storage System Project

# **Petition for Modification Tanager Battery Energy Storage System Project**

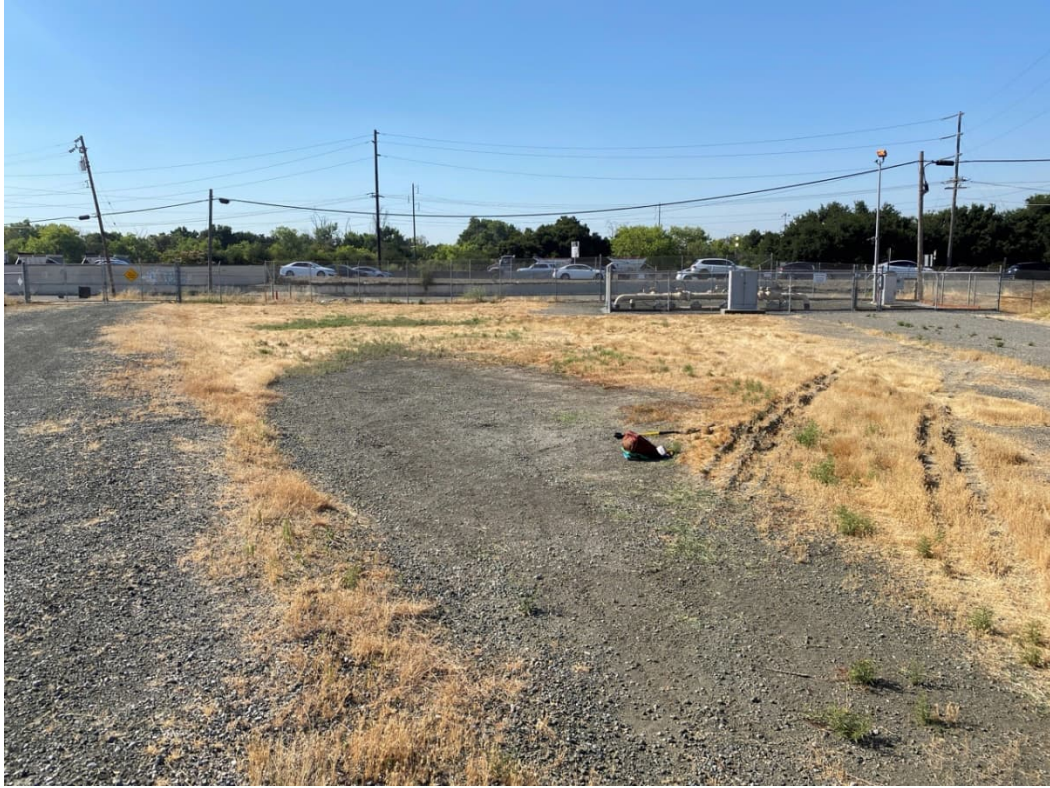
Photo 2. Graveled depression where sample points SP-1A and SP-2A were located. Photo taken looking south on July 3, 2024.

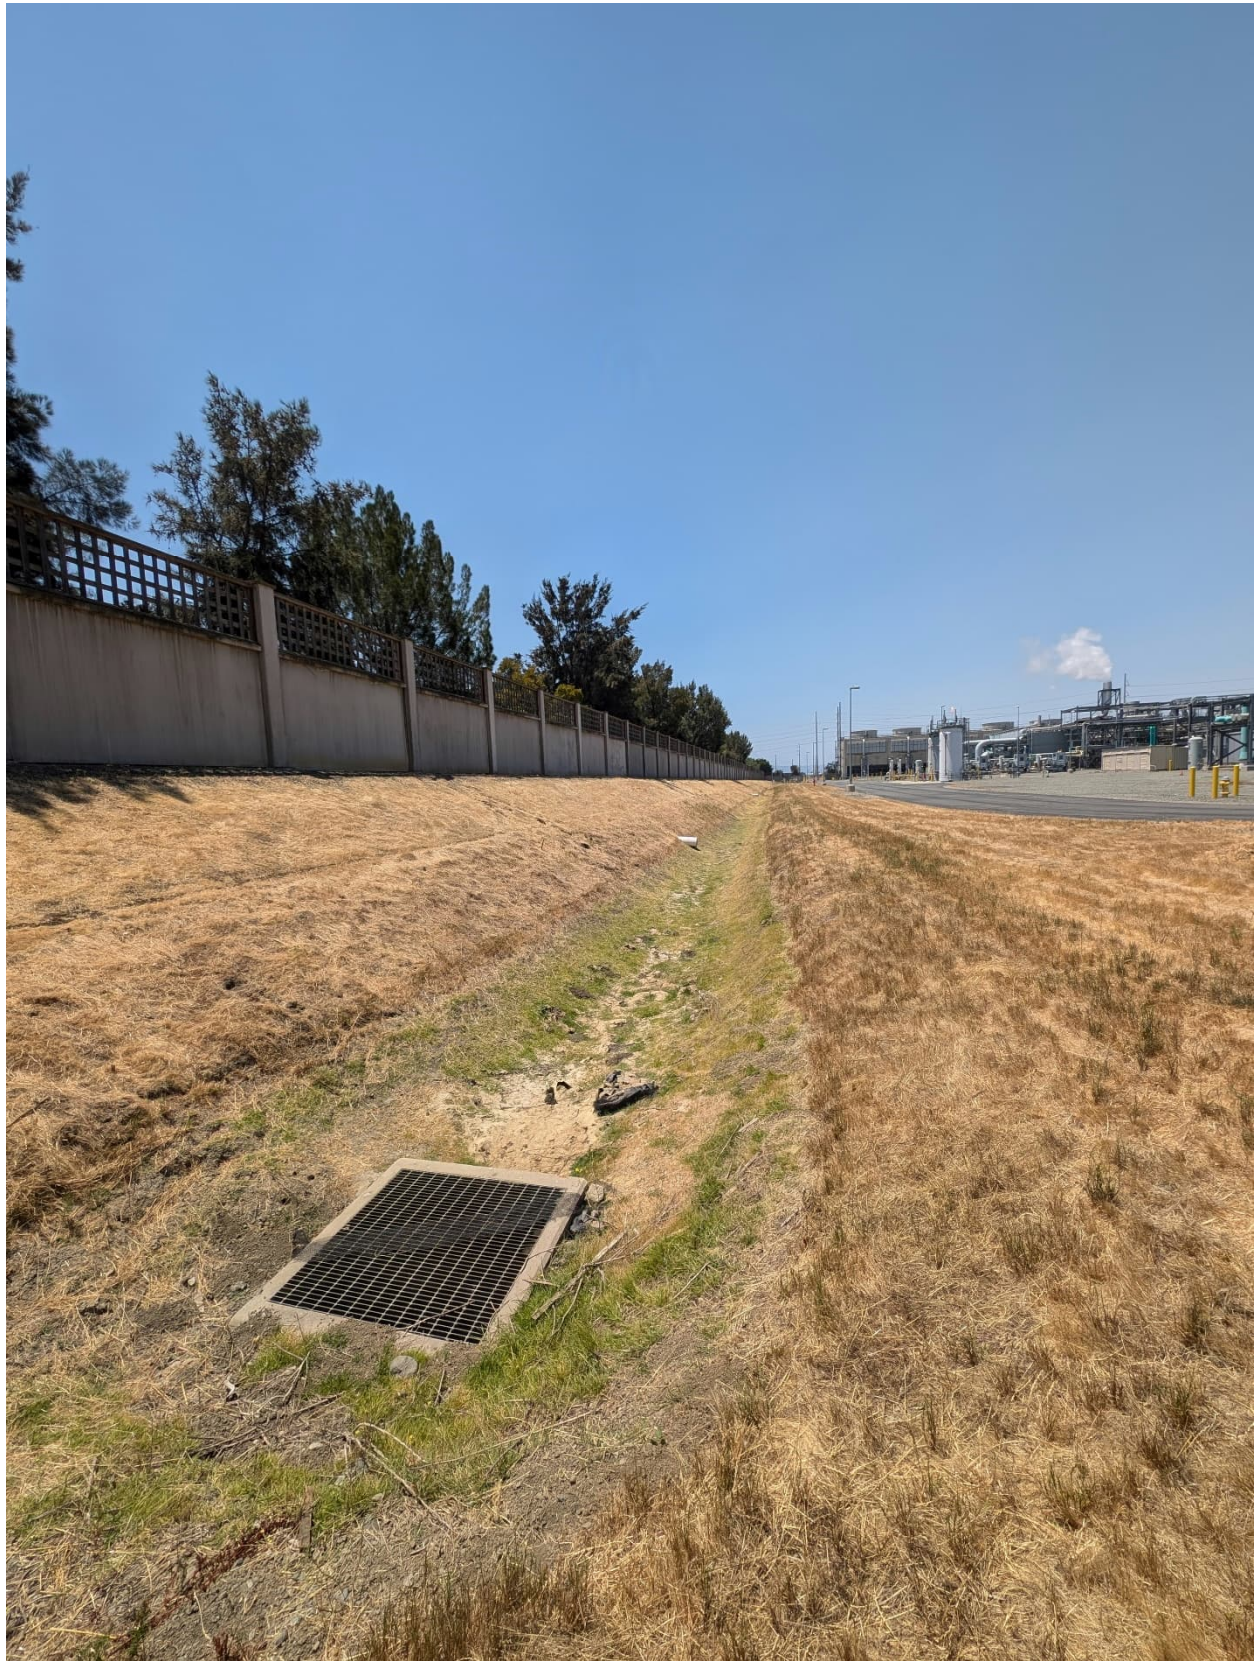
Photo 5. Ditch D-1 as viewed looking west from its eastern end. Drain leads to storm water capture system in the Los Esteros Critical Energy Facility. Photo taken on July 3, 2024.

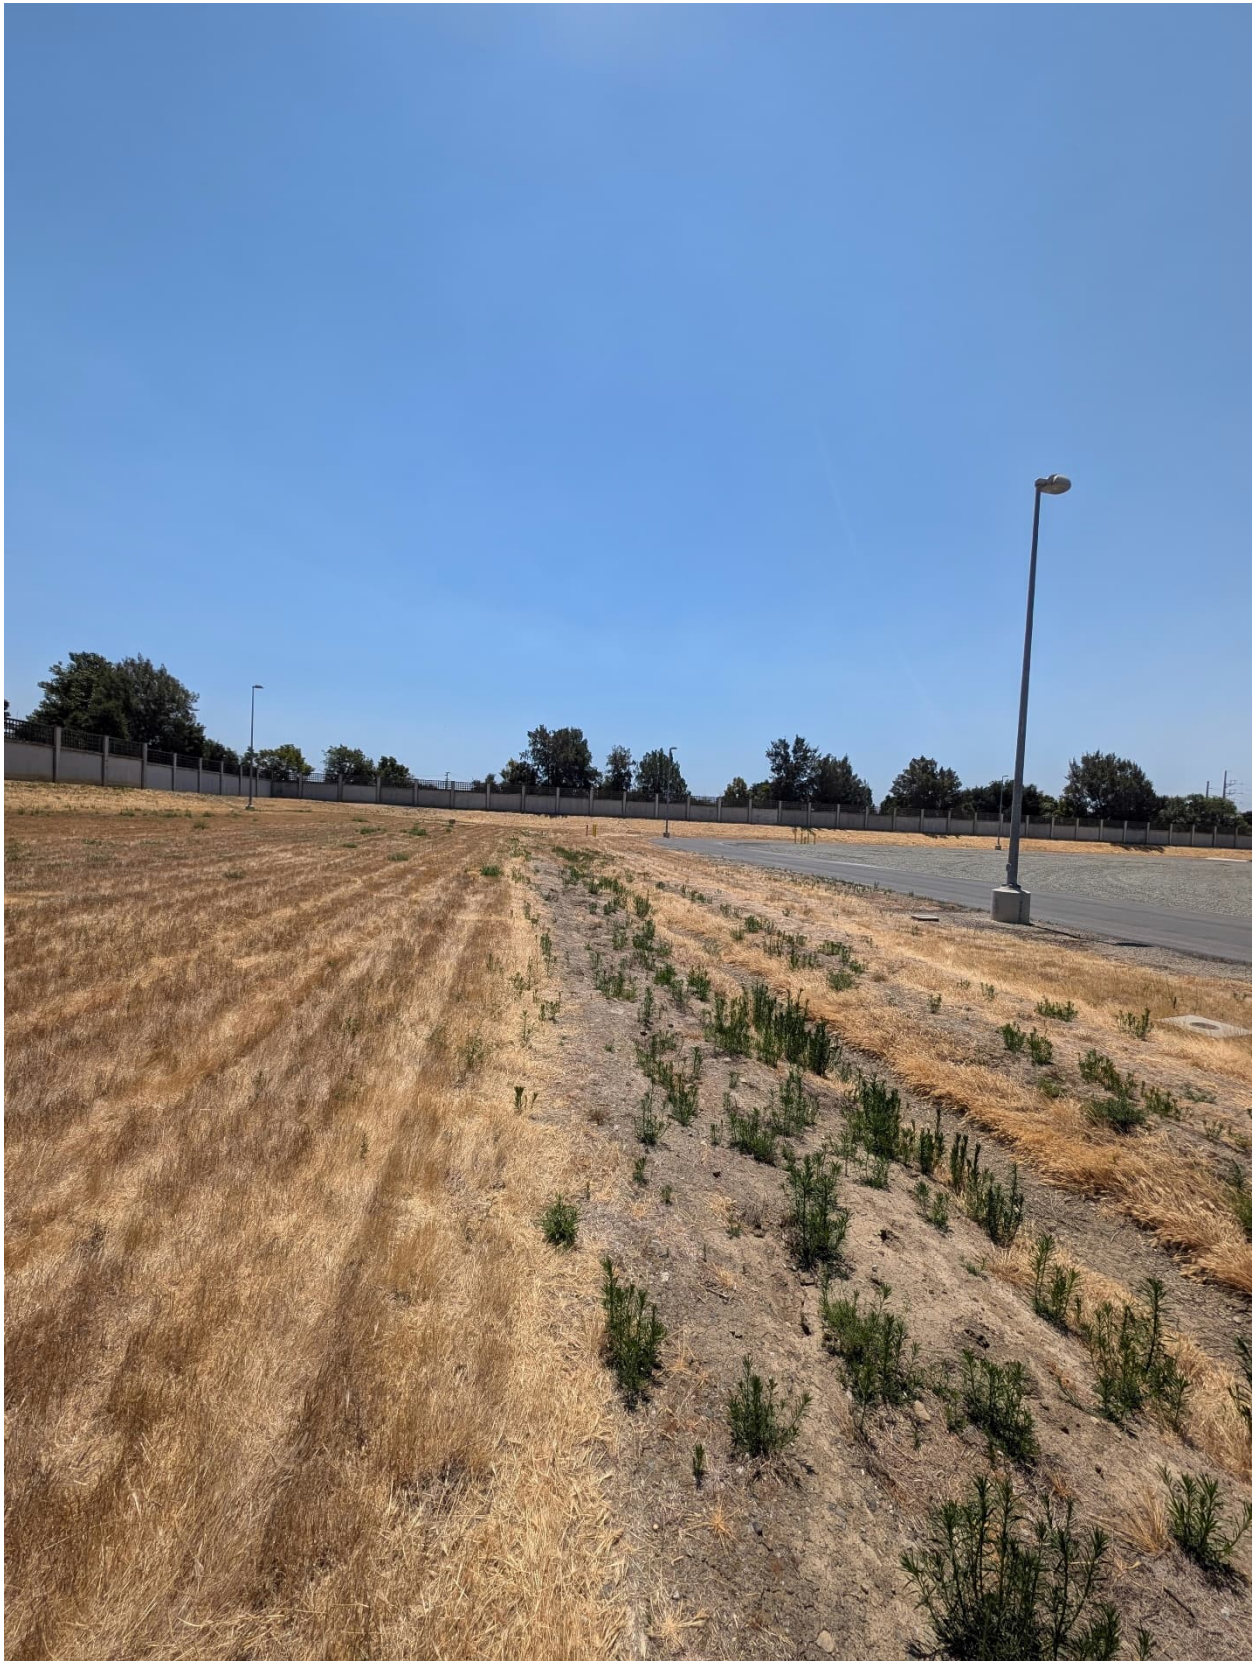
Photo 6. Ditch D-2 as viewed from the northern end looking south. Drains to storm water capture system in the Los Esteros Critical Energy Facility. Photo taken on July 3, 2024.

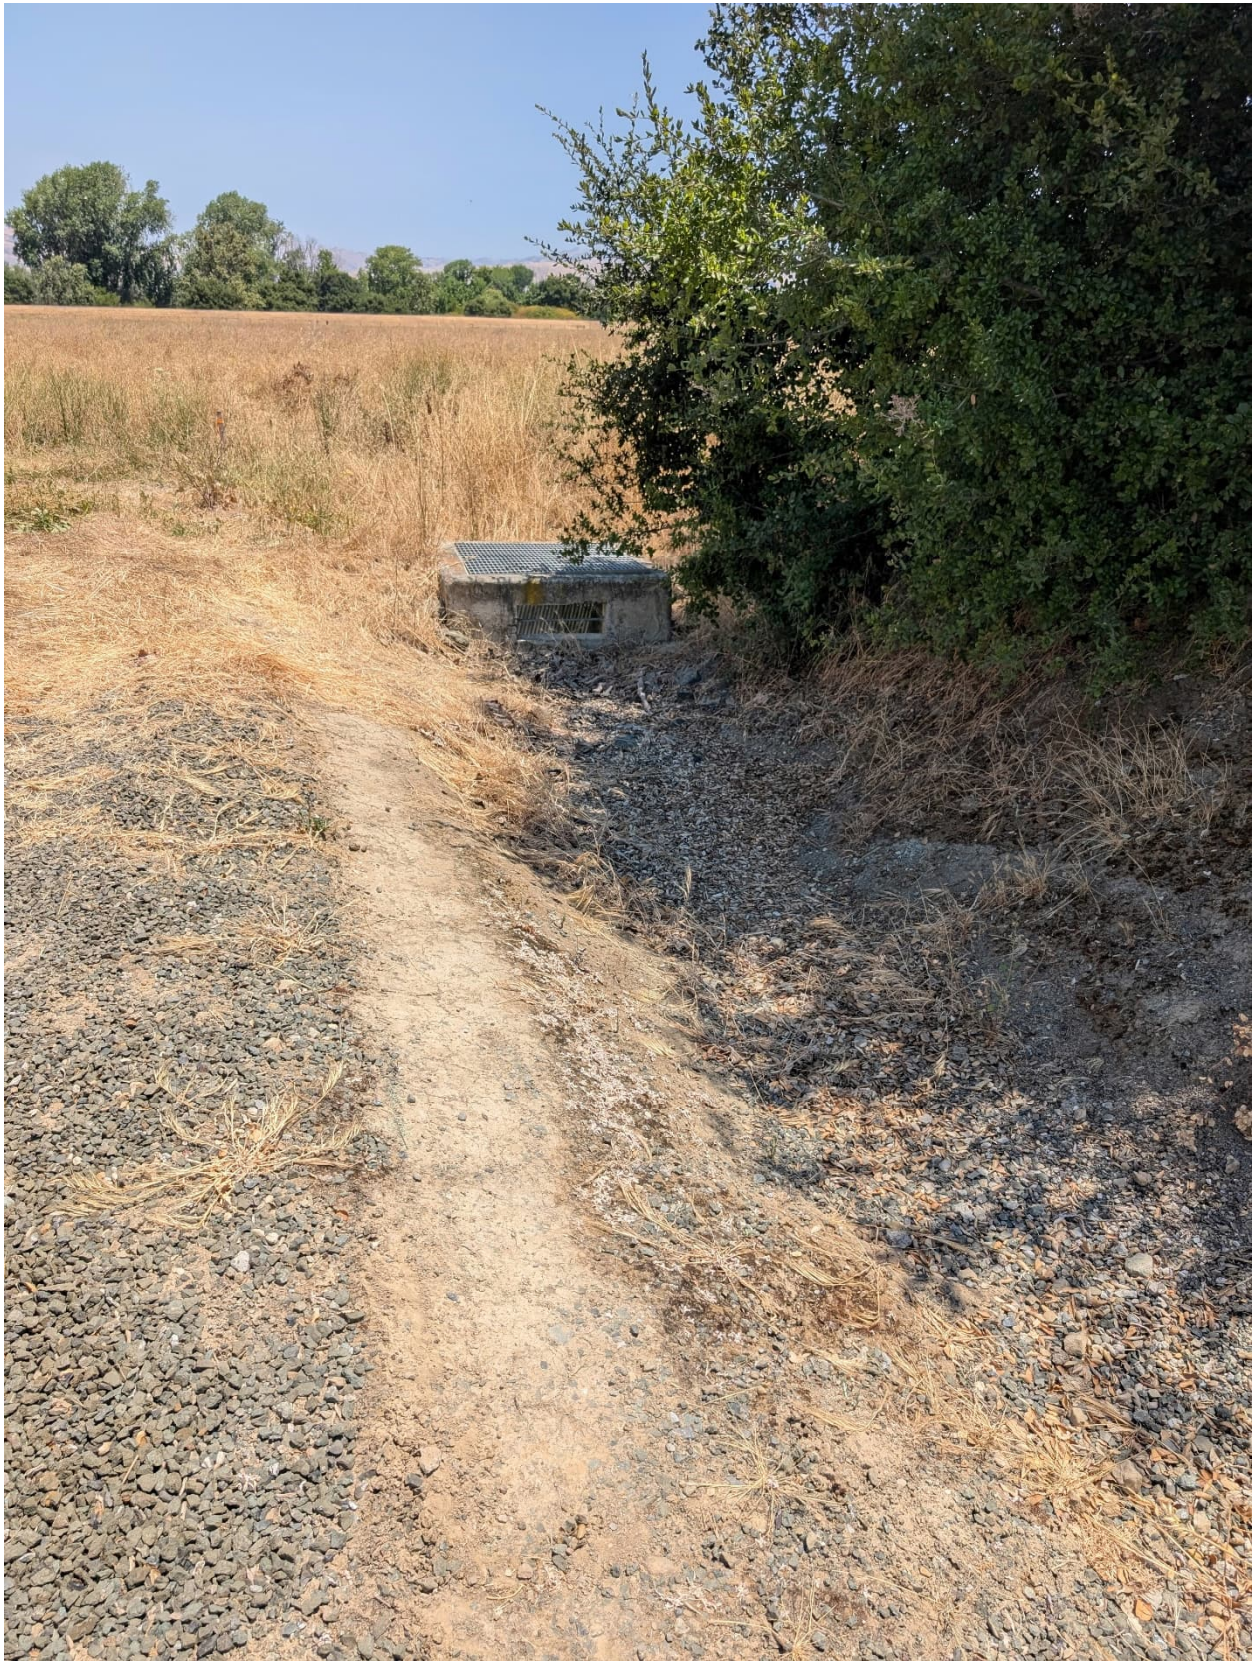
Photo 7. Ditch D-3 as viewed from the gen-tie alignment looking east. Drains to storm water capture system in the Los Esteros Critical Energy Facility. Photo taken on July 3, 2024.

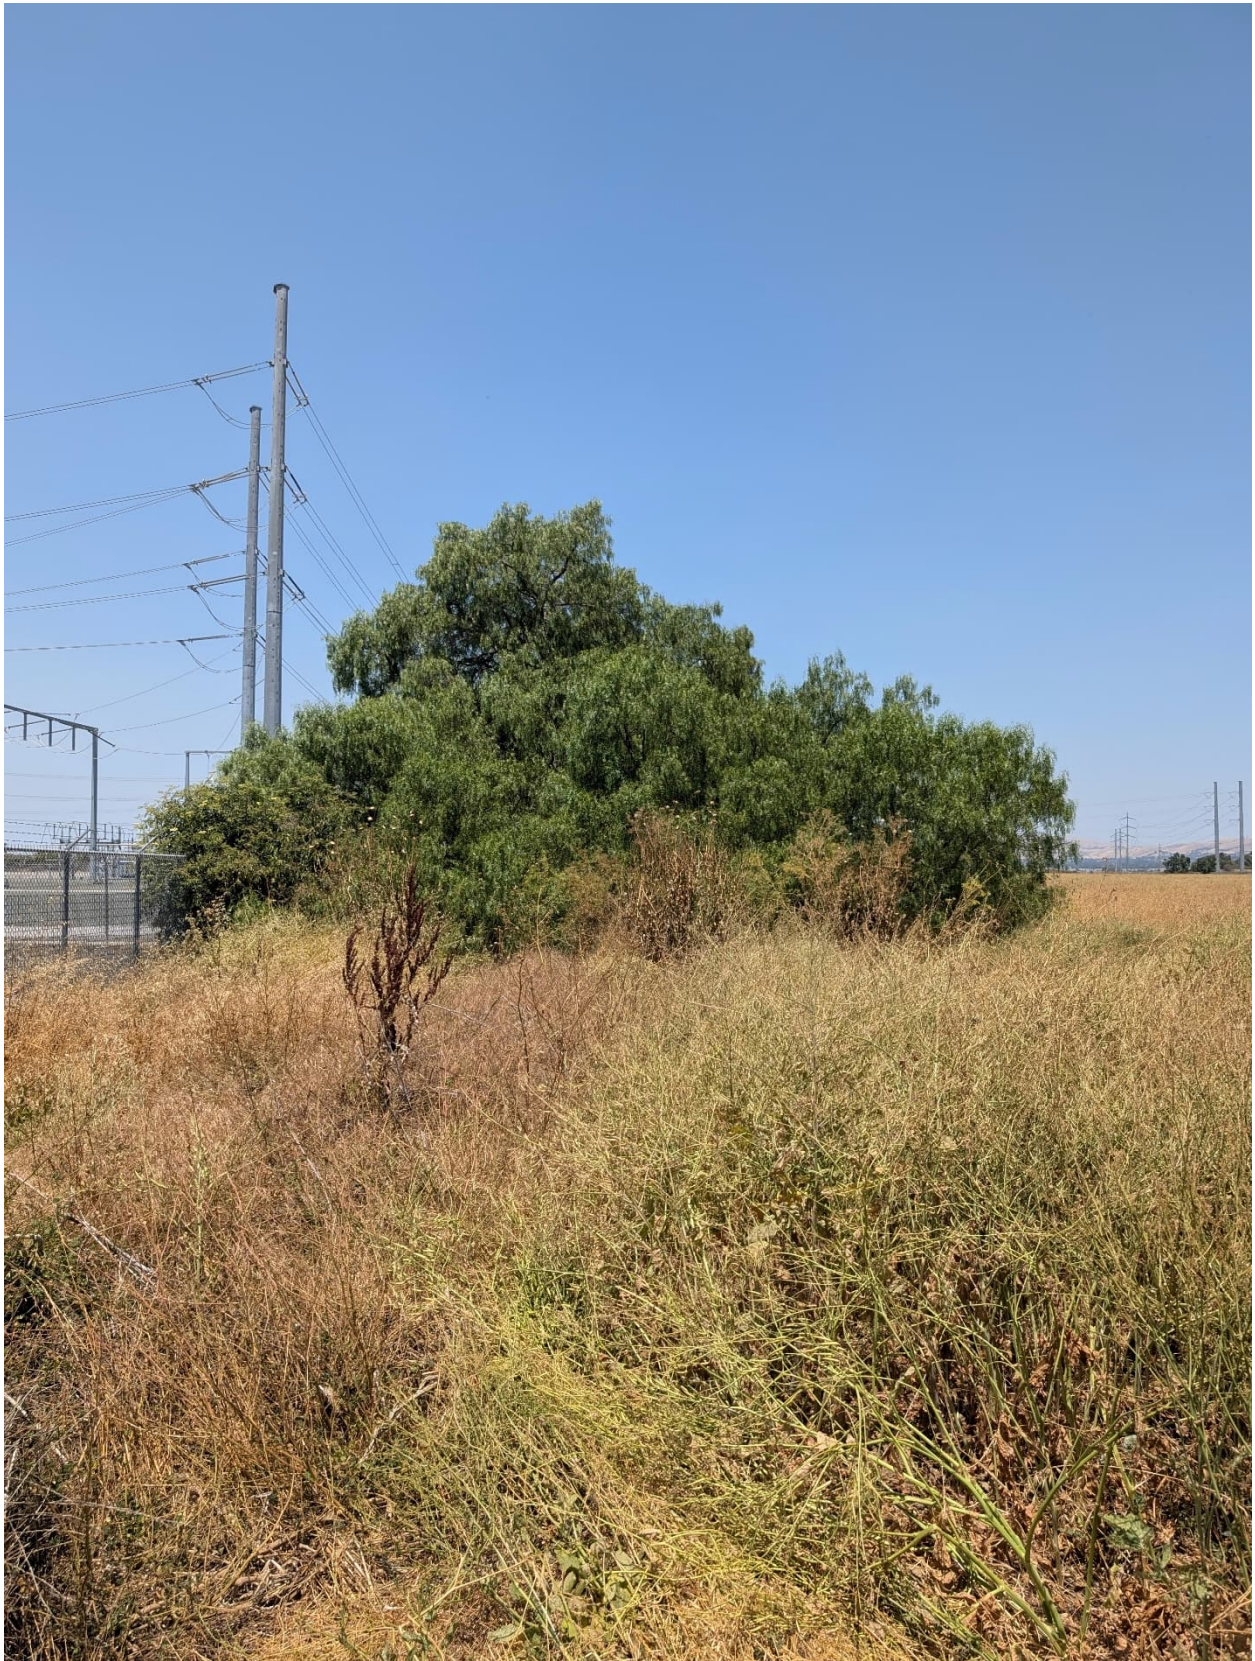
Photo 8. Gen-tie alignment as viewed from ditch D-3 looking north. Photo taken on July 3, 2024.

Three ditches, D-1 through D-3, were delineated within the existing LECEF (Figure 4). These function to capture and divert storm water to LECEF facilities and do not discharge to any of the surrounding waterways. A total of 0.139 acre of other waters were delineated in these canals (Table 4). The Cowardin classification assigned to these waters is Riverine, Lower Perennial, Unconsolidated Bottom (R2UB) (Cowardin et al. 1979).

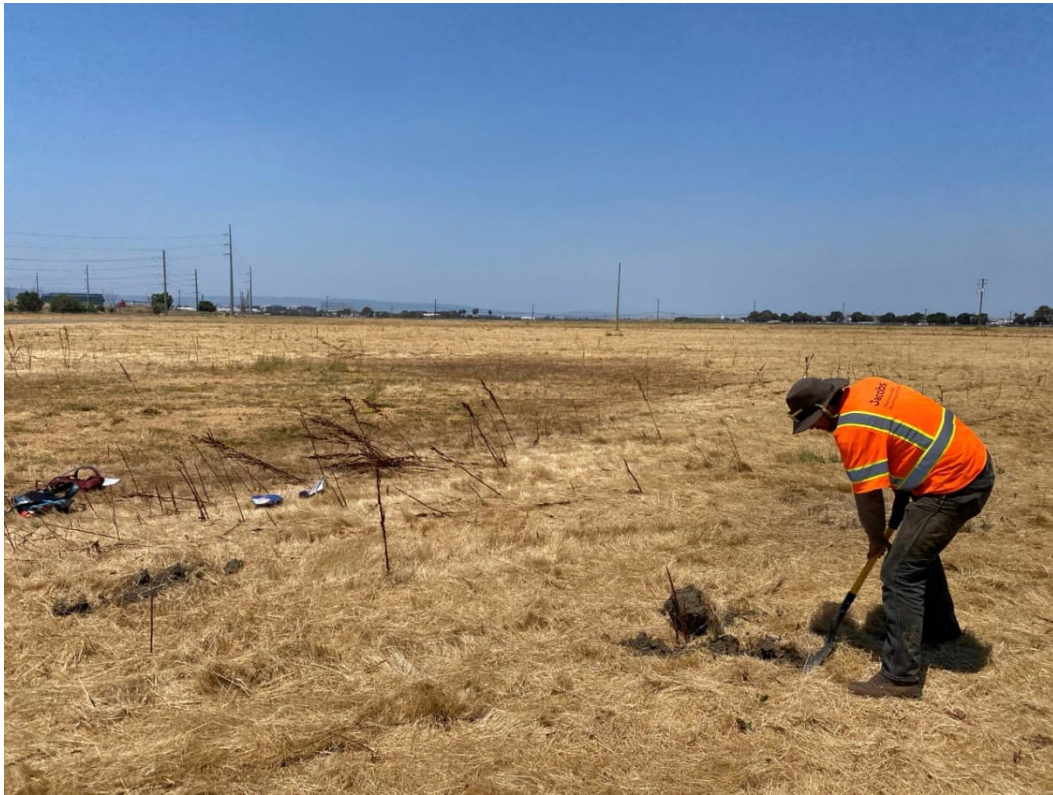
Photo 9. Sample point W3A at wetland W-1 adjacent to the north of Thomas Foon Chew Way as viewed looking west. Photo taken on July 3, 2024.

A single wetland feature was identified along the access route to the Project area immediately north of the Thomas Foon Chew Way pavement (Figure 4). This feature is a seasonal depression dominated by spikerush (*Eleocharis macrostachya*) and is a total of 0.239 acre in size from the road shoulder to approximately 168 feet north of the roadway which will be used for access to the Project footprint. The Cowardin classification assigned to this feature is Palustrine Emergent, persistent, seasonally flooded (PEM1C) (Cowardin et al. 1979).

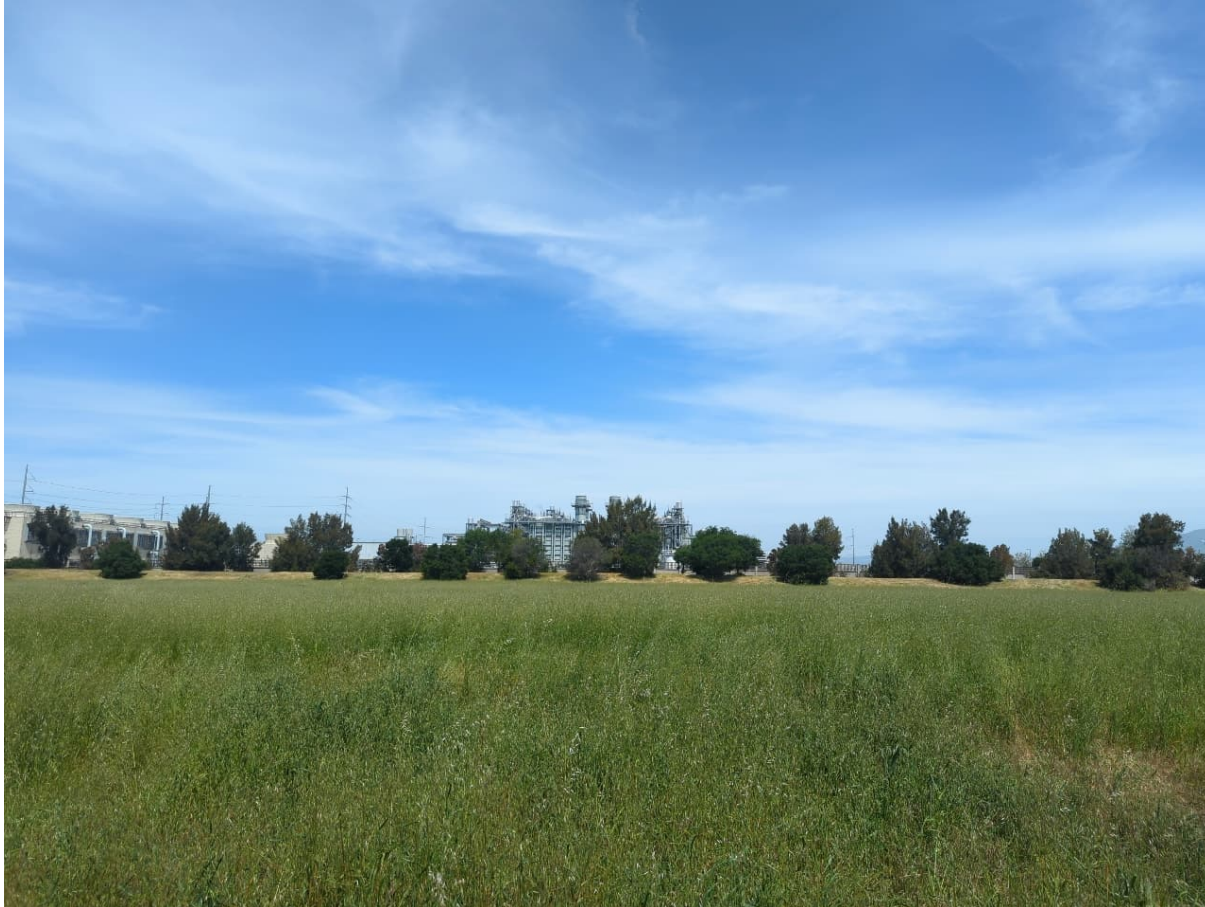
**Figure 2. Looking North from Alviso Milpitas Road Area toward the LECEF**

generator, a cooling tower, ancillary equipment, switchyard, 550-foot-long pipelines, and a 230-kV transmission line (CEC 2024). The facility's most visible features appear as an industrial building comprised of a broad, beige rectangular form topped with short cylindrical shapes and a separate unit comprised of several tall, connected gray cylinders of varying heights interspersed with horizontal and vertical elements (Figure 2).

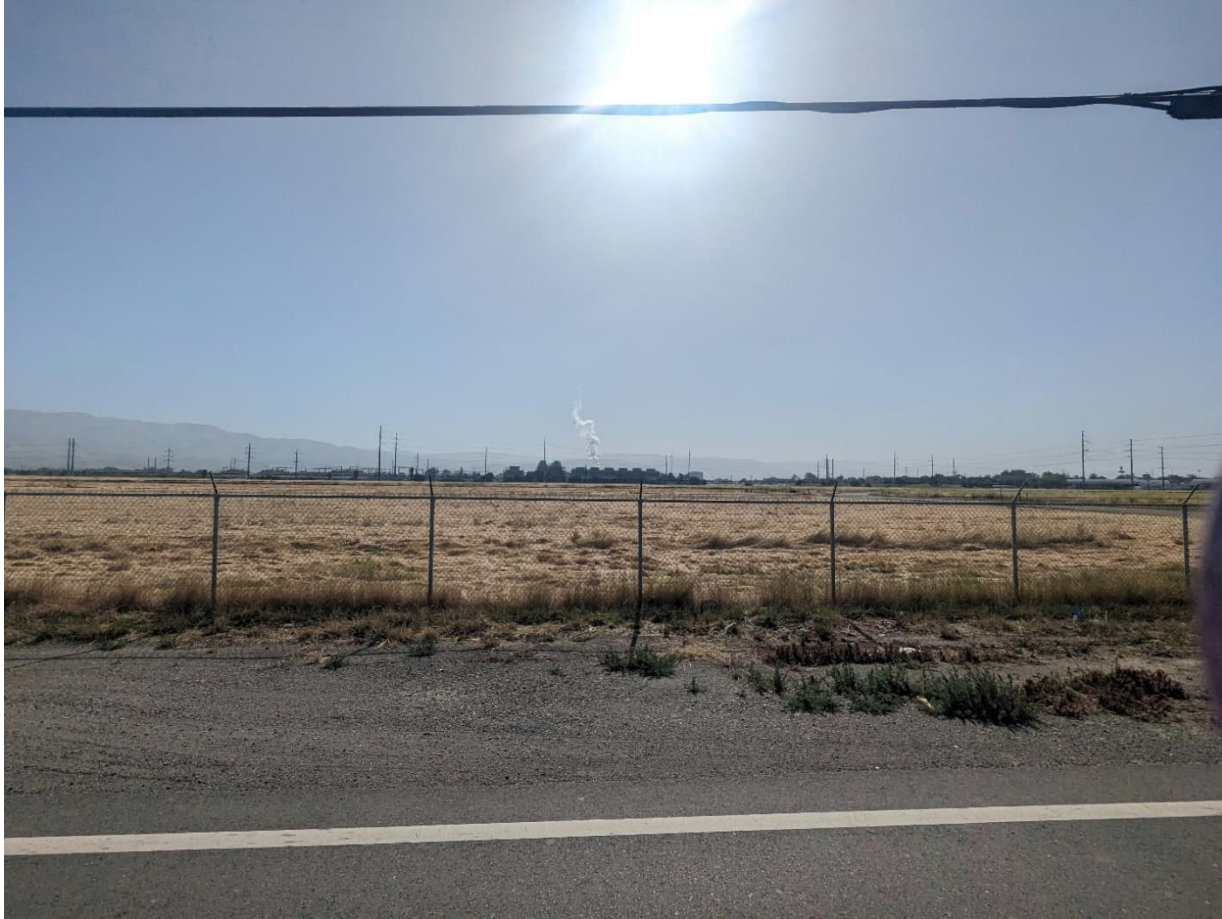
**Figure 3. Looking East from Zanker Road toward the LECEF (Center) and Los Esteros Substation (Left)**

The existing LECEF components use operational lighting. The rounded forms of green, deciduous trees are dispersed in an east-west row along the west, south, and east sides of the LECEF, partially obscuring the facility. The Los Esteros Substation, which is owned and operated by the Pacific Gas & Electric Company, occupies approximately 16.5 acres directly adjacent to the north side of the LECEF (Google Maps 2022). Substations typically consist of substation transformers, circuit breakers and switches, and capacitors (Stein 2024). The Los Esteros Substation appears as a series of vertical gray posts connected by horizontal bars and wires (Figure 3).

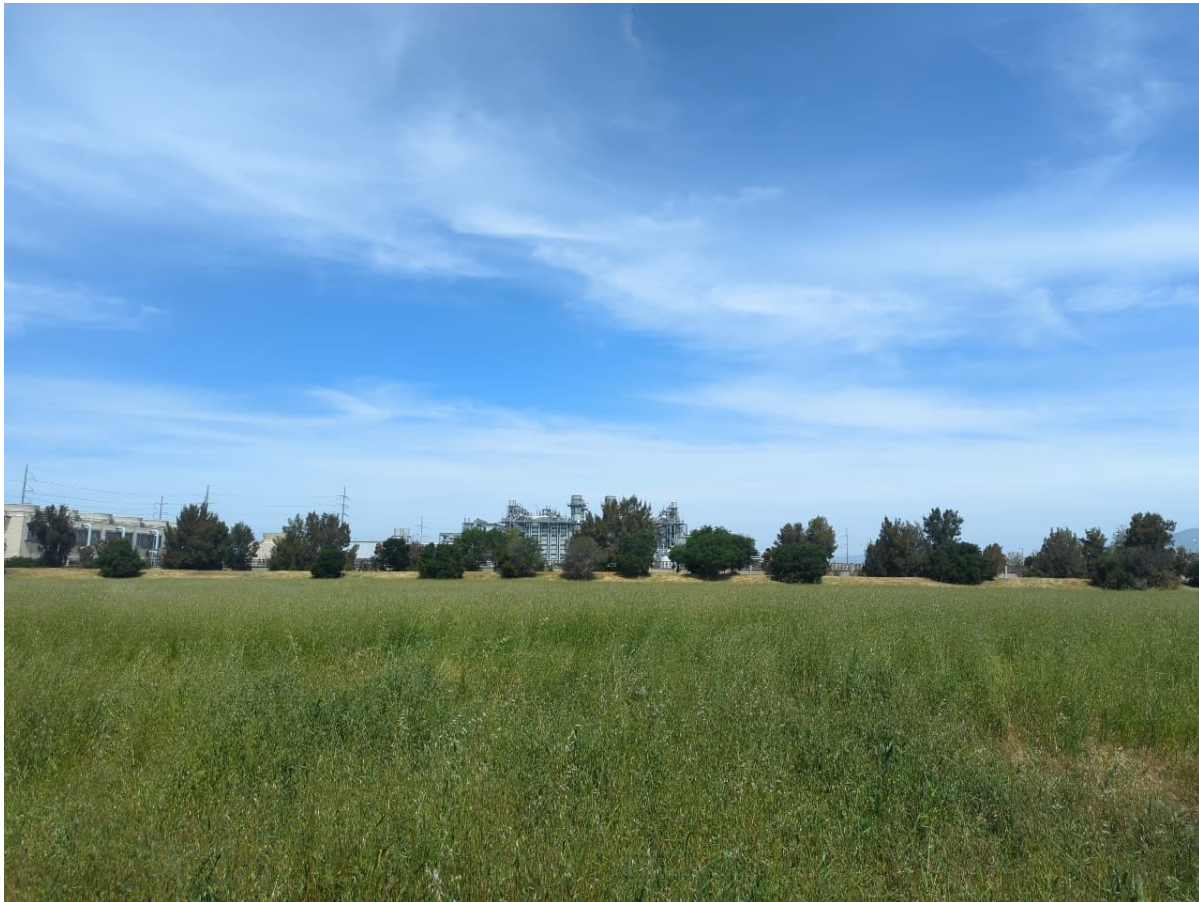
**Figure 6. KOP 1 — View from SR 237 Traveling Westbound or Highway 237 Bikeway, Looking North**

Figure 6 depicts the view looking north from KOP 1, immediately adjacent to the southern boundary of the Project site. KOP 1 represents views for travelers on SR 237 and, to a lesser extent, travelers on Alviso Milpitas Road, including cyclists and possibly pedestrians. Average annual daily traffic is 101,000 for SR 237 east of Zanker Road (Caltrans 2023, 2015). The photograph for KOP 1 was not taken from the highway for safety reasons and therefore does not include a slightly elevated view of the existing concrete guardrail, chain-link fence, and overhead utility wires that occupants of motor vehicles would see.

The landform in this view is generally flat. A broad swath of vacant land covered in green grass rises slightly beyond the immediate foreground. Some green, textured trees form rounded clumps in an intermittent horizontal row from west (left) to east (right) along the low rise approximately 450 feet north of the viewpoint. A tall, beige, rectangular building topped with short cylinders is to the west. A broad industrial structure comprised of tall, gray, interconnected cylinders and vertical and horizontal forms is in the approximate center of the view. Other indistinguishable structures are partially visible. Vertical poles and interconnecting wires rise above these structures to the west; shorter poles are to the east. All of these human-made structures are partially obscured by the row of trees. A bright blue sky with translucent white wisps fill the upper half of the view.

The expanse of grass and row of trees provide a sense of manipulated naturalness in an otherwise highly developed setting. Although the trees are not sufficiently tall or broad enough to completely obscure the LECEF structures beyond them, which intrude upon the view, the majority of the scene appears natural but not memorable. For these reasons, visual quality at KOP 1 is low, with a rating of “C” (Table 2).
