DOCKETED	
Docket Number:	01-EP-10C
Project Title:	Enterprise Emergency Peaker Project - Compliance
TN #:	262238
Document Title:	Supplemental Petition for Post-Certification Amendment, Appendices D and E
Description:	Provides the Applicant's Supplemental Petition submittal for Post-certification Amendment Appendices D and E, which include the Biological Resources Technical Report provided as Appendix D and the Cultural Resources Technical Report (Public Version) provided as Appendix E.
Filer:	Grace Myers
Organization:	Rincon Consultants, Inc.
Submitter Role:	Applicant Consultant
Submission Date:	3/18/2025 2:59:51 PM
Docketed Date:	3/18/2025

BIOLOGICAL RESOURCES TECHNICAL REPORT

Subject: Biological Resources Technical Report to Support CEC Supplemental Petition for Post-Certification Amendment for the Enterprise BESS Project in Escondido, San Diego County, California

Revised Cultural Resources Technical Report (Public Version)

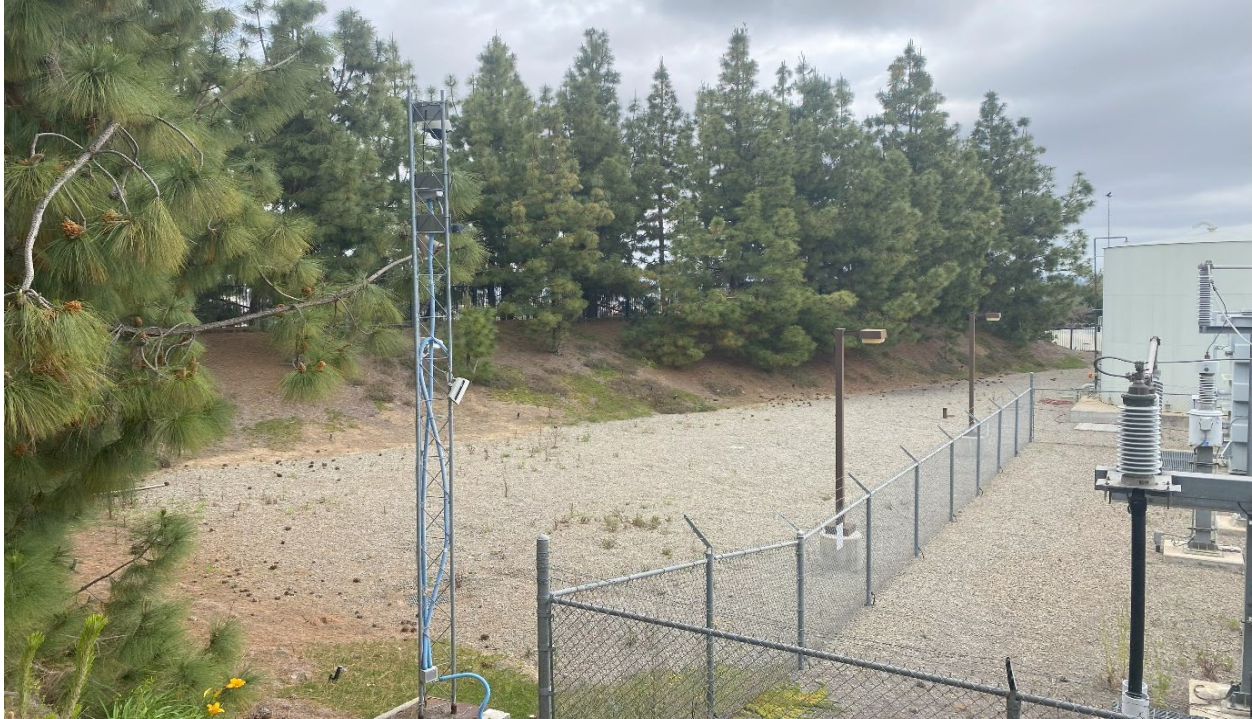
Photograph 7. View of northern portion of EEPP facility, graded and graveled lot with ornamental coniferous trees, facing northeast in area of proposed BESS cable tray and elevated switchgear platform

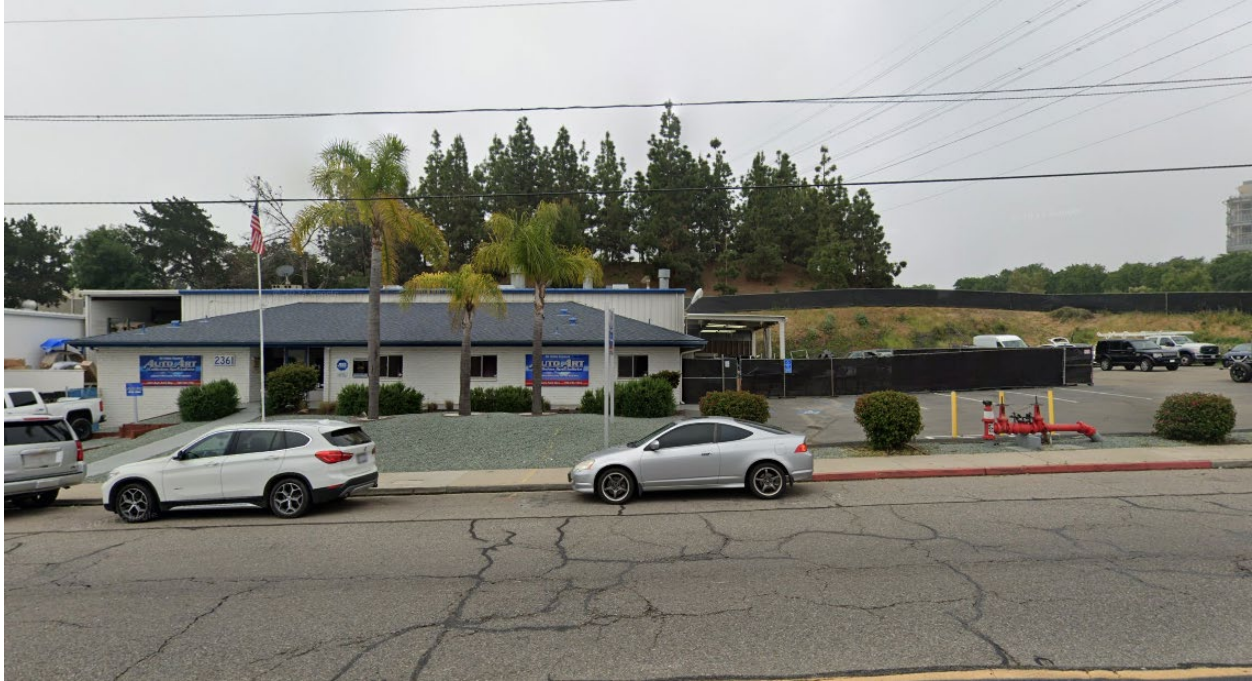
Photograph 13. View of the auto body shop and associated ornamental trees and shrubs. The proposed location of the cable tray installation, the norther slope, is visible in the background, facing south

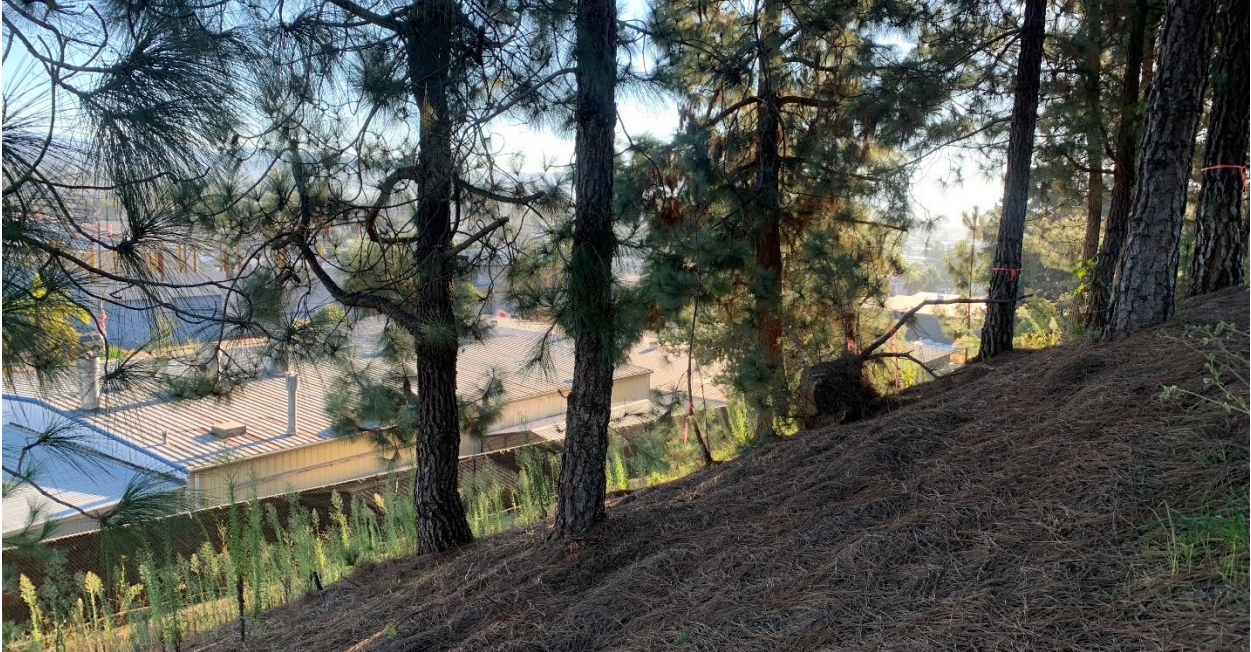
Photograph 15. View of the auto body shop from the proposed location of the cable tray installation on the norther slope, facing northeast

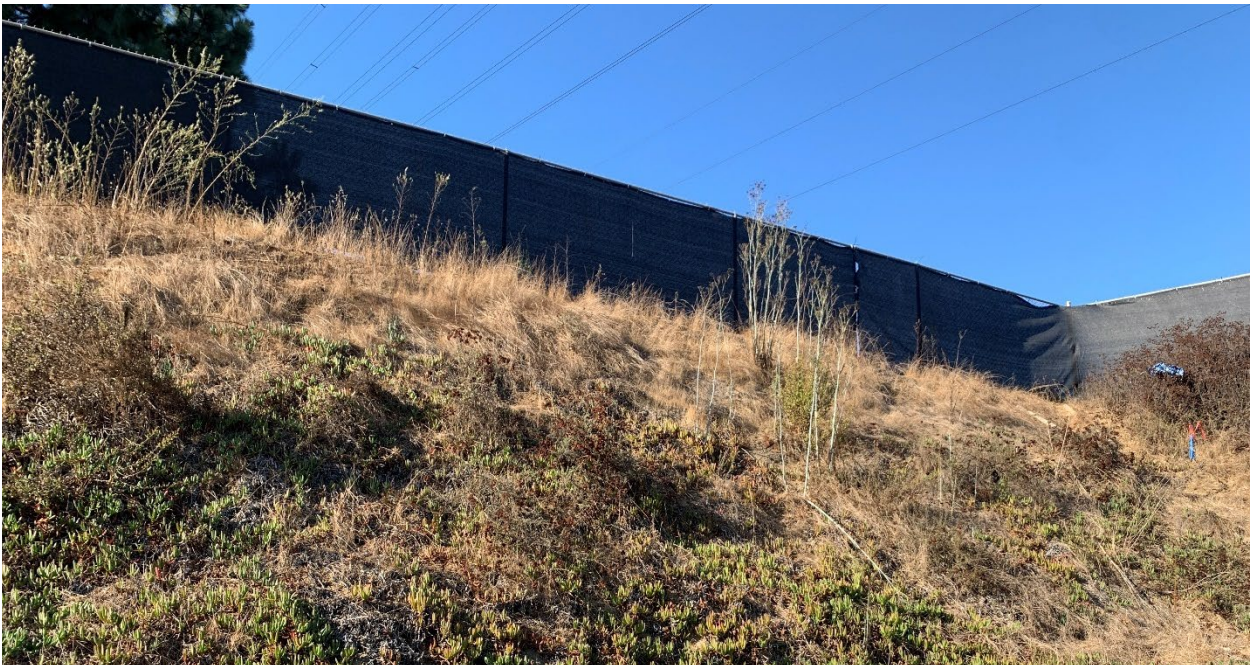
Photograph 16. View of the proposed cable tray installation location on norther slope from the auto body shop, facing Southeast

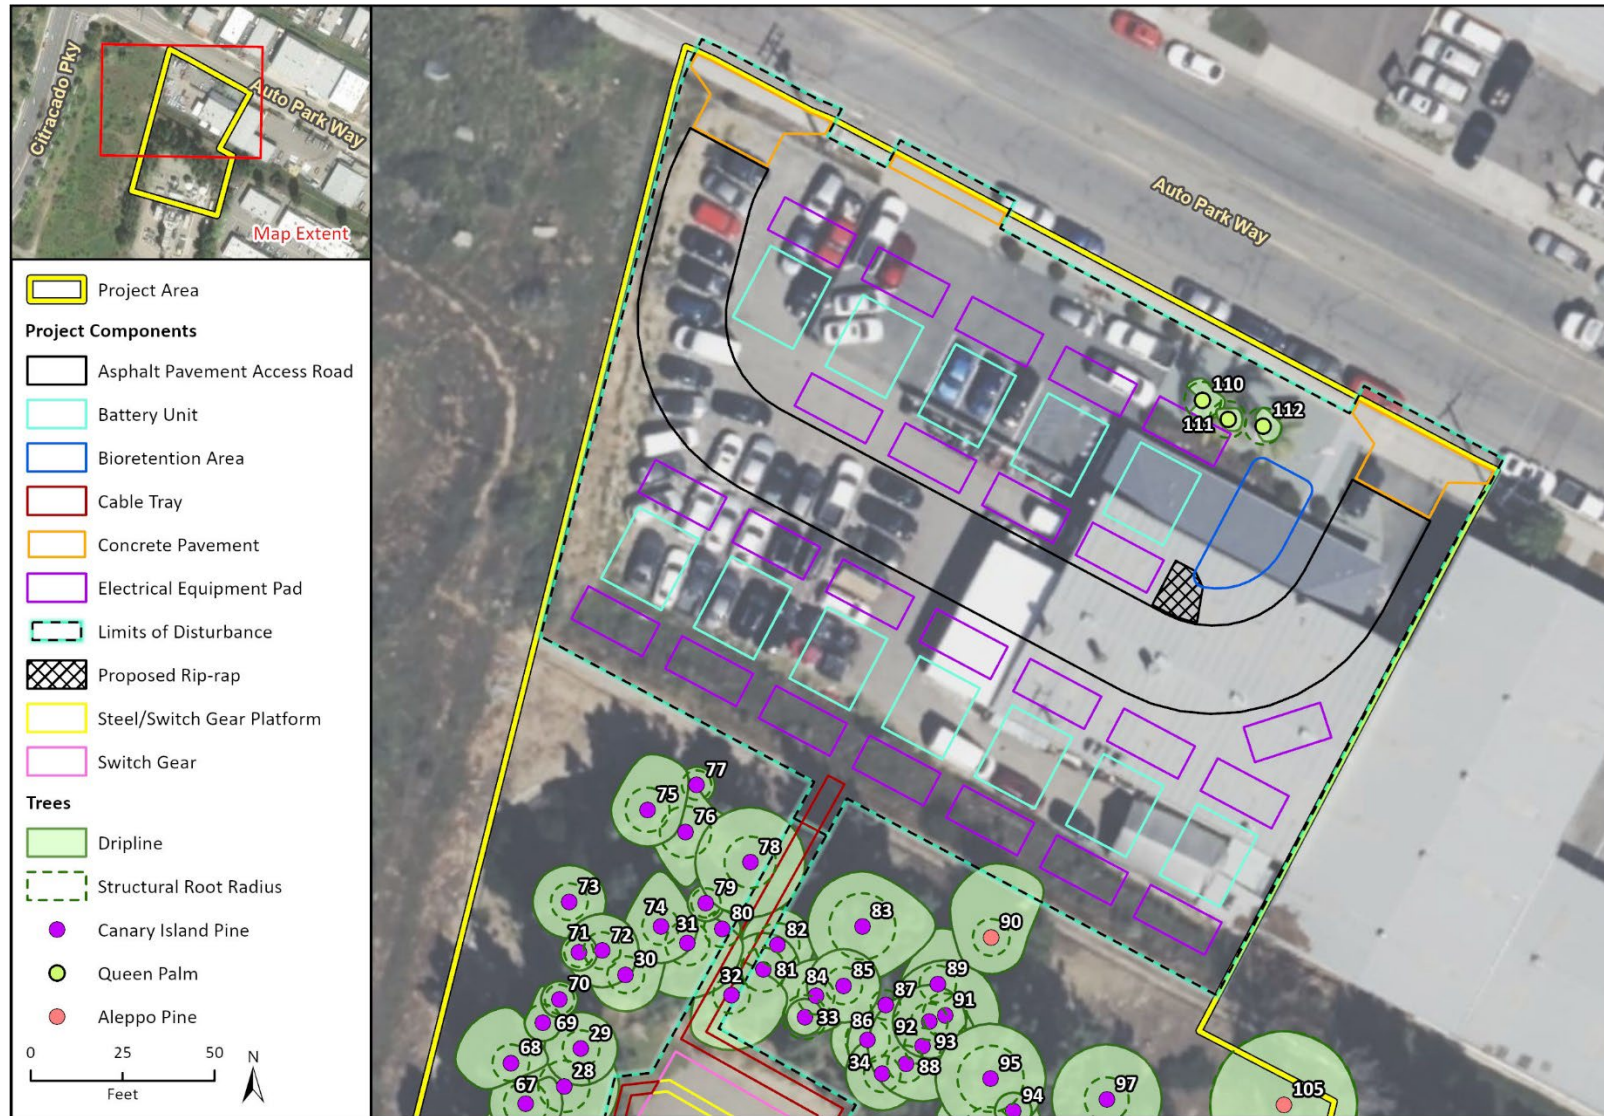
Figure 4 Tree Impacts – North

Tree Number	Species	Aggregate DBH (in)	Protection Class	Anticipated Impact Severity	Removal Required?	Proposed or Potential Impact Description
27	Canary Island Pine	16	Mature	Minor	No	Cable Tray
28	Canary Island Pine	16	Mature	Minor	No	
31	Canary Island Pine	13	Mature	Substantial	Yes	
32	Canary Island Pine	12	Mature	Substantial	Yes	
78	Canary Island Pine	16	Mature	Substantial	Yes	
80	Canary Island Pine	11	Mature	Severe	No	
81	Canary Island Pine	14	Mature	Substantial	Yes	
82	Canary Island Pine	13	Mature	Substantial	Yes	
90	Aleppo Pine	12	Mature	Minor	No	Electrical Equipment Pad on North Parcels
110	Queen Palm	11	Mature	Substantial	Yes	
111	Queen Palm	12	Mature	Substantial	Yes	
112	Queen Palm	12	Mature	Substantial	Yes

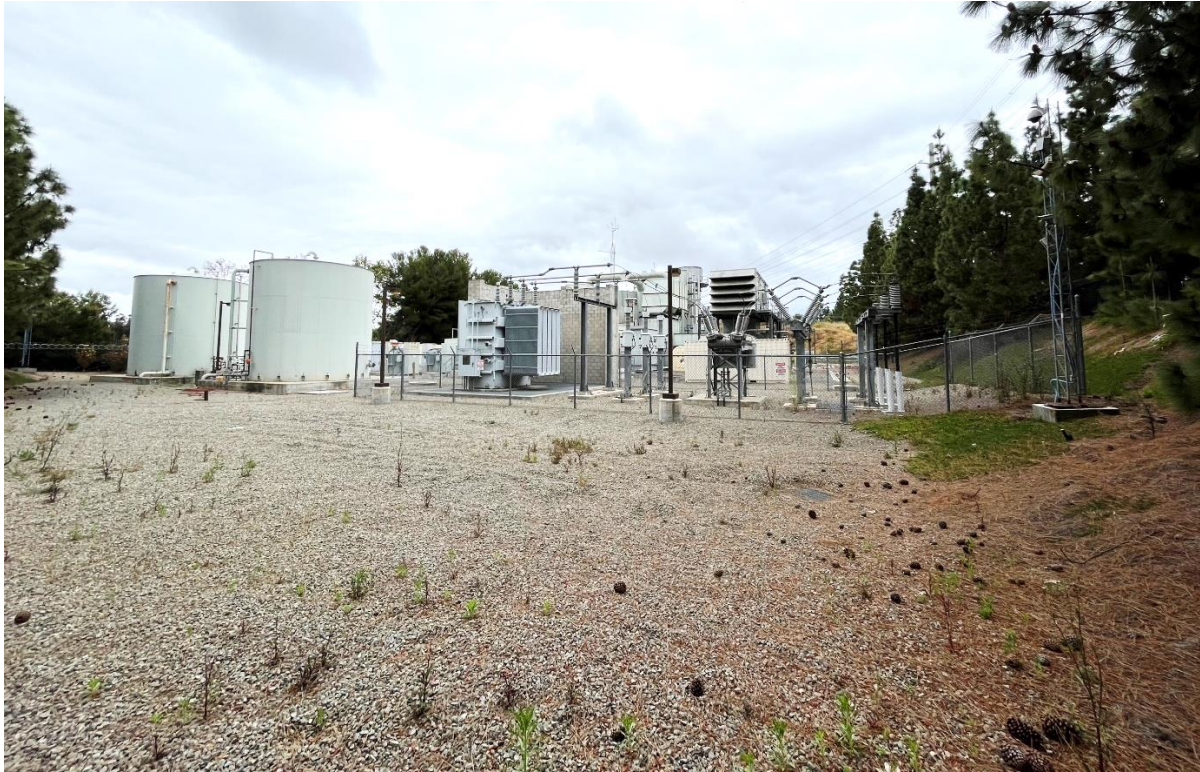
Photograph 1 Overview of Switchyard/Interconnection Area on Northern Portion of EEPP Facility, View Looking South

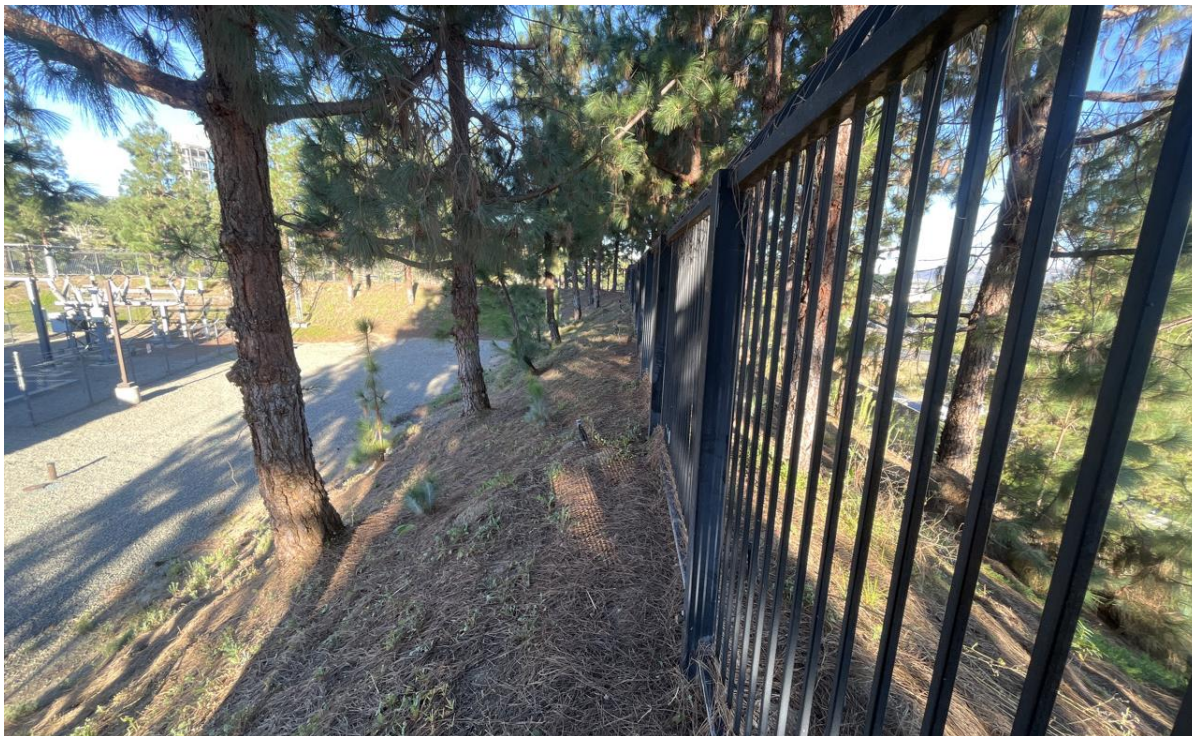
Photograph 4 Overview of Central Portion of Project Area, View East from Hillside North of EEPP Facility where Aboveground Gen-tie on Cable Tray is Proposed

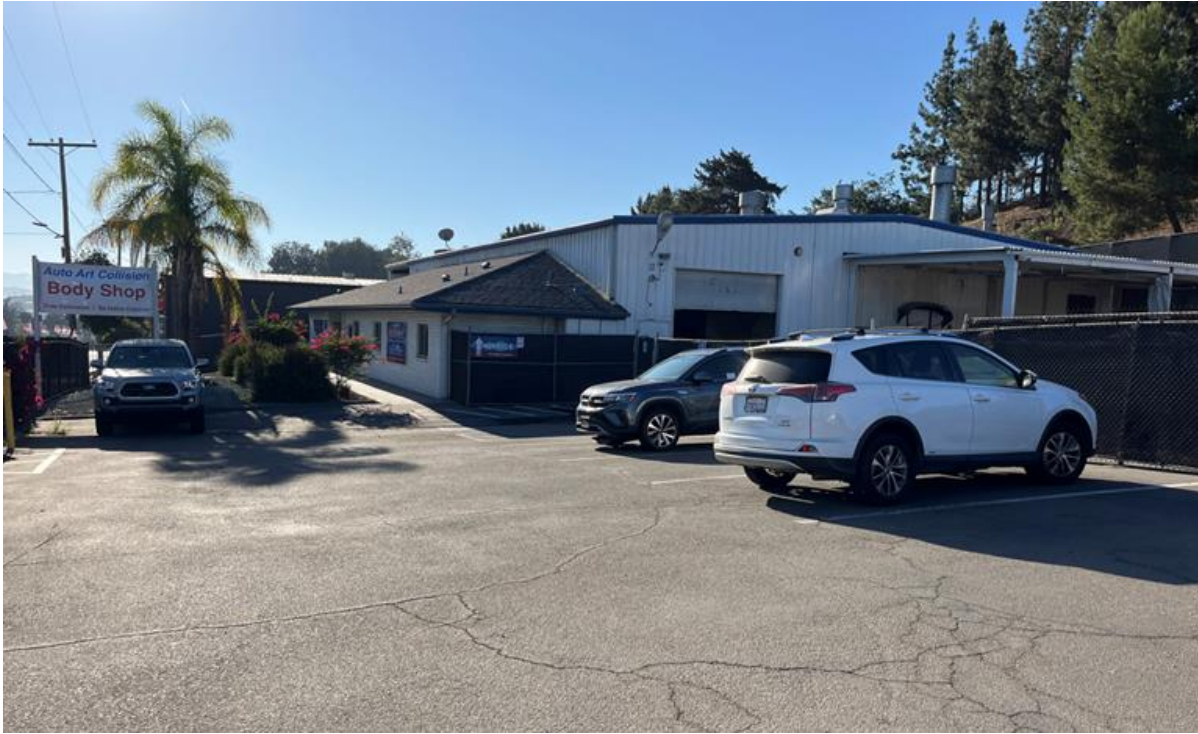
Photograph 9 2361 Auto Park Way North and West Elevations, View Southeast from Northwest Corner of Property

2361 Auto Park Way sits on the south side of Auto Park Way in the northwest portion of the City of Escondido. Before the 1960s, the area was rural and developed with agricultural properties; however, after World War II and the expansion of the suburbs and automobile use, the surrounding area developed with commercial and industrial properties. In 1971, Dr. Lionel and Marilyn Burton and Charles and Dorothy Helferich purchased the subject property (TRC Environmental Corporation 2025). In 1973, Tacoma Wheel Inc. leased the property from the owners and constructed the extant commercial building with the front commercial space and rear repair shop originally addressed as 2361 Vineyard Avenue (*Daily Times-Advocate* 1973a).

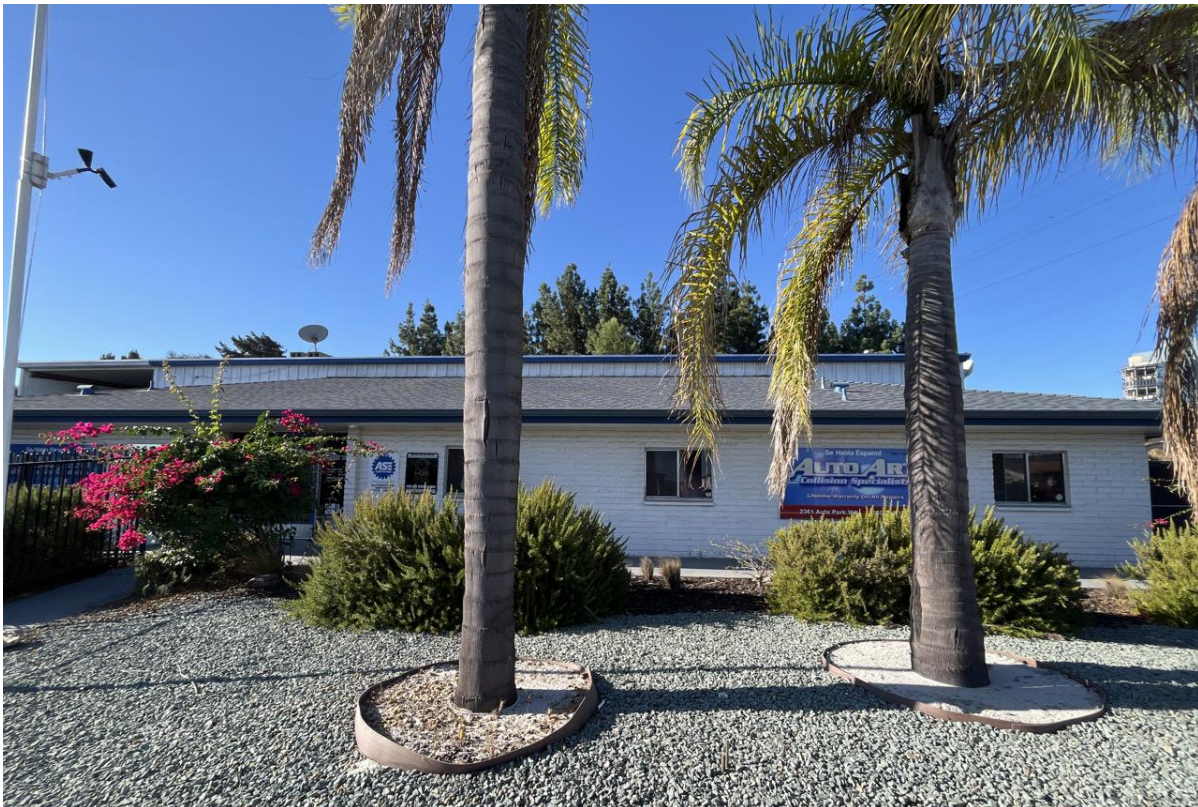
Photograph 10 2361 Auto Park Way North Elevation, View South from Front of Property

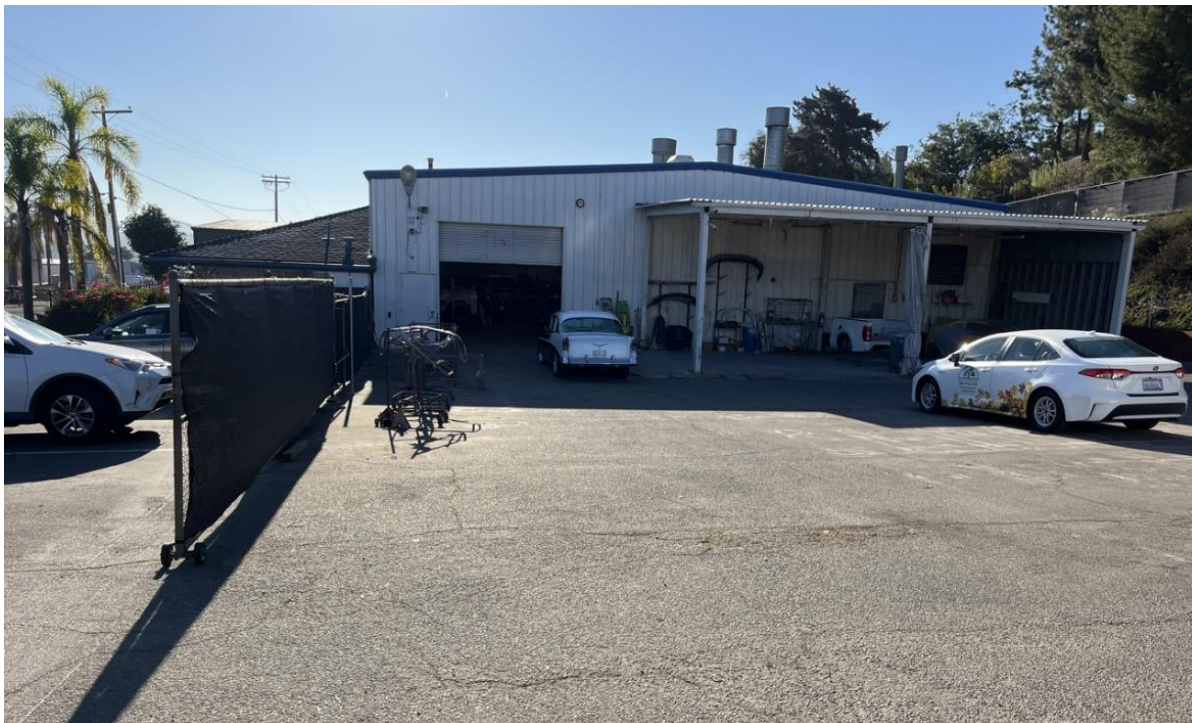
Photograph 11 2361 Auto Park Way West Elevation, View East from Western Edge of Property

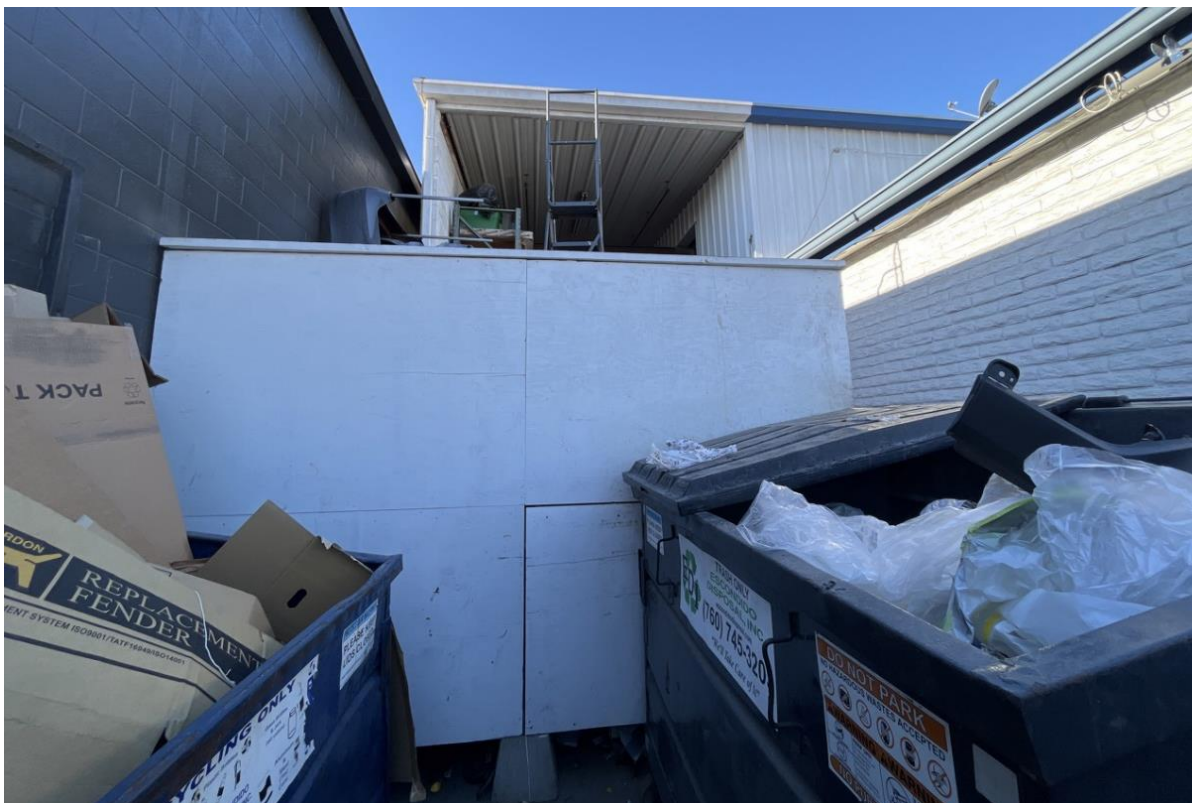
Photograph 12 2361 Auto Park Way East Elevation, View South from Southeastern Corner of Property

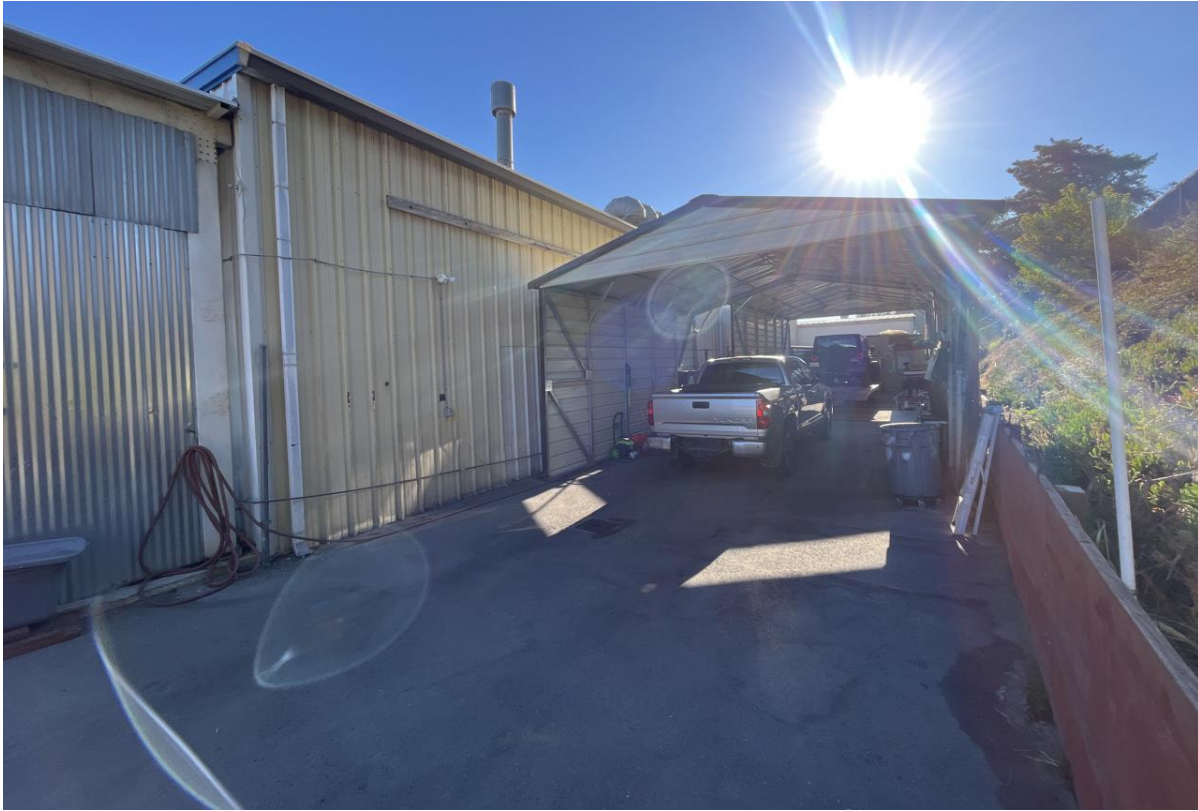
Photograph 13 2361 Auto Park Way South Elevation, View Northeast from Northcentral Portion of Project Area

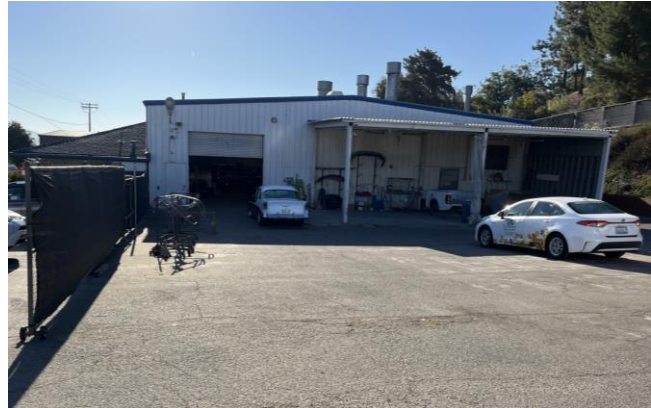
Photograph 3: West elevation showing rear repair shop of building and carport addition, view east.

The rear portion of the building is a repair shop constructed of steel framing and clad in sheets of corrugated metal. This portion of the building has a low-pitched side gable roof, and this portion of the building is slightly taller than the front, public-facing storefront. The west elevation has two openings towards the northern end of the elevation: an entrance with a flush metal door and a large opening for cars to enter the repair shop with a roll-up metal door (Photograph 11). A carport addition was constructed to the southern end of the west elevation between 1995 and 1996. Capped with a flat roof clad in sheets of corrugated metal, the carport is constructed of steel framing and enclosed with sheets of corrugated metal at the south elevation.

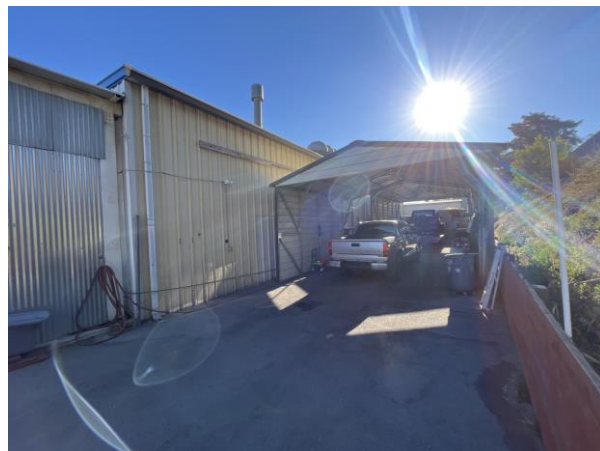
Photograph 5: South elevation and two detached carports, view northeast.

The east elevation of the rear repair shop has an open porch which spans the length of the elevation (Photograph 12). The porch is capped by a flat roof clad in sheets of corrugated metal. The southern elevation of the rear repair shop has no architecture features, though two detached steel-framed carports sit south of the south elevation adjacent to the hillside. Constructed between 1995 and 1996, the carports are capped with side gable roofs and enclosed with sheets of corrugated metal at the north, south, and east elevations (Photograph 13).
