**2024 ANNUAL CALIFORNIA ENERGY COMMISSION
INTERIM CONDITIONS OF COMPLIANCE REPORT**

**BOTTLE ROCK POWER, LLC
GEOTHERMAL FACILITY**

MAYACMA GEOTHERMAL LLC

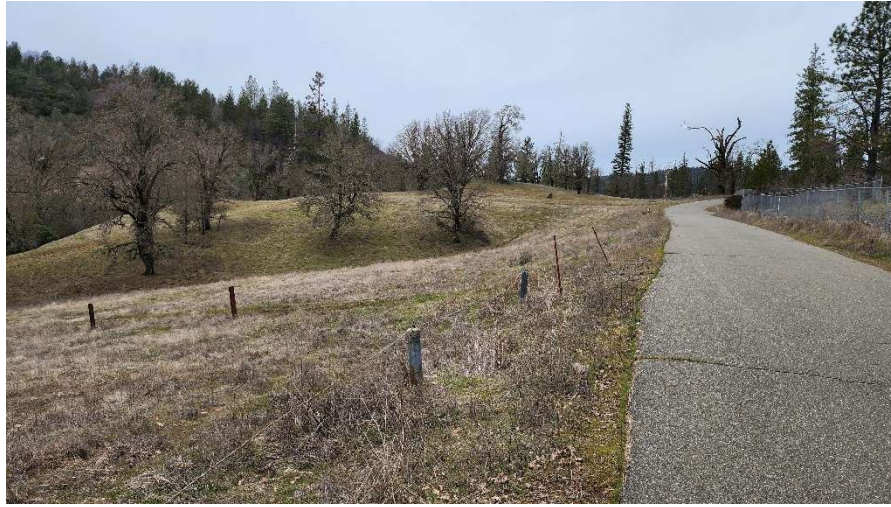
Photo 1: Lower re-seeded section of High Valley Road

High Valley Road: Photos of roads appear as they did in 2019. Outside of the minor clearance work described above, no additional work was performed in 2024. BRP will continue monitoring for changes.

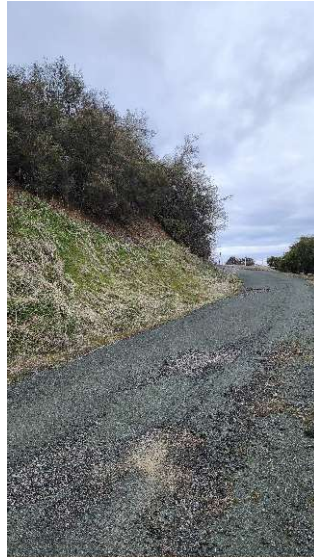
Photo 3: Area around West Coleman Road

West Coleman Road: Photos of roads appear as they in 2019. Drainage ditches, energy dispersers, culverts, inlets, outlets, and diversions were inspected, and the road surface was clear. No further work was indicated or performed for 2024.

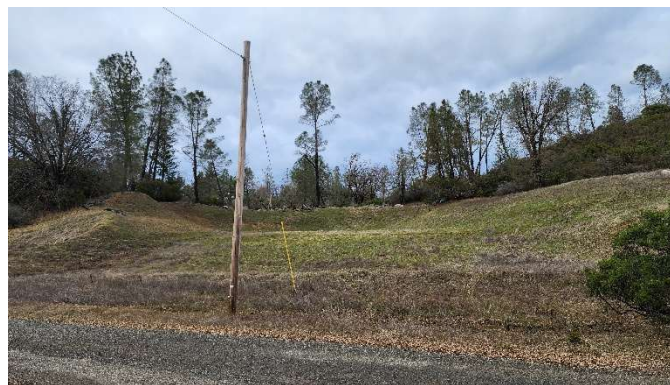
Photo 4: Area around Francisco Spoils

The Francisco Spoils Pile and Steam field yard sedimentation areas: Photos appear as they did in 2019. Area remains completely covered with growth; basin controls (inlets, outlets, diversions, weirs, spillways) were in good working order. No additional work was performed in 2024.

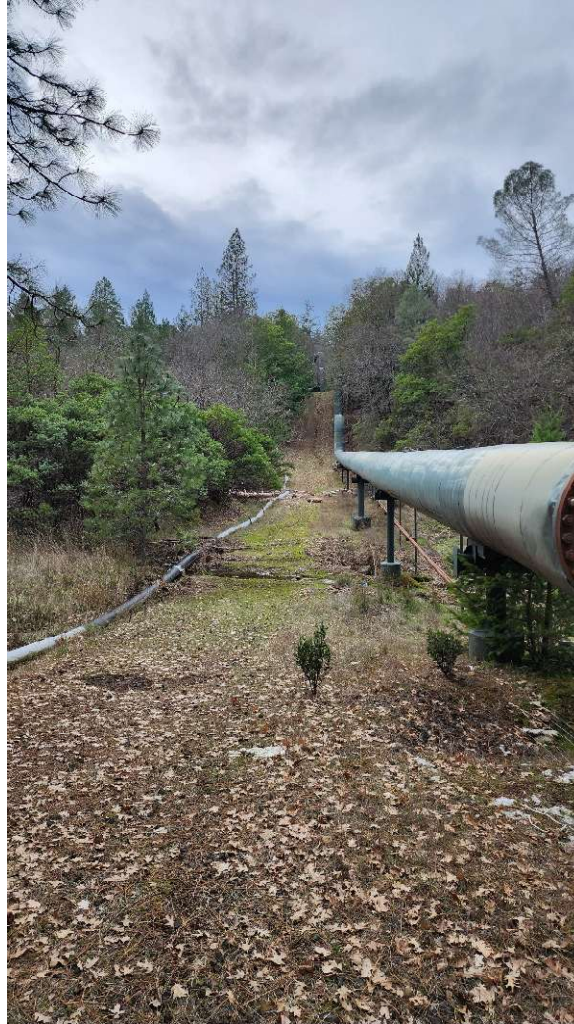
Photo 5: Injection Line Area

Re-Injection line: Photos of roads appear as they did in 2019. Additional anchoring supports installed in 2014 continued to prevent the line from expanding into the access road and stabilized the line on the roadway crossing Cow Creek. No additional work was performed in 2024.

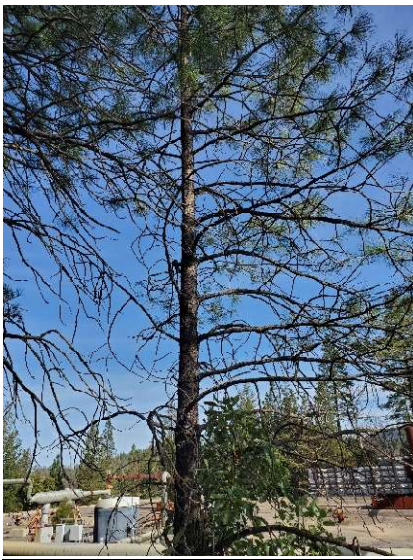
Photo 6: Tree A-1

There were no significant changes in tree health from 2019 to 2024, so photos of trees appear the same as they did in 2019. Since inter-pad access roads (asphalt and dirt) are not utilized as they were during operations, there are no emissions in the area to impact the adjacent vegetation. At the Coleman Pad and surrounding area, the trees in the area were in good health with new needle growth. Smaller trees in more sun-exposed slopes continue to exhibit some drought stress, indicated by reduced needle length and reduced needle density. The monitored trees (A-1 and A-2) both had bare bottoms (3/4 of trees), and the rest of the trees looked healthy with green pine needles. A-1 had a few brown needles peppered throughout, with normal lower canopy; shaded understory needle and branch shedding has continued A-1.

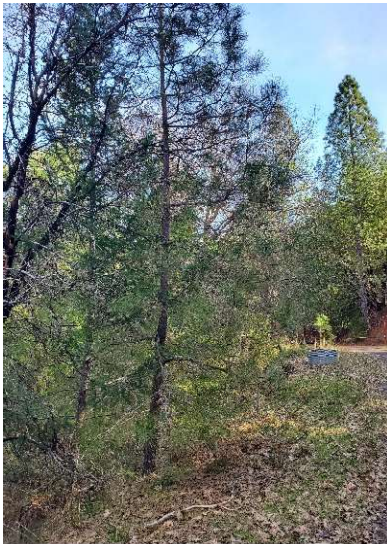
Photo 8: Tree B-1

There were no significant changes in tree health from 2019 to 2024, so photos of trees appear the same as they did in 2019. Since inter-pad access roads (asphalt and dirt) are not utilized as they were during operations, there are no emissions in the area to impact the adjacent vegetation. At the West Coleman Pad and surrounding area, the trees were in good health with new needle growth. Smaller trees in more sun-exposed slopes continue to exhibit drought stress, as indicated by reduced needle length and reduced needle density. The monitored trees varied in drought-related health. Trees designated as B-1 and B-2 are younger trees, showing some light needle browning at the tips of their needles. The tree designated as B-3 is a mature tree with no needle browning noted.

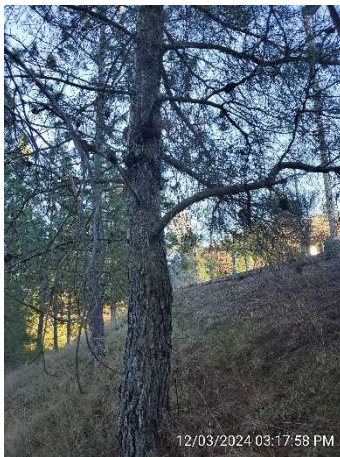
Photo 13: Tree D-1

There were no significant changes in tree health from 2019 to 2024, so photos of trees appear the same as they did in 2019. Since inter-pad access roads (asphalt and dirt) are not utilized as they were during operations, there are no emissions in the area to impact the adjacent vegetation. Near the main plant and surrounding area, the trees in the area are overall in good health. Smaller trees in more sun-exposed slopes exhibit drought stress, as indicated from reduced needle length, reduced needle density, and some needle tip burning. D-1 and D-2 on the uppermost slope with greatest sun exposure, are younger trees. No needle browning was noted. The tallest tree (D-3, > 10 meters) downslope on more shaded, level ground exhibited good new needle growth. Normal lower canopy, shaded understory needle and branch shedding has continued D-3. A photo was taken of adjacent tree to show healthy needle growth in this immediate area.
