# Data Response Set 2 (Responses to Data Requests A9 to A20)

Sutter Decarbonization Project (97-AFC-02C) March 2025

# **Aquatic Resources Delineation Report**

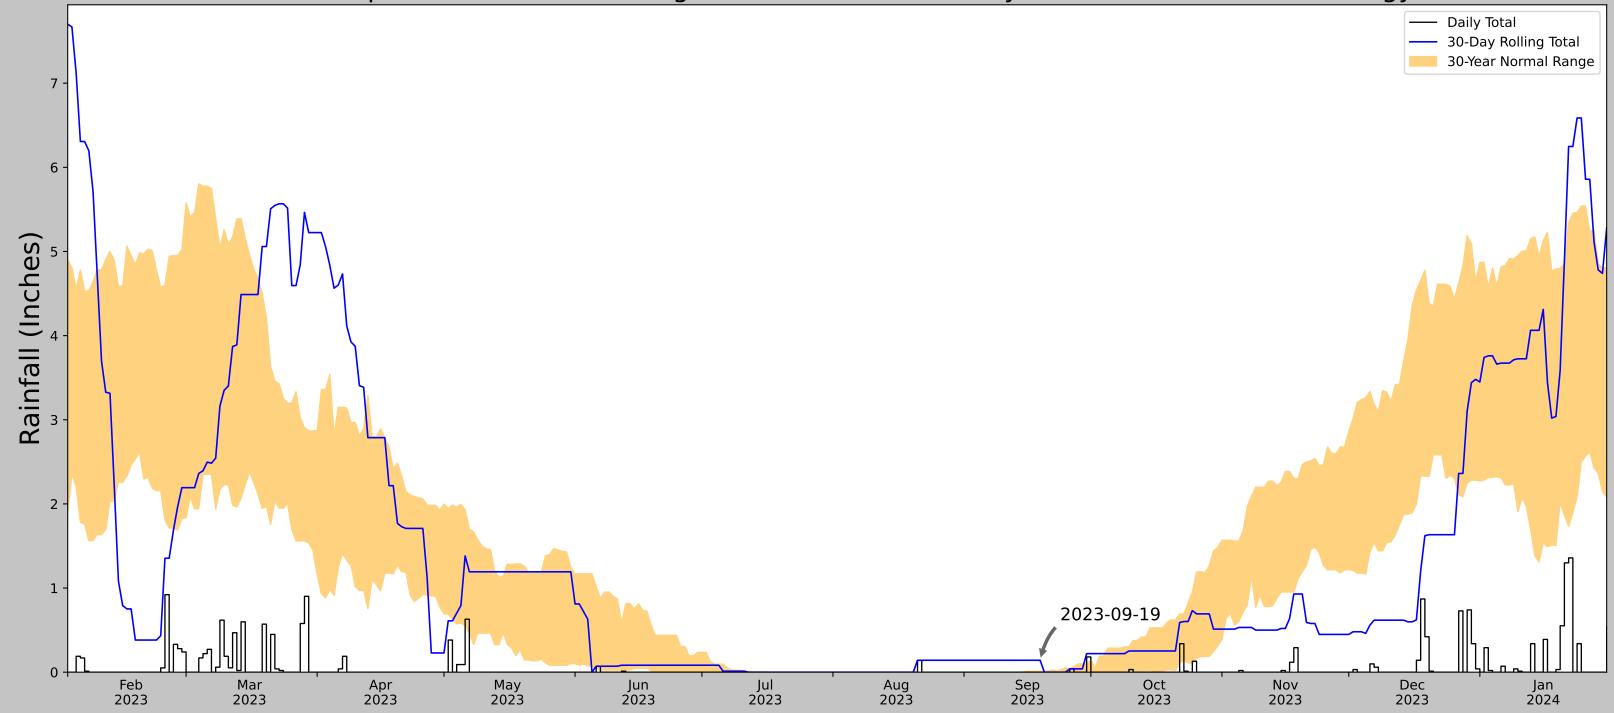
Coordinates	39.047035, -121.699742
Observation Date	2023-09-19
Elevation (ft)	40.087
Drought Index (PDSI)	Incipient wetness
WebWIMP H <sub>2</sub> O Balance	Dry Season

30 Days Ending	30 <sup>th</sup> %ile (in)	70 <sup>th</sup> %ile (in)	Observed (in)	Wetness Condition	Condition Value	Month Weight	Product
2023-09-19	0.0	0.011811	0.141732	Wet	3	3	9
2023-08-20	0.0	0.0	0.0	Normal	2	2	4
2023-07-21	0.0	0.0	0.0	Normal	2	1	2
Result							Wetter than Normal - 15

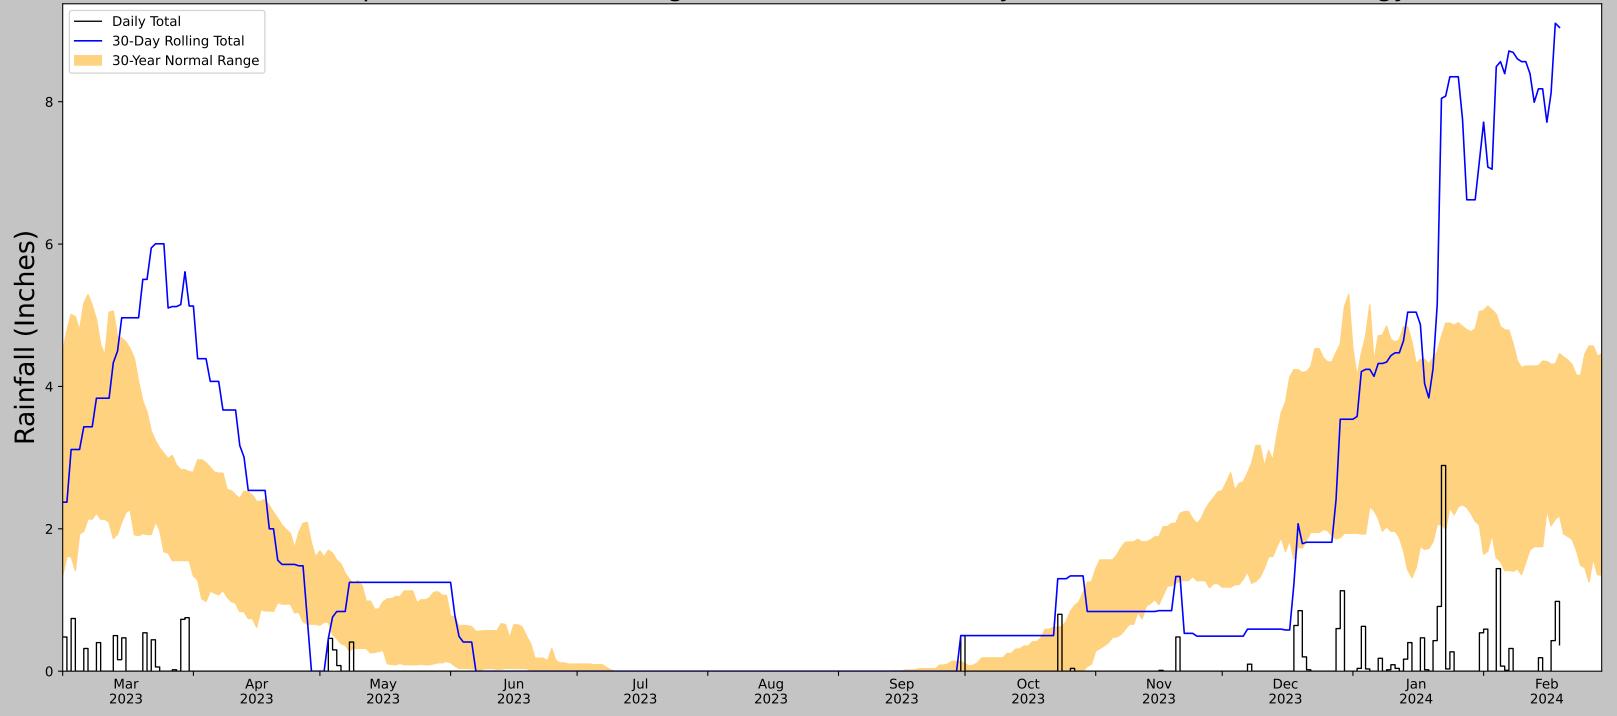
Coordinates	39.022763, -121.739217
Observation Date	2023-09-20
Elevation (ft)	41.338
Drought Index (PDSI)	Incipient wetness
WebWIMP H₂O Balance	Dry Season

30 Days Ending	30 <sup>th</sup> %ile (in)	70 <sup>th</sup> %ile (in)	Observed (in)	Wetness Condition	Condition Value	Month Weight	Product
2023-09-20	0.0	0.035039	0.0	Normal	2	3	6
2023-08-21	0.0	0.0	0.0	Normal	2	2	4
2023-07-22	0.0	0.0	0.0	Normal	2	1	2
Result							Normal Conditions - 12

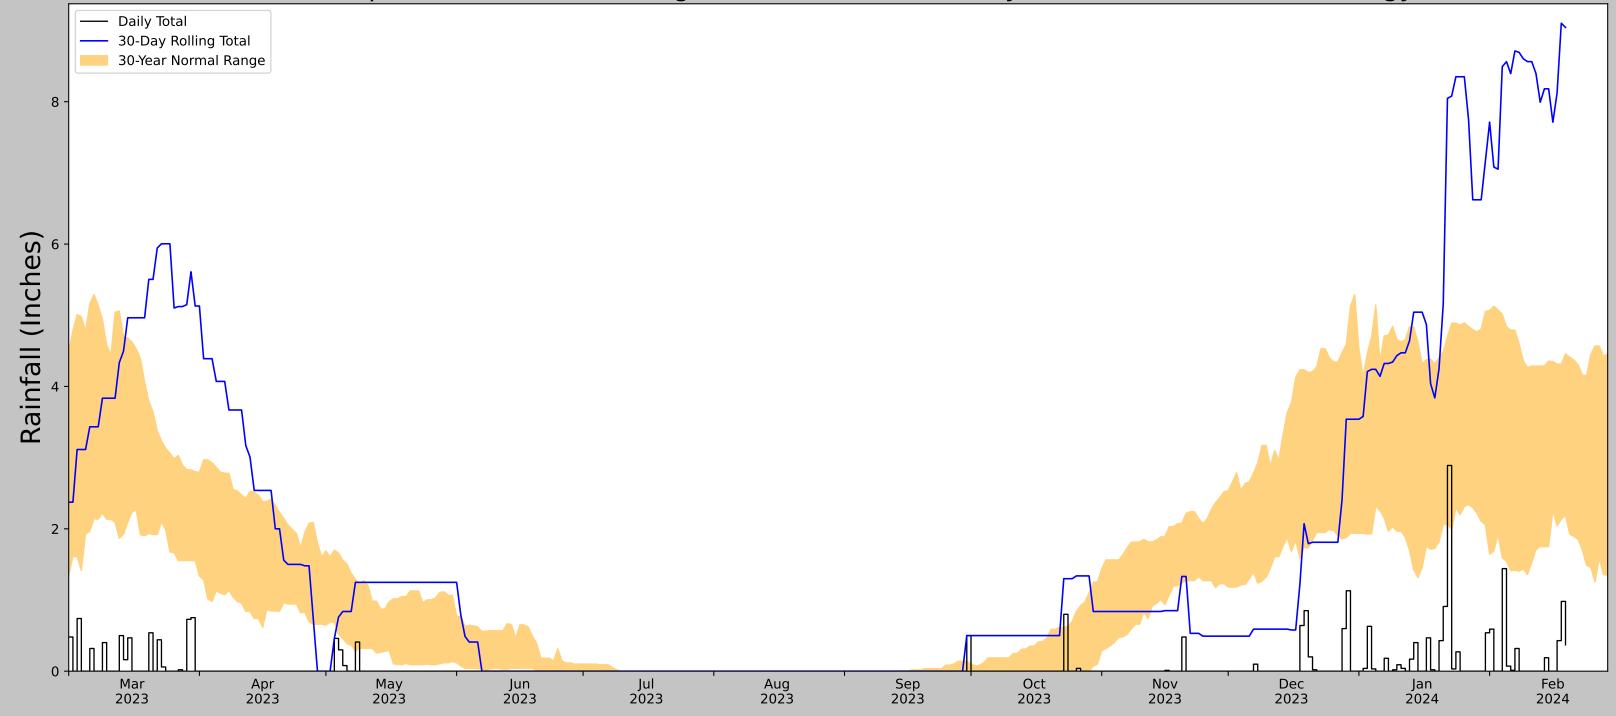
Coordinates	38.901747, -121.745767
Observation Date	2023-09-21
Elevation (ft)	21.021
Drought Index (PDSI)	Incipient wetness
WebWIMP H <sub>2</sub> O Balance	Dry Season

30 Days Ending	30 <sup>th</sup> %ile (in)	70 <sup>th</sup> %ile (in)	Observed (in)	Wetness Condition	Condition Value	Month Weight	Product
2023-09-21	0.0	0.035039	0.0	Normal	2	3	6
2023-08-22	0.0	0.0	0.0	Normal	2	2	4
2023-07-23	0.0	0.0	0.0	Normal	2	1	2
Result							Normal Conditions - 12

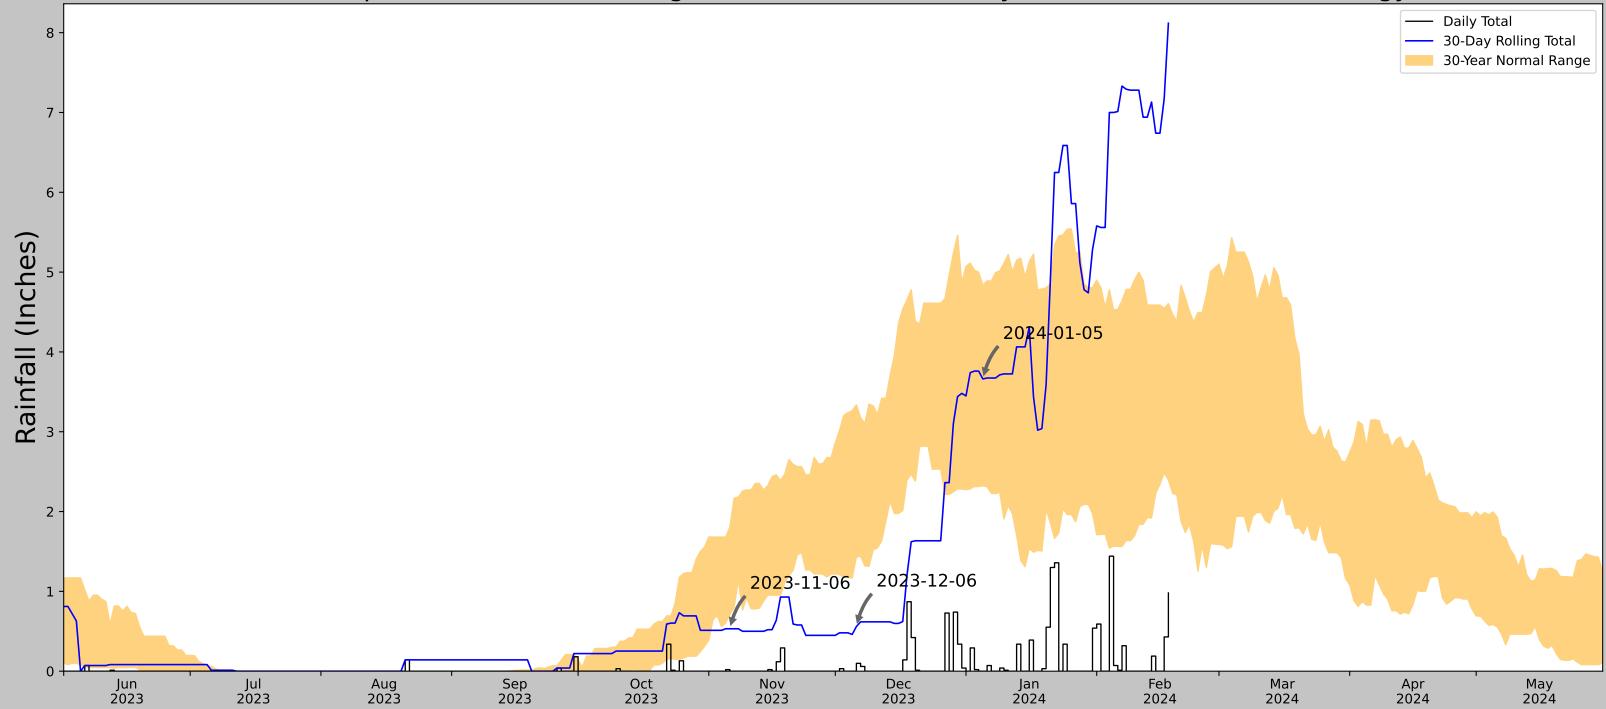
Coordinates	39.052517, -121.694901
Observation Date	2024-01-05
Elevation (ft)	41.261
Drought Index (PDSI)	Normal
WebWIMP H <sub>2</sub> O Balance	Wet Season

30 Days Ending	30 <sup>th</sup> %ile (in)	70 <sup>th</sup> %ile (in)	Observed (in)	Wetness Condition	Condition Value	Month Weight	Product
2024-01-05	2.322835	4.834646	3.661417	Normal	2	3	6
2023-12-06	1.428347	3.337402	0.559055	Dry	1	2	2
2023-11-06	0.711417	1.807087	0.531496	Dry	1	1	1
Result							Drier than Normal - 9

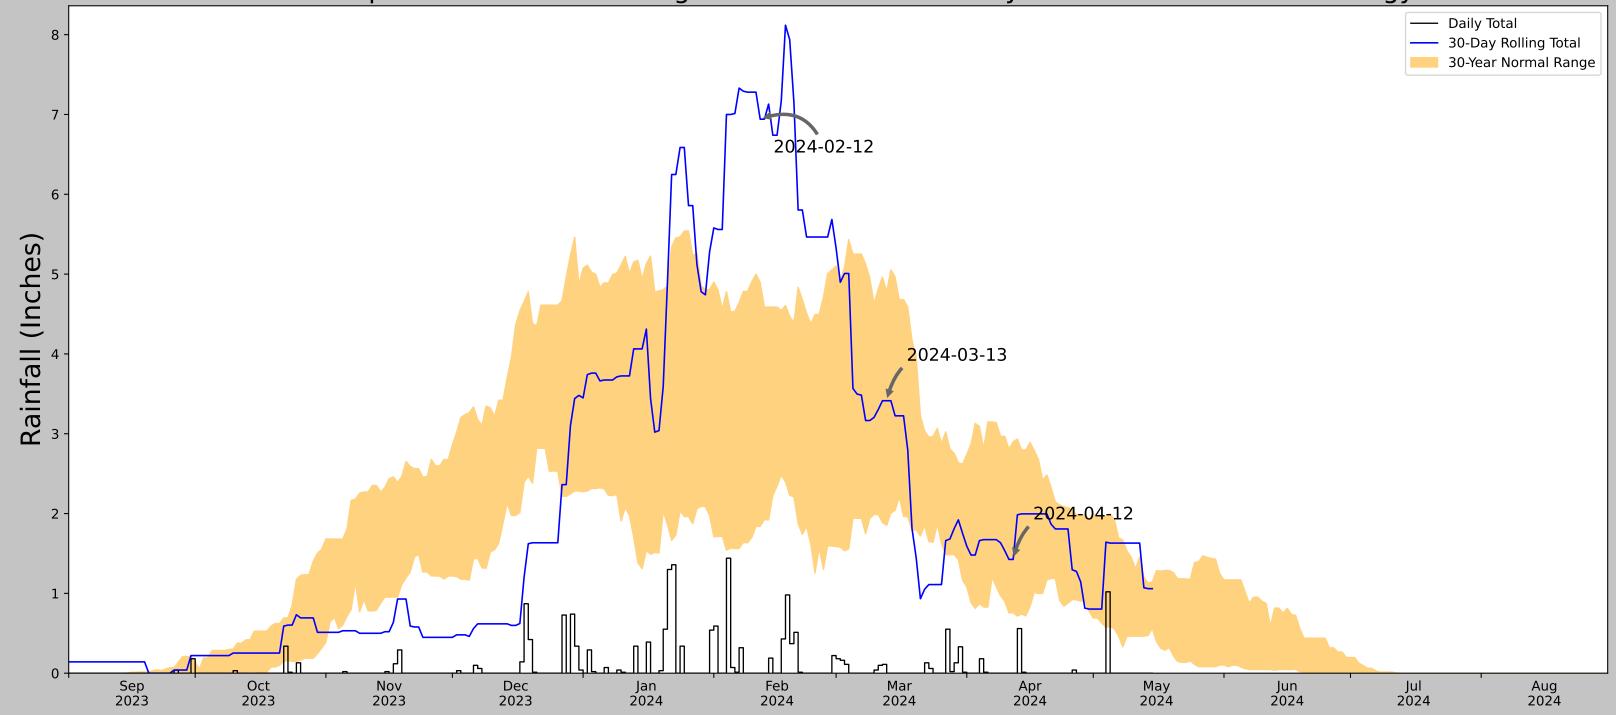
Coordinates	39.05128, -121.693056
Observation Date	2024-04-12
Elevation (ft)	39.474
Drought Index (PDSI)	Incipient wetness
WebWIMP H <sub>2</sub> O Balance	Dry Season

30 Days Ending	30 <sup>th</sup> %ile (in)	70 <sup>th</sup> %ile (in)	Observed (in)	Wetness Condition	Condition Value	Month Weight	Product
2024-04-12	0.756299	2.898425	1.425197	Normal	2	3	6
2024-03-13	1.85315	4.78189	3.413386	Normal	2	2	4
2024-02-12	1.83937	4.896063	6.940945	Wet	3	1	3
Result							Normal Conditions - 13

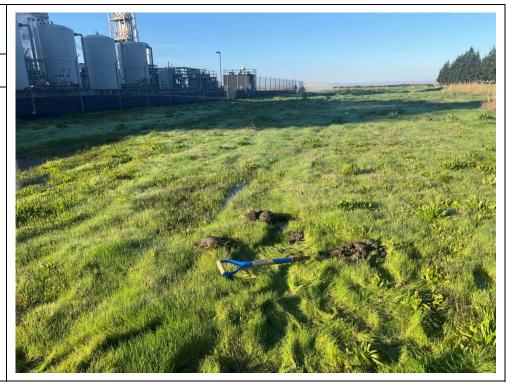
Description:
View of sample
point SEC-1. This
area had shallow
ponding at the time
of survey but lacked
hydric soils. No
aquatic resources
were delineated in
this location. Photo
taken facing west.

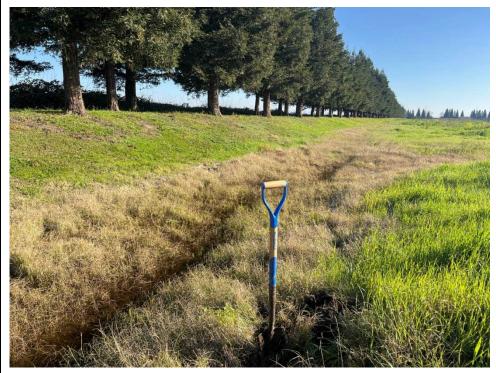
Description: View of sample point SEC-2 located in a swale on the western side of the Sutter Energy Center. This swale had shallow ponding at the time of survey but lacked hydric soils and hydrophytic vegetation. No aquatic resources were delineated in this location. Photo taken facing east.

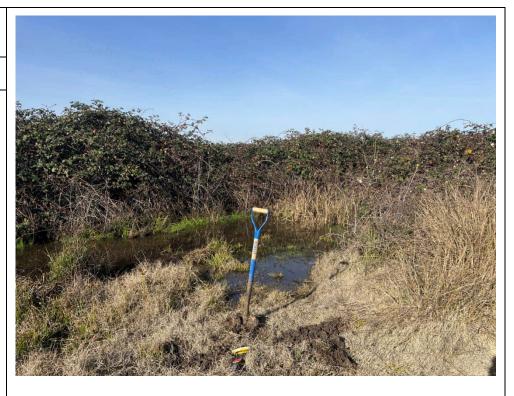
Photo ID: 4

View of sample point SEC-3 located in a shallow ditch on the western side of the Sutter Energy Center. This ditch had shallow ponding at the time of survey but lacked hydric soils and hydrophytic vegetation. The ditch was delineated as non-wetland waters based on indicators of an ordinary high water mark (OHWM). Photo taken facing northwest.

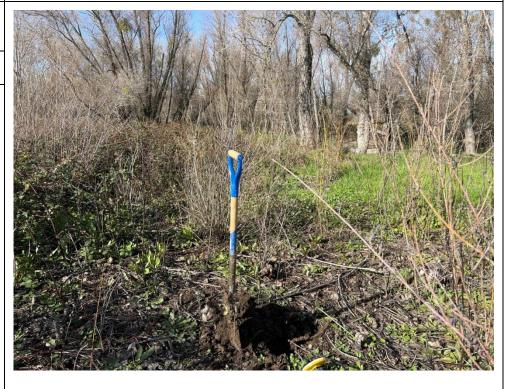
Description: View of sample point SEC-4 located in a shallow, abandoned process water treatment pond. The pond had wetland hydrology and was dominated by hydrophytes but lacked hydric soils. The pond was delineated as nonwetland waters based on indicators of an OHWM. Photo

taken facing north.

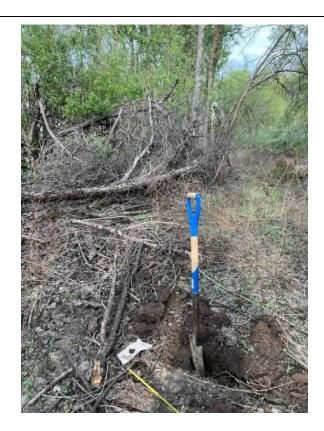
View of sample point SEC-6 in abandoned process water treatment pond. The pond was inundated in January 2024. The wetland sample point established in April 2024 lacked hydric soil indicators. The pond was delineated as non-wetland waters based on indicators of an OHWM. Photo taken facing southwest.

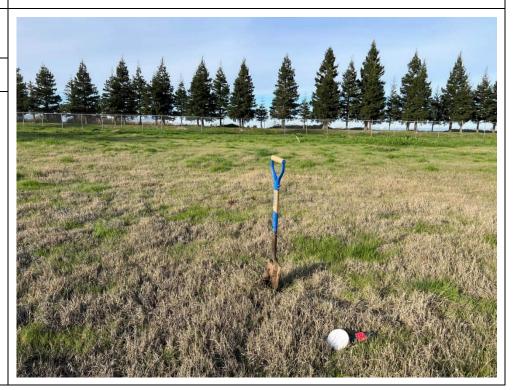
View of sample point SEC-5. This area had wetland hydrology at the time of survey but lacked hydric soils and hydrophytic vegetation. No aquatic resources were delineated in this location. Photo taken facing north.

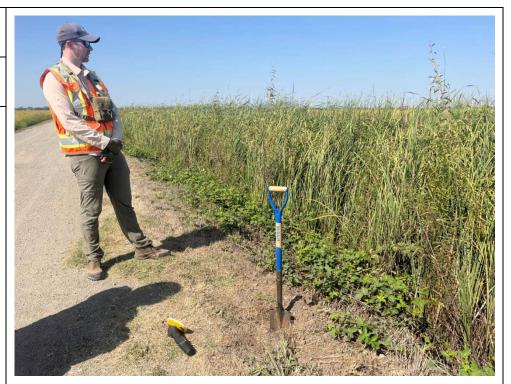
View of sample point SP-1. The sample point was established in the ditch to the right of the shovel. The sample point had wetland hydrology and hydrophytic vegetation but lacked hydric soils. The ditch was delineated as non-wetland waters based on indicators of an OHWM. Photo taken facing northwest.

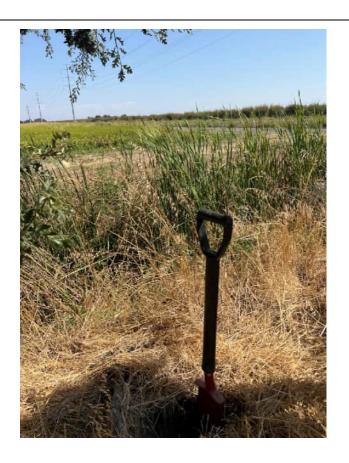
View of sample point SP-2. The sample point was established in the ditch behind the shovel. The sample point had wetland hydrology and hydrophytic vegetation but lacked hydric soils. The ditch was delineated as non-wetland waters based on indicators of an OHWM. Photo taken facing southeast.

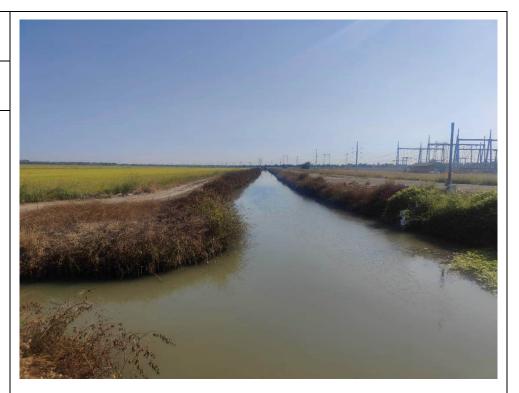
Photo ID: 10 Date: September 19, 2023

View of the Snake
River at the Obanion
Road crossing and
the location of the
OHWM-1 transect.
This riverine feature
is highly modified
and appears to
primarily convey
irrigation water.
Photo taken facing
south.

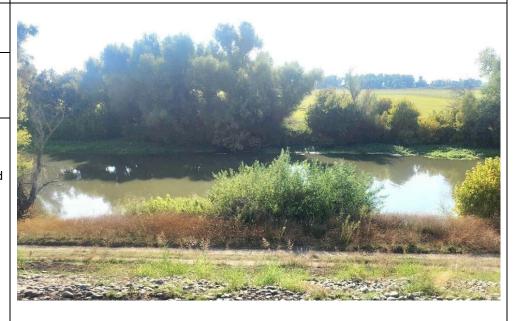
View of the channel on the east side of the Sutter Bypass and the location of the OHWM-2 transect. The OHWM was delineated based on a break in slope the elevation of mature trees. Photo taken facing west.

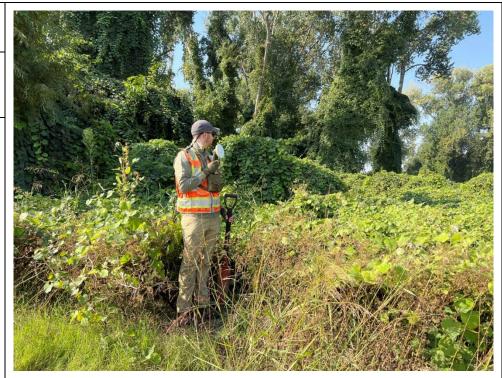
View of sample point SP-3. The sample point was established in riparian habitat on the west side of the Sutter Bypass. The sample point had wetland hydrology and hydrophytic vegetation but lacked hydric soils. Indicators of wetland hydrology were due to high flow events in the preceding wet season. No aquatic resources were delineated in this location. Photo taken facing west.

- Sample Point SP-3 was established in the Sutter Bypass in an area identified in the NWI as forested wetlands (Figures 3 and 4). This location was selected because it is representative of riparian habitat in the Sutter Bypass. The sample point had wetland hydrology and hydrophytic vegetation but lacked hydric soils. Indicators of wetland hydrology were due to high-flow events in the preceding wet season. No aquatic resources were delineated in this location.

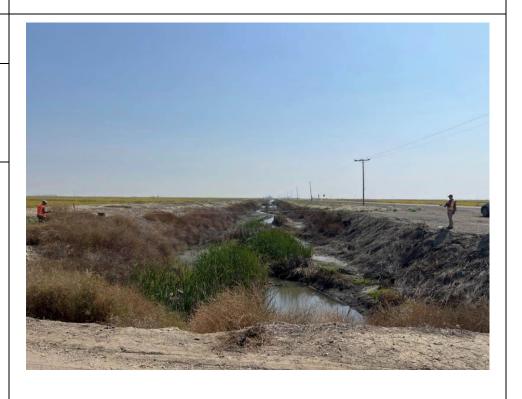
Description:
View of irrigation
canal at the
intersection of Tudor
Road and
Reclamation Road.
Photo taken facing
south.

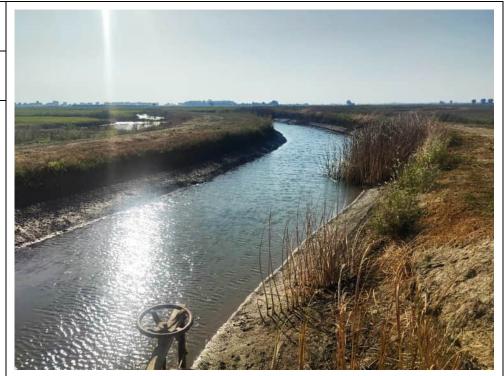
View of feature R-3. This feature appears to be a remanent of a natural channel that is now used to manage irrigation water. Photo taken facing southwest.

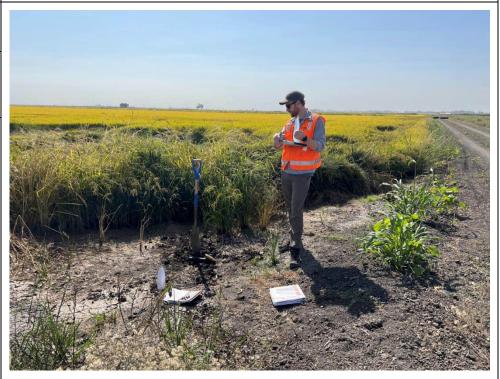
Photo ID: 14 Date: September 20, 2023

View of sample point SP-4 located on the margins of a rice field. This sample point had wetland hydrology and hydrophytic vegetation but lacked hydric soils. Wetland hydrology was associated with seasonal flood irrigation. No aquatic resources were delineated in this location. Photo taken facing southeast.

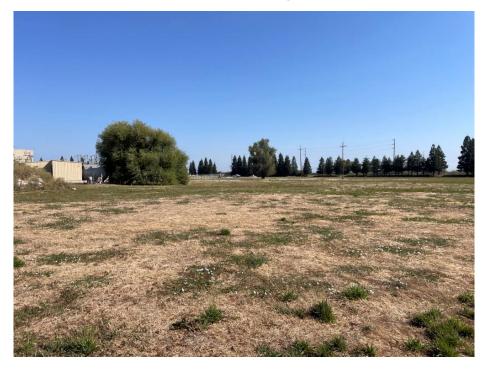
**Photo 1.** Non-native grasslands within the SEC facility following routine mowing. This area lacks suitable nesting substrate and has marginal foraging opportunities for Crotch's bumble bee in the form of bindweed (*Convolvulus arvensis*). September 2023.

The habitats within the proposed pipeline alignment and wells pads are dominated by intensive agriculture, which reduces the quality of habitat for species that Crotch's bumble bee rely on for nesting substrates in the form of burrows. Additionally, frequent flooding of agricultural fields, particularly for rice production, exclude the possibility of bees nesting within these portions of the Project footprint (Appendix A; Photos 2, 5, and 6). Similarly, riparian areas within the Project footprint, including those within the SEC site and those associated with the Sutter Bypass, are considered unsuitable nesting areas because of the lack of suitable nesting substrate. While ruderal and barren areas along the proposed pipeline alignment and within the SEC facility may contain potentially suitable burrows for nesting, because of vehicle traffic, routine mowing, proximity to irrigation canals with variable seasonally water levels, and proximity to disturbance associated with agricultural operations, it is highly unlikely Crotch's bumble bee would select nest sites in these small, narrow strips of potentially suitable habitat (Appendix A; Photos 1 and 3).

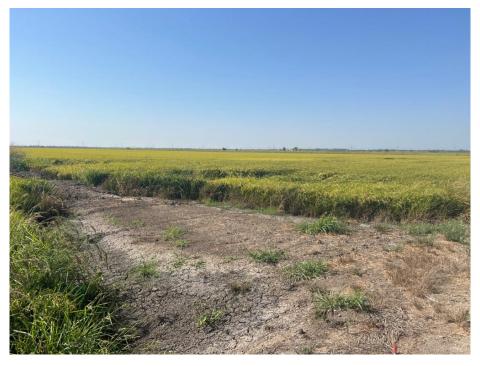
**Photo 2.** Rice fields and agricultural road southwest of SEC facility in the proposed pipeline alignment. Areas such as these lack foraging and nesting opportunities for Crotch's bumble bee. September 2023.

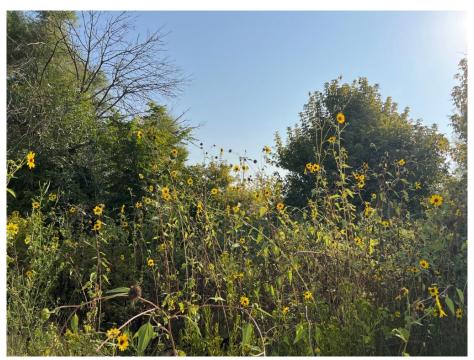
**Photo 3.** Ruderal and barren habitats along levee road by Sutter Bypass (left site of photograph). Marginally suitable nesting habitat on levee slope but burrows not observed. Riparian habitats on the right are unsuitable for nesting. September 2023.

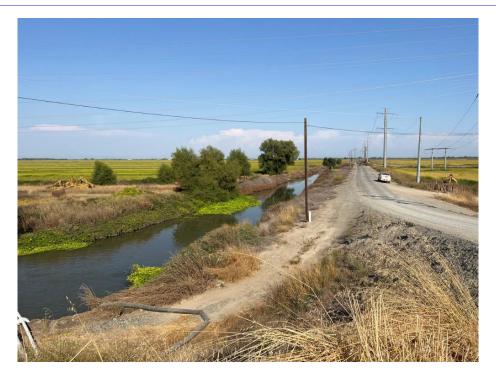
**Photo 5.** Irrigation canal and agricultural roads within Project footprint. These habitats are unlikely to support Crotch's bumble bee nesting because of limited burrows and high disturbance. September 2023.

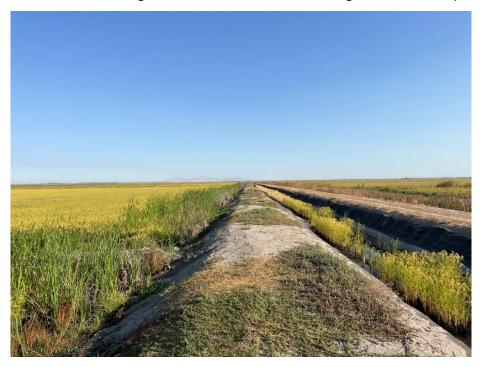
**Photo 6.** Barren and ruderal habitat along a berm between canal and rice fields. There are limited burrows and foraging resources along the berm itself. Seasonal inundation on either side of the berm likely excludes Crotch's bumblebee from nesting. September 2023.
