**Subject: PALEN SOLAR HOLDINGS, LLC'S SUPPLEMENTAL RESPONSE TO
CEC STAFF DATA REQUESTS 56
PALEN SOLAR ELECTRIC GENERATING SYSTEM
DOCKET NO. (09-AFC-7C)**

*Resource Name or # (Assigned by recorder) Desert Center District (P-BE-001)

*P11. Report Citation: (Cite survey report and other sources, or enter "none.") Class II and III Cultural Resources Survey Report for the Palen Solar Electric Generating System Riverside County, California AECOM 2013

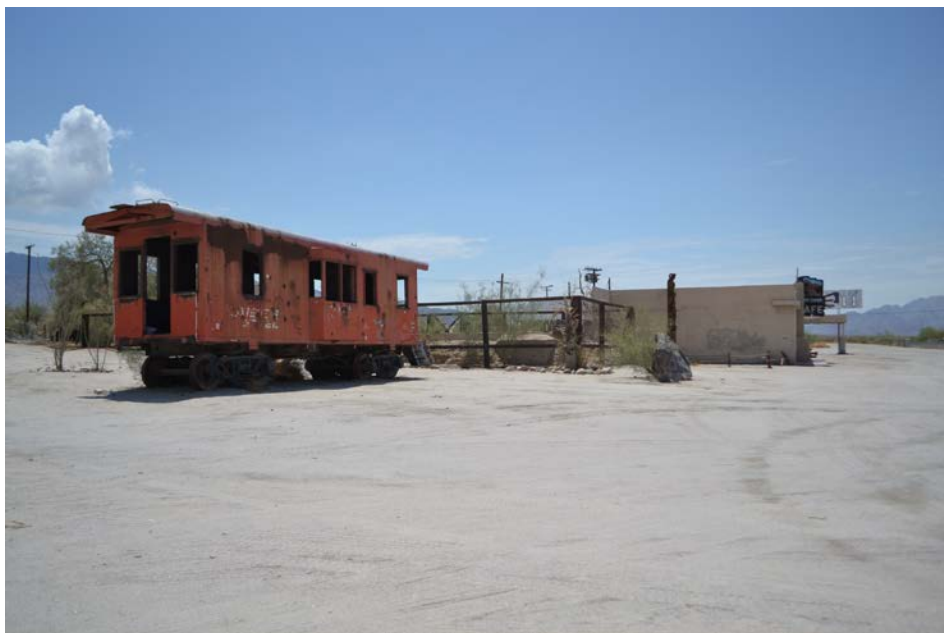
P5b. Description of Photo: (View, date, accession #) Camera facing SW, DSC 0814, 7/11/13

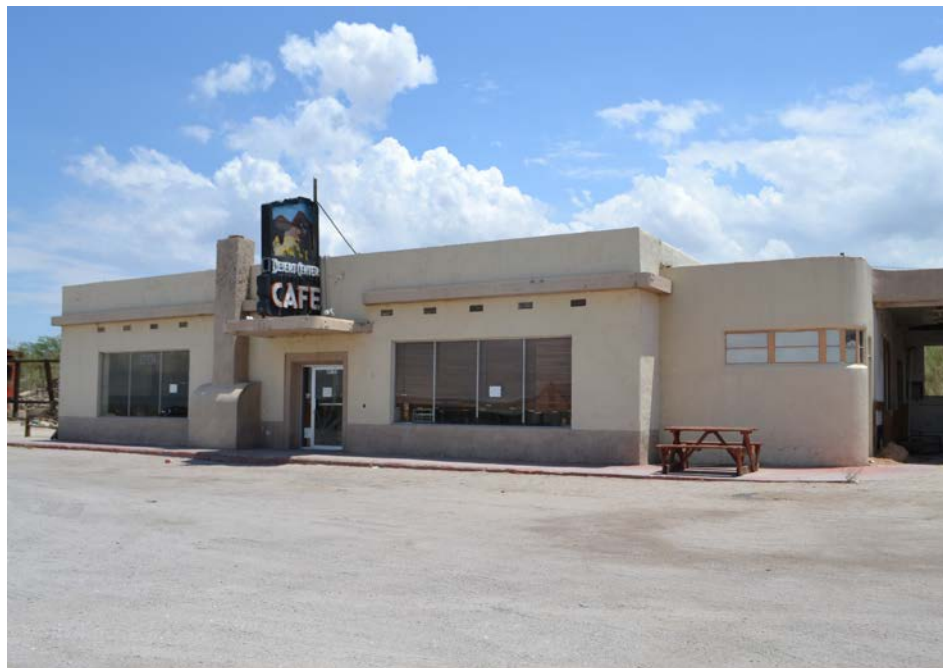
P5b. Description of Photo: (View, date, accession #) Photograph 2, Restaurant, camera facing southeast, 7/11/13

Parcel 808-102-007 contains a restaurant, garage/gas station, swimming pool. The adjacent and associated parcel contains three cabins. The restaurant, designed in the Art Moderne style features a flat roof, curved walls clad in stucco, and metal frame ribbon windows (**Photograph 2**). The primary entrance is set with single-entry aluminum frame glass door with a sidelight. Above the entrance is a flat roof extension and a neon sign that reads "Desert Center Café."

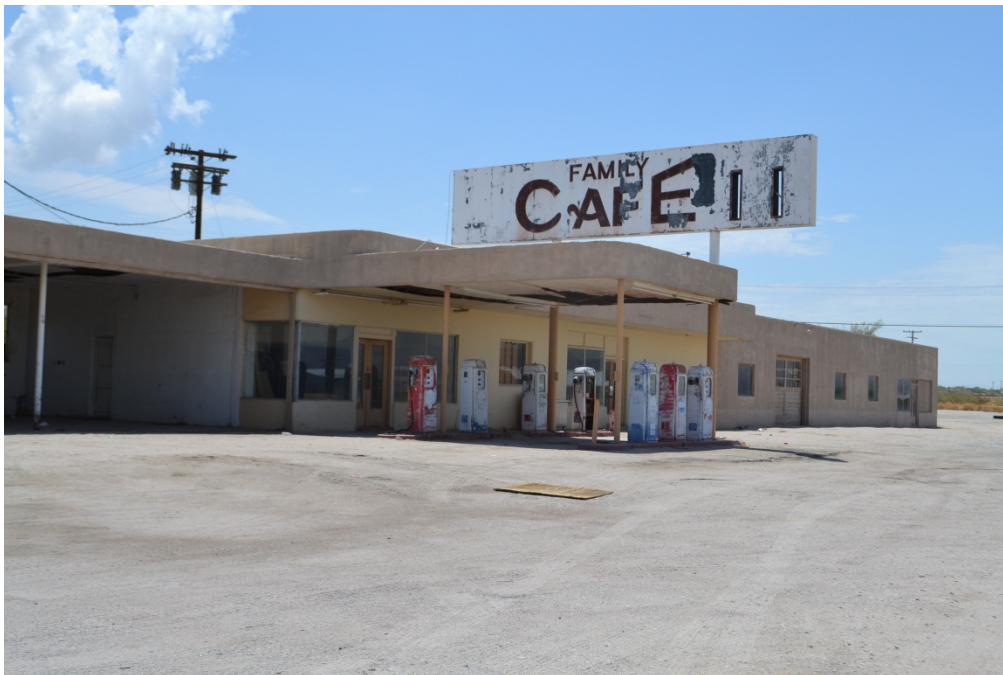
Photograph 3. Desert Center Cafe Gas Station/Garage

Connected to the café on its west elevation is a garage/gas station (**Photograph 3**, see following Continuation Sheet). Connecting the two buildings are two bays with a flat roof, open on its north elevation and featuring metal frame windows. Most of the panes of glass are missing. (See following Continuation Sheet)

The gas station/garage has similar design elements as the café, with rounded walls, stucco siding and a flat roof. Windows are fixed aluminum frame. The entrances on the north elevation are set with glazed wood, double doors. The original gas pumps are sheltered by a flat roof extension supported by round steel posts. The garage portion of the building has wood tilt-up doors with metal framed windows on the north and west elevations.

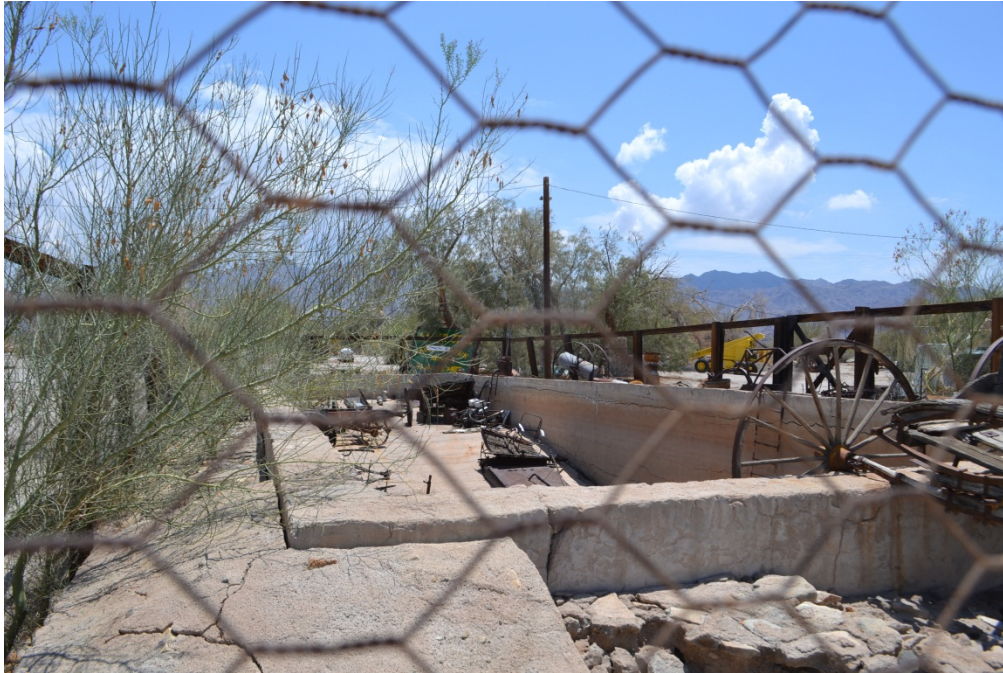
Photograph 4. Swimming pool

East of the gas station/garage and the café is a swimming pool (**Photograph 4**), It is concrete lined, rectangular in plan and now filled with debris and no water.

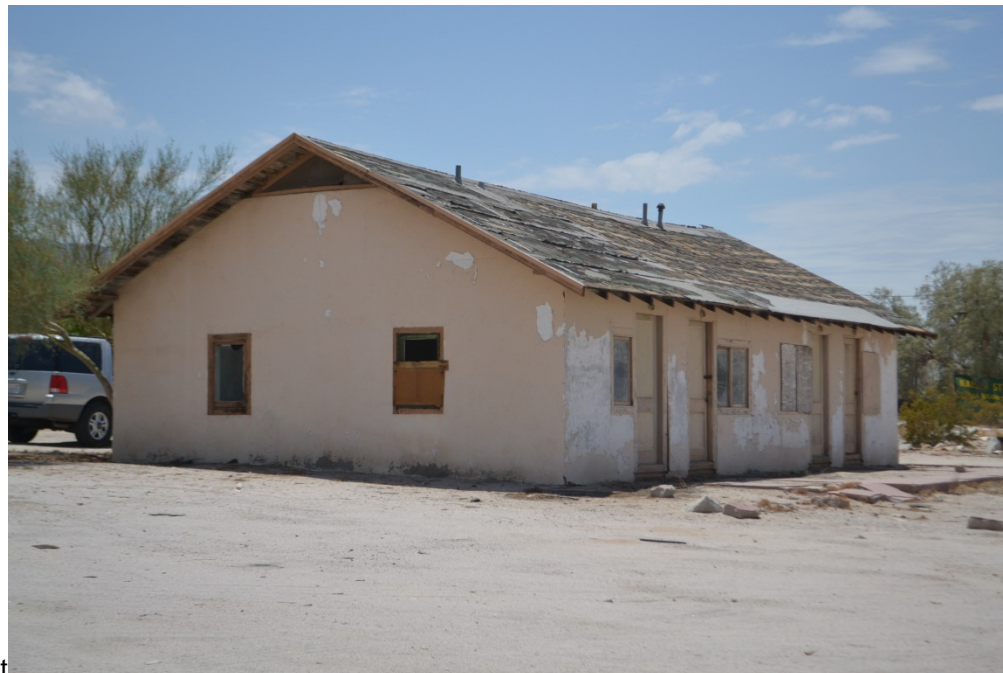
Photograph 5. Cabin to southeast of the Desert Center Café

On the adjacent eastern parcel are three cabins (**Photograph 5**) that are southeast of the café and gas station/garage. Each one is rectangular in plan with a front-gable roof, stucco siding, single entrance on the west elevation. Beneath the gables are louvered wood vents. Windows are metal frame and most are missing their glazing or are covered by wood. Each entrance has a shed roof extension that shelters a concrete stoop porch. All are missing their doors.

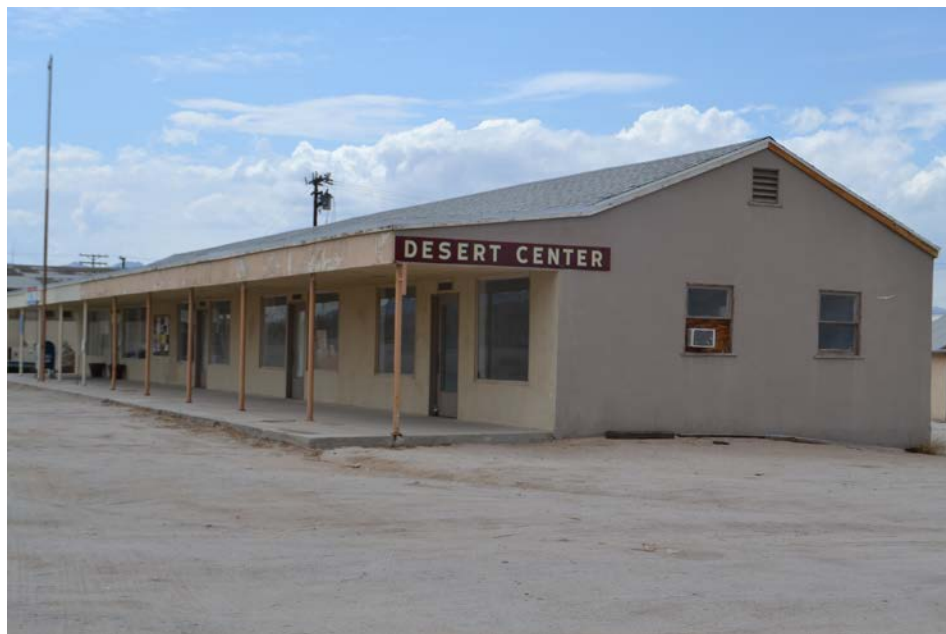
P5b. Description of Photo: (View, date, accession #) Photograph 6, camera facing NW, DSC 0962, 7/11/13

The Desert Center Post office is a long rectangular building with a side gabled composition roof. It features stucco siding, casement and fixed pane windows and single entry doors. A shed roof porch supported by metal posts shelters the front elevation which also includes a concrete platform. A sign reading, "Desert Center" is affixed to the porch.

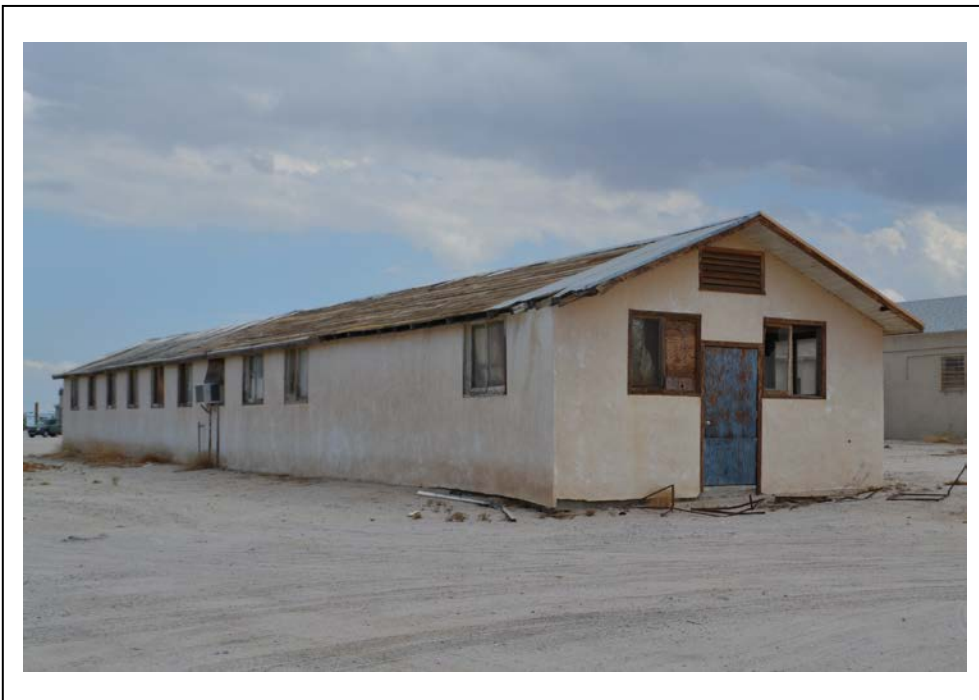
A church is in close vicinity to the post office and is similar in the design to that building. It is a long, front gable roofed building with an overhanging eave on the front elevation. Windows are sliding sash style and most are broken or boarded over. A single entry door accesses the building. The building overall, including the composition roof, shows signs of deterioration.

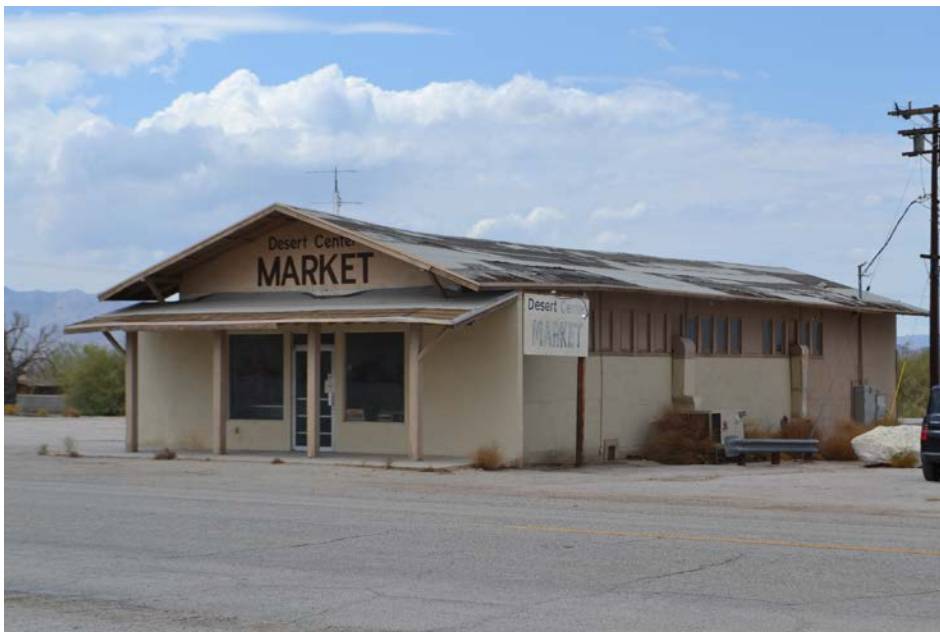
The Desert Center Market is a long rectangular building featuring a composition front gabled roof and walls sided with stucco. Windows are casement style and a single entry door is on the front elevation. A shed roofed porch with metal posts is also on this elevation. The building including the roof shows signs of deterioration and neglect.

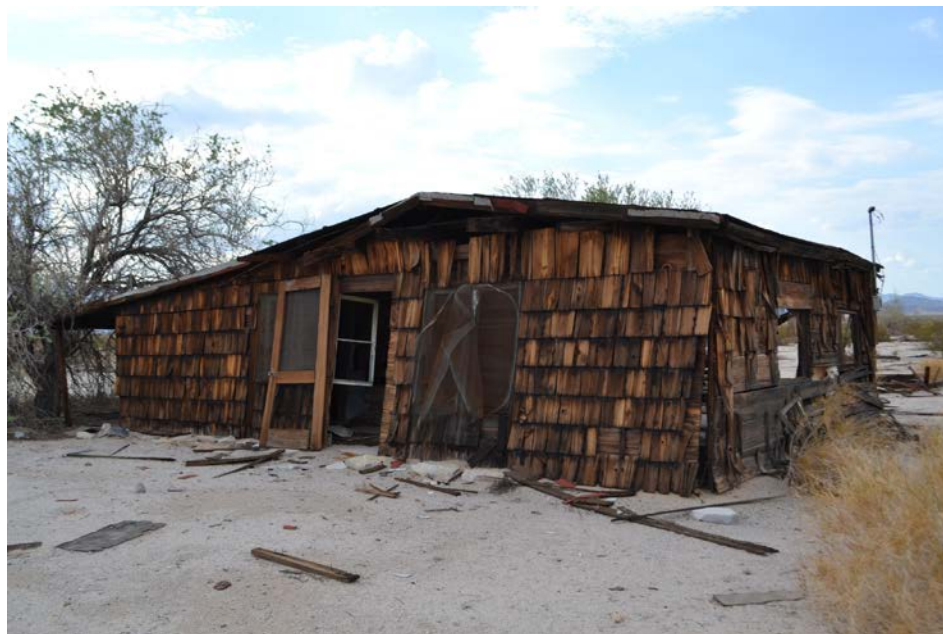
Both shanties are wood-frame buildings with shallow shed roofs. Wood single-entry doors access each building and windows are boarded over or missing. Shanty #11 features wood shingle siding and Shanty #10 includes clapboard siding. Each building is extremely deteriorated and nearly collapsed.

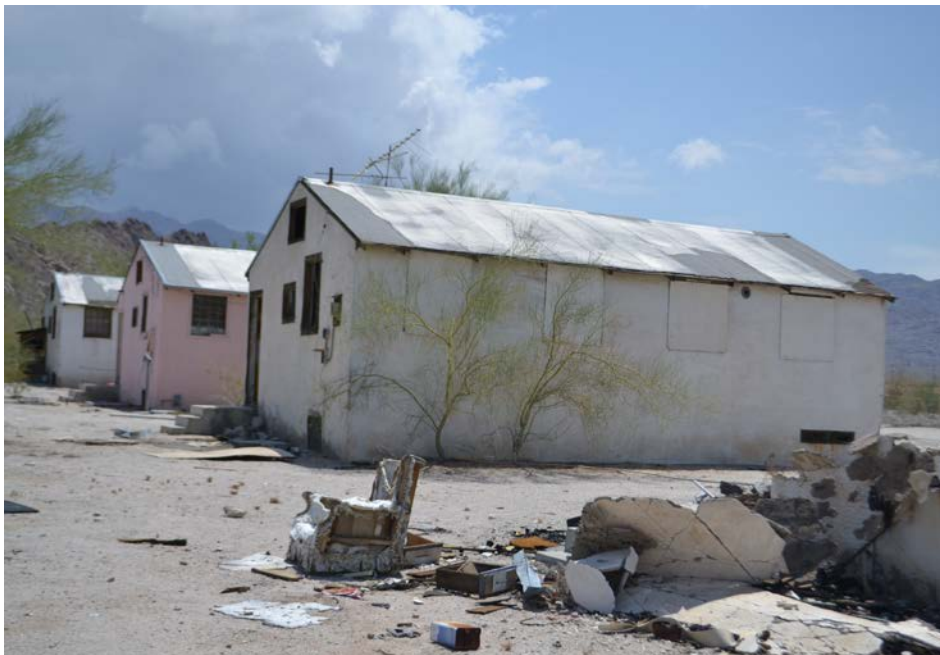
Presently seven buildings remain the parcel and one building is collapsed. The seven buildings are gable roofed rectangular structures with single entry doorways and wood-frame window openings. The buildings are sided with stucco and feature composition roofs. Most of the doors and windows are missing and some openings have been boarded over. Small porches shelter each entryway. Overall, the property is in poor condition as the buildings are heavily deteriorated with broken windows, doors, and patched or missing siding.

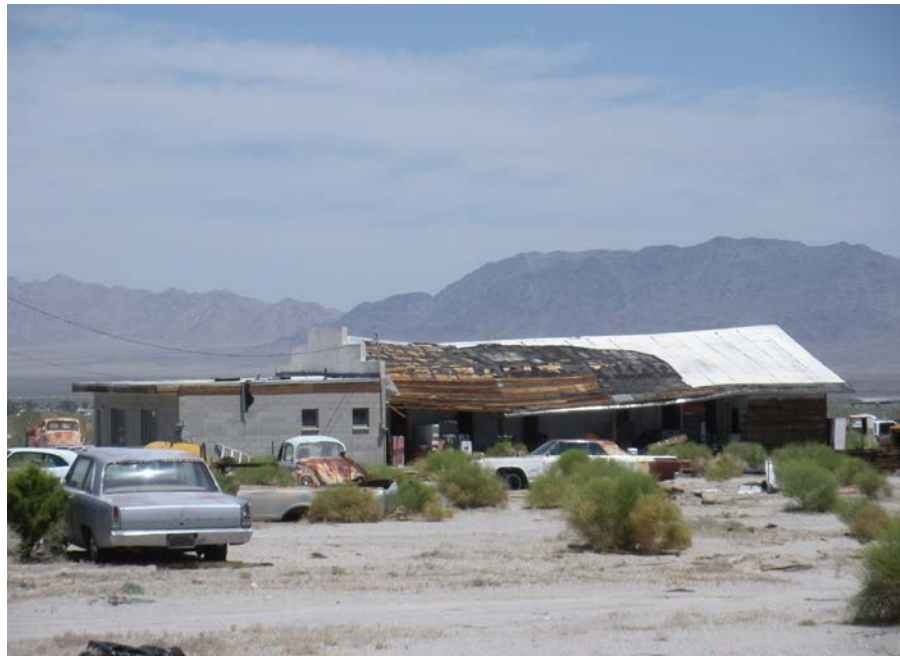
The Old School House is a rectangular building with a composition side gable roof and stucco walls. Windows are tall double hung style. A partially collapsed shed roof porch is located on the front elevation. The west elevation features a concrete masonry unit addition with a flat roof and aluminum-frame windows. Overall, the building is deteriorated and neglected and several abandoned cars are located on the property.
