Docket Number:	09-AFC-07C
Project Title:	Palen Solar Power Project - Compliance
TN #:	200175
Document Title:	Applicant Response to CEC Data Request 57- Part 5.1
Description:	N/A
Filer:	Tiffani Winter
Organization:	Galati Blek, LLP
Submitter Role:	Applicant's Representative
Submission Date:	8/13/2013 11:07:01 AM
Docketed Date:	8/13/2013

*Resource Name or # Desert Center Red Brick School Building

Resource Name or # (Assigned by recorder) Desert Center Red Brick School Building

*Resource Name or # (Assigned by recorder) Totem Pole Date Ranch

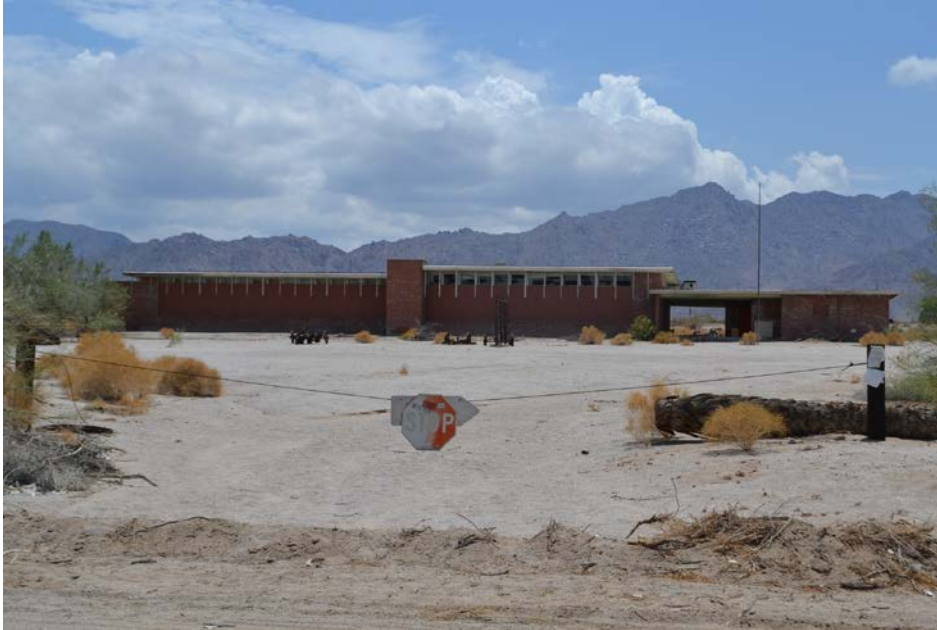
The resource was revisited on July 11, 2013. It appears unchanged since its previous recording. It does not appear eligible for the NRHP and CRHR.

Camera facing south, 07/11/2013.

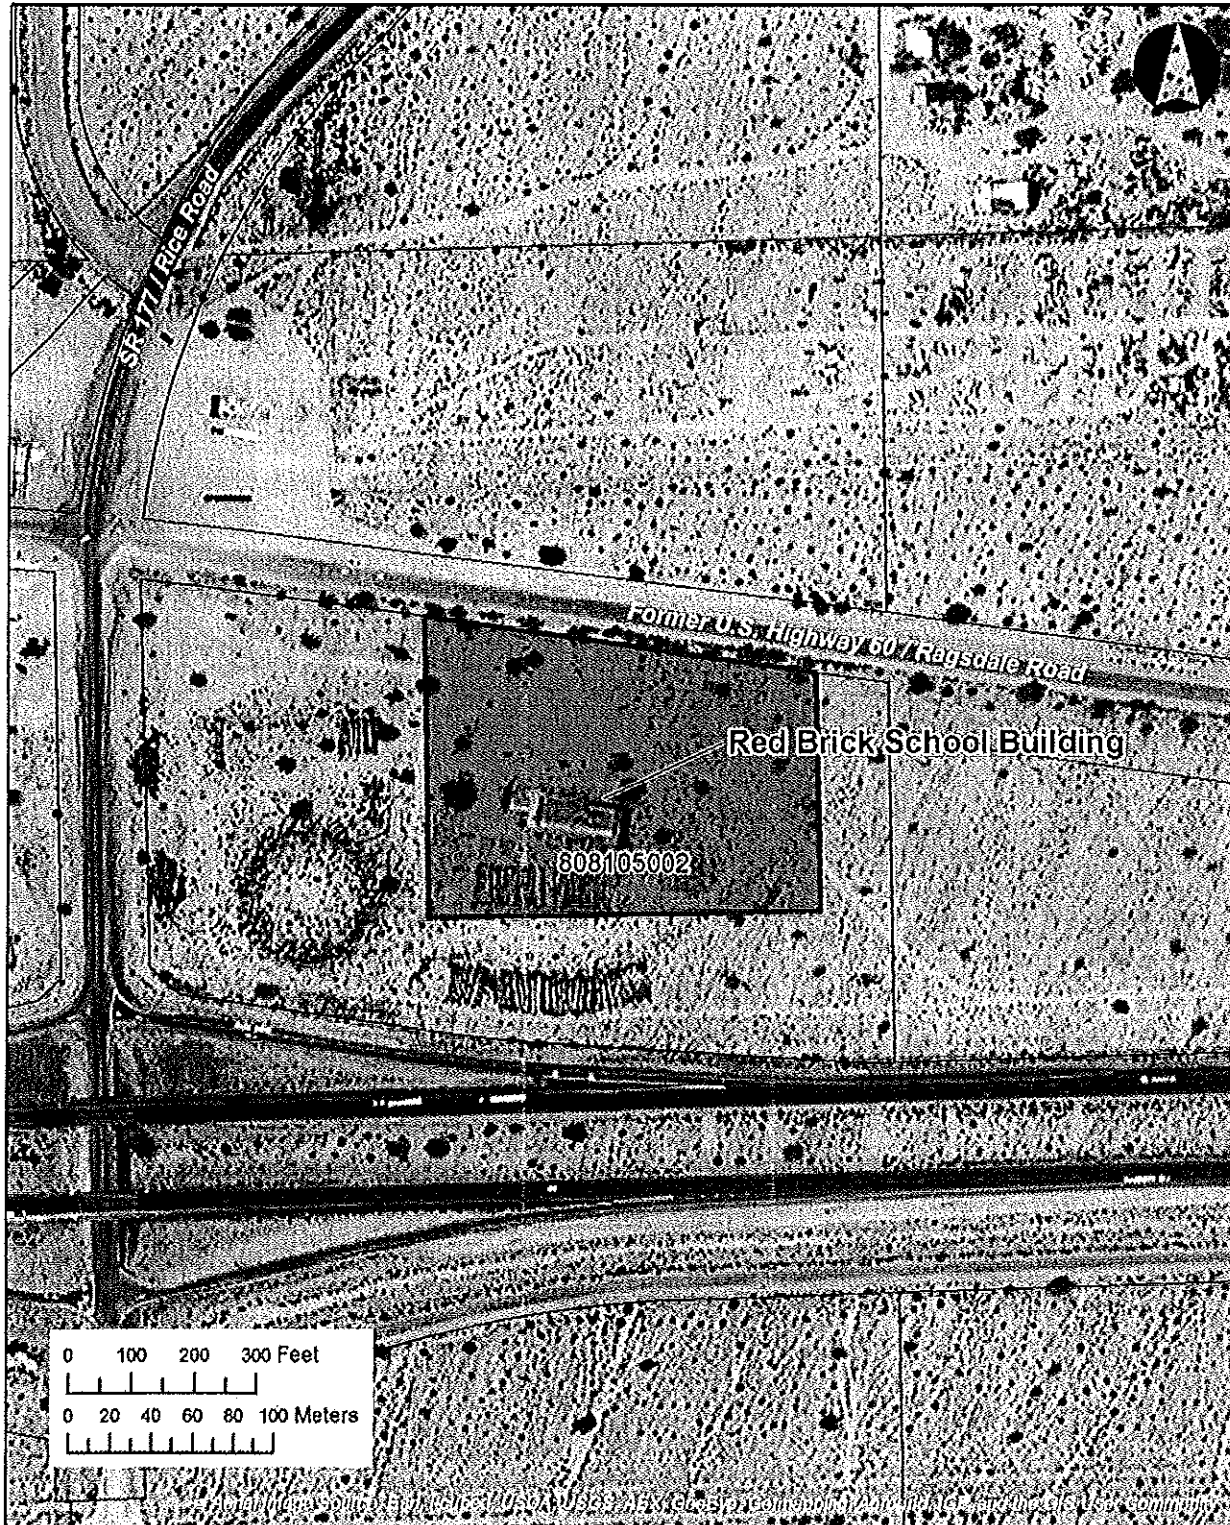
Figure 1. The location of the red brick school building within APN 808-105-002.

See attached sketch map (Figure 1) for location of building

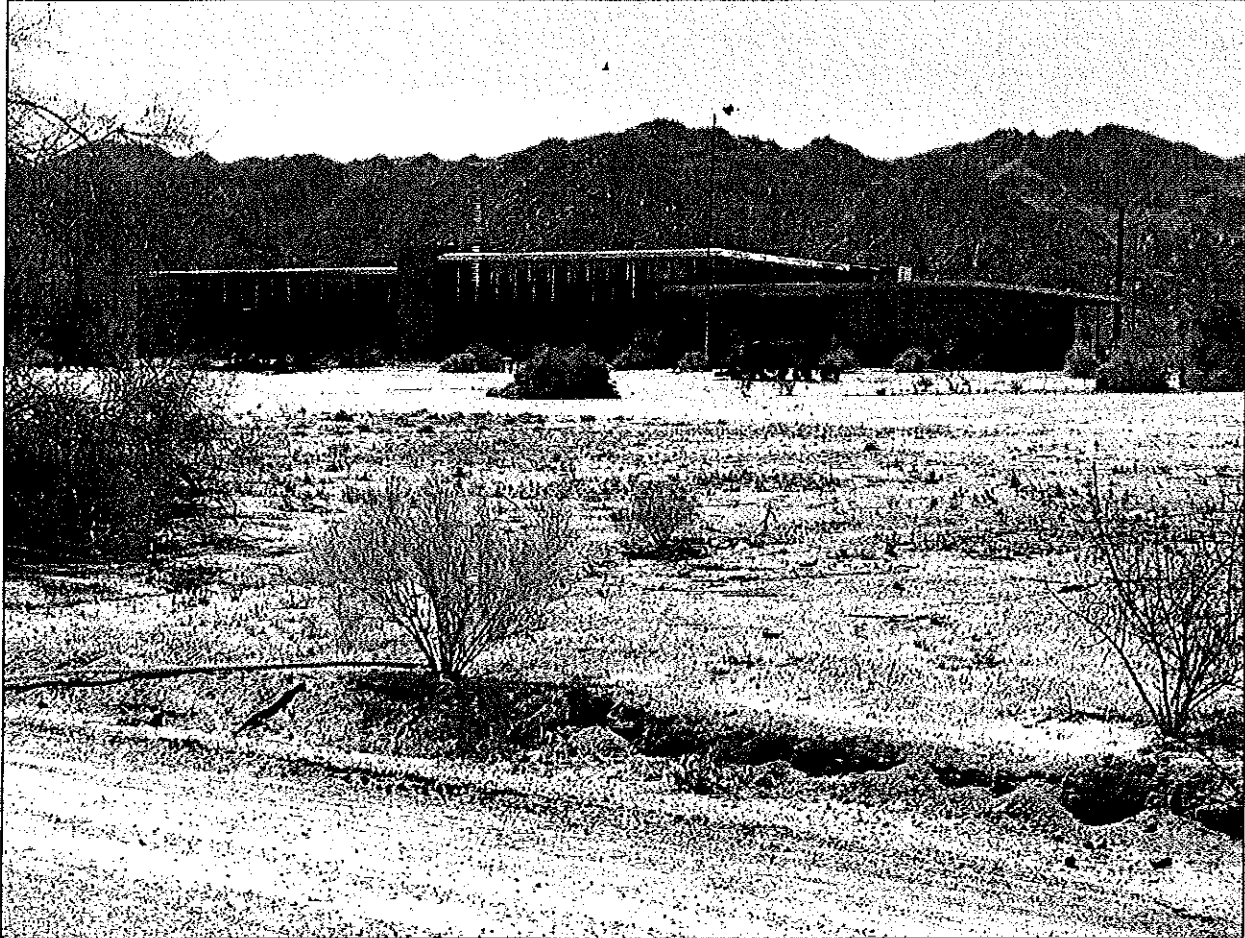
Figure 2. The red brick Desert Center School that was constructed around 1953 to replace the previous wood-frame schoolhouse. Photograph of the primary façade, taken from the edge of former U.S. Highway 60/Ragsdale Road (view to the southeast at the north and west-facing elevations; photograph taken April 3, 2012).

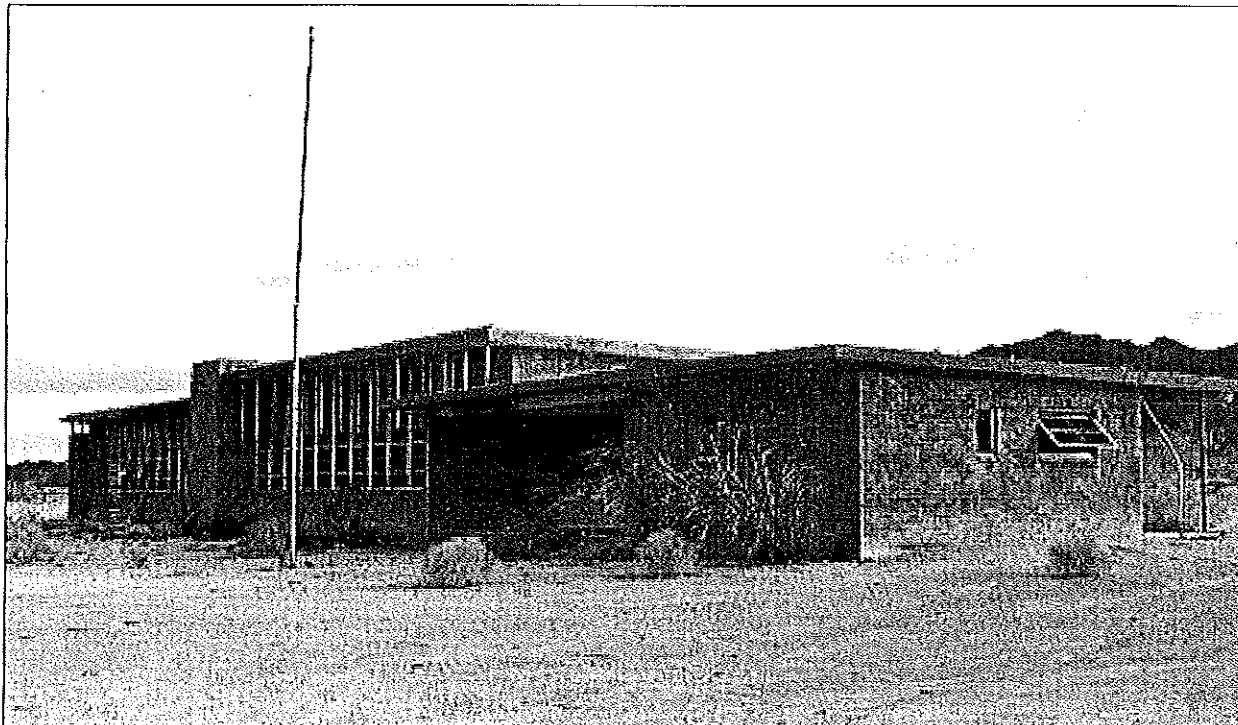
Based on a photograph of the Desert Center School from around 2008, the glass curtain walls that were once a feature on the front of the classroom and auditorium wings have since been filled with brick (Figure 3). This resulted in a substantial alteration of the original construction design, as one of the primary character-defining features of this building type was omitted in the process.

Figure 3. A photograph of the Desert Center School from around 2008. Note the glass curtain walls on the front of the classroom and auditorium wings have since been filled with brick.

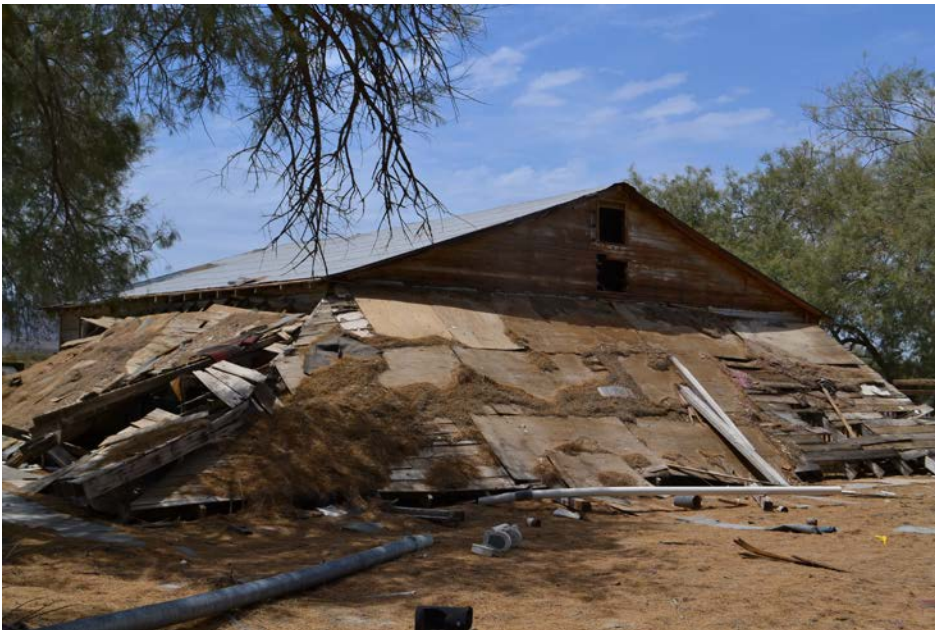
The property was revisited on July 10, 2013. The property has been abandoned for an unknown period. Three of the four previously recorded structures were identified on the property, with all remaining structures in a damaged condition. The ranch house located on the property features missing windows, a collapsed veranda, and a generally deteriorated exterior. The pool is drained and contains household debris and appliances. Also on the property, there are farm rows of date trees that are in a state of decay.

P5b. Description of Photo: (View, date, accession #) Camera facing S, 7/10/2013. DSCN 0606

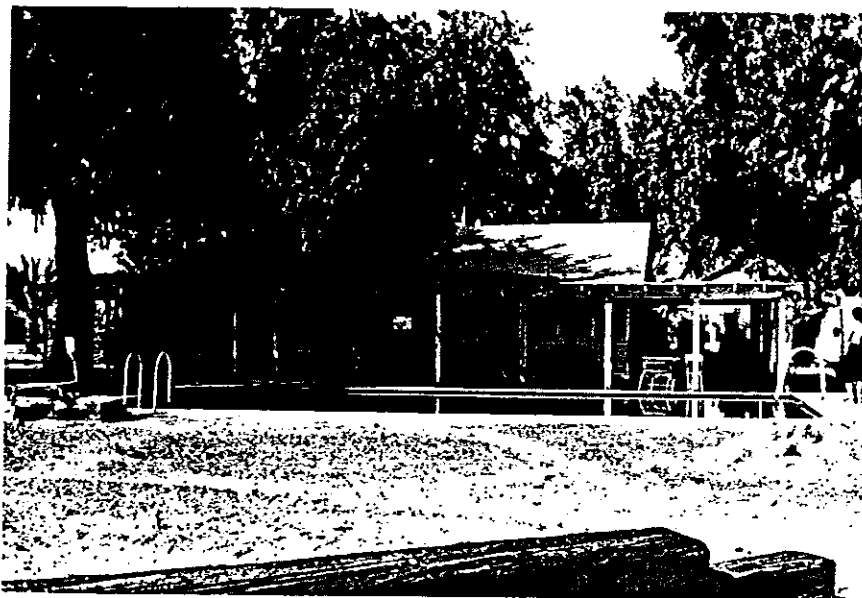
Rectangular in plan with a composition gable roof, the wood frame ranch house at 18050 Rice Road has clapboard siding, double-hung windows, a brick chimney, a band of square plate glass windows, and an encircling veranda with square porch posts, exposed rafters and flat roof.

A swimming pool now used as a fish pond sits next to the ranch house.

A wood slat cylindrical tank sits atop a tower, with cables around the slats.

Also on the property is a stucco shed with flat roof and a young date garden.

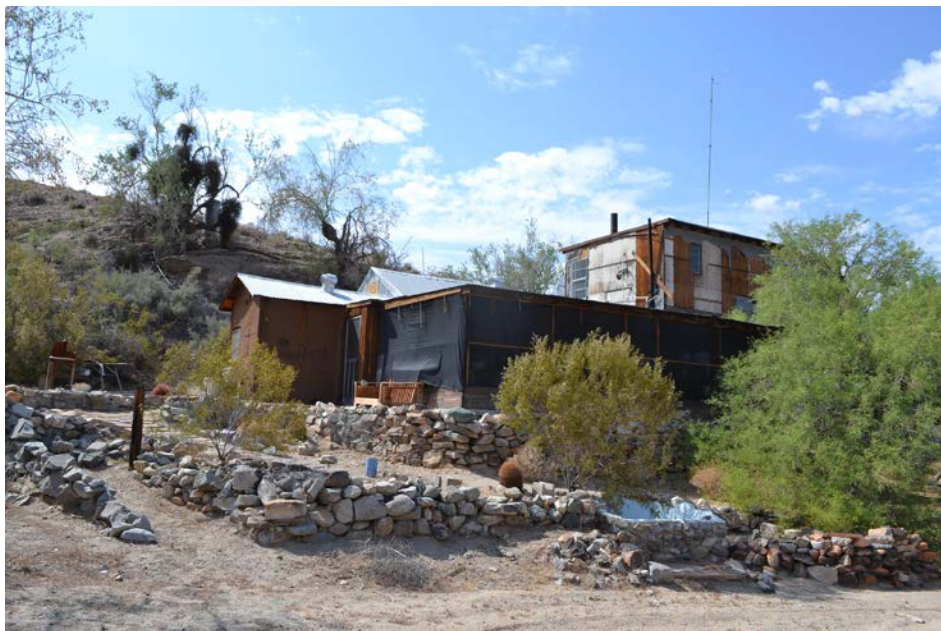
The property was revisited on July 10, 2013. All previously identified structures were observed during the survey. All buildings appear deteriorated, featuring missing or punched out windows and doors, and dilapidated wood siding. The windmill and tank are rusted and appear to be in disrepair. The cabin on the property appears inhabited, and has a new roof constructed of corrugated metal.

P5b. Description of Photo: (View, date, accession #) Camera facing NW, 7/10/2013, DSCN_0652
