Docket Number:	09-AFC-07C
Project Title:	Palen Solar Power Project - Compliance
TN #:	200176
Document Title:	Applicant Response to CEC Data Request 57- Part 5.2
Description:	N/A
Filer:	Tiffani Winter
Organization:	Galati Blek, LLP
Submitter Role:	Applicant's Representative
Submission Date:	8/13/2013 11:07:01 AM
Docketed Date:	8/13/2013

HISTORIC RESOURCES INVENTORY

State of California – The Resources Agency
DEPARTMENT OF PARKS AND RECREATION
PRIMARY RECORD

BUILDING, STRUCTURE, AND OBJECT RECORD

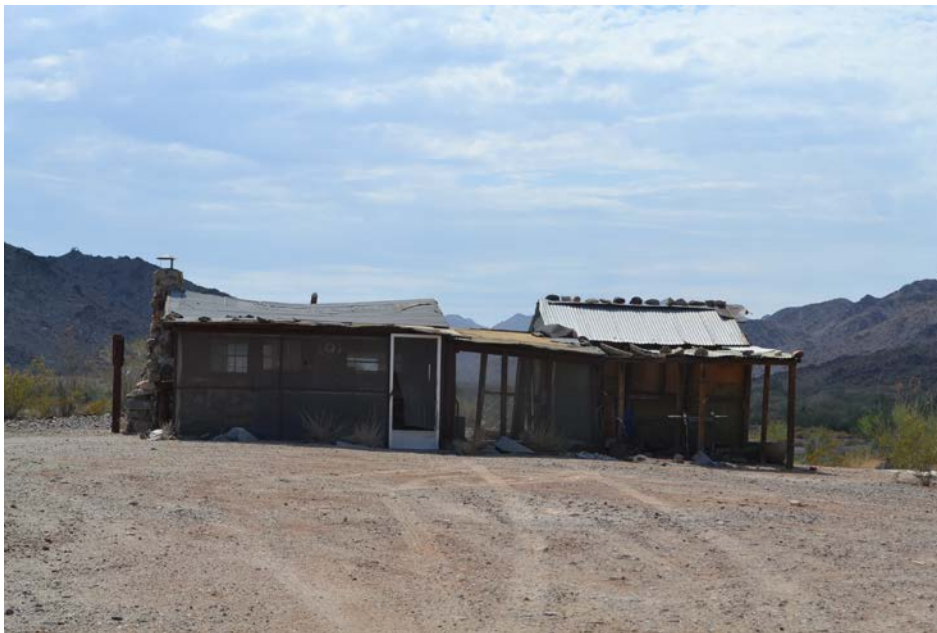
P5b. Description of Photo: (View, date, accession #) Camera facing W, 7/10/2013. DSCN 0646

This property was recorded in 1982 by the Riverside County Historical Community. The property was observed to include an unnamed prospecting operation in Desert Center that dates to the 1930s. Six structures were observed on the property: a cabin, shed, ore processing mill, water tank, well, and windmill.

The property was re-visited on July 10, 2013. Five of the six structures appear, while one, the windmill, no longer exists on the property. The cabin and shed show signs of decay, featuring broken windows and doors, collapsing roofs, and deteriorated or removed siding. The mill site and water tank appear unchanged from the previous visit.

The property does not appear to meet the criteria for the NRHP or CRHR based on its lack of integrity. This homestead-type property on Corn Springs Road was constructed circa 1932, and the complex is associated with early prospecting and mining in the area. Little information is known about this property, however, it was developed during a period when individuals were taking advantage of the Desert Land Act passed in 1877. Through the act, Congress encouraged and promoted the economic development of arid land such as that found in the Chuckwalla Valley. Settlers often lived in converted trailers on their newly claimed land or built their own homes from rock, wood, or concrete (Anderson 1998). As it became evident that wells could be successfully drilled for irrigation, more families were drawn to the Chuckwalla Valley and the mountains.
