Docket Number:	09-AFC-07C
Project Title:	Palen Solar Power Project - Compliance
TN #:	200180
Document Title:	Applicant Response to CEC Data Request 57- Part 7.1
Description:	N/A
Filer:	Tiffani Winter
Organization:	Galati Blek, LLP
Submitter Role:	Applicant's Representative
Submission Date:	8/13/2013 11:07:01 AM
Docketed Date:	8/13/2013

State of California – The Resources Agency
DEPARTMENT OF PARKS AND RECREATION
PRIMARY RECORD

*Resource Name or # (Assigned by recorder) Eagle Mountain Pumping Plant

*P11. Report Citation: (Cite survey report and other sources, or enter "none.") Class II and III Cultural Resources Survey Report for the Palen Solar Electric Generating System Riverside County, California AECOM 2013

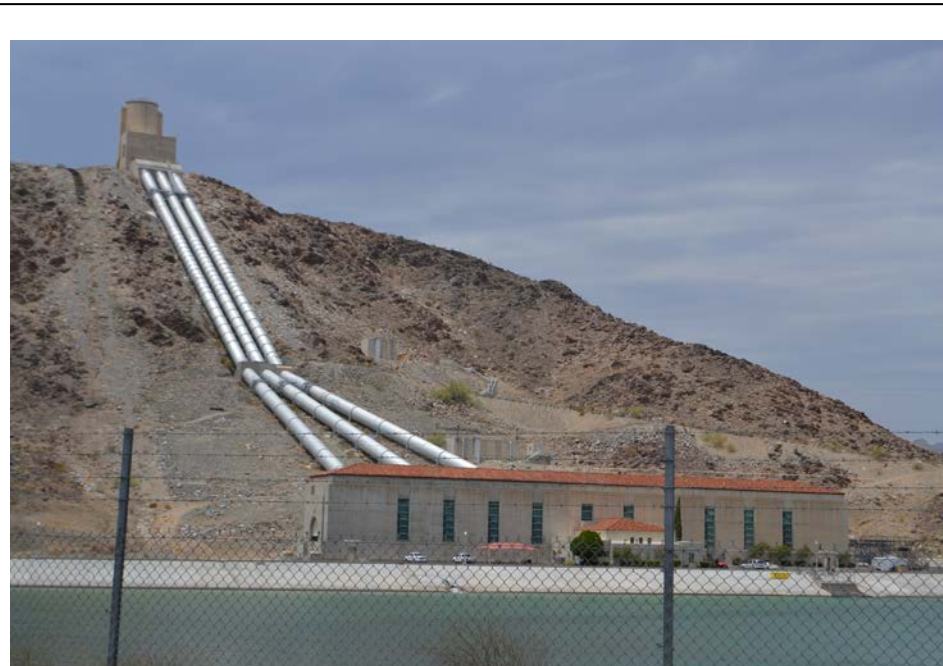
P5b. Description of Photo: (View, date, accession #) Camera facing SW, 7/10/2013. DCSN 0475

The resource was originally recorded as the Eagle Mountain Pumping Plant, built from 1936 to 1939 and associated with the Colorado River Aqueduct. The pumping plant complex consists of the main four-story Art Deco-style pumping building, three concrete delivery pipes connected to a surge tower, nine motors, nine pumps, a switch house, a concrete outlet, a reservoir, street lights, and three workers' houses. The structures on the property looked to be largely unchanged from last recording; however, a full observation of the property and its structures did not take place, as the gate to the road leading to the plant was closed, restricting access. The additional building were not accessible, but are also outside of the viewshed of indirect impacts for the current study.

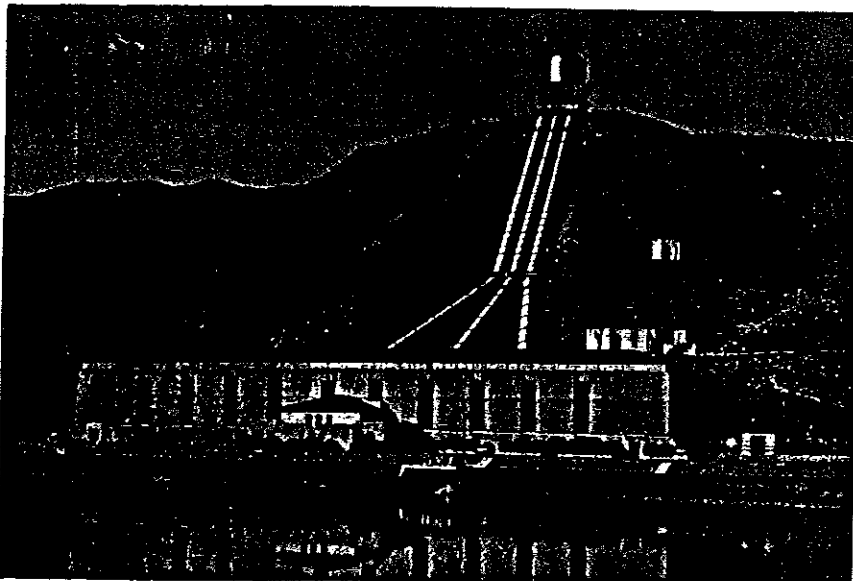
2. Date(s) of enclosed photograph(s)
March 27, 1982
18-79-31-31

Central in this complex is the four-story main pumping building which is rectangular in plan with a two-story main control room attached to one side of the building. Constructed of reinforced concrete and steel, the main pumping building has an additional three stories below ground level. There are elements of Moderne and Art Deco styling including at each end the department seal in cement, and small lamps, flat cement urns and curved cement curbs flanking the large arched entries. On each side of the building are located ten two-story high mullioned windows and curved raised flower beds on the earlier constructed section. Spanish tile hip roofs cap both the main building and the control room.

Three concrete delivery pipes extend from the rear of the building up the mountain side, converging in a cement structure before continuing parallel to a second structure at the top of the mountain, achieving a

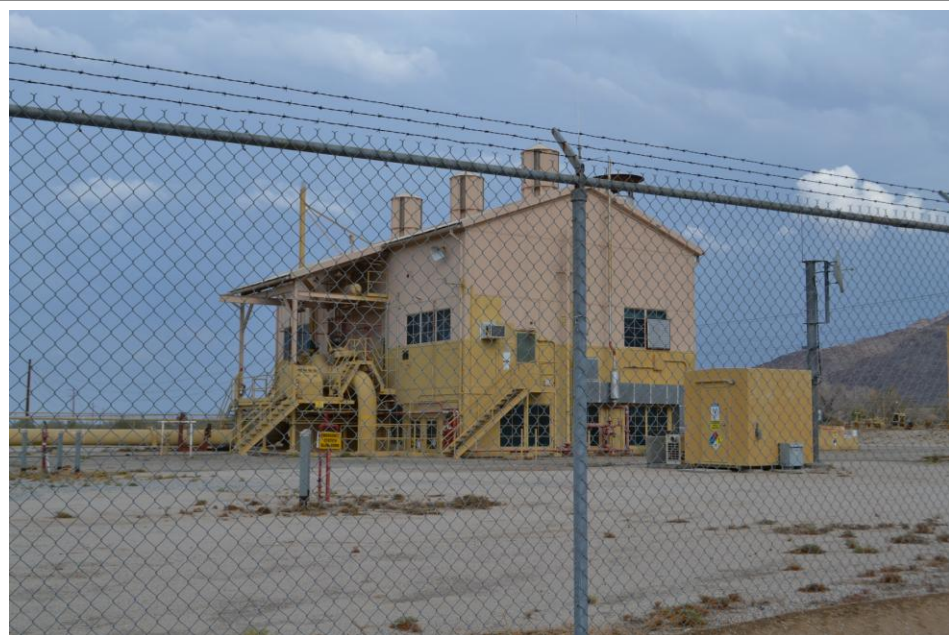
P5b. Description of Photo: (View, date, accession #) Camera facing SE,
7/11/2013. DSCN 0180.

This resource is a pumping station located at 43025 Aztec Ave (Parcel 808-112-006) south of Interstate 10 near Desert Center. The resource is a tall steel utilitarian facility with a series of pipelines. The second level is accessed by metal stairs. Stack vents are on the roof and fenestration consists of metal-framed multi-light windows. It is enclosed by a cyclone fence topped with barbwire.

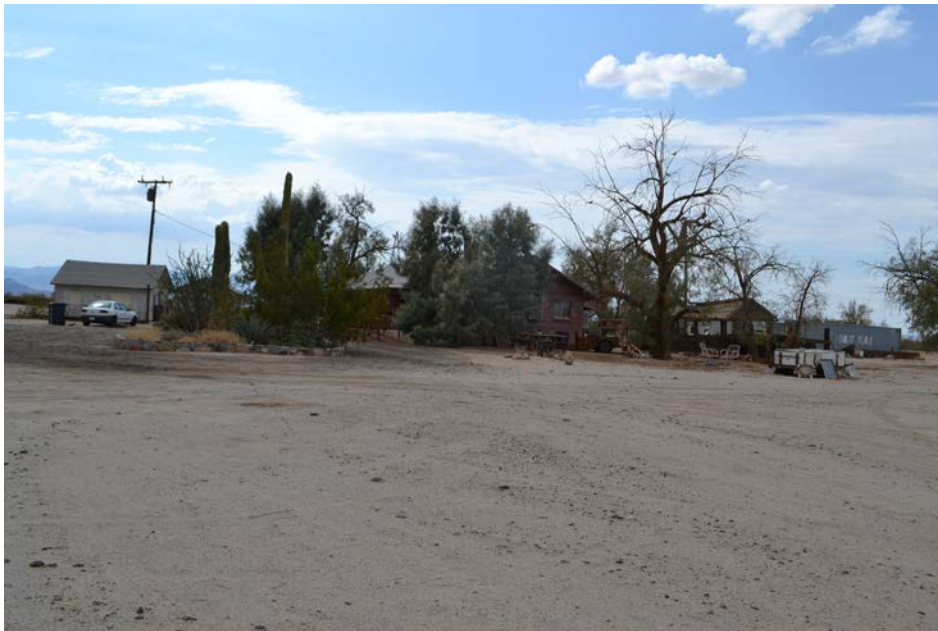
P5b. Description of Photo: (View, date, accession #) Camera facing NW,
7/11/2013. DSCN 0068

This resource is a residential cluster of vernacular buildings located at 24475 Rice Rd (Parcel 811-121-003) that appears to date from circa 1960 (based on topographic maps and visual observation). There are two main residential buildings and several secondary buildings and sheds on the parcel. The two residential buildings are one-story Ranch-style vernacular residences with low-pitched roofs, synthetic or mixed siding, mixed wood, aluminum and synthetic windows, and full-length porches. Another building appears to be a converted mobile home. Another primary building is a one-story residence with a rectangular plan, clapboard siding, a low-pitched roof, wood multi-light sash windows, and a five-panel wood door. Two other clapboard sided buildings are located on the parcel.

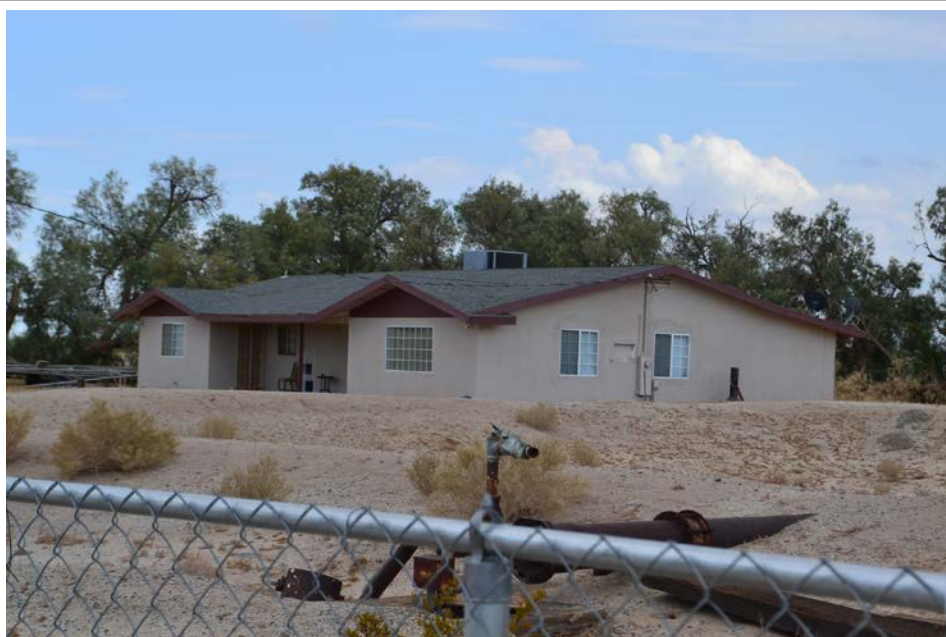
P5b. Description of Photo: (View, date, accession #) Camera facing S, 7/11/2013.
DSCN_0071.

This resource is a residential and agricultural property located at 22100 Rice Road (Parcel 811-122-004). It includes a one-story, Ranch-style residence with low-pitched side-gabled roof, stucco siding, replacement vinyl windows, and a recessed porch with square posts. The property also contains a shed outhouse.
