**Subject: PALEN SOLAR HOLDINGS, LLC'S LAKE OR STREAMBED
ALTERATION AGREEMENT AMENDMENT NOTIFICATION
PALEN SOLAR ELECTRIC GENERATING SYSTEM
DOCKET NO. (09-AFC-7C)**

Enclosed please find the Lake or Streambed Alteration Agreement amendment notification for the Palen Solar Electric Generating System project. The original LSA permit number for this project, formerly called the Palen Solar Power Project, is 1600-2009- 0123-R6.

- The LSA amendment notification, including a set of continuation pages
- Attachment 1 – “The Supplemental Spring 2013 Biological Resource Surveys”, which includes the State Waters delineation for the amended project.
- A check in the amount of \$560.25

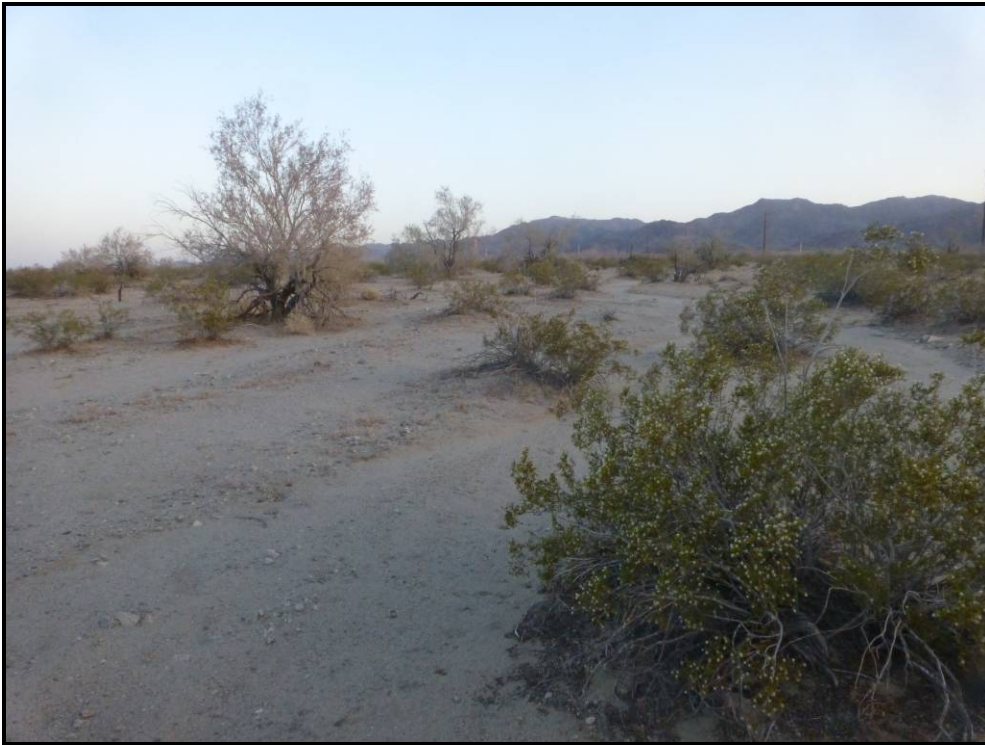
Photograph A-1. Typical sheet flow, part of the Desert Dry Wash Woodland designation, on the gentle. This sheet flow is a mixture of single-thread and discontinuous channels, ranging from moderately vegetated arboreal washes to sparsely vegetated channels with primarily upland vegetation.

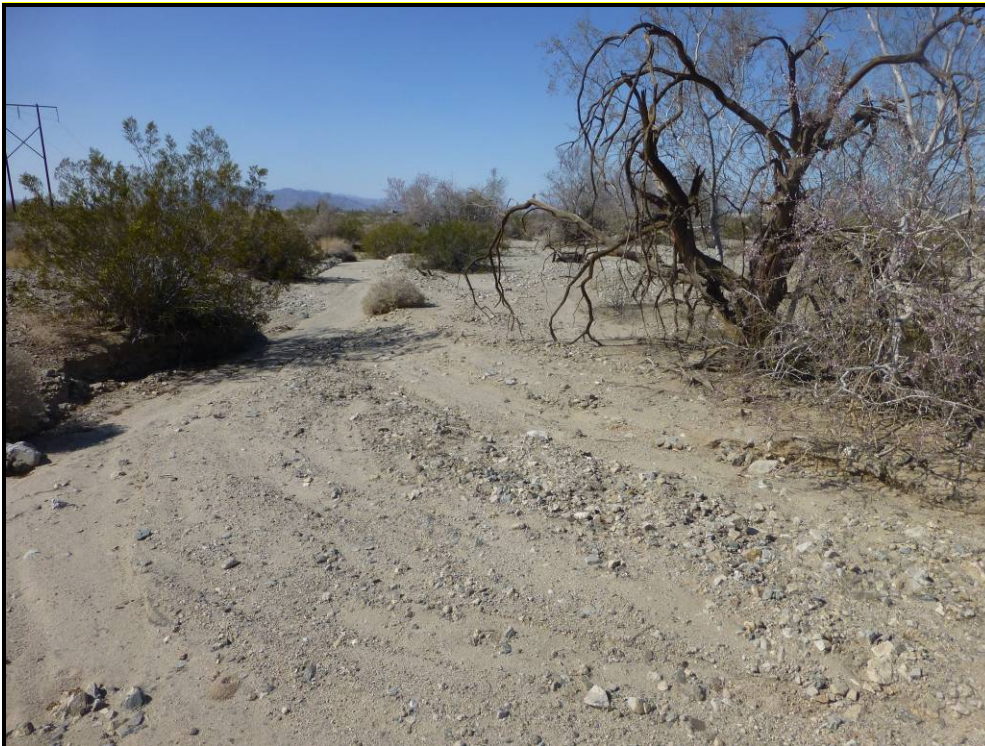
Photograph A-2. The most vegetated channels in the sheet flow characteristic of both Linear Facilities. Note that ironwood is nearly the sole wash-dependent species due to the poor water availability. Upland species, particularly creosote bush, are dominant in this community here.

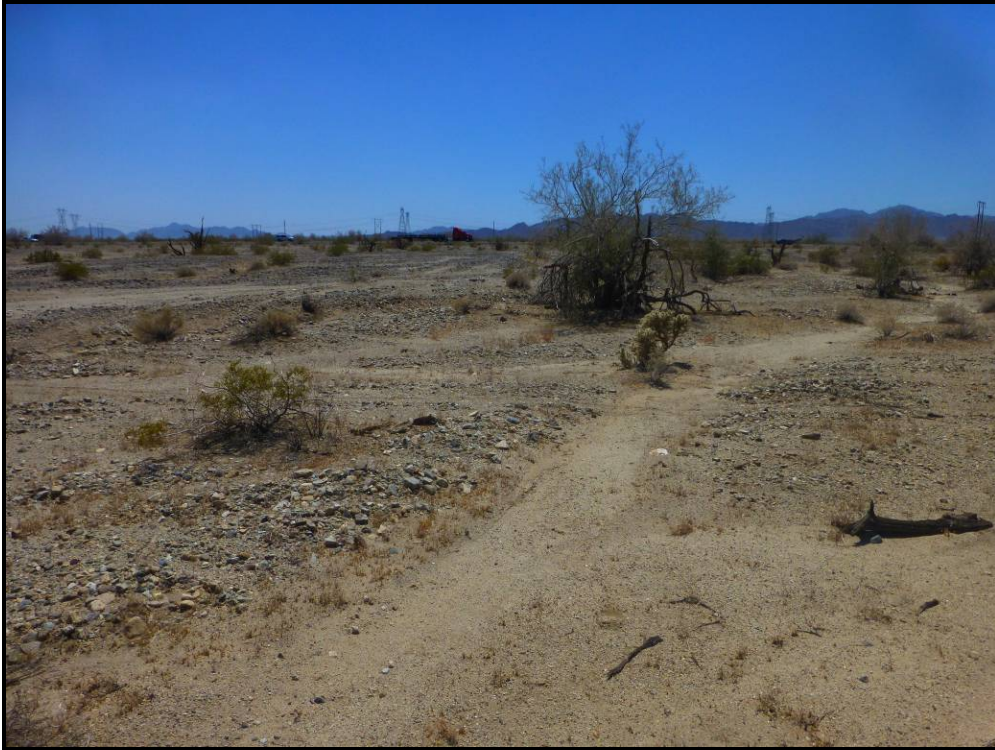
Photograph A-3. The more poorly vegetated, generally discontinuous, channels that are part of the sheet flow system characteristic of the Linear Facilities.

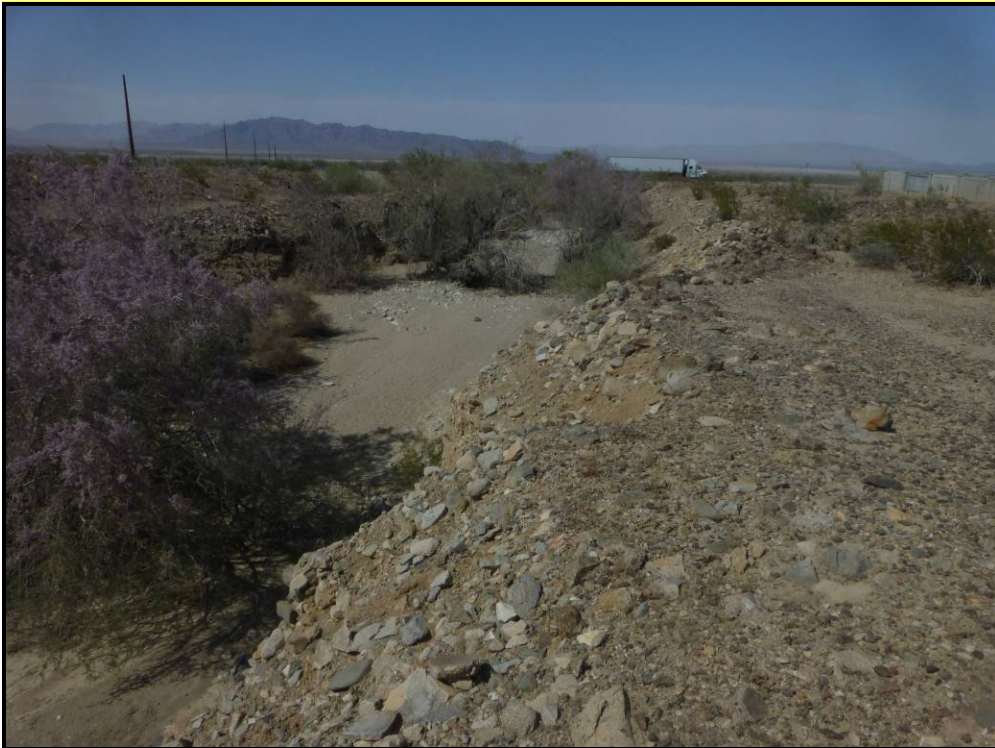
Photograph A-4. The incised, arboreal wash that crosses the gen-tie next to the RBS. This large wash is well-vegetated with multiple wash-dependent species other than ironwood.

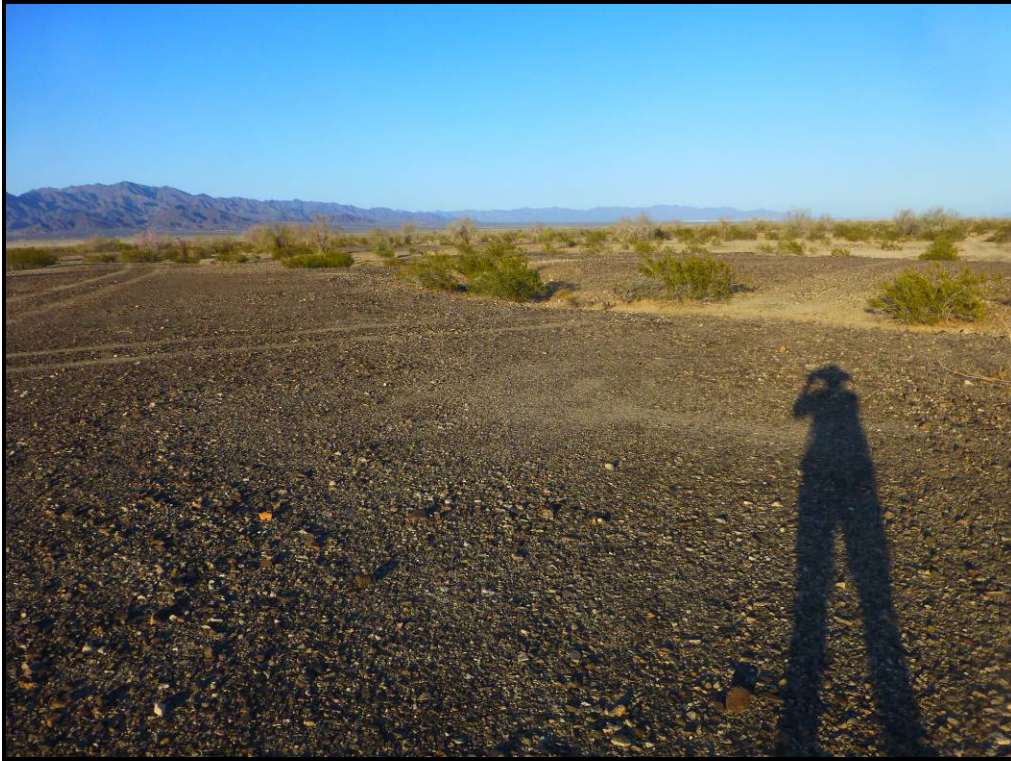
Photograph A-5. Well-developed desert pavement on the Linear Facilities.

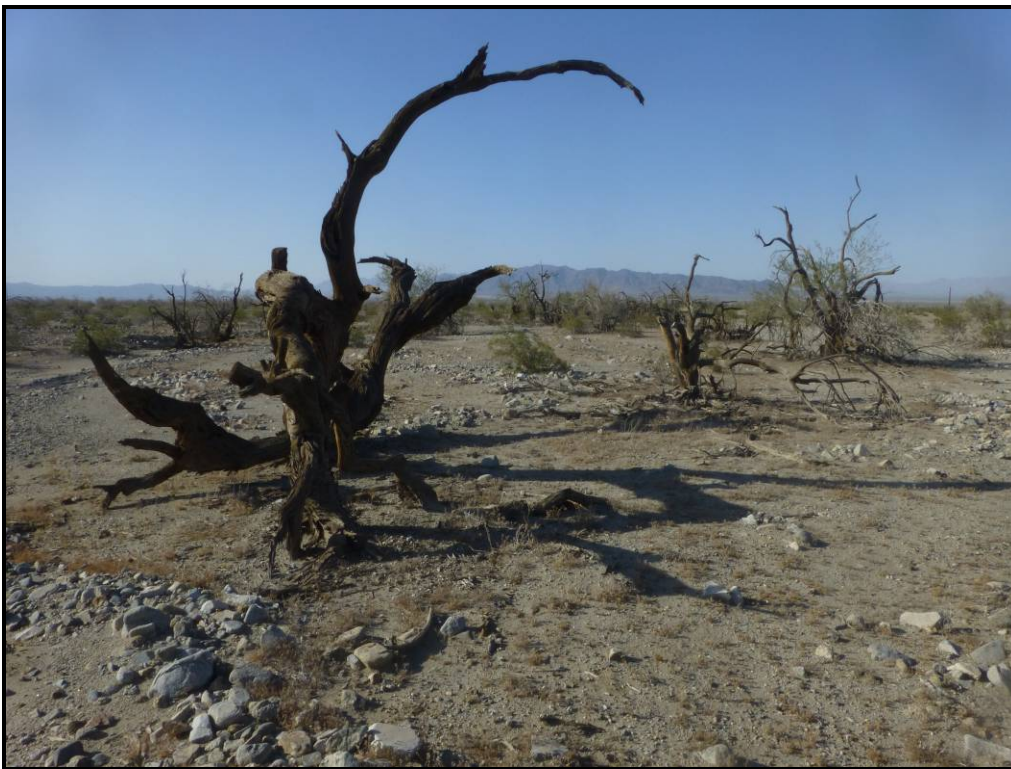
Photograph A-6. Dead and dying ironwood north of I-10, where the flow from upslope was severed by construction of I-10.

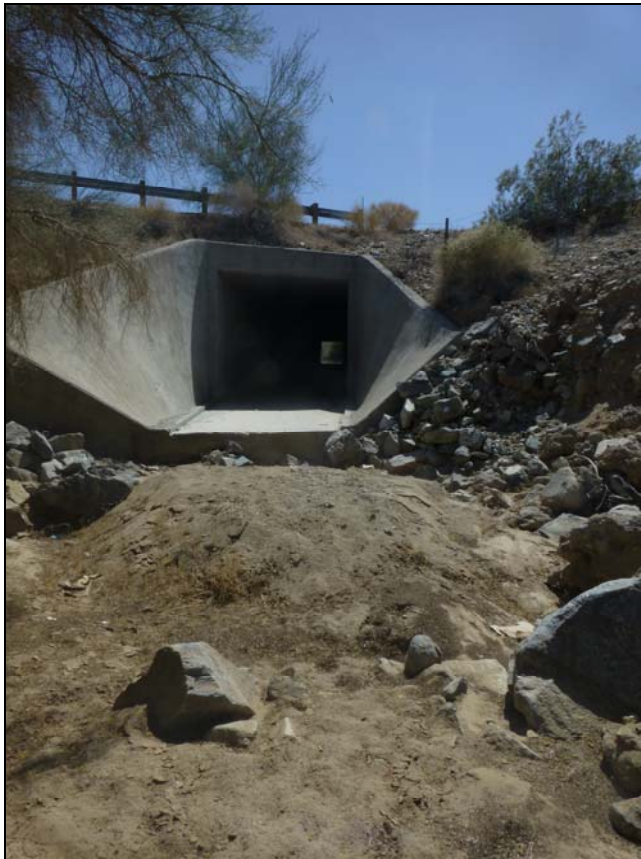
Photograph A-7. Box culvert I-10 underpass west of the modified gen-tie.

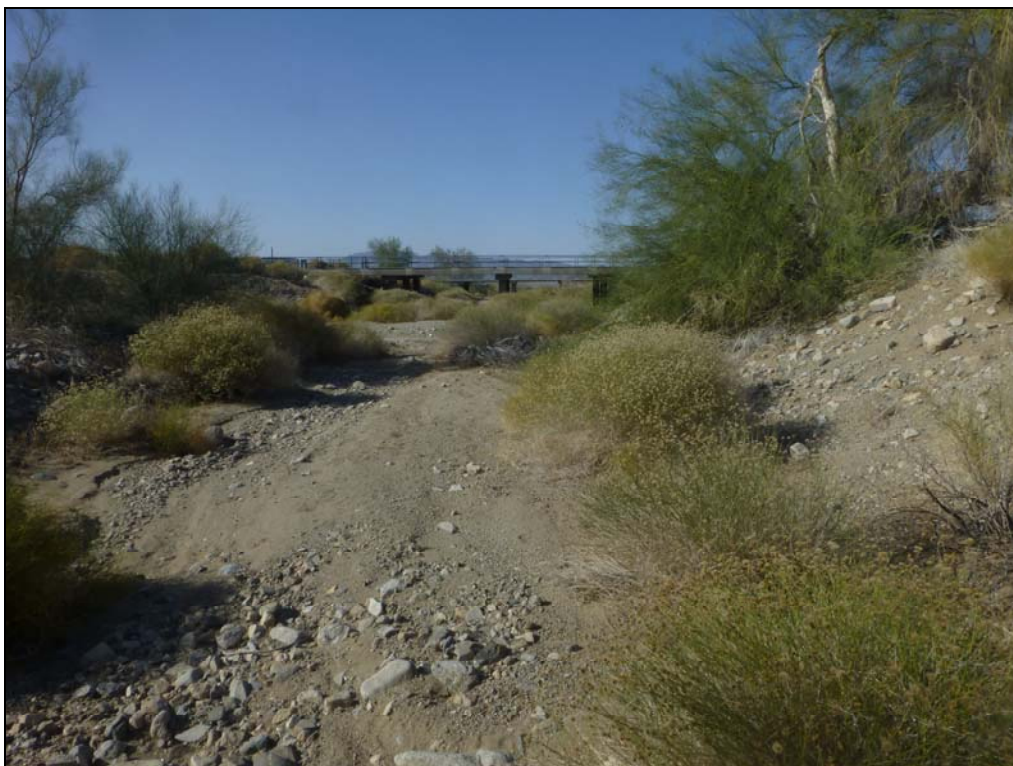
Photograph A-8. Natural wash I-10 underpass. This wash is approximately 0.25 miles west of the modified gen-tie.

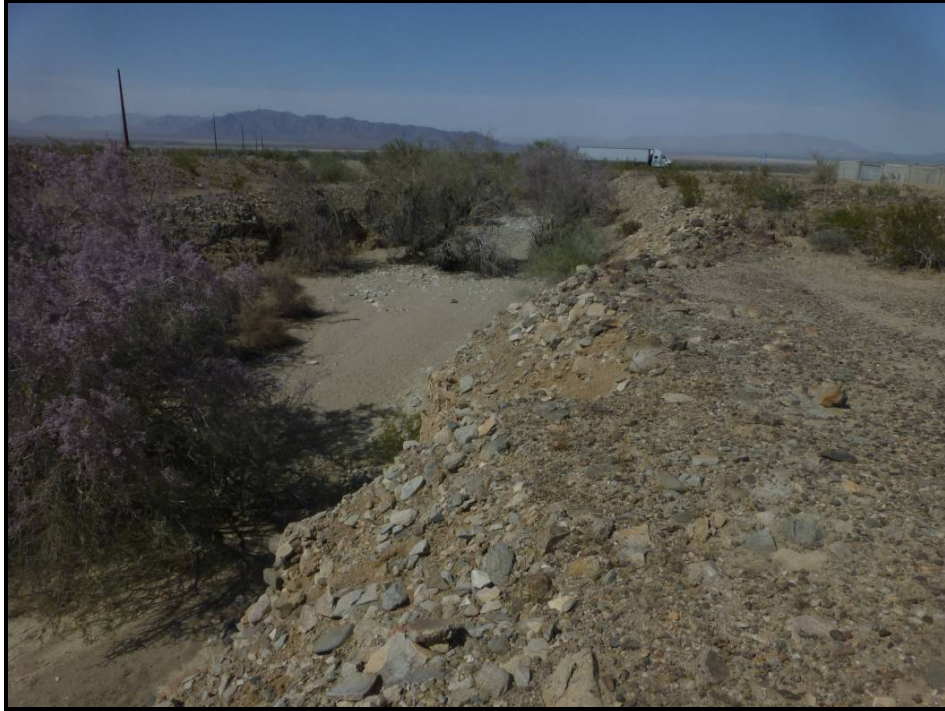
Photograph C-1. A primary channel and DDWW. This channel is several meters deep, is a main tributary, and has multiple wash-dependent tree and shrub species.

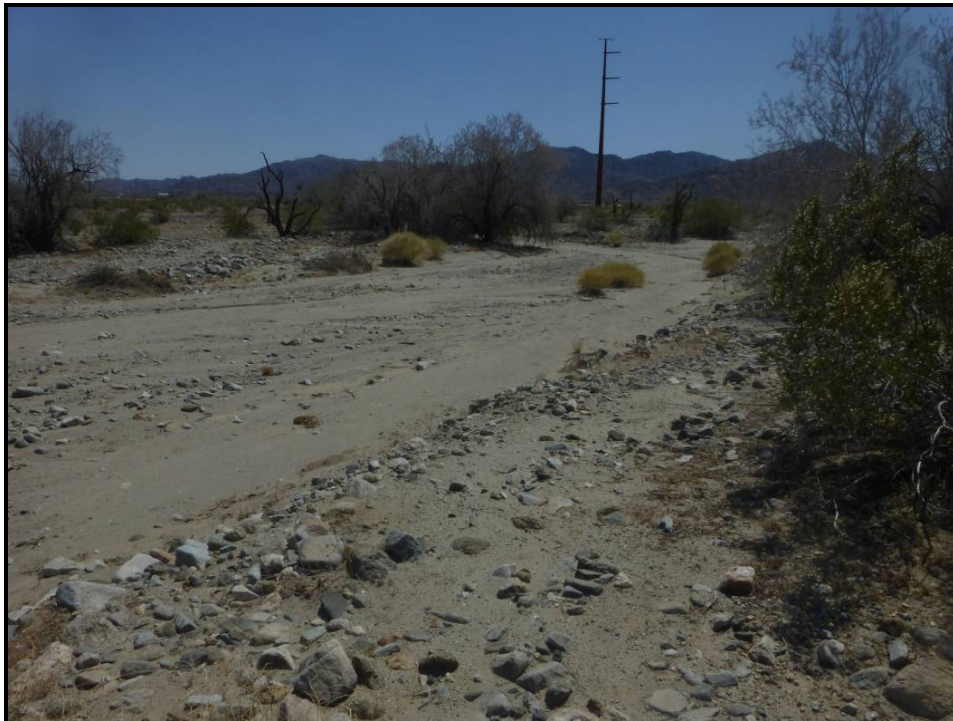
Photograph C-2. Another example of a primary wash and DDWW at PSEGS. This channel has a distinct bed and bank, even though shallow, two wash-dependent species and is dominated by a riparian tree species (*Olneya tesota*).

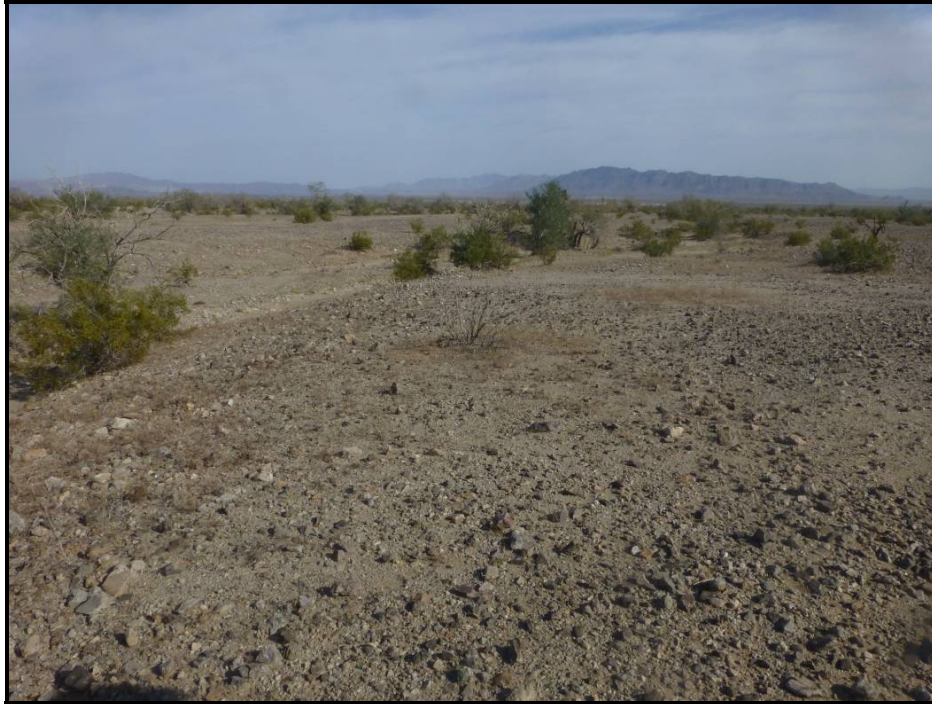
Photograph C-3. Small, shallowly incised wash dominated by upland vegetation, but ironwood trees, albeit stunted, are common. This wash was categorized as DDWW because of the number of trees, although it is of marginal quality.

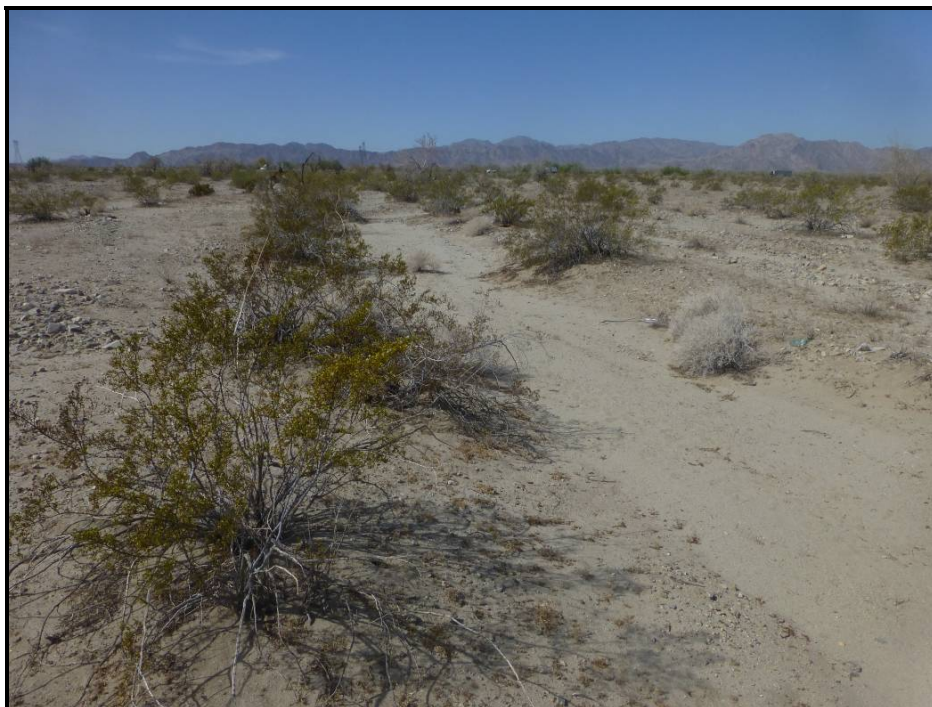
Photograph C-4. Very shallow wash dominated by upland shrubs. This wash is not DDWW at this point.. Upslope, this wash diminished completely (discontinuous channel). Downslope it ultimately became more defined and ironwood became common (DDWW downslope).

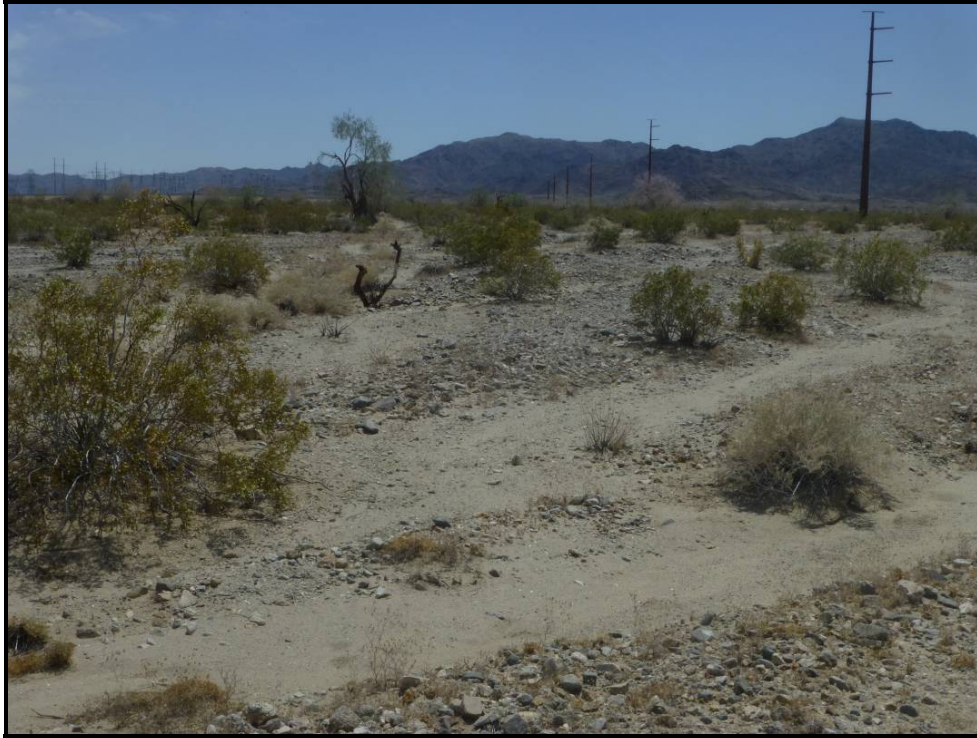
Photograph C-5. DDWW sheet flood. This is a matrix of braided discontinuous and single-thread channels, some of which are secondary and primary channels. Note the scattered ironwood trees and the gravel rills that indicate water flow.

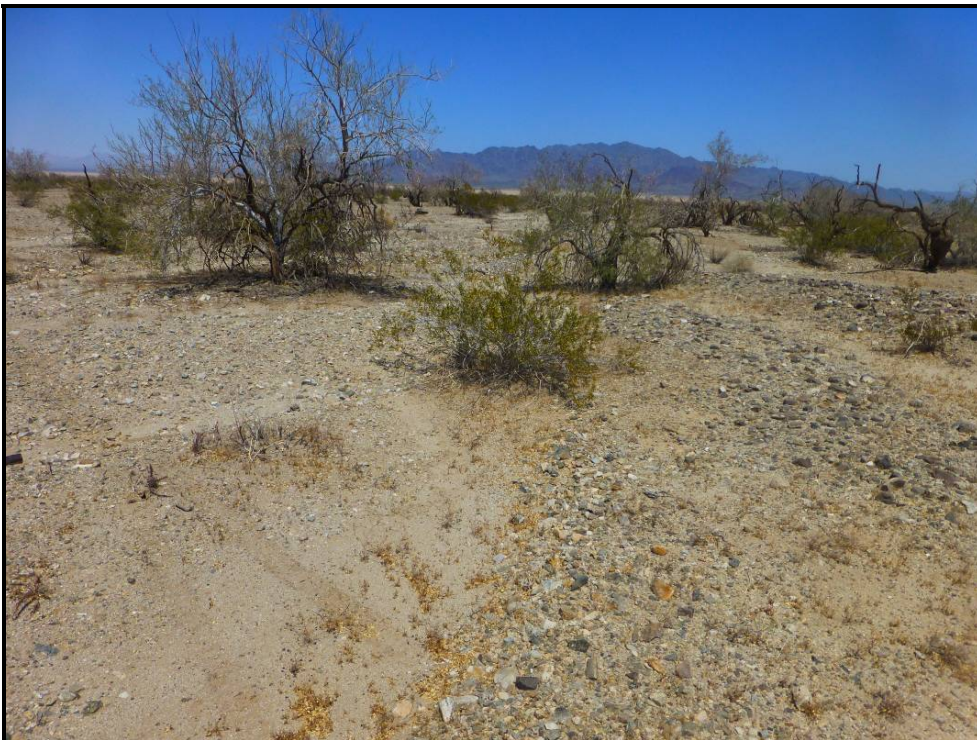
Photograph C-6. DDWW sheet flood on the gas pipeline ROW, north of I-10. Note the many dead and dying ironwood trees resulting from the severing of this sheet flow by the freeway.

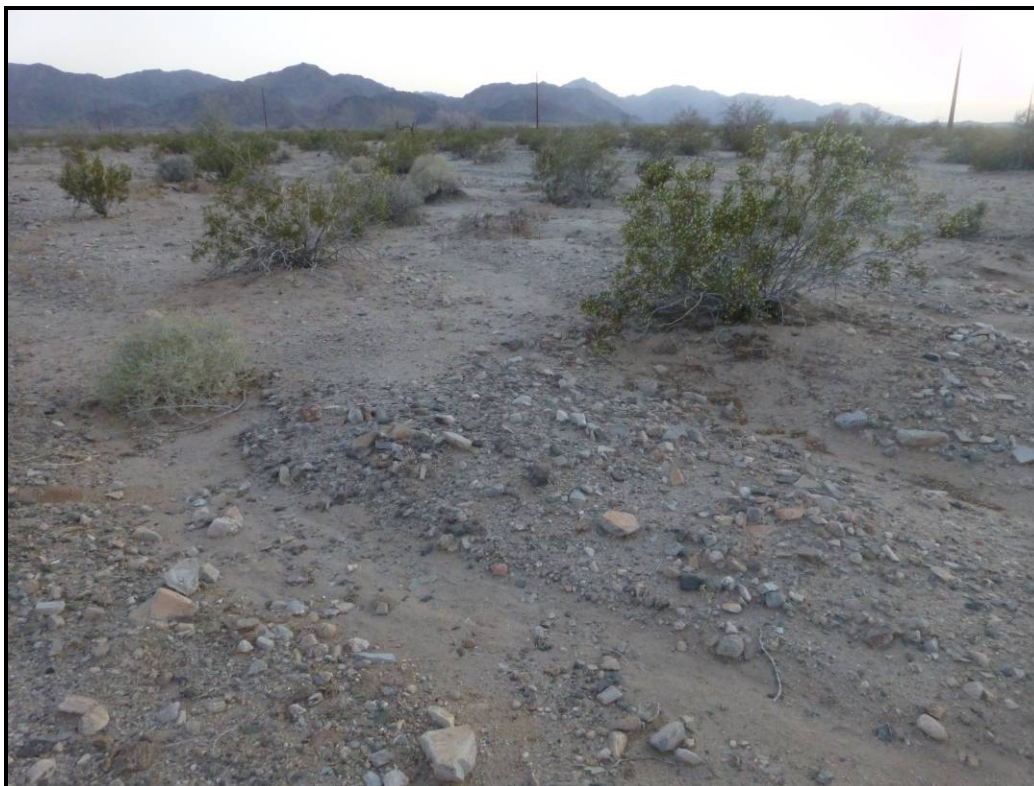
Photograph C-7. Sheet flood with only upland species. This sheet has unvegetated ephemeral washes, discontinuous channels and gravel rills indicating water flow throughout the sheet matrix.

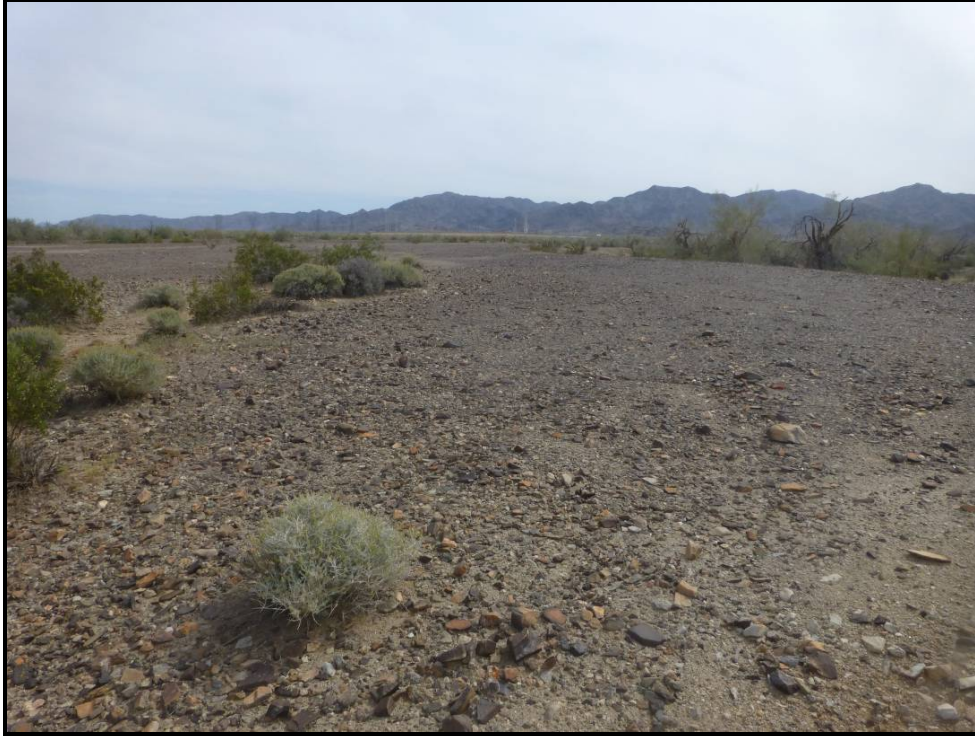
Photograph C-8. A U_H channel, with high density of shrubs, all upland species. This channel began as a swale upslope on the desert pavement. Note the secondary wash in the right side of the photograph.

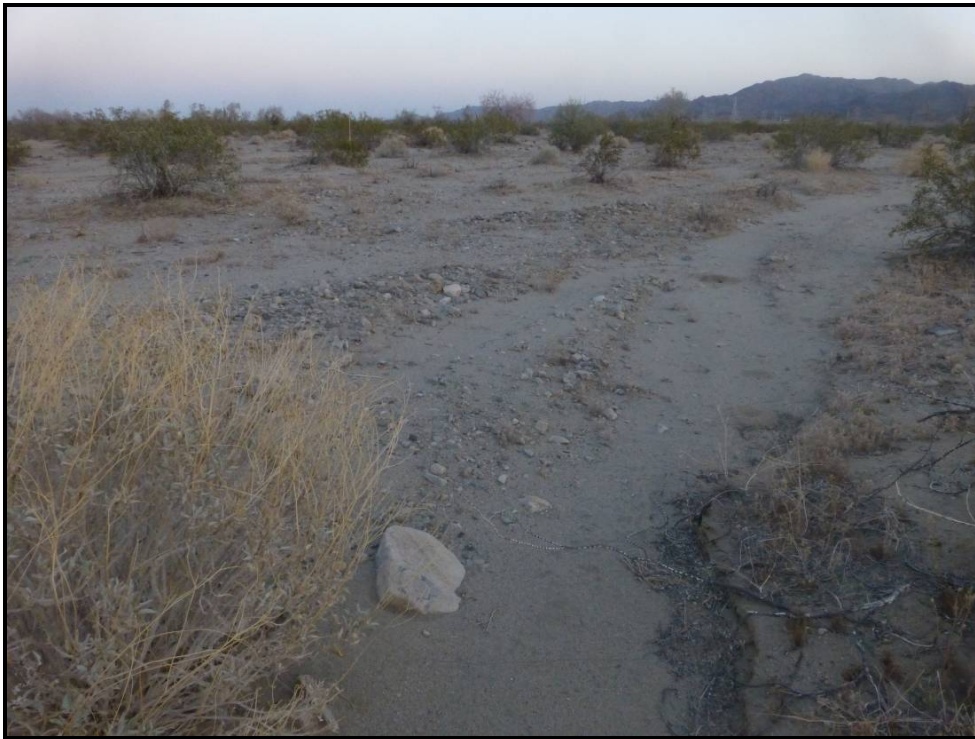
Photograph C-9. A U_L channel, with low density of shrubs, all upland species. This is a discontinuous channel.
