Final Test and Evaluation Results from the Solar Two Project

SAND2002-0120
Unlimited Release
Printed January 2002

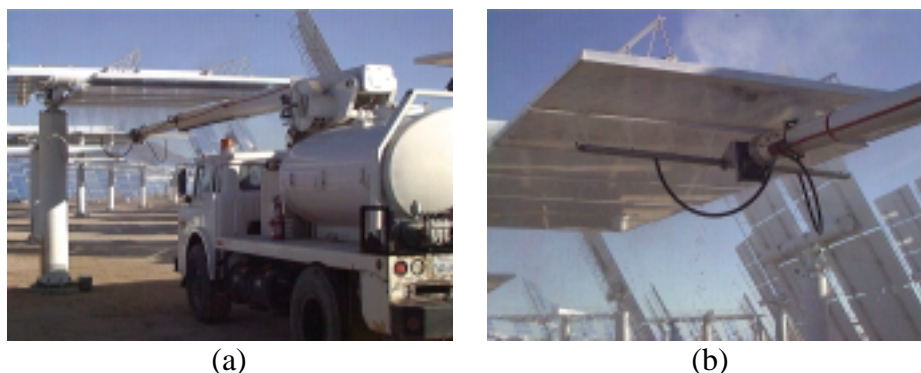
Figure 2-6. The Solar Two wash truck (a) and close-up of spray bar (b).

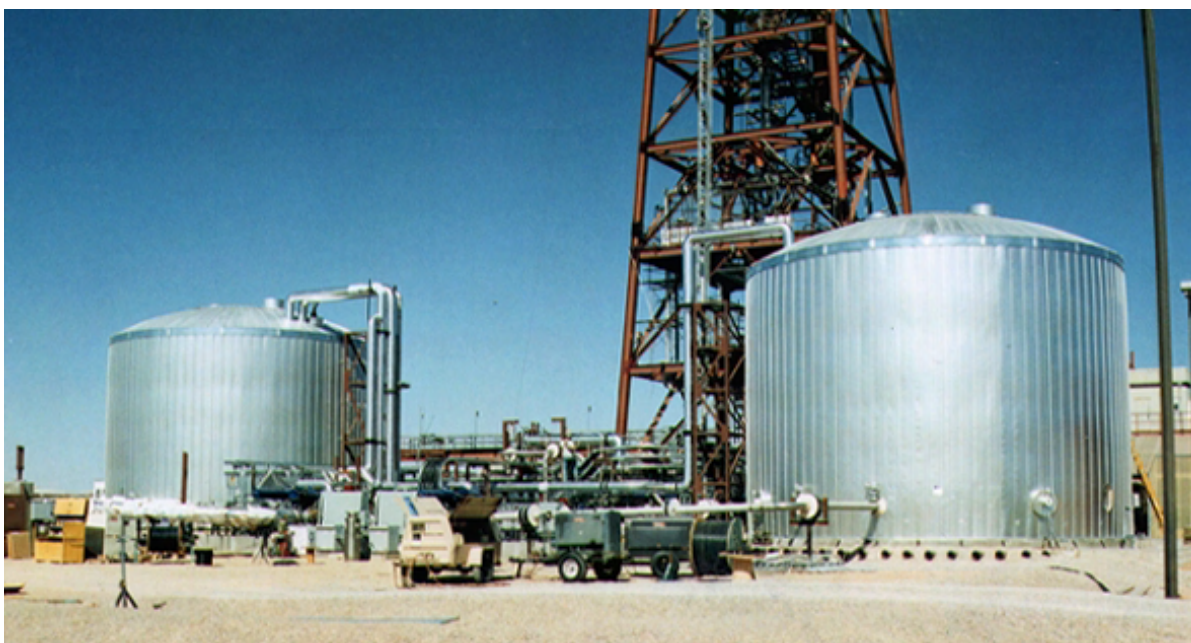
Figure 4-1. Cold (left) and hot (right) nitrate salt storage tanks.

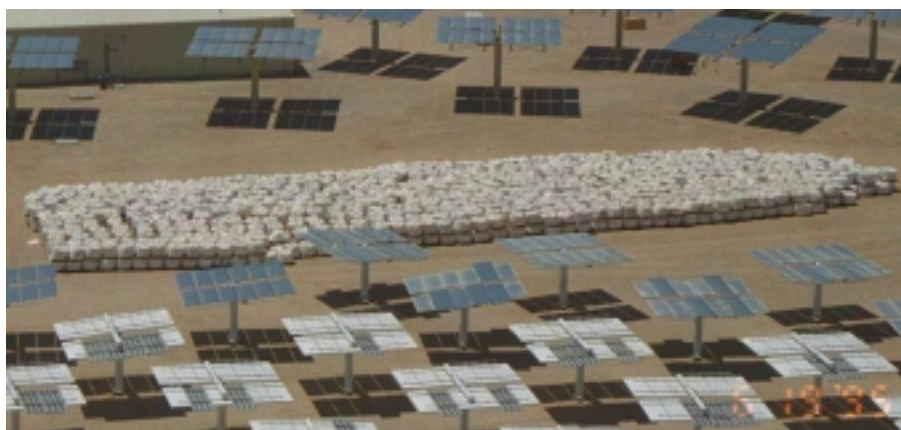
Figure 4-3. 1380 tonnes of nitrate salt awaiting melting at Solar Two.

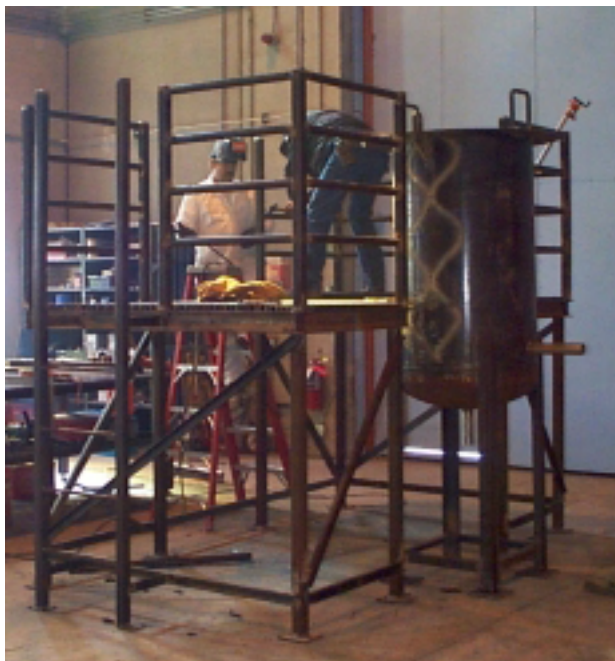
Figure 4-5. Salt recycler used to return spilled salt to the thermal storage system.

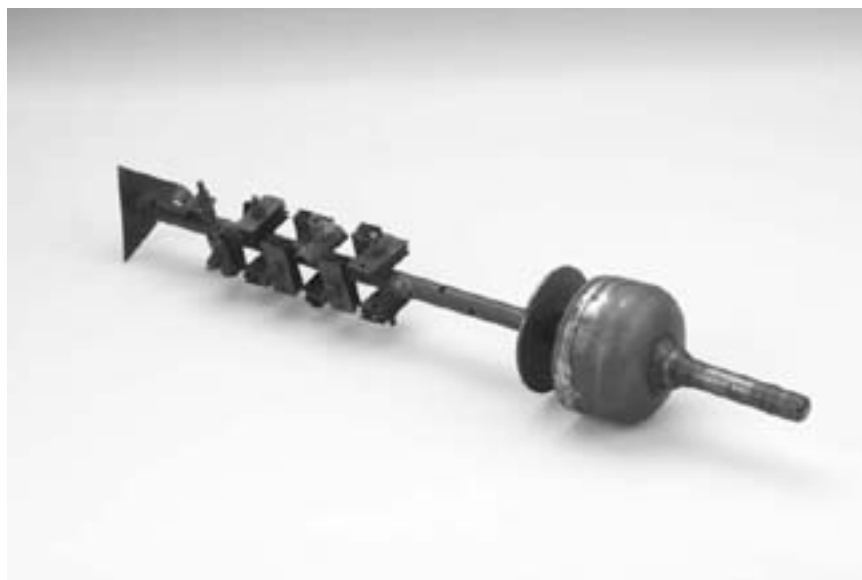
Figure H-3. Specimen mounting tree after removal from Chamber Y-251, with branches and specimens for first sampling interval already removed from the end of the tree nearest end cap.

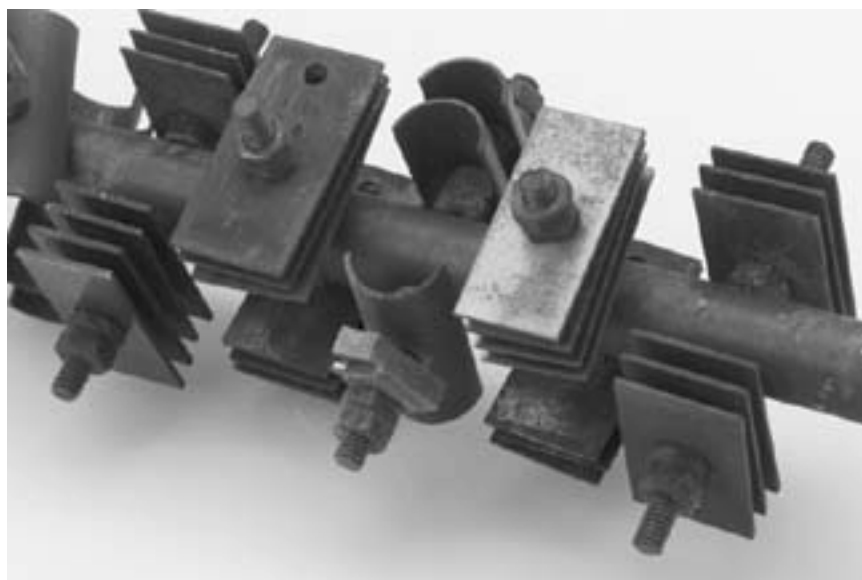
Figure H-4. Typical specimen mounting arrangement from the chamber Y-251 specimen tree. Flat coupons include 304SS and 316SS. Curved coupons are pieces of 316SS Solar Two receiver tubing.

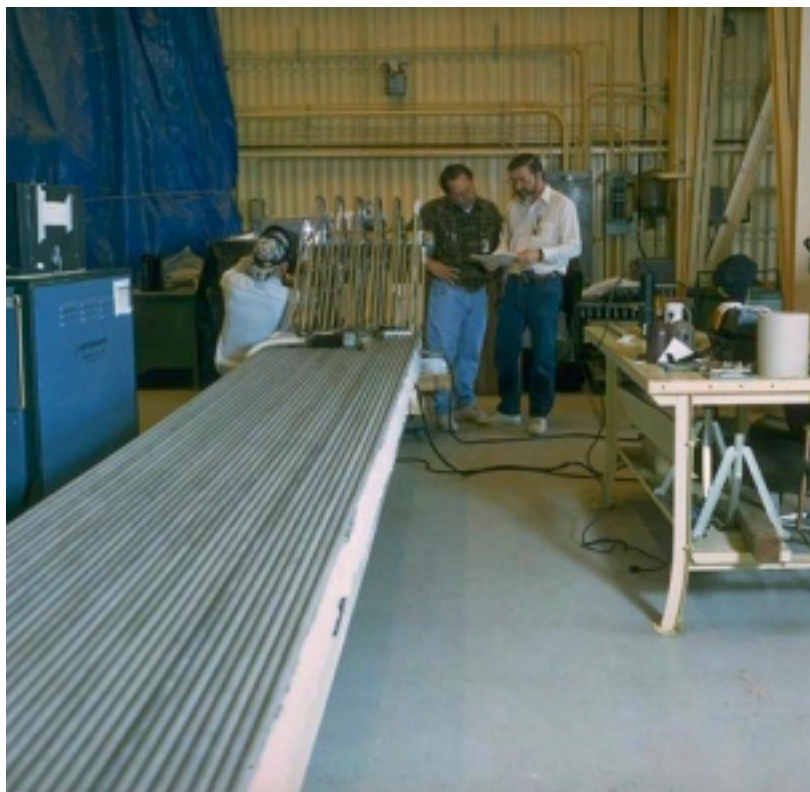
Figure H-11. Single panel from Solar Two receiver. Individual tubes can be seen in the foreground and the headers are in the background. This is before installation vertically into the receiver.

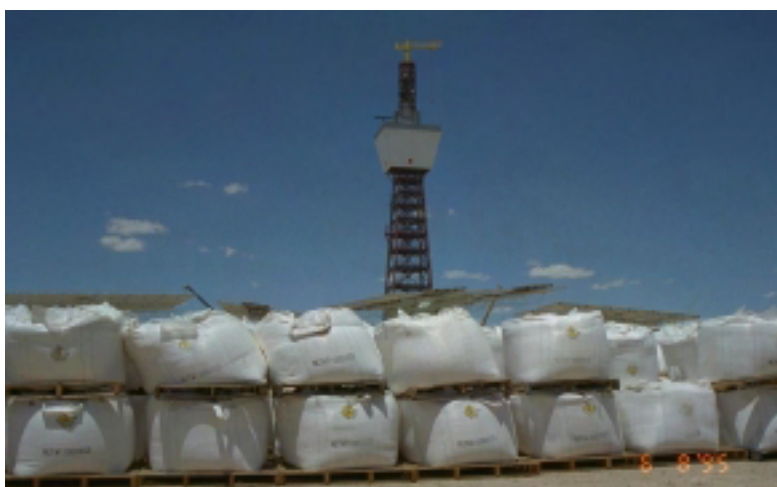
Figure L-2. 1000 kg bags of nitrate salt awaiting melting at Solar Two. The Solar One tower in the background is being prepared for installation of the new molten salt receiver.

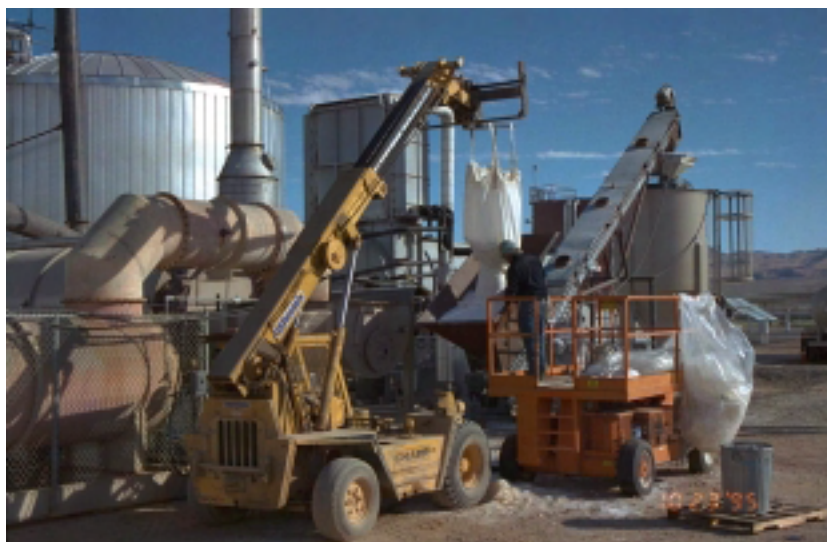
Figure L-3. The salt handling system crushed the salt and transported it to the melter.

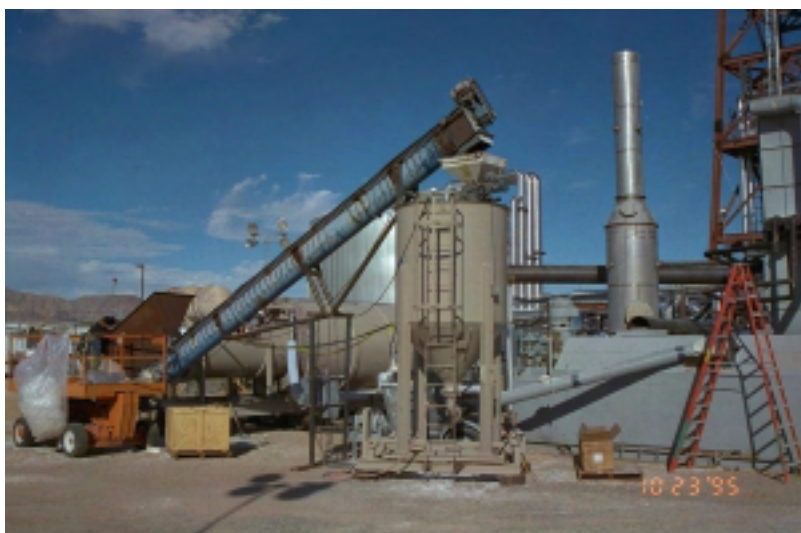
Figure L-4. Conveyor belt feeding crushed salt from the hammer mill into the salt hopper. The screw auger can be seen as the pipe feeding into the wall next to the ladder. The vent stack to dilute the NO_x can be seen in the background.

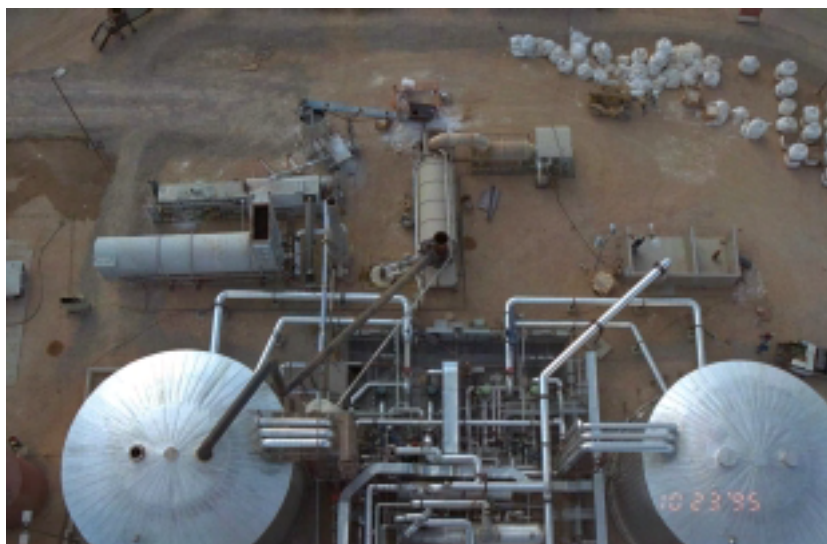
Figure L-5. Overhead view of the salt fill operation; the hot tank is on the left and the cold tank is on the right.
