| <b>Project Title:</b> | MARIPOSA ENERGY PROJECT - Compliance |
| <b>Document Title:</b> | Staff Response to Robert Sarvey's Comments |

**SUBJECT: MARIPOSA ENERGY PROJECT (09-AFC-3C)  
Staff Response to Robert Sarvey's Comments**

**MARIPOSA ENERGY PROJECT  
(09-AFC-3C)  
PETITION TO MODIFY  
Staff's Response to Comments**

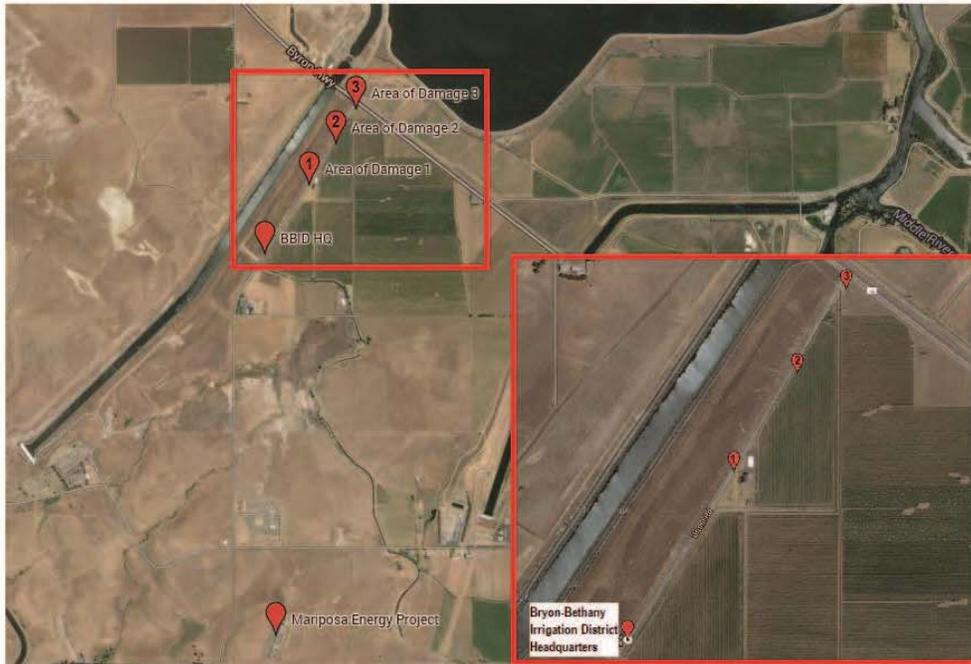
Locations of Identified Damage to Bruns Road (Numbers correspond to photos)

The first area of road damage is labeled "1" on the attached map and is the most severe. Here, the pavement is crushed at the eastern edge of the northbound lane for a distance the length of a standard truck or SUV. (See **Attachment C** for a photo of this area of damage and other areas of damage corresponding to the locations shown on the map.) The second area of road damage, labeled "2" on the attached map, consists of a minor spider web of cracks. The final area of damage is labeled "3" on the attached map. Here, a crack results in a slight difference in grade in the northbound lane of Bruns Road, near the center divide.

any roads, the MEP owner would be responsible for restoring the roads and coordinating with the CPM and the applicable agencies in accordance with **TRANS-2**. Before and after construction of the water tanks, and also before and after water transportation and demolition activities associated with the end of water curtailment, the MEP owner would need to submit documentation of road conditions to the CPM, in compliance with **TRANS-2**, and repair any road damage caused by the project.

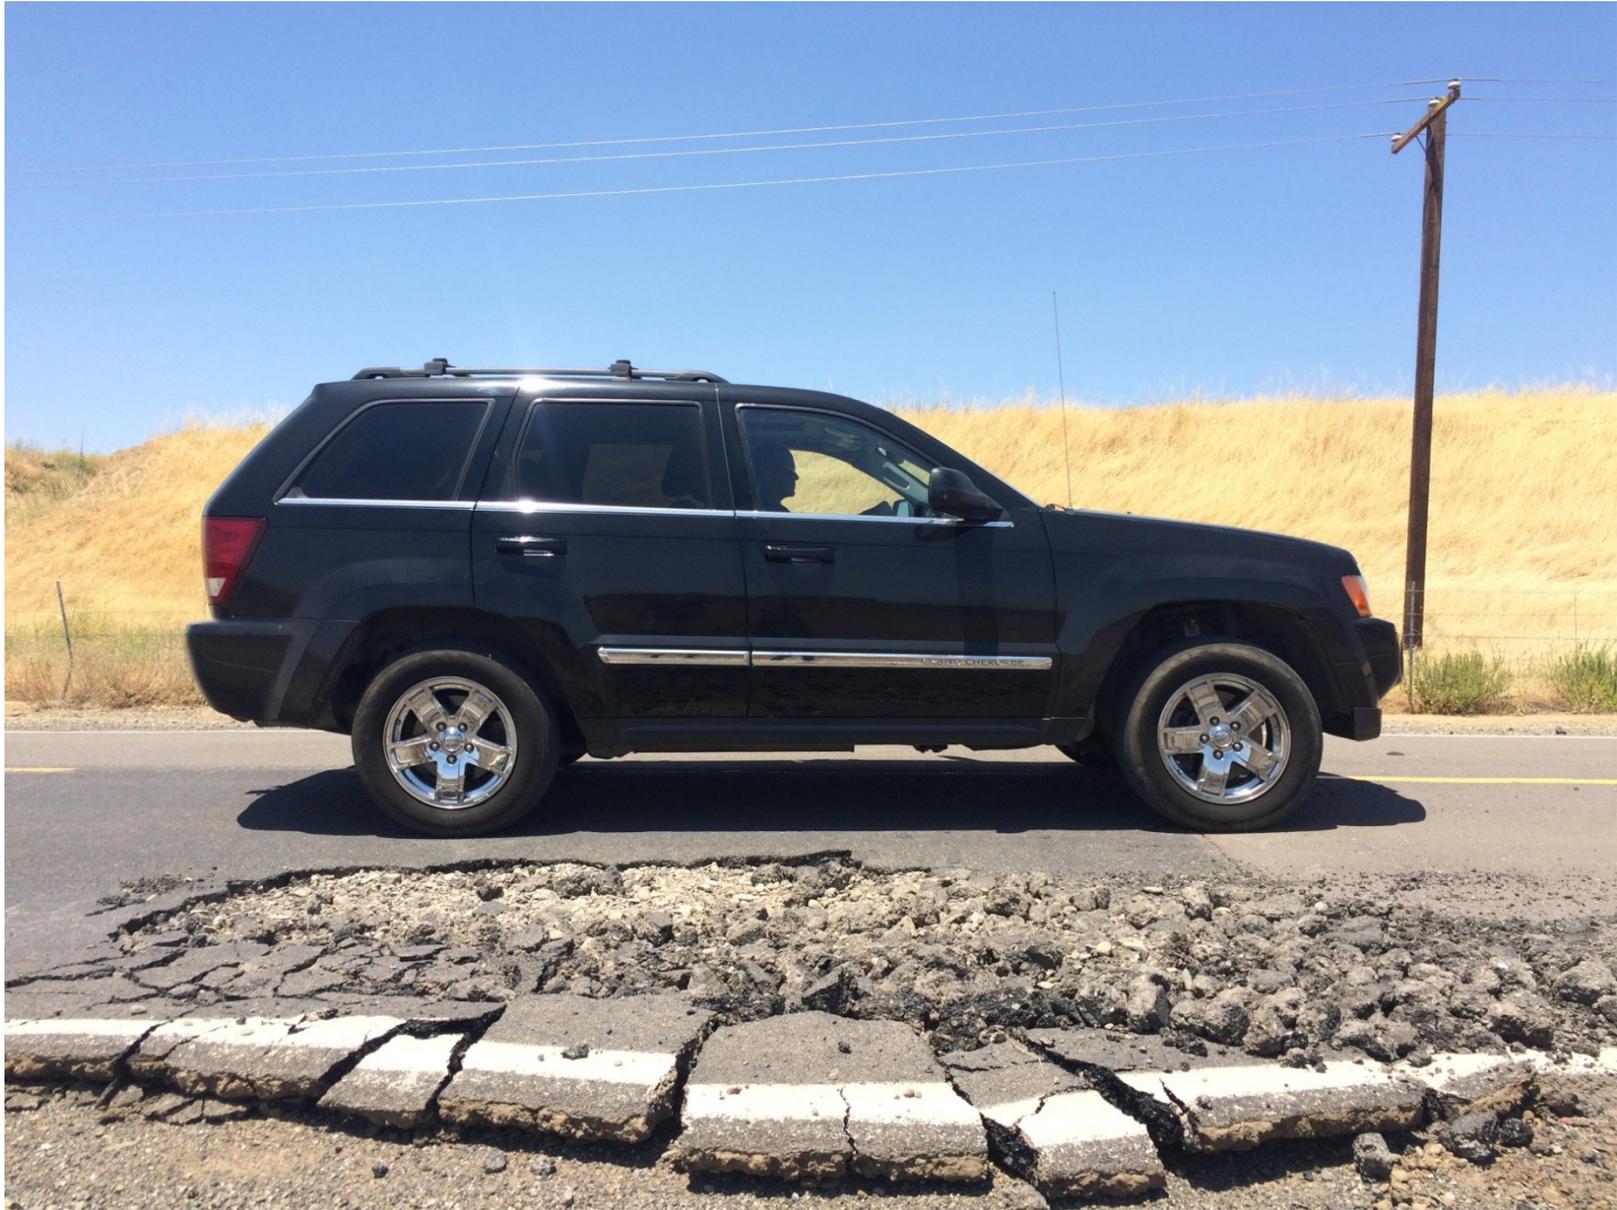
**Area of Damage 1**

Staff considers the only significant area of damage to be the area labeled "1". This damage occurred in an area that was recently paved. Staff spoke with Mr. Rich Montoya, Road Maintenance Supervisor of Contra Costa County, who said the fresh paving on Bruns Road was completed during the summer of 2014 by a utility company operating windmills in the area (TN 205295). Mr. Montoya also said that when he visited Bruns Road three or four weeks ago, the road damage that staff noticed was not present (TN 205296).

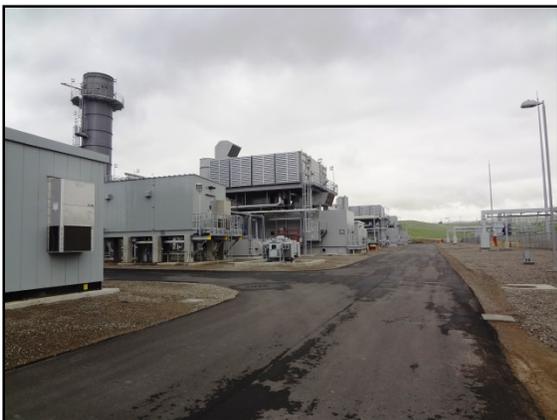
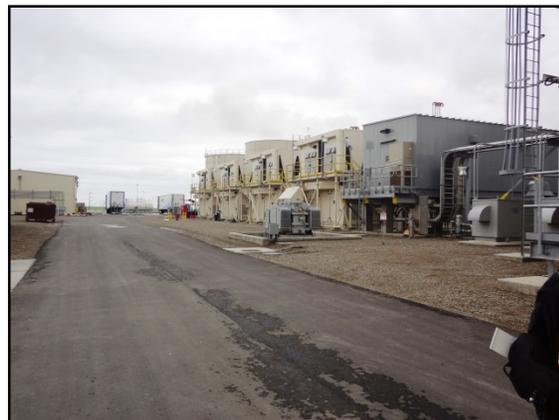
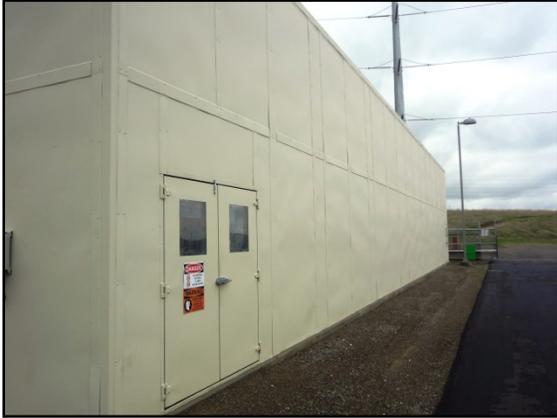
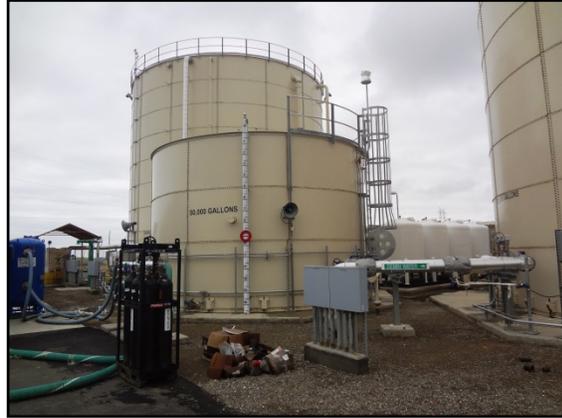
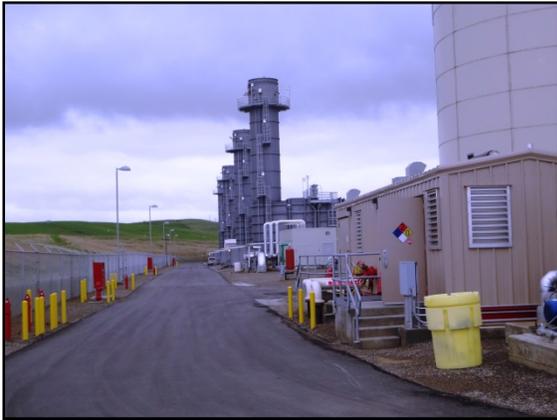
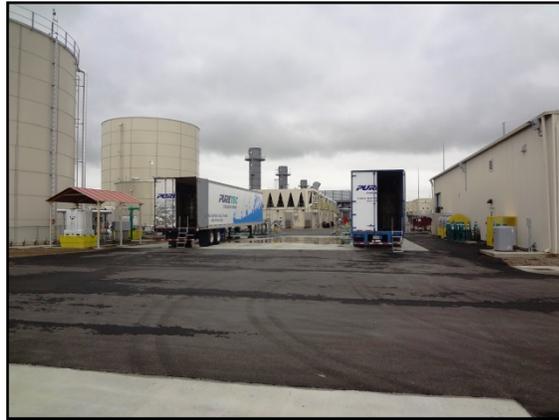
Staff has provided photographs (below) taken by staff during a site visit on December 6, 2012, showing the surface treatment of project structures and buildings. Surfaces of all project structures and buildings visible to the public are treated to minimize visual intrusion, color contrast, and reflectivity in the landscape.

Surfaces were treated with ANSI 70, or Munsell Number 5BG 7.0/0.4 (“gray”), the color specified for most major elements of the power plant. Tanks and buildings are colored Desert Tan, or Munsell Number 2.6Y 8.4/1.4 (“tan”). Staff determined the facility remained compliant on June 25, 2015.

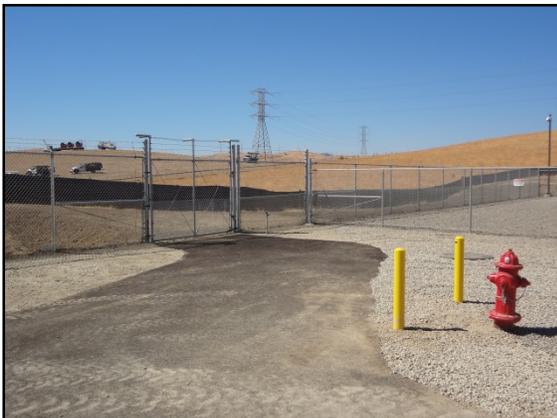
Staff has provided photographs taken by staff during site visits on September 20, 2012, and December 6, 2012, showing surface restoration. The project owner restored the ground surface to the pre-construction condition or better condition, and replaced vegetation removed during construction, where project development did not preclude it. Staff determined after the December 6<sup>th</sup> visit the facility was in compliance with **VIS-2**. Staff determined the facility remained compliant on June 25, 2015.

Surface restoration being performed in Sept. 2012.

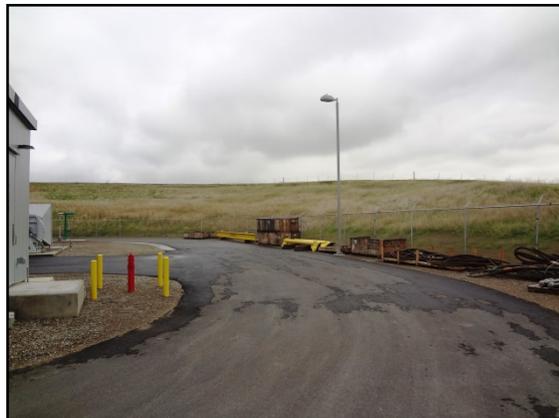
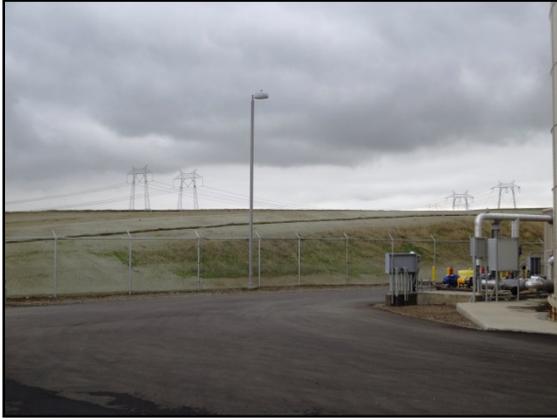
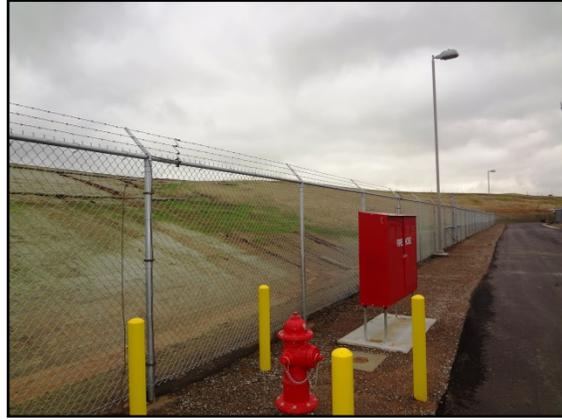
Surface restoration completed. (Dec. 6, 2012)

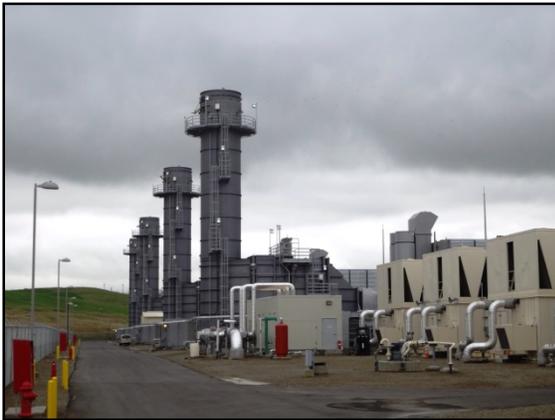
The installation of permanent exterior lighting for the facility was completed in May 2012. All exterior light fixtures are cut-off reflector type or hooded/shielded. Flood lights are positioned for optimal angle to intended area. See photos below. Staff found no written record of a light trespass complaint being received as of July 1, 2015.

Photo shows installed shielded light fixtures on the exhaust stacks and perimeter lighting fixtures (Holophane Mongoose lighting luminaires) for the Mariposa Energy Project. (Dec. 6, 2012)

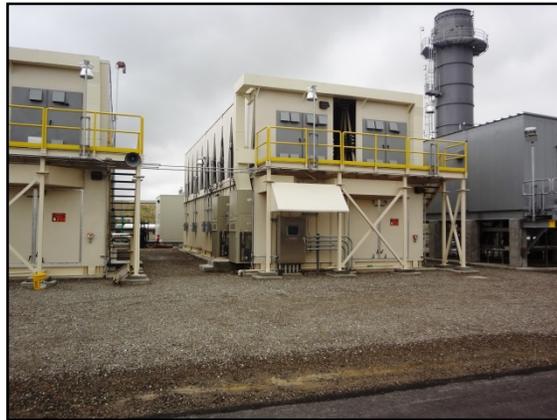
Photo shows installed shielded light fixtures on the chiller air-cooled radiator and a flood light fixture directed downward. (Dec. 6, 2012)

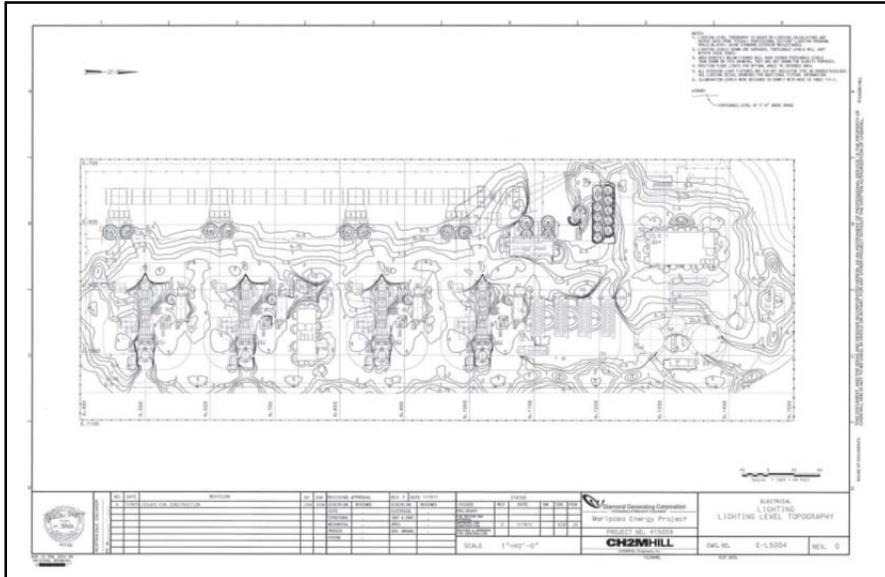
Lighting level topography (dated Nov. 18, 2011) in the permanent exterior lighting plan filed with the CEC for the Mariposa Energy Project. The permanent exterior lighting plan was approved by staff on December 15, 2011.

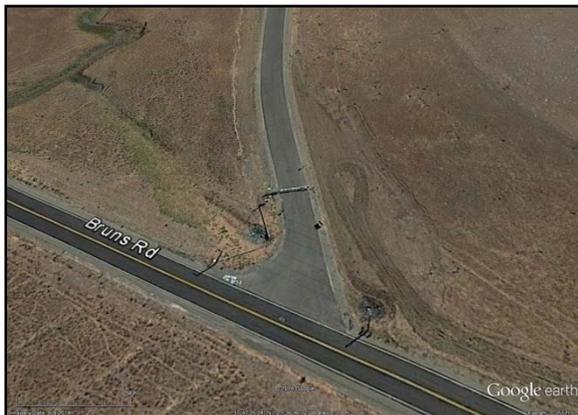
Mariposa Energy, LLC, installed a publicly visible facility identification sign near the vehicle access gate, approximately 40 feet from Bruns Road. The framed sign dimensions are 4 feet wide by 6 feet tall supported by two painted aluminum posts with two feet of ground clearance underneath. The sign was reviewed by the Alameda County Community Development Agency. The sign was approved by Energy Commission staff on January 23, 2014.

Google Earth aerial view showing the installed facility sign identifying the Mariposa Energy Project near the vehicle access gate. (June 9, 2014)

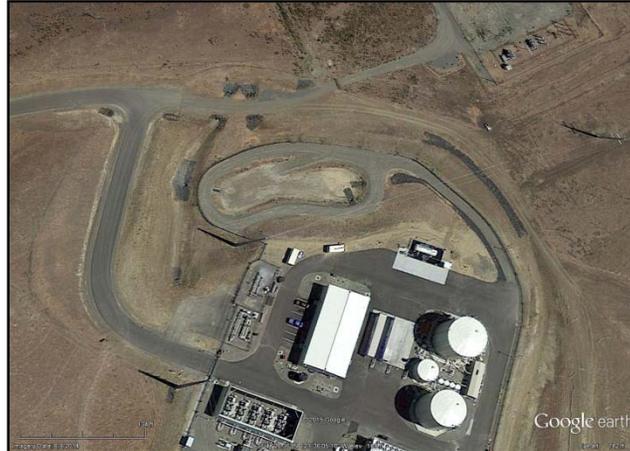
The Landscape and Irrigation Plan for the Mariposa Energy Project was reviewed by the Alameda County Community Development Agency. It was approved by staff on March 13, 2012. Mariposa Energy, LLC, installed drought tolerant plant species along the northern boundary of the facility site. The toyon species (an evergreen shrub to small tree usually grows to 6-8 ft. high and 4-5 ft. wide) was selected using the Alameda

Aerial view of the northern boundary of the facility site shows planted toyon (dark dots) along the retention pond and grassland revegetation. (June 9, 2014)

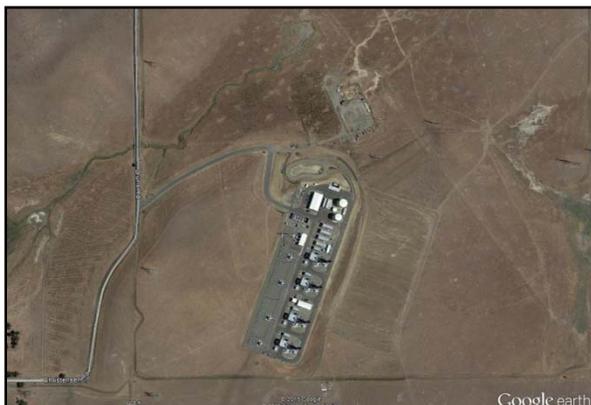
As explained in staff's analysis for the additional water storage tanks, the water tanks are to be located on a portion of the site of the former Byron Power Cogeneration Plant, a two-acre site immediately north of the Mariposa facility site. The 6.5 megawatt plant was demolished sometime after 2012. About 1.3 acres of the site remains disturbed since the demolition of the cogeneration plant.

Aerial view of the Mariposa facility and the former Byron Power Cogeneration Plant site. The view also shows restored surface area. (2014)
