Docket Number:	16-AFC-01
Project Title:	Stanton Energy Reliability Center
TN #:	220821
Document Title:	Stanton Energy Reliability Center Data Request Response Set 2, for Data Requests A64 through A70
Description:	N/A
Filer:	M. Finn
Organization:	CH2M
Submitter Role:	Applicant Consultant
Submission Date:	8/17/2017 2:02:53 PM
Docketed Date:	8/17/2017

Responses to California Energy Commission Staff
Data Requests A64 through A70

Stanton Energy Reliability Center

16-AFC-1

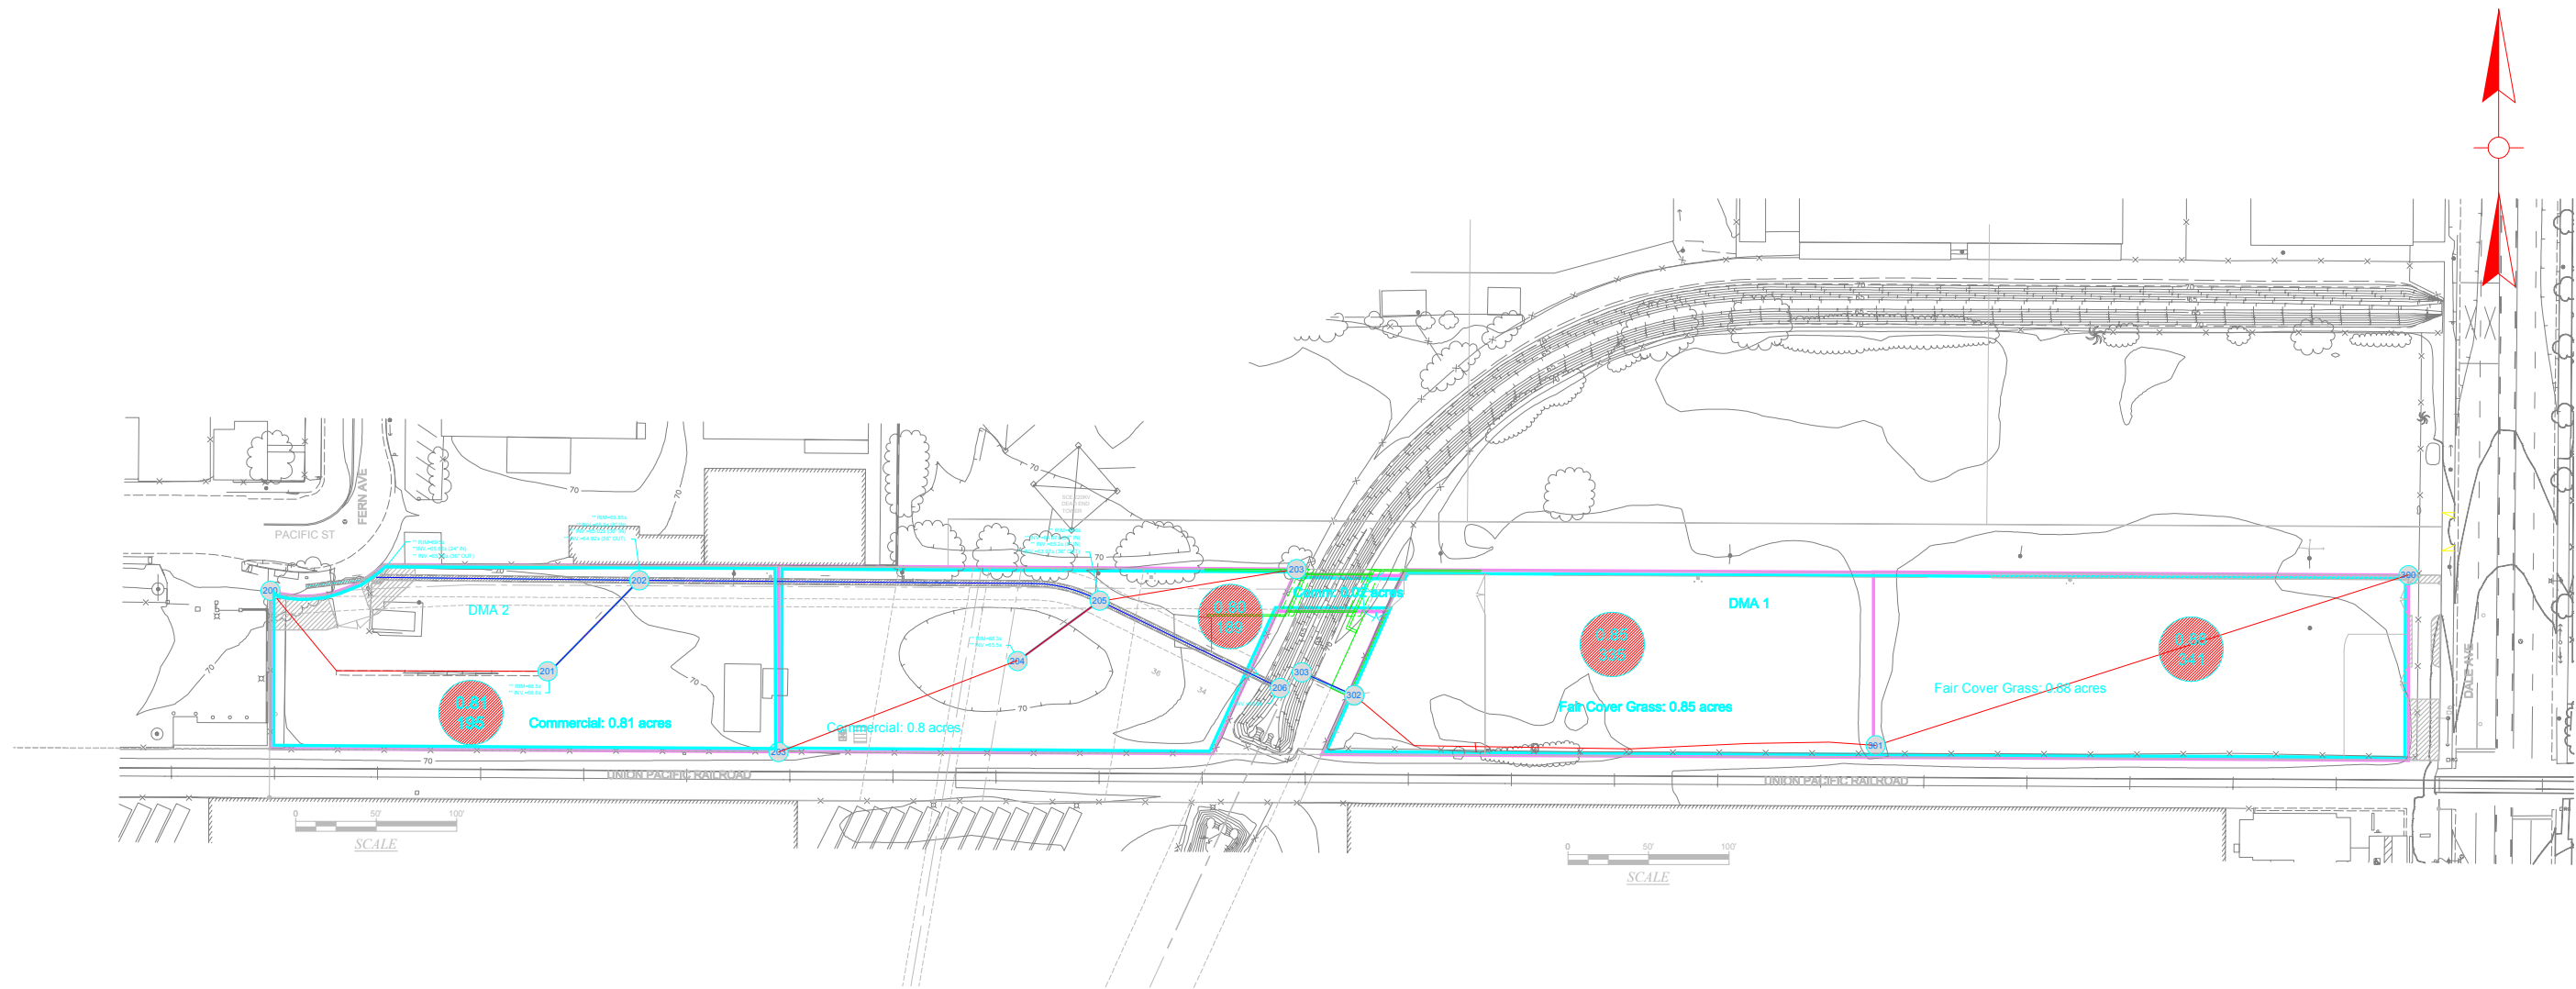
Figure DRA70-1
Hydrology Map of the Existing System

Response: SERC LLC's response to Staff's Data Requests A38 included figures for each parcel showing the pre- and post-project stormwater drainage features (reproduced here as Figures DRA70-1 and DRA70-2, respectively). Parcel 2 (the western parcel) has two existing catch basins that collect stormwater, identified by Node Nos. 201 and 204 in Figures DRA70-1 and DRA70-2. The catch basins at Nodes 201 and 204 will be retained and are each independently connected via 8-inch ductile iron pipes to an existing 36-inch reinforced concrete pipe that runs from west to east just south of the northern border of Parcel 2 (connections are at Node Nos. 202 and 205, respectively). This large pipe conveys stormwater from the residential area located northwest of Parcel 2 to the Stanton Storm Channel, which passes through the east end of Parcel 2. The discharge location of the 36-inch reinforced concrete pipe is identified as Node No. 206 in Figures DRA70-1 and DRA70-2. No new catch basins are proposed for Parcel 2.

Parcel 1 (the eastern parcel) has a single existing catch basin that collects stormwater from Parcel 1 as well as the property north of Parcel 1. This catch basin, identified by Node No. 302 in Figure DRA70-1, currently discharges via an existing 24-inch corrugated metal pipe to the Stanton Storm Channel at Node No. 303 in Figure DRA70-1. Post-project, this catch basin will be reconfigured to accept only stormwater from the property north of Parcel 1 via a new 18-inch pipe that will parallel the Stanton Storm Channel. An inlet to the new 18-inch pipe will be incorporated into the structure for the new traffic bridge that will be in the northeast corner of Parcel 1. Thus, no project stormwater will flow through the existing stormwater facilities on Parcel 1.

Figure DRA70-1
Hydrology Map of Existing System
 Stanton Energy Reliability Center AFC
 Stanton, California
