Stanton Energy Reliability Center

CEC Docket No. 16-AFC-01
Monthly Compliance Report No. 8
Reporting Period: September 2019

Prepared by Stanton Energy Reliability Center, LLC (SERC)
Submitted October 12, 2019

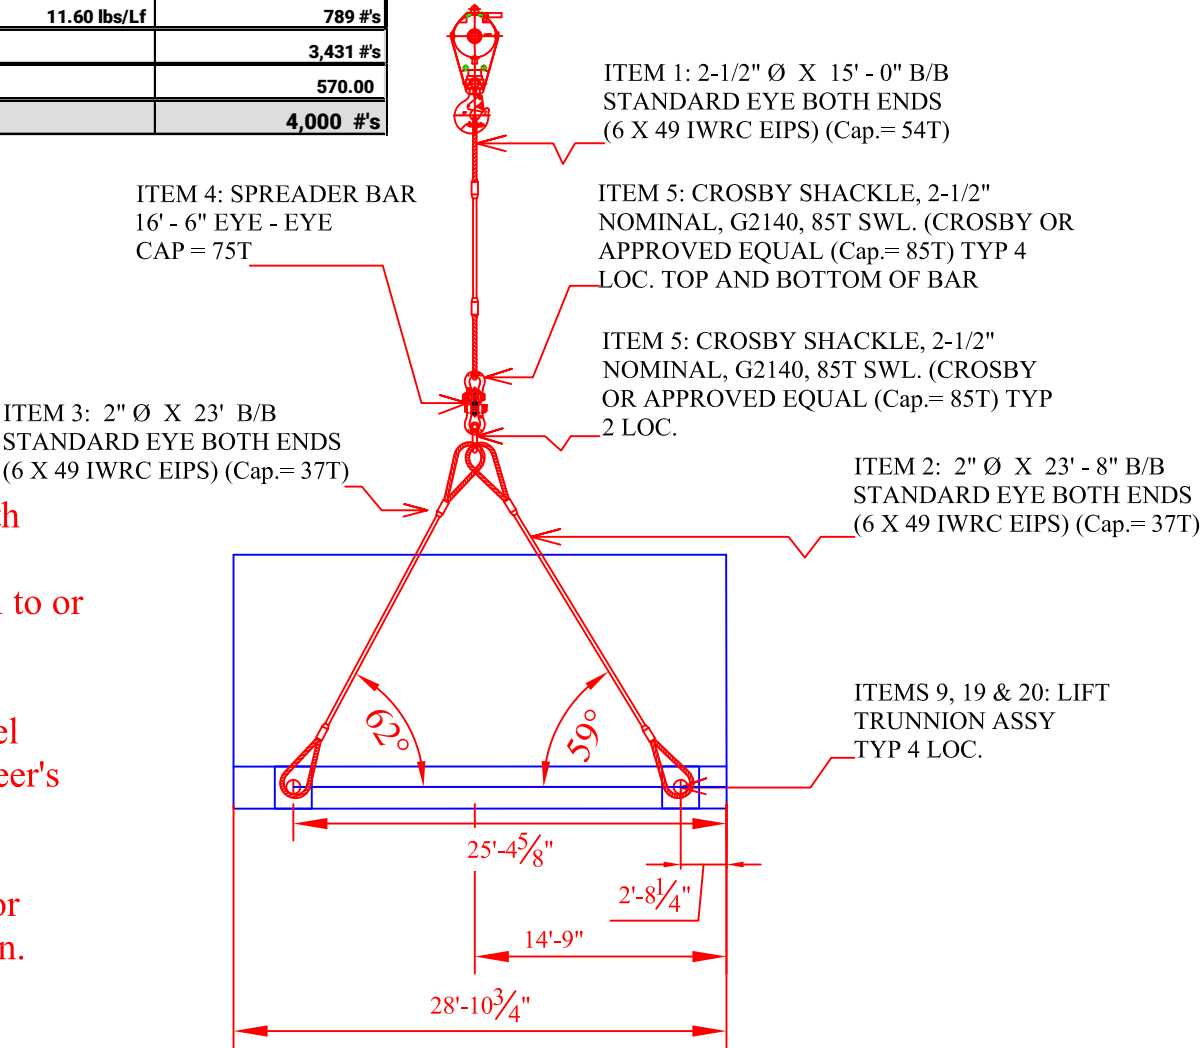
SIDE VIEW

LOAD WEIGHT = 95,918 lbs.

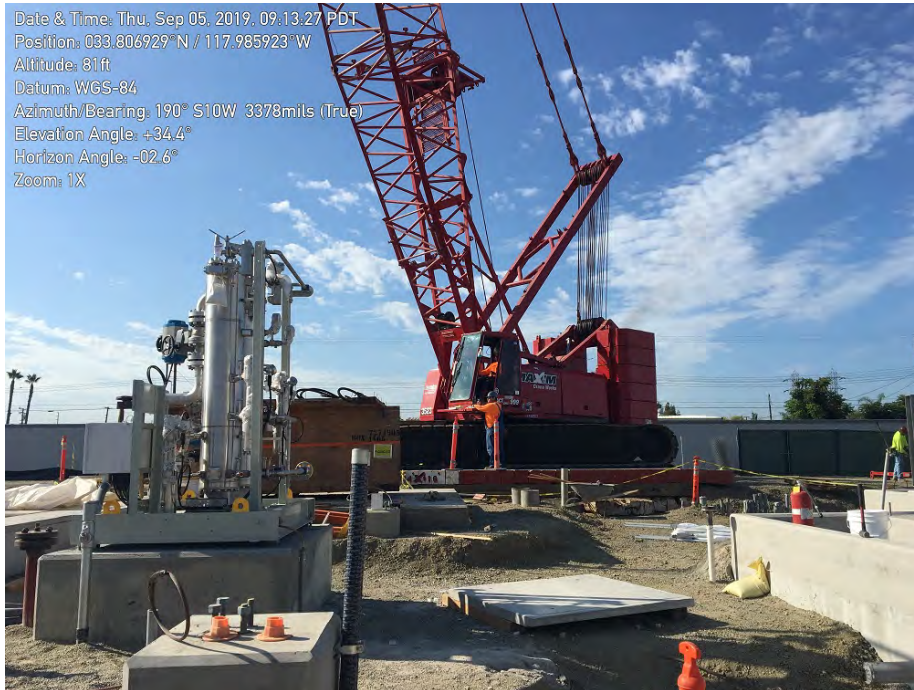
Location	SERC – Eastern Parcel	Description	View west from western portion of Eastern Parcel at 999 crawler crane in position on pad, ready to lift gas compressor unit into place. This crane has a 275-ton (U.S.) lifting capacity.
-----------------	-----------------------	--------------------	---

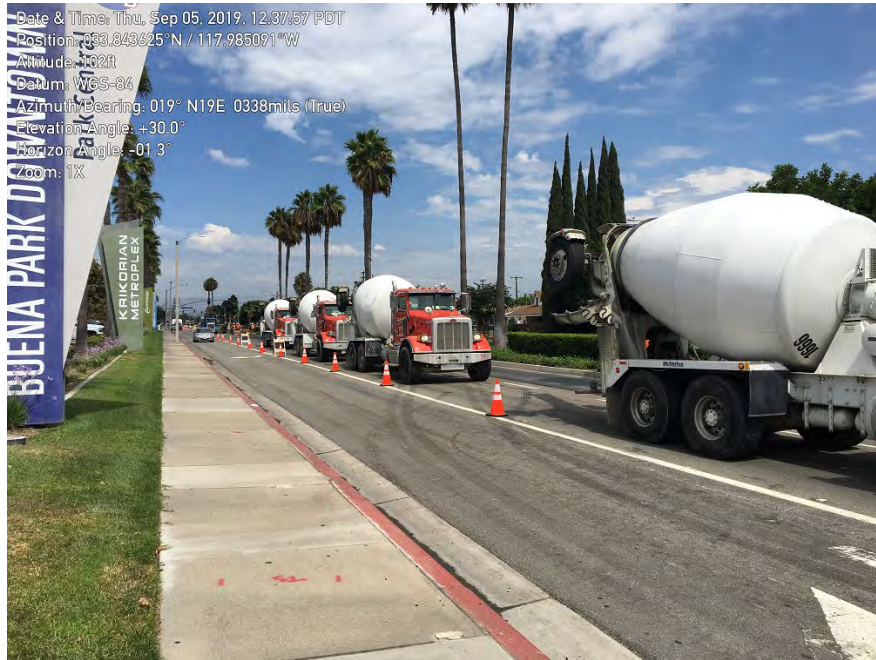
Photo 11

Location	Dale Avenue Gas Pipeline – Northern Section	Description	View north-northeast along Dale Avenue of cement trucks staged and ready to pour slurry into pipeline excavation.
----------	---	-------------	---

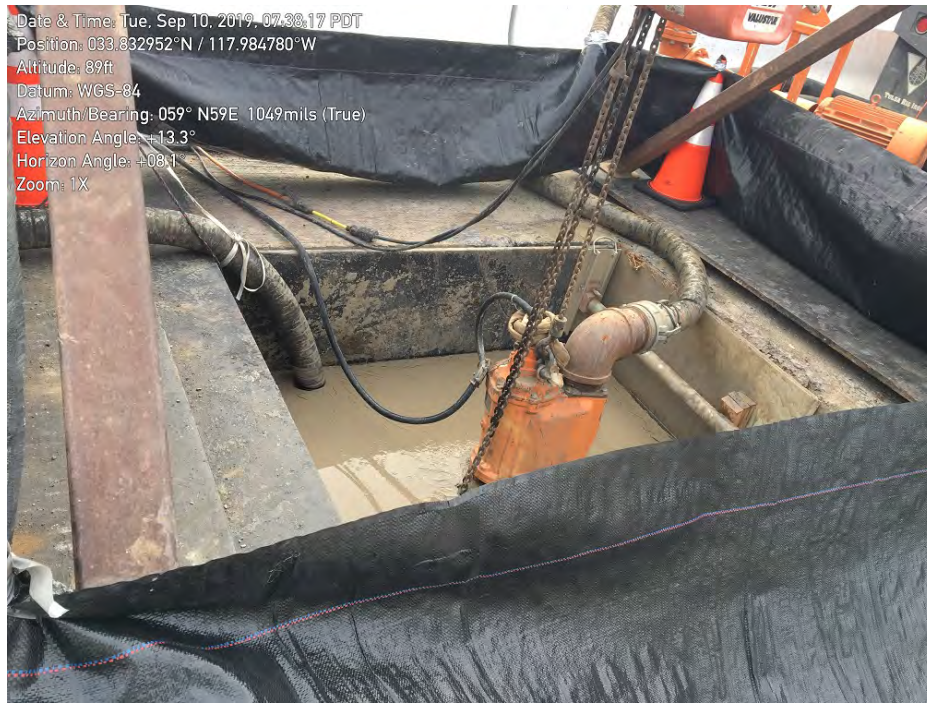
Photo 3

Location	Dale Avenue Gas Pipeline – Middle Section – HDD	Description	View of mudpit adjacent to HDD entry point for receiving fluid from bore hole prior to processing by the recycler.
-----------------	---	--------------------	--

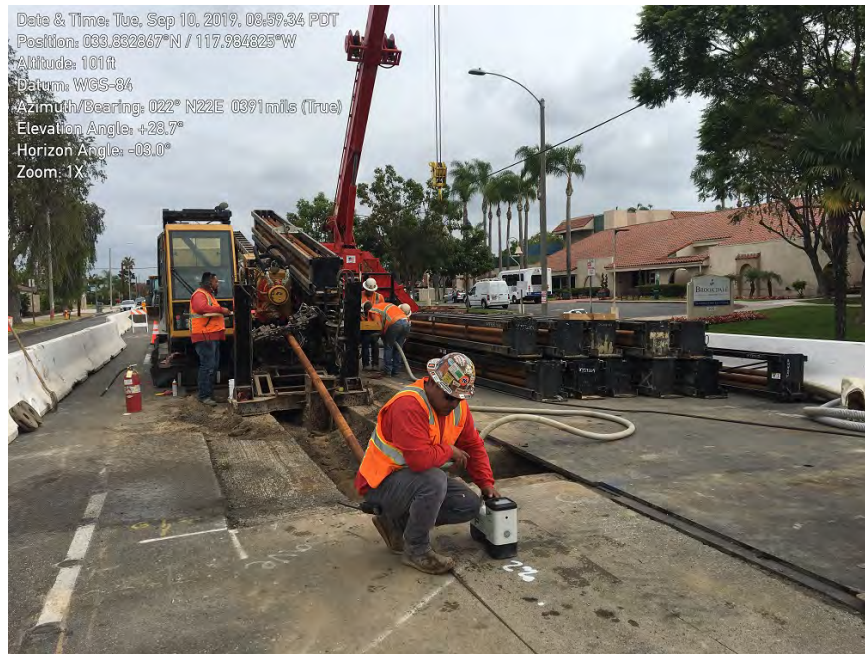
Photo 5

Location	Dale Avenue Gas Pipeline – Middle Section – HDD	Description	View north-northeast along Dale Avenue at driller using a wireless receiving device to assess exact location and depth of drill head.
----------	---	-------------	---

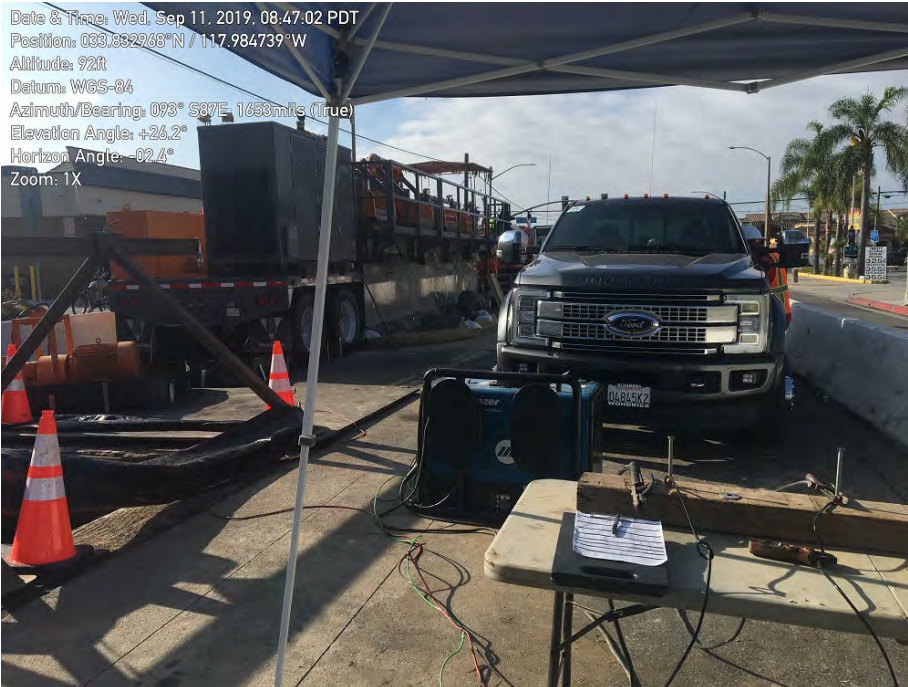
Photo 2

Location	Dale Avenue Gas Pipeline – Middle Section – HDD	Description	View south along Dale Avenue north of the intersection with Lincoln Avenue at recycler (at left) and truck (at right) where readout of data from drill head is being monitored.
-----------------	---	--------------------	---

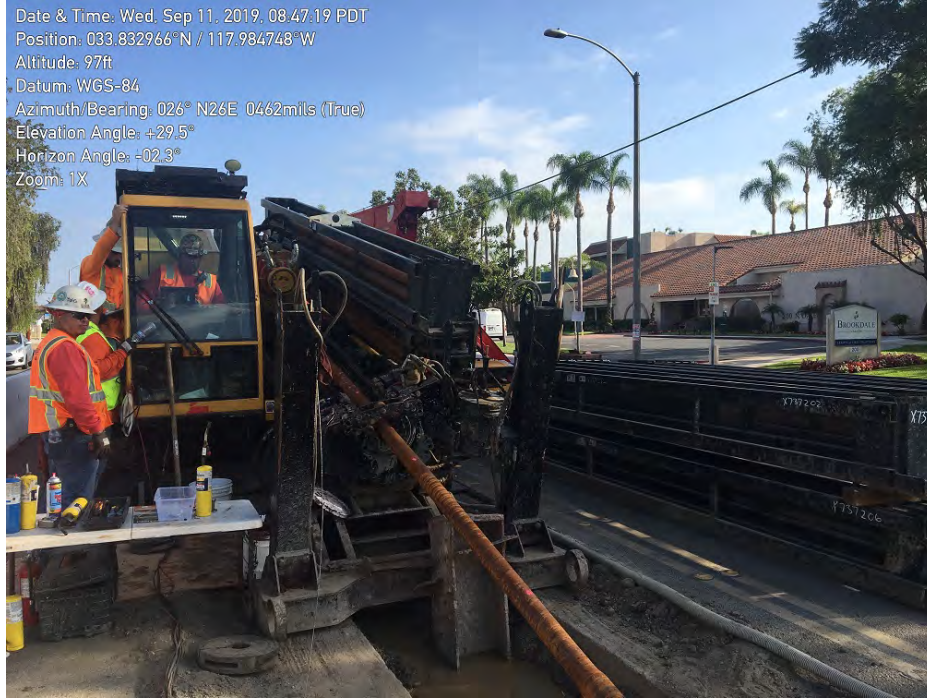
Photo 3

Location	Dale Avenue Gas Pipeline – Middle Section – HDD	Description	View north-northeast along Dale Avenue north of the intersection with Lincoln Avenue at HDD rig operator in cab of machine, directing the borer (at center of photo) angle and speed of entry.
----------	---	-------------	--

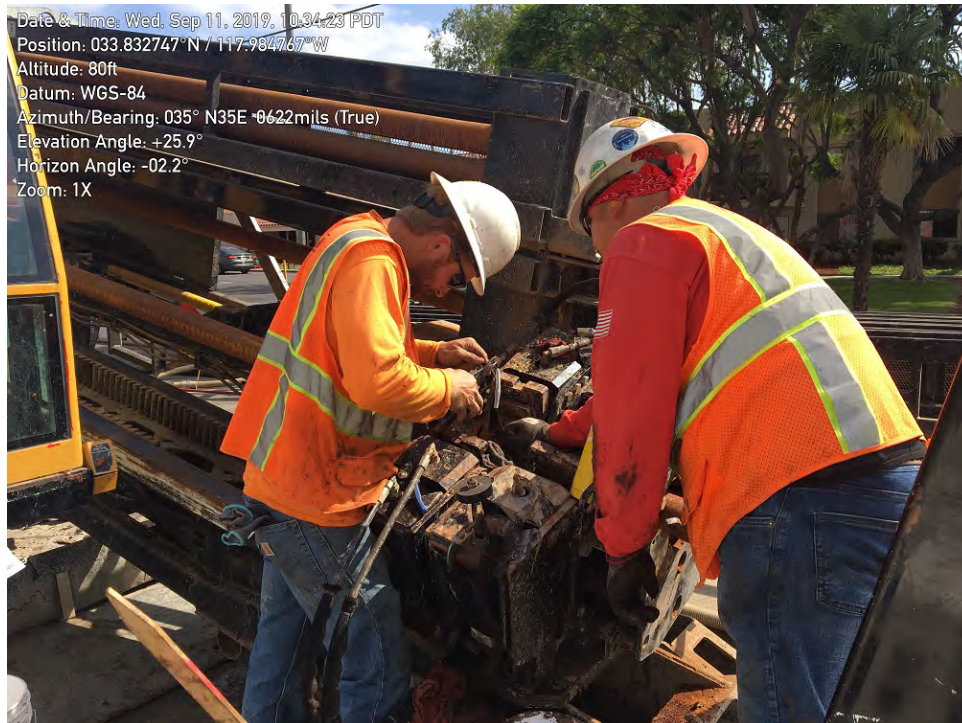
Photo 4

Location	Dale Avenue Gas Pipeline – Middle Section – HDD	Description	View of workers splicing locator line for insertion into the next boring section.
----------	---	-------------	---

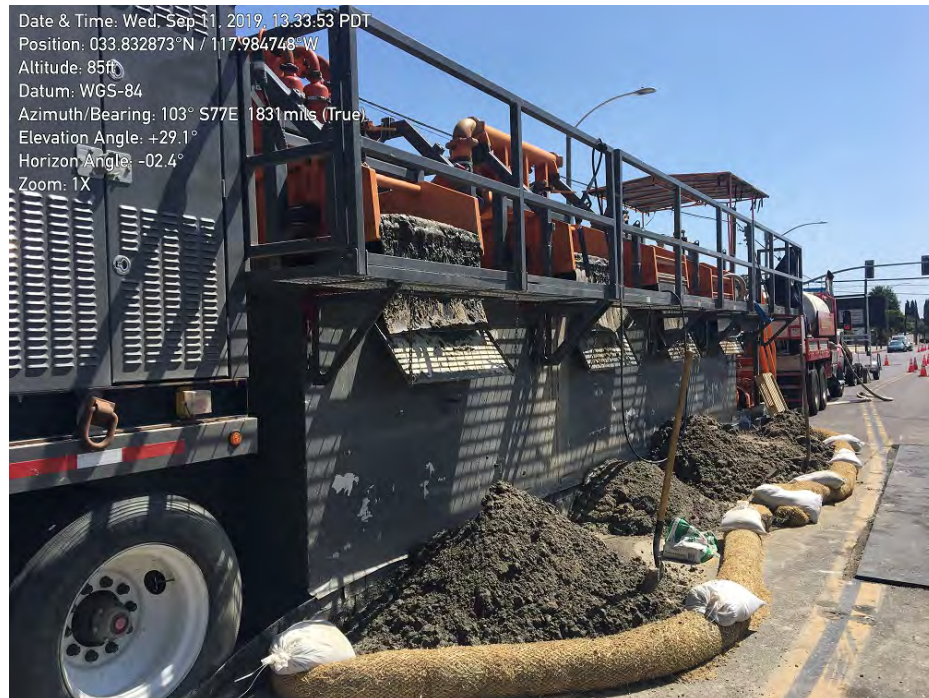
Photo 6

Location	Dale Avenue Gas Pipeline – Middle Section – HDD	Description	View south-southeast along Dale Avenue north of the intersection with Lincoln Avenue at piles of tailings being extruded from the mud pit recycler.
----------	---	-------------	---

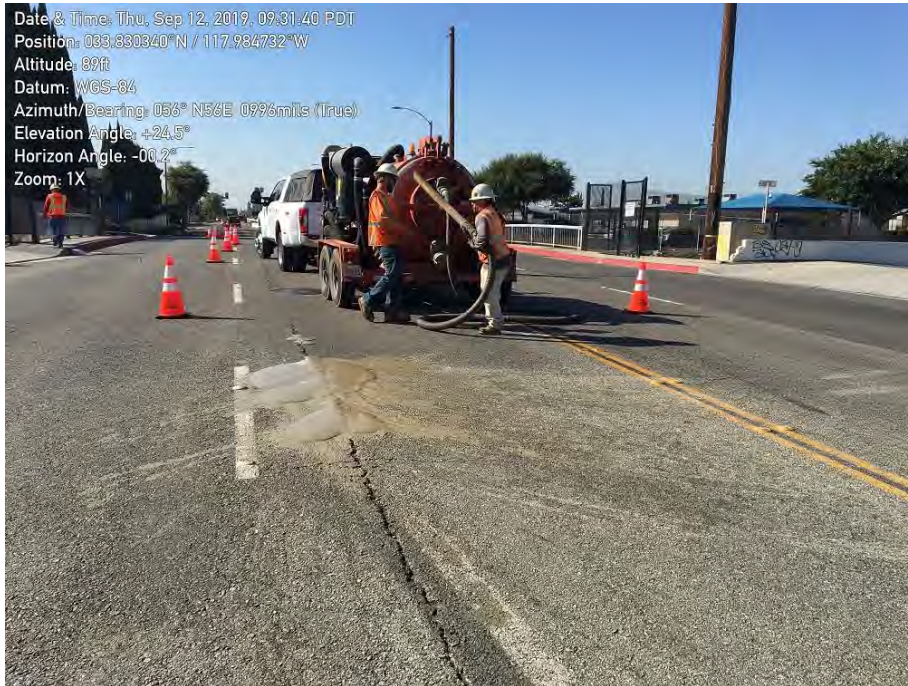
Location	Dale Avenue Gas Pipeline – Middle Section – HDD	Description	Drilling mud seeping from an old fissure in the Dale Avenue asphalt north of Carbon Creek. View facing south.
----------	---	-------------	---

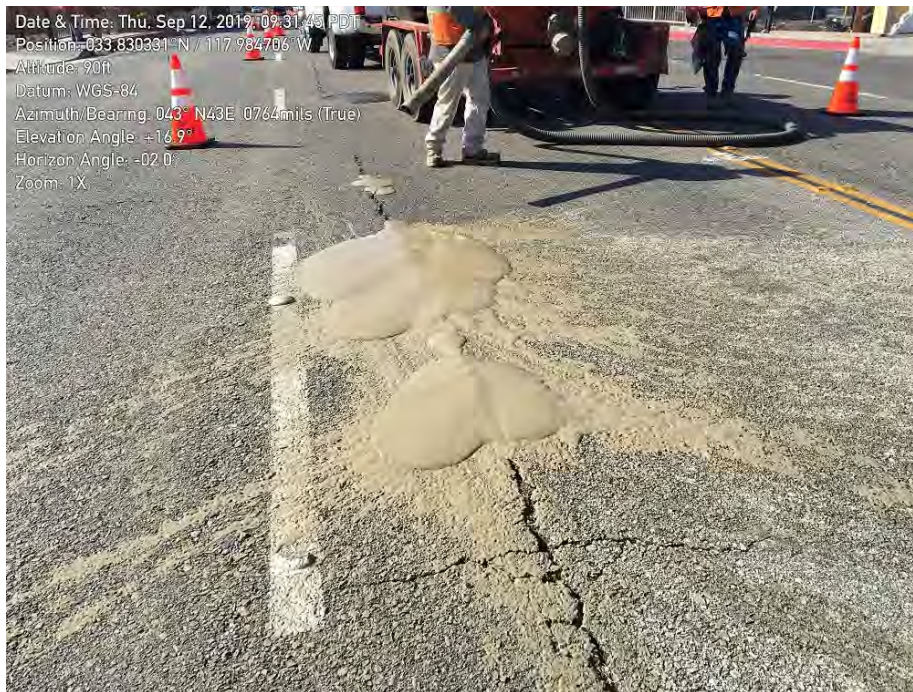
Photo 2

Location	Dale Avenue Gas Pipeline – Middle Section – HDD	Description	Drilling mud seeping from an old fissure in the Dale Avenue asphalt north of Carbon Creek. View facing south.
----------	---	-------------	---

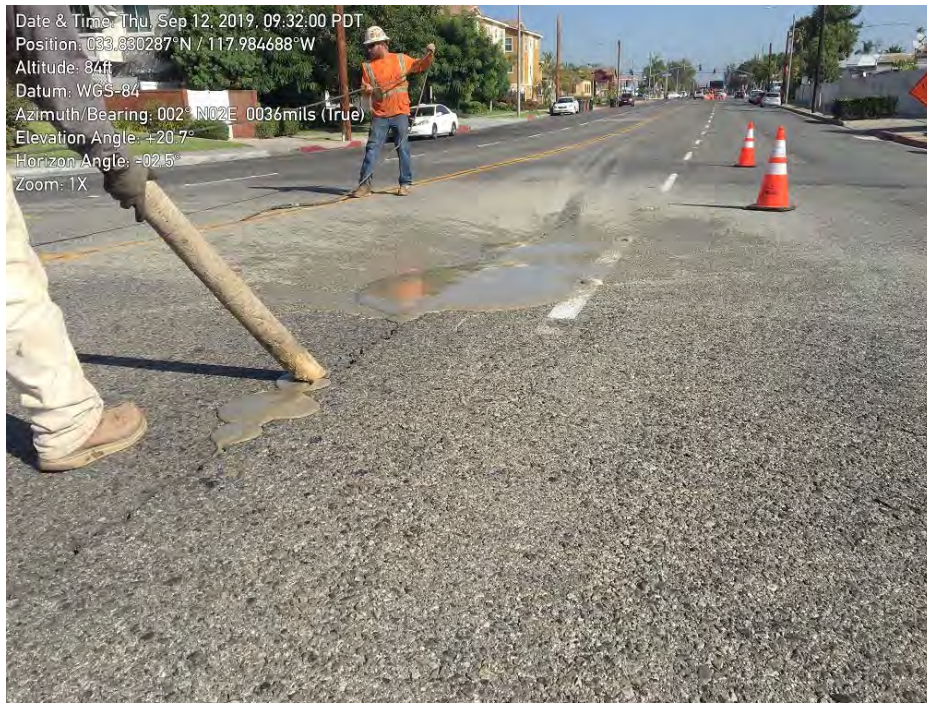
Photo 3

Location	Dale Avenue Gas Pipeline – Middle Section – HDD	Description	Clean-up of drilling mud seeping from an old fissure in the Dale Avenue asphalt north of Carbon Creek. View facing north.
-----------------	---	--------------------	---

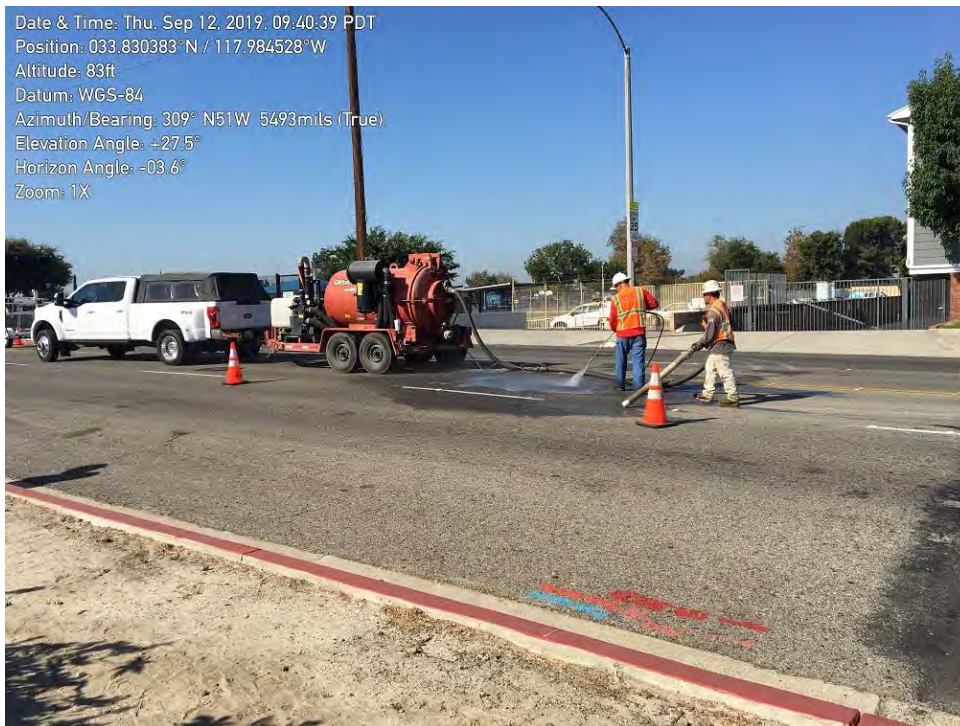
Photo 4

Location	Dale Avenue Gas Pipeline – Middle Section – HDD	Description	Clean-up of drilling mud seeping from an old fissure in the Dale Avenue asphalt north of Carbon Creek. View facing west.
-----------------	---	--------------------	--

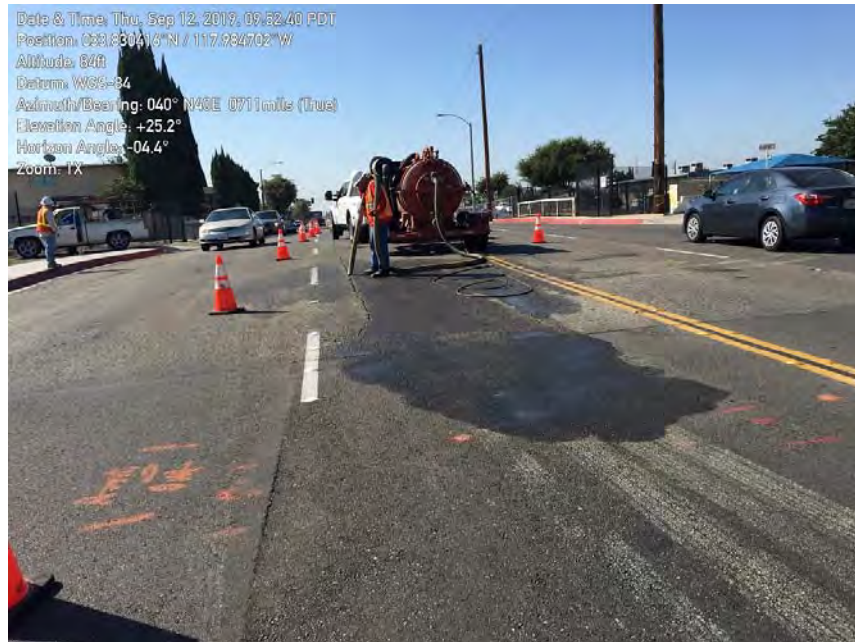
Photo 5

Location	Description
Dale Avenue Gas Pipeline – Middle Section – HDD	Clean-up of drilling mud seeping from an old fissure in the Dale Avenue asphalt north of Carbon Creek. View facing south.

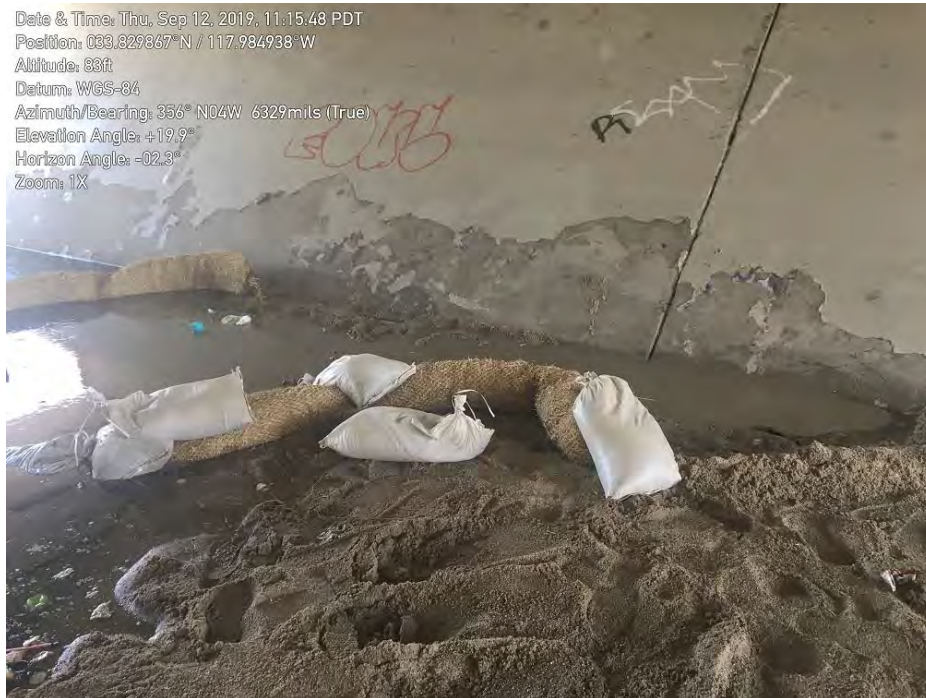
Photo 6

Location	Description
Dale Avenue Gas Pipeline – Middle Section – HDD	Containment of drilling mud in Carbon Creek under the Dale Avenue bridge. View facing north.

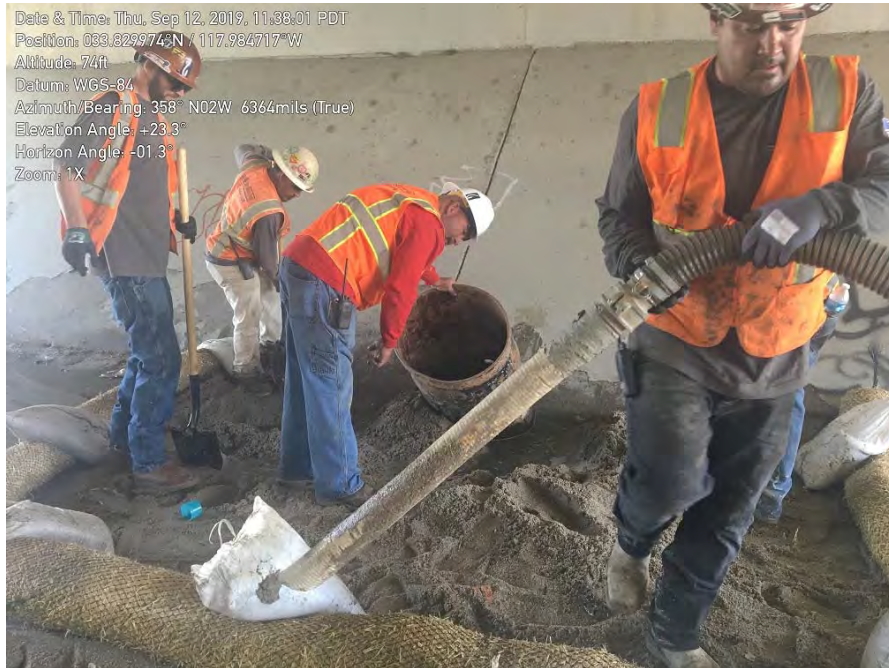
Photo 7

Location	Dale Avenue Gas Pipeline – Middle Section – HDD	Description	Containment and clean-up of drilling mud in Carbon Creek under the Dale Avenue bridge. View facing north.
----------	---	-------------	---

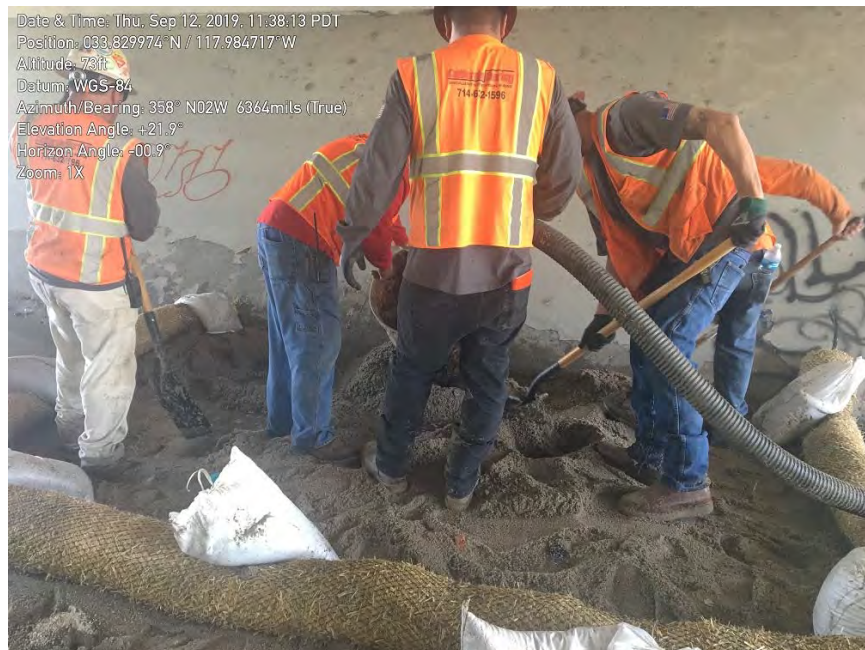
Photo 8

Location	Dale Avenue Gas Pipeline – Middle Section – HDD	Description	Containment and clean-up of drilling mud in Carbon Creek under the Dale Avenue bridge. View facing north.
----------	---	-------------	---

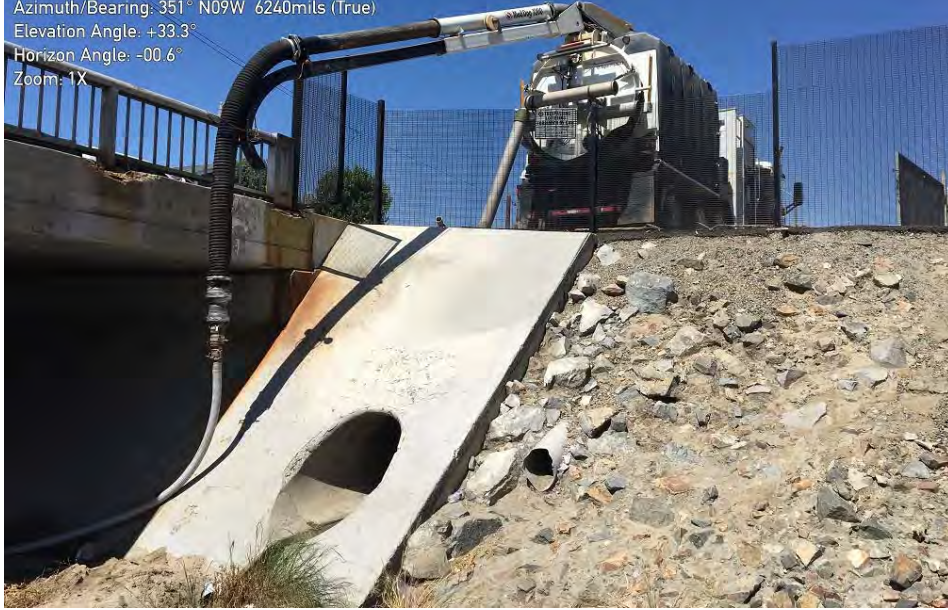
Photo 9

Vacuum truck used for clean-up of drilling mud in Carbon Creek
under the Dale Avenue bridge. View facing north.

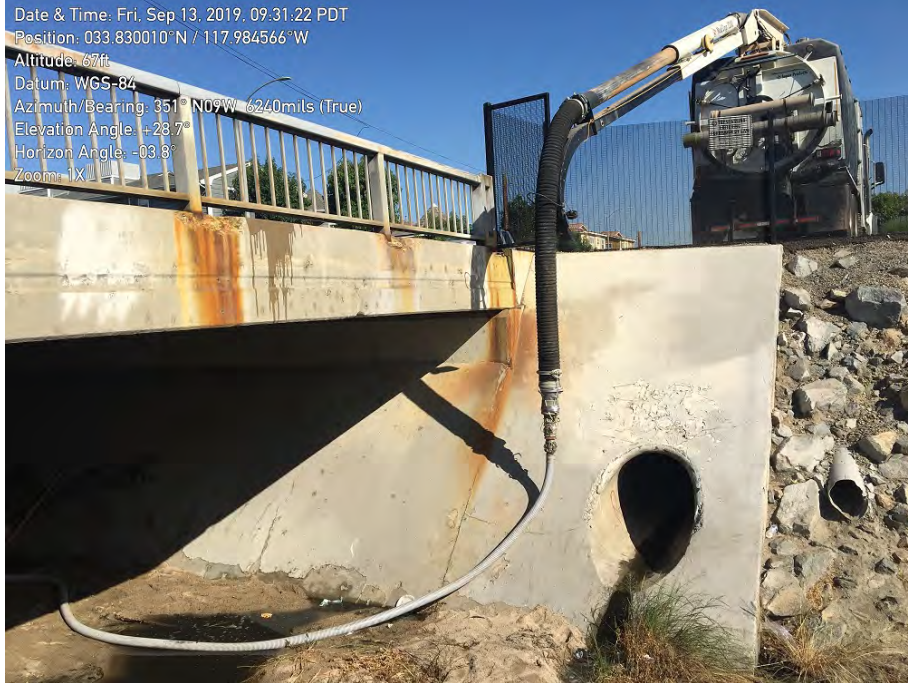
Photo 1

Location	Dale Avenue Gas Pipeline – Middle Section – HDD	Description	View from Carbon Creek of large hydro-vac truck staged in case of frac-out at site of previous day's incident.
----------	---	-------------	--

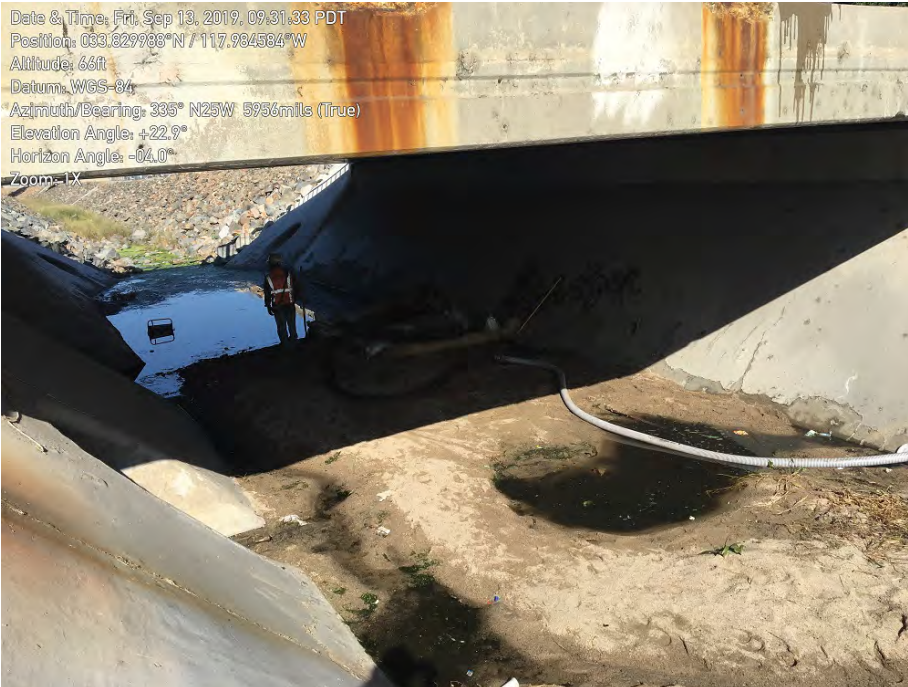
Photo 3

Location

Dale Avenue Gas Pipeline –
Middle Section – HDD

View of containment set-up at site of previous day's frac-out under
the Carbon Creek Bridge.

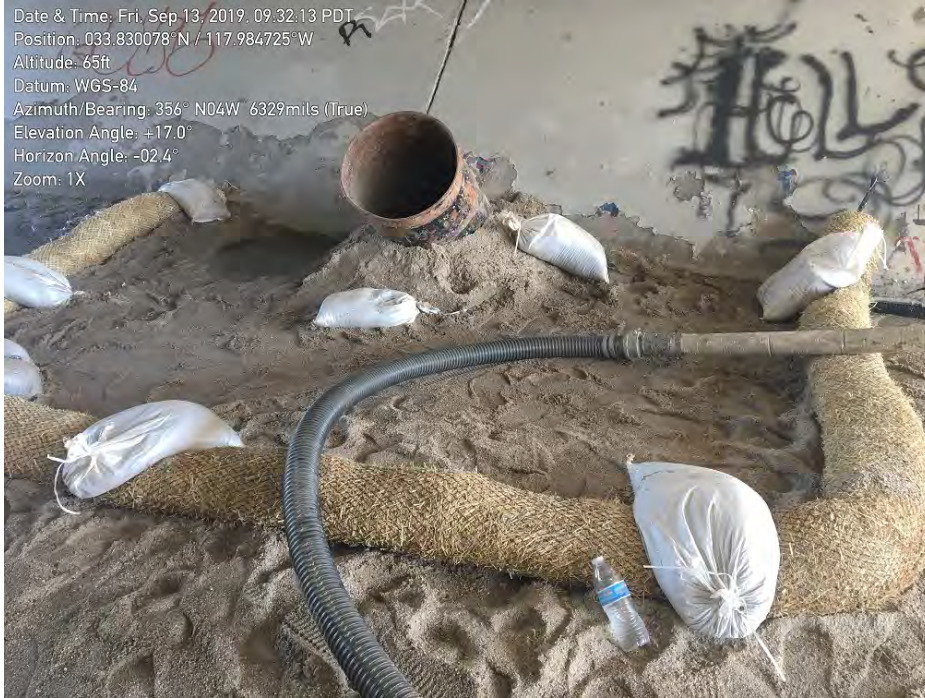
Photo 4

Location

Dale Avenue Gas Pipeline –
Middle Section – HDD

View north from south of Carbon Creek at a second drill rig set up at
the exit pit.

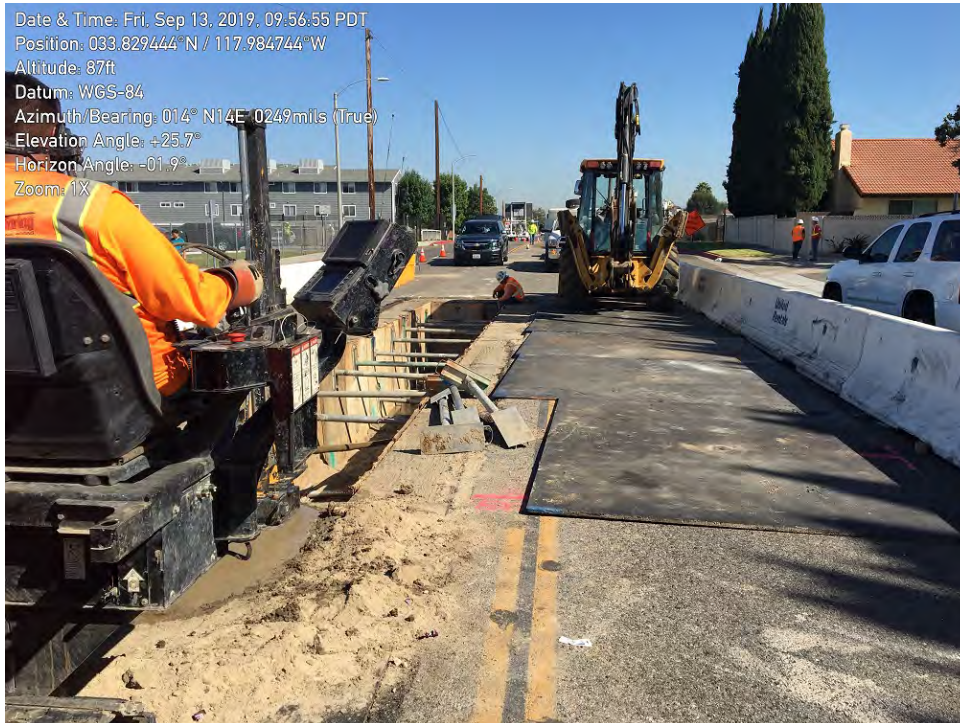
Photo 5

Location	Dale Avenue Gas Pipeline – Middle Section – HDD	Description	Another view (south) from south of Carbon Creek at second drill rig set up at the exit pit.
----------	---	-------------	---

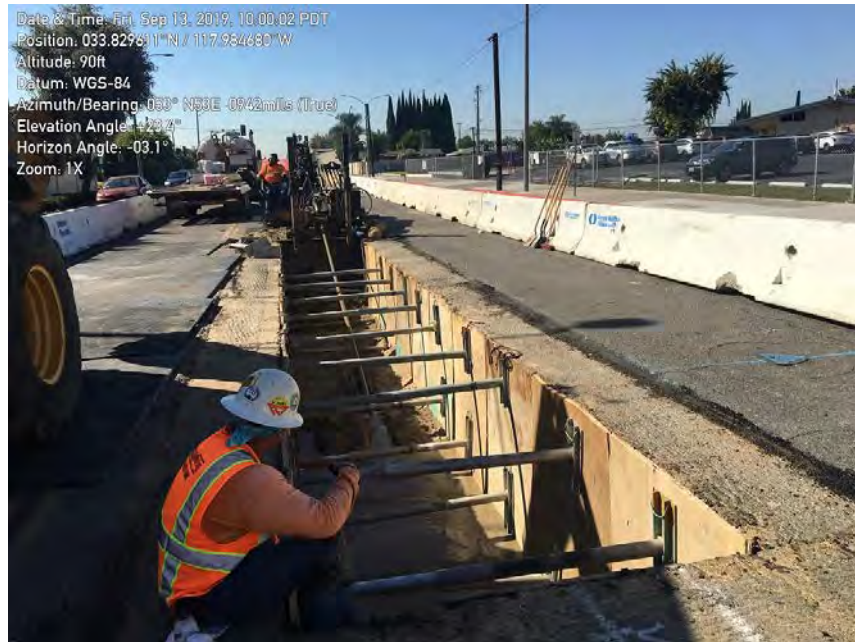
Photo 6

Location	Dale Avenue Gas Pipeline – Middle Section – HDD	Description	View northwest from mud pit at drillers working on primary drill rig at entry pit.
----------	---	-------------	--

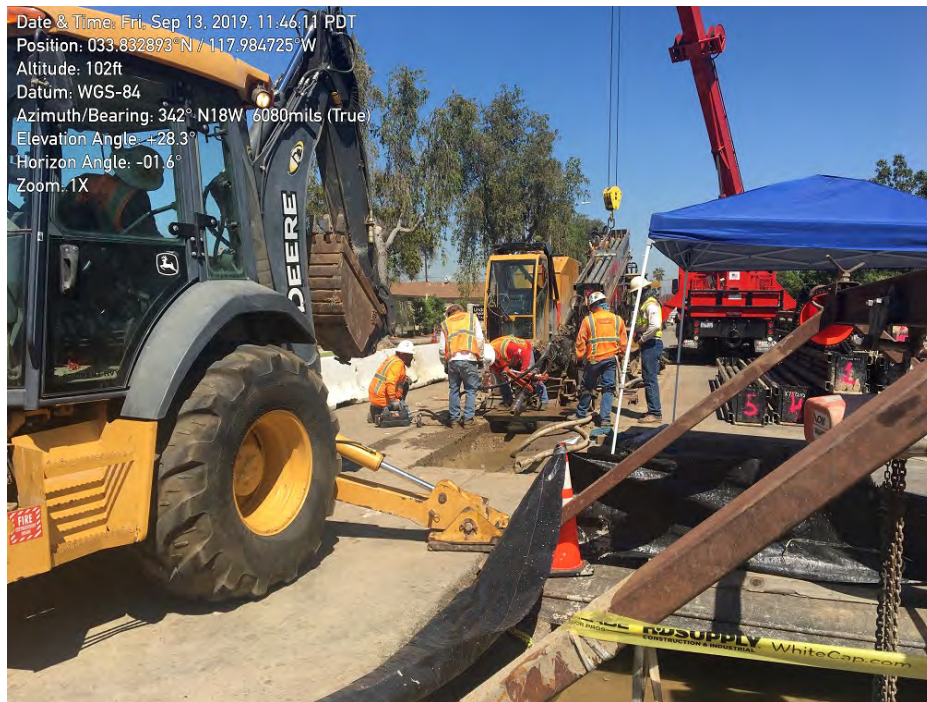
Photo 7

Location	Dale Avenue Gas Pipeline – Middle Section – HDD	Description	View north at primary drill rig ready to begin drilling again with wireless system set up for collection of real-time data from bore head.
----------	---	-------------	--

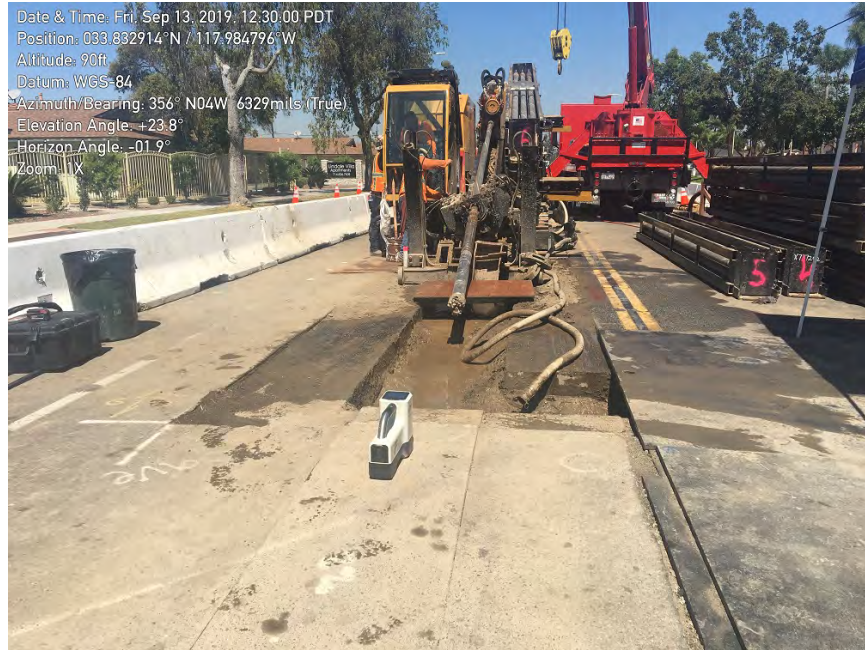
Photo 8

Location	Dale Avenue Gas Pipeline – Middle Section – HDD	Description	Mud flowing into exit pit ahead of bore head.
----------	---	-------------	---

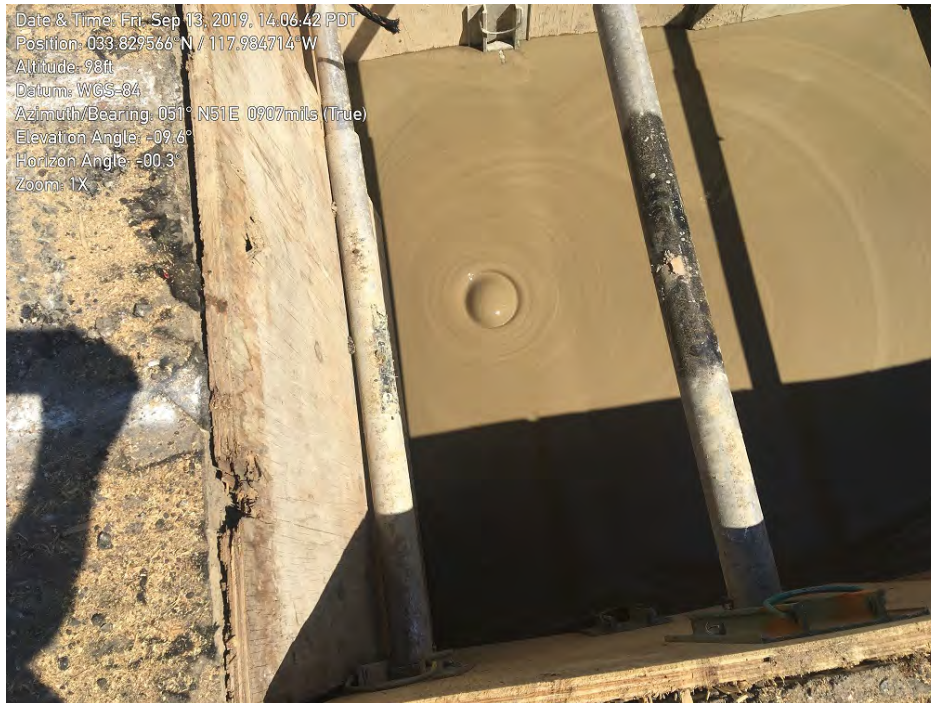
Photo 9

Location	Dale Avenue Gas Pipeline – Middle Section – HDD	Description	Bore head and attached rods emerge from mud in exit pit, heading south.
-----------------	---	--------------------	---

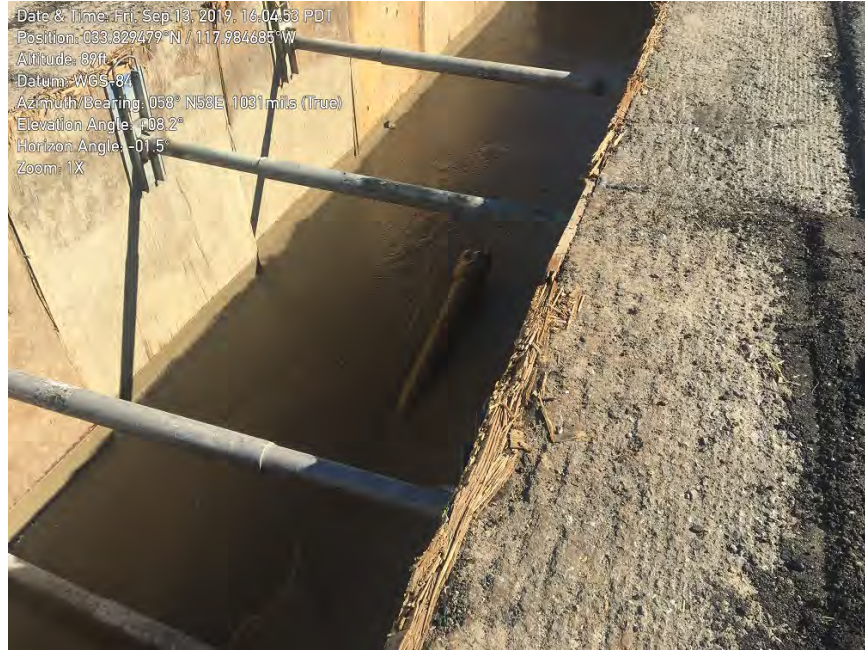
Photo 10

Location	Dale Avenue Gas Pipeline – Middle Section – HDD	Description	View south along Dale Avenue south of Carbon Creek at drillers cleaning bore head and attached rods as they emerge from exit pit, heading south
-----------------	---	--------------------	---

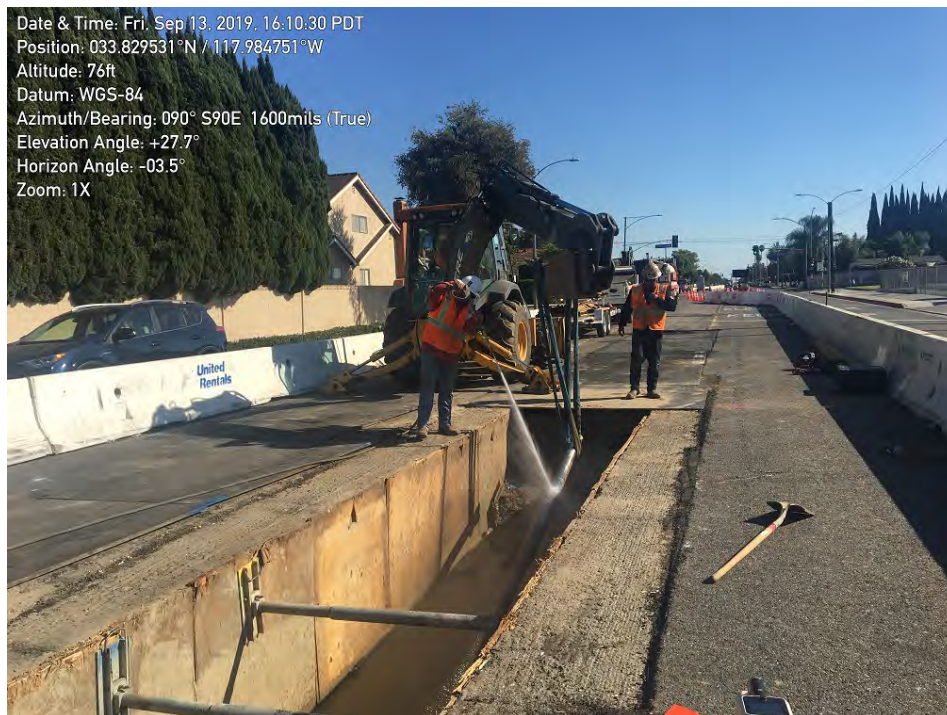
Photo 11

Location	Dale Avenue Gas Pipeline – Middle Section – HDD	Description	Another view (see Photos 9 and 10) south along Dale Avenue south of Carbon Creek at bore head and attached rods after they emerged from exit pit, heading south
----------	---	-------------	---

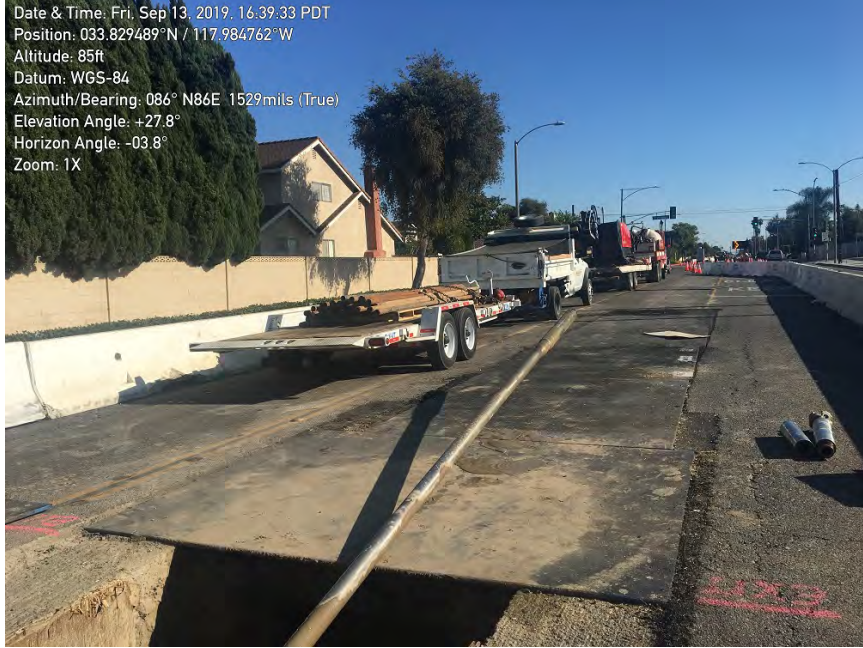
Photo 12

Location	Dale Avenue Gas Pipeline – Middle Section – HDD	Description	View northeast of reamer attached to rods at entry pit, ready to be pushed through bore hole the following morning.
----------	---	-------------	---

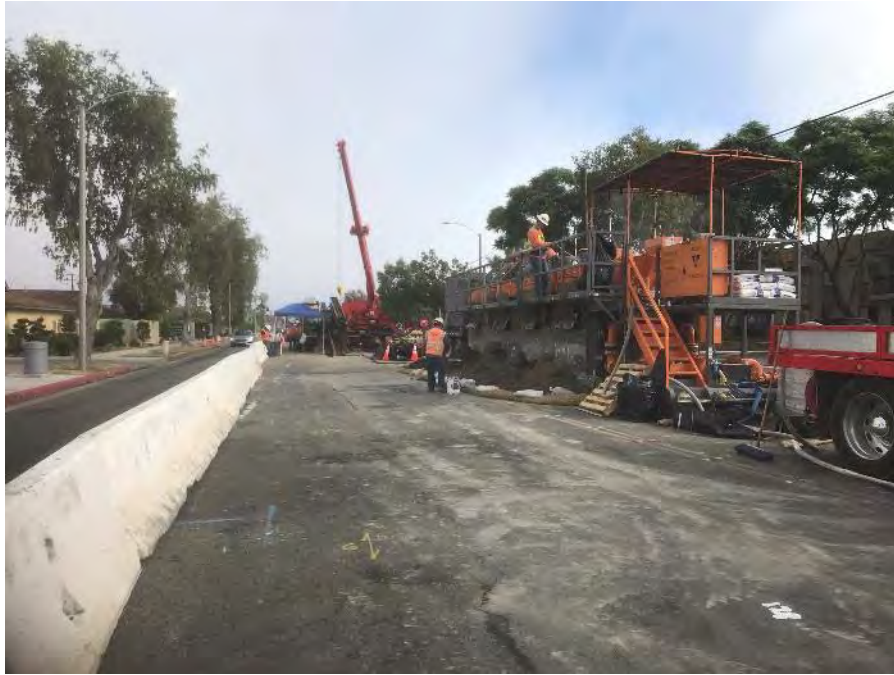
Photo 2

Location	Dale Avenue Gas Pipeline – Middle Section HDD		View south at drill pipe exiting south hole as part of reaming process.
-----------------	---	--	---

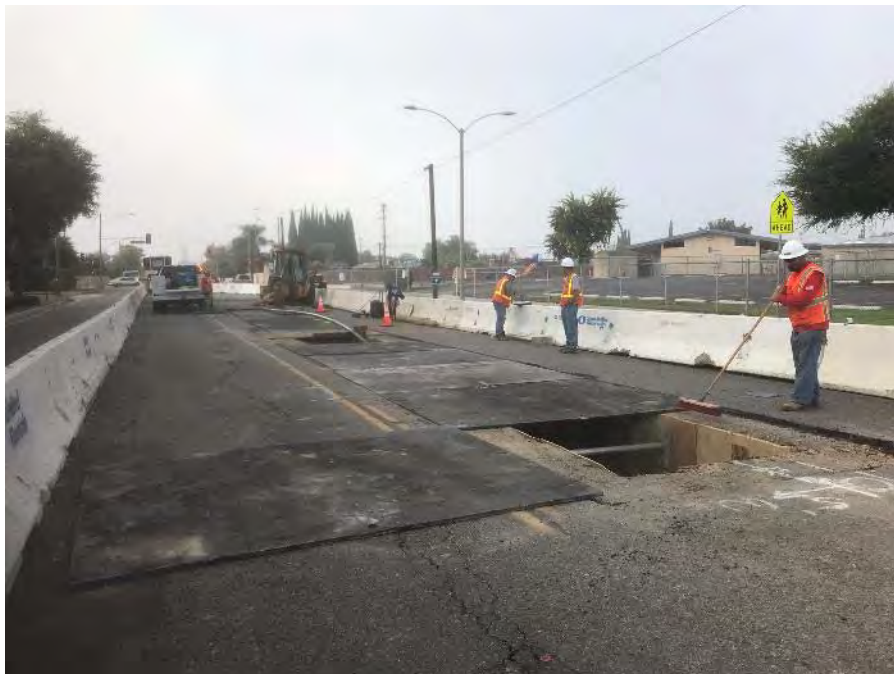
Photo 3

Location	Dale Avenue Gas Pipeline – Middle Section HDD	Description	View northwest of crew removing sections of drill pipe (rods) as it exits south hole.
-----------------	---	--------------------	---

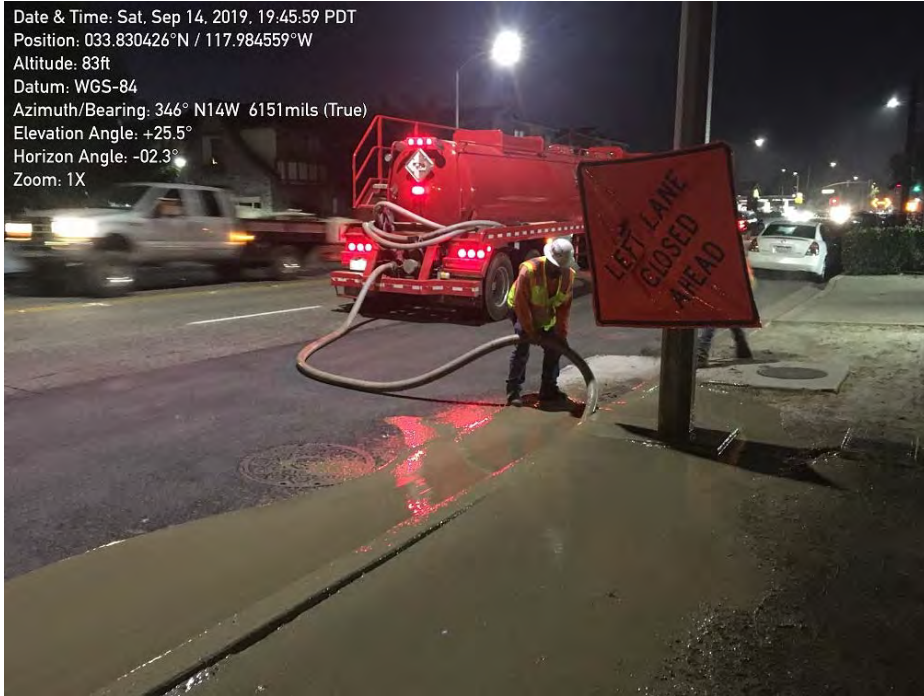
Photo 6

Location	Dale Avenue Gas Pipeline – Middle Section HDD	Description	View southwest from north of bridge over Carbon Creek at workers cleaning up frac-out with Ditch-Witch.
----------	---	-------------	---

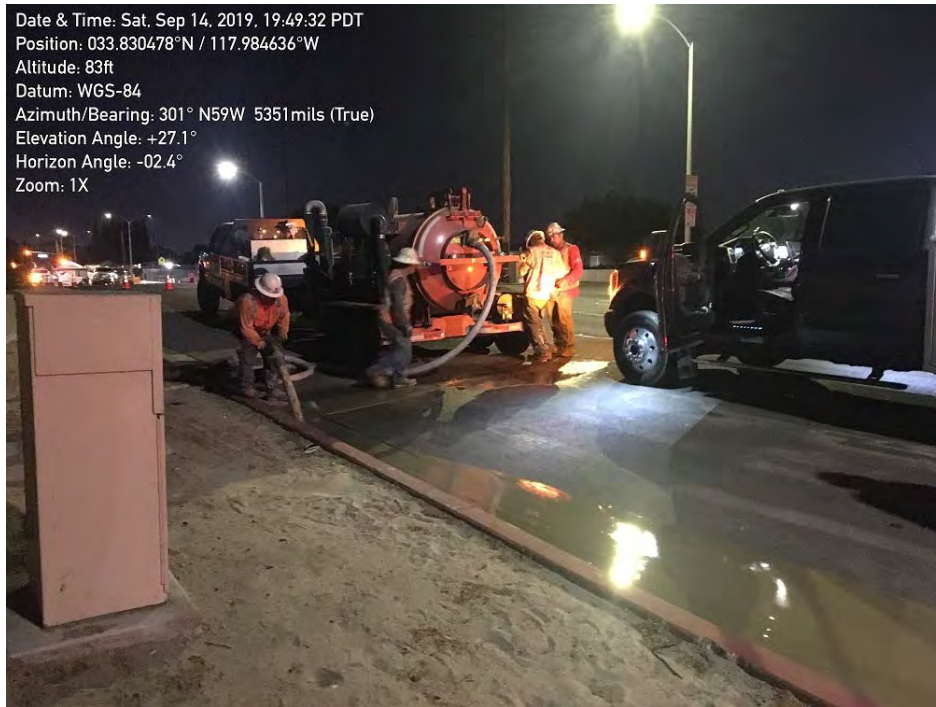
Photo 7

Location	Dale Avenue Gas Pipeline – Middle Section HDD	Description	View northwest from north of bridge over Carbon Creek at workers cleaning up frac-out with hydro-vac, Ditch-Witch, shovels, and brooms.
----------	---	-------------	---
