Stanton Energy Reliability Center

CEC Docket No. 16-AFC-01
Monthly Compliance Report No. 8
Reporting Period: September 2019

Prepared by Stanton Energy Reliability Center, LLC (SERC)
Submitted October 12, 2019

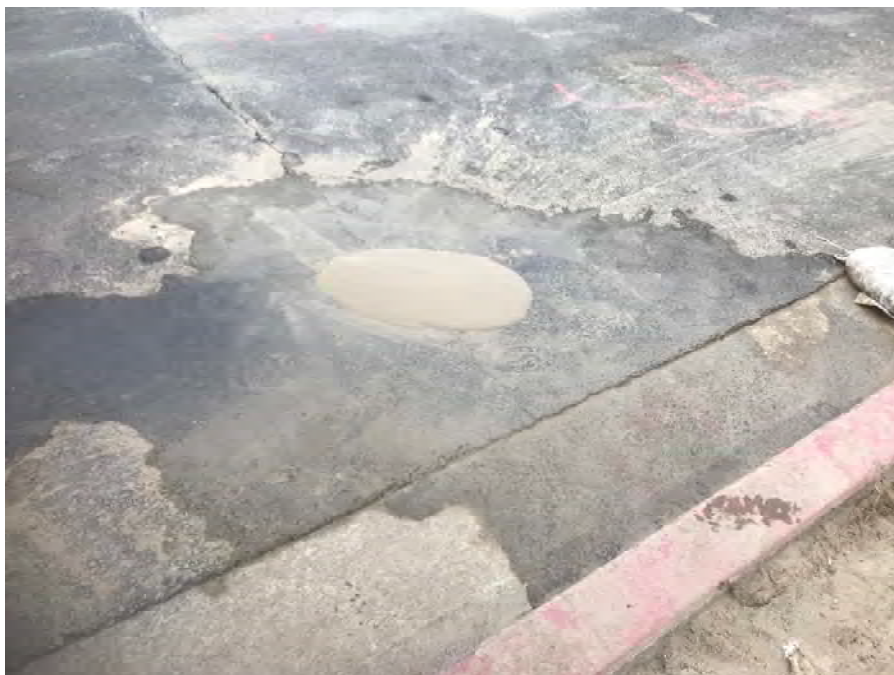
Photo 1

Location	Dale Avenue Gas Pipeline – Middle Section HDD	Description	View of seep in the earlier Dale Avenue frac-out area.
-----------------	---	--------------------	--

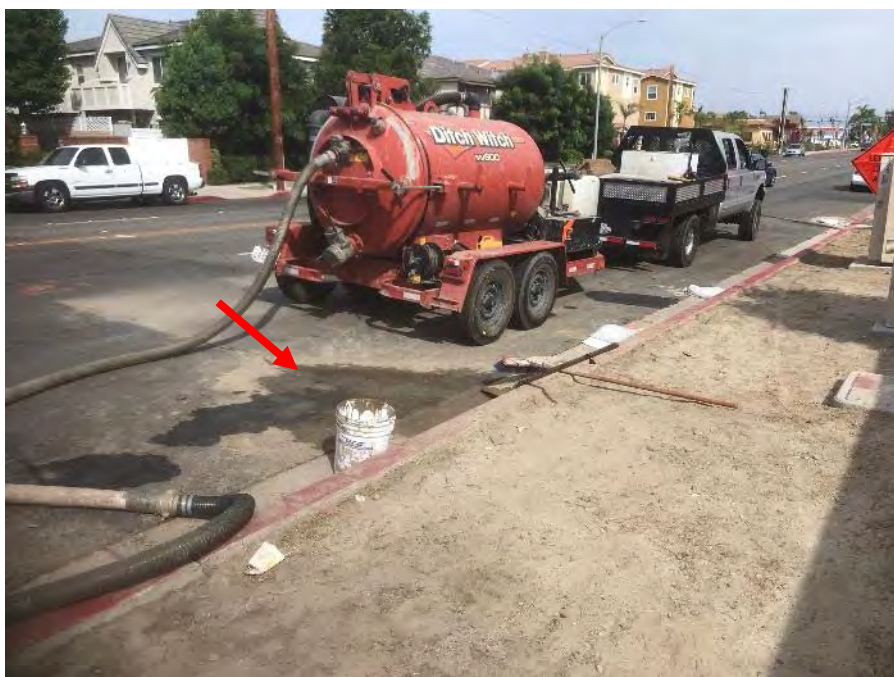
Photo 3

Location	Dale Avenue Gas Pipeline – Middle Section HDD	Description	View northeast of reamer clean-up at the entry/north hole in preparation for additional reamer pass-through.
----------	---	-------------	--

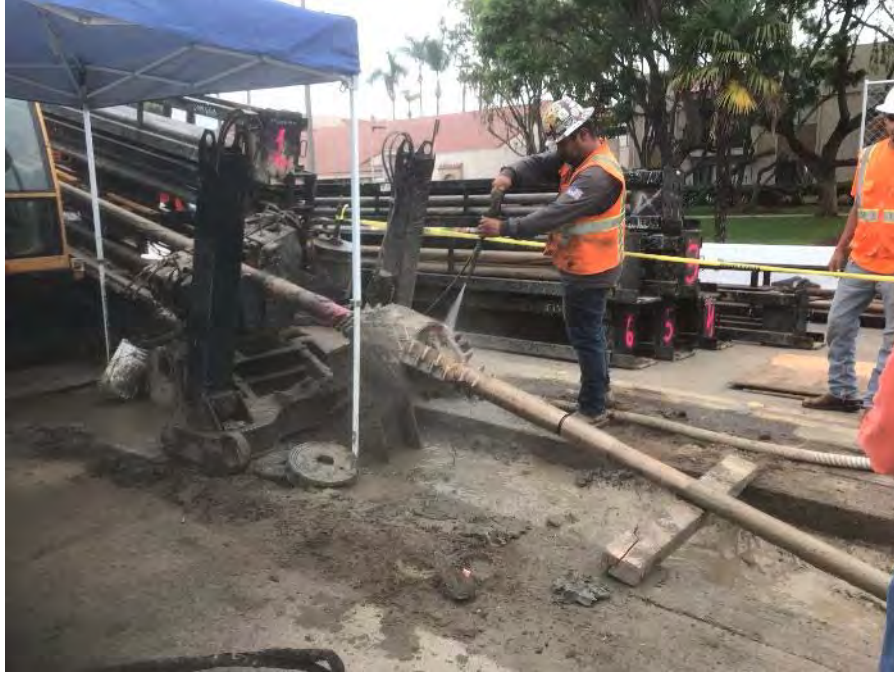
Photo 4

Location	Dale Avenue Gas Pipeline – Middle Section HDD		View north at drill rig pushing drill pipe to exit/south hole in preparation for additional reamer pass-through.
----------	---	--	--

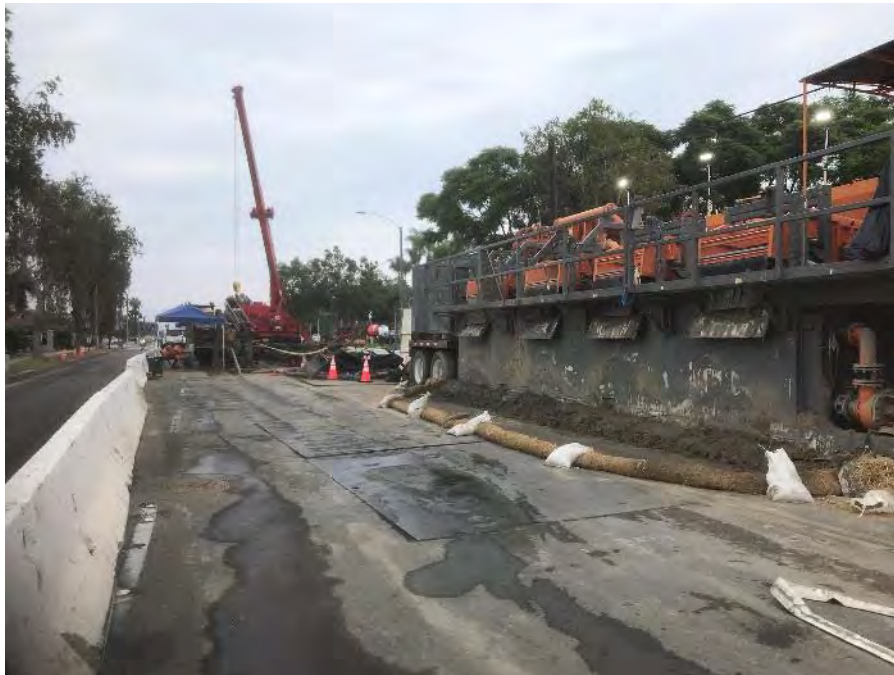
Photo 5

Location	Dale Avenue Gas Pipeline – Middle Section HDD	Description	View southwest of crew finalizing reamer connection into drill pipe in preparation for additional reamer pass-through at the exit/south hole.
-----------------	---	--------------------	---

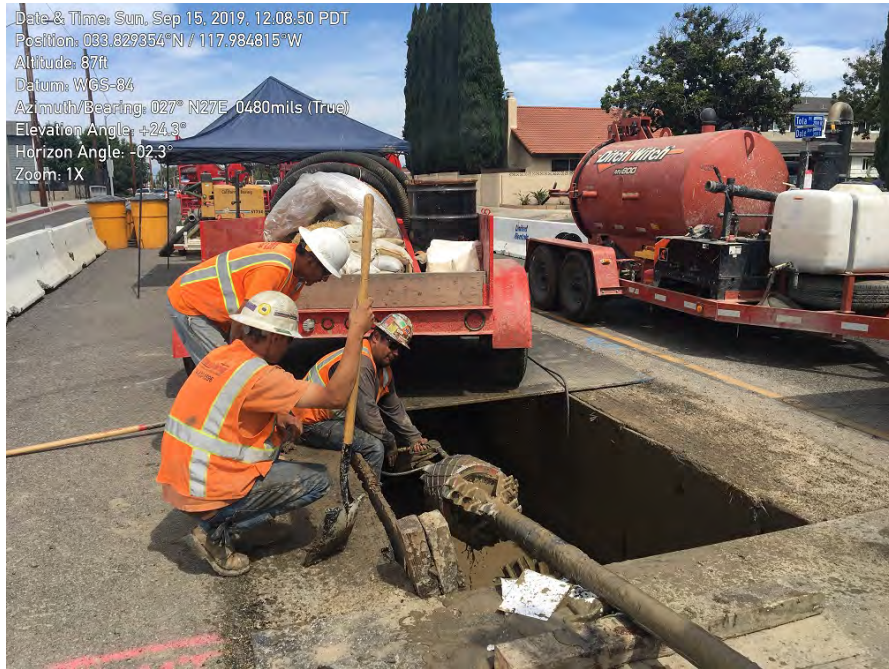
Photo 2

View southwest at location of earlier seepage north of Carbon Creek Bridge.

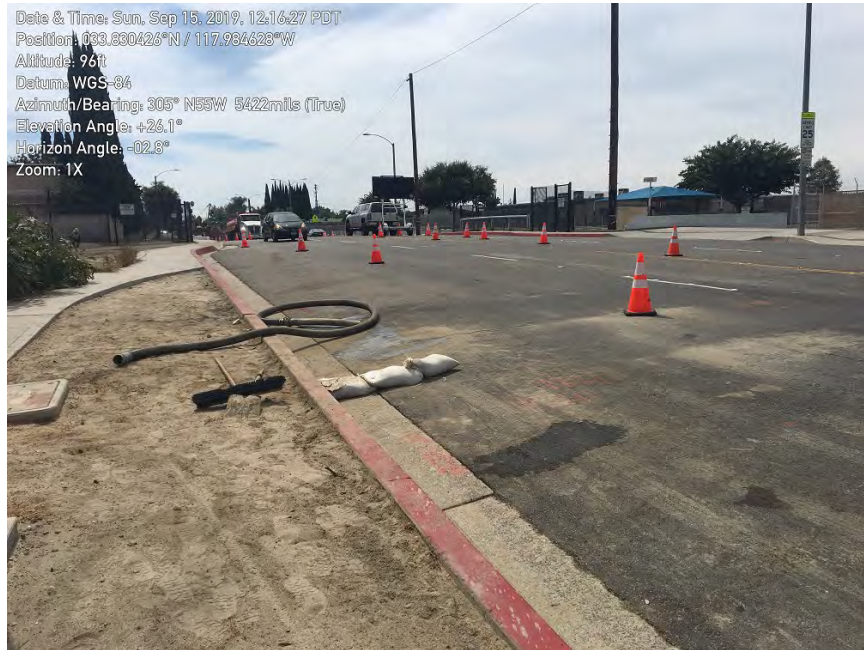
Photo 3

Location	Dale Avenue Gas Pipeline – Middle Section HDD	Description	View southeast at entry pit (foreground), the mud pit, just beyond, and portion of recycler at right in photo. Sound baffle installed the previous night is visible at center of photo.
-----------------	---	--------------------	---

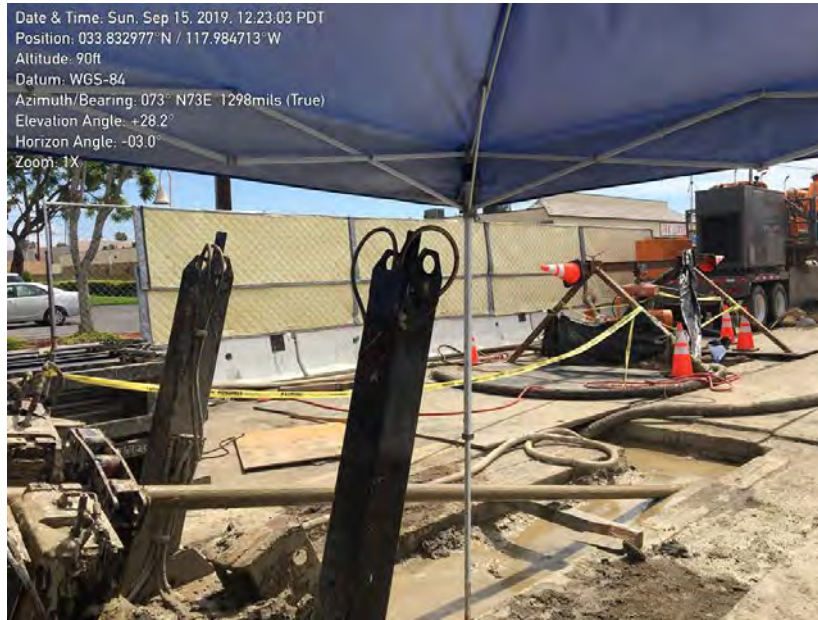
Photo 4

Location	Dale Avenue Gas Pipeline – Middle Section HDD	Description	View south from exit pit at long train of rods ready to be pulled north back through the bore hole to the entry pit north of Lincoln Avenue.
-----------------	---	--------------------	--

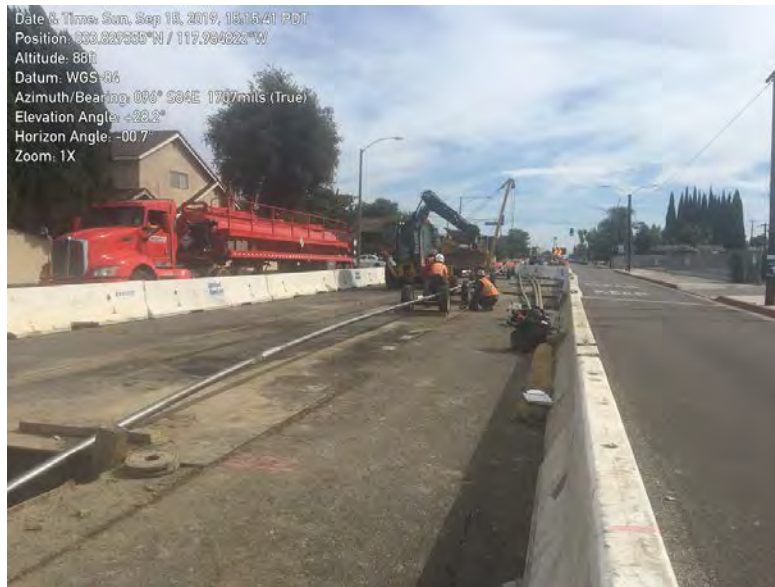
Photo 5

View south of hydro-vac tanker offloading mud collected from exit pit south of Carbon Creek Bridge, through entry pit and into mud pit for processing by recycler.

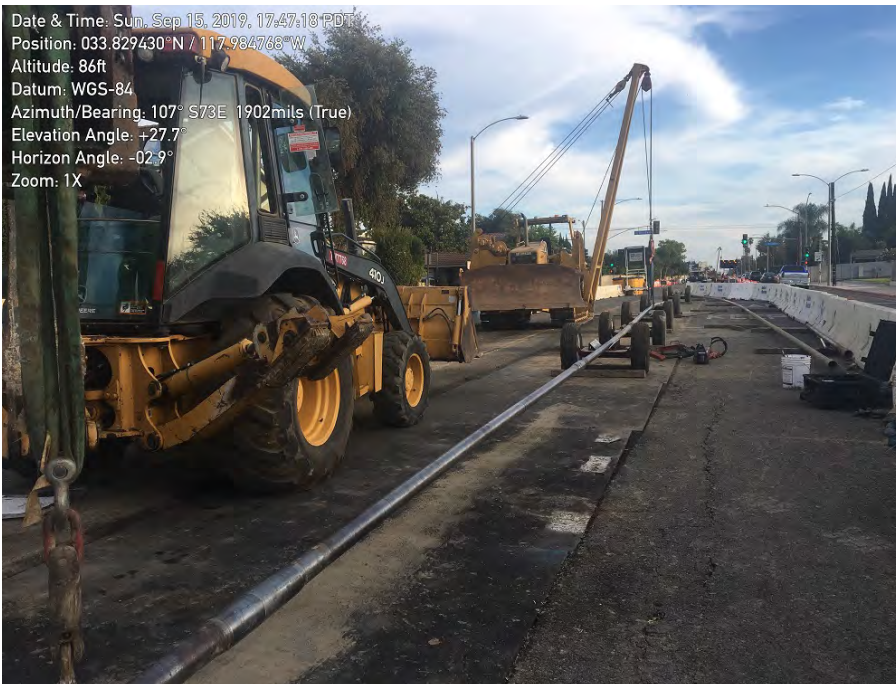
Photo 7

Location	Dale Avenue Gas Pipeline – Middle Section HDD	Description	Another view (north; see Photos 8 and 10) from south of exit pit at long train of rods being pulled north back through the bore hole to the entry pit north of Lincoln Avenue.
----------	---	-------------	--

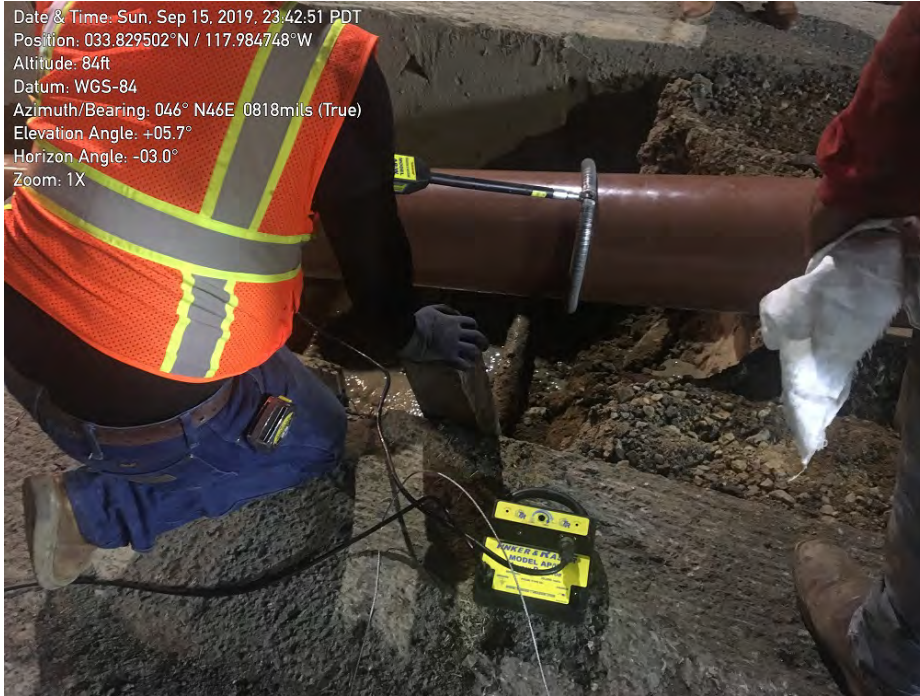
Photo 10

The gas pipeline is checked for defects before entering borehole as
it is slowly and carefully pulled north. If found, defects are sealed
and cured before pipe continues journey north.

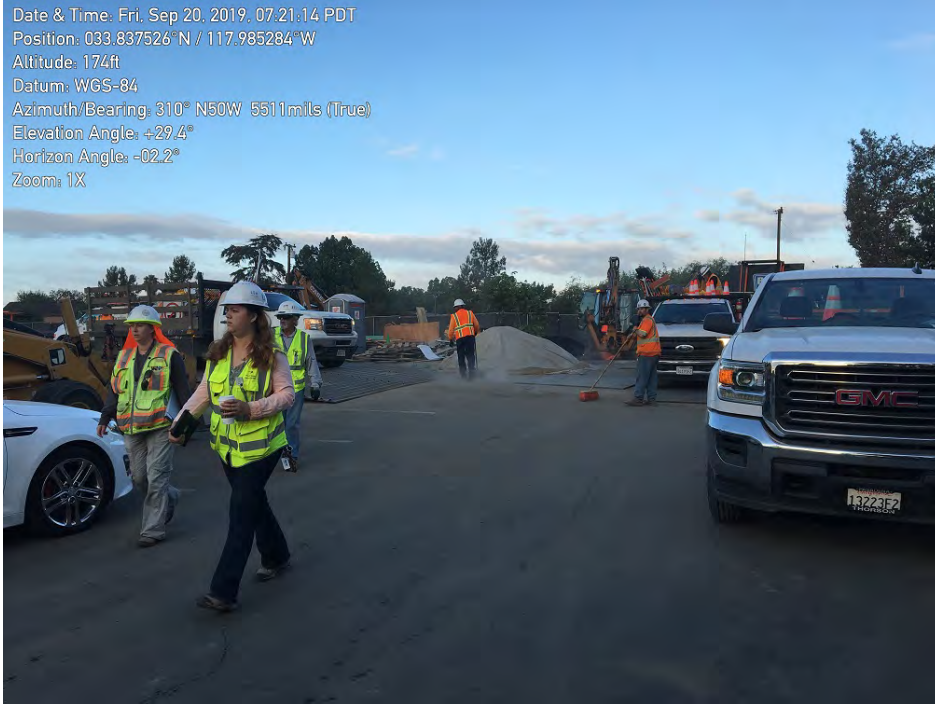
Photo 1

Location	SERC – Greek Orthodox Church Laydown	Description	View west from northern portion of Greek Orthodox Church Laydown at monitors leaving morning tailgate (left) and workers sweeping up around covered and contained spoils pile (center).
----------	--------------------------------------	-------------	---

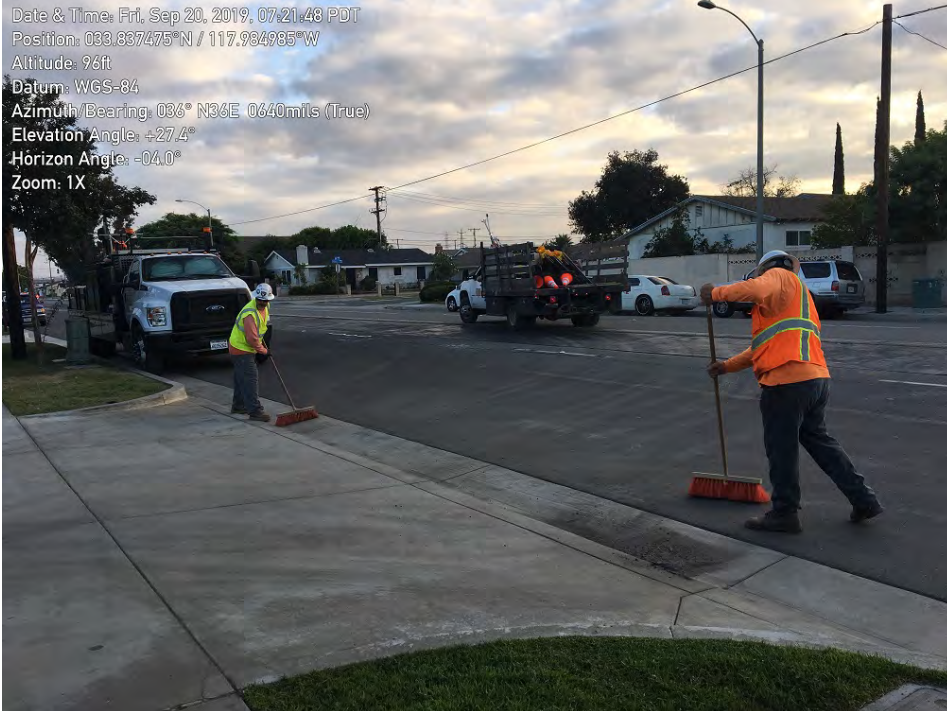
Photo 2

Location	SERC – Greek Orthodox Church Laydown	Description	View northwest from outside Greek Orthodox Church Laydown entrance at workers sweeping up track-out.
----------	--------------------------------------	-------------	--

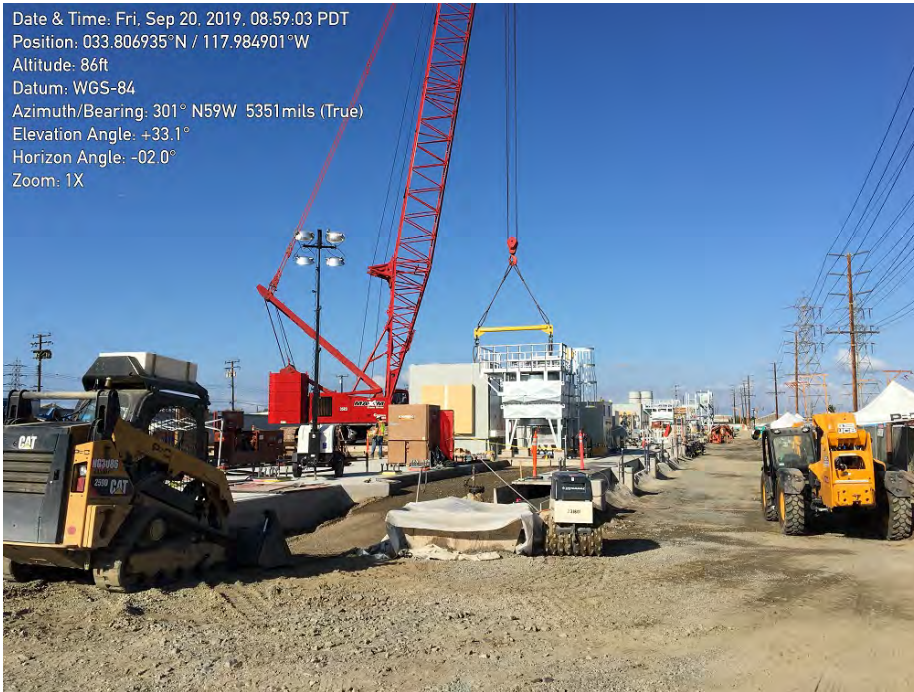
Photo 4

View west from eastern portion of Eastern Parcel at 999 crawler crane in position on pad, after lifting large piece of equipment into place. This crane has a 275-ton (U.S.) lifting capacity.

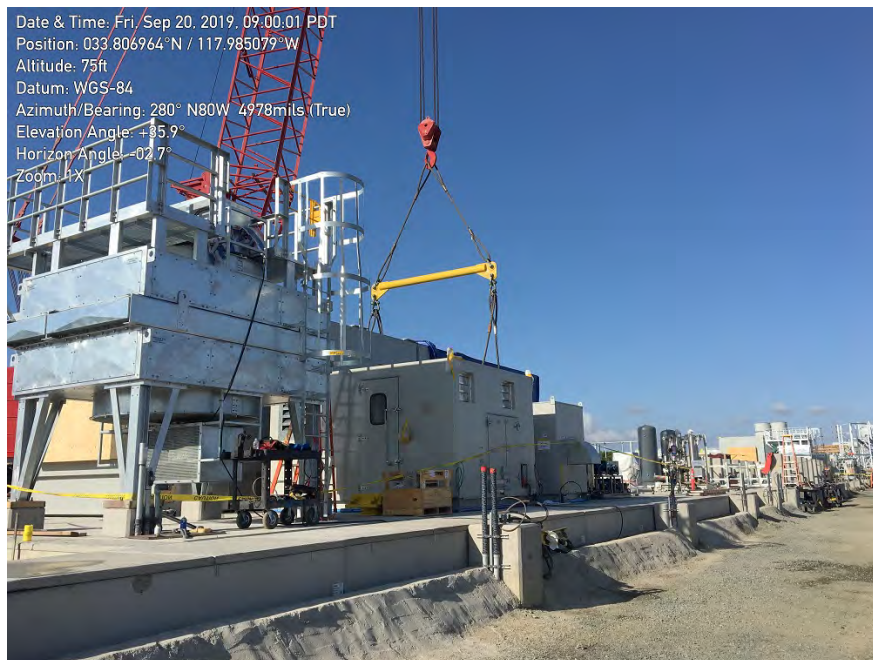
Photo 5

View southwest from eastern portion of Eastern Parcel at above-ground power plant infrastructure.

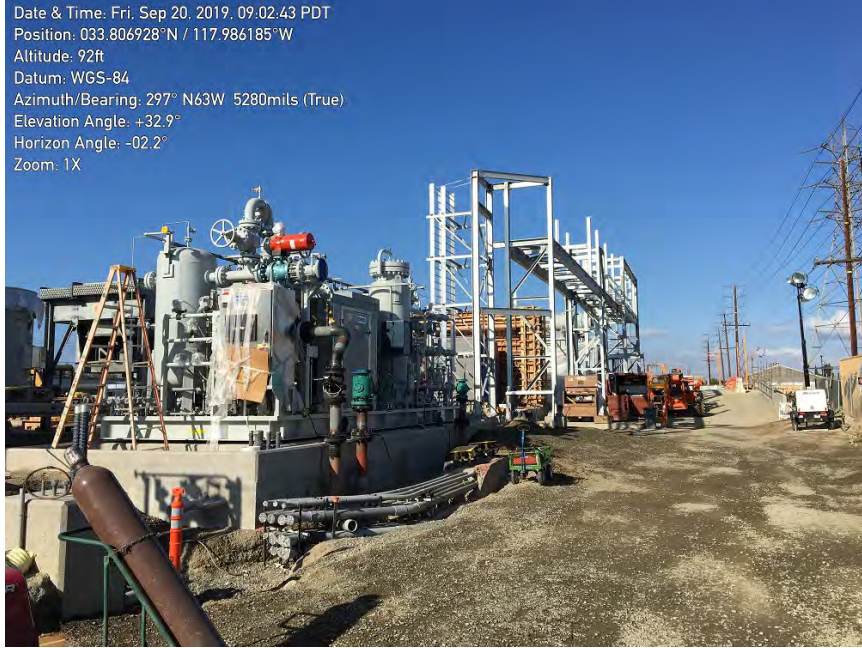
Photo 8

Location	SERC – Eastern Parcel	Description	View west from western portion of Eastern Parcel at above-ground power plant infrastructure. Vehicle bridge to Western Parcel is at right in photo.
----------	-----------------------	-------------	---

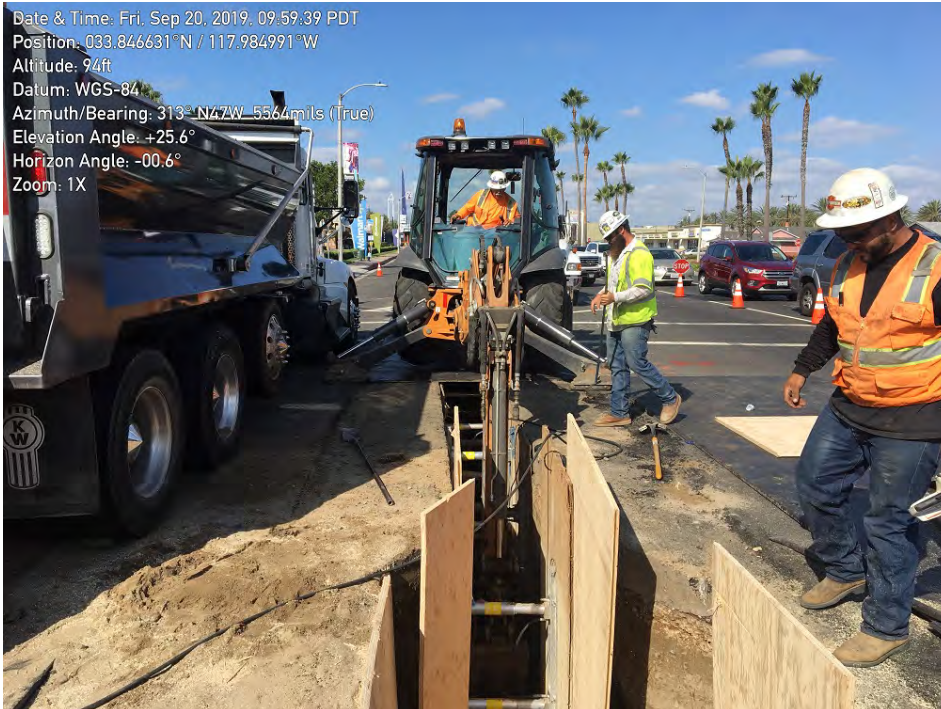
Photo 9

Location	Dale Avenue Gas Pipeline – Northern Section	Description	View west from intersection of La Palma and Dale Avenues at excavation and shoring work in process.
----------	---	-------------	---

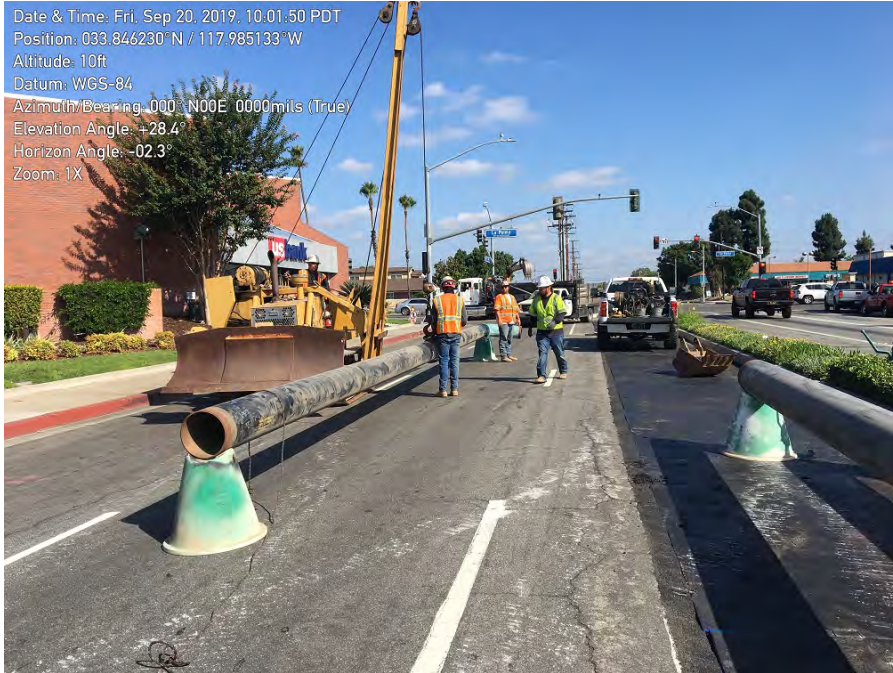
Photo 10

Dale Avenue Gas Pipeline –
Northern Section

View north from just south of intersection of La Palma and Dale
Avenues at pipes staged and ready for installation.

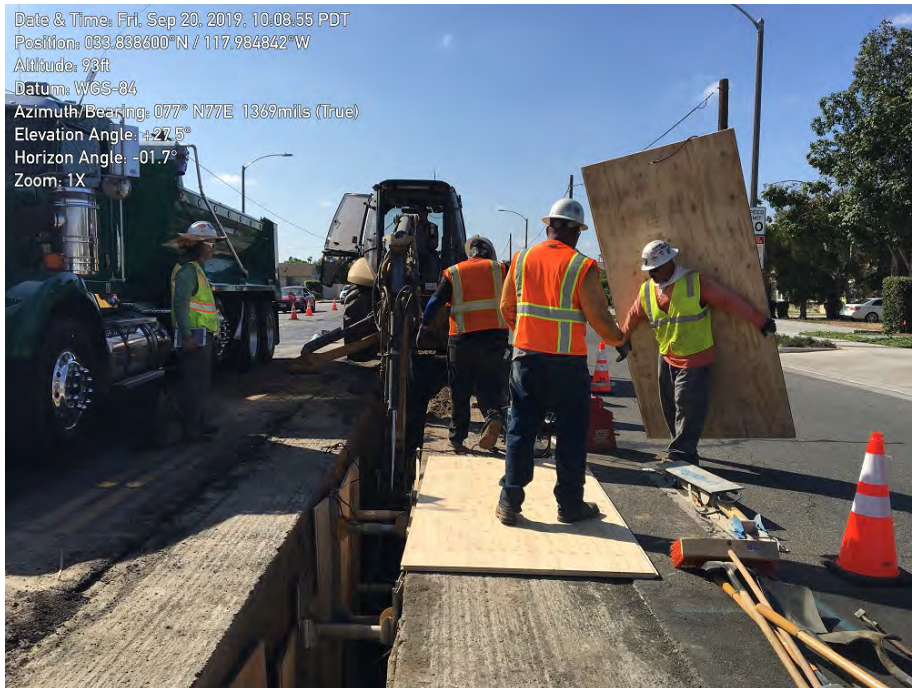
Photo 11

Dale Avenue Gas Pipeline –
Northern Section

View south from northern section of Dale Avenue pipeline
excavation and shoring work in process.

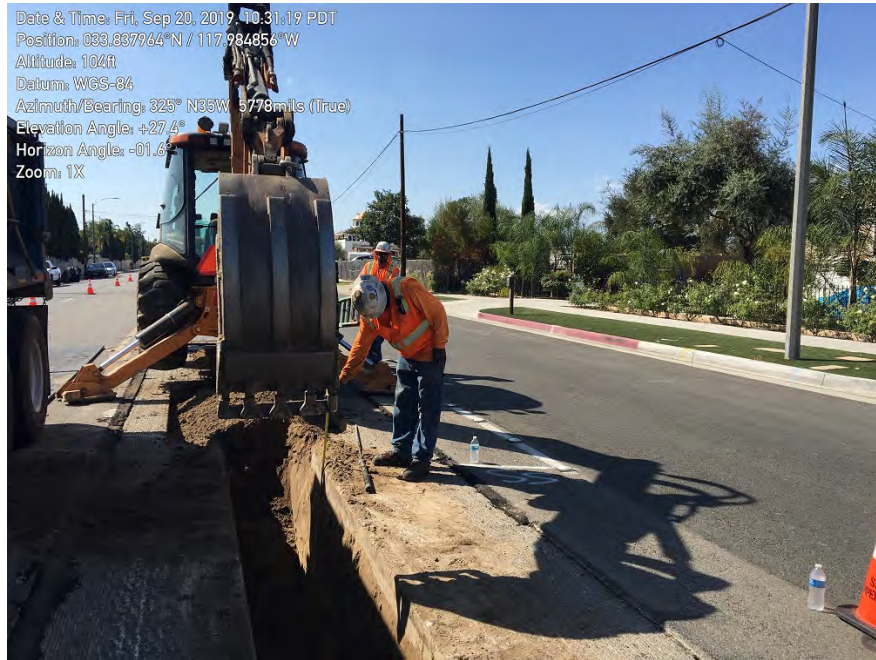
Photo 12

Location	Dale Avenue Gas Pipeline – Northern Section	Description	View south from northern section of Dale Avenue pipeline south of photo 9 location at another crew engaged in excavation and shoring work.
----------	---	-------------	--

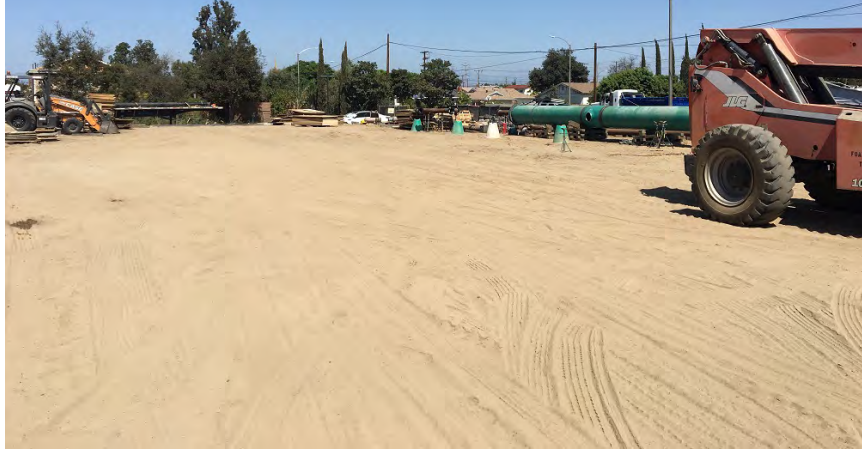
Photo 14

Location	SERC – Greek Orthodox Church Laydown	Description	View north-northeast from southern portion of Greek Orthodox Church Laydown.
-----------------	--------------------------------------	--------------------	--

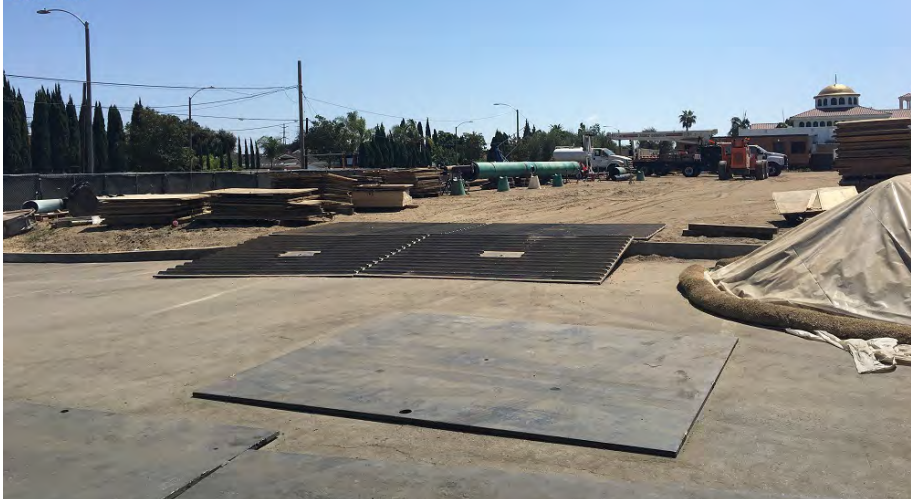
Location	SERC – Greek Orthodox Church Laydown	Description	View southeast from northern portion of Greek Orthodox Church laydown. Area at center of photo is where pipe fabricators conduct their work.
-----------------	--------------------------------------	--------------------	--

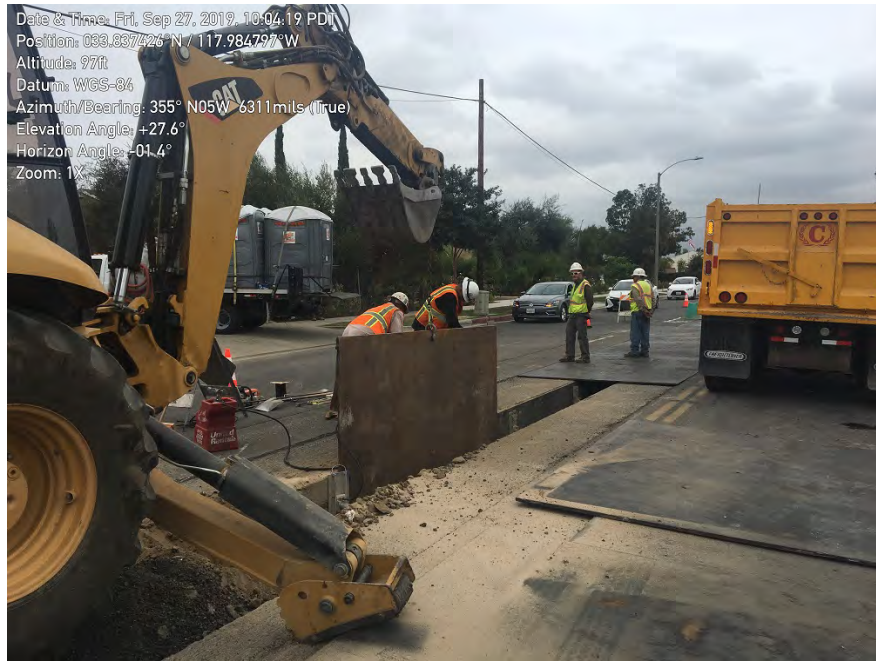
Photo 4

Location	Dale Avenue Gas Pipeline – Northern Section	Description	View northwest from adjacent to Greek Orthodox Church Laydown at workers inserting steel shoring into sandy area of pipeline excavation.
----------	---	-------------	--

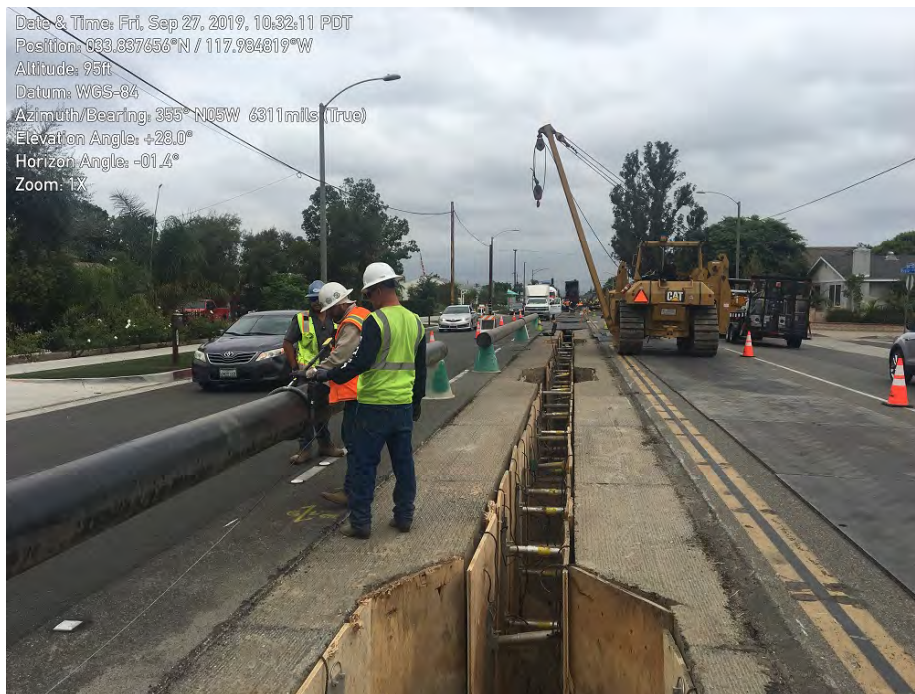
Photo 5

Location	Dale Avenue Gas Pipeline – Northern Section	Description	View north from adjacent to Greek Orthodox Church Laydown at workers inspecting pipe for defects before lowering into excavation.
----------	---	-------------	---

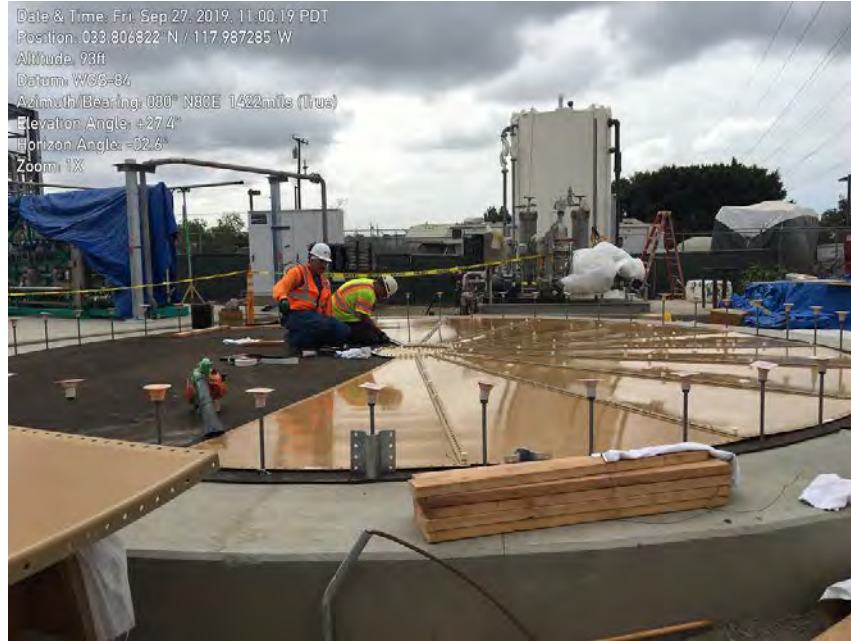
Photo 10

Location	SERC – Western Parcel	Description	View south from eastern portion of Western Parcel water demineralization tank foundation construction.
----------	-----------------------	-------------	--

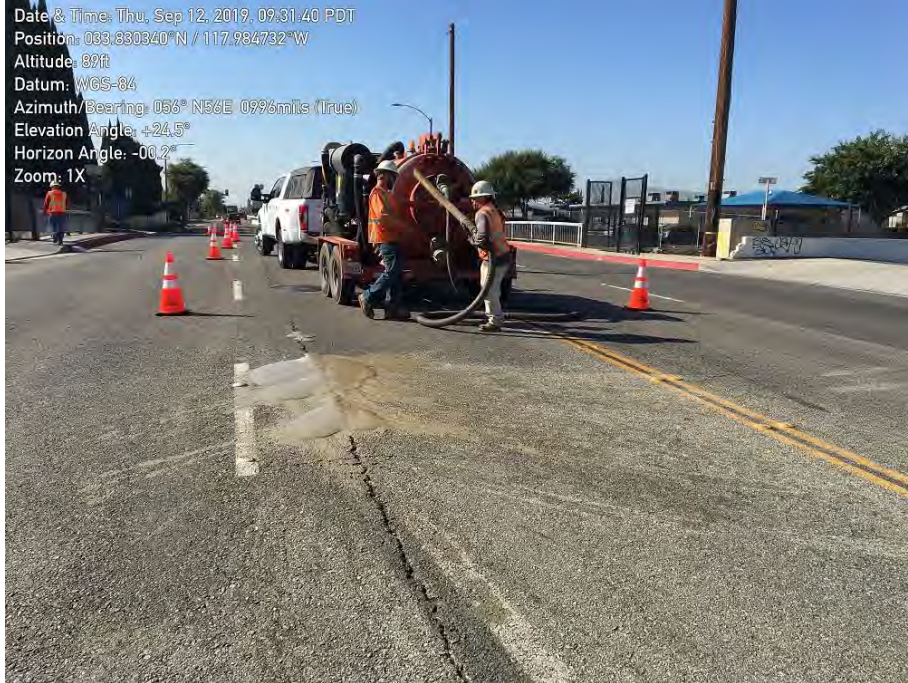
Location	Dale Avenue Gas Pipeline – Middle Section – HDD	Description	Drilling mud seeping from an old fissure in the Dale Avenue asphalt north of Carbon Creek. View facing south.
----------	---	-------------	---

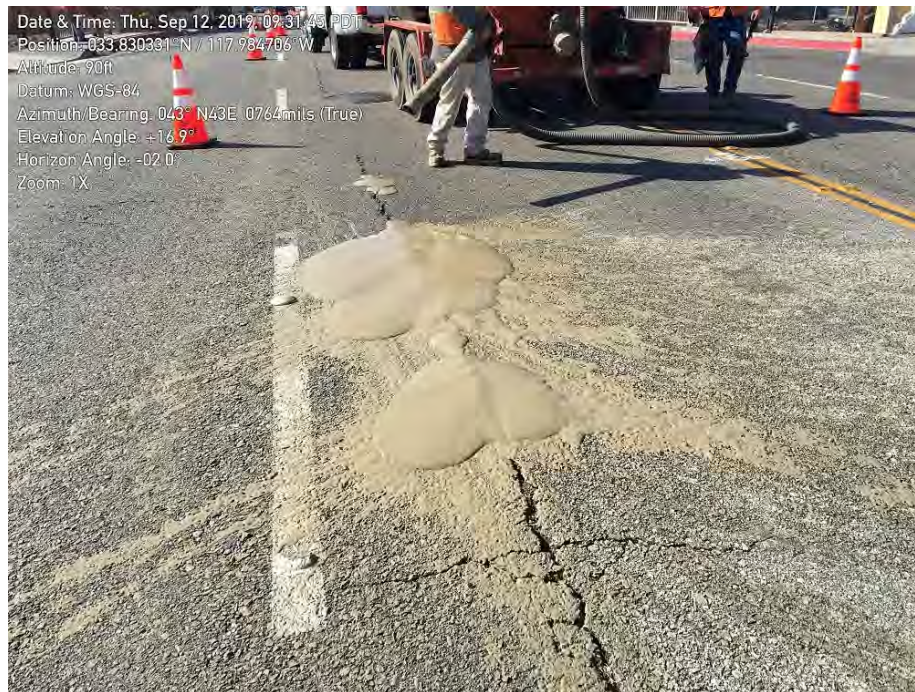
Photo 2

Location	Dale Avenue Gas Pipeline – Middle Section – HDD	Description	Drilling mud seeping from an old fissure in the Dale Avenue asphalt north of Carbon Creek. View facing south.
----------	---	-------------	---

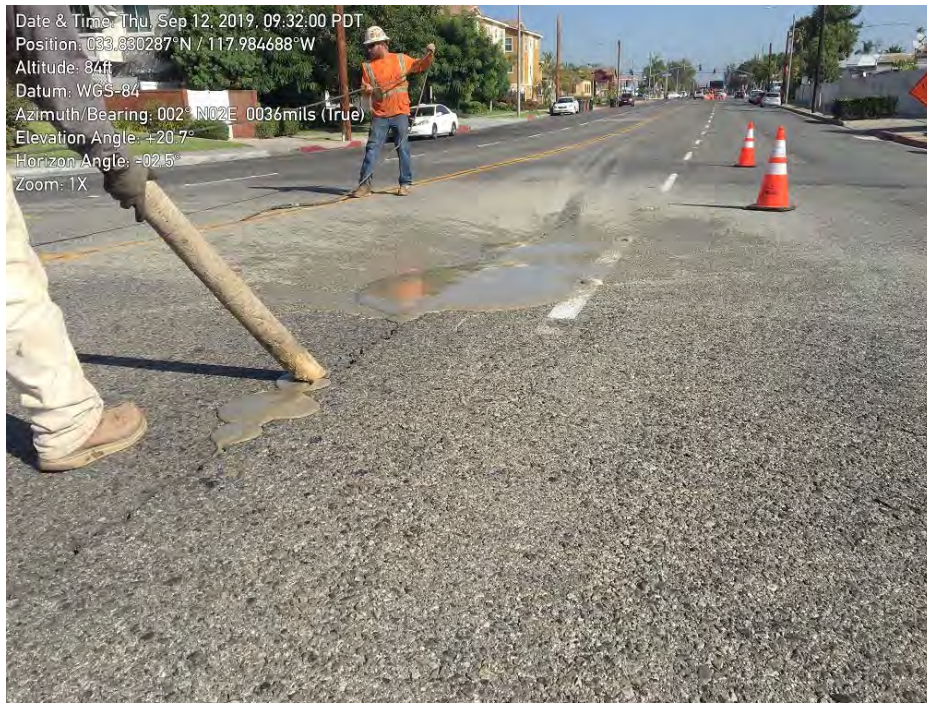
Photo 3

Location	Dale Avenue Gas Pipeline – Middle Section – HDD	Description	Clean-up of drilling mud seeping from an old fissure in the Dale Avenue asphalt north of Carbon Creek. View facing north.
----------	---	-------------	---

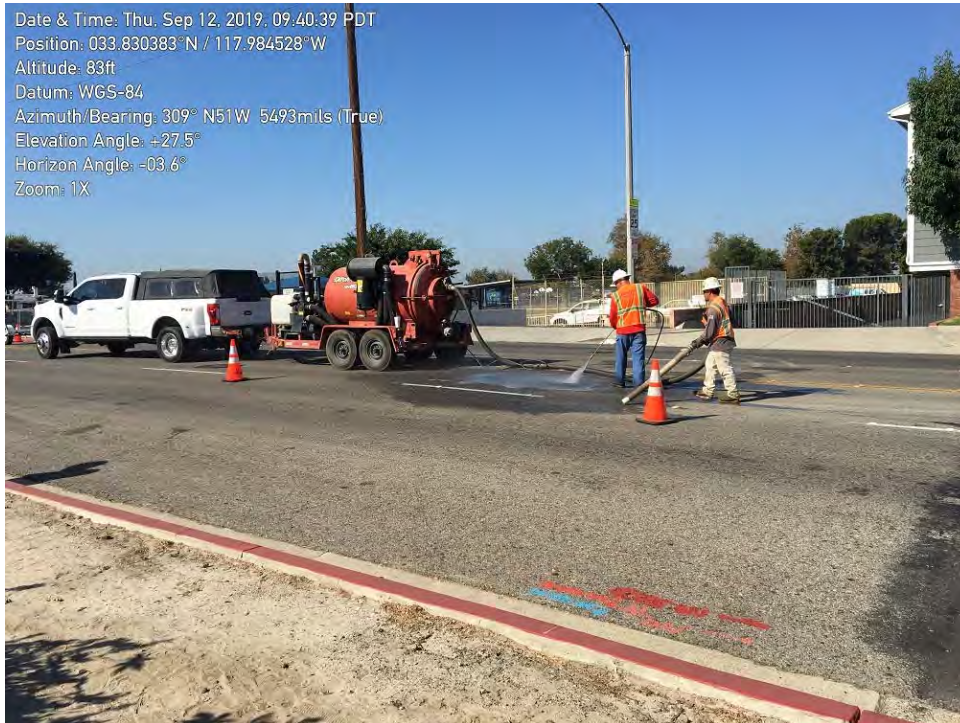
Photo 4

Location	Dale Avenue Gas Pipeline – Middle Section – HDD	Description	Clean-up of drilling mud seeping from an old fissure in the Dale Avenue asphalt north of Carbon Creek. View facing west.
----------	---	-------------	--

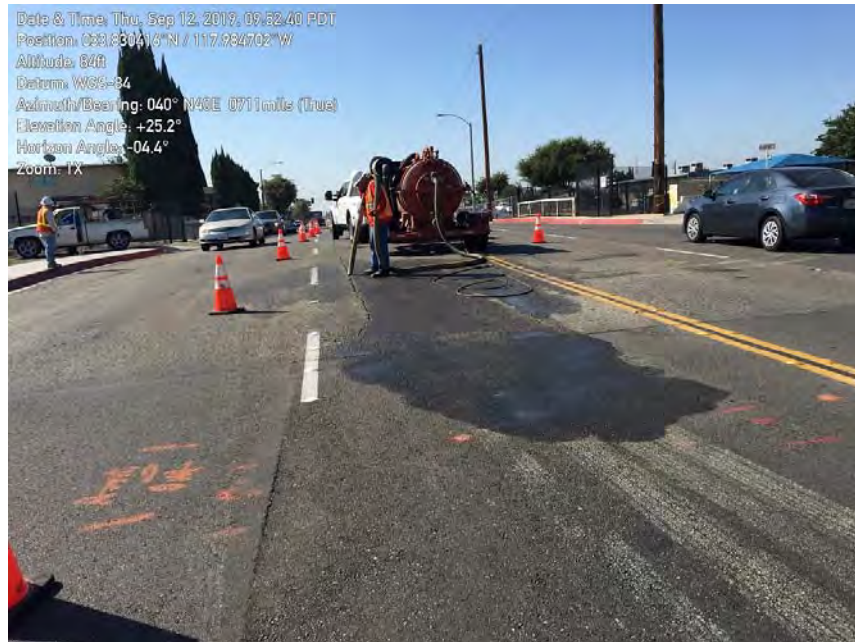
Photo 5

Location	Description
Dale Avenue Gas Pipeline – Middle Section – HDD	Clean-up of drilling mud seeping from an old fissure in the Dale Avenue asphalt north of Carbon Creek. View facing south.

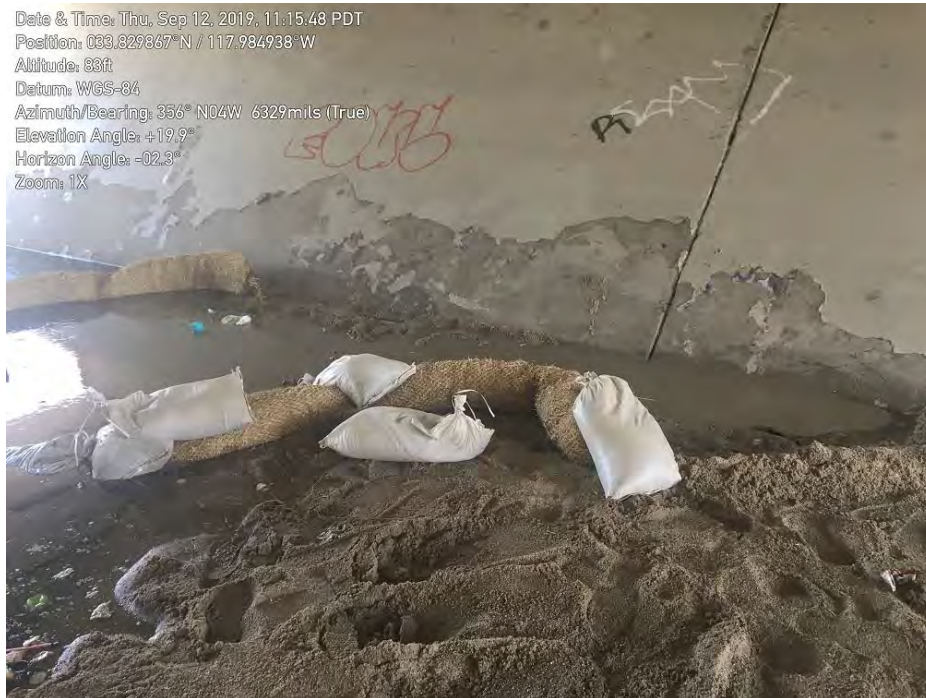
Photo 6

Location	Description
Dale Avenue Gas Pipeline – Middle Section – HDD	Containment of drilling mud in Carbon Creek under the Dale Avenue bridge. View facing north.

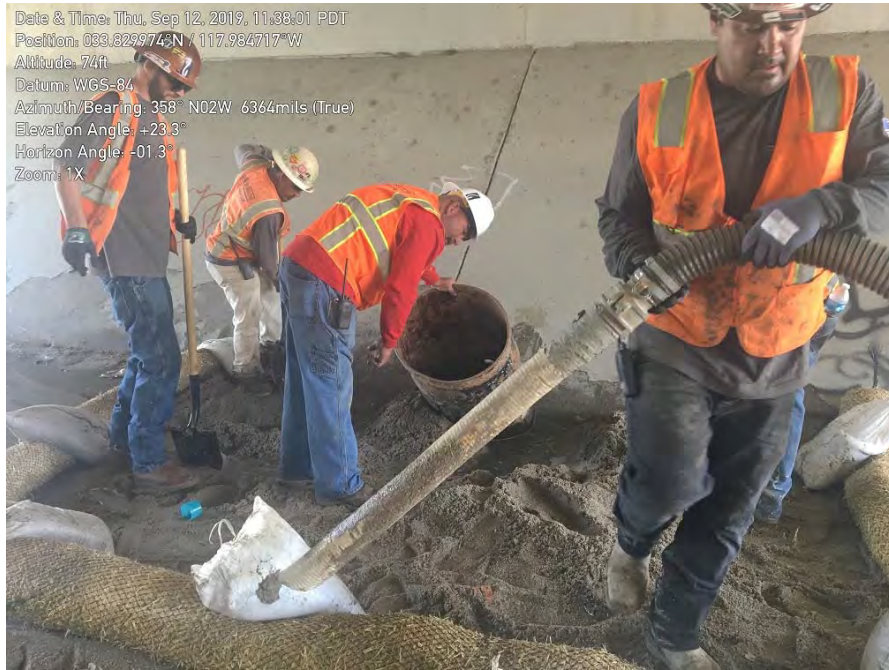
Photo 8

Location	Dale Avenue Gas Pipeline – Middle Section – HDD	Description	Containment and clean-up of drilling mud in Carbon Creek under the Dale Avenue bridge. View facing north.
----------	---	-------------	---

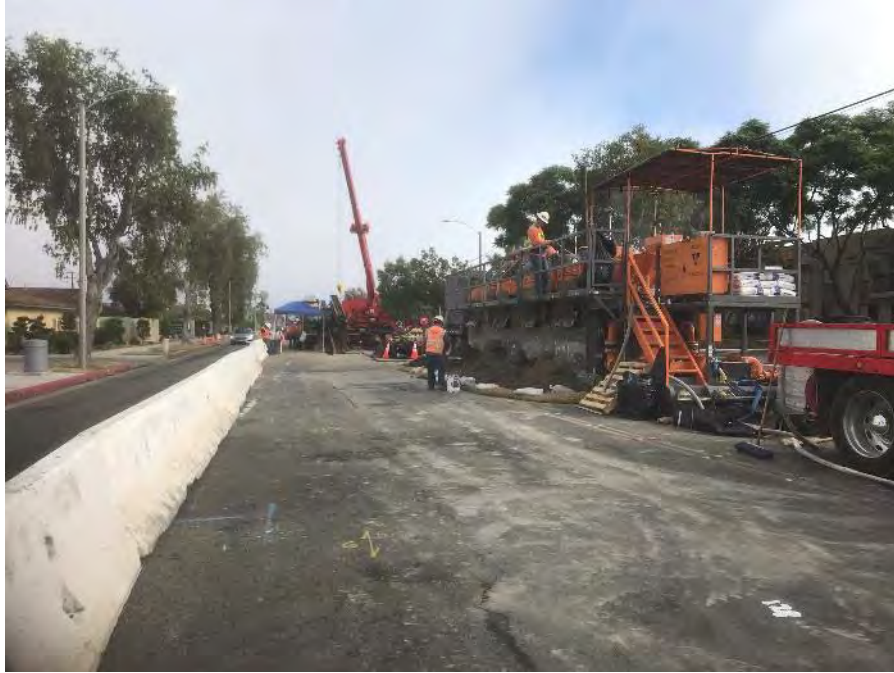
Photo 2

Location	Dale Avenue Gas Pipeline – Middle Section HDD	Description	View north of drill rig at entry/north hole pushing feeding drill pipe and reamer.
-----------------	---	--------------------	--

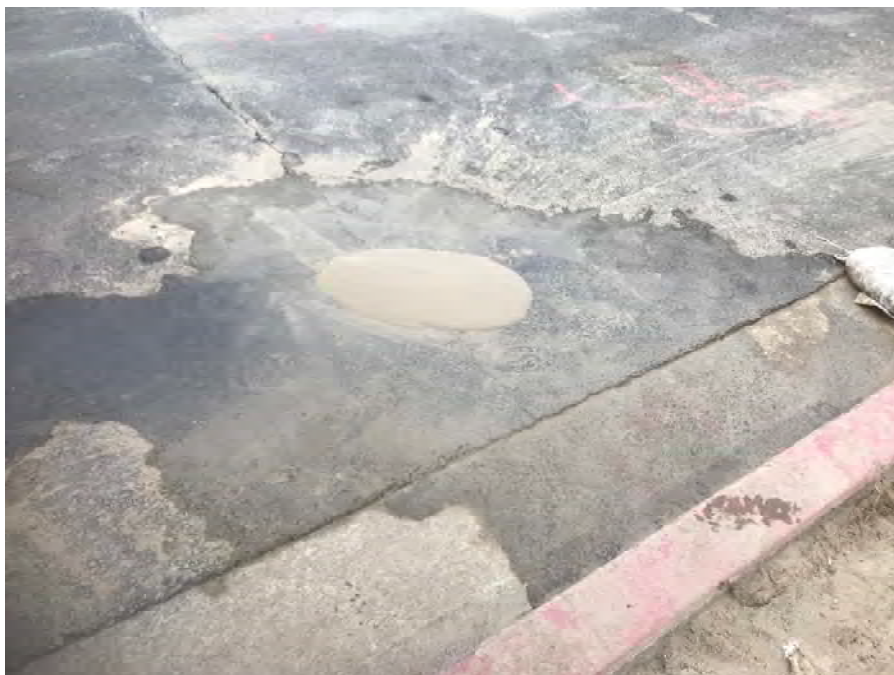
Photo 1

Location	Dale Avenue Gas Pipeline – Middle Section HDD	Description	View of seep in the earlier Dale Avenue frac-out area.
-----------------	---	--------------------	--

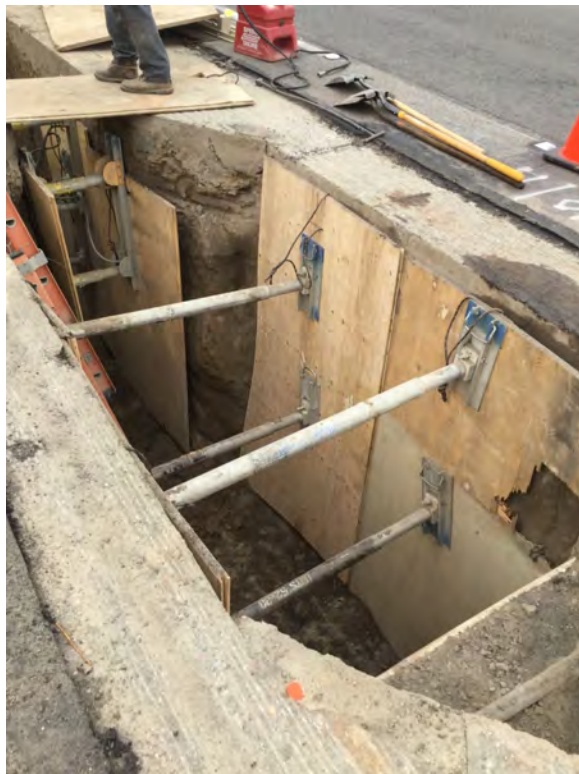
Holocene sands within the trench

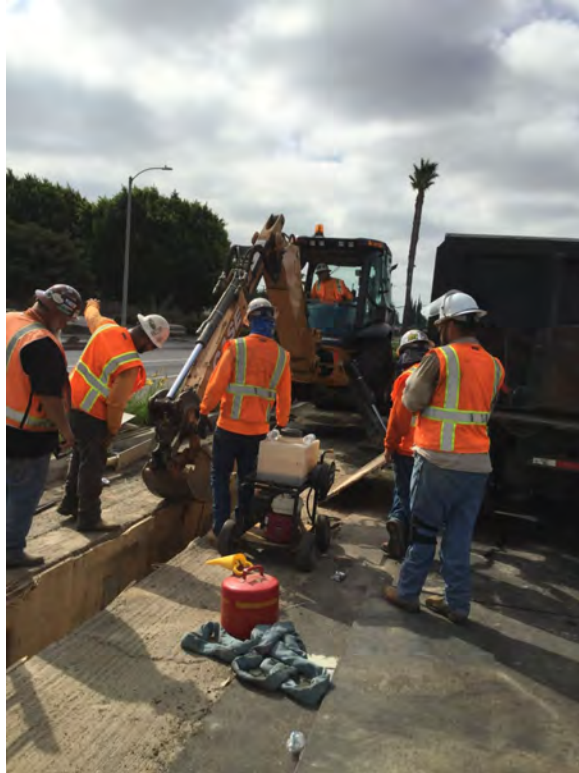
Excavations at La Palma and Dale; very sandy at depths of 7-8ft within Holocene alluvium

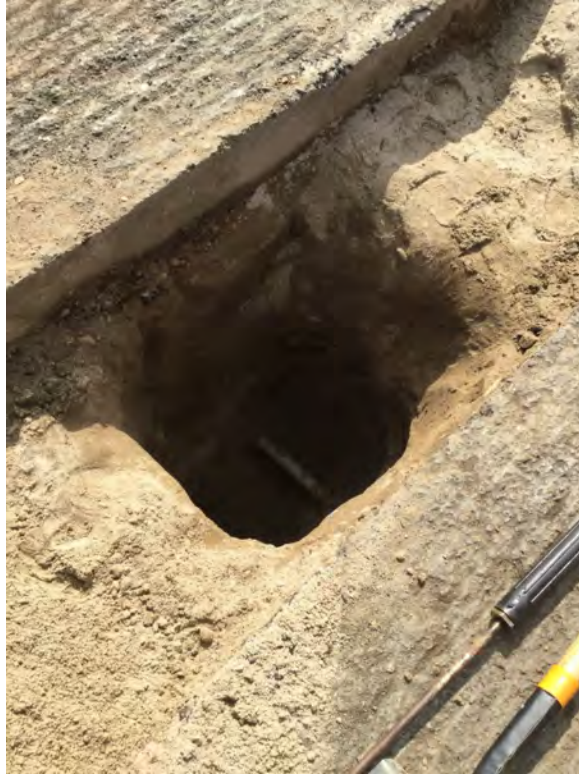
Pothole at Buena Park Downtown; existing pipeline is at approximately 4ft down. 3 feet of fill underlaid by clean medium sands of Holocene age.
