Stanton Energy Reliability Center

CEC Docket No. 16-AFC-01
Monthly Compliance Report No. 8
Reporting Period: September 2019

Prepared by Stanton Energy Reliability Center, LLC (SERC)
Submitted October 12, 2019

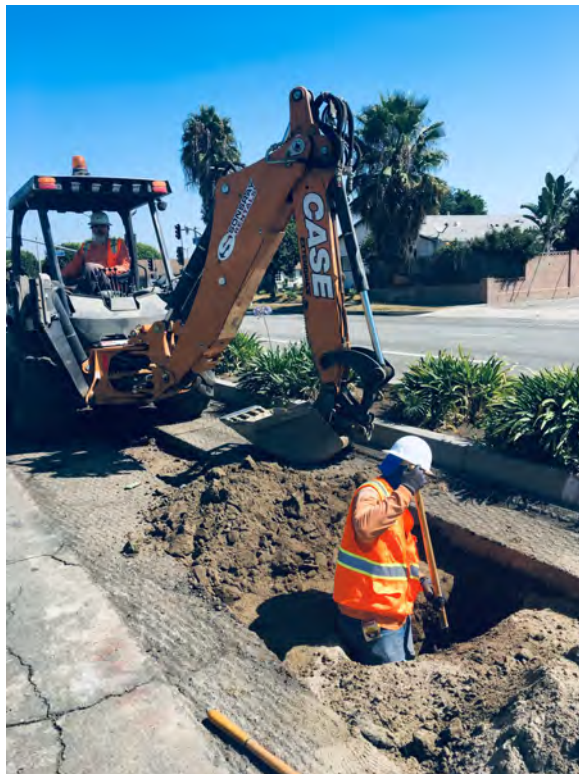
Pot holing for electrical conduit down to max depth of 5 ft north of Station # 900

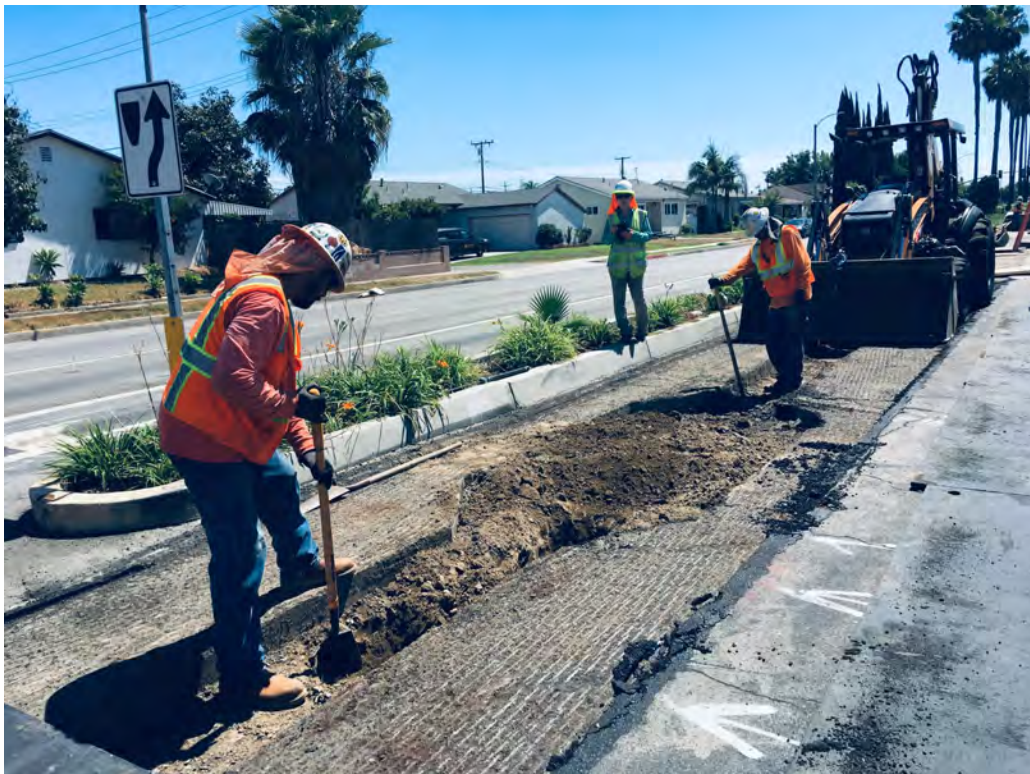
Hand digging to locate underground utilities just north of Station #700

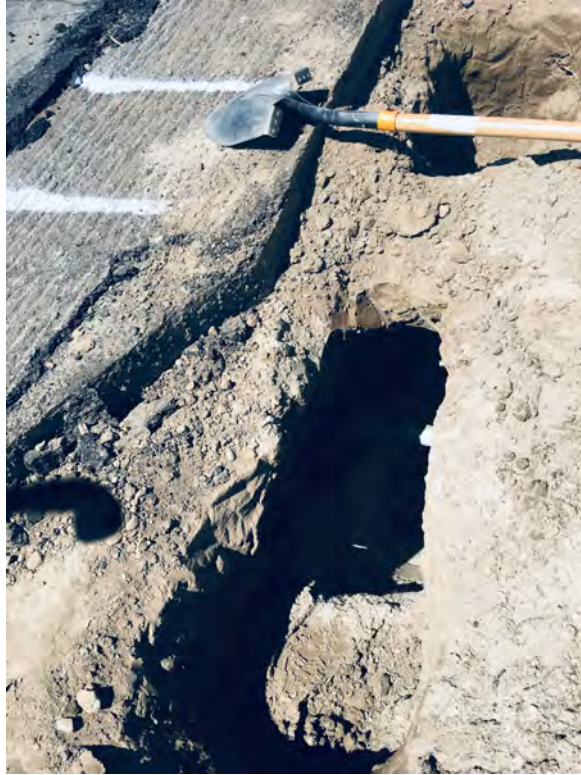
Hand dug holes for utilities down to about 2-3 ft.

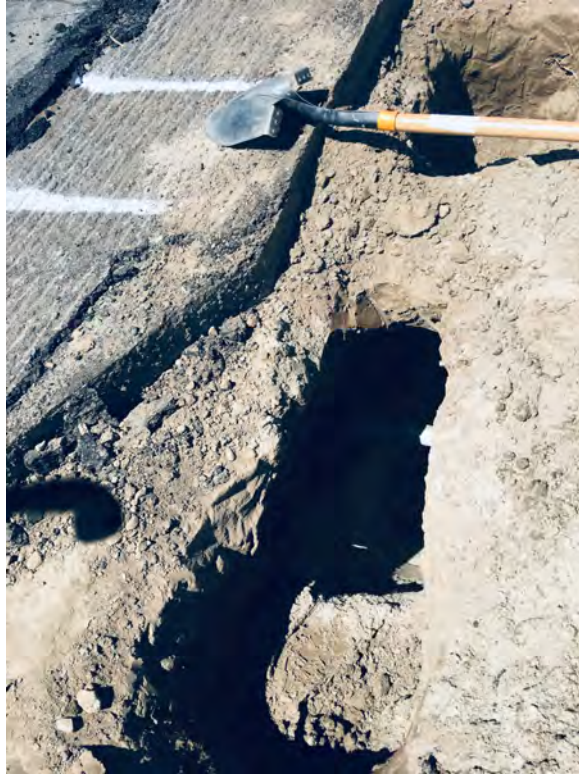
Hand dug holes to locate underground utilities down to about 2-3 ft just north of Station # 700

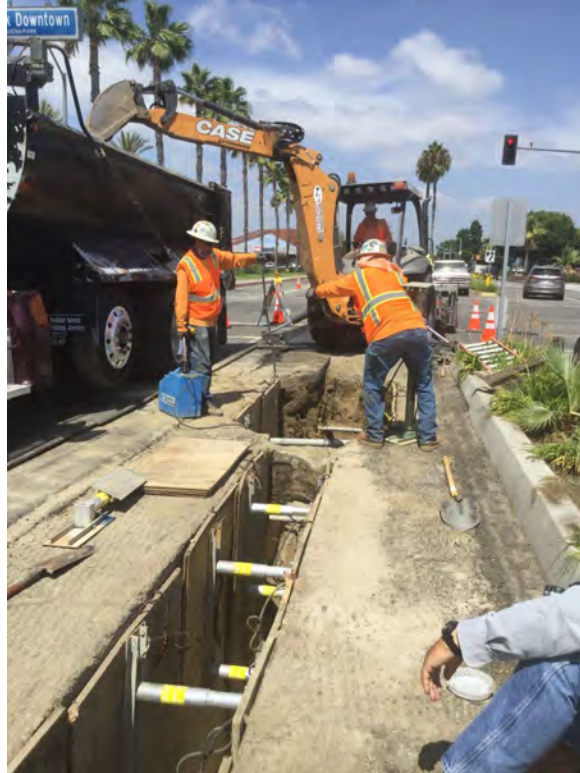
Crew finalizing the trench at the imtersection of Dale and Tamarack, North.

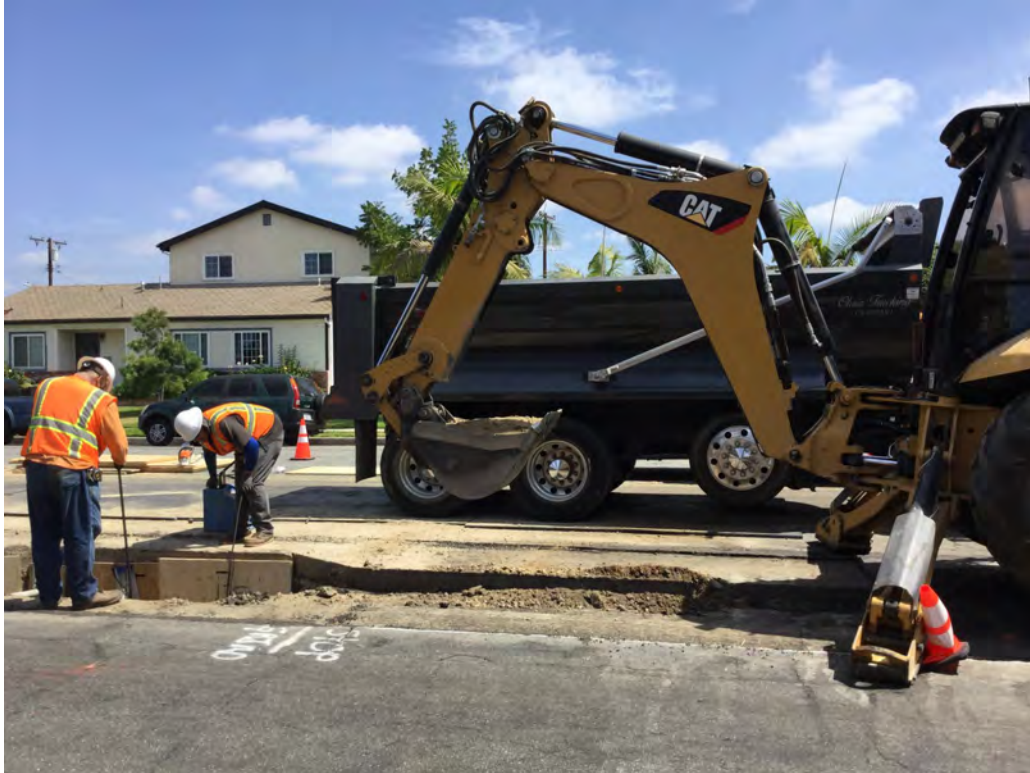
Trenching for gas pipeline installation in HS 22 + 00.

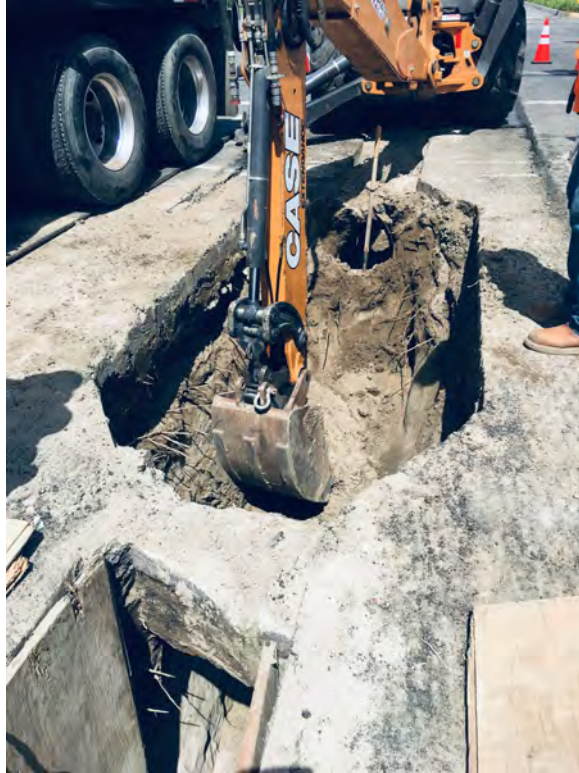
Trenching for Bell-hole north of Station # 680

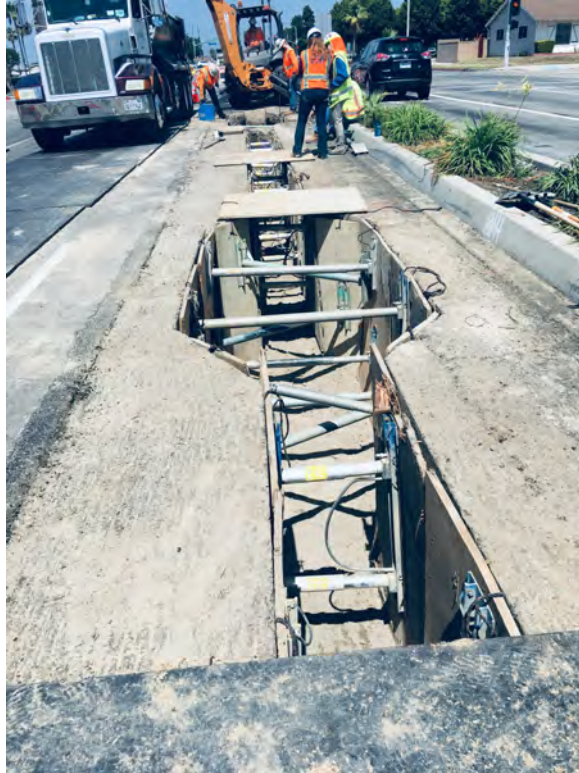
Trenching activity for Sept.09, 2019 at the north end close to Buena Park Downtown street sign.

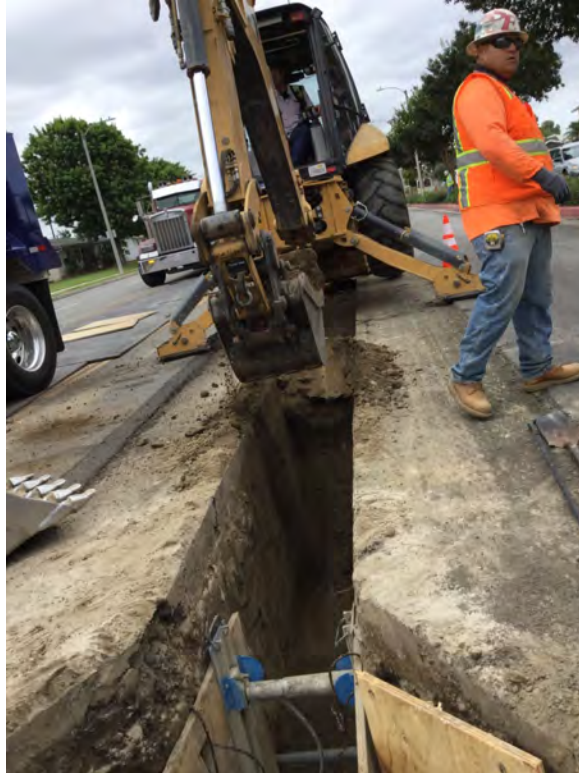
Trenching for gas pipeline installation between HS 22 + 00 and HS 22 + 50.

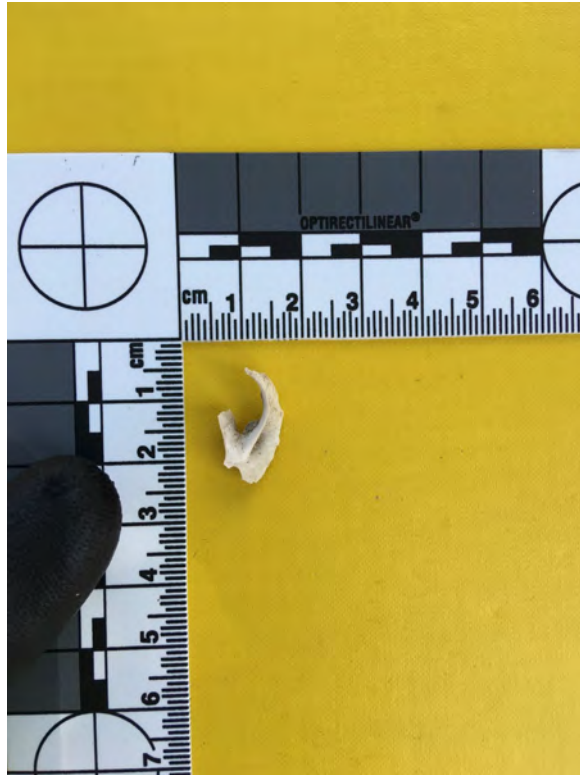
A gastropod shell fragment was observed.

Another view of gastropod shell fragment.

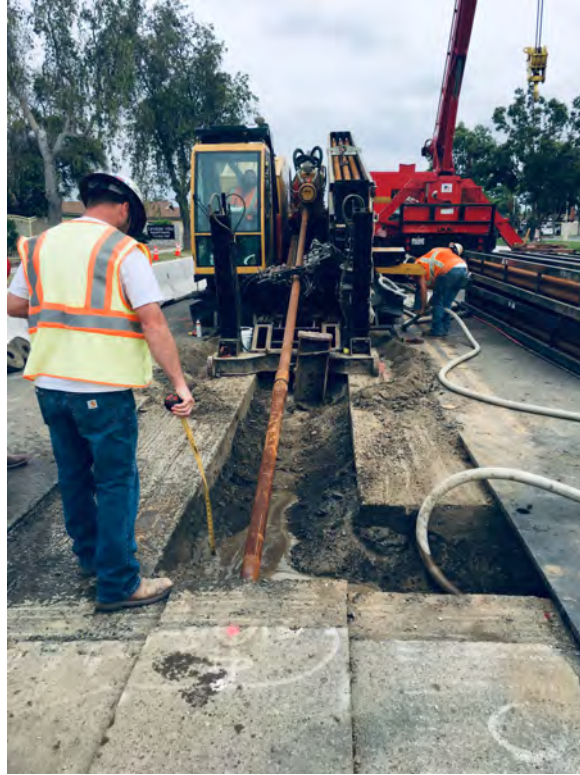
HDD operation in progress with Entry Pit close to Station # 5125

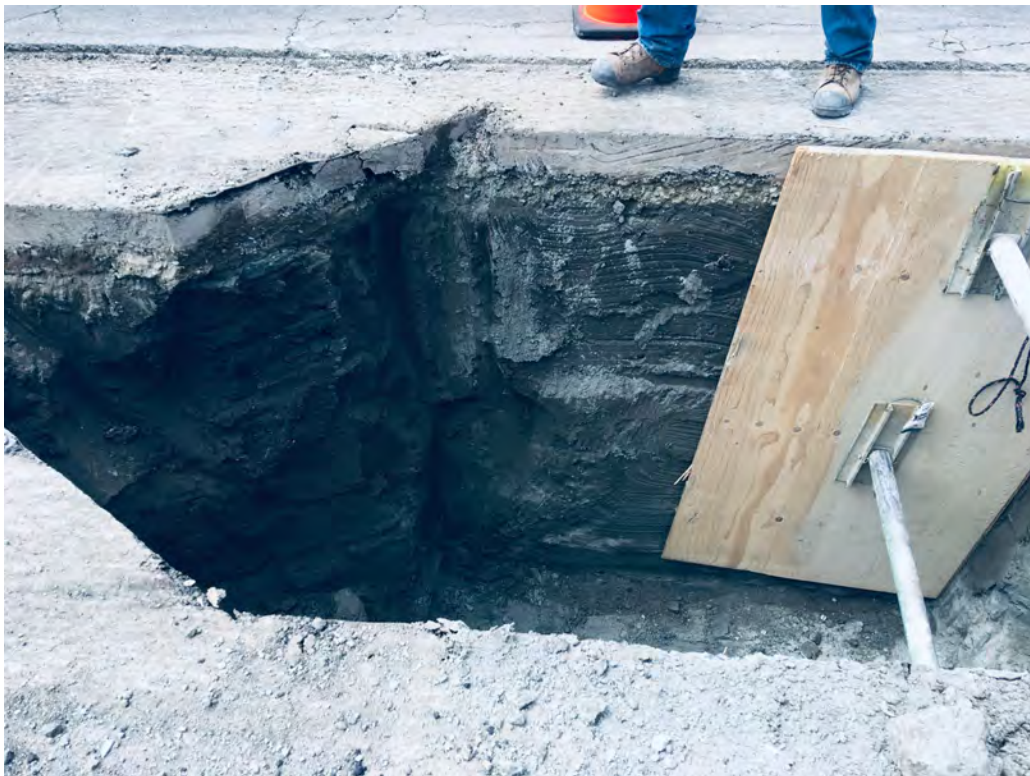
Greenish gray friable silty sands probably of marine origin just south of Station # 2400

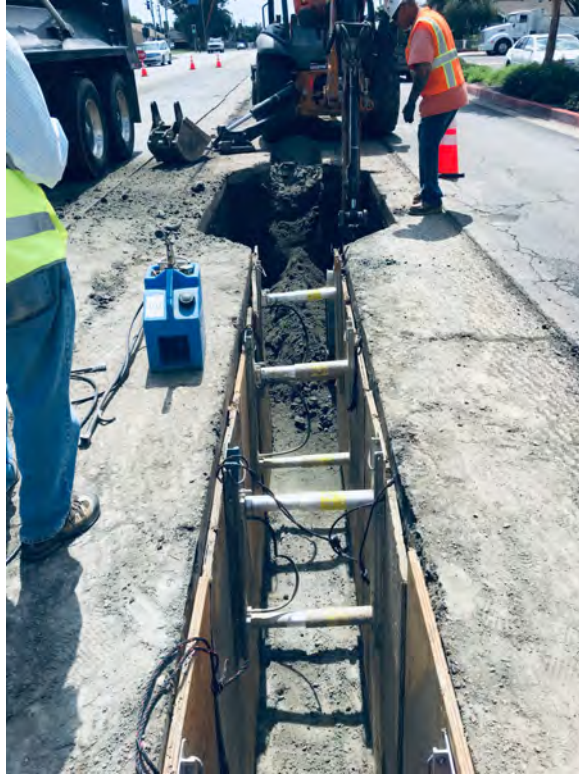
Trenched length for the day south of Station # 2400

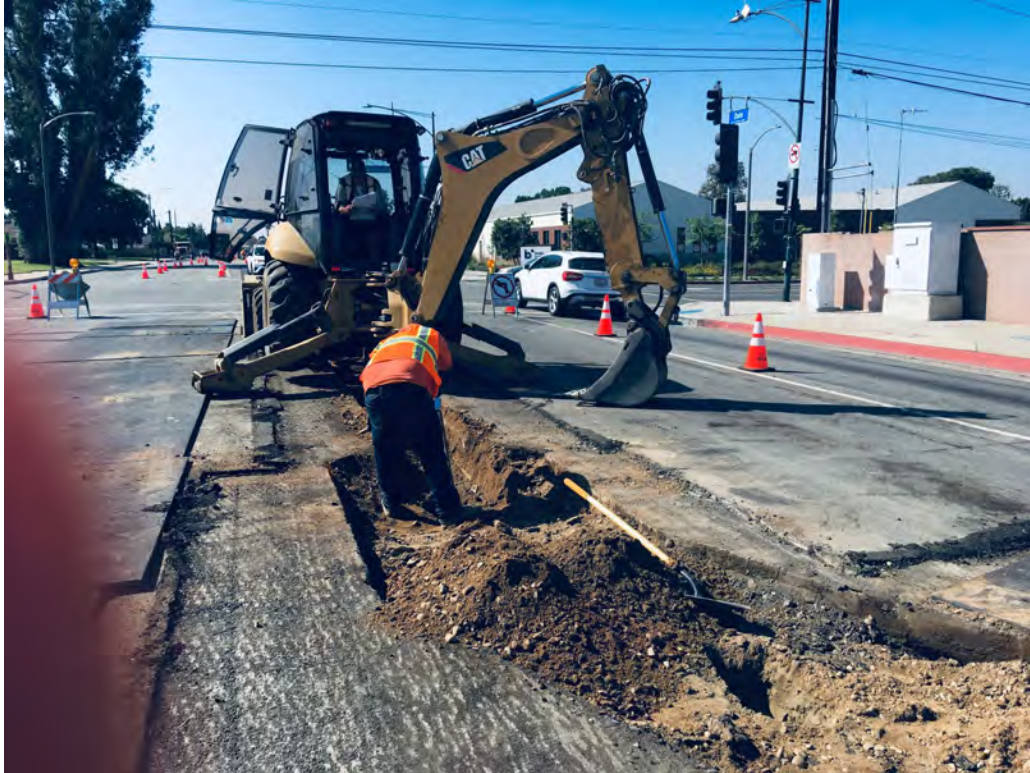
Pot holing for underground utilities near Station # 2640

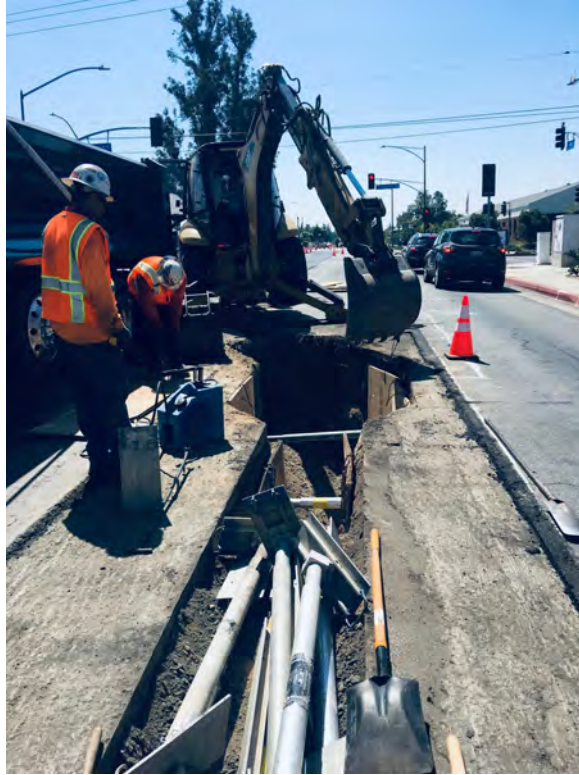
Trenched length for the day. Cave-in observed during trenching activity near Station # 2640

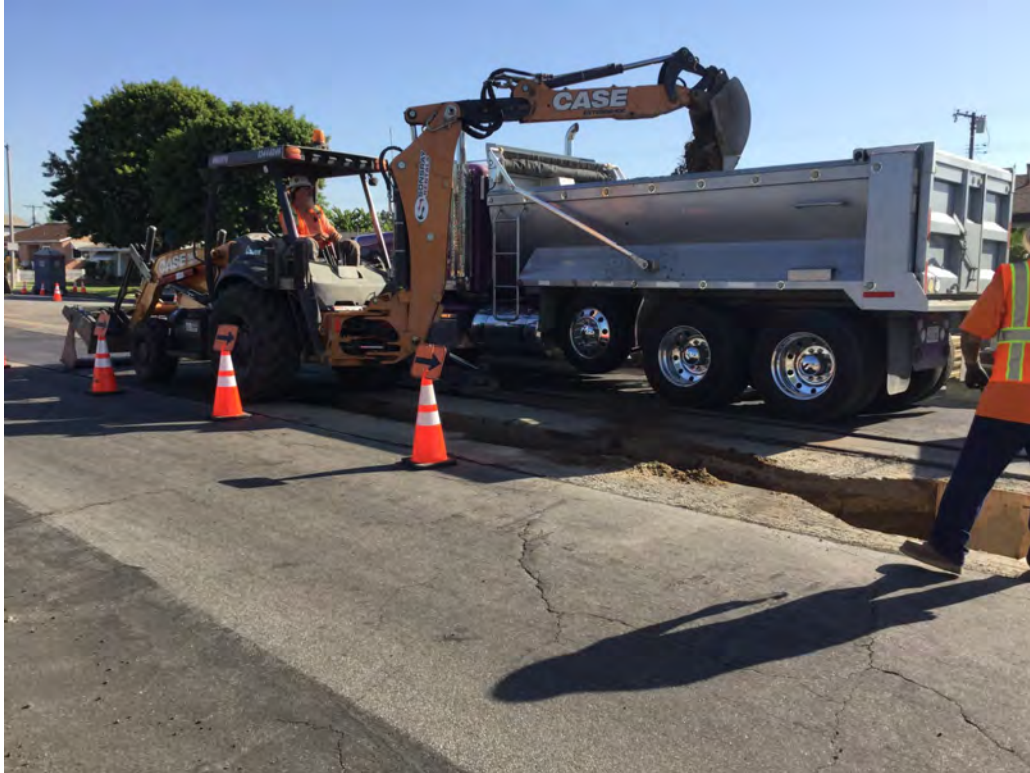
Excavation starting with 5 ft wide section between 25+80 and 25+85 that they could not finish yesterday. (7 ft depth). East

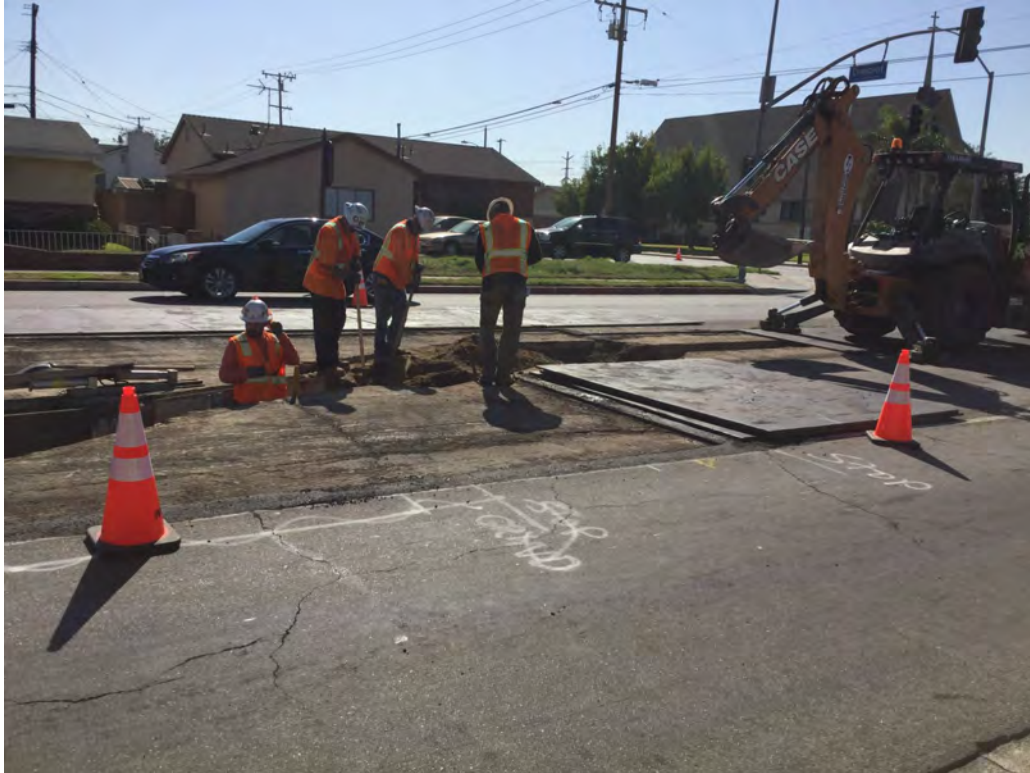
Potholing at 26+50 for gas utilities. East

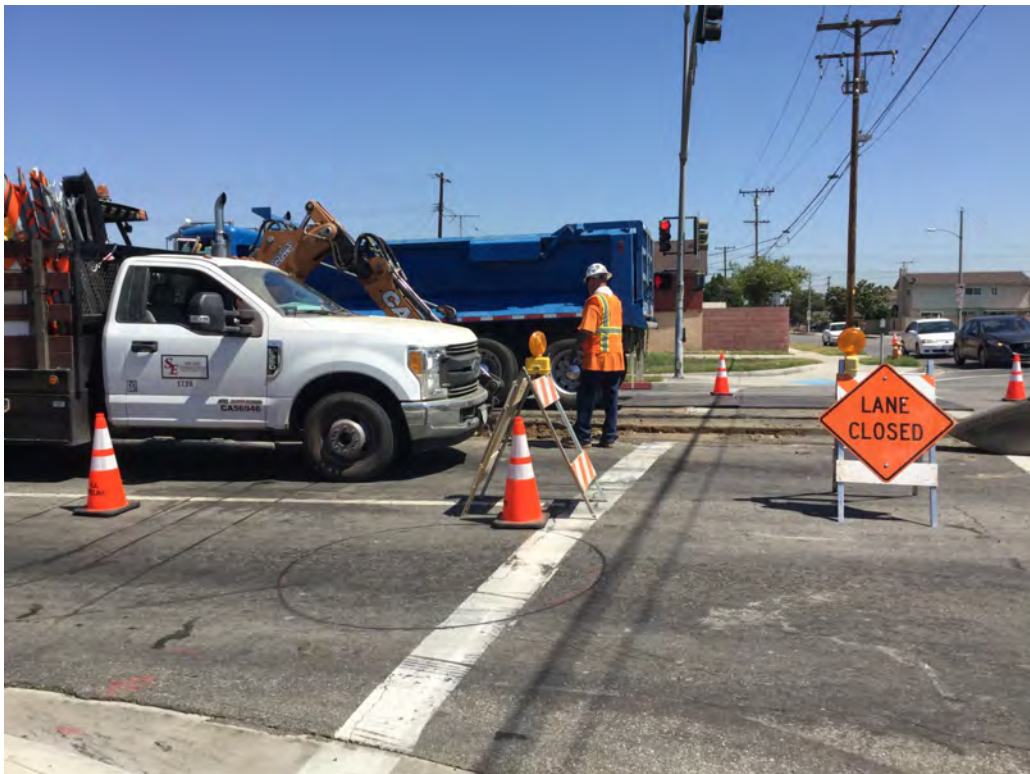
East. Backhoe started removing asphalt at 1:10.

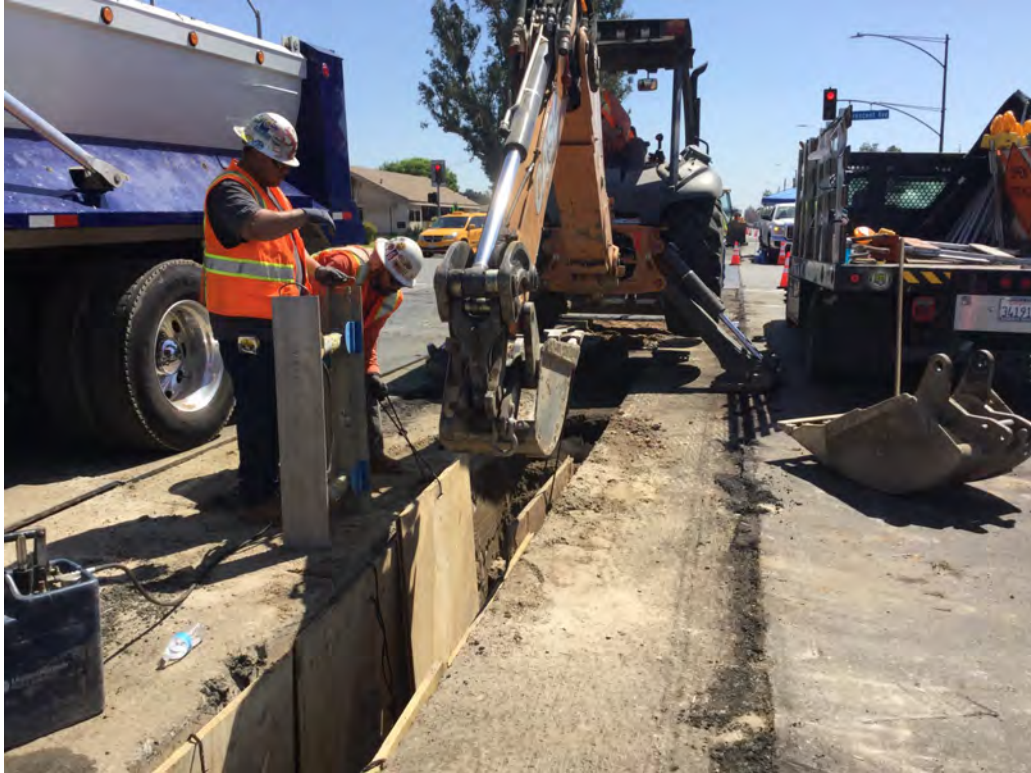
South. Finishing up the last segment of trenching for the day at 26+75

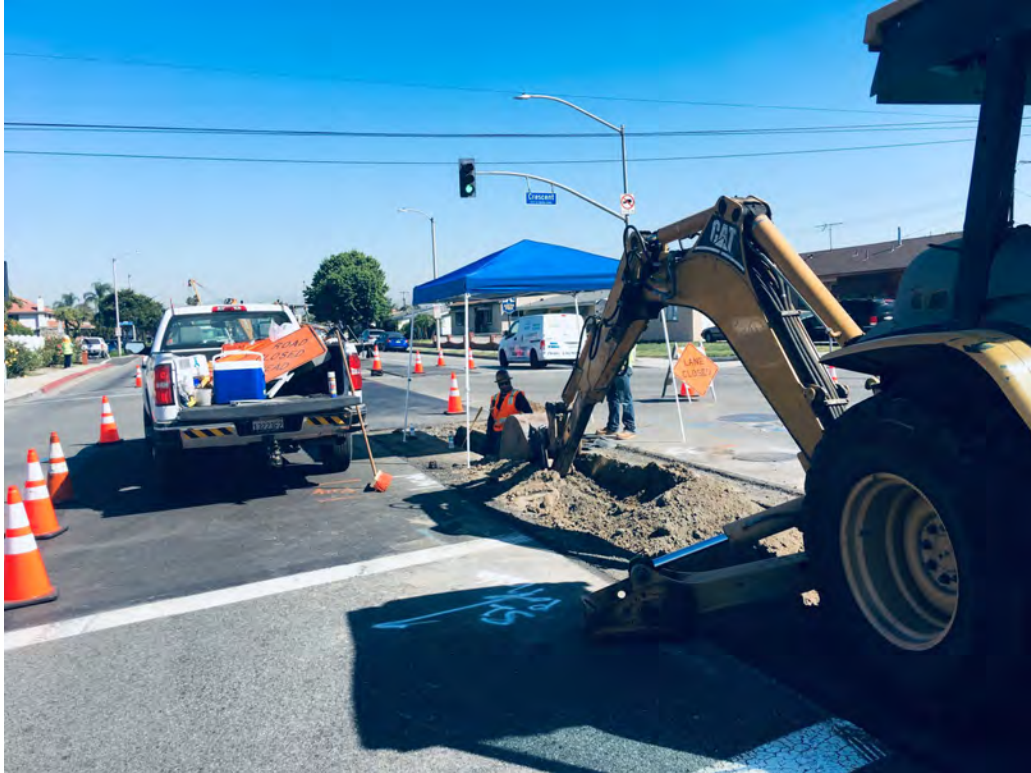
Pot holing for multiple underground utilities at the intersection of Crescent Ave and Dale Ave near Station # 2750

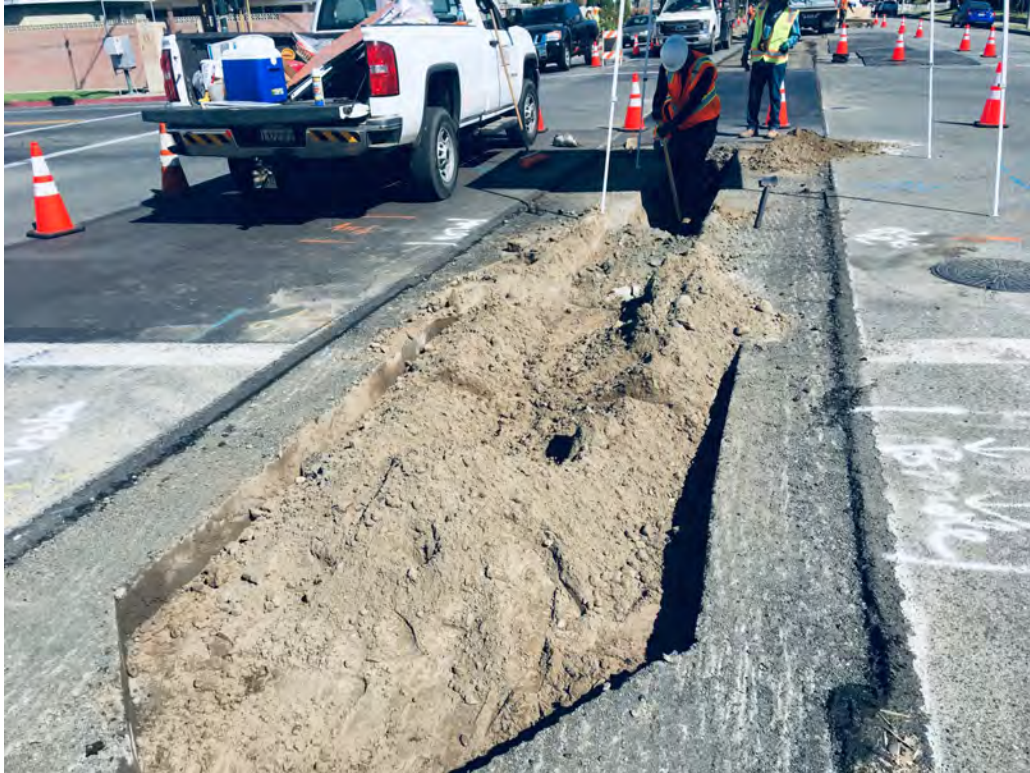
Pot holing for multiple utilities just south of Station # 2750 intersection of Crescent Ave and Dale Ave.

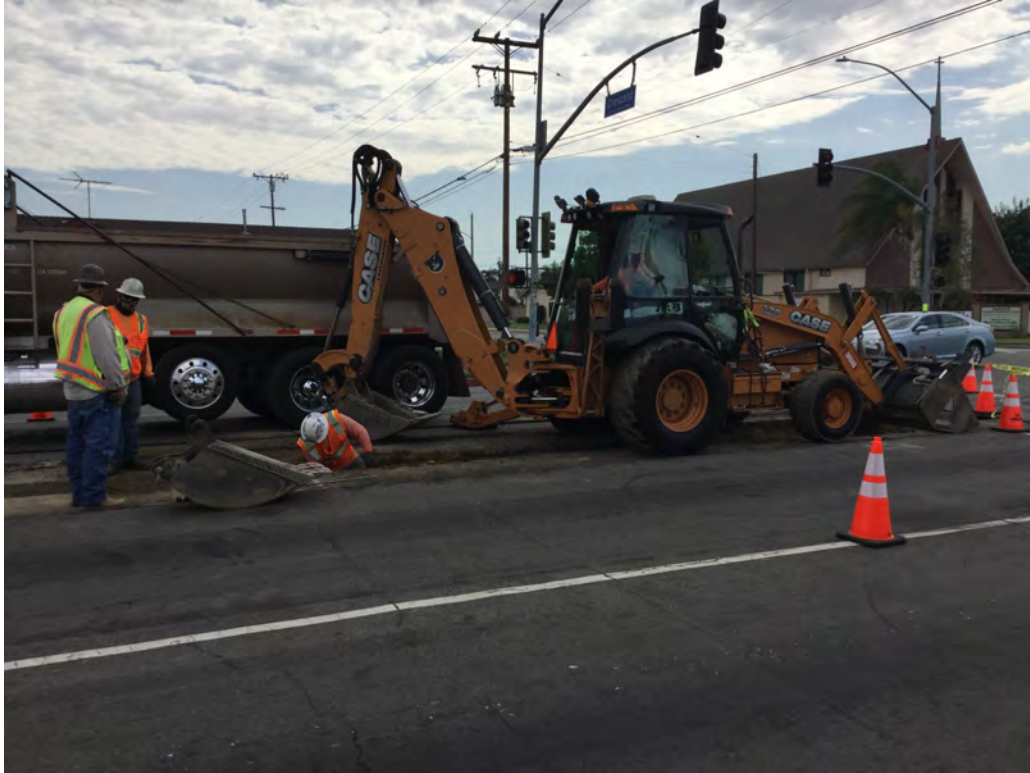
East. Start of work at 26+75 digging began at 10:00.

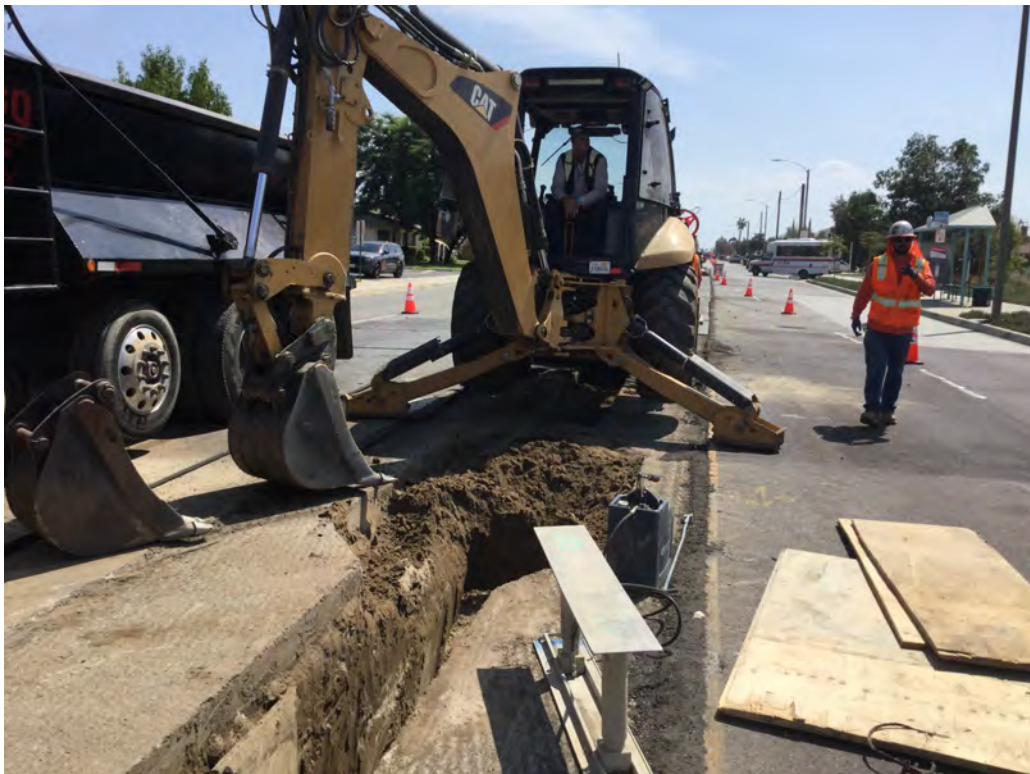
South, 2nd crew finishing up at 28+75.

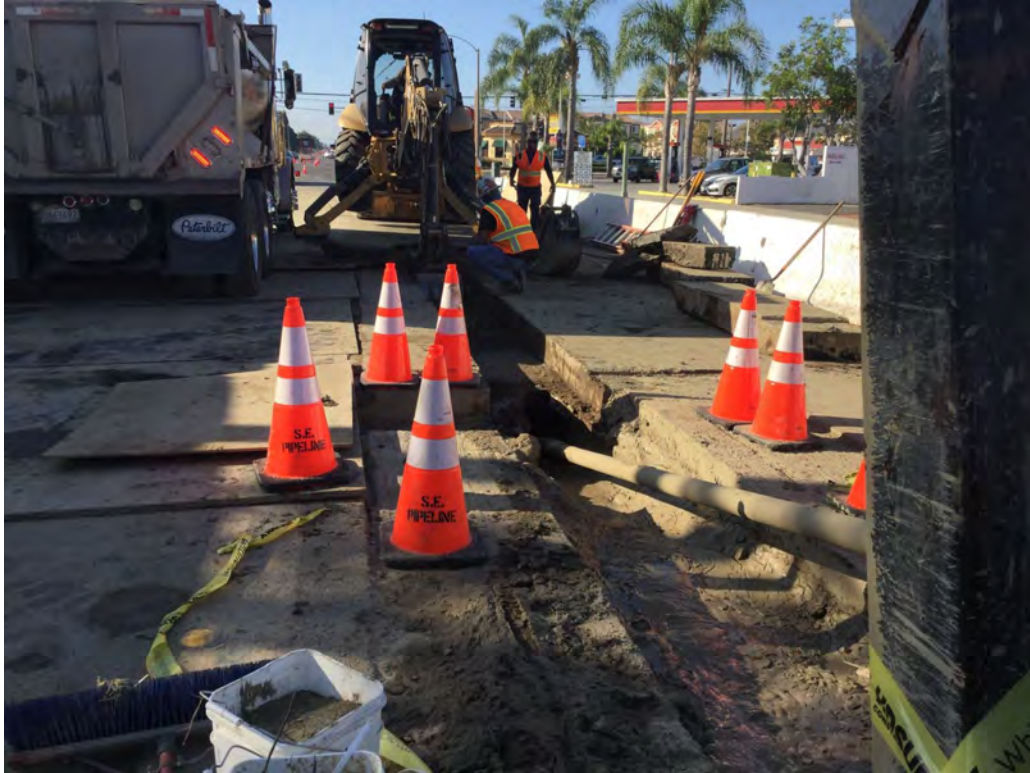
South, HDD backhoe being used to help excavate around HDD drill shaft. @ Lincoln and Dale Ave.

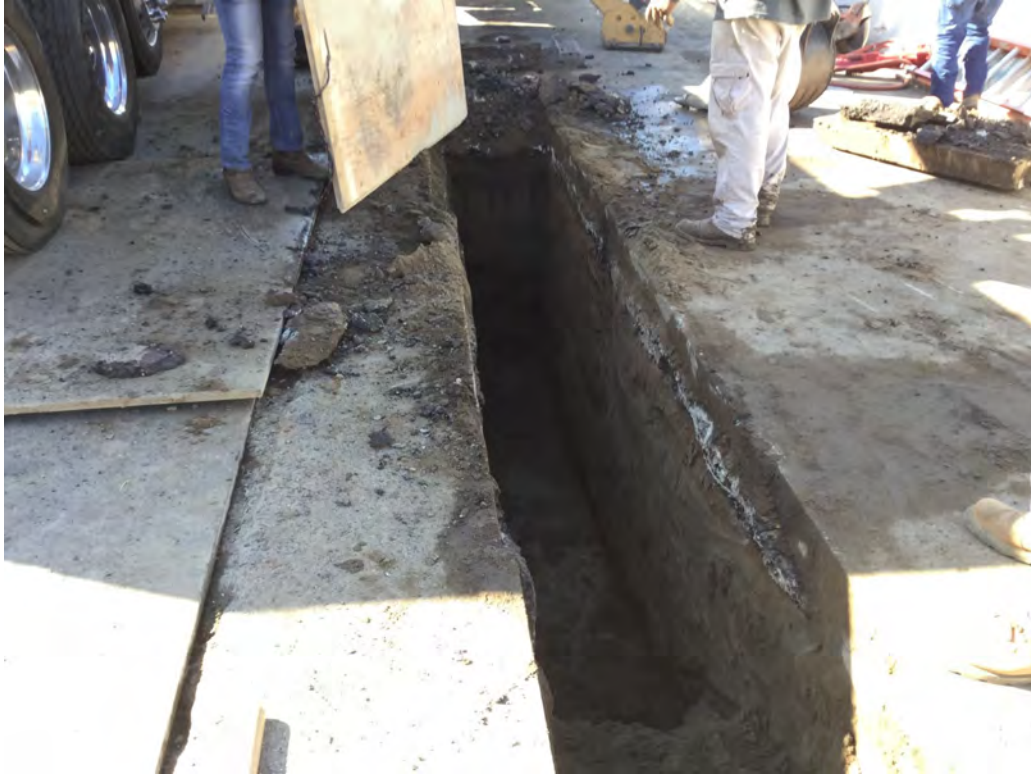
South, HDD dug down to drill, 6 ft.

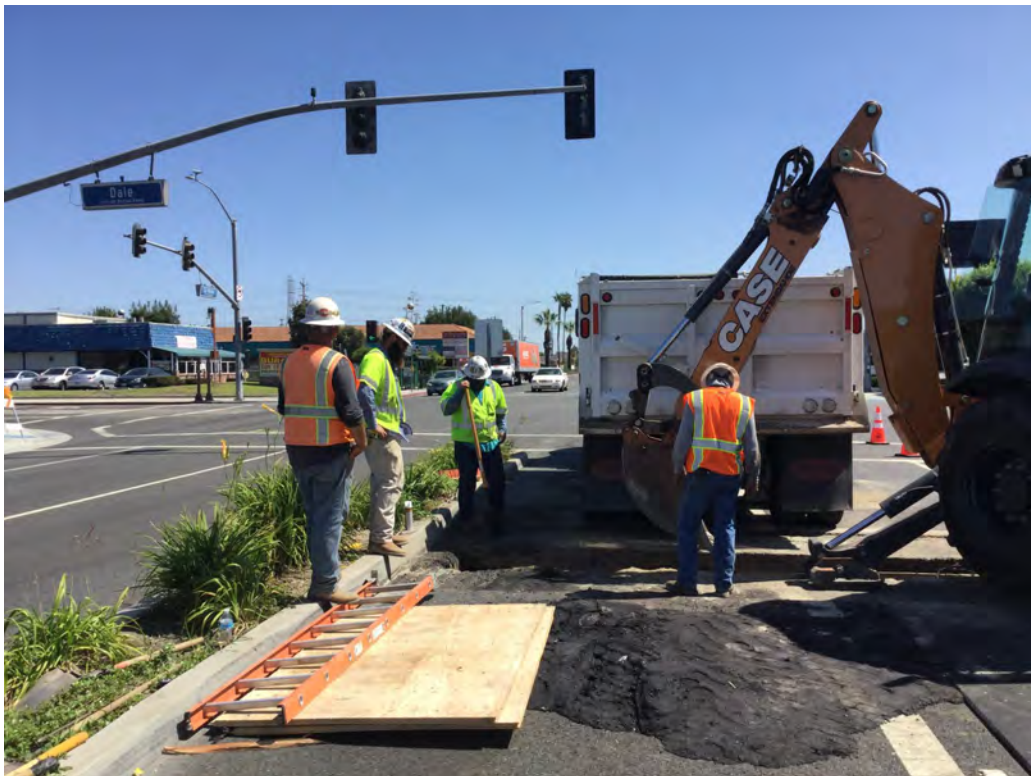
East, at Dale and La Palma. 4th crew excavating across median.

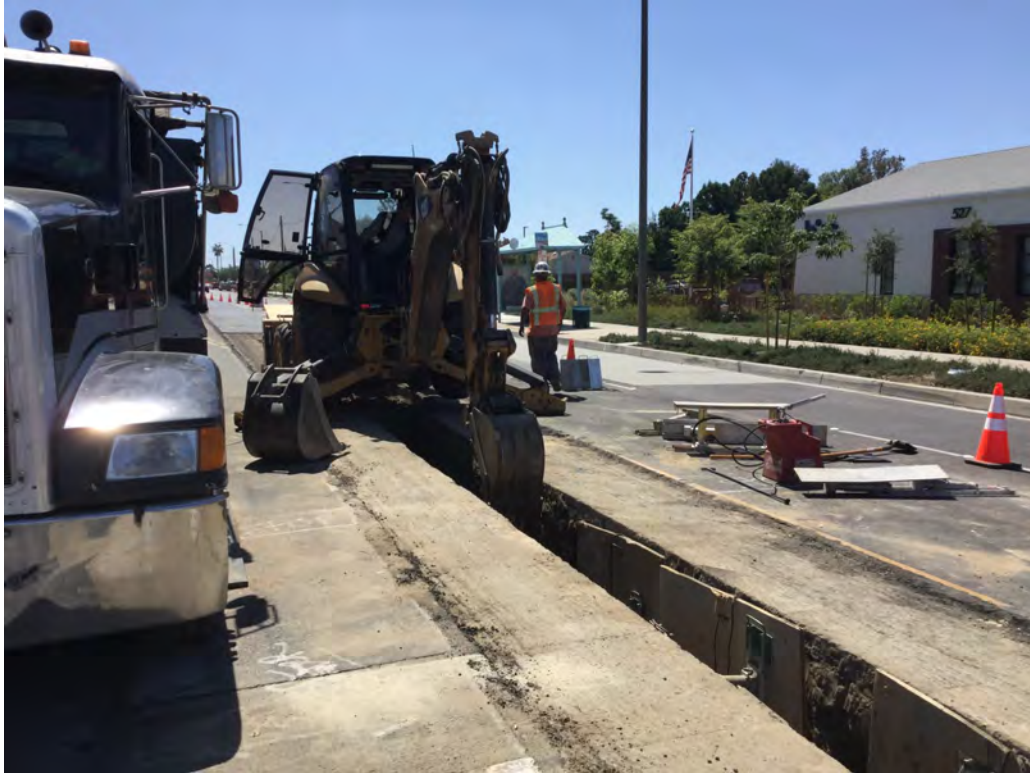
South. Southeast Construction Crew south of Crescent continuing to trench after lunch.

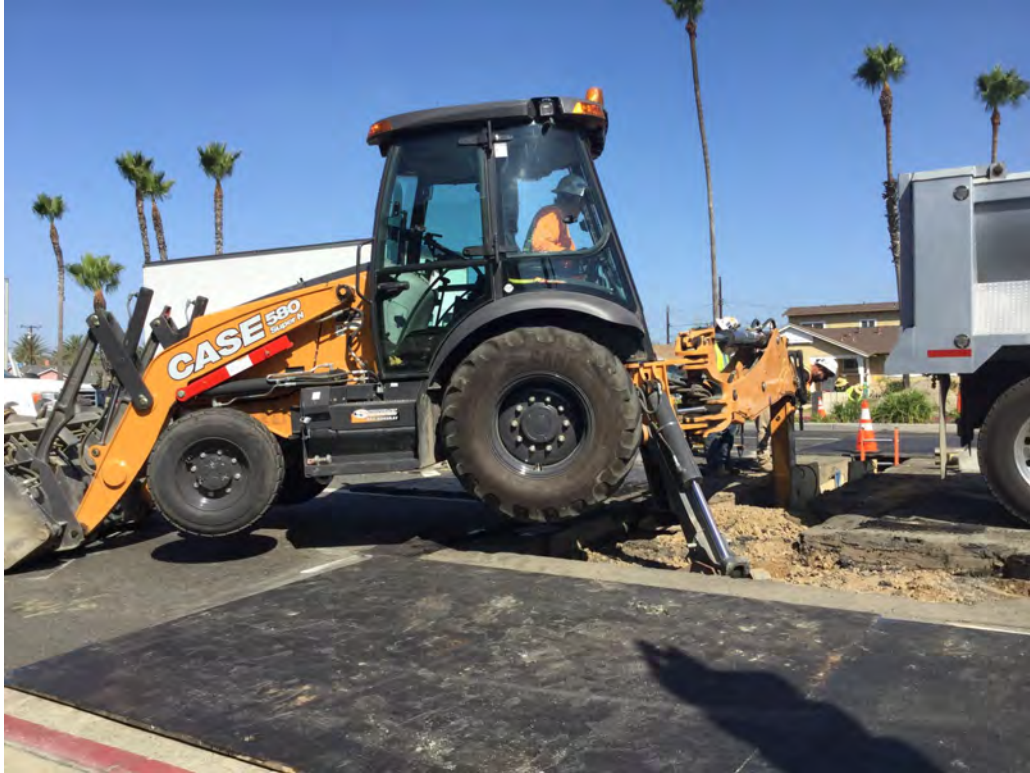
North, backhoe continuing trench from yesterday at 0+60

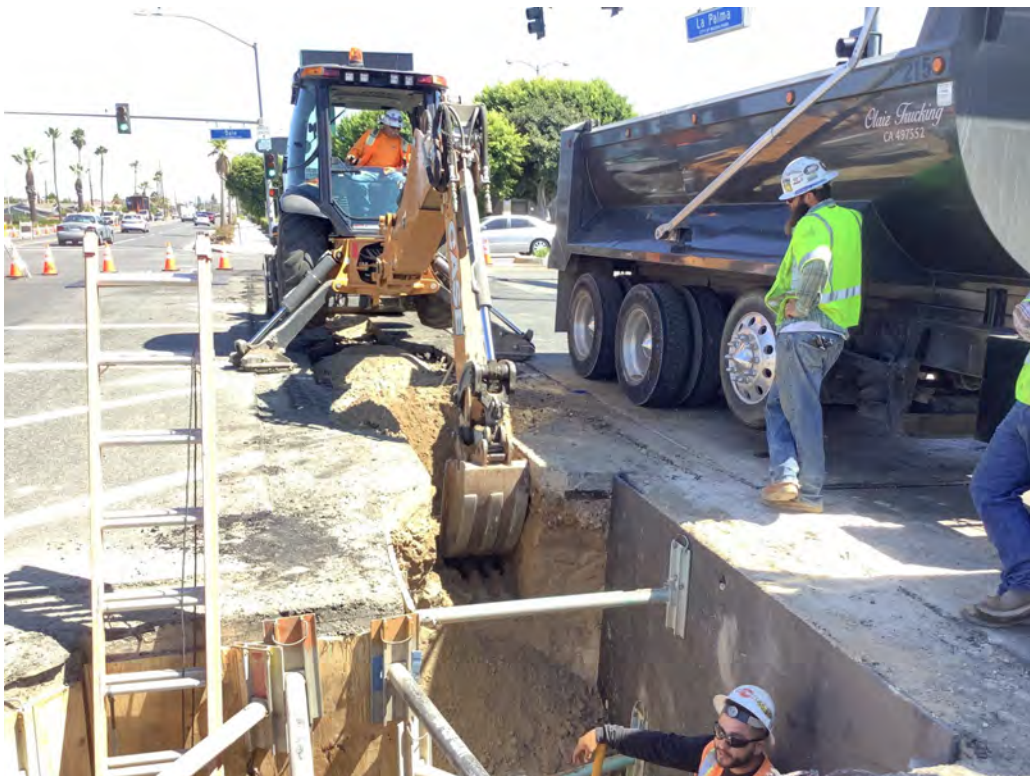
East, southeast crew continuing at 0+75 digging down to 8 ft depth.

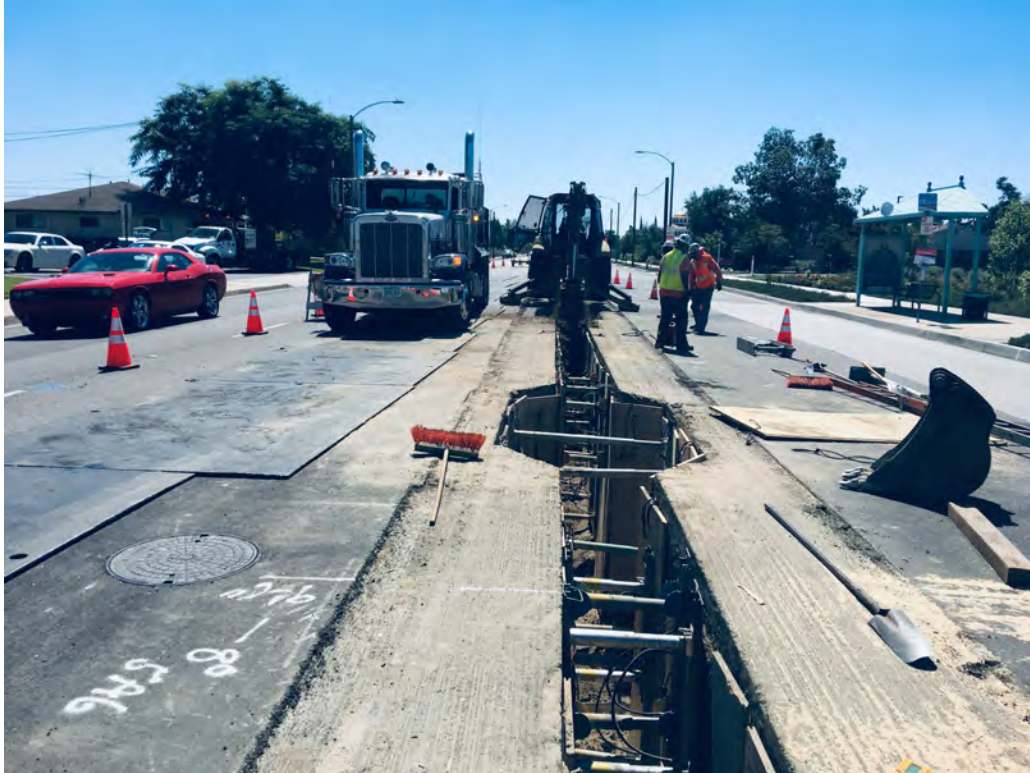
Trenched section south of Station # 2900 down to max depth of about 10 ft.

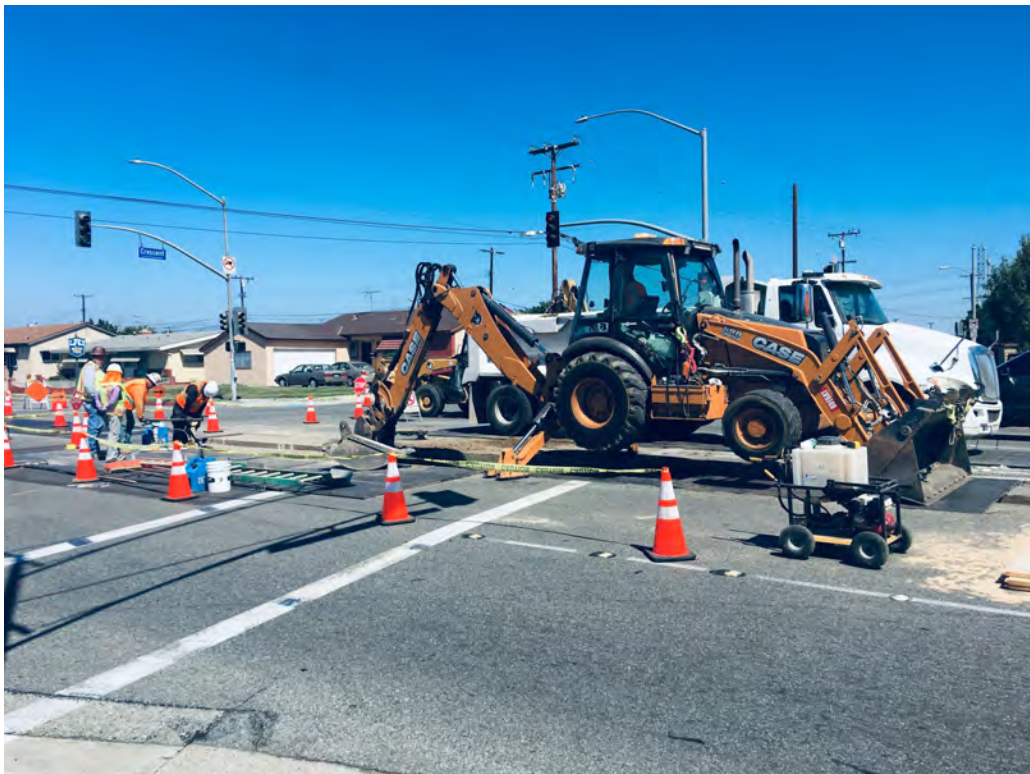
Trenching activity at the intersection of Crescent Ave and Dale Ave

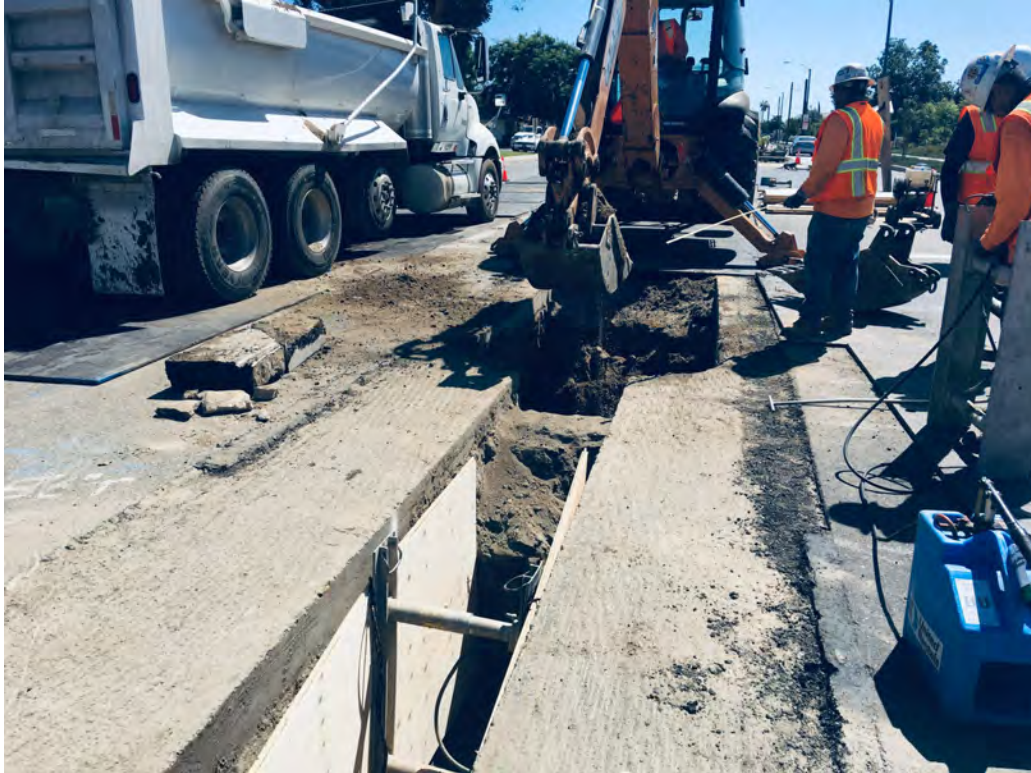
Trenched section from near Station # 2750 with maximum depth of about 13 ft.

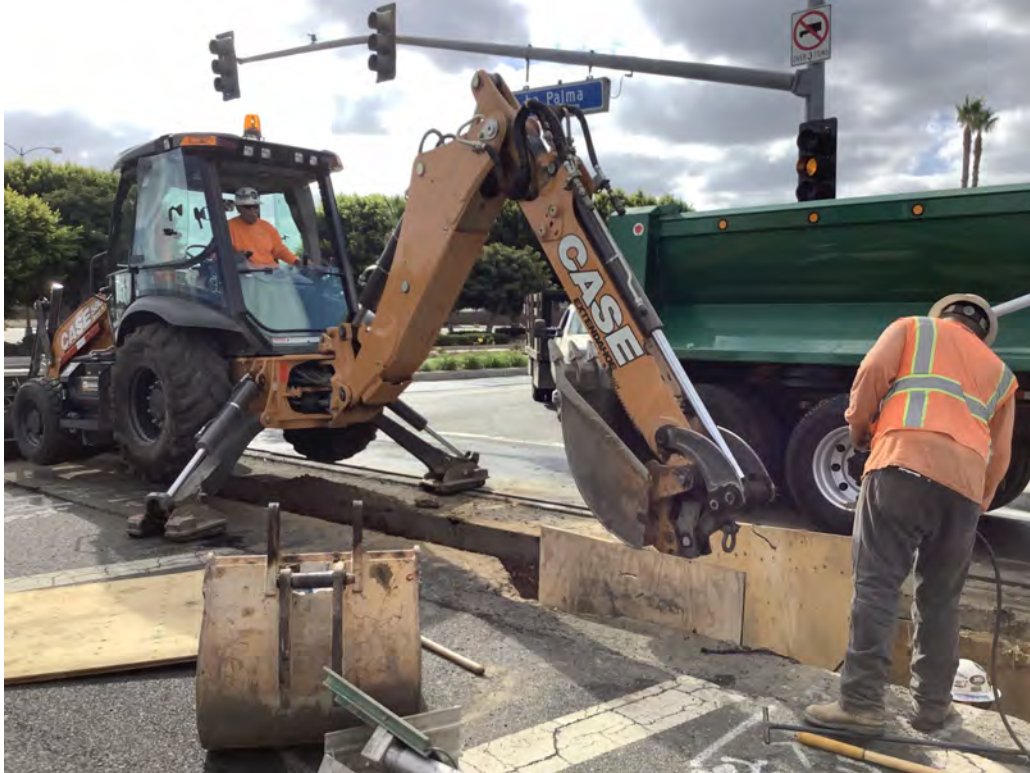
Southeast, start of digging at dale and LaPalma at 0+80
