Stanton Energy Reliability Center

CEC Docket No. 16-AFC-01
Monthly Compliance Report No. 8
Reporting Period: September 2019

Prepared by Stanton Energy Reliability Center, LLC (SERC)
Submitted October 12, 2019

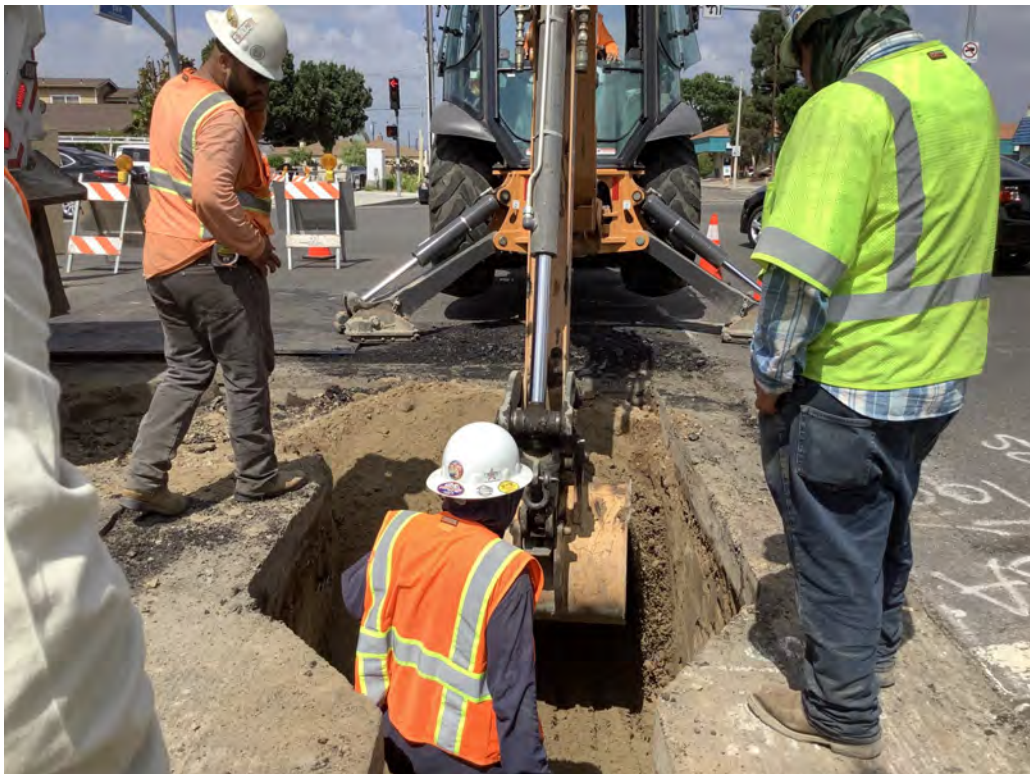
North, crew excavating around water main at intersection. (1+45)

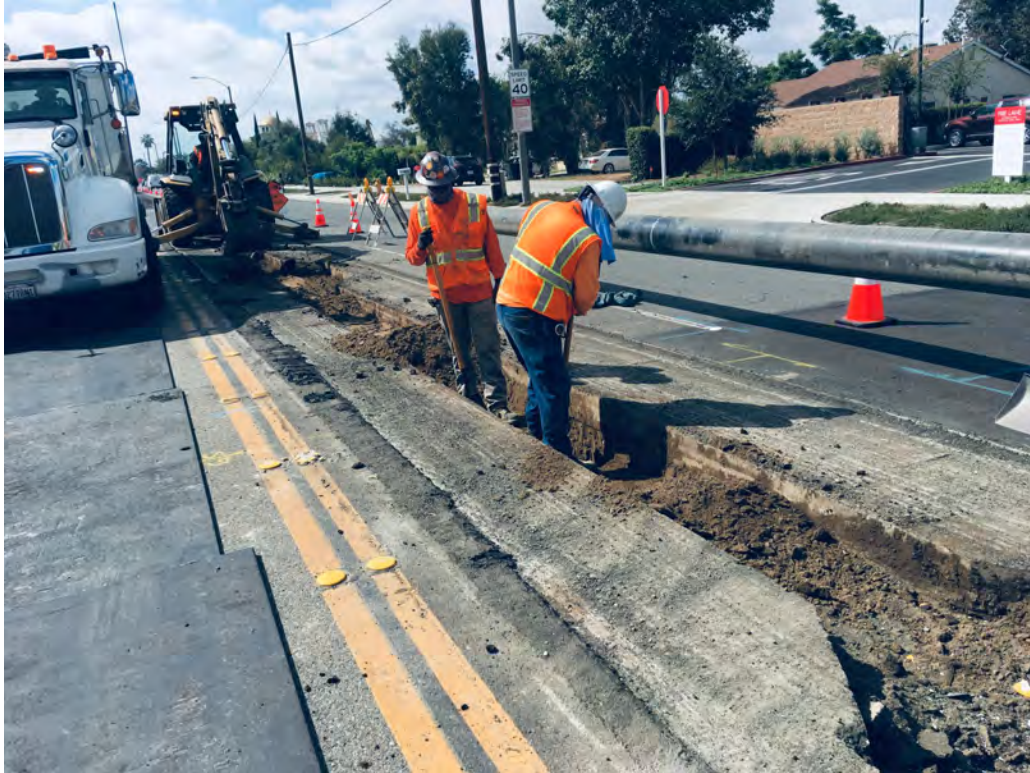
Pot holing for utilities near Station # 3050

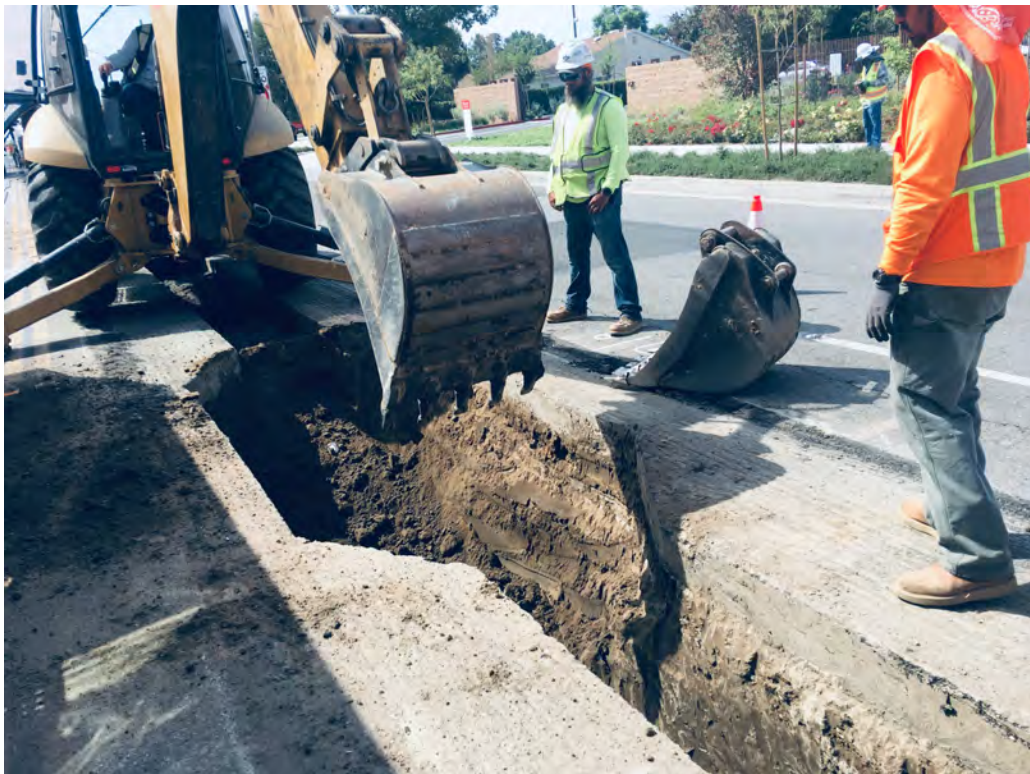
Trenching activity south of Station # 3000

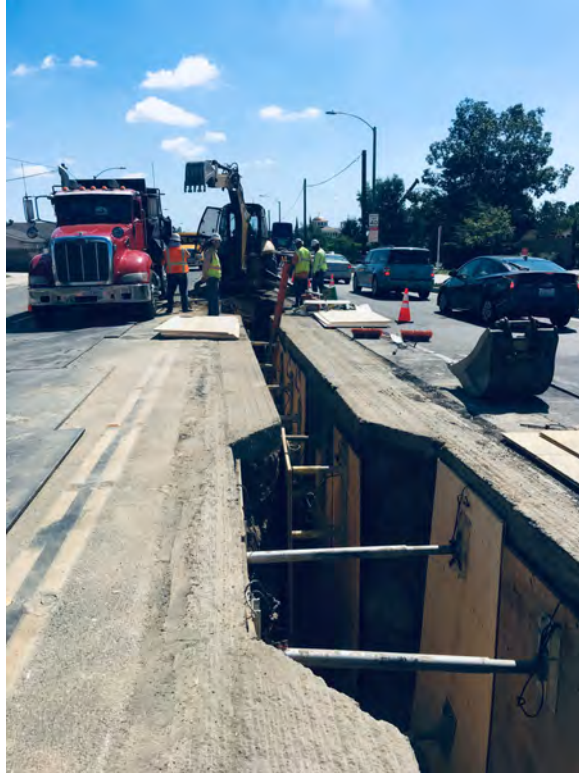
Trenched length south of Station # 3000

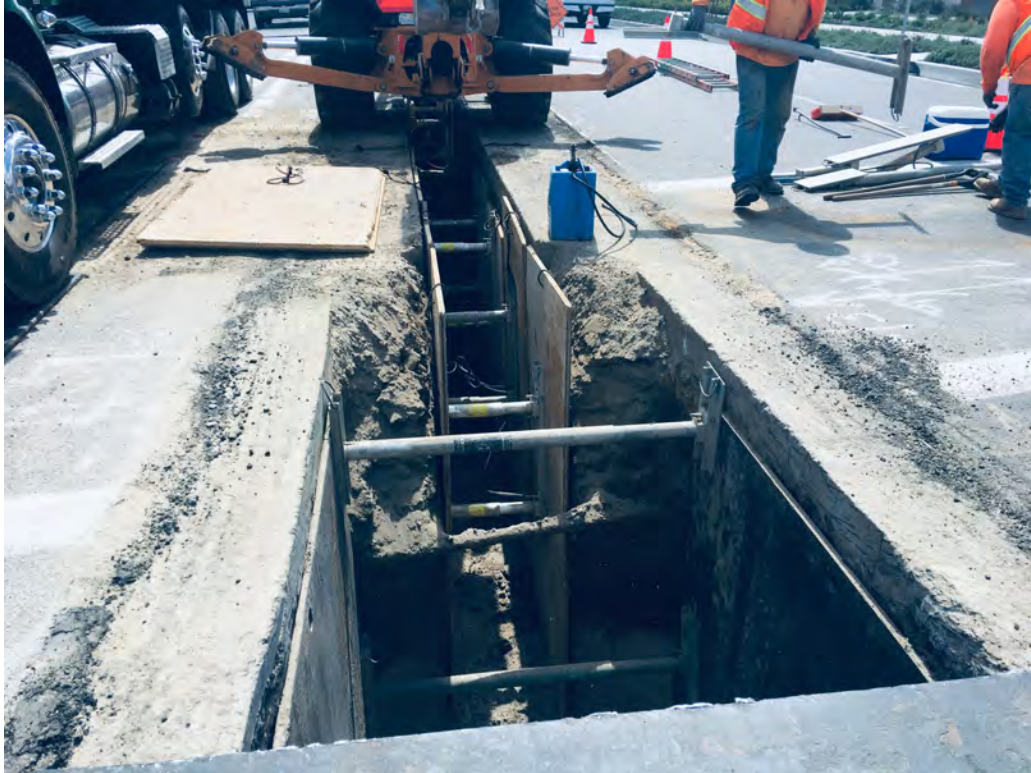
Trenching activity south of Crescent Ave/Dale Ave intersection. Crew worked under tight street safety conditions.

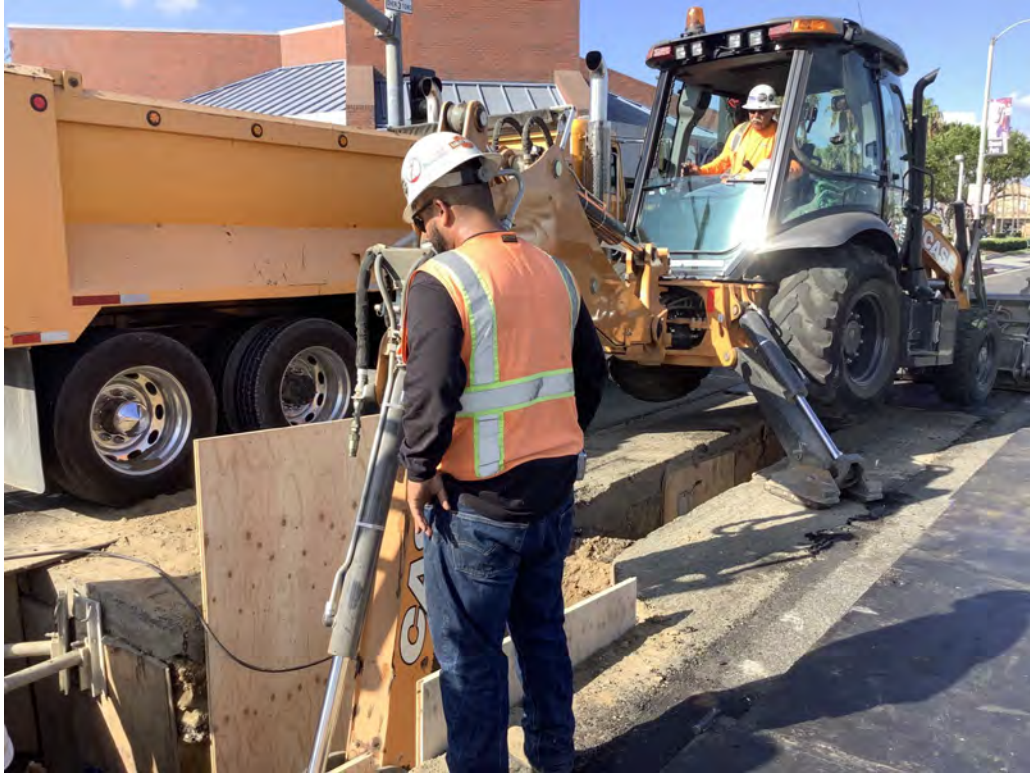
Southwest, finishing up intersection trench segment between 1+30 and 1+80

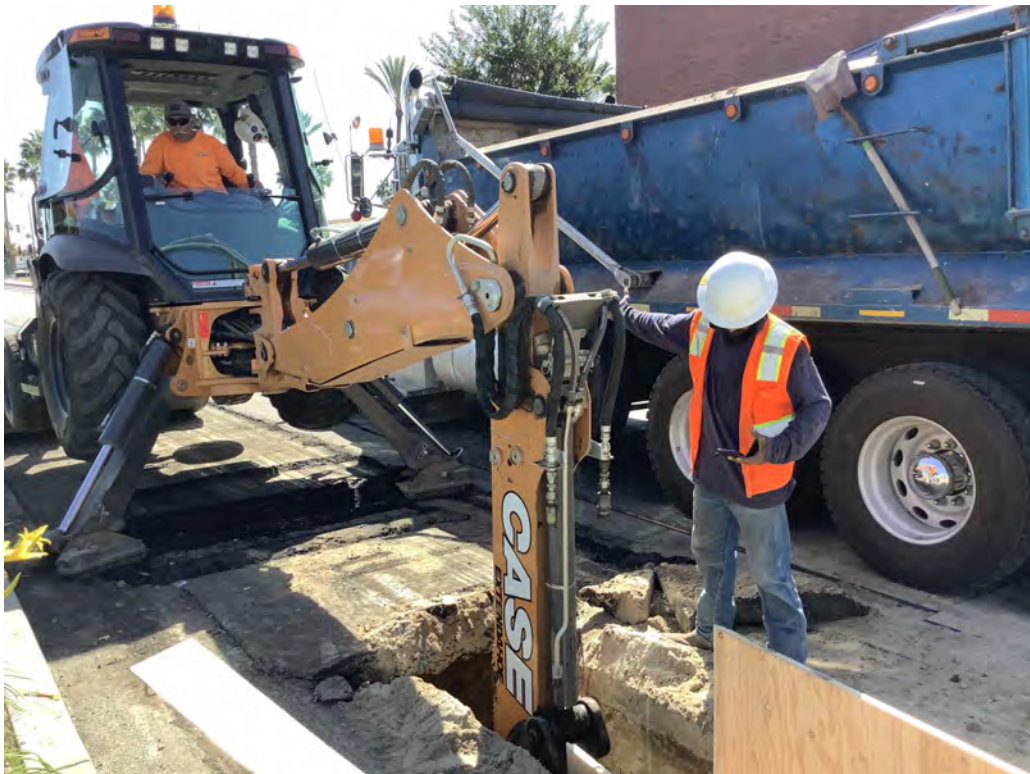
Southwest. Crew finishing digging segment of trench at 1+90

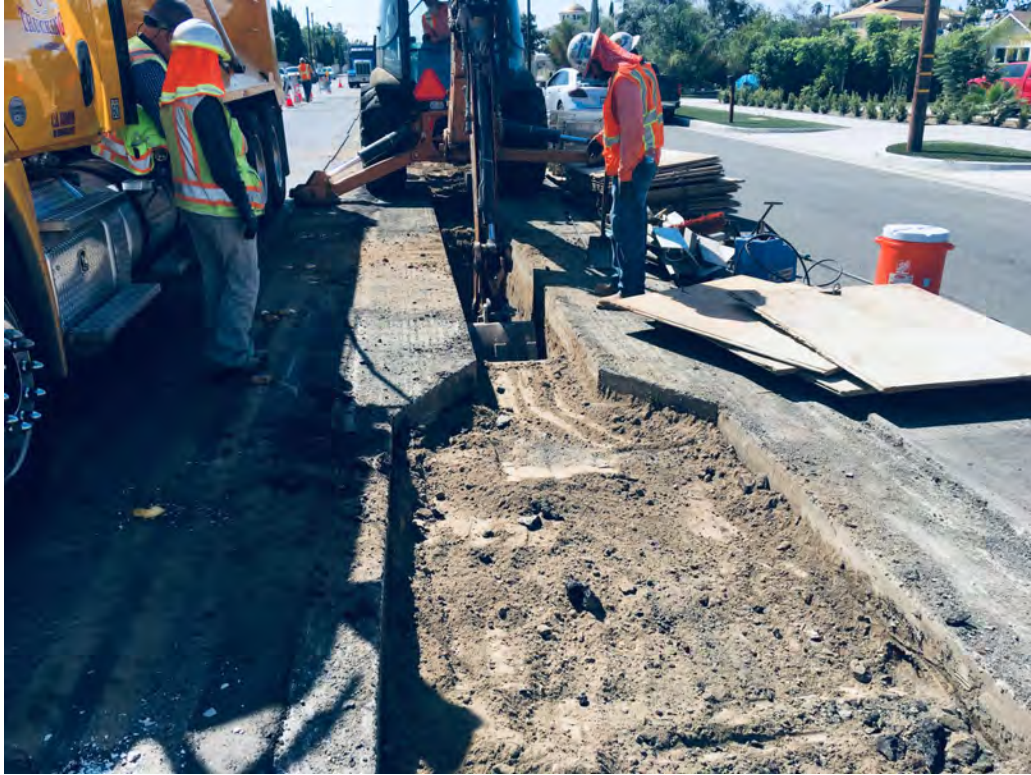
Trenching activity near Station #3300

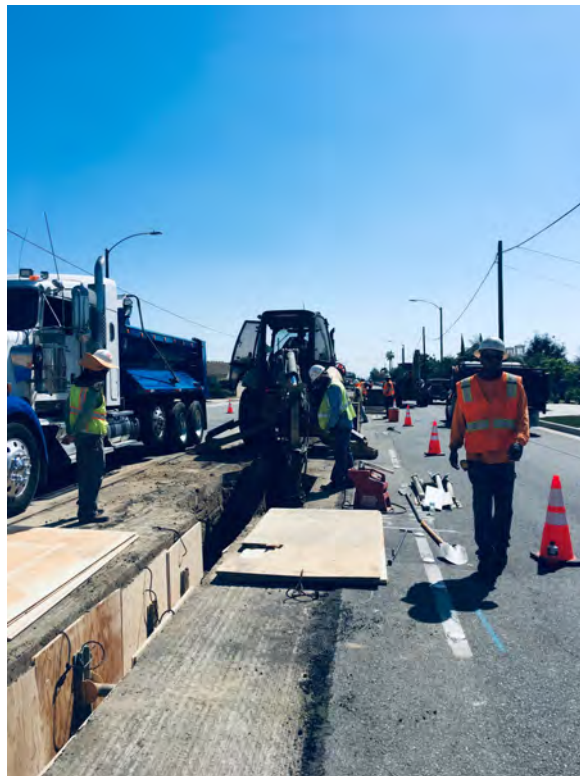
Trenching activity going south from Station #3065

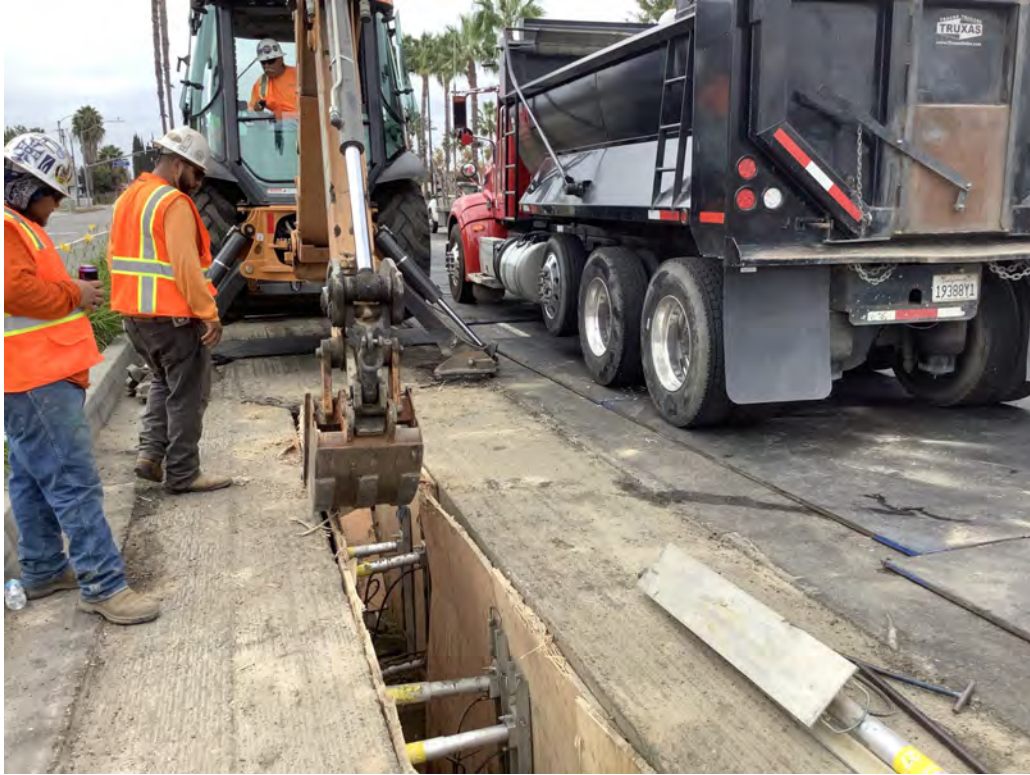
South, start of excavation at 1+85 at beginning of day.

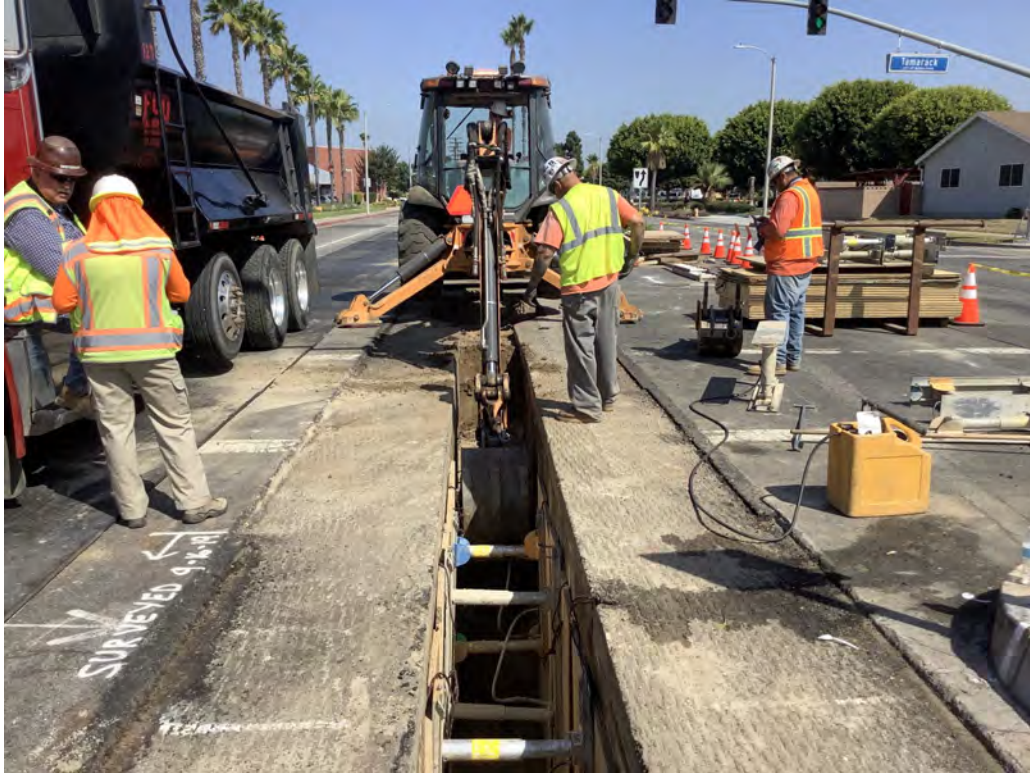
North. 2nd crew at Buena Park downtown and Dale ave. Trenching down to 7.5 ft (6 +75)

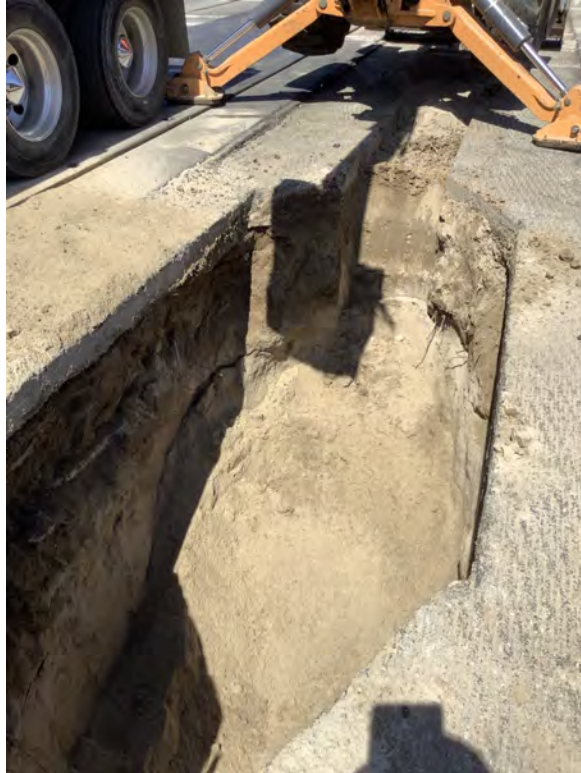
North, inside of trench at tamarack and Dale. Sand is starting to become soft

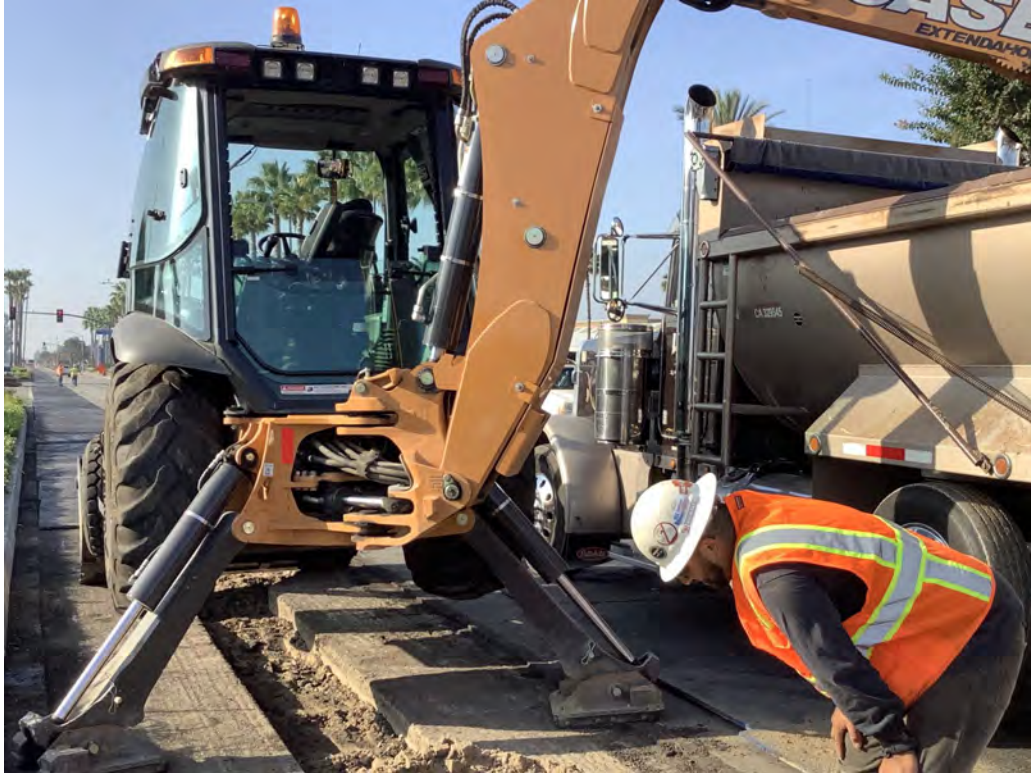
South, start of trenching at 8:45 2+00

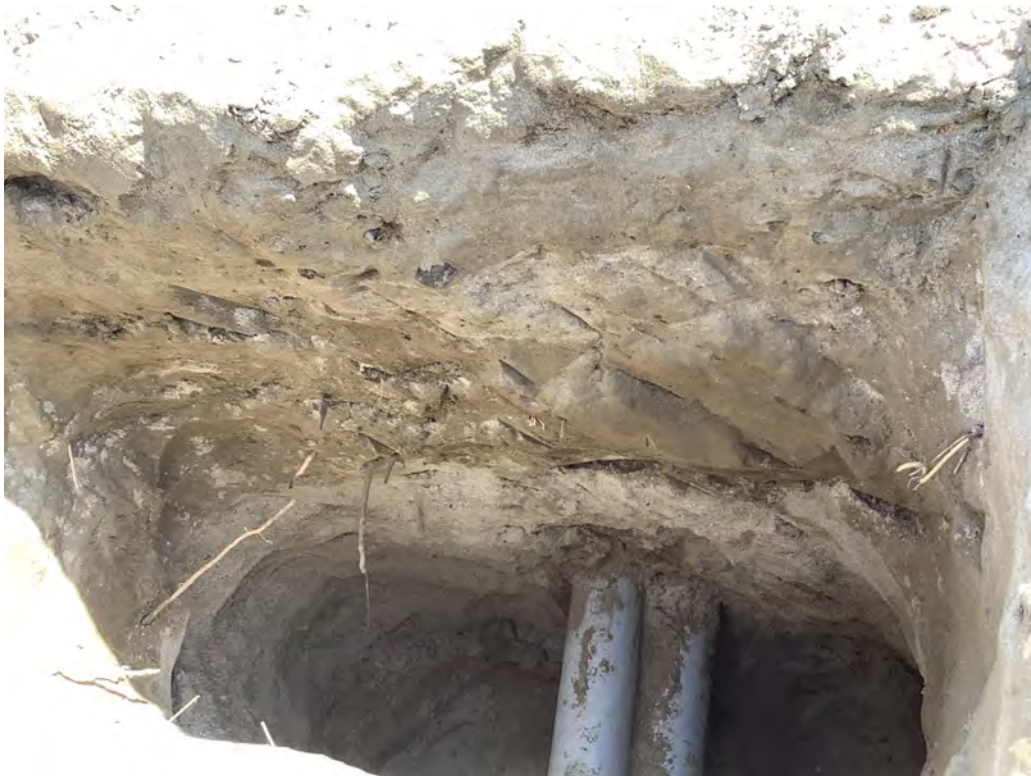
East. Pothole to 57 inches with pipes 12 inches above bottom. All fill.

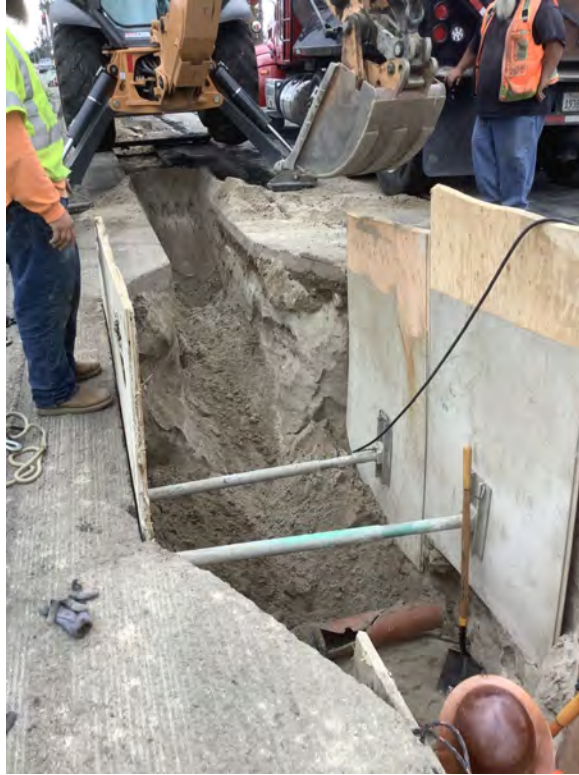
South, crew hit an unmarked sewer pipe and are in the process of excavating around it to determine next step.

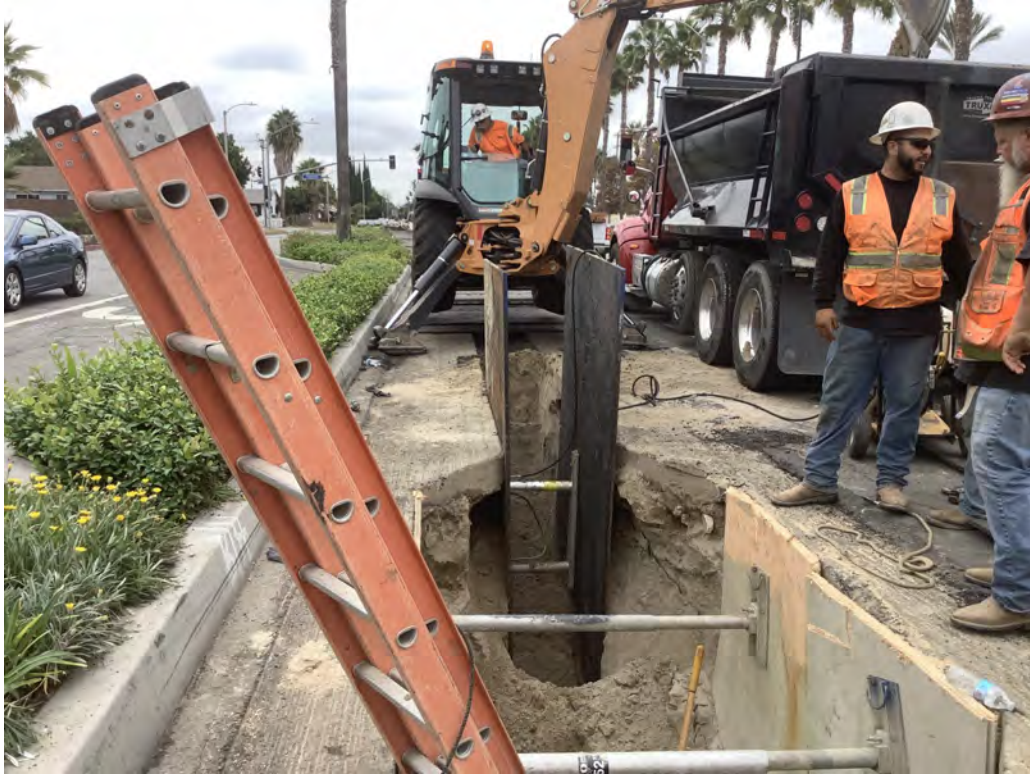
South, start of machine excavation at 2+75. Depth going to max 9 ft. Soft sand starts at 2 ft and continues all the way down.

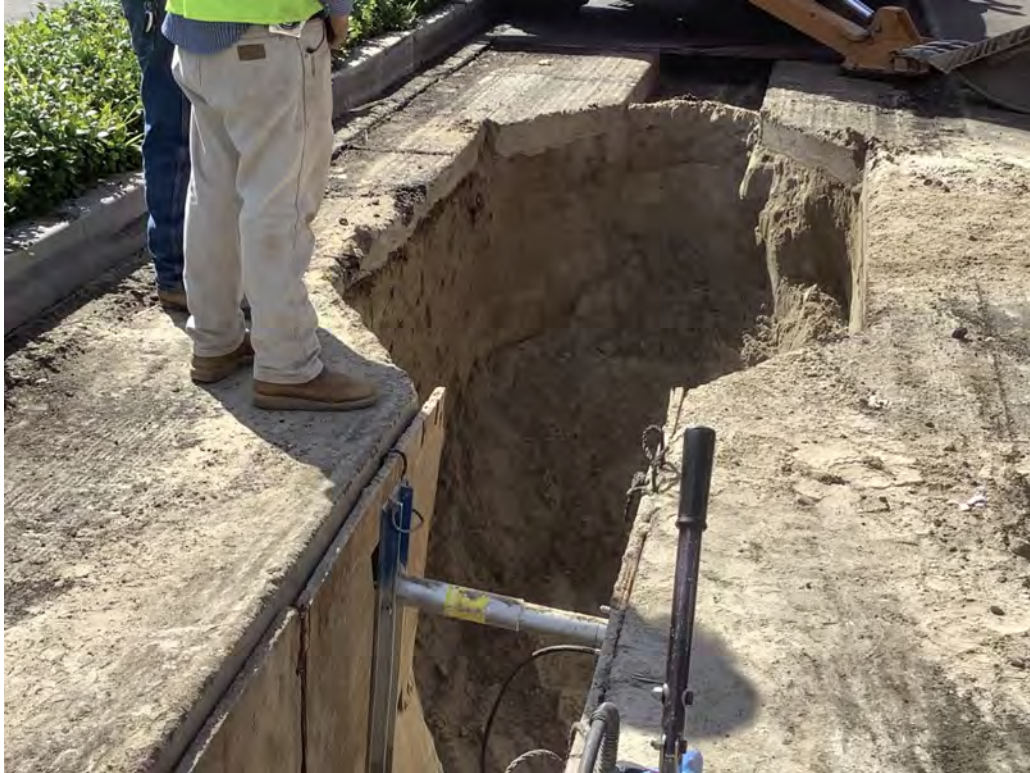
South. Crew excavating down to 7 ft at bel hole (3+20)
