<b>Docket Number:</b>	21-ESR-01
<b>Project Title:</b>	Energy System Reliability
<b>TN #:</b>	245522
<b>Document Title:</b>	Women's Energy Matters Comments - on Diablo Canyon Power Plant
<b>Description:</b>	N/A
<b>Filer:</b>	System
<b>Organization:</b>	Womens Energy Matters
<b>Submitter Role:</b>	Public
<b>Submission Date:</b>	8/19/2022 3:40:35 PM
<b>Docketed Date:</b>	8/19/2022

Re: Docket No. 21-ESR-01 (*Energy System Reliability*)  
Comments re: Newsom's Joint Agency Presentation August 12, 2022  
Retire Diablo Canyon and Invest in Real Solutions Now !

# DIABLO CANYON POWER PLANT HISTORICAL SITE ASSESSMENT REPORT

JUNE 2018

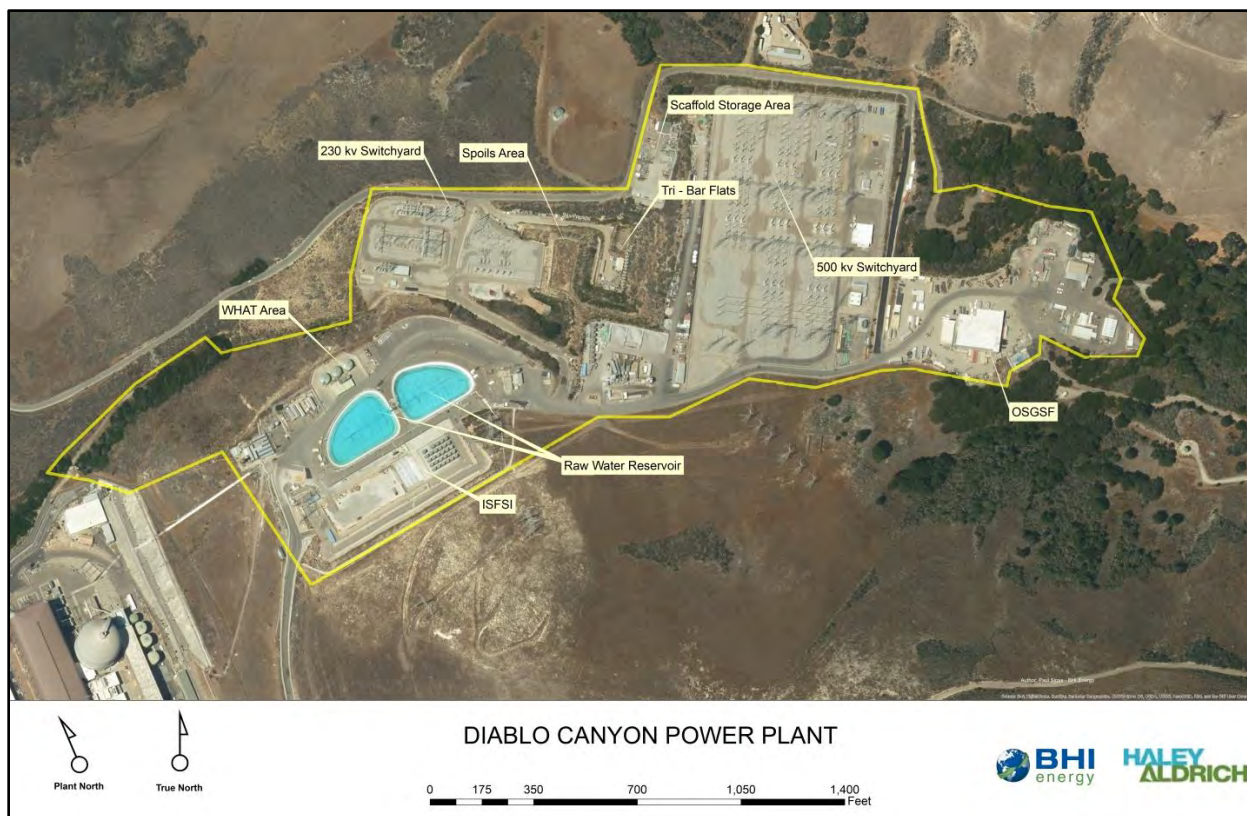
**Figure 5.1-1. Structures and Areas within the NOCA**

The North Owner Controlled Area (NOCA) at Diablo Canyon Power Plant is a radiologically impacted area that encompasses approximately 259,000 m<sup>2</sup>. It includes Old Steam Generator Storage Facility (OSGSF), Waste Holding and Treatment (WHAT) Facility, Independent Spent Fuel Storage Installation (ISFSI), Raw Water Reservoirs, 230 kV Switchyard, 500 kV Switchyard, Make Up Water System and other out buildings, Tri-Bar Flats Area, Scaffold Laydown Area, and a Spoils Area. **Diablo Canyon Creek runs generally east to west through the area.** The NOCA is bounded on the north, east, and south by non-impacted areas. To the west, the NOCA abuts the SOCA and NPA.

The area contains one permanent radiological controlled area (RCA), the Independent Spent Fuel Storage Installation (ISFSI) pad. This facility is expected to remain onsite until the Department of Energy accepts used fuel and greater than class C wastes.

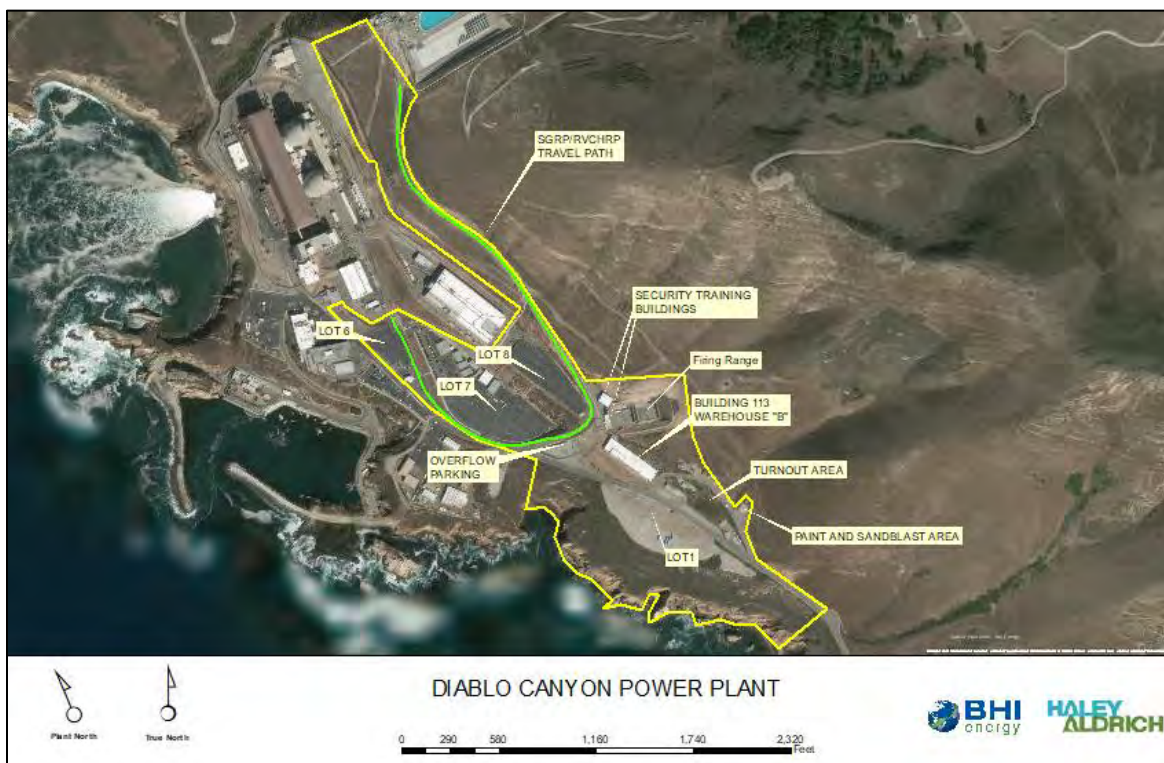
**Figure 5.2-1. Structures and Areas within the SOCA**

The South Owner Controlled Area (SOCA) occupies approximately 249,600 m<sup>2</sup> and includes Diablo Canyon/Shore Cliff Road, Reservoir Road, Warehouse “B”, the Security Training Building, Firing Range, and Parking Lots 1, 6, 7, and 8. Most of the area surrounding buildings is asphalt-covered; however, there are areas covered by vegetation, riprap, and sand/gravel. A large portion of the SOCA lies within the southeast sector, which is a predominant downwind sector for gaseous effluent, and therefore may be subject to impact from effluent deposition or rainout events. Figure 5.2-1 shows the major structures and open land areas within the SOCA.

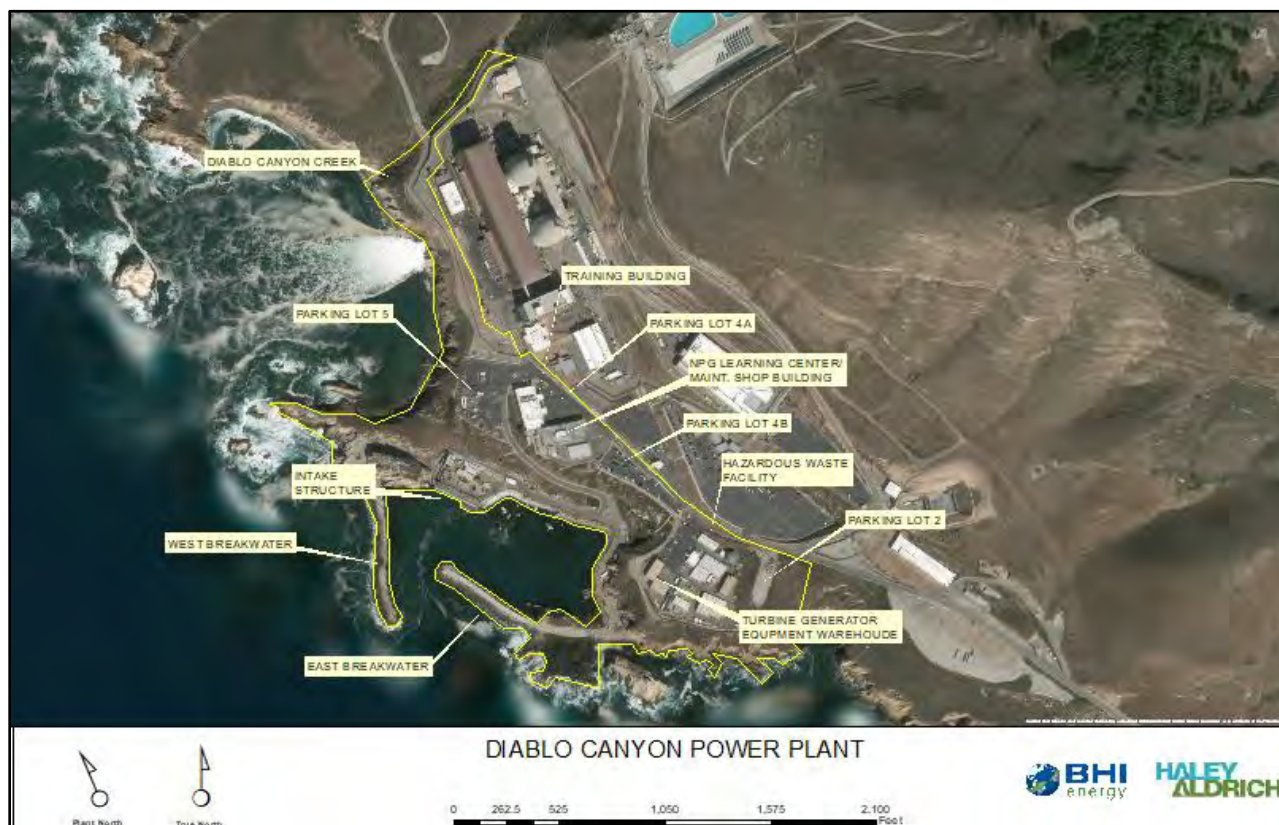
**Figure 5.3-1. Structures and Areas within the WOCA**

The West Owner Controlled Area (WOCA) occupies approximately 207,400 m<sup>2</sup> and includes primarily areas west of Diablo Canyon/Shore Cliff Rd. It includes Area 10, the Intake area, the Training Building, the NPG Learning Center/Maintenance Shop Building, and Parking Lots 2, 3, 4a, 4b, and 5. The area continues along the western edge of the Protected Area and extends north and east to include the terminal portion of Diablo Canyon Creek. Figure 5.3-1 shows the major structures and open land areas within the WOCA.

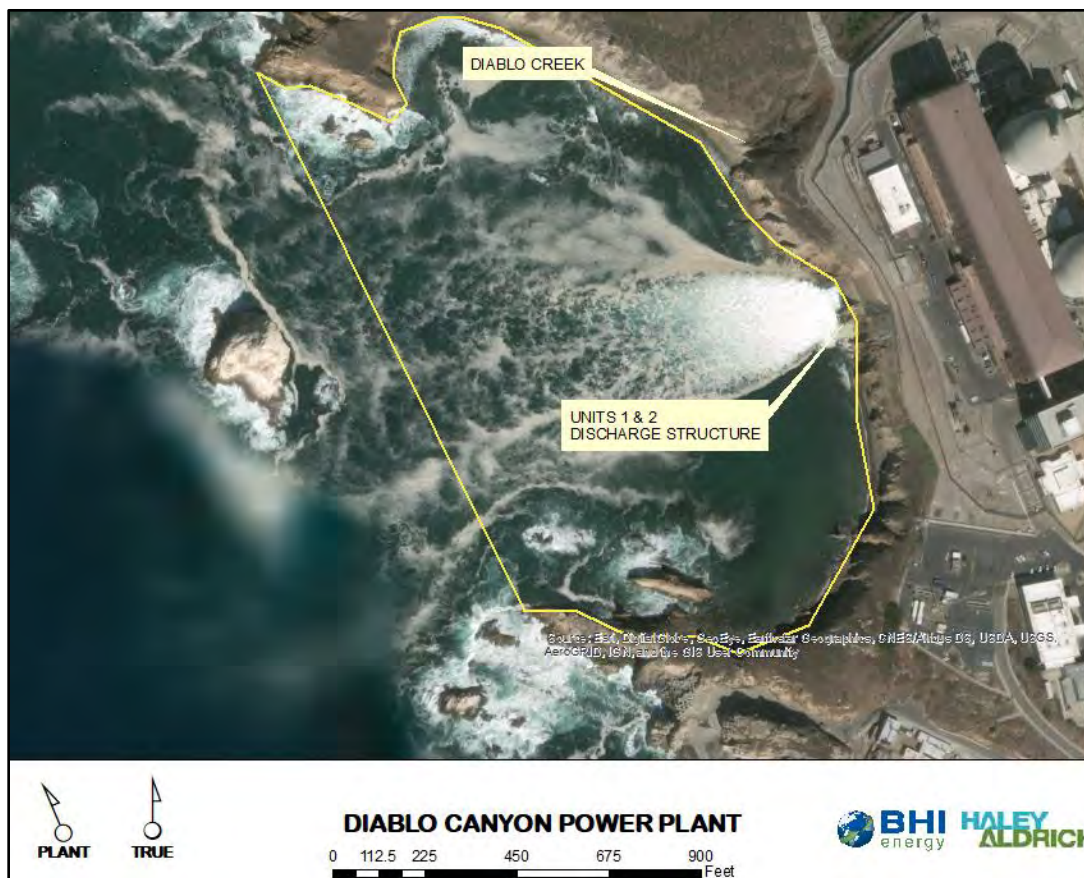
**Figure 5.4-1. Structures and Areas within the DCA**

The Discharge Cove Area (DCA) is the body of water immediately west of the power block area outside the protected area fence, encompassing approximately 115,000 m<sup>2</sup>. The DCA opens to the Pacific Ocean to the west. It serves as the receiving waters for the circulating water system via the Units 1 and 2 Discharge Structure. The DCA is completely submerged at all times and is bounded by the mean high tide line. The cove's floor is covered with sand, gravel, and rocks. There is also an area immediately west of the discharge structure that is covered by and approximately 2-foot-thick bed of broken shells. Figure 5.4-1 shows the general orientation of area DCA.

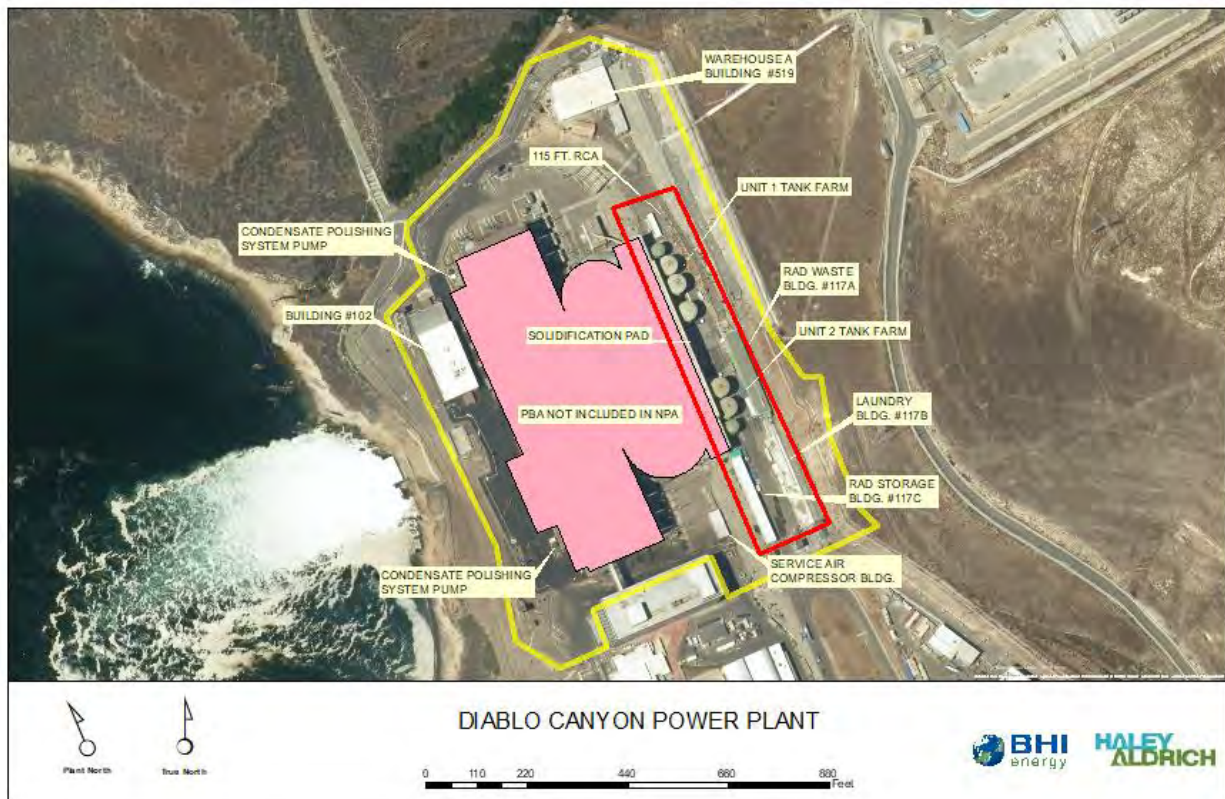
**Figure 5.5-1. Structures and Areas within the NPA**

The NPA contains the Make-Up Water tanks, Fire Water tank, Radwaste buildings, Solidification Pad, Transformers, Service Air Compressors, several smaller shops, a warehouse, and office space for plant support activities. Laydown, staging, and temporary storage areas have been routinely established in the NPA to support plant outage activities.

Figure 5.5-1 shows the general orientation of NPA as well as major plant structures included in the area.

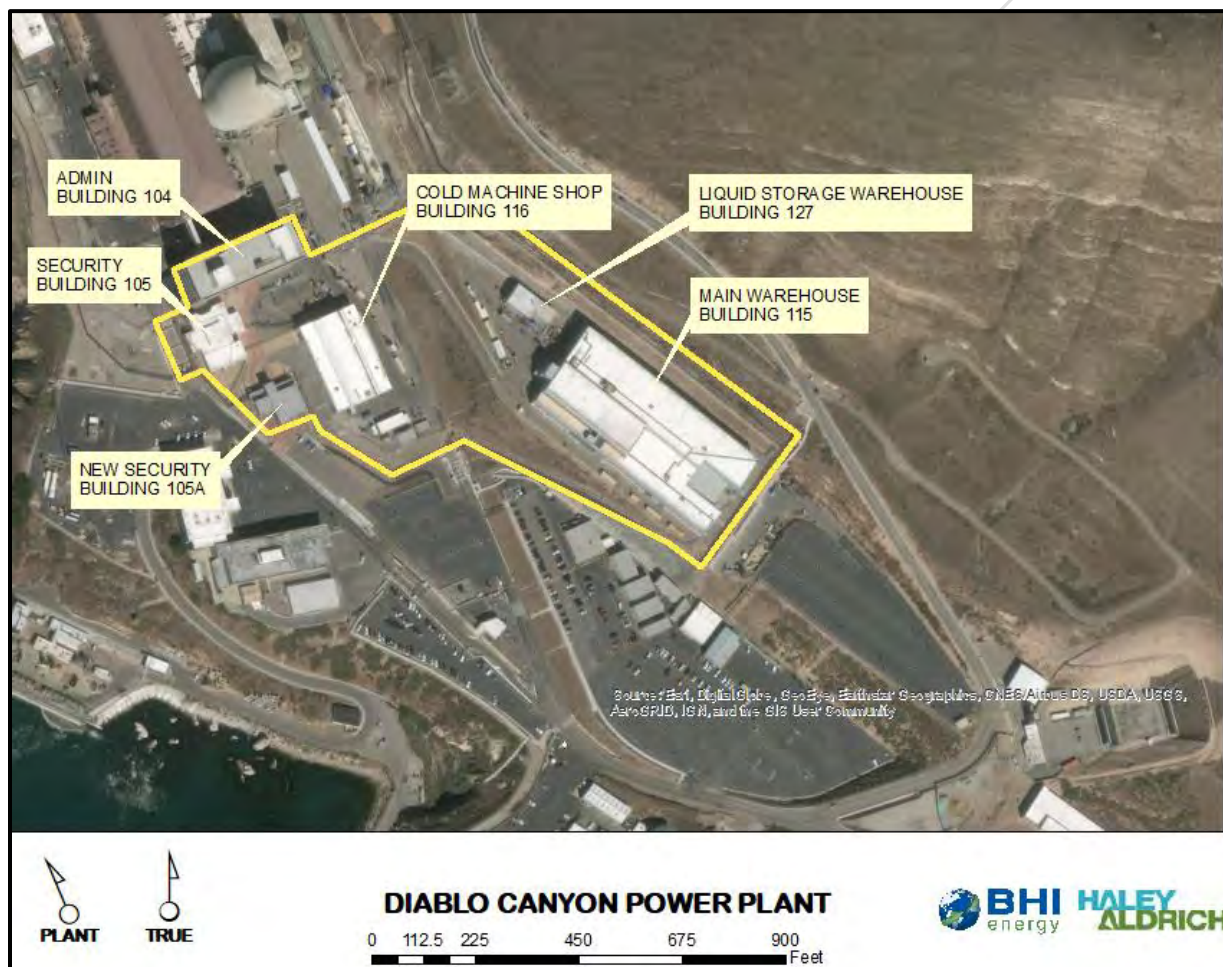
Figure 5.6-1. Structures and Areas within the SPA

All buildings in the SPA area are located close to the plant vent stacks where tritium and C-14 are/have been released. Condensate from air conditioning units associated with all the buildings in the area discharge directly to the ground. Radionuclides (tritium and C-14) entrained in the condensate would have been released to the ground.

The SPA is bounded to the north by the North Protected Area and to the east, west, and south by the South Owner Controlled Area.

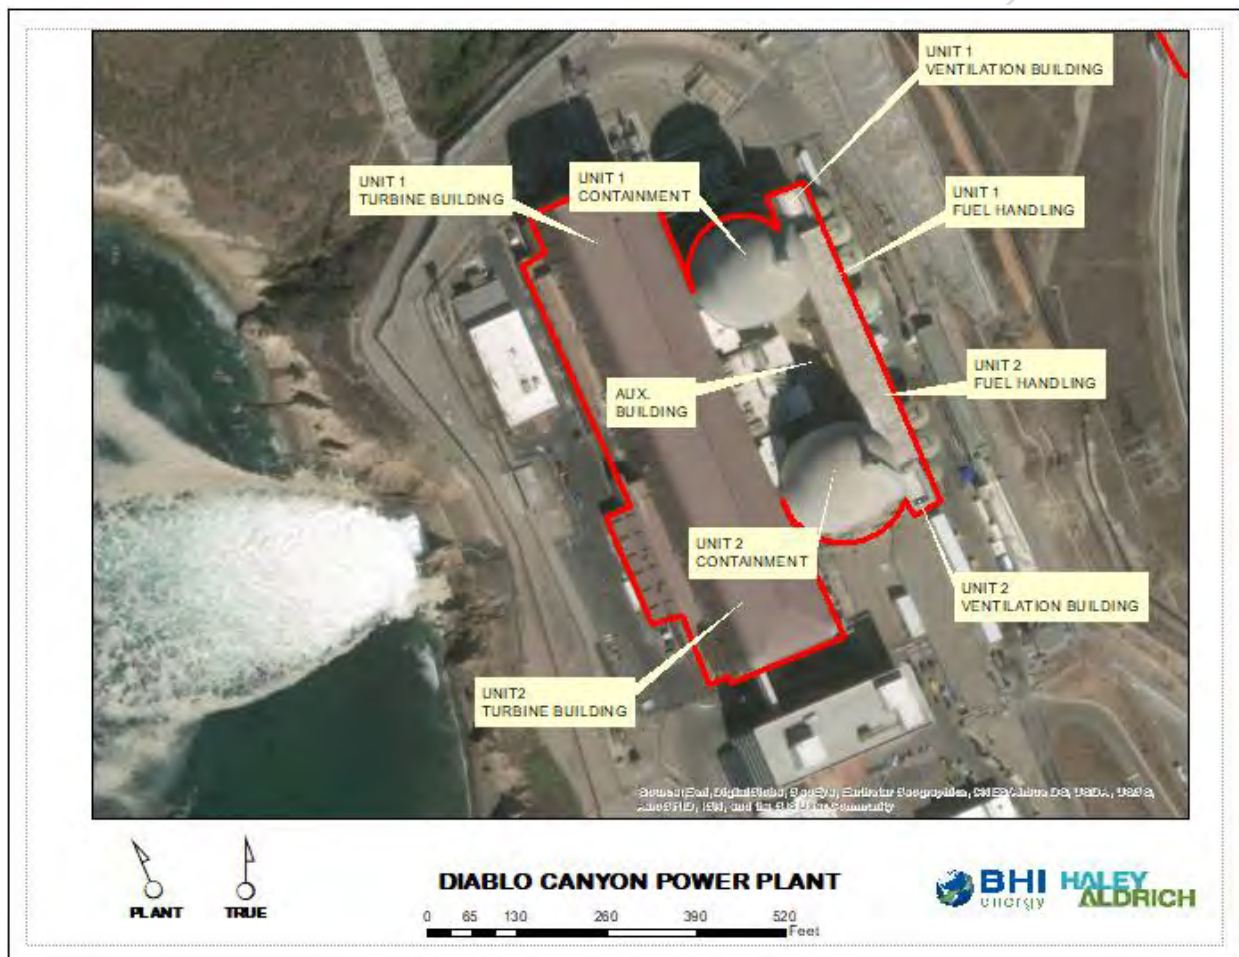
Figure 5.7-1. Structures and Areas within the PBA

1. Containment buildings that houses the nuclear steam supply system
2. Fuel handling buildings that handle new and used nuclear fuel bundles
3. Auxiliary Building that houses reactor coolant clean-up systems, liquid and gaseous radwaste systems, and the control room
4. Turbine building that houses the turbine-generators, the full-flow polishing demineralizer system, and the diesel generators.

Figure 5.7-1 shows the general orientation of the PBA.
