DOCKETED	
Docket Number:	24-OPT-02
Project Title:	Compass Battery Energy Storage
TN #:	255577-7
Document Title:	Appendix 4-3D_Department of Parks and Recreation 523 Form Updates for P-30-176642
Description:	2023 recordation and DPR form continuation sheet for P-30-176642.
Filer:	Erin Phillips
Organization:	Dudek
Submitter Role:	Applicant Consultant
Submission Date:	4/8/2024 3:57:30 PM
Docketed Date:	4/8/2024

Department of Parks and Recreation 523 Form
Updates

*Resource Name or #: P-30-12-176642 Bathgate Ranch Property Historic District

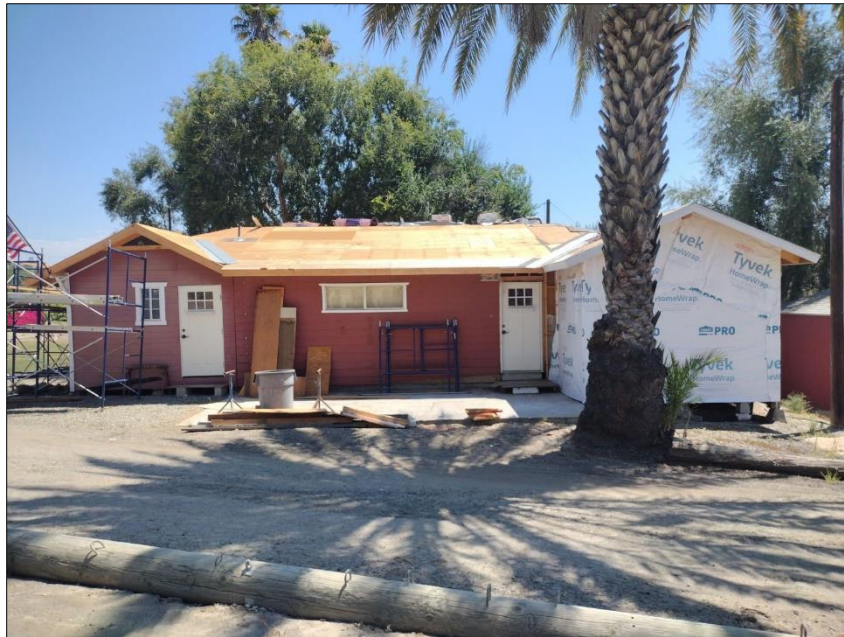
Figure 1: Multi-Purpose Building, view east.

To note, terracing associated with the 2001 recorded location of Farm-house #1 and Farm-house #2 was still present in 2021, however no historic-era refuse, building foundations, or other building materials were observed in this area. Additionally, the Multi-Purpose Building was observed as undergoing renovations to the exterior during the pedestrian survey in August 2023. Figures 1 and 2 depict the Multi-Purpose Building with exterior scaffolding, new plywood sheathing on the roof, the absence of a porch roof, and additional exterior renovations to the east side of the structure.

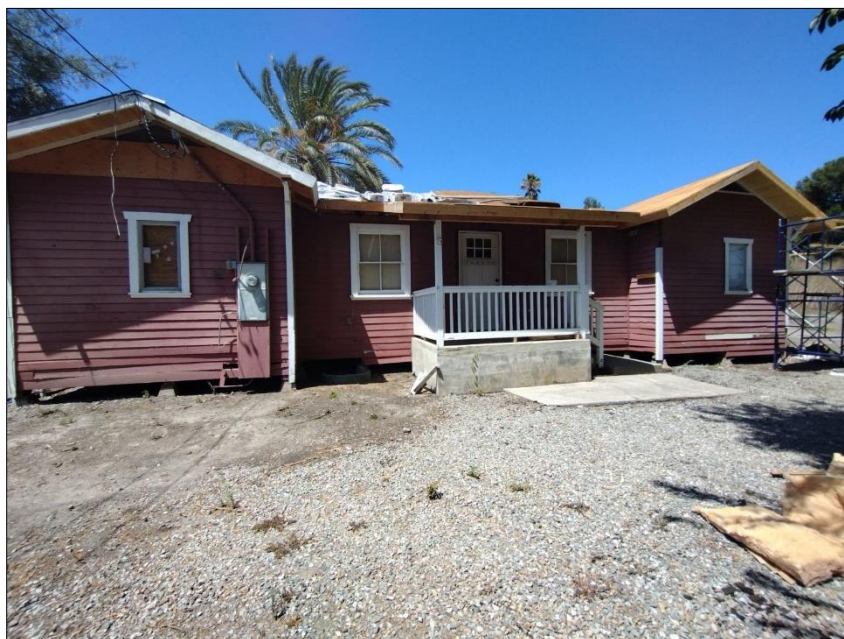
Figure 2: Multi-Purpose Building, view west.

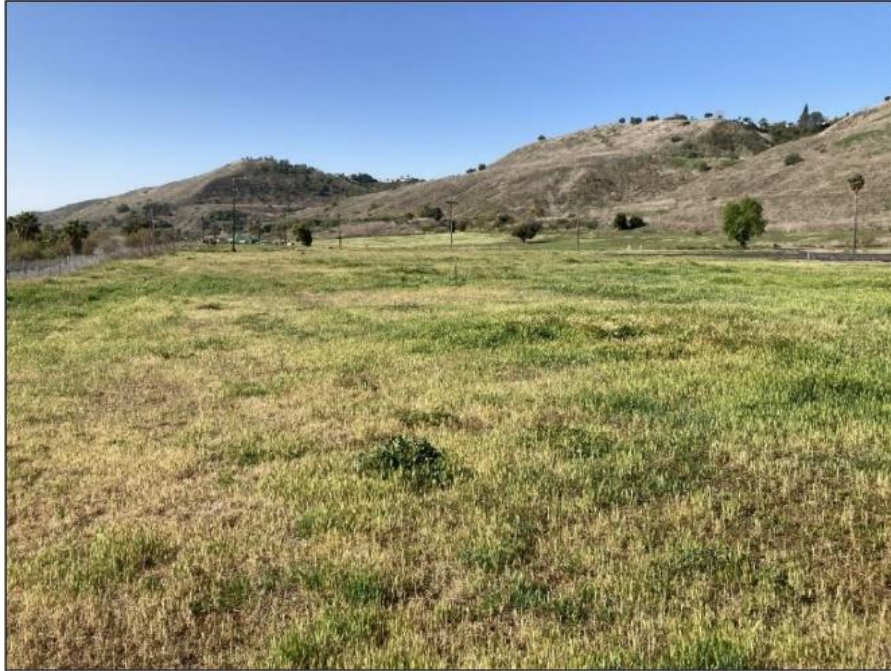
Figure 3: Previous location of Bathgate Ranch citrus trees, view to southwest.

An intensive-level cultural resources pedestrian survey was conducted in support of the Compass Energy Storage Project in 2021 and 2023 by Dudek archaeologists Loukas Barton, Adam Giacinto, Roshanne Bakhtiary and David Alexander. The survey included the entire historic parcel boundary of the Bathgate Ranch Property, as well as several additional parcels to the north that encompass the Saddleback Church Rancho Capistrano Property. The 2021 pedestrian survey revealed that only one of the four historic-era structures remains extant within the historic parcel boundary. The last remaining structure was identified as the Multi-Purpose Building (Figures 1 and 2). Farm-house #1, Farm-house #2, and Farm-house #3 had all been razed by time of survey. Archival research indicates that these three structures were likely razed sometime between 2012 and 2014 (NETR 2023). Additionally, the majority of the citrus trees associated with the historic use of the property had been removed and additional grading and disturbances (vehicle overland travel paths, modern debris, landscaping, and rodent bioturbation) were observed within the central portion of the parcel (Figure 3) during time of survey.
