RE: Hydrogen Energy California Project
Application for Certification 08-AFC-8

Responses to CEC Data Requests Set One (Nos. 17, 65, 77, and 85 through 90)

Revised Application for Certification (08-AFC-8) for HYDROGEN ENERGY CALIFORNIA Kern County, California

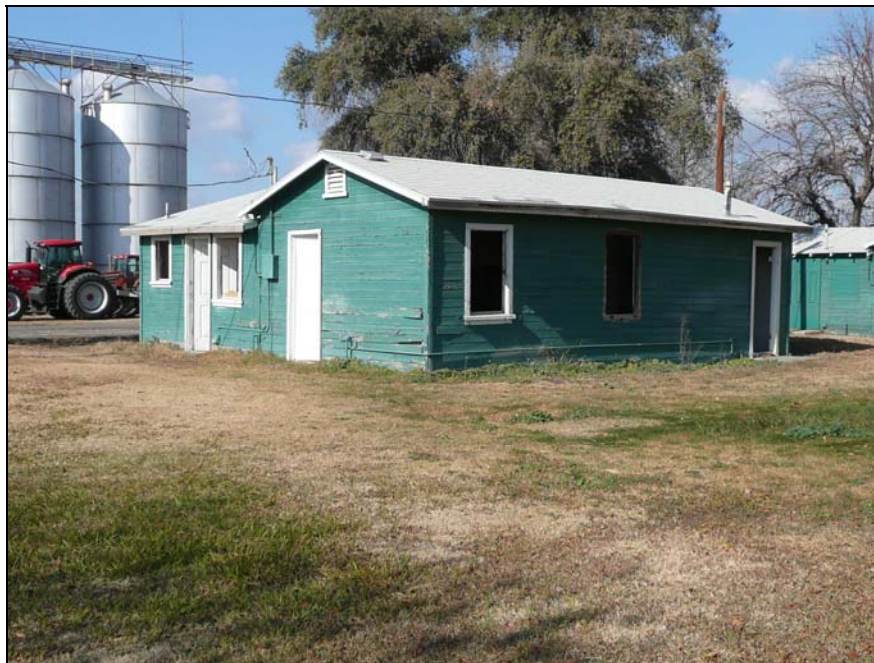
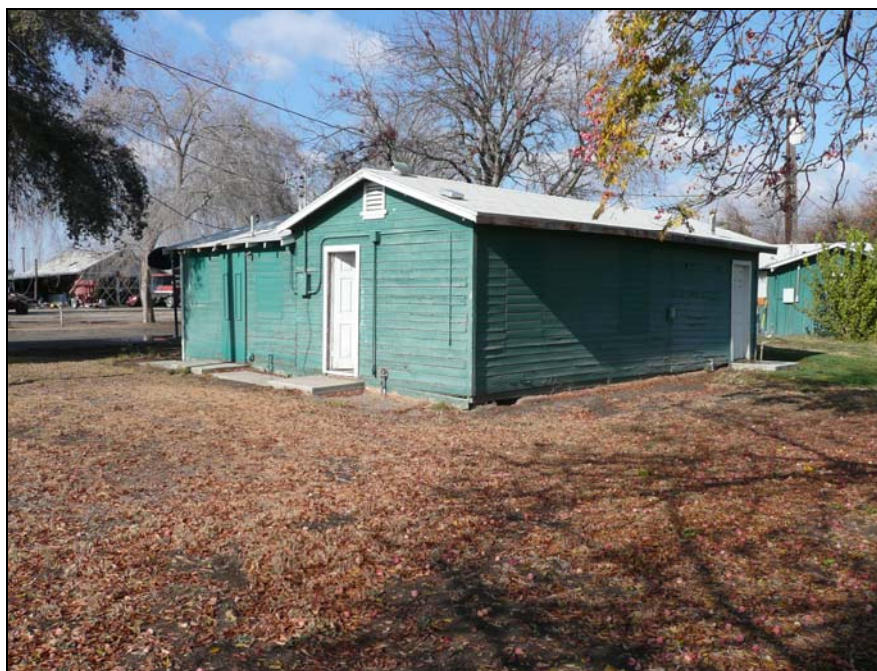
Buildings 2 and 3 have an off-center front door and two secondary entrances on their south sides, all sheltered only by the roof's overhang (**Photographs 4 and 5**). Both of these buildings are currently not in use. Building 2 is missing its windows (though the openings retain their wood surrounds), and the window openings of Building 3 are infilled with wood siding and the surrounds have been removed. The exterior walls are clad in wood drop siding.

Photograph 4. Building 2, residence, facing northwest.

Photograph 5. Building 3, residence, facing northwest.

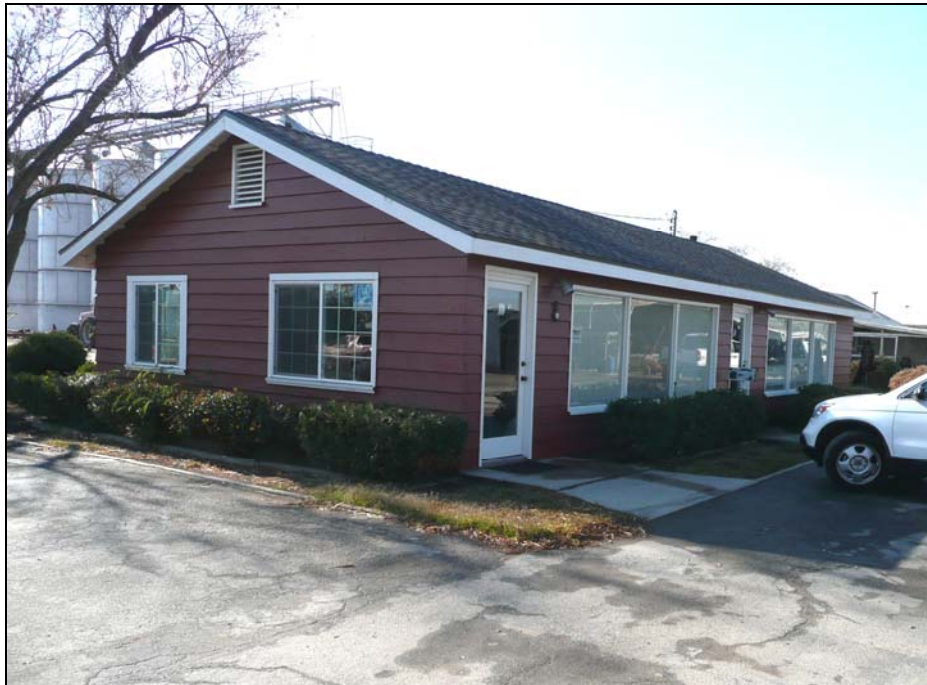
Building 10 is positioned northwest of Building 4, and currently functions as an office. It has a rectangular footprint, concrete foundation, wood bevel siding, and front-gabled composite shingle roof with medium-width eaves and wood fascia board (**Photograph 11**). Its primary façade is its north side, which consists of two entry doors, each flanked by a triplet of replacement single-pane fixed windows set in a wood frame. A third door is located on the opposite (south) side of the building. Fenestration also includes variably-sized vinyl replacement sliding windows with snap-in muntins on the south, east, and west façades. These alterations occurred after 2000.

Photograph 11. Building 10, office, facing southwest.

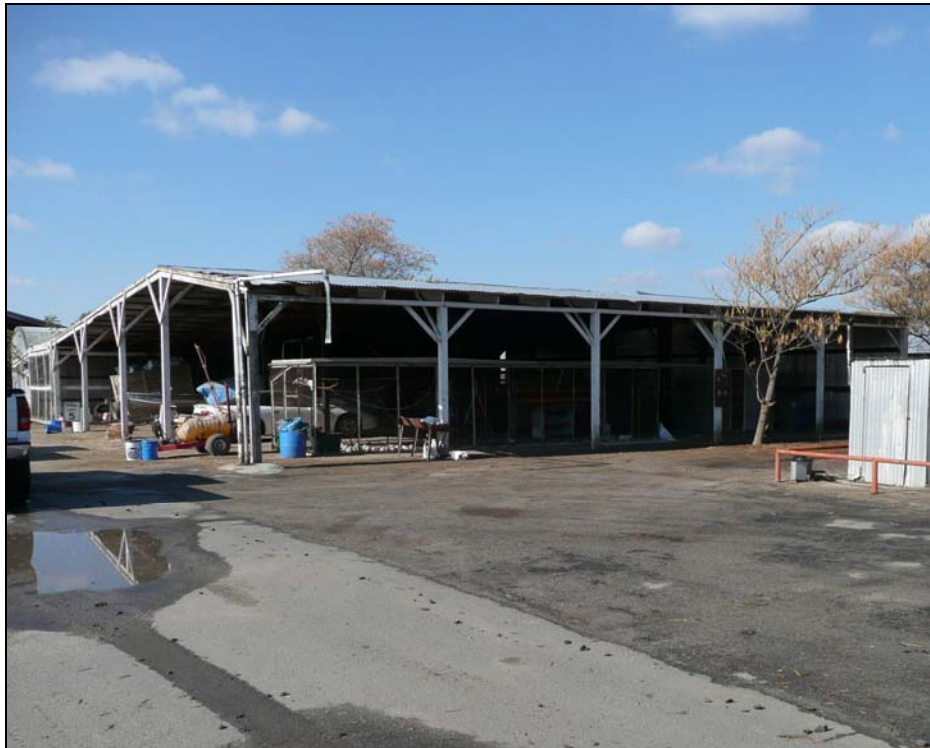
A five-bay-wide wood-framed equipment shelter with an asymmetrical gabled roof sits north of Building 13 (**Photograph 17**). The westernmost bay is screened and has a swing door. A corrugated metal Quonset hut with a board-form concrete foundation (Building 14) is attached to the west side of this structure. It has a steel door and steel four-light fixed window on its south end, a sliding door with a railroad tie sill on its west side, and a shed-roofed room extension with vertical wood board siding at its northwest corner (**Photograph 18**).

Photograph 17. Equipment shelter, facing northwest.

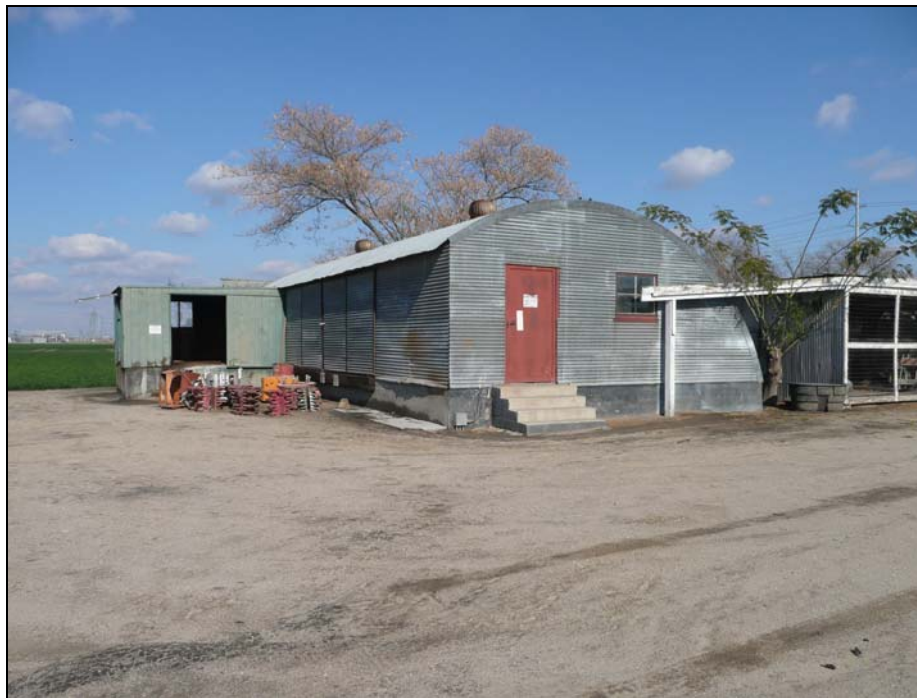
Photograph 18. Quonset hut, facing northeast.

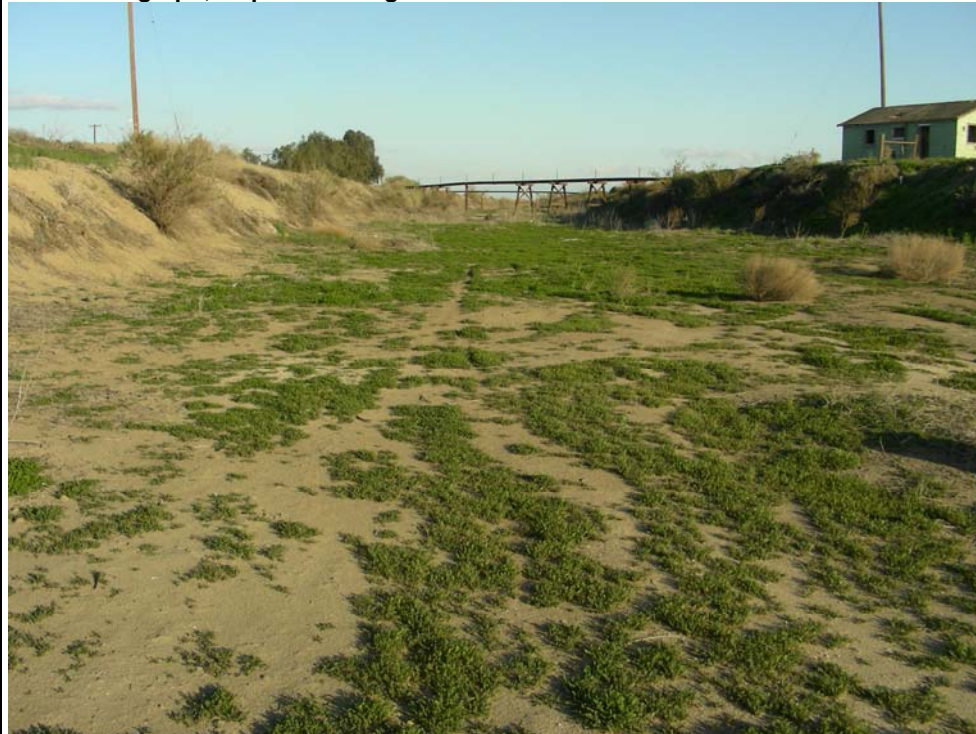
L3. Description: (Describe construction details, materials, and artifacts found at this segment/point. Provide plans/sections as appropriate.) The Kern Valley Water Company Canal is a roughly trapezoidal earthen canal. The slopes and floor of the canal are vegetated with grasses and sagebrush. A dirt road bed has been cut in the northern side of the canal, traverses the canal, and continues up the gentler southern side. East of the end of Freeborn Road are concrete pilings embedded with metal pipes that have been cut off. A similar structure is located farther to the east. In the easternmost example, a metal pipe lies across the top of the pilings, like a pipeline. Photographs at the BVWSD indicate that wooden structures could be hung off these traversing pipelines to operate as water control features.

KVVCC canal, “pipeline” check structure in the distance. Camera facing east, March 9, 2009

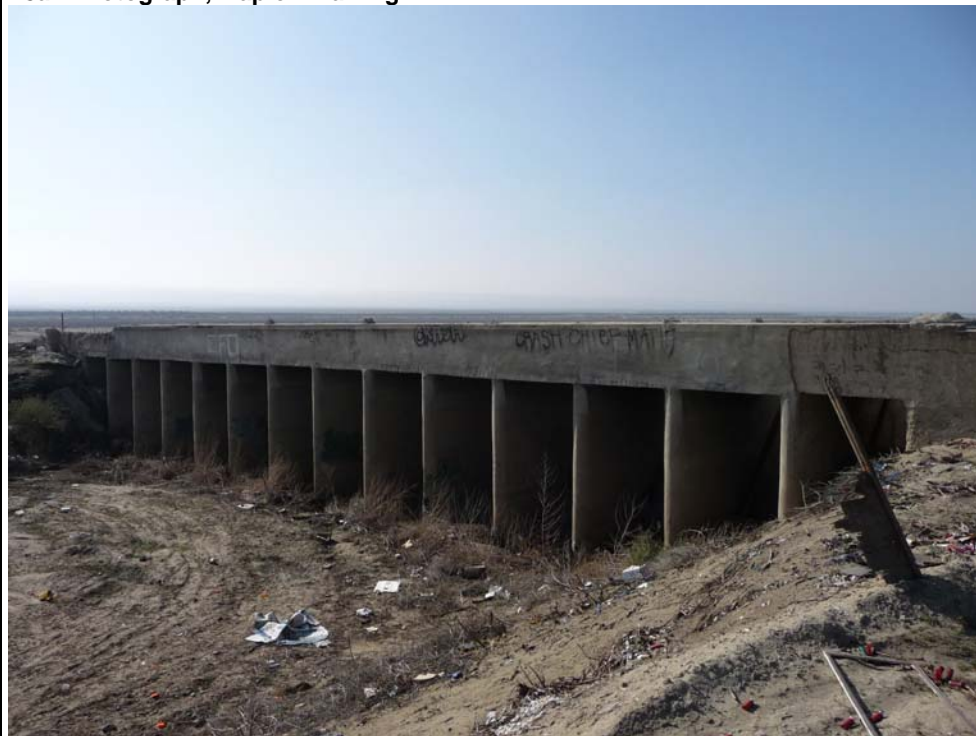
L3. Description: (Describe construction details, materials, and artifacts found at this segment/point. Provide plans/sections as appropriate.) The Kern Valley Water Company Canal is a roughly U-shaped canal. The path of the canal is irregular. The southern side is built up and resembles a levee or sand bar in areas. The height of this southern side is irregular and undulating, with a gentler slope into the canal. A steel reinforced concrete weir crosses the canal at this point. Northwest of the weir, the southern edge of the canal is slightly more regular. The weir has thirteen gates with metal guides for angled boards. A solid concrete railing tops the weir on the eastern side. A dirt road crosses the weir. West of the road is a replacement metal walkway above the gates with a metal railing. East of the weir is an inlet to the West Side Canal. The inlet has a concrete head wall and flanking walls. A square metal gate is raised and lowered by a screw mechanism. The gate leads to an underground culvert connecting the two canals.

The canal suffers from erosion and deposition of garbage and unwanted items.

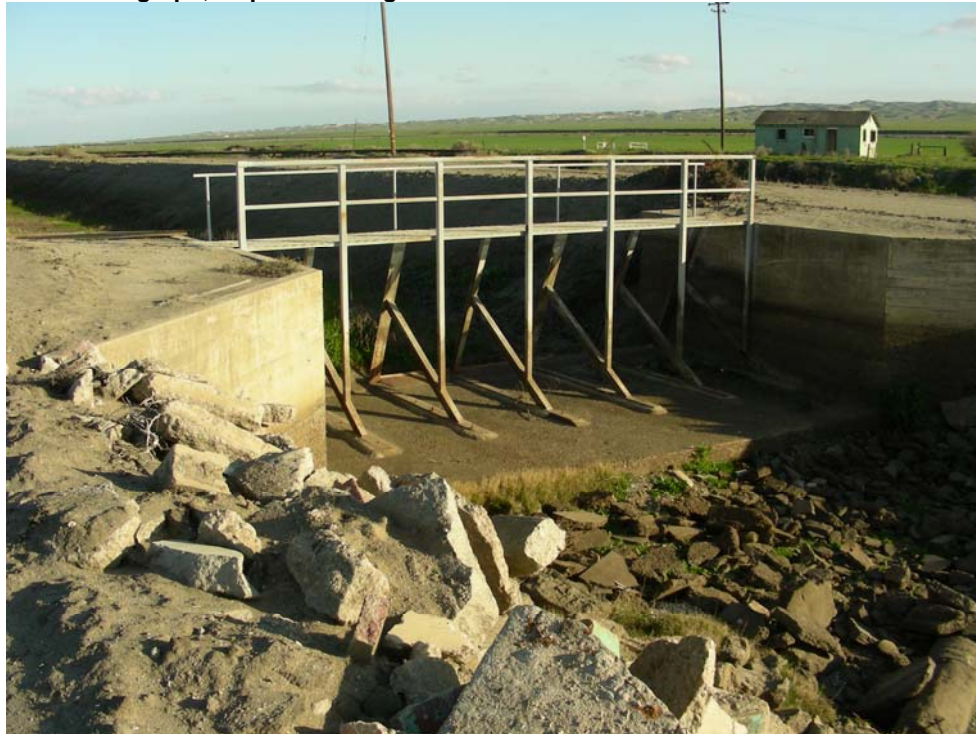
L3. Description: (Describe construction details, materials, and artifacts found at this segment/point. Provide plans/sections as appropriate.) The West Side Canal is a neatly shaped earthen ditch with a trapezoidal cross section. Two pipelines cross the canal. One is supported by two vertical pipes with a cross piece; the pipeline then lies across the crosspiece. Photographs at the BVWSD indicate that temporary check dams have been hung from these pipelines. Two gates are located along the northern side of the canal. Each gate has a concrete head wall and flanking walls. One of the two has a trash gate. Each circular metal gate is operated by a vertical screw mechanism. Northwest of Adohr Road is a concrete check dam. The dam has a concrete base and sides. Slats may be slid into six sections framed with metal guides. A metal walkway with railings is across the top of the check dam. The date 11-14-86 is incised into the concrete check dam. Concrete rubble lines the canal northwest of the check gate.

Check gate at West Side Canal, camera facing southeast, March 9, 2009

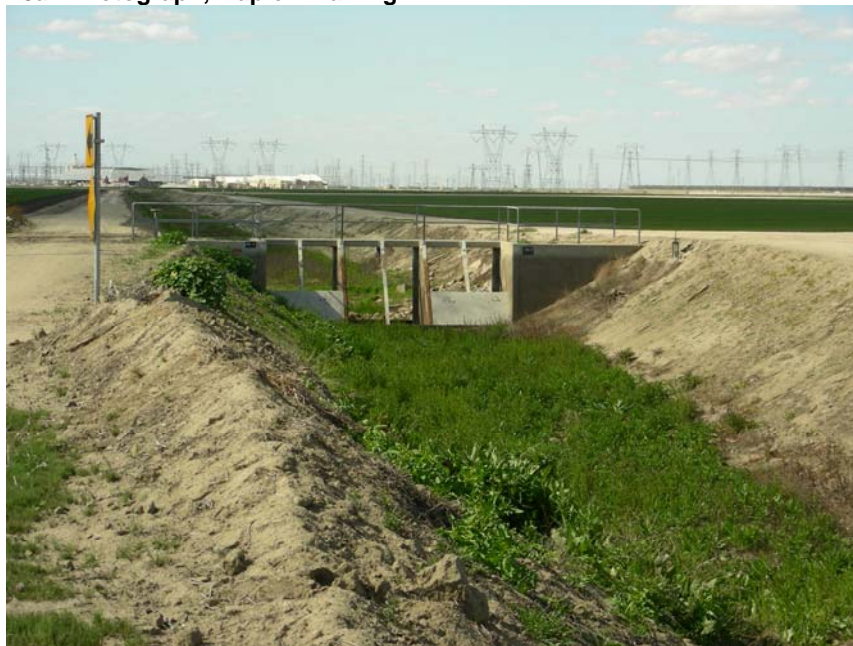
L3. Description: (Describe construction details, materials, and artifacts found at this segment/point. Provide plans/sections as appropriate.)
The East Side Canal is a trapezoidal earthen canal flowing northwest. A check gate is north of Buerkle Road. The gate is concrete, dated 1976, with six slots framed with metal. Drop gates consist of concrete slabs. Downstream of the check is a section of rubble lining. South of the check gate is the center pylon of a bridge. The concrete pylon is narrow and runs about 6 feet along the center of the canal.

East side canal and check gate, camera facing northwest, March 9, 2009.

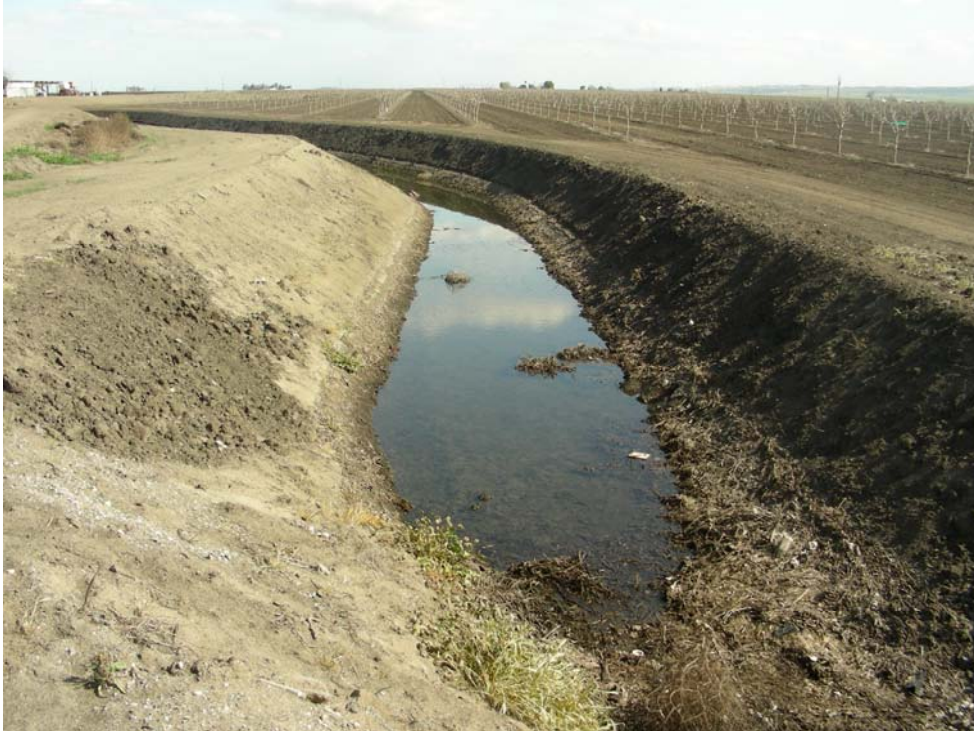
L3. Description: (Describe construction details, materials, and artifacts found at this segment/point. Provide plans/sections as appropriate.) Main Drain is an earthen canal with a trapezoidal cross section. The drain is free of vegetation and is conveyed under Brite Road via a corrugated metal culvert. The eastern side is approximately 2 feet higher than the west.

L8b. Description of Photo, Map, or Drawing (View, scale, etc.) Main Drain camera facing south, March 9, 2009

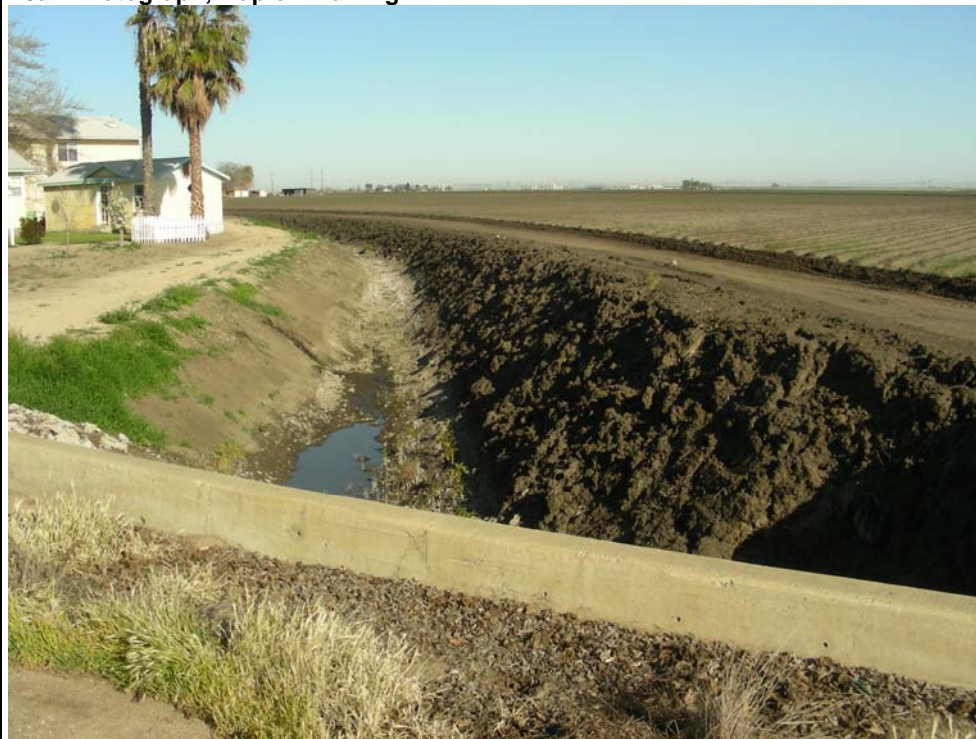
L3. Description: (Describe construction details, materials, and artifacts found at this segment/point. Provide plans/sections as appropriate.) Main Drain is a narrow trapezoidal earthen ditch. The drain crosses under Stockdale Road via a round culvert with concrete head wall.

Photograph 1: Main Drain
camera facing north,
March 11, 2009.

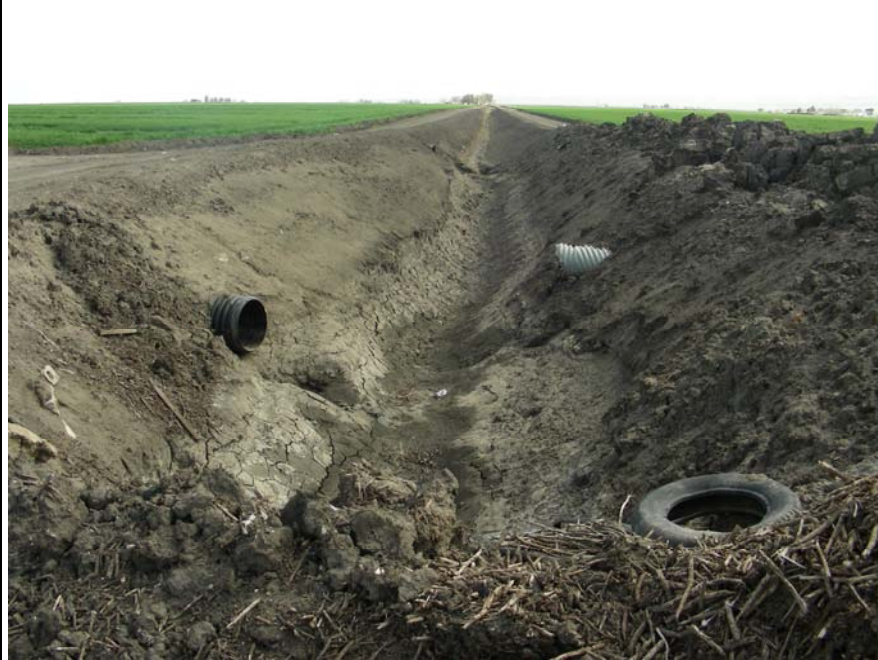
L3. Description: (Describe construction details, materials, and artifacts found at this segment/point. Provide plans/sections as appropriate.) Depot Drain is an earthen canal with a narrow trapezoidal cross section. The ditch is conveyed under the road via a single round concrete pipe. Earth is slightly mounded on either side of the ditch. The ditch is piped for approximately 200 feet north of Burkle Road. The portion south of Burkle Road had been freshly excavated when the canal was recorded. Two pipes debouch into the canal south of Burkle Road.

Camera facing south, March 9, 2009

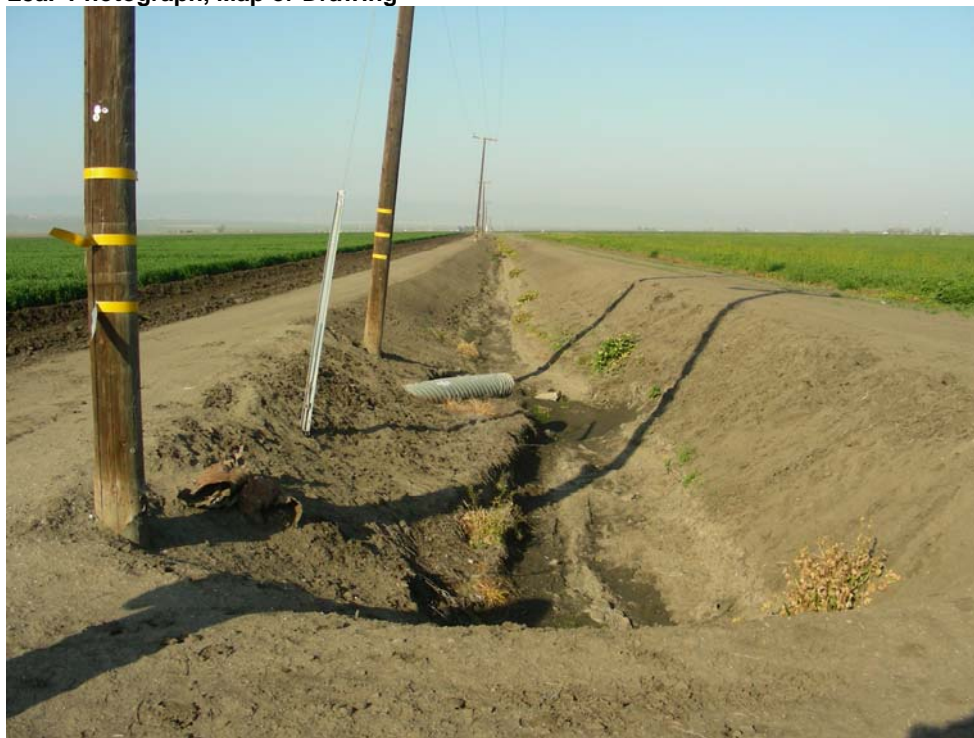
L3. Description: (Describe construction details, materials, and artifacts found at this segment/point. Provide plans/sections as appropriate.) Depot Drain is a narrow trapezoidal earthen canal. The north side is higher than the south. The drain is conveyed under Dunford Road via a round corrugated metal pipe. A smaller corrugated metal pipe debouches into the canal west of Dunford Road.

Photograph 1: camera facing west, March 12, 2009

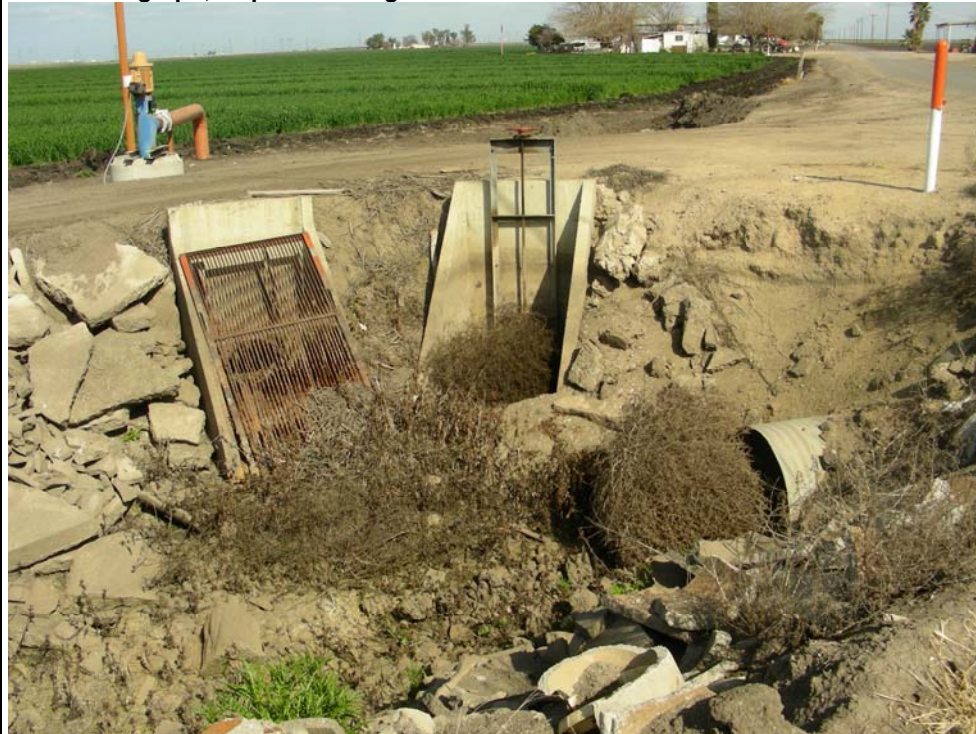
L3. Description: (Describe construction details, materials, and artifacts found at this segment/point. Provide plans/sections as appropriate.) Deep Wells Ditch is a trapezoidal earthen excavation. A round metal pipe conveys the water under Brite Road. North of Brite Road is an earthen farm bridge with metal culvert. Between the road and farm bridge, the canal is lined with concrete rubble. A delivery gate with concrete headwall and flanking walls is north of the road. A circular metal gate is raised and lowered via a vertical screw mechanism. North of the road is also a second gate with concrete headwalls and a trash gate. This gate appears to be connected with a pump 10 feet away. No additional features are located south of the road.

Gates north of road, camera facing east, March 9, 2009.

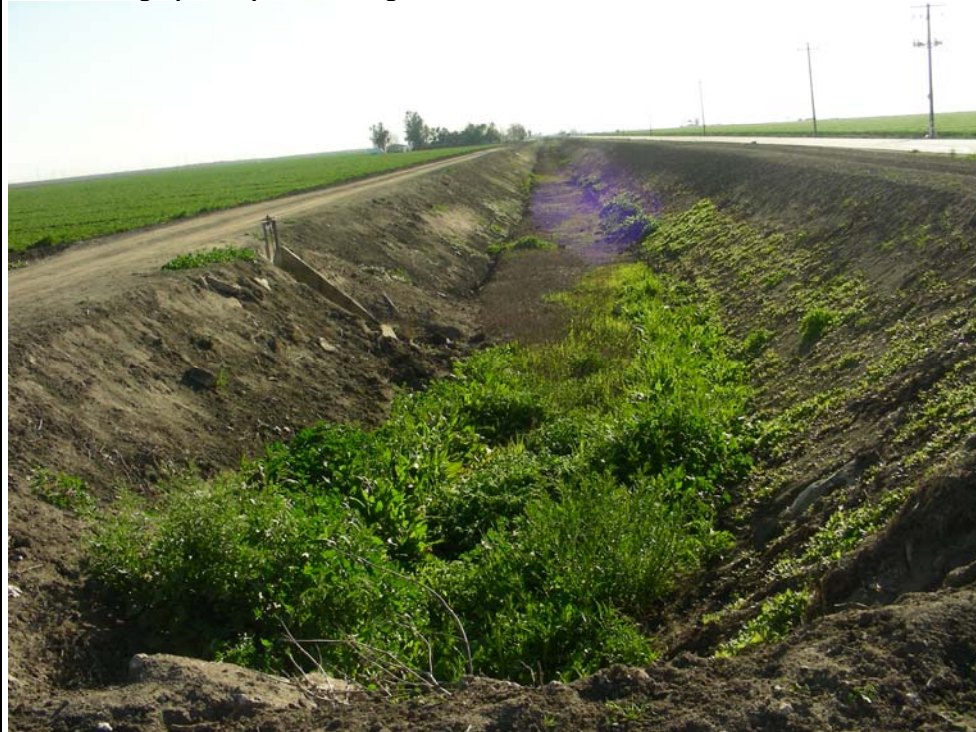
L3. Description: (Describe construction details, materials, and artifacts found at this segment/point. Provide plans/sections as appropriate.) Deep Wells Ditch continues as an earthen trapezoidal excavation. The ditch crosses under Dunford Road via two corrugated metal pipes. A single delivery gate is located along the north side of the road east of Dunford Road. The gate has a concrete headwall and flanking walls. The circular metal gate is operated with a vertical screw mechanism.

Photograph 1: camera facing north, March 12, 2009

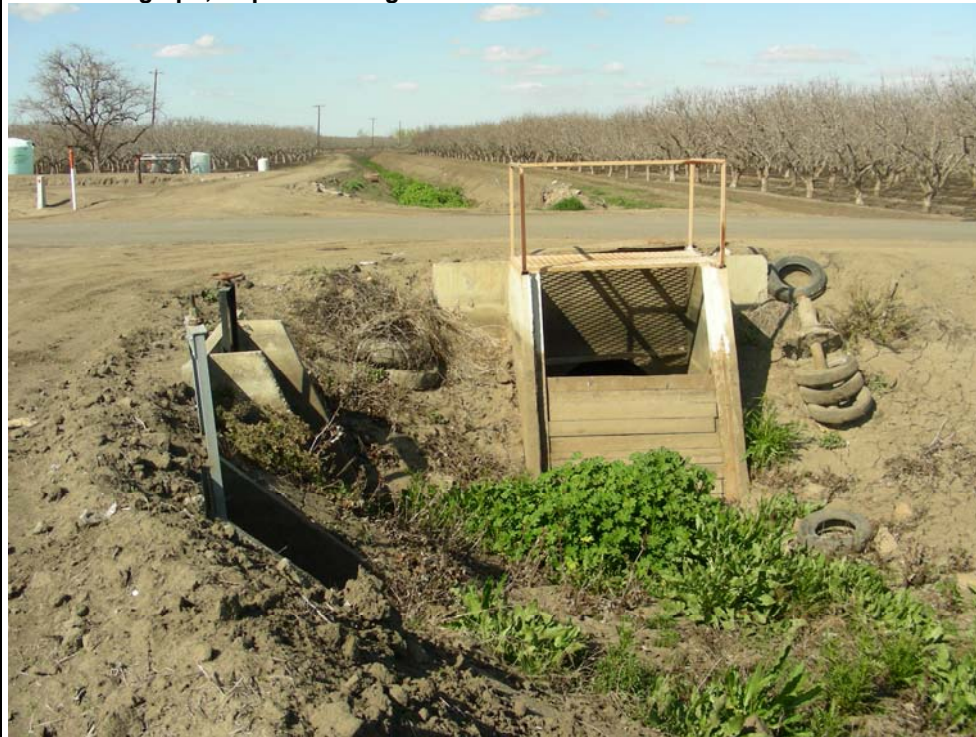
Check gate culvert at Brite Road, camera facing north, March 9, 2009.

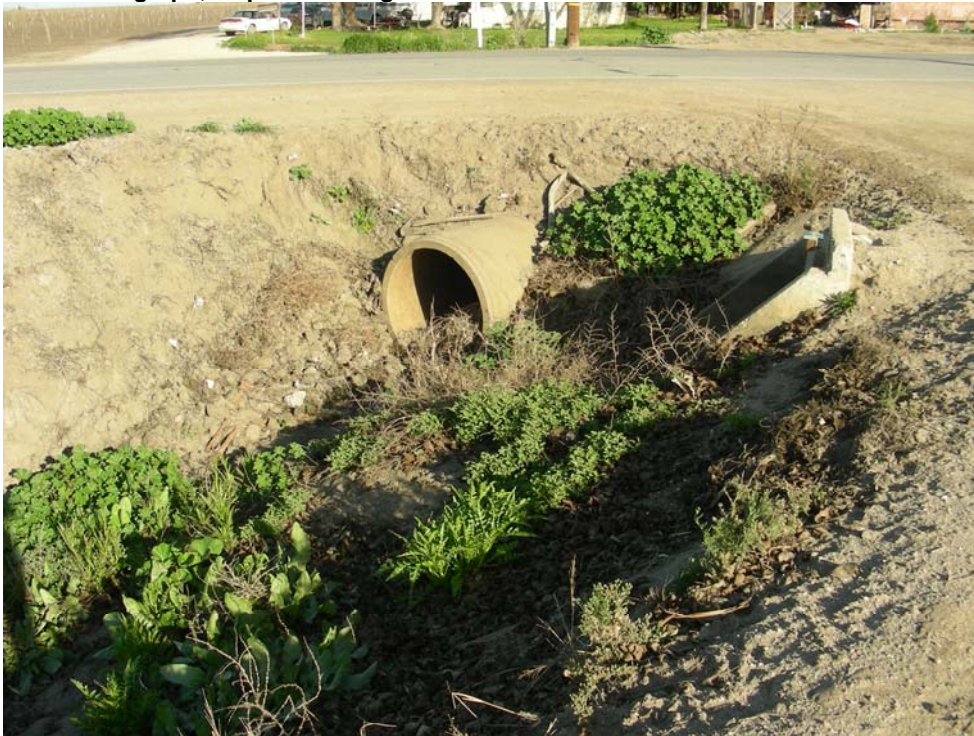
L3. Description: (Describe construction details, materials, and artifacts found at this segment/point. Provide plans/sections as appropriate.) Weed Island Ditch is an earthen ditch with trapezoidal cross section. The narrow base leads to a round concrete culvert that transports the water under Wasco Avenue. Southwest of Wasco Avenue is a delivery gate with concrete head wall and flanking walls. The circular metal gate is lifted and lowered by a vertical screw mechanism.

Weed Island Ditch camera facing east, March 9, 2009.

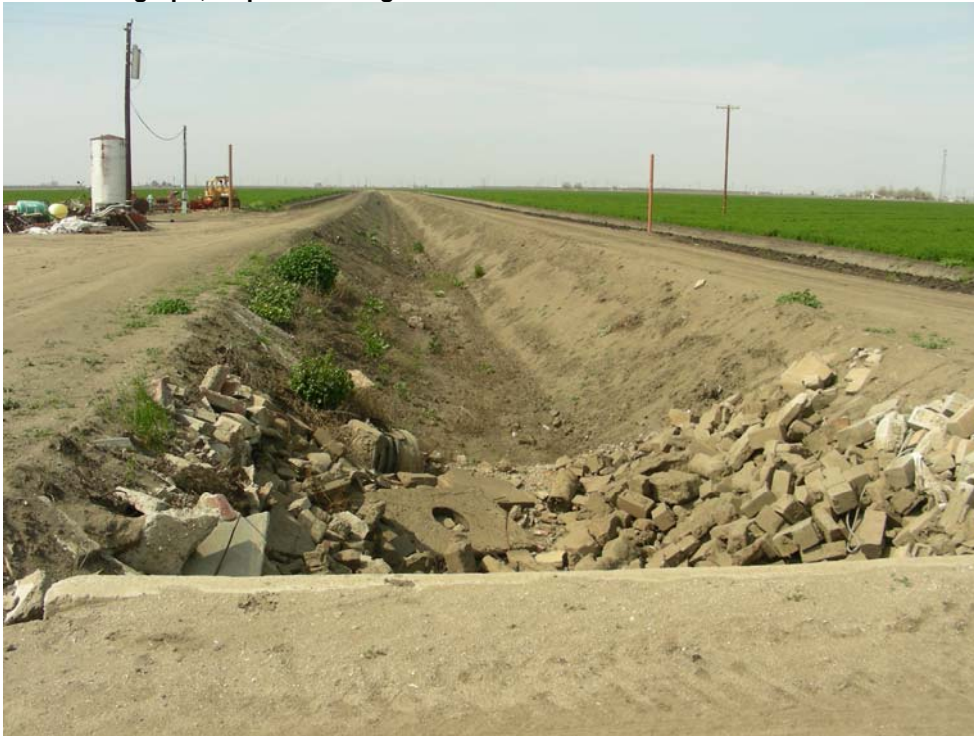
L3. Description: (Describe construction details, materials, and artifacts found at this segment/point. Provide plans/sections as appropriate.) Weed Island Ditch derives from the Arizona Ditch at this point. The earthen trapezoidal ditch has a concrete head gate that also acts as a farm bridge. The head gate has a concrete headwall and circular metal gate operated by a vertical screw mechanism. Incised in the concrete is the date 11-18-81. Northwest of the head gate, the ditch is lined with concrete rubble for several feet.

Photograph 1: camera facing west, March 11, 2009

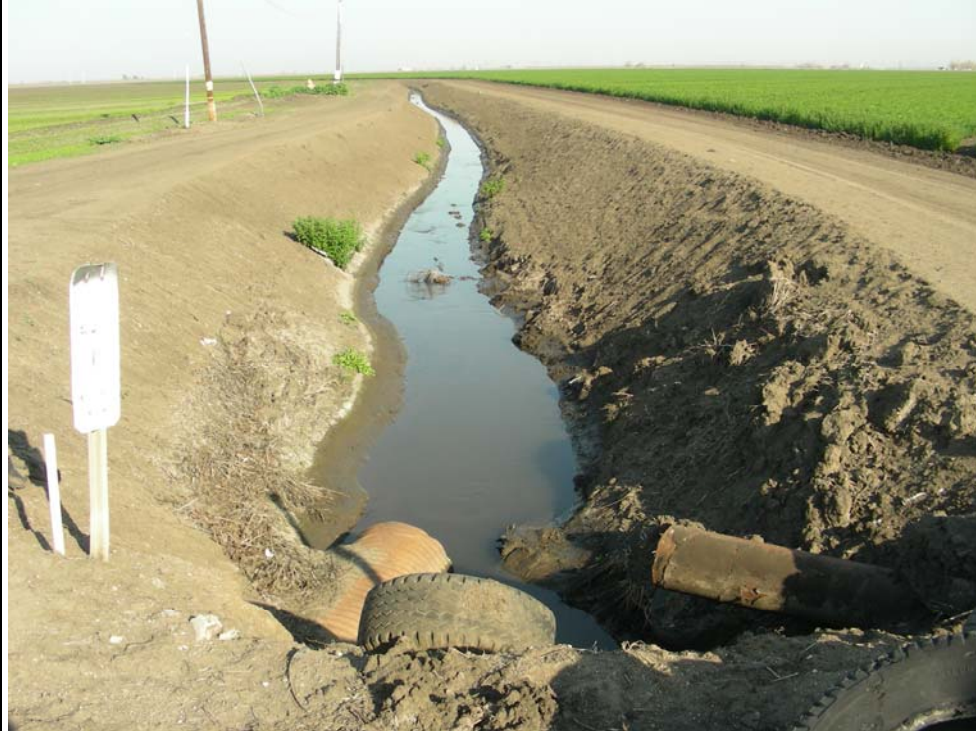
L3. Description: (Describe construction details, materials, and artifacts found at this segment/point. Provide plans/sections as appropriate.) The Florida Drain is an earthen canal with a trapezoidal cross section. The drain crosses under Stockdale Road via a corrugated metal pipe. Another smaller metal pipe releases water into the drain north of the road.

Camera facing north,
March 12, 2009

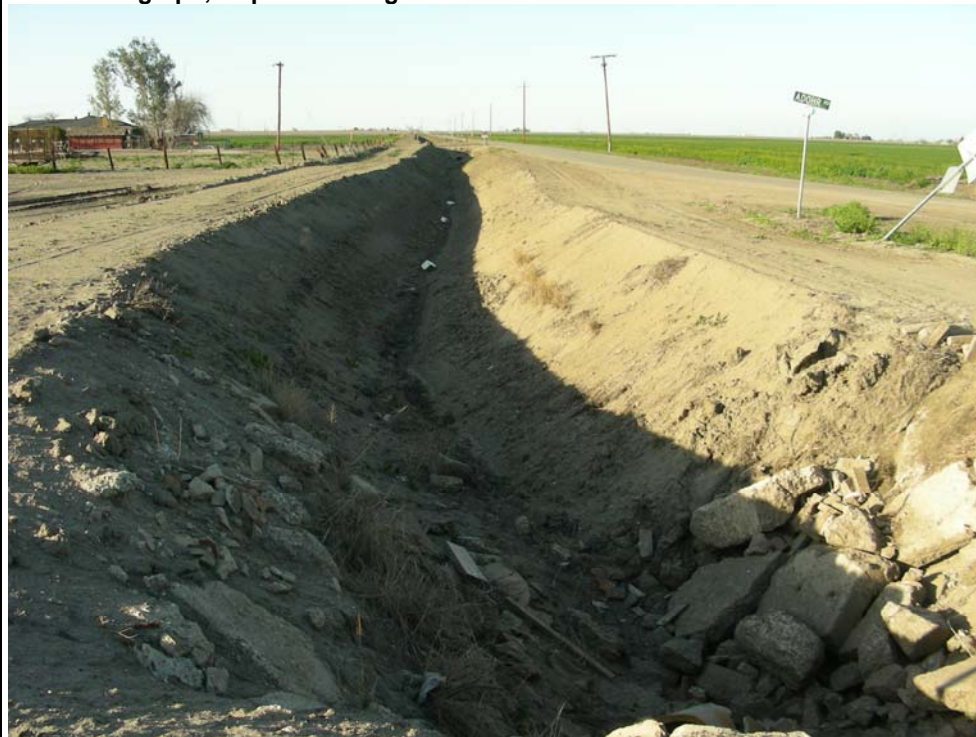
L3. Description: (Describe construction details, materials, and artifacts found at this segment/point. Provide plans/sections as appropriate.) The Florida Ditch is a V-shaped earthen canal. The Florida Ditch joins the West Side Canal at this point. A head gate on the west side canal releases water into the Florida Drain through a round concrete culvert. The gate is operated via a manual vertical screw mechanism and has a metal round gate cover.

Photograph 1: Florida Ditch facing north, March 9, 2009.
