DATE: August 2, 2012**TO:** Interested Parties**FROM:** Mary Dyas, Compliance Project Manager**SUBJECT: El Segundo Power Redevelopment Project Complaint (12-CAI-03)**

EL SEGUNDO POWER REDEVELOPMENT PROJECT COMPLAINT (12-CAI-03) STAFF REPORT

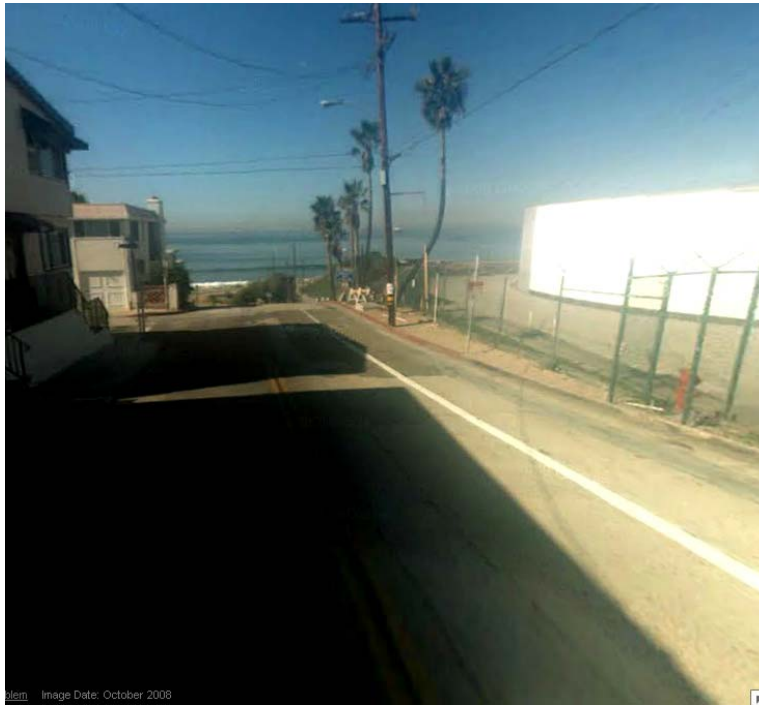
Figure 1a. View of historic fence line along 45th Street showing path (from Google Earth).

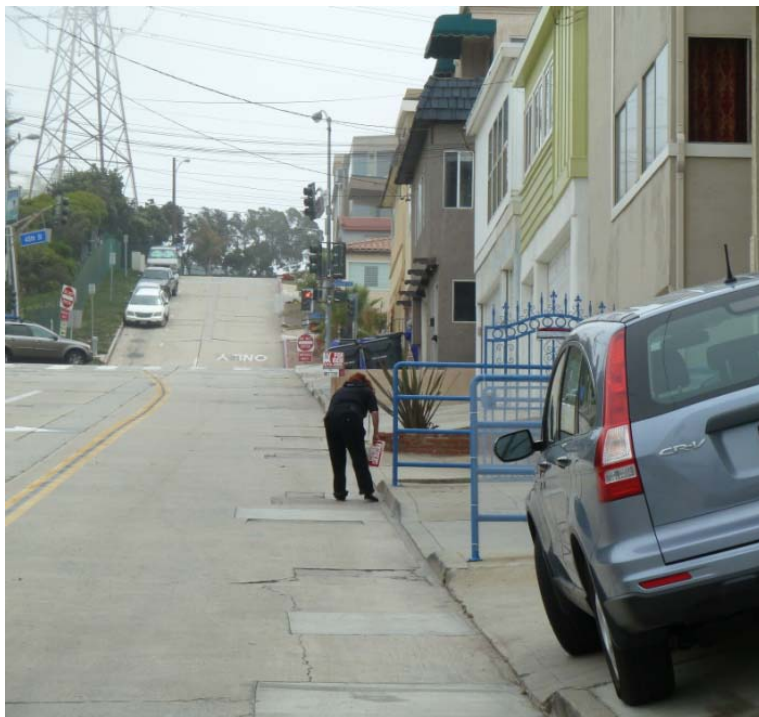
As shown in **Figure 1b**, an existing four-foot sidewalk located on portions of the southern side of 45th Street was at one time available for pedestrian use, but has since been deemed unusable due to residents installing concrete walls, planter boxes and various other obstructions within the sidewalk. This is in violation of Manhattan Beach zoning codes, but the city has not taken steps to enforce the removal of these obstructions.

Figure 1b: View of encroachments onto sidewalk on Manhattan Beach side of 45th Street which impede pedestrian use.

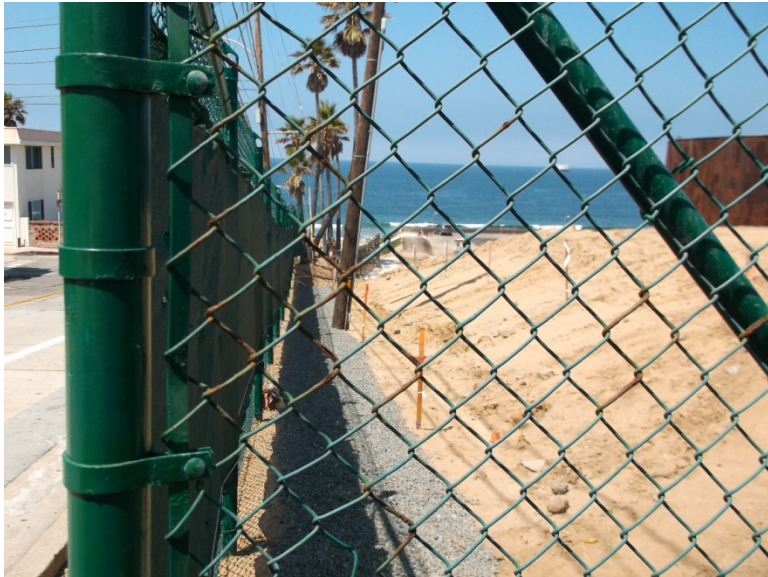
Figure 1c: View from eastern property boundary west along 45th street, showing distance from fence to toe of slope, estimate to be 4'-6'.

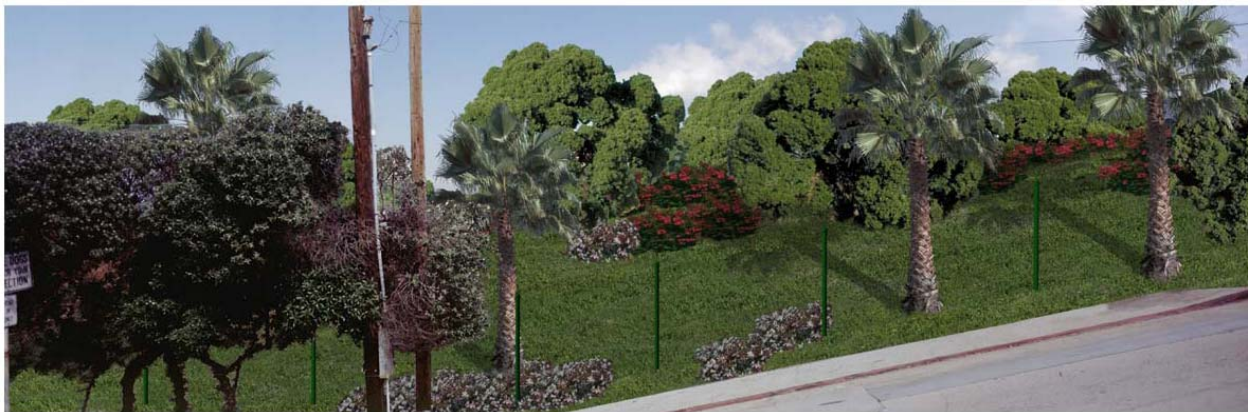
A cross sectional view of the berm shown in a 2007 version of the plan provided in the Complaint depicts the fence placement towards the middle segment of the landscaped berm. The photo simulations provided by NRG in their May 15, 2002 Visual Enhancement Proposal show the fence further back from the curb than where it is today and what appears to be a sidewalk (see **Figure 1d** and **Figure 1e**). Both city planning managers confirmed at the June 6, meeting that it was their understanding that the fence was to be located on the slope portion of the landscaped berm. Further, landscape plans that were provided by NRG during the meeting on June 6, 2012, depicted the fence placement towards the middle segment of the landscape berm.

Figure 1d: Simulation from the lower level of 4420 The Strand shows location of proposed fence from the 2002 Visual Enhancement Proposal

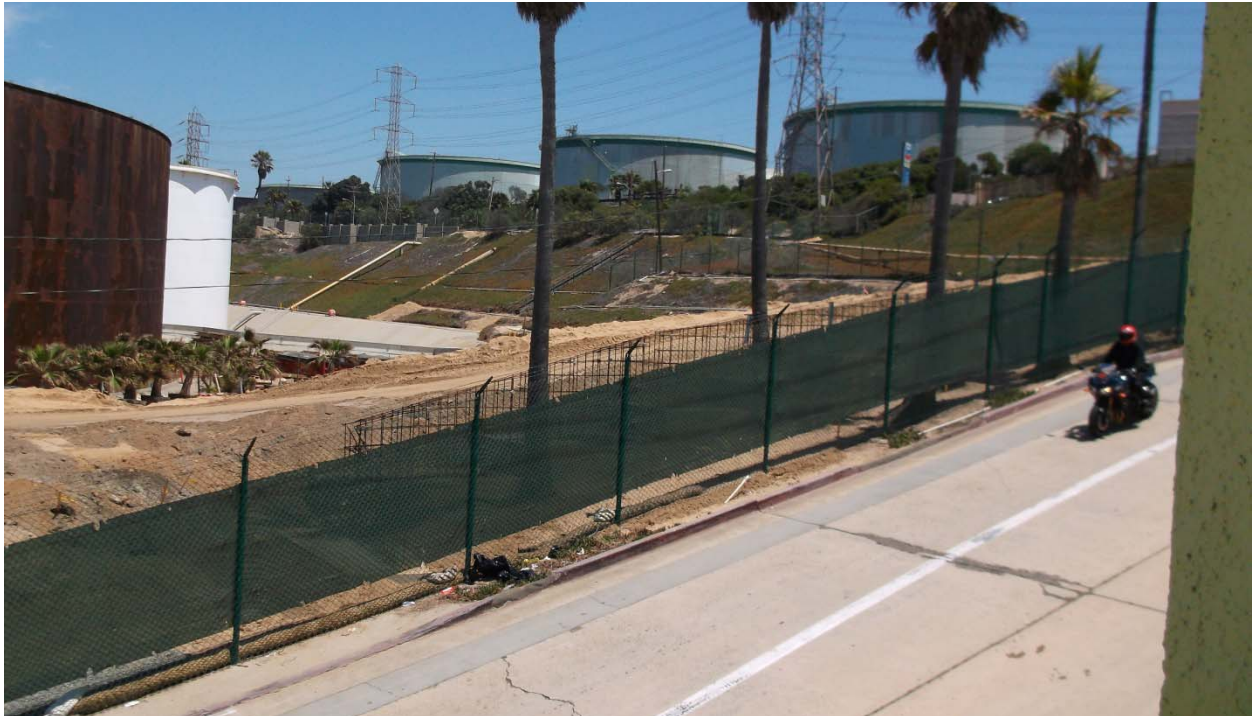
Site reconnaissance on July 25, 2012, confirmed that the current existing fence line is approximately 3'1" to 3'3" from the outside edge of the curb on 45th Street (**Figure 1e**), with the toe (bottom) of the slope located approximately 4'-6' inside the fence line (staff was unable to measure inside the fence line). This is seen in **Figure 1c**. This differs from the 4'0" from curb to toe shown on the Berm Concept study dated May 8, 2002. **Figure 1d** shows the simulated berm and the proposed fence location from 2002. Staff has concluded that the placement of the fence is in response to the effort to preserve the existing palm trees. All CPM-approved landscape plans called for the palms to be removed, the berm constructed and new plantings provided. The 2002 photo simulation shows the berm plantings including new palm trees at regularly spaced intervals. The attempt to preserve the existing palms at the request of residents in December 2011 affects not only fence line placement but forces changes in the grading of the berm. This is discussed further in Issue No. 2, below.

locations than where it was installed. The present location of the chain link fence is non-compliant with the conditions of certification and CPM-approved landscape plans.

Figure 1e: Present day picture from 4420 The Strand showing the current location of the fence.

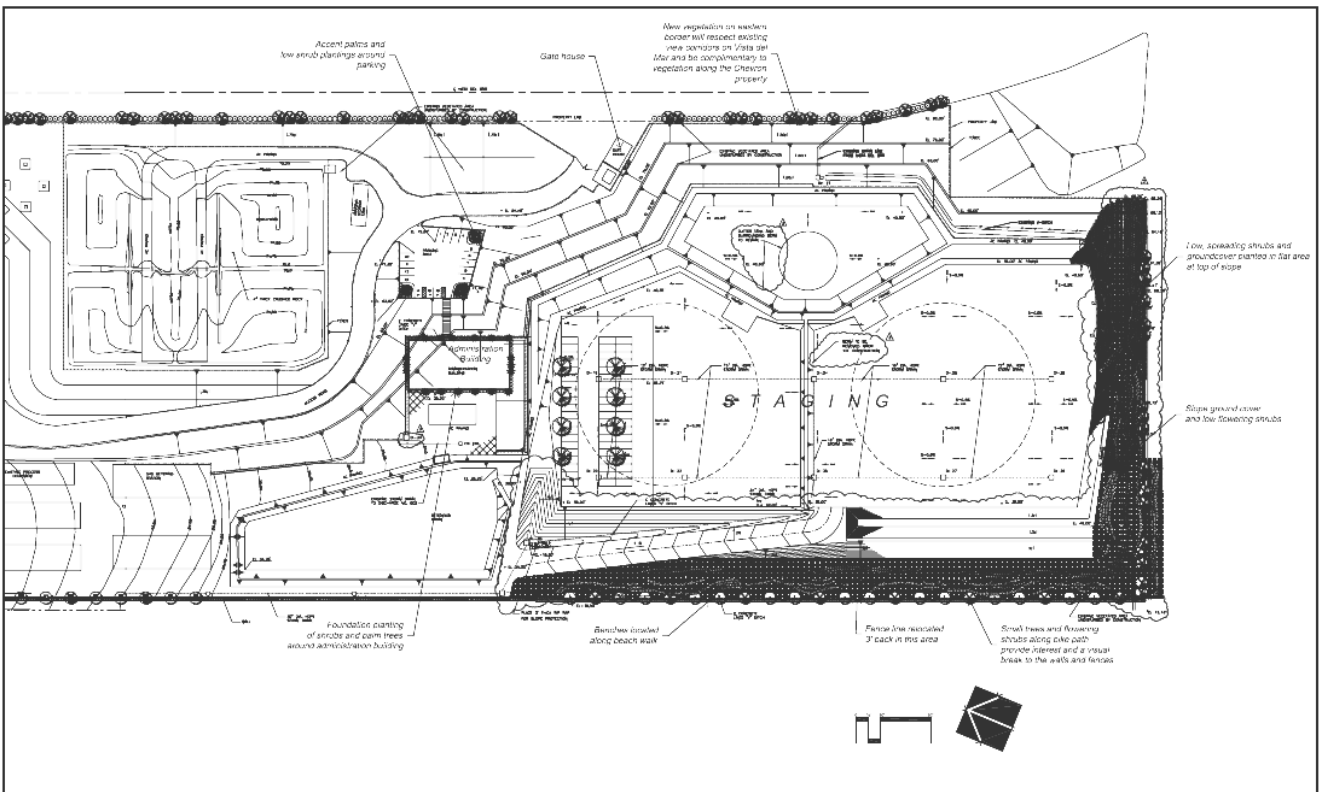
VIS-2 in the Commission's 2005 and 2010 decisions states that the "Landscape Plan shall be consistent with the Landscape Concept Plan presented at Evidentiary Hearings...." (Page 184). Staff assumes the concept plan referenced in VIS-2 is the plan reproduced in the Final Staff Assessment as Figure 16B (shown in this report as Figure 1f). This plan does not clearly depict a fence line. The updated landscape plan approved by the CPM on April 10, 2012, also did not depict the fence along 45th Street. However, plans submitted in 2007 and approved by the CPM in 2008 show a fence line that varies from its distance to the curb, but further back from 45th Street in certain

Figure 1f: Landscape Concept Plan from the September 2002 Final Staff Assessment

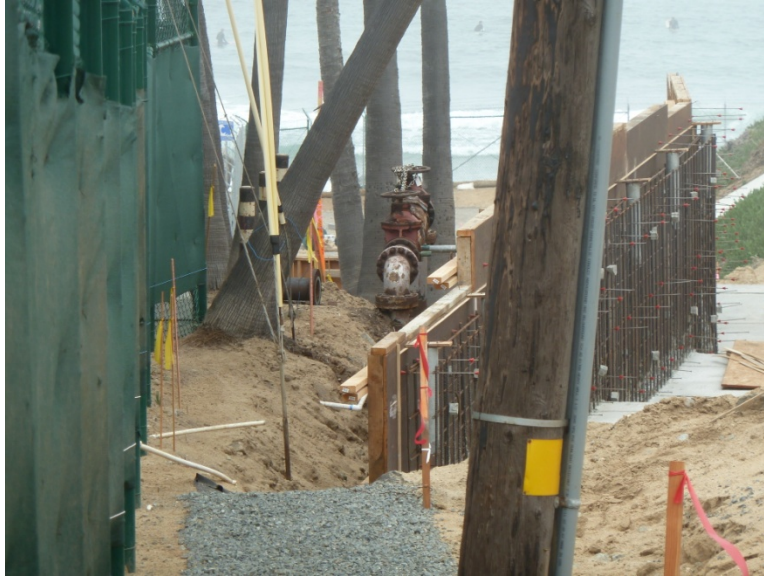
Complainants state that NRG is constructing a concrete retaining wall approximately 80 feet long near the southern boundary of the project site. Complainants claim it was unnecessary to build the wall to save the existing palm trees and that the Energy Commission's decision required both that the trees be saved and that no such unsightly concrete structure be built along 45th Street.

According to NRG, the purpose of the retaining wall is to protect the shallow root ball of the existing palm trees on the southern portion of the NRG property adjacent to 45th Street. The berm, as originally designed and indicated in the grading on Berm Concept Plan (May 8, 2002) from NRG's Visual Enhancement Proposal, would have had a uniform slope of 3:1 facing 45th Street. Staff concurs that this would necessitate removal of the palms to create the new slope. The existing grade of the crown of the rootball cannot be changed without damaging the trees. Burying the trunk and crown would eventually kill the trees. The CPM-approved landscaping plan never intended to retain the existing palms, but remove them and plant new trees as shown in the photo simulation (**Figure 1d**). A very similar photo simulation was provided in Exhibit 23 of NRG's Facility Visual Enhancement Plan dated January 26, 2007, and approved by the CPM on or about September 26, 2008. Because residents asked for the palm trees to remain, NRG began construction of the retaining wall. It is fairly reasonable to conclude, based on observation of the current conditions that the construction of the retaining wall was intended to preserve the existing grade at the base of each tree, while at the same time allowing for the berm to be built up behind it. Work has stopped on the construction of the retaining wall, pending resolution of the complaint. The retaining wall as shown in **Figure 2a** would be a large concrete wall, with no apparent architectural enhancement. This wall will be in clear view to the residents until such time as landscape plants provide partial screening of the wall. The Berm Concept Plan from NRG's Visual Enhancement Proposal, and reproduced in the Final Staff Assessment as Figure 14, depicts a retaining wall on the north side of the berm, not on the south side of the berm. The simulation (**Figure 1d and Exhibit 23**) does not show a retaining wall, only a vegetated berm as required by Condition of Certification VIS-1, which states: "If berms are used, they shall be vegetated and maintained with evergreen, native, and/or species requiring little or no irrigation" (Page181). The retaining wall partially installed by NRG on the 45th Street side of the berm is non-compliant with the Commission Decision and CPM-approved plans.

Figure 2a: View of concrete retaining wall under construction on July 11, 2012. The existing palm trees and backflow preventer can be seen in this view.

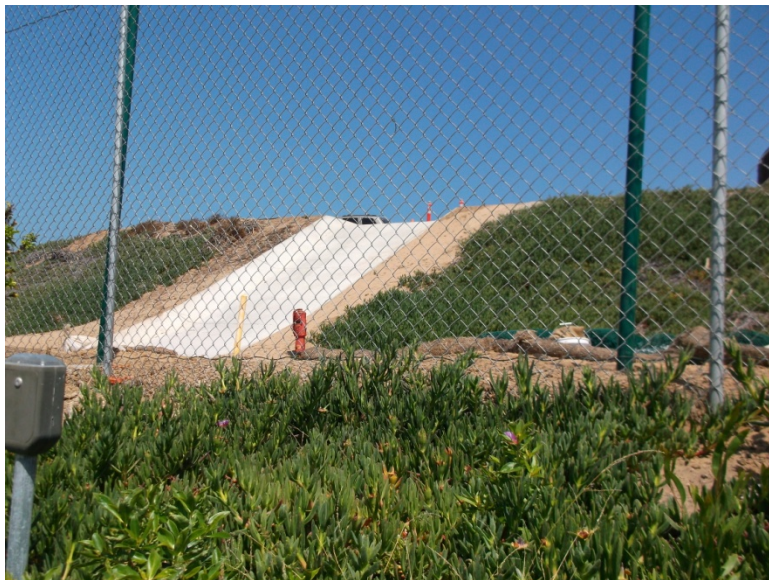
As indicated earlier under the chain link fence discussion, a landscaping plan was reviewed by the cities of Manhattan Beach and El Segundo, and approved by the CPM in 2008. The CPM-approved plan did not show a spillway, but the updated plan submitted in 2012 shows an unlabeled feature in the spillway location. Because of its immense size, staff does not believe that landscaping will obscure or soften the view of

this massive concrete structure, particularly when viewed from the Strand and beach, and from porches of residences on 45th Street (**Figure 4a**). Recent correspondence from NRG and the Chief Building Official indicates that the spillway as it exists today was designed in early 2012. It was shown on the most recent plans for the landscape plantings and irrigation (2012) but was not labeled or called out in any way on the landscape drawing. There is a cross-section view of this drainage structure on one of the irrigation detail drawings, but it is not cross-referenced to the landscape drawing to show where this structure would be located. Visual resources staff was not consulted on the spillway design and relationship to the berm and plantings prior to design or construction. The concrete drainage system is non-compliant with CPM-approved landscape plans. Sheet P-3 from the 2008 CPM-approved landscape plan shows subsurface drainage leading away from the berm and wall. Staff is uncertain as to why the spillway was installed.

Figure 4a: Close-up view of concrete spillway.

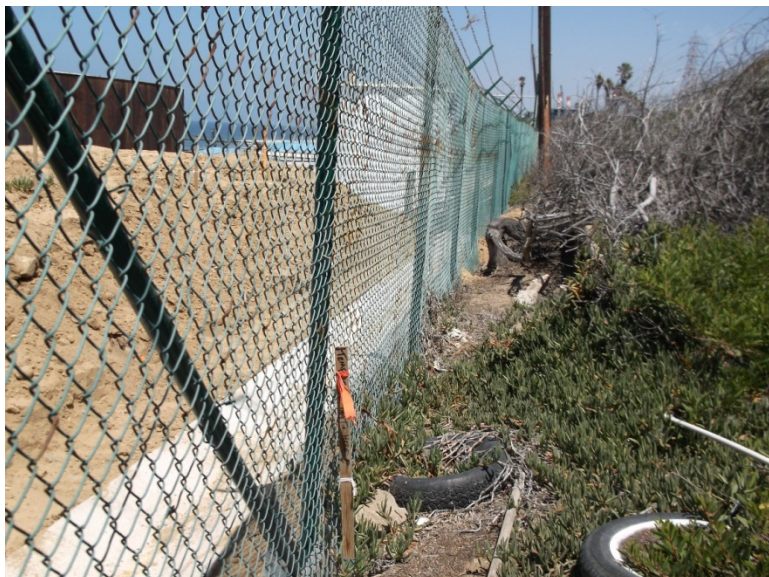
Figure 4b: View of new drainage ditch at eastern property boundary near 45th Street.

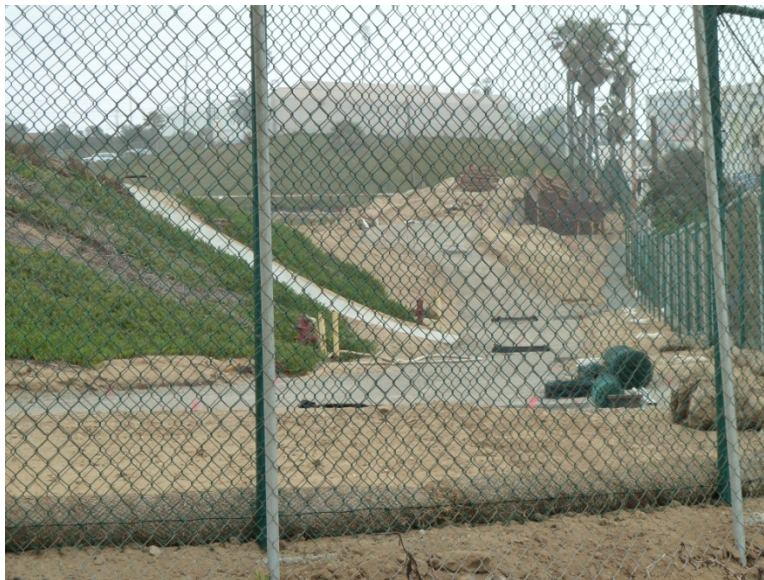
Complainants state that NRG has started to construct an asphalt road along the southern boundary of the property ending on the top of the berm near the tank farm. This road is not depicted on the CPM-approved landscape plans, which show the tank road to be constructed along the western boundary to the tank farm area. **Figure 5a** shows the road questioned in the Complaint. It also appears in the Google Earth image taken prior to construction of the berm (**Figure 5b**). It may be that it was recently paved, possibly in connection with the installation of the concrete spillway. It is not a feature in the approved landscape plans. It may be in use solely for construction access. Staff needs more information to determine if this complaint is valid and whether the road is non-compliant with the CPM-approved plans. It may have also been constructed solely for access for construction vehicles and delivery of soil for the berm construction, and eventually used for delivery of plants to the completed berm.

Figure 5a: Asphalt road leading to new berm and side view of concrete spillway.

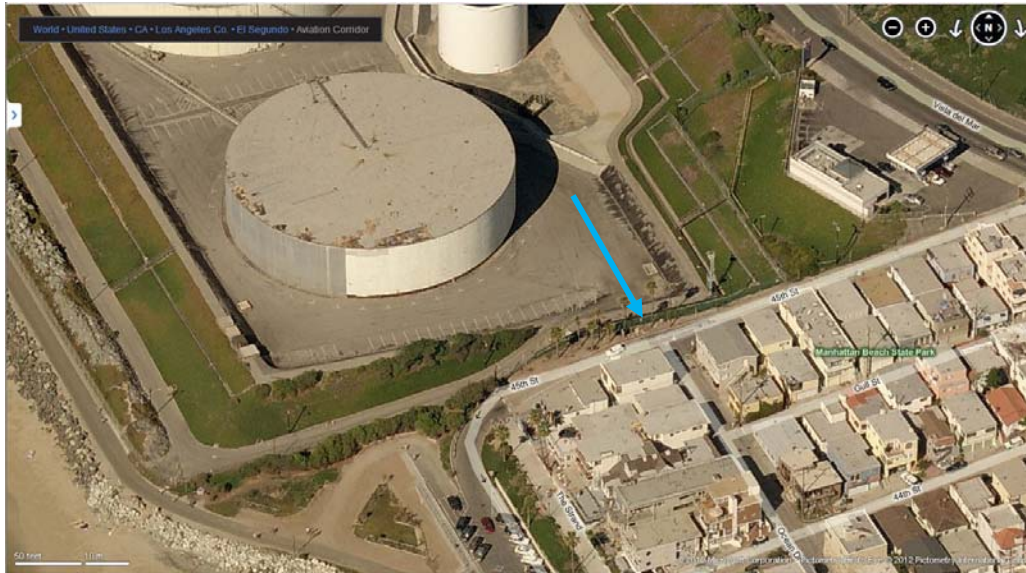
Figure 5b: Aerial view of site prior to construction in berm area. Road in question visible wrapping around southwest corner. Arrow points to pre-construction fence line.
(From Bing Maps)

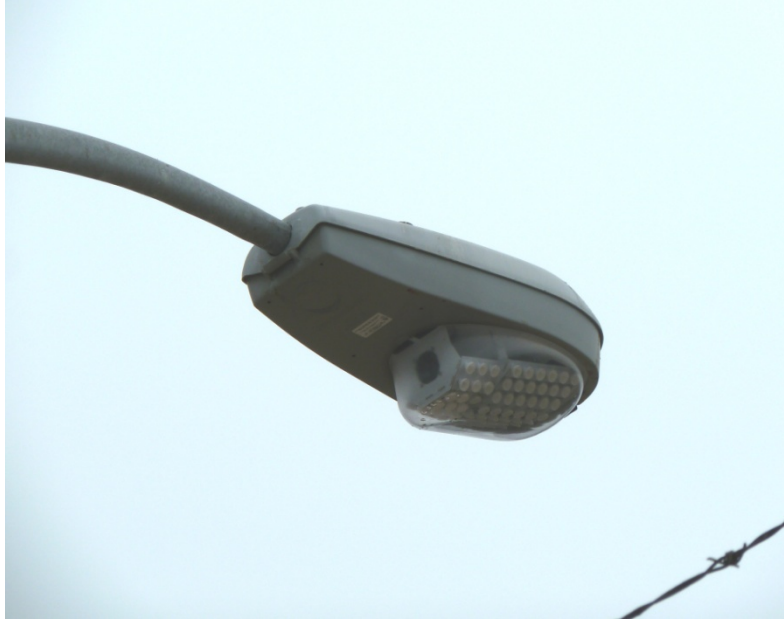
Staff inspected the newly installed light fixtures on the western boundary of the El Segundo project site, and the light fixtures are the new, more efficient LED lighting fixtures. Staff took a photo of one of the light fixtures, **Figure 6a**, and from inspection of the close up photo, each lighting fixture consists of approximately 50 LED bulbs. These lighting fixtures are similar to what was approved for the Genesis Solar Project. Based on a telephone conversation with the Genesis lighting engineer, the LED lighting fixtures are designed to provide directional lighting without the installation of shielding or hoods.

Because the lighting fixtures at the El Segundo project site have not been turned on, staff was not able to evaluate whether light spillage would occur beyond the project site. The Energy Commission's conditions of certification require that the project owner notify the CPM before the first turbine roll (VIS-6) or before tank demolition (VIS-7) that lighting has been completed and is ready for inspection. Energy Commission staff typically conducts an onsite inspection of the lighting fixtures in the evening hours to ensure compliance with the lighting requirement. If light spillage occurs, NRG will be required to install shielding or hoods to prevent light spillage outside the boundaries of the project site. To date, NRG has not yet contacted staff to conduct a lighting inspection, since it is premature for staff to inspect the lights at this time based on the verifications set forth in conditions referenced above.

Figure 6a: Light fixture installed on western property boundary adjacent to bike path.
