Sensor-Operated Plumbing Fixtures

Do They Save Water?

March, 2010

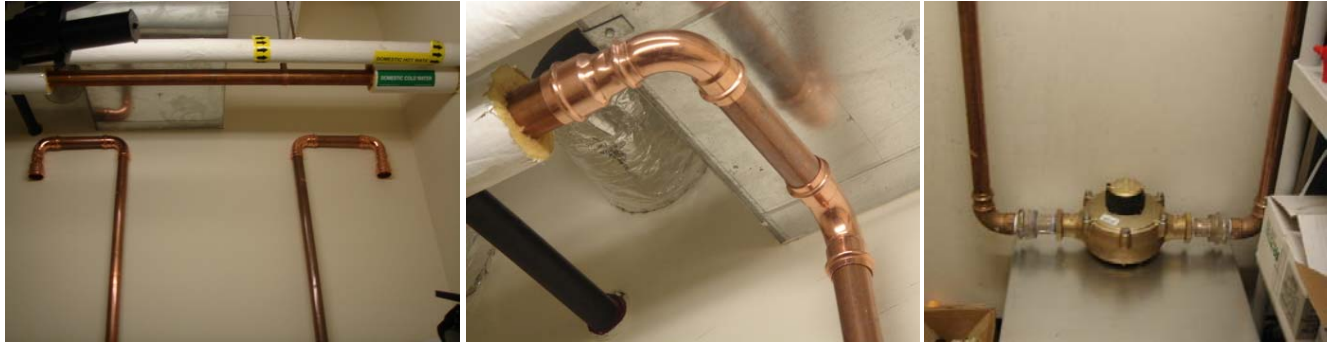
The above photographs show existing supply piping, piping modifications, and the new water meter.

A plumbing company was hired to install a water meter on the supply piping⁵ and a datalogger was connected to the water meter during the entire monitoring period. Because it was necessary to take weekly water meter readings as part of the project, the water supply piping was re-routed such that the water meter could be installed below eye level, on a small table against the back wall of the janitor's closet (see photos on next page).

A datalogger (Brainard Meter-Master 100) was installed on the meter and Tampa Bay Water Conservation staff periodically read the meter and downloaded the information from the data logger on a bi-weekly basis.

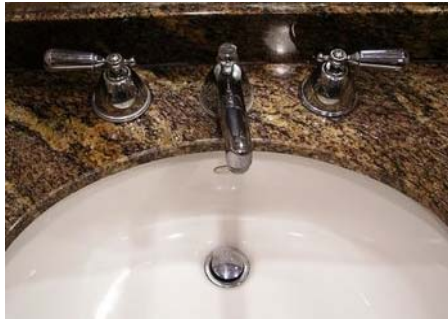
Existing Faucet – general area

The existing faucets in the mens' and ladies' washrooms were two handle, single spout models, with larger handles and a gooseneck spout on the sinks located in the handicap stalls (see photos on following page). These were replaced with new sensor-operated faucets on January 29, 2008. The new faucets were graciously donated to the project by Sloan Valve Company⁶.

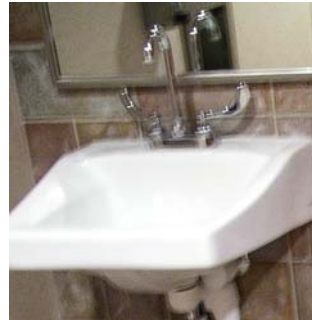
Existing Faucet – handicap stall

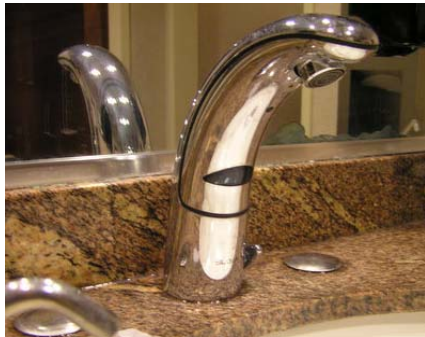
Sensor-operated Faucet – general area

The average flow rate of the manual faucets was measured as 1.32 gallons per minute (with the valve fully open) and the average flow rate of the sensor faucets was slightly less at 1.21 gallons per minute (valve fully open). Water demands were monitored for the 127-day period from the date of installation until June 4, 2008. The average daily water demand of the washrooms during this period was 856 gallons per day – an increase of 202 gallons or 30% per day. Figure 2 on the

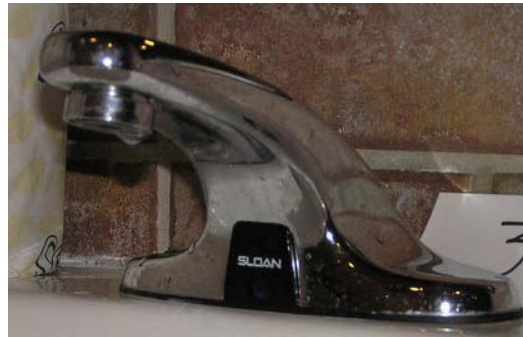
Sensor-operated Faucet – handicap stall

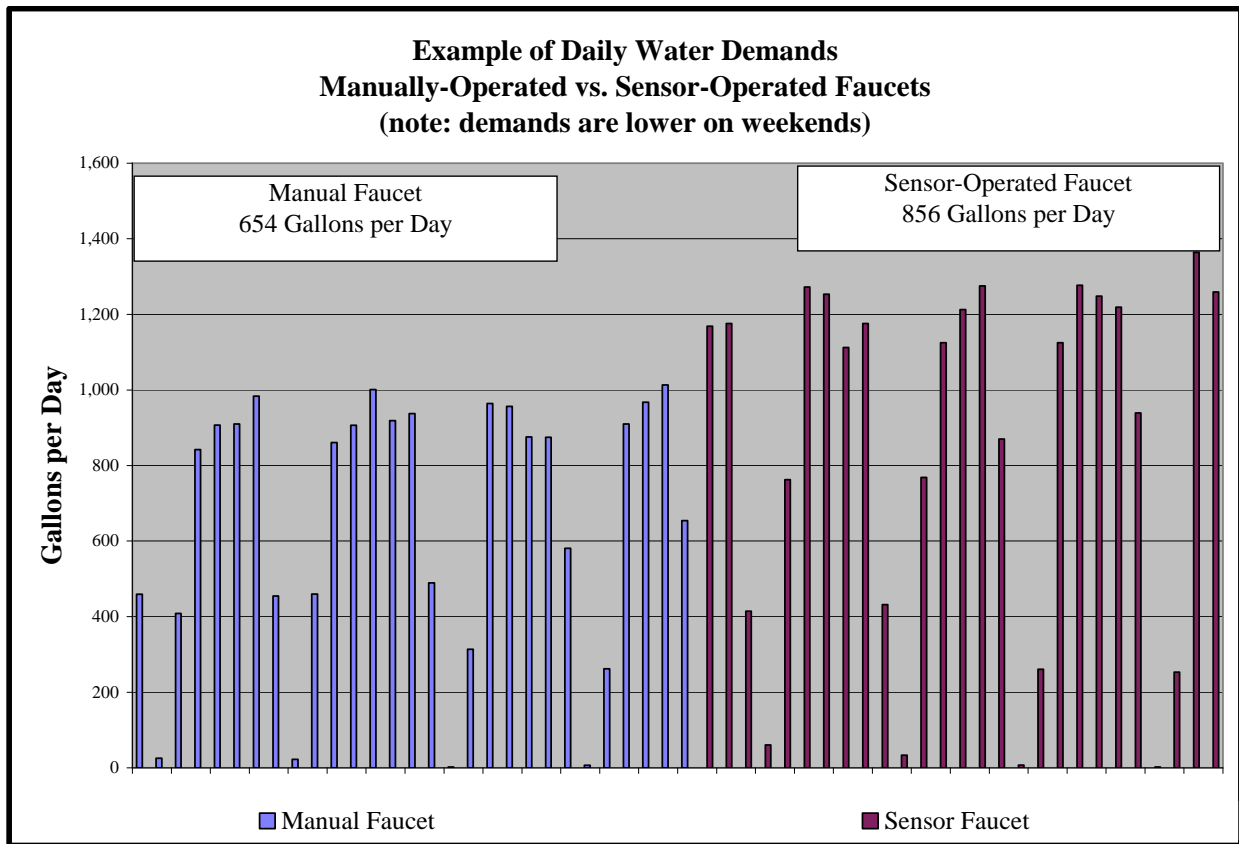
following page illustrates the change in water demands when the sensor-operated fixtures were installed. Note that only a portion of the pre and post data is included in Figure 2 to make the chart easier to read.

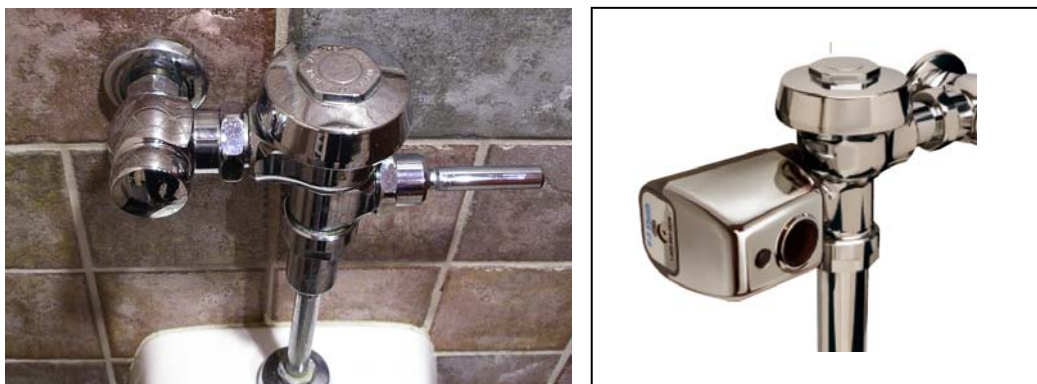
To ensure that any change in water demands was related to a change in the operating system utilized by the flush valve rather than in a change to the flush valve itself, it was decided that rather than replace the existing flush valves, the project would, instead, simply replace the existing manual flush handles on the urinals with battery-powered retrofit sensor-operated valves graciously provided by Zurn (AquaSense® E-Z Flush – see photos below).
