Public Interest Energy Research (PIER) Program  
FINAL PROJECT REPORT

**EFFICIENCY CHARACTERISTICS AND  
OPPORTUNITIES FOR NEW  
CALIFORNIA HOMES (ECO)**

Prepared for: California Energy Commission  
Prepared by: Proctor Engineering Group, Ltd.

MARCH 2011  
CEC-500-2012-062

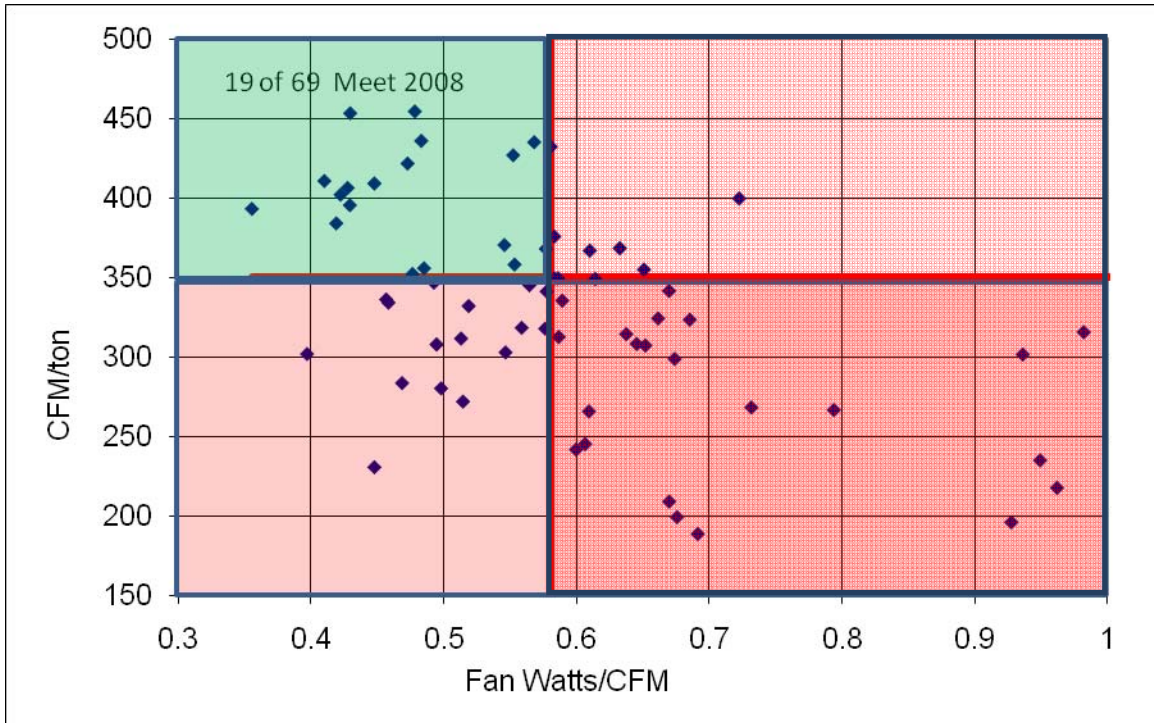
**Figure 9: Cooling Airflow and Fan Power**

Title 24–2008 provides a prescriptive standard for cooling airflow and fan power. Figure 9 shows that only 19 of 69 systems tested (28 percent) meet this standard. Potential causes of the failure to meet this standard are discussed in the Air Distribution section.

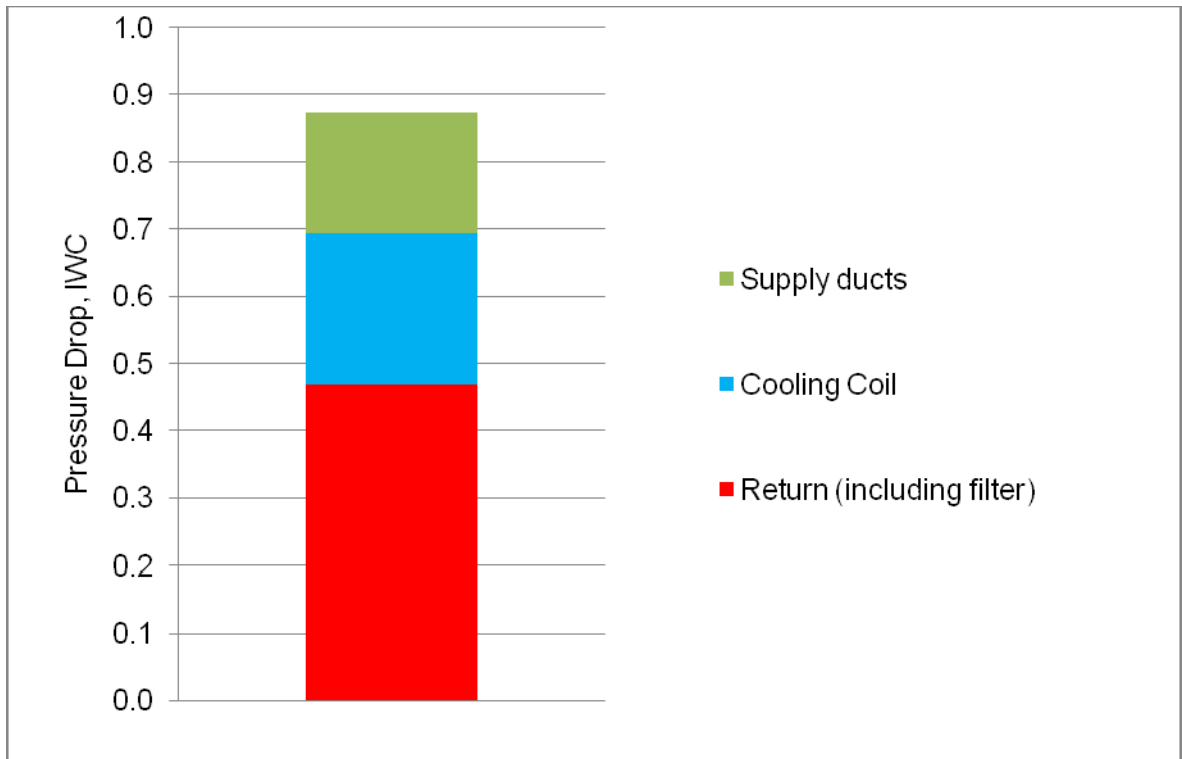
**Figure 10: Cooling Airflow Average External Static Pressure**

One cause of the low airflows and high watt draws per CFM is the restrictive nature of these duct systems. The average return system pressure drop (including filter), coil pressure drop, and supply pressure drops are shown in Figure 10. Notice that the average return system alone is almost equal to the nameplate certified maximum TOTAL cooling static pressure of 0.50 IWC for all but three of the air conditioners.

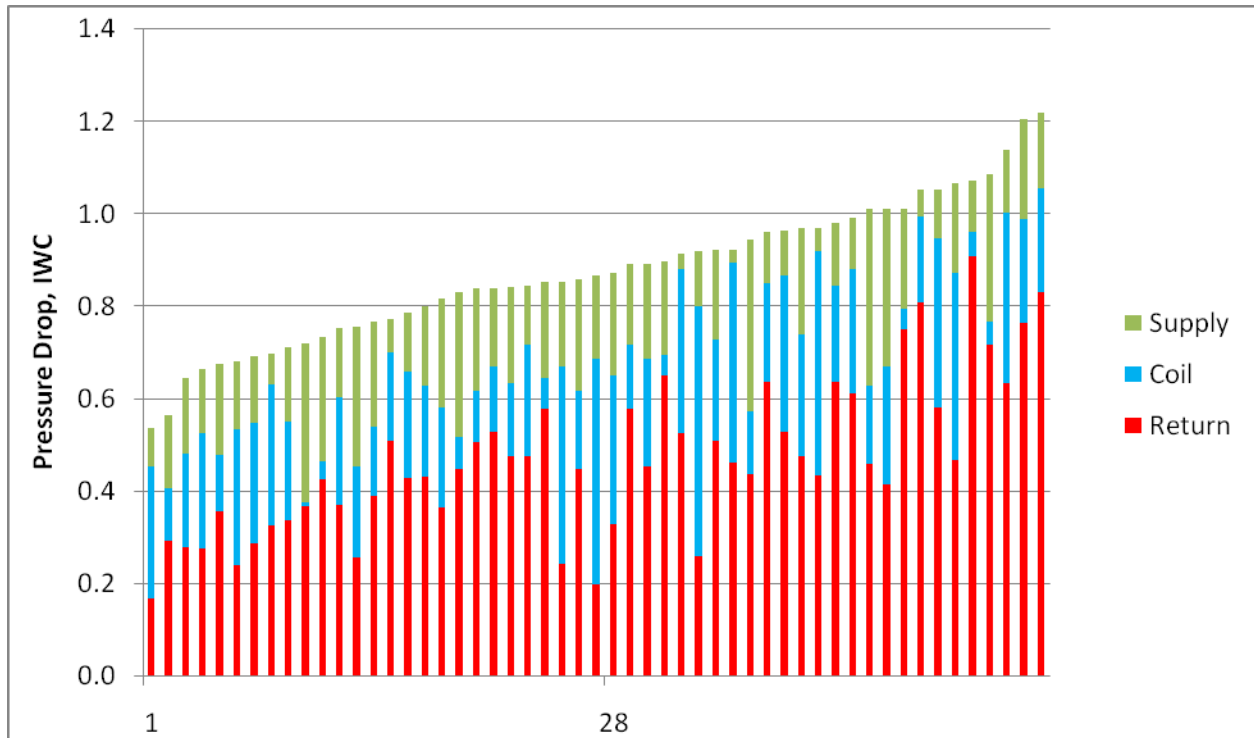
**Figure 11: Cooling Airflow External Static Pressure by Component**

Figure 11 shows the pressure drops in the return, evaporator coil, and supply duct system arranged from the least restrictive system to the most restrictive system. The dominant influence of the return flow resistance is evident in this graph.

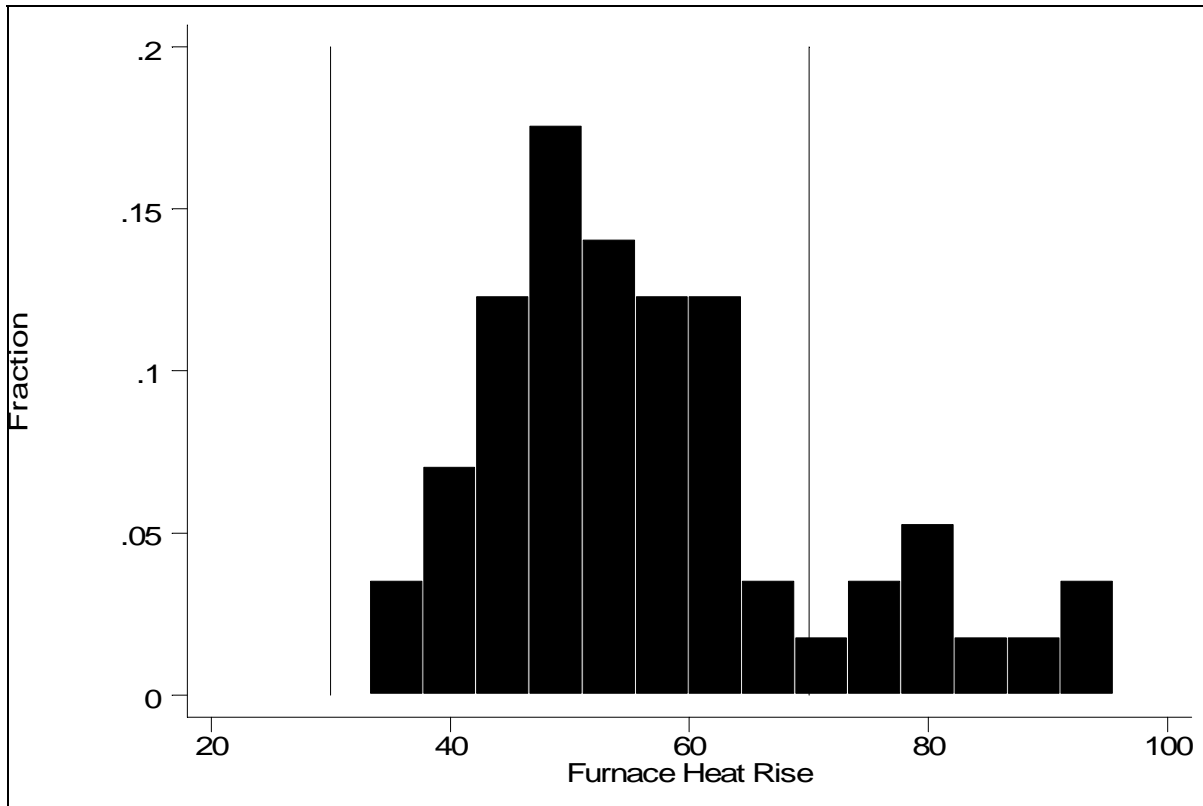
**Figure 18: Calculated Furnace Heat Rise**

Based on a steady state efficiency of .85, the heat rise ranges between 34°F and 96°F, as shown in Figure 18.<sup>3</sup> Approximately 20 percent of the units exceed the manufacturer’s certified heat rise; substantially more of the units exceed their optimum heat rise. Higher heat rises reduce the efficiency of the units below their AFUE rating.

With proper airflow the data would range from 30°F to 70°F and be a normal distribution centered at about 50°F. This data is skewed to the right (high heat rise due to low airflow). Low airflow not only lowers the efficiency of the furnace, it can also cause the unit to cycle the gas off and on by the limit switch, potentially increasing heat exchanger fatigue and corrosion.

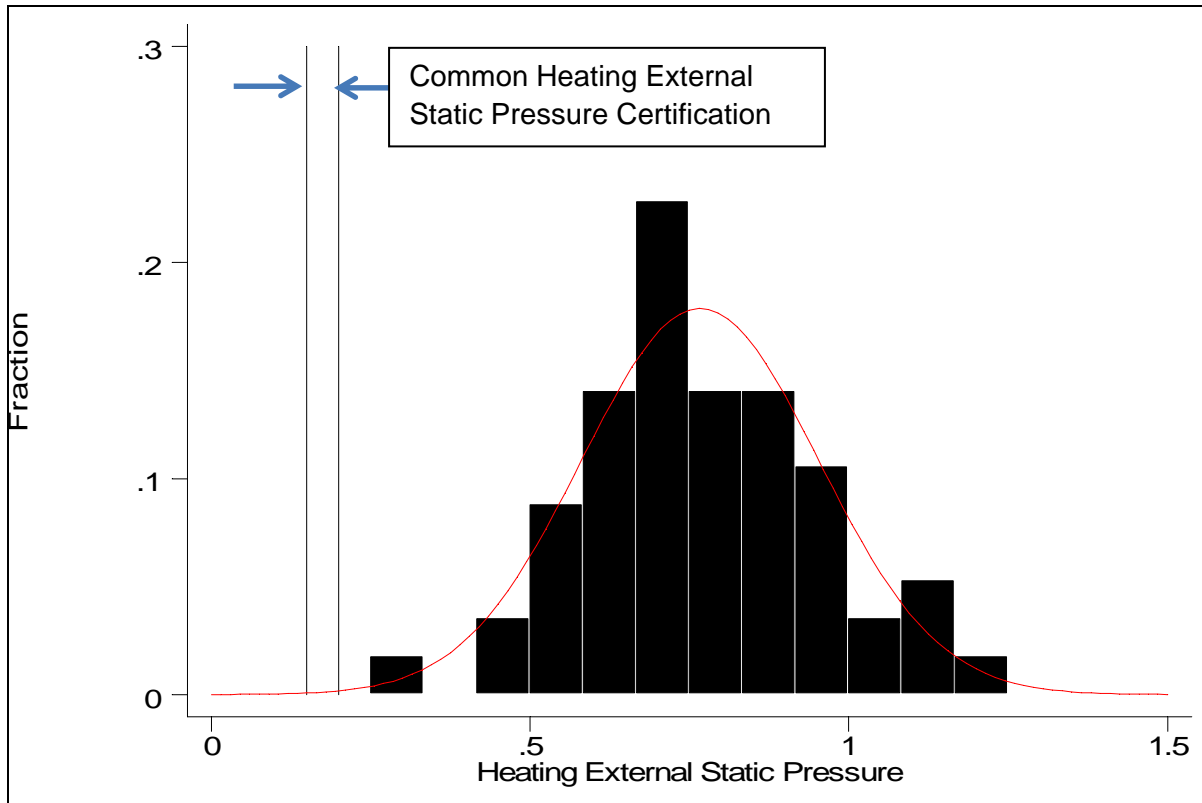
**Figure 19: Heating Mode External Static Pressure vs. Common Certification Range**

The cause of the low airflow is a combination of unrealistically low heating static pressure certifications (generally between 0.15 Inches of Water Column and 0.25 Inches of Water Column) and the true external static pressures displayed in Figure 19.

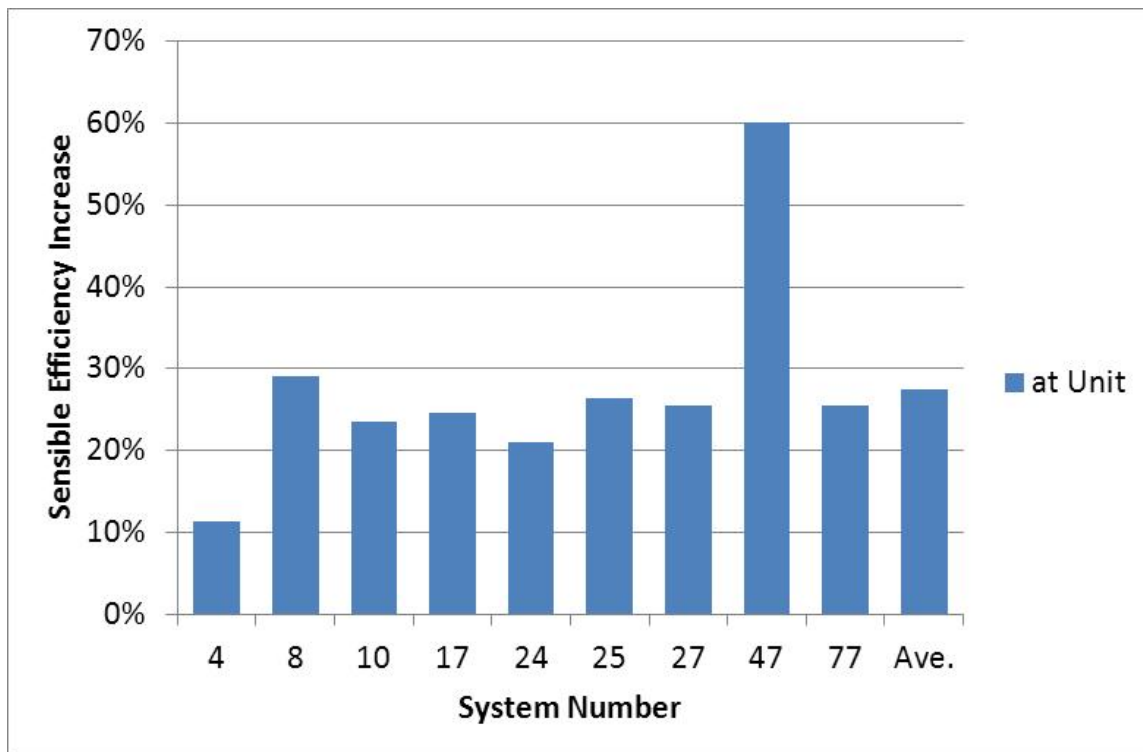
**Figure 25: Normalized Sensible EER Improvement**

All three levels of repairs showed statistical significance at 0.01 level in paired tests. The repairs improved the measured Normalized Energy Efficiency Ratio – Sensible (NEERs) between 3 percent and 60 percent. The NEERs is the sensible capacity corrected to standard conditions (95 °F outside, 80 °F 50 percent relative humidity inside). The efficiency improvement was 24 percent± 13 percent. Figure 25 displays the improvement from pre to post for each unit.

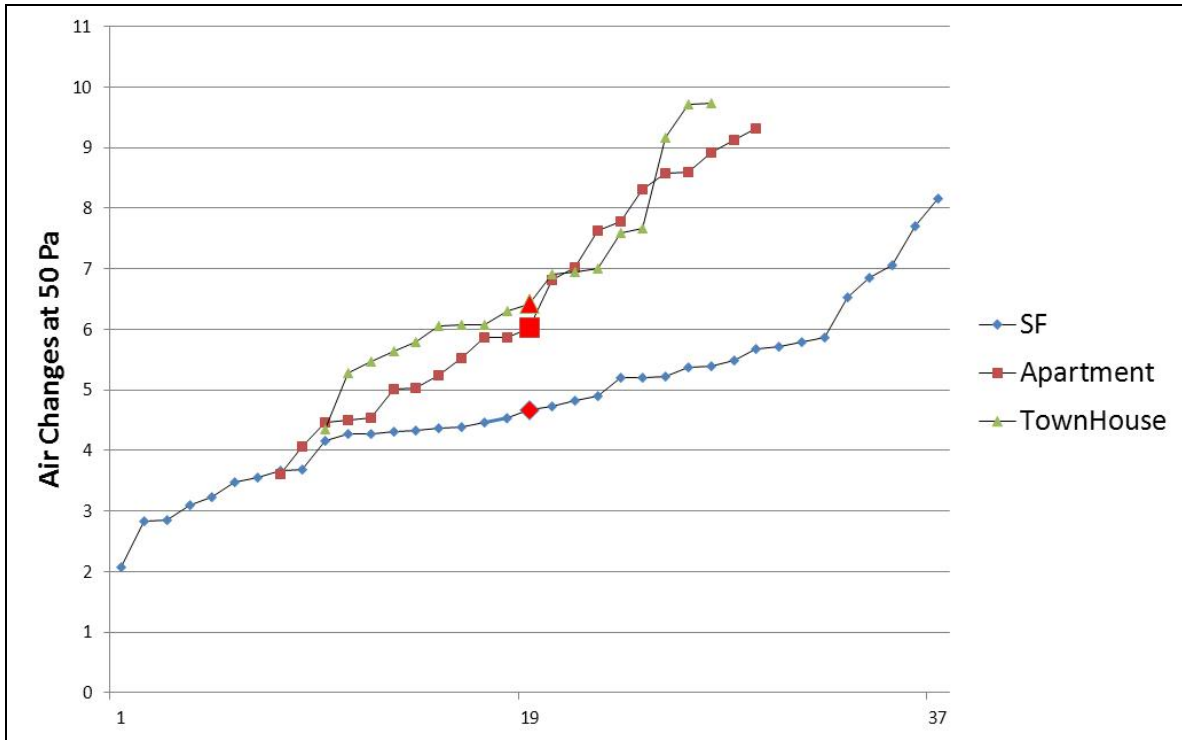
**Figure 56: Building Air Change Rates at 50 Pascals**

The study found that single-family homes were very tight, with a median value of 4.66 Air Changes per Hour at 50 pascals pressure (ACH50). Multifamily homes, however, were substantially leakier to outside the individual unit. The median leakage for multifamily units was over 6 ACH50. Both apartments and townhomes showed higher leakage to outside the unit than single-family homes. These results are displayed in Figure 56.

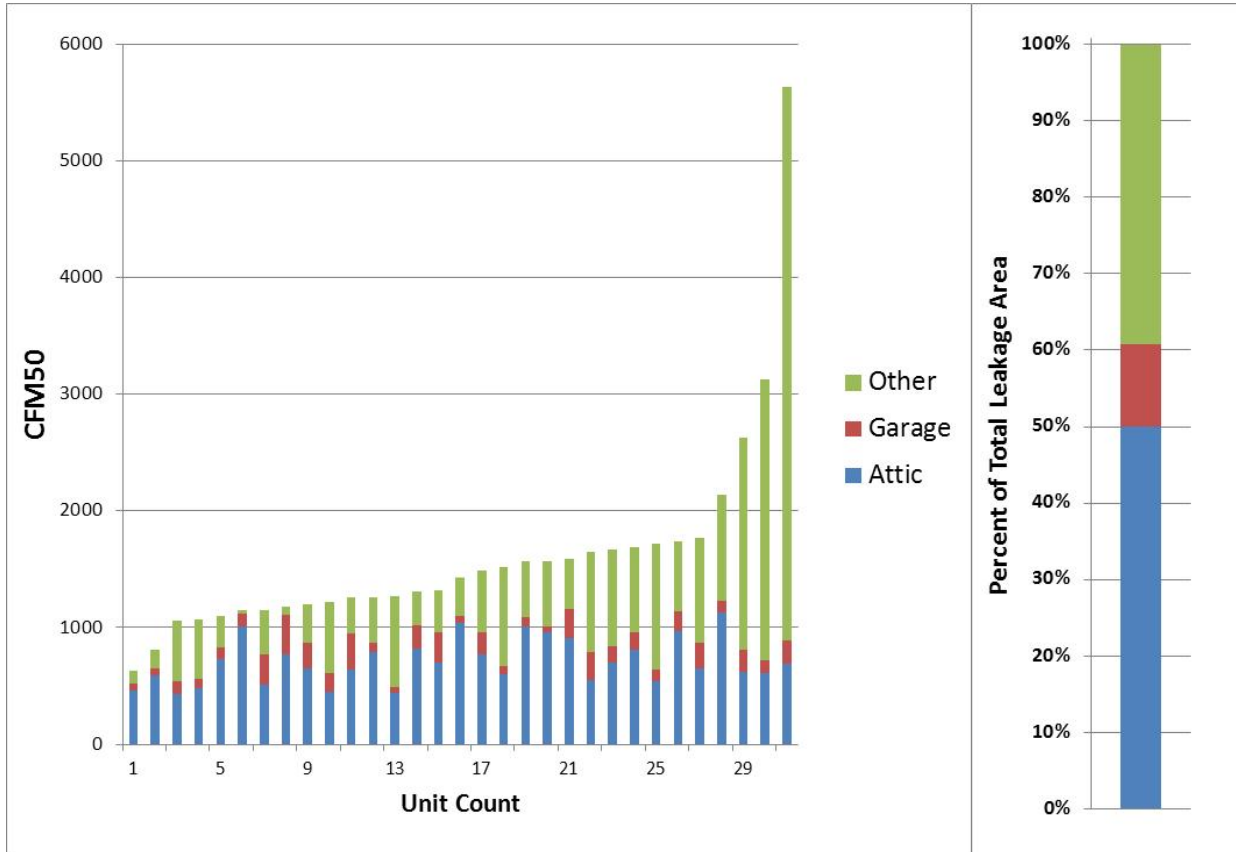
**Figure 587: Leakage Areas Between House and Attic/Attached Garage**

As shown in Figure 58, for homes with attics and attached garages, an average 51 percent of the total house air leakage area is between the conditioned space and the attic and 11 percent is to/from the garage.

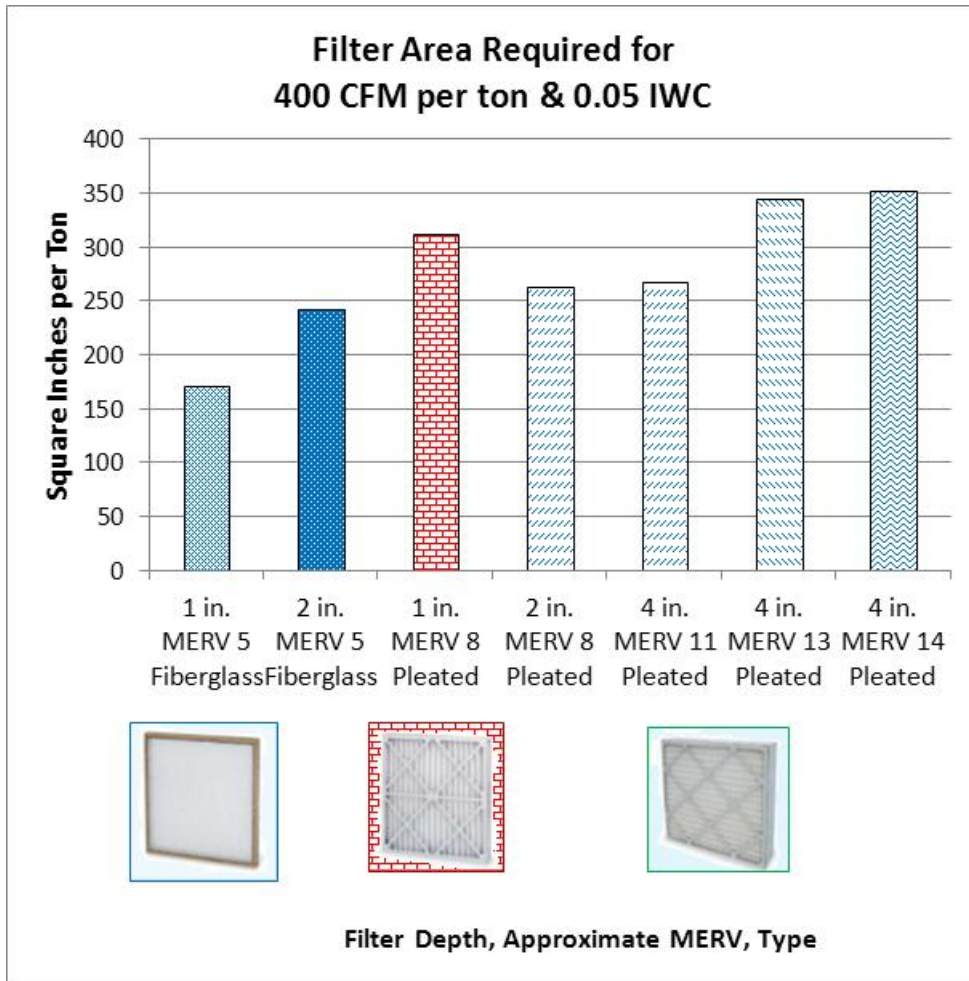
**Figure 59: Required Air Filter Area for 400 CFM per Ton at 0.50 IWC**

The standard filters assumed by the manufacturers and installed “in the old days” were simple 1 in. deep fiberglass mats with the ability to stop large objects like pet hair and dryer lint. Increasingly, homeowners are substituting 1 in. “high efficiency” pleated filters that offer about twice the resistance of the fiberglass filters to airflow when clean. These filters are nearly “a brick wall” to airflow. This is a growing problem and a significant contributing factor to low sensible efficiency. Figure 59 displays the filter area needed per ton to have a clean filter drop of 0.05 IWC at 400 CFM per ton.

To overcome the negative effects of the use of 1 in. deep pleated filters, the filter area will need to be increased to over 300 square inches per ton.
