Docket Number:	06-AFC-09C
Project Title:	Colusa Generating Station - Compliance
TN #:	231056
Document Title:	Annual Compliance Report 2018
Description:	Annual compliance Report
Filer:	Anwar Ali
Organization:	PG&E
Submitter Role:	Applicant
Submission Date:	12/10/2019 12:58:48 PM
Docketed Date:	12/10/2019

**Subject: Colusa Generating Station (06-AFC-9)
Condition of Certification COM-7 (BIO-2; HAZ-1; Noise-8; Soil and Water 2, 7, 8, 9;
TLSN-3; VIS-1, 3; Waste-5 – Annual Operating Report**

Appendix A
Site Photo

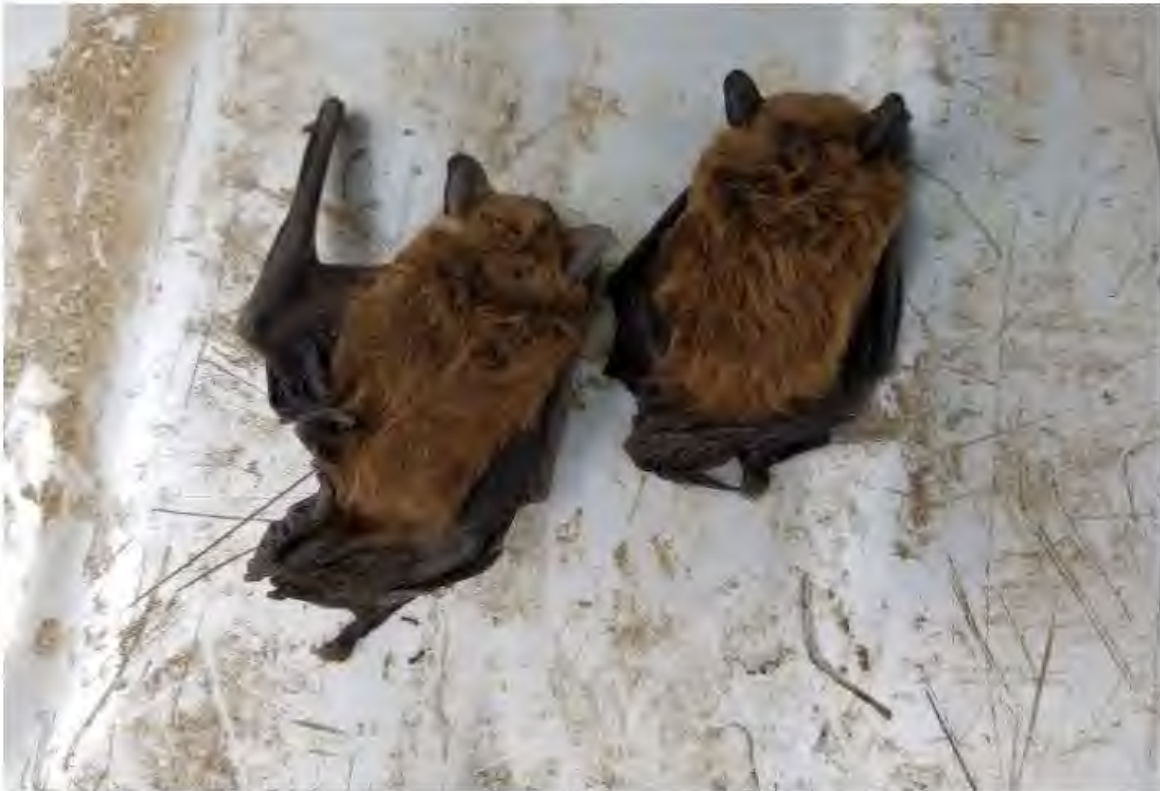
Photo 48, of 27 dead Myotis sp. bats observed and collected during general wildlife and rattlesnake surveys, 7/13/18.

July 13th, the DB conducted rattlesnake surveys and general wildlife surveys. The rattlesnake surveys inside and outside the facility were negative. The general wildlife survey identified 27 *Myotis* sp. bat carcasses (Photo 48) and 2 big brown bat (*Eptesicus fuscus*) carcasses (Photo 49) under the ACC, all carcasses were collected for identification and then disposed of. The DB also observed the head of a dead barn owl (Photo 50) along the western perimeter fencing with no the owl body located.

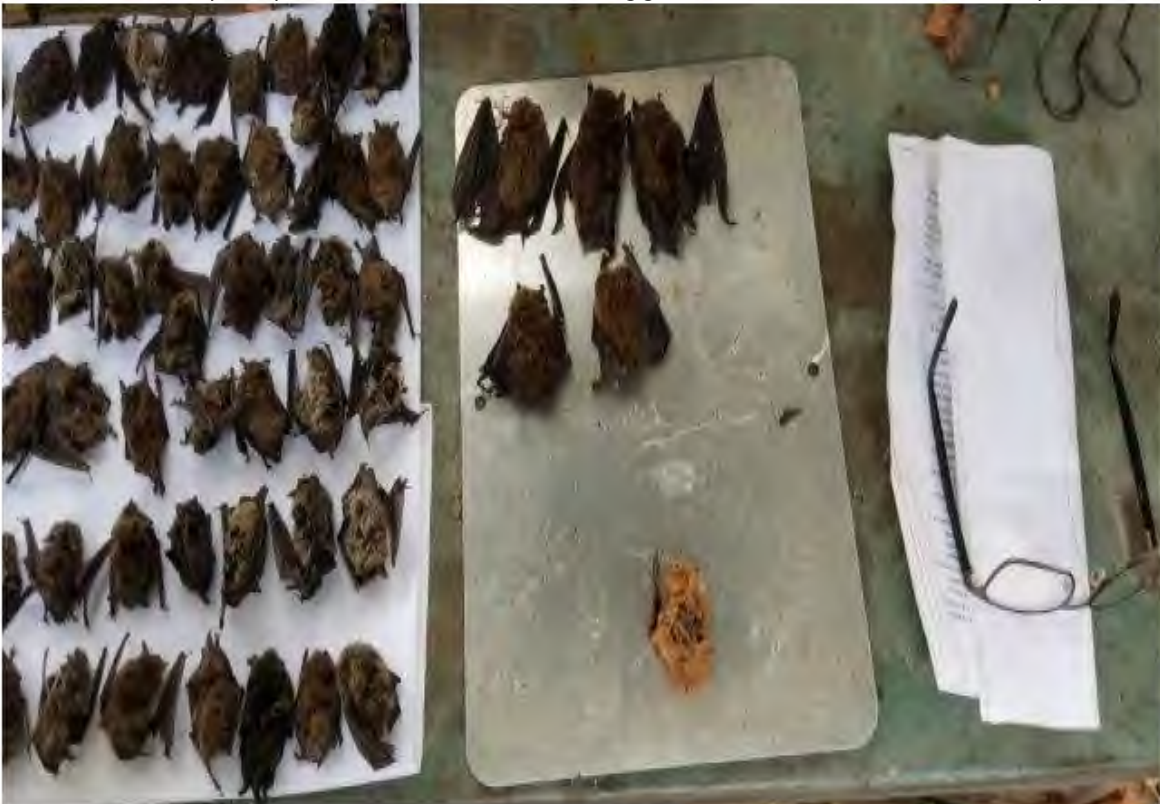
Photo 61, of 128 Myotis sp. bats collected under ACC during general wildlife and rattlesnake surveys, 8/10/18.
