<b>DOCKETED</b>	
<b>Docket Number:</b>	87-AFC-01C
<b>Project Title:</b>	COMPLIANCE-Luz Solar Electric Generating System Cogeneration AFC (150 MW) Units III-VII.
<b>TN #:</b>	241138
<b>Document Title:</b>	Petition to Amend Boundary Change Appendix B Part I - SEGS III-VII
<b>Description:</b>	N/A
<b>Filer:</b>	Scott Galati
<b>Organization:</b>	DayZenLLC
<b>Submitter Role:</b>	Applicant Representative
<b>Submission Date:</b>	1/11/2022 2:18:22 AM
<b>Docketed Date:</b>	1/11/2022

## **APPENDIX B**

Monthly Compliance Reports and Biological Memorandum

Subject: SEGS III-VII Decommissioning (87-AFC-01C) Monthly Compliance Report for June 2021

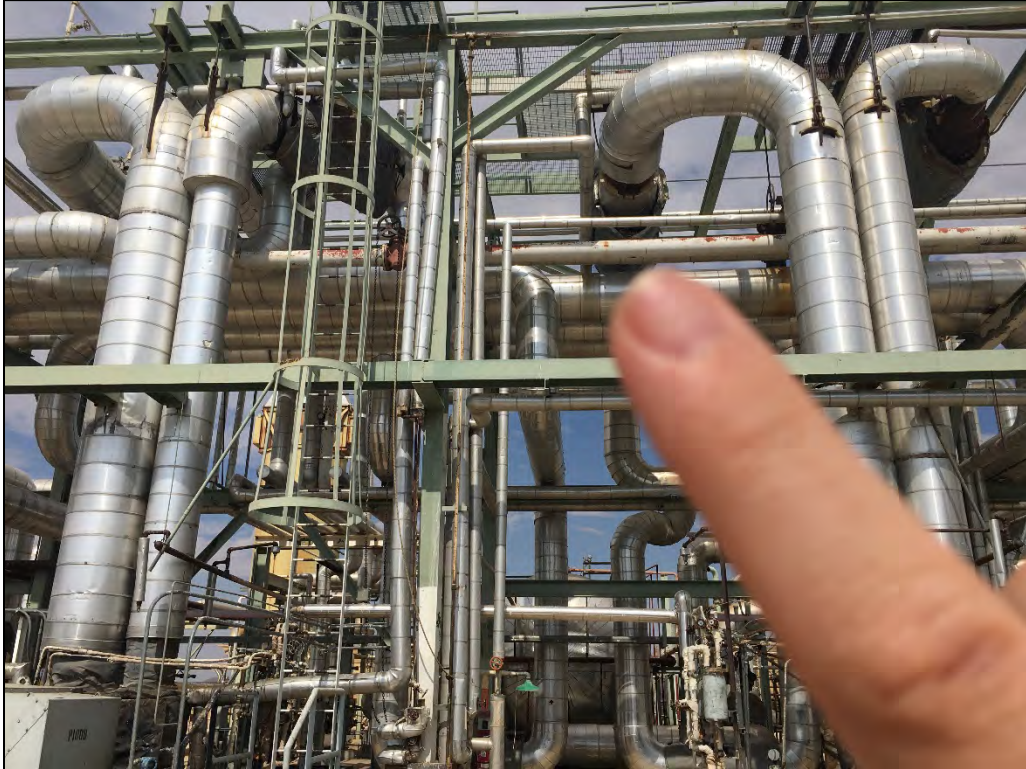
Photo 4: Old stick nest in pipe lining, inactive, likely common raven.

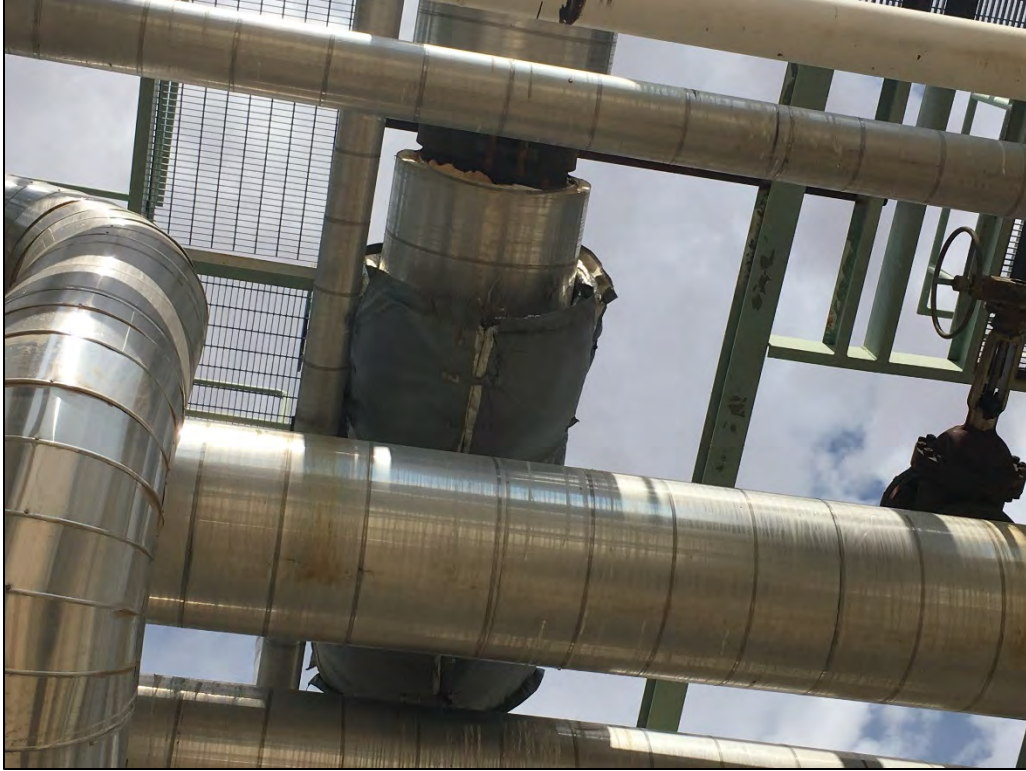
Photo 5: Underside view of inactive nest in pipe lining.
