# Investigation Report

## Calpine Russell City Steam Turbine/Generator Event

### May 27, 2021

Calpine Corporation - Russell City Energy Center

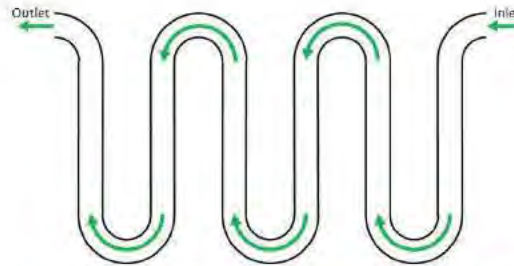
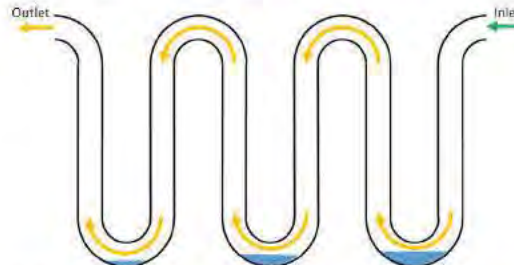
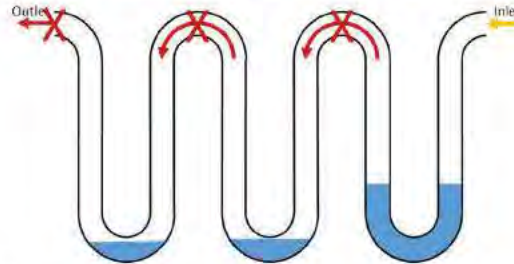
**Figure 5-11 - Loop Seal Depiction**

To aid in the investigation (3) the steam saturation temperature was calculated based on the HRSG #1 RH inlet and outlet pressures and trended through the operation period. The 3 drains identified above quickly dropped in temperature to the saturation temperature after the unit shut down. Approximately ( ) after block 1 shut down, (4) RH harp 1 drain temperature dropped below the steam saturation temperature, quickly followed by the (5) RH harp 3 drains. This indicates that steam condensed within the HRSG. Approximately ( ) later, the HRSG #1 RH inlet and outlet pressures began to separate, indicating that a sufficient amount of water had accumulated in the lower turns of the harps to form loop seals, as depicted in **Figure 5-11**, and was preventing free flow through the circuit.

**Free flowing pipe system**

- No flow restrictions preventing flow through piping loops
- Equal inlet and outlet pressures

**Restricted flow pipe system**

- Accumulation of liquid in the bottom loops partially restricts flow through piping loops
- Flow restriction may result in a small pressure reduction through the piping system

**Obstructed flow pipe system**

- Accumulation of liquid in the bottom loops obstructs flow through piping loops
- Inlet pressure is able to increase substantially over the outlet pressure

Along with this maintained pressure, the temperatures within the RH system were at or near saturation temperature. The maintained pressure acted as one force driving accumulated water into the IP ST via the HRH pipe when the exit pressure of HRSG #2 dropped. The second driving force was the additional pressure created as portions of the high temperature water boiled off (flashed) and expanded as the HRH header pressure dropped.
