**BEFORE THE PUBLIC UTILITIES COMMISSION OF THE STATE OF CALIFORNIA**

**ORDER INSTITUTING INVESTIGATION REGARDING  
SAN ONOFRE NUCLEAR GENERATING STATION  
UNITS 2 AND 3**

Attachment A: July 18, 2012 San Onofre Nuclear Generating Station – NRC  
Augmented Inspection Team Report

On March 19, 2012, an Augmented Inspection Team (AIT) was dispatched to San Onofre Nuclear Generating Station to gather facts and understand the circumstances surrounding the January 31, 2012 Unit 3 primary-to-secondary leak and failure of eight steam generator tubes to maintain structural integrity as required by plant technical specifications during testing the week of March 13, 2012. The primary-to-secondary leak was the result of a single tube in Unit 3 steam generator 3E0-88 failing to maintain structural integrity.

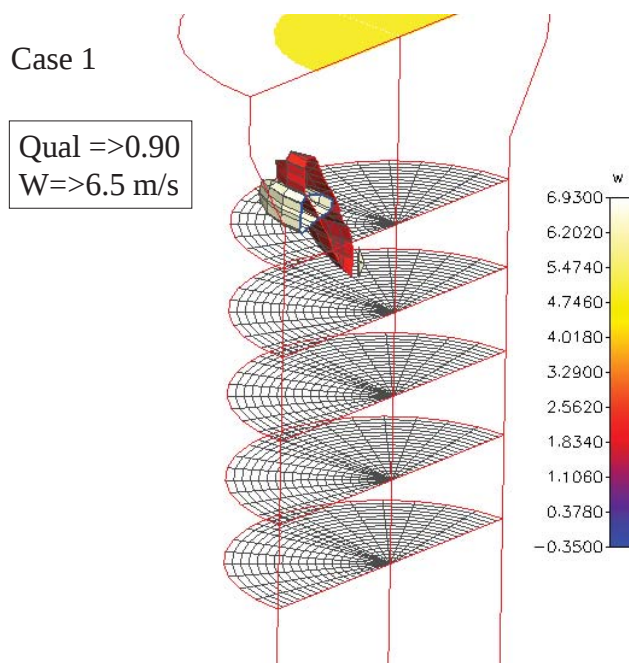
**Figure 1**

Figures 1 through 4 (different view angles of same results) show results, with low  $T_{\text{hot}}$  and low steam pressure and present a 3D isometric encapsulation of steam qualities (red scale) at and above 0.9 (i.e., void fraction > 0.99) and field velocities at and above 6.0 m/sec (white scale).

The ATHOS model results of high steam quality and steam velocity closely align with the area of concern (tube-to-tube wear) in the Unit 3 replacement steam generators. In Figure 5, the code predicted regions of high void fraction and high steam velocities (vertically located z-axis cut at about 20 inches above the 7<sup>th</sup> TSP) are superimposed with tube-to-tube wear indications from Unit 3 steam generator 3E0-88.
