Docket Number:	23-OPT-02
Project Title:	Darden Clean Energy Project
TN #:	253033-1
Document Title:	Appendix L Visual Simulations Methodology and Data Sheets_Volume 1_Darden Clean Energy
Description:	Volume 1 provides Federal Highway Administration (FHWA) Visual Impact Assessment Worksheets and visual simulations methodology.
Filer:	Evelyn Langsdale
Organization:	Rincon Consultants
Submitter Role:	Applicant Consultant
Submission Date:	11/7/2023 4:13:56 PM
Docketed Date:	11/7/2023

Appendix L - Volume 1

Truescape Visual Simulations Methodology

Truescape TrueView Photo Simulations, October 2023

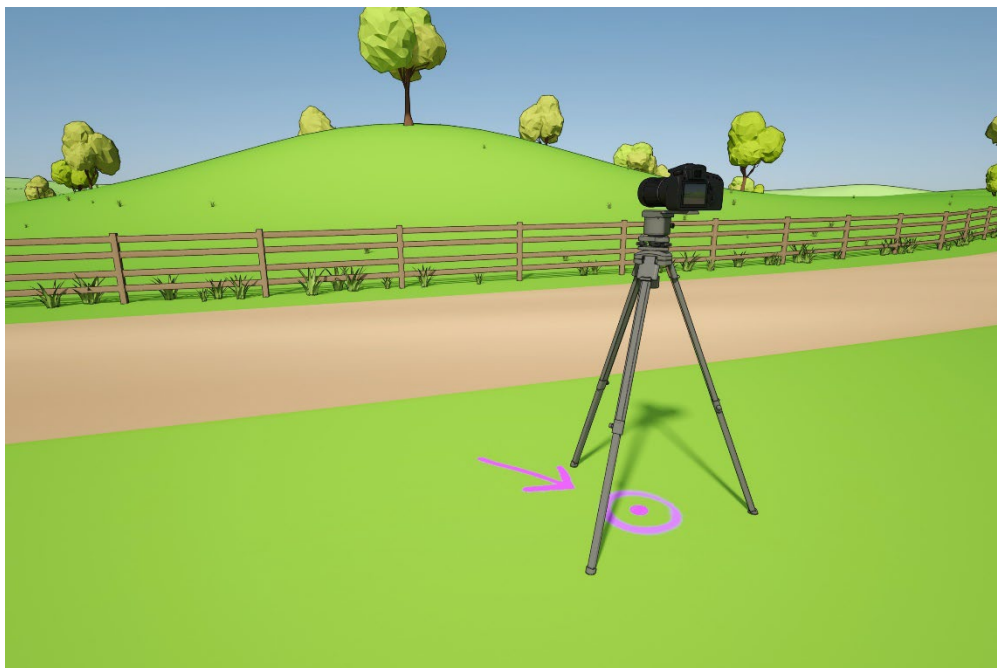
The site visit is undertaken to capture the necessary photographs, ground mark the photo point position, and identify reference points for a surveyor to geolocate.

A digital SLR Full Frame 50.6-megapixel camera is used to take the photography. This camera produces photographs at a resolution and clarity as good as current technology will allow when generating simulations.

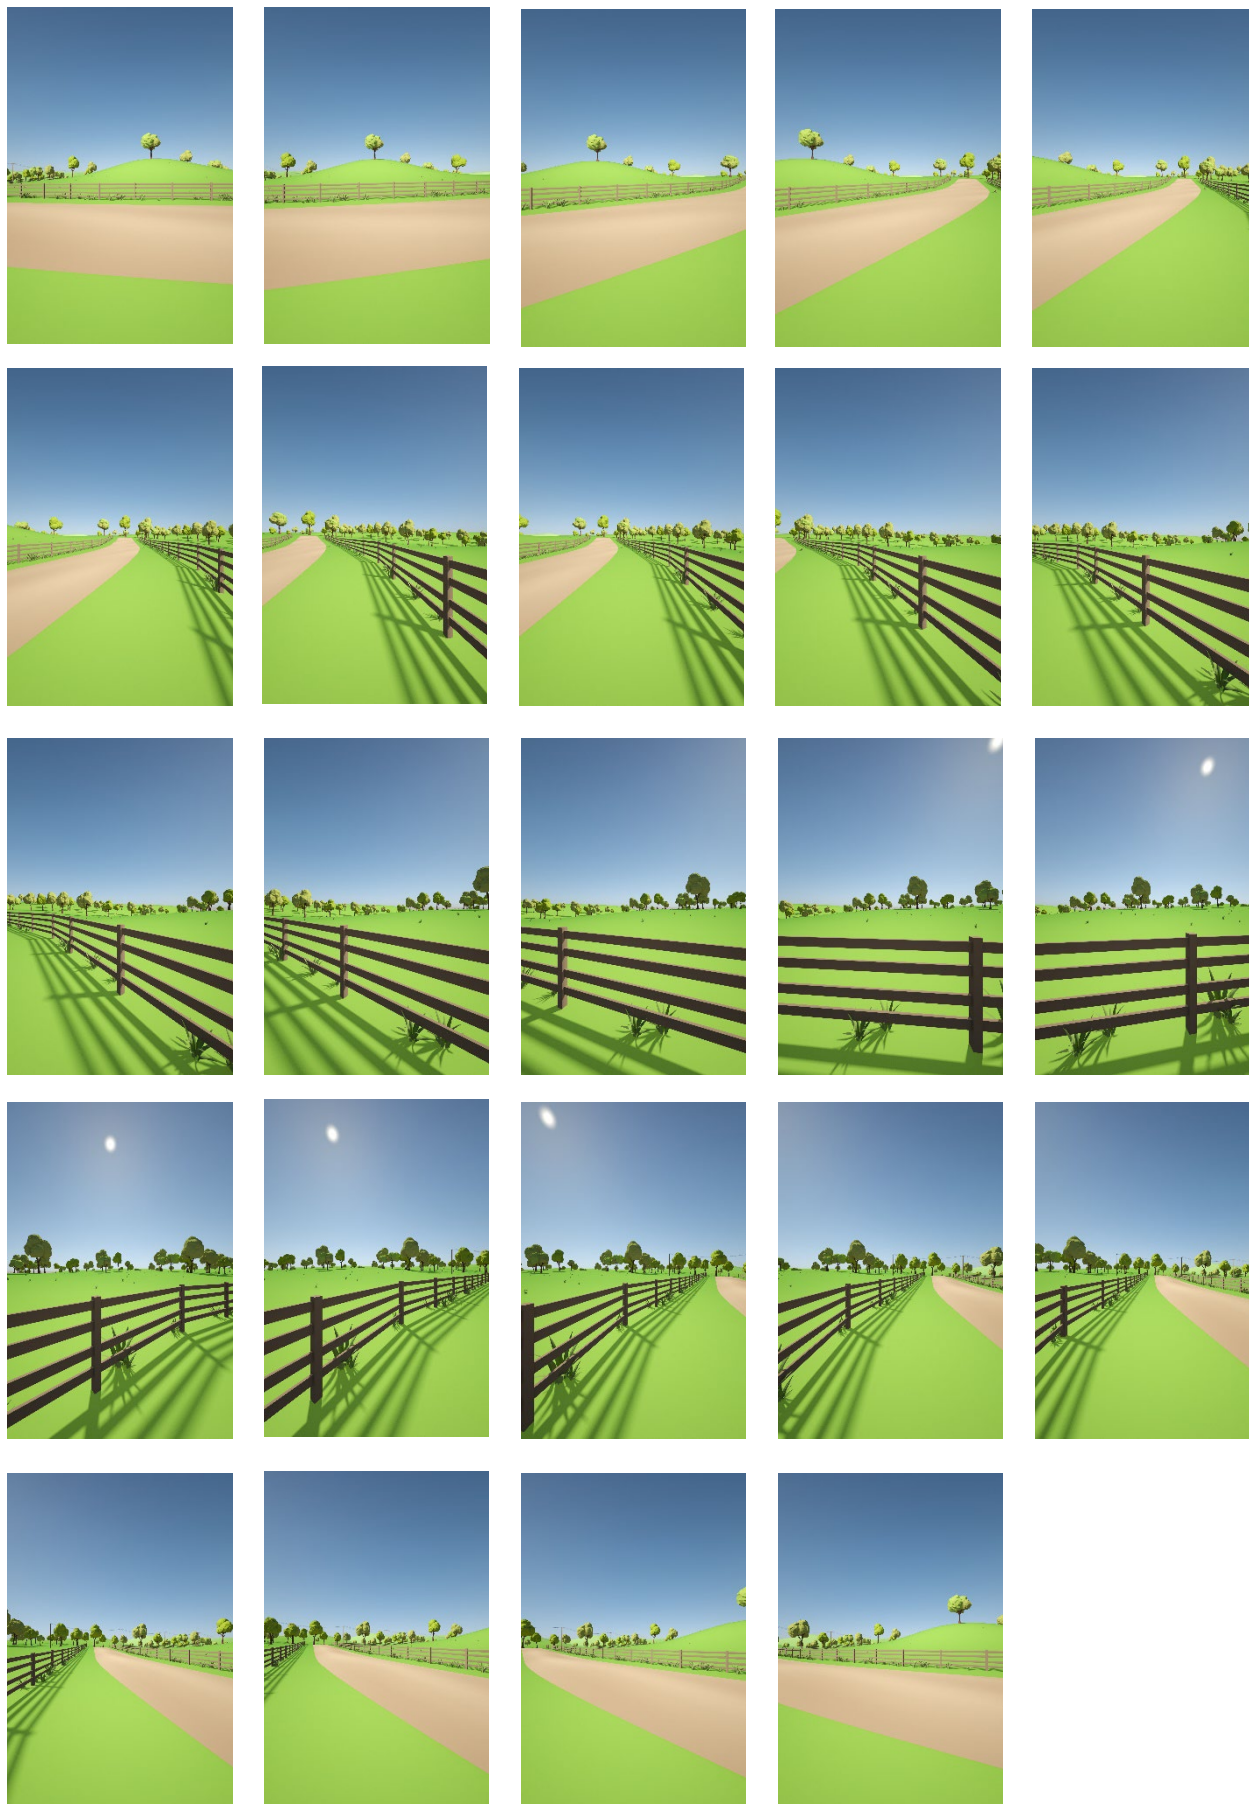
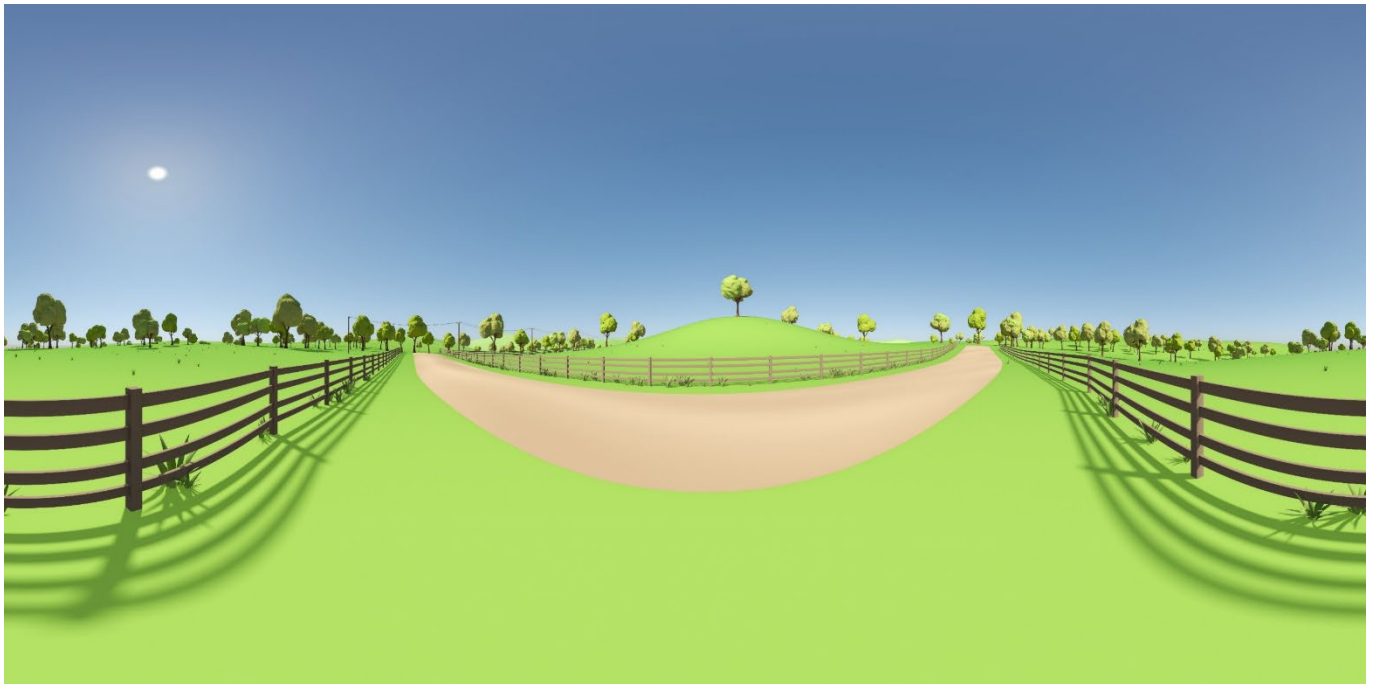
Creating the 360° Photo-simulation

Using a series of quality-controlled computer processes the 24 photographs are blended together to create the 360° panorama.

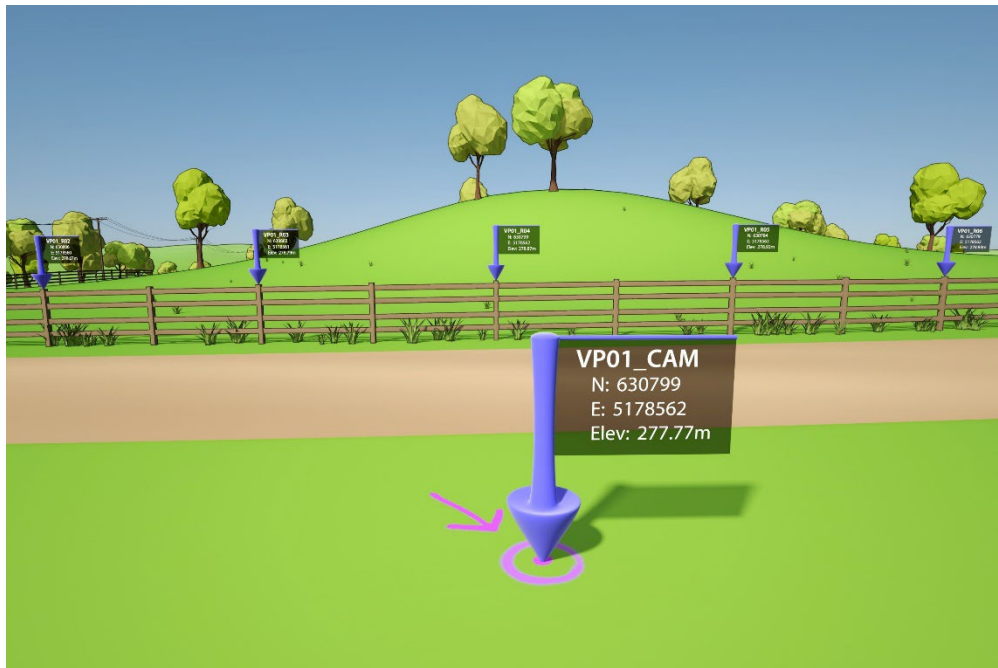
Capturing the surveyed reference points

To accurately create a 360° photo simulation the exact position of the camera is survey fixed by a professional surveyor.

Additional reference points are identified during the site visit so that the 3D model can be accurately placed into the photograph. These reference points are fixed objects that can include items such as fences, vegetation, houses, road markings and survey pegs. The surveyor is directed to geolocate each of these points.

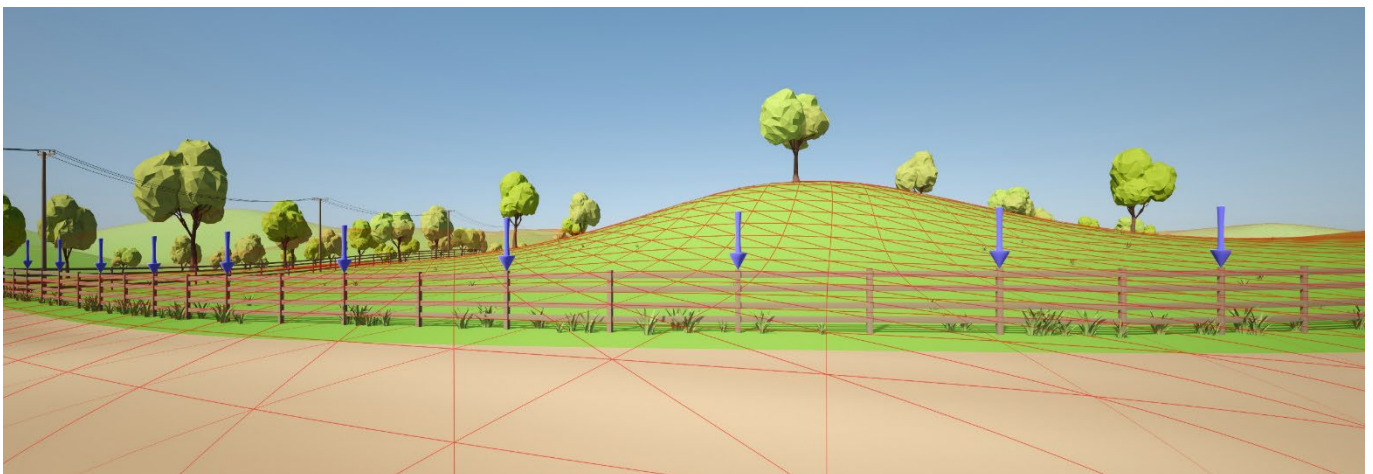
Aligning the surveyed reference points

The next step is to construct the 3D computer model. Using Autodesk® 3ds Max® 3D computer simulation software the survey-fixed camera and reference points are imported. We also source digital elevation models to create an accurate 3D terrain model which is used to further confirm the accuracy of the alignment.

A “computer camera” is created which accurately matches the field of view of the 360° image. The simulated “computer camera” is then positioned at the same survey coordinates as the physical viewpoint positions.

The 360° panorama image is referenced within the software and the “computer camera” is aligned by matching the reference points and terrain to the image.

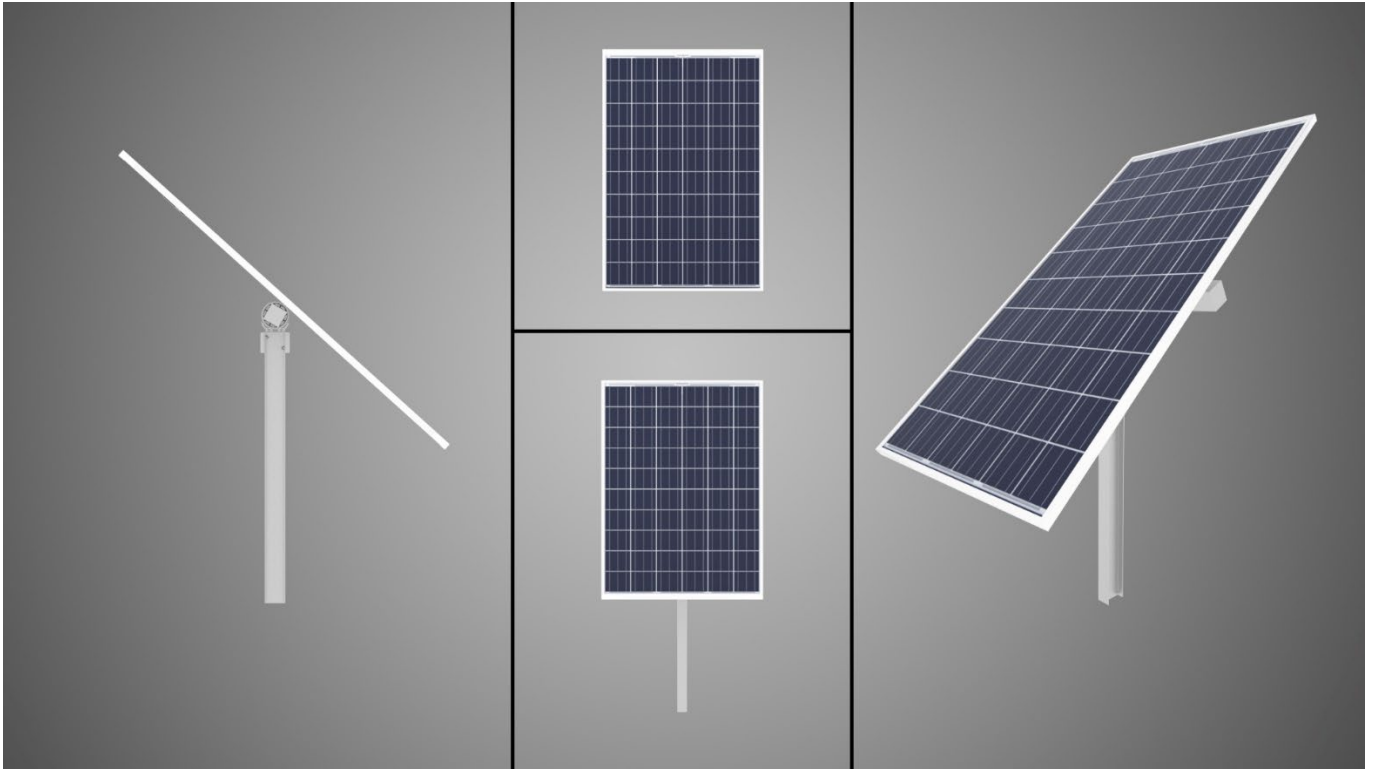
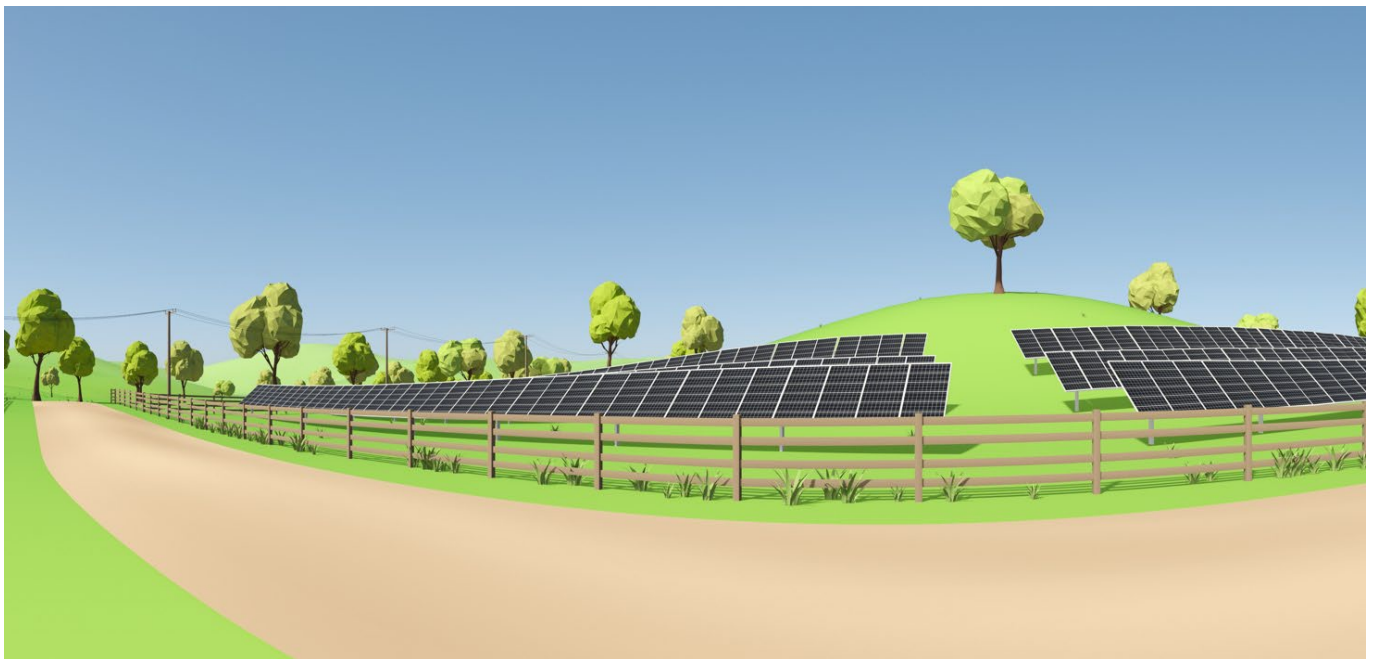
Building the proposed project in 3D

The proposed changes or additional objects are modelled accurately in 3D and placed correctly into the simulation.

The simulation software allows the sun to be simulated at the precise time (including date and geographic location) to match where and when the original photography was captured. This ensures the lighting of the proposed structures as well as the shadows they cast are an accurate depiction of how the Project would appear in the photograph at the same time of day and reflecting the same lighting conditions as those experienced at the time the photography was taken. The model is rendered out of the simulation software to be composited into the photography.

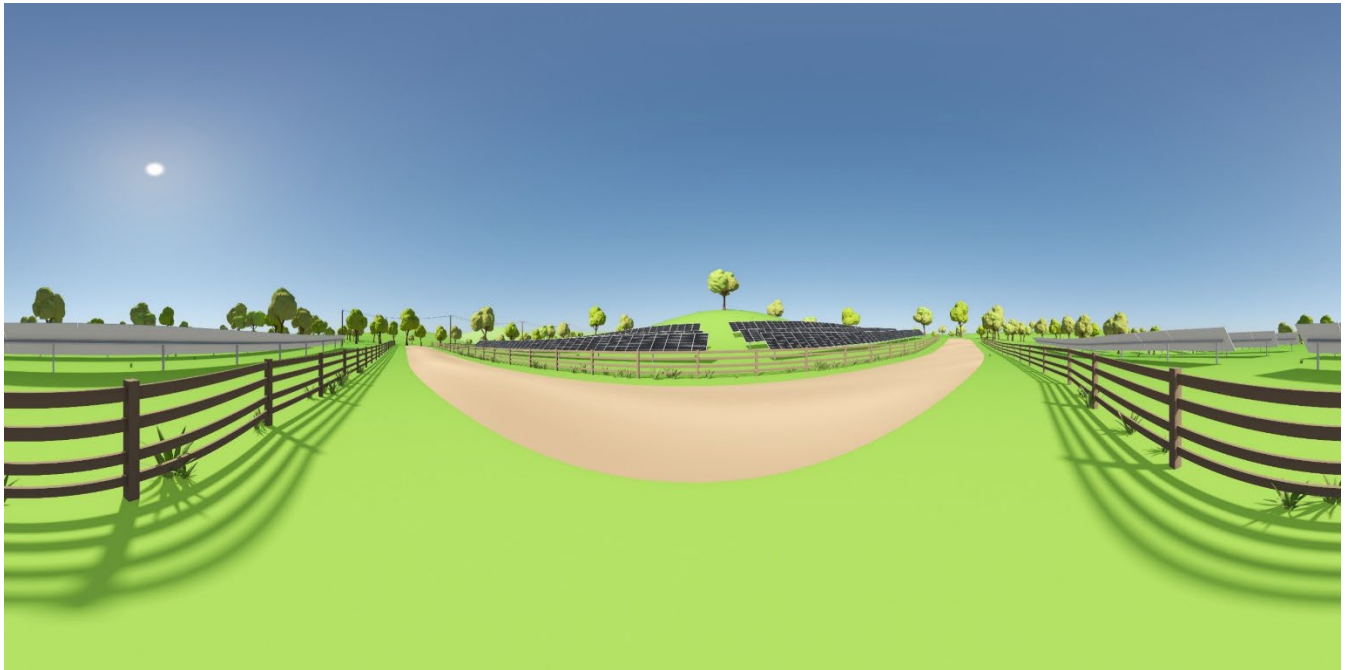
The final 360° photo-simulation

In order to correctly simulate the visual impact of the proposed development, the rendered model is masked behind objects that will appear in front of the development such as trees and terrain using photo editing software.

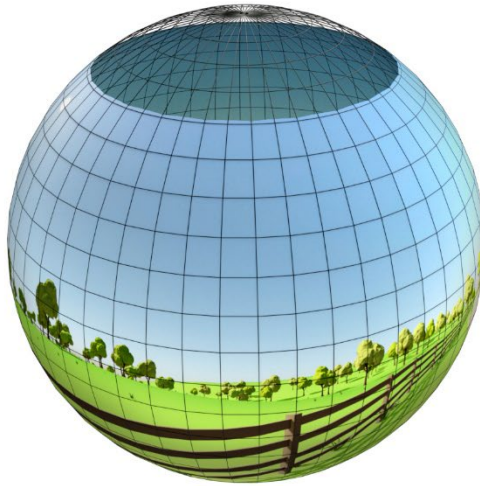
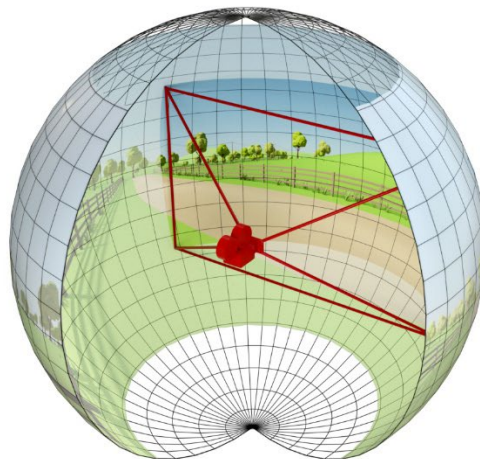
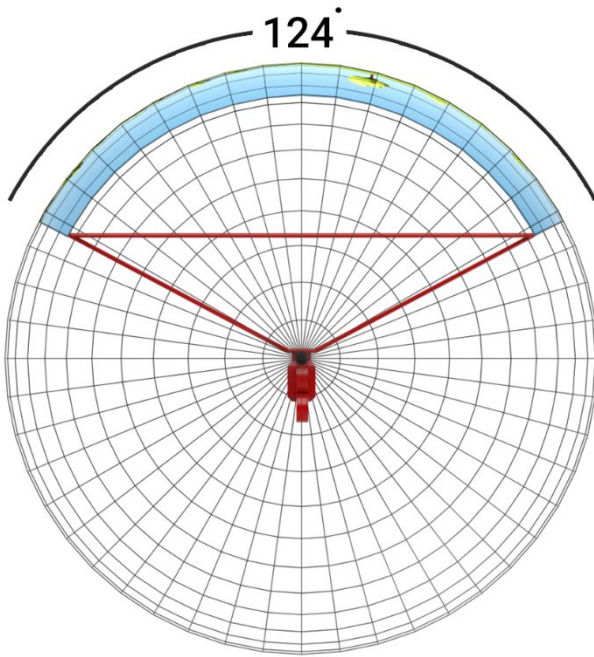
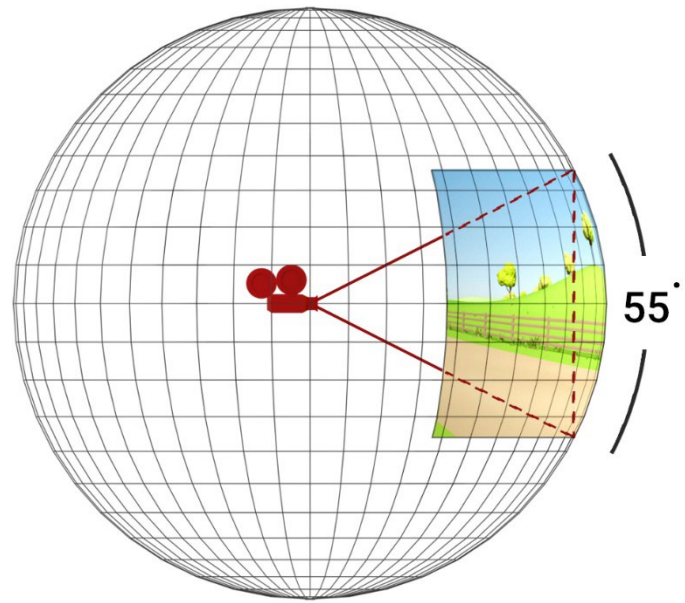
Visualization Extraction from a 360° photo-simulation

In order to extract a visualization, we need to take the full 360 and identify an area of $124^\circ \times 55^\circ$ to extract a static image from. The following steps are used to extract a visualization from a 360° photo-simulation.

1. Identify and collect the 360° photo-simulation.

2. Insert a virtual camera with the field of view of $124^\circ \times 55^\circ$ into the 360° photo-simulation. (For demonstration purposes the 360°-spheres below are shown partially opened and transparent)

Top view (Horizontal field of view)

Side View (Vertical field of view)

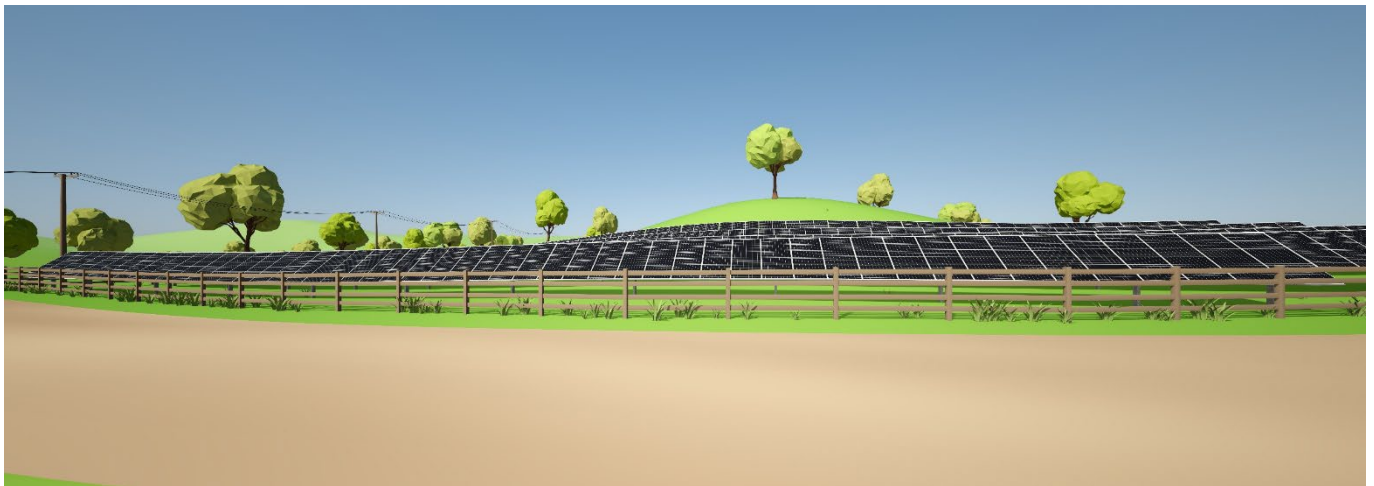
3. The visualization is then extracted from the 360° photo-simulation as a static flat image, which can be used for print or digital purposes.

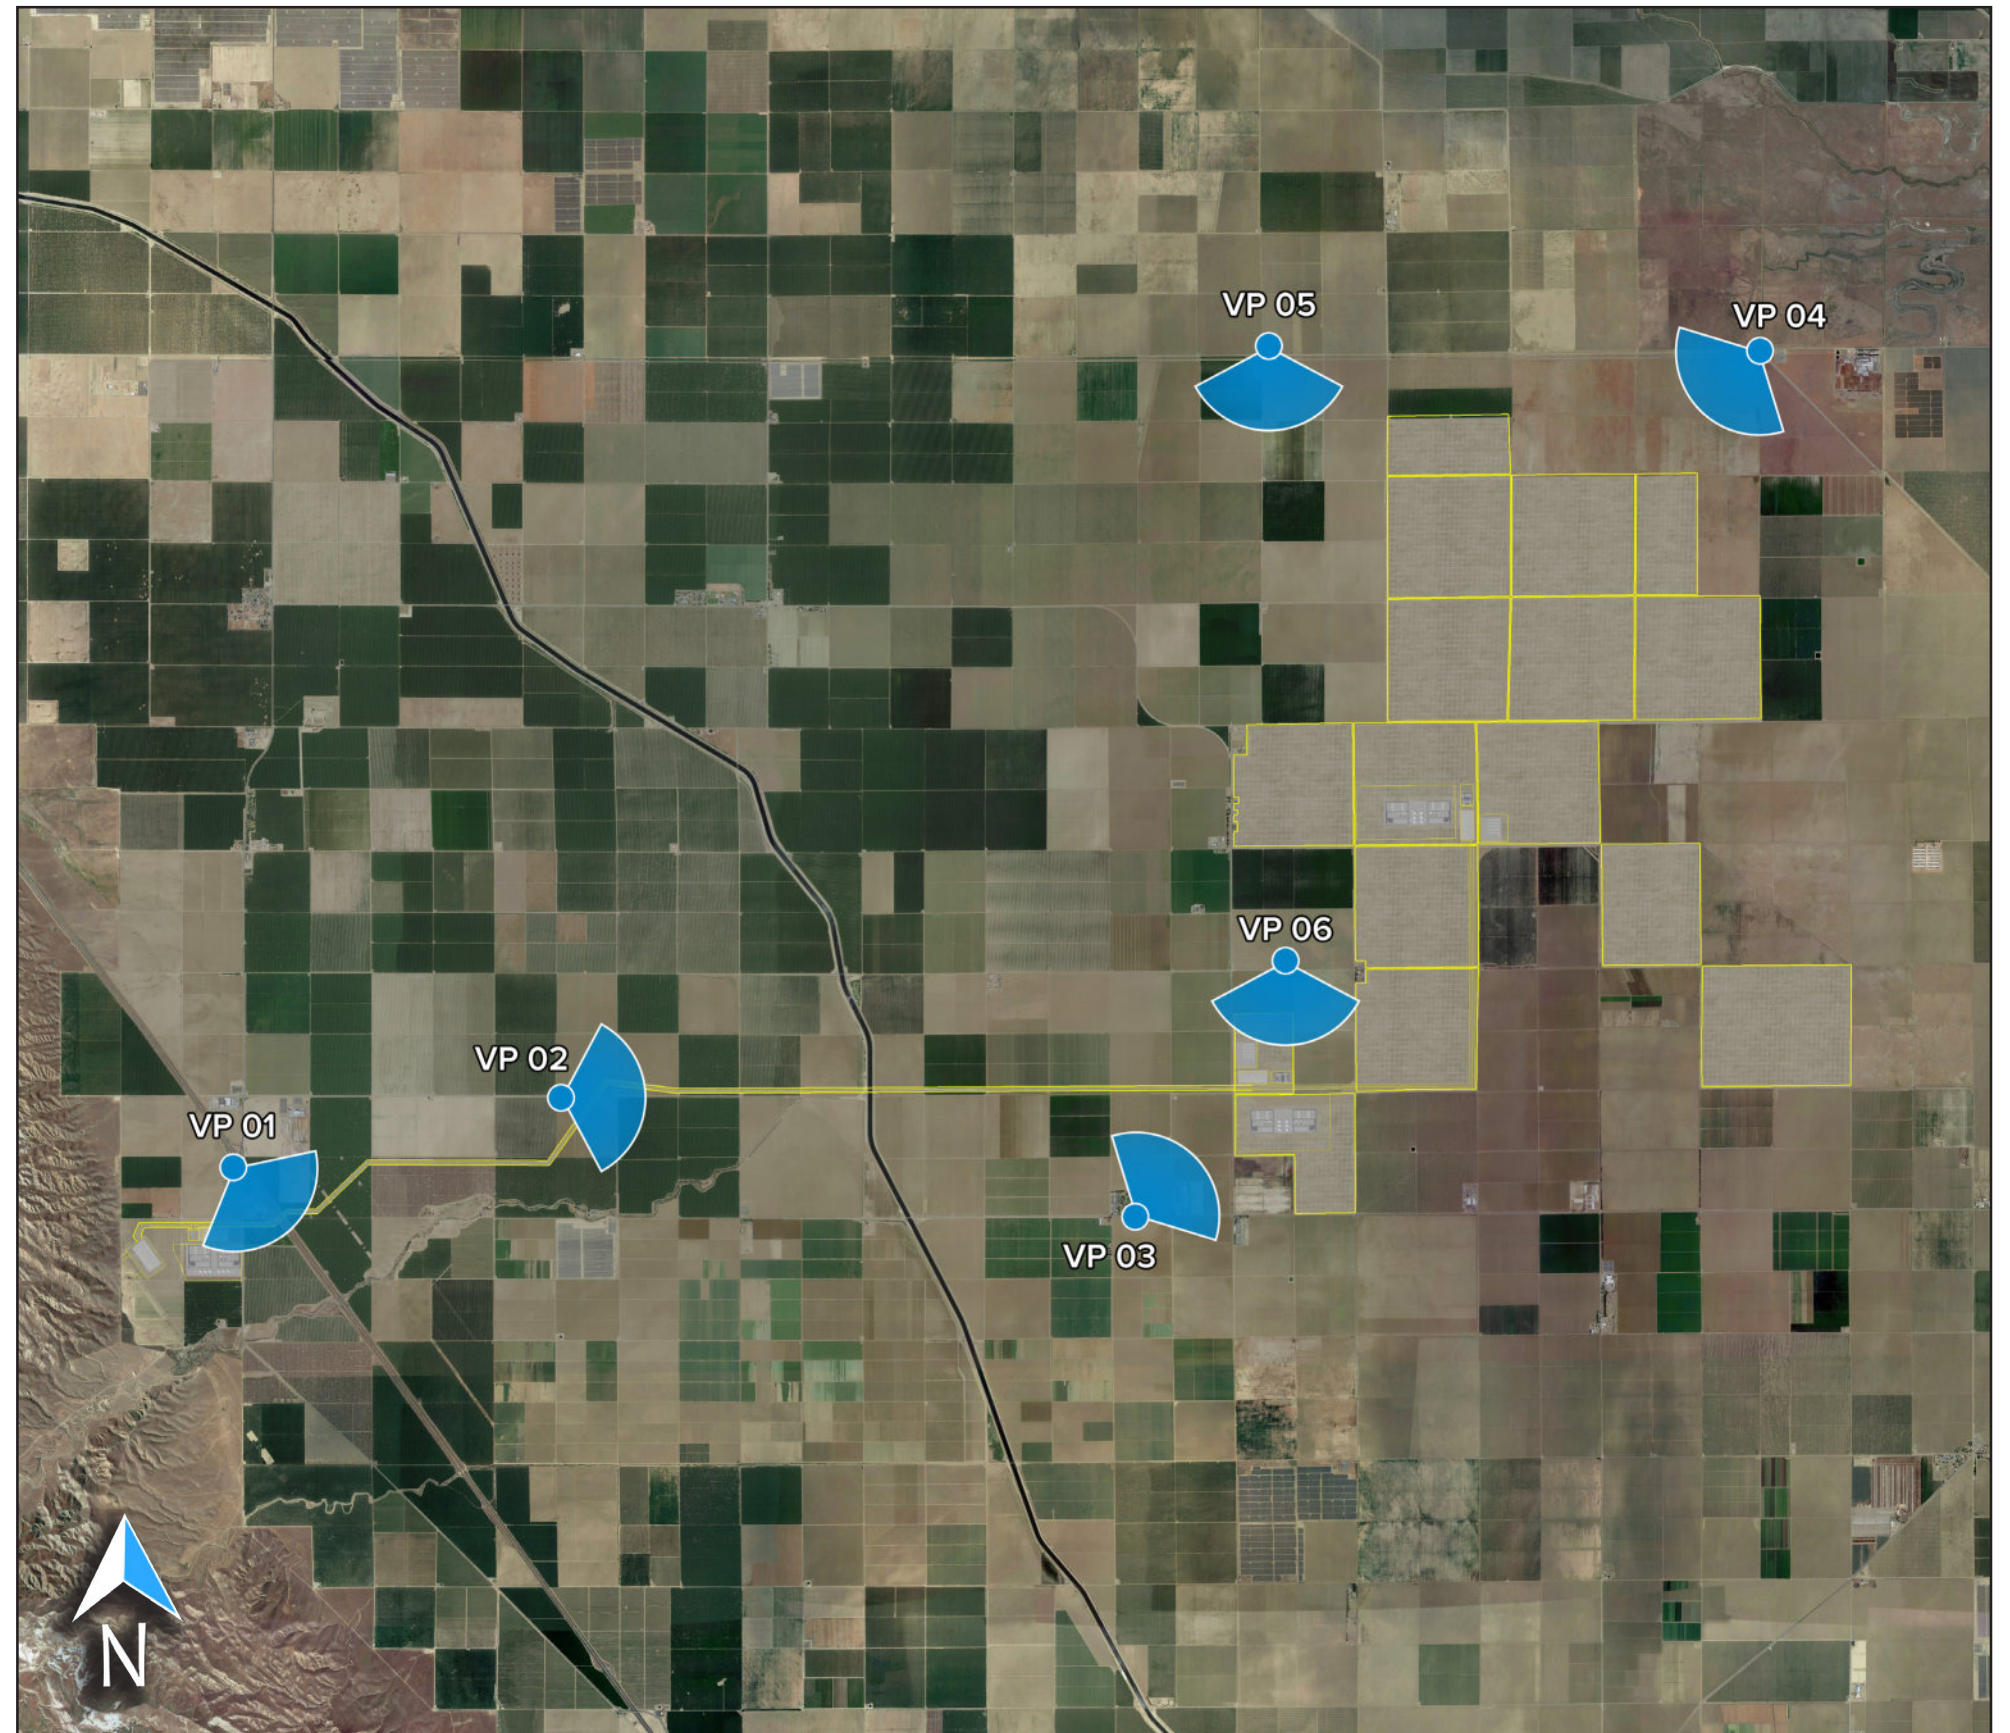
Viewpoint 1 - S Derrick Ave & West Side Fwy, Looking Southeast - Existing View

Easting Position: 120.394500°
Northing Position: 36.434767°
Elevation of Viewpoint Position (MAD3): 504.5
Height of Camera Above Ground (ft): 5.58
Date of Photography: 16-Aug-23 at 5:06 pm
Orientation of View: SW
Horizontal Field of View: 124°
Vertical Field of View: 55°

Visual Resource Survey:		
Viewpoint: KOP 1	Key View:	
Date: 10/3/23	Existing Conditions	
Description: Looking southeast toward southbound I-5 from South Derrick Avenue overpass		
Photo Orientation: Southeast		
Viewer Position: _____ Inferior _____ Level <u> X </u> Superior		
View	Notes <i>(describe existing conditions)</i>	
Foreground (0 - 1/2 mile)	The foreground of the view is dominated by manmade elements attributed to the proximate transportation corridor. The asphalt surface of South Derrick Avenue is painted with typical 2-lane street markings. The freeway onramp creates a sweeping curve downhill onto the I-5 roadway. The green, red, and blue road signs for the I-5 freeway entrance contrast highly with their surroundings. Vertical features in the foreground view include overhead lighting structures, sign post supports, and white/yellow reflector stakes. Vegetation in the foreground of the view includes continuous masses of brown and tan annual grasses and weeds, with scattered silver and green-toned shrubs dotting the roadside.

Middleground (1/2 - 4 miles)	The middleground of the view is dominated by the continuous masses of brown and tan annual grasses and weeds, which fill the landscape between each roadway. I-5 is a two-lane freeway, visually cluttered with a variety of vehicles. An existing distribution line strung along wooden poles can be seen crossing over the I-5 onramp, and continues across the center of the view before disappearing into the distance. Mature orchards present as a solid, green mass on the east side of I-5. A nearby commercial building presents as a solid, white block near the right side of the view with intermittent trees surrounding the parcel. A line of palm trees separates the commercial property from the transportation right-of-way. A solar array presents as a grey, horizontal cluster in front of the building. Behind the building, rows of agricultural crops and orchards present as a solid, green line near the center of the view.

Background (> 4 miles)	The Big Blue Hills are visible through the haze to the southwest. The faint outline of distant lattice steel towers are visible as grey, vertical features through the haze to the southeast.	
Vividness		
Feature	Score*	Notes <i>(describe existing conditions)</i>
Landform	3	The valley floor contains relatively flat, dry terrain that slopes gently uphill to the west before rising sharply to the distant hills.
Vegetation	3	Naturalized vegetation includes solid masses of tan/brown annual weeds and grasses; grey and green-toned shrubs are scattered near the roadside. Distant trees are dotted near the existing commercial facility. Cultivated vegetation including various agricultural row crops and orchards are typical of the area.
Water Feature		No water features in the view.
Human-Made	3	The view is cluttered with human-made features, including asphalt roads, various colored signs, tall lighting structures, the existing commercial facility, and existing utility infrastructure. These features are not distinct or dramatic.

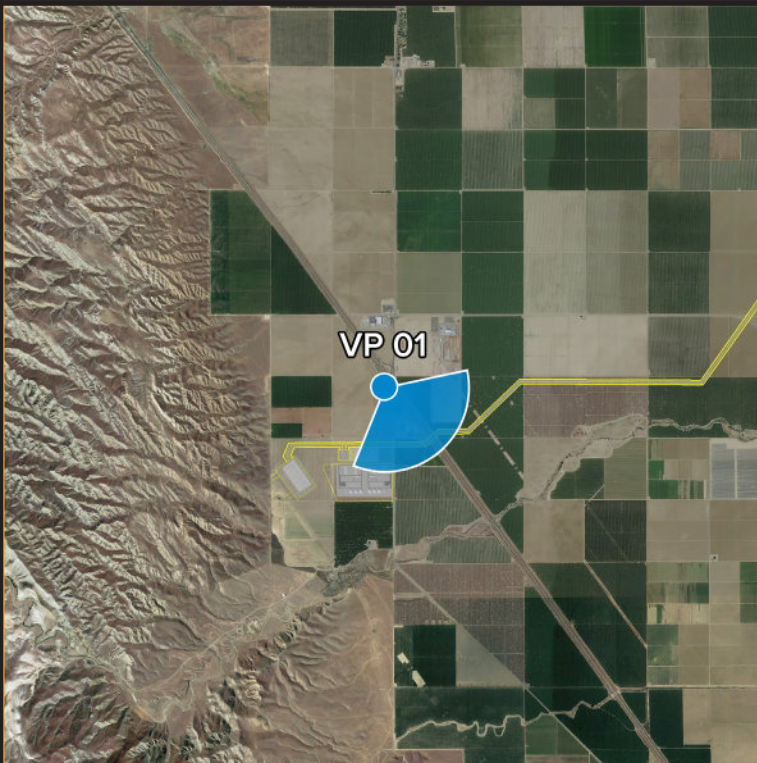
Viewpoint 1 - S Derrick Ave & West Side Fwy, Looking Southeast - Proposed View

Easting Position: 120.394500°
Northing Position: 36.434767°
Elevation of Viewpoint Position (MAD3): 504.5
Height of Camera Above Ground (ft): 5.58
Date of Photography: 16-Aug-23 at 5:06 pm
Orientation of View: SW
Horizontal Field of View: 124°
Vertical Field of View: 55°

Visual Resource Survey:		
Viewpoint: KOP 1	Key View:	
Date: 10/3/23	With Project	
Description: Looking southeast toward southbound I-5 from South Derrick Avenue overpass		
Photo Orientation: Southeast		
Viewer Position: _____ Inferior _____ Level <u> X </u> Superior		
View	Notes <i>(change from existing conditions)</i>	
Foreground (0 - 1/2 mile)	The Project does not change the condition of the foreground view.	
Middleground (1/2 - 4 miles)	Various features including the Project gen-tie, existing distribution infrastructure, existing commercial facility, and existing road surfaces visually clutter the middleground view and compete for dominance. The Project gen-tie presents as tall, grey steel structures with faint, horizontal lines strung in between. The Project transmission structures are skylined and have moderate contrast against the sky. The Project transmission structures appear similar to the other various vertical features within the view, such as the existing distribution infrastructure and existing lighting structure. The Project gen-tie line would cross over I-5 approximately 0.75 mile southeast of KOP 1, south of (behind) the existing commercial building and solar array. The gen-tie would be strung across galvanized steel structures (H-frame or tubular steel poles), at least 120 feet tall, with a maximum height of 200 feet. The Project doesn't change the mature orchards that present as a solid, green mass on the east side of I-5.

Background (> 4 miles)	The Project does not change the condition of the background view.	
Vividness		
Feature	Score*	Notes <i>(change from existing conditions)</i>
Landform	3	The Project does not change the existing landform nor block views of the near and distant landscape.
Vegetation	3	The Project does not change vegetation in the view.
Water Feature		No water features in the view.
Human-Made	3	The Project gen-tie add human-made features into the existing landscape which clutter the view and compete for visual dominance.
Overall	3.0	
Intactness		
Overall	2.5	The Project and gen-tie is highly visible and further reduces the intactness of the view.
Unity		
Overall	2.5	The Project adds human-made features that compete for dominance within the view.
Overall Visual Quality Score	2.7

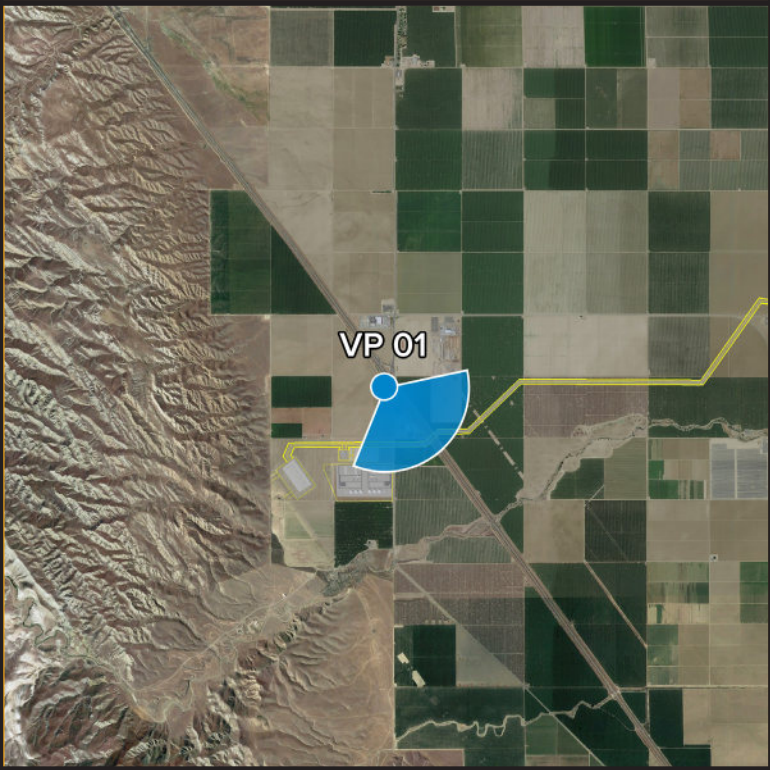
Viewpoint 1 - S Derrick Ave & West Side Fwy, Looking Southeast - Proposed Overlay View

Easting Position: 120.394500'
Northing Position: 36.434767'
Elevation of Viewpoint Position (MAD3): 504.5
Height of Camera Above Ground (ft): 5.58
Date of Photography: 16-Aug-23 at 5:06 pm
Orientation of View: SW
Horizontal Field of View: 124'
Vertical Field of View: 55'

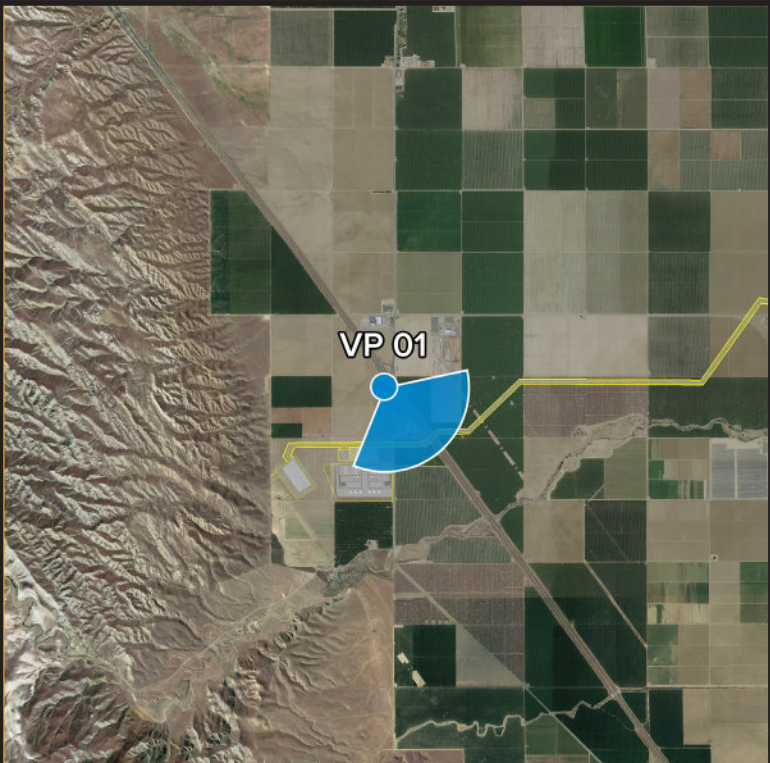
Viewpoint 1 - S Derrick Ave & West Side Fwy, Looking Southeast - Proposed View with Crop Outline

Easting Position: 120.394500°
Northing Position: 36.434767°
Elevation of Viewpoint Position (MAD3): 504.5
Height of Camera Above Ground (ft): 5.58
Date of Photography: 16-Aug-23 at 5:06 pm
Orientation of View: SW
Horizontal Field of View: 124°
Vertical Field of View: 55°

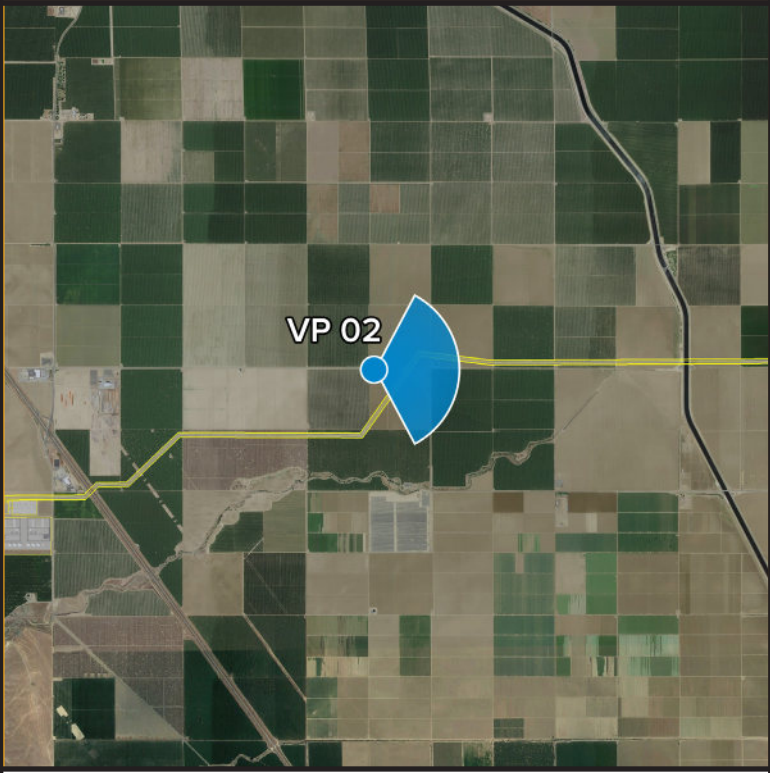
Viewpoint 2 - W Harlan Ave - Corner, Looking East - Existing View

Easting Position: 120.346257'
Northing Position: 36.443098'
Elevation of Viewpoint Position (MAD83): 399.8
Height of Camera Above Ground (ft): 5.58
Date of Photography: 16-Aug-23 at 11:47 am
Orientation of View: E
Horizontal Field of View: 124°
Vertical Field of View: 55°

Visual Resource Survey:			
Viewpoint: KOP 2		Key View: Existing Conditions	
Date: 10/3/23			
Description: Looking east along West Harlan Avenue			
Photo Orientation: East			
Viewer Position: _____ Inferior <u> X </u> Level _____ Superior			
View	Notes (describe existing conditions)		
Foreground (0 - 1/2 mile)	Multiple ground-level features compete for dominance in the foreground of the view. West Harlan Avenue is paved with asphalt and contains two lanes, one in each direction. To the left of the roadway are expansive, green fields of agricultural row crops which disappear into the distance. An existing distribution line strung across wooden poles are skylined, contrasting highly against the sky, and follow the roadway into the distance at regular intervals. To the right of the roadway, a road shoulder approximately 15 to 20 feet wide is an irregular, compacted surface made of exposed brown earth and gravel. A brown-toned above-ground pipe parallels follows the length of the road shoulder, delineating the shoulder from the adjacent agricultural parcel. The agricultural parcel contains a compacted earth access road and regularly-spaced small and medium-sized orchard trees with bare, brown earth between. Vegetation in the foreground is mostly comprised of cultivated agricultural row crops and orchard. Weedy green and tan grasses and shrubs are intermittently scattered along the road shoulder and within the loose earth berm on the orchard-side of the above ground pipe.

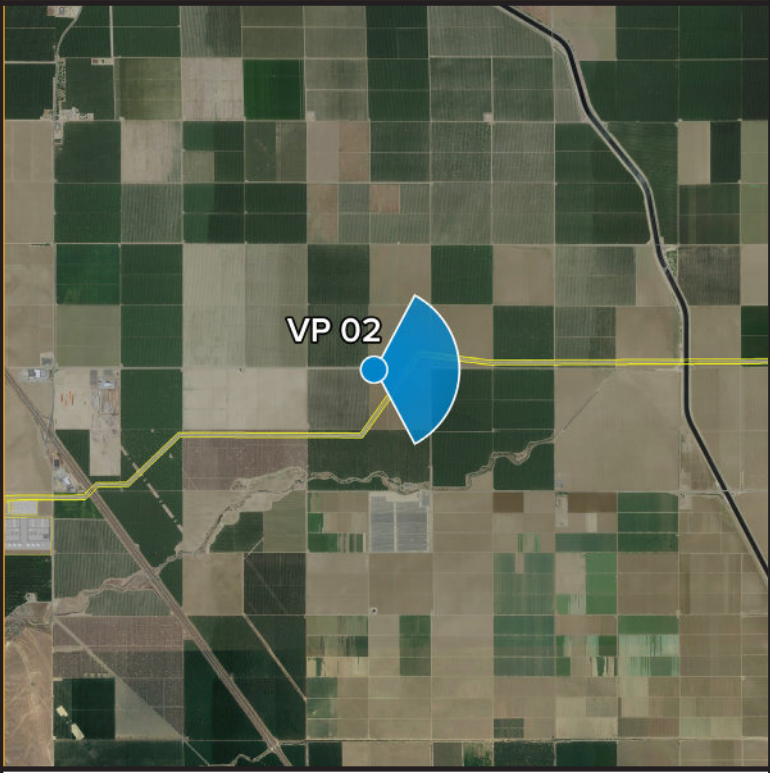
Viewpoint 2 - W Harlan Ave - Corner, Looking East - Proposed View

Easting Position: 120.346257'
Northing Position: 36.443098'
Elevation of Viewpoint Position (MAD83): 399.8
Height of Camera Above Ground (ft): 5.58
Date of Photography: 16-Aug-23 at 11:47 am
Orientation of View: E
Horizontal Field of View: 124°
Vertical Field of View: 55°

Visual Resource Survey:		
Viewpoint:	KOP 2	Key View: With Project
Date:	10/3/23	
Description:	Looking east along West Harlan Avenue	
Photo Orientation:	East	
Viewer Position:	_____ Inferior <u> X </u> Level _____ Superior	
View	Notes (change from existing conditions)	
Foreground (0 - 1/2 mile)	The Project gen-tie line crosses over the roadway approximately 0.25 miles (1,320 feet) distant, creating a set of horizontal lines across the center of the view. The Project gen-tie structures are taller than the existing distribution lines along West Harlan Avenue, and are skylined. The existing distribution structures appear less distinct with the addition of Project structures. The Project structures add distinct vertical and angular features to the view, and have a grey steel finish that moderately contrasts against the sky.	
Middleground (1/2 - 4 miles)	Where the Project gen-tie structures continue into the distance, they create a clutter of vertical and angular grey lines in the middleground near the center of the view.

Background (> 4 miles)	The Project gen-tie structures disappear into the background near the center of the view, but largely do not change the condition of the background view. The Project solar array is present approximately 5.5 miles away but is not visible in the view.	
Vividness		
Feature	Score*	Notes (change from existing conditions)
Landform	4	The Project does not change the existing landform nor block views of the near and distant landscape.
Vegetation	4	The Project does not change vegetation in the view.
Water Feature		No water features in the view.
Human-Made	2	The Project gen-tie line and structures add human-made features to the view, and become the primary focus of this view.
Overall	3.3	
Intactness		
Overall	2	Increased visibility of utility infrastructure results in a decrease of intactness in the view.
Unity		
Overall	3	The addition of Project gen-tie lines and structures set against the backdrop of the sky increases their visibility and reduces visual unity.

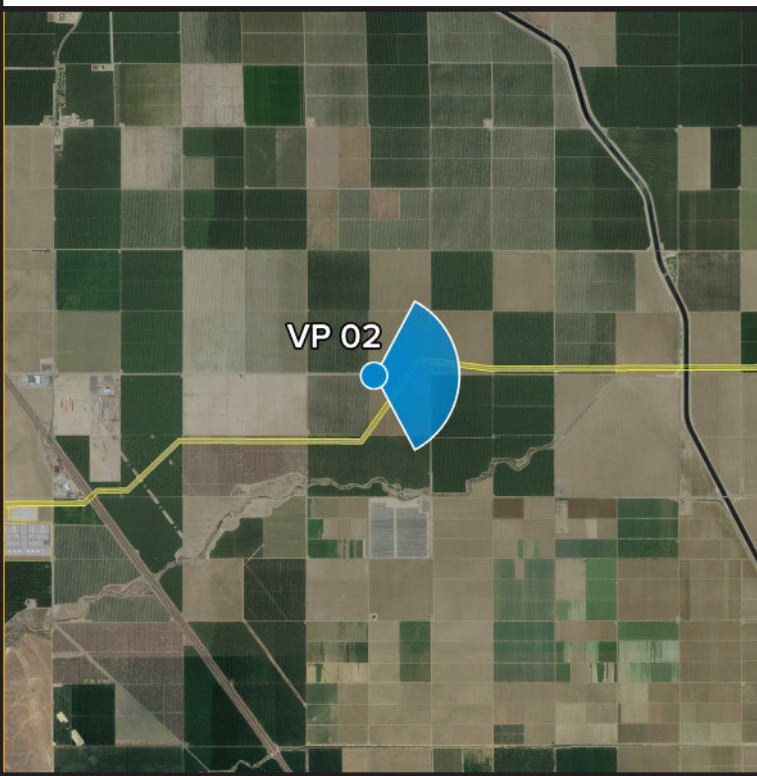
Viewpoint 2 - W Harlan Ave - Corner, Looking East - **Proposed Overlay View**

Easting Position: 120.346257'
Northing Position: 36.443098'
Elevation of Viewpoint Position (MAD83): 399.8
Height of Camera Above Ground (ft): 5.58
Date of Photography: 16-Aug-23 at 11:47 am
Orientation of View: E
Horizontal Field of View: 124°
Vertical Field of View: 55°
