| DOCKETED | |
|---|--|
| Project Title: | Willow Rock Energy Storage Center |
| Document Title: | Willow Rock Jurisdictional Drainages Additional Information Text |

**Additional Information Related to DR128 -
Delineation of Jurisdictional Waters**
Willow Rock Energy Storage Center (21-AFC-02)

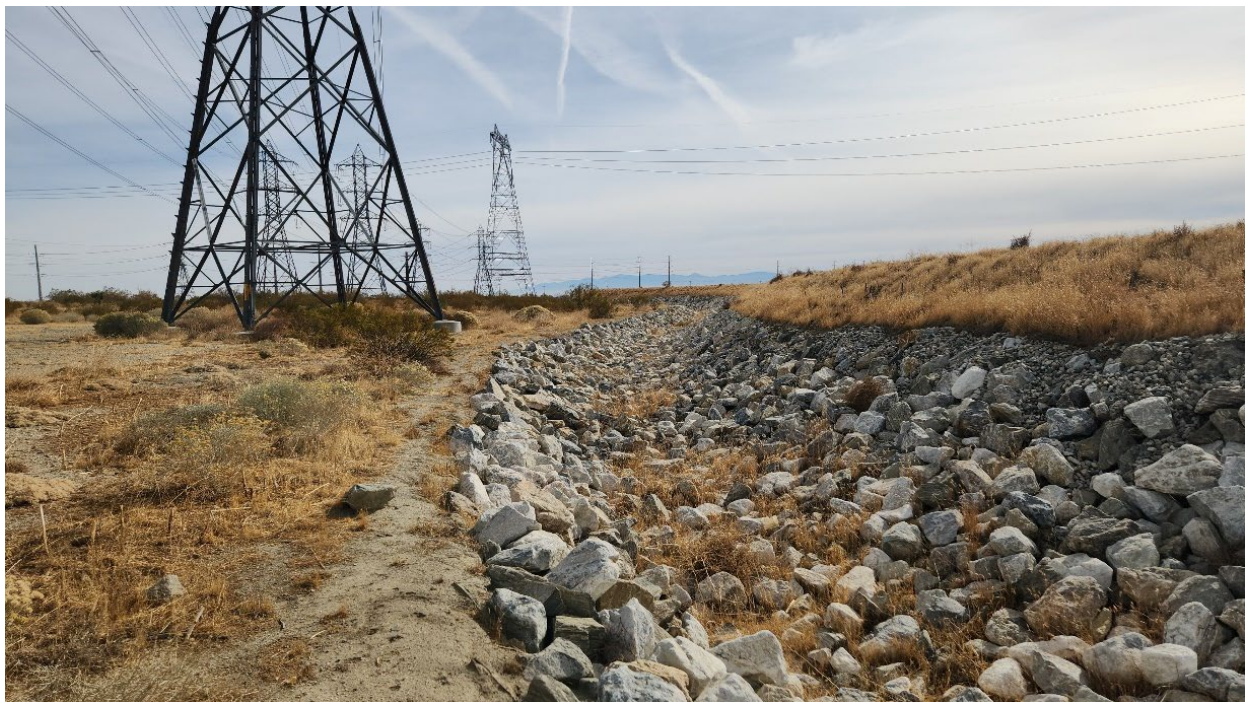
Photo Drainage 2a-1. Looking southeast at Drainage 2a from the northeast corner of the SCE Whirlwind substation.

Drainage 2a is classified as an active artificial flow diversion surrounding the northern side of the SCE Whirlwind Substation, west of 170th Street W. This feature is a rock-bottom erosion riprap approximately 15 feet in width (**Photo Drainage 2a-1**). Bordering vegetation primarily consists of disturbed/developed communities, with scattered grasses. This drainage was dry during all site visits with no indication of flowing water. Drainage 2a is recommended as a state and federal non-jurisdictional feature as it is an excavated ditch which lacks riparian vegetation and does not carry a relatively permanent flow of water. However, LRWQCB has indicated that a natural or manmade geomorphological feature need only the ability to convey water to meet their interpretation of California “Waters of the State” for this area.

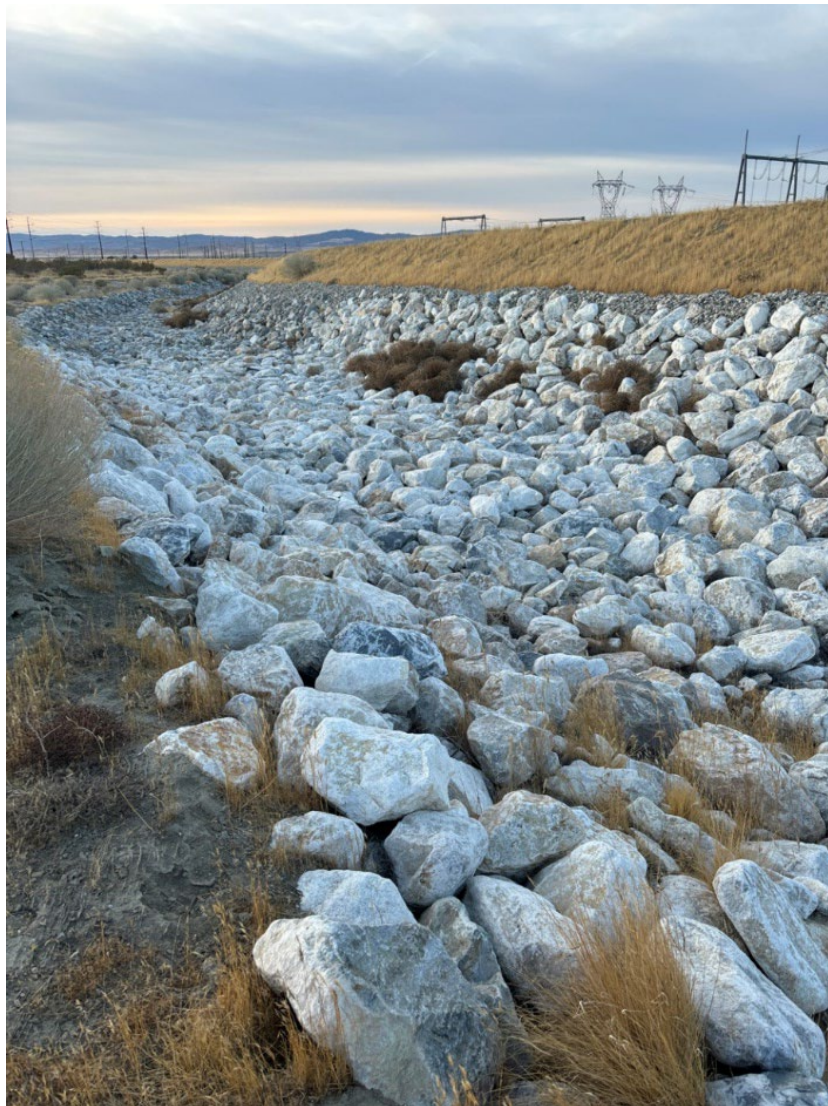
Photo Drainage 2b-1. Looking south at Drainage 2b along the eastern side of the SCE substation.

Drainage 2b is classified as an active artificial flow diversion surrounding the south-eastern side of the SCE Whirlwind Substation, west of 170th Street W. This feature is a rock-bottom erosion riprap approximately 20 feet in width (**Photo Drainage 2b-1**). Bordering vegetation primarily consists of disturbed/developed communities with scattered desert grasses and with no indication of riparian vegetation. This drainage was dry during all site visits with no indication of flowing water. Drainage 2b is recommended as a state and federal non-jurisdictional feature as it is an excavated ditch which does not carry a relatively permanent flow of water, and it does not connect to any jurisdictional waters. However, LRWQCB has indicated that a natural or manmade geomorphological feature need only the ability to convey water to meet their interpretation of California “Waters of the State” for this area.

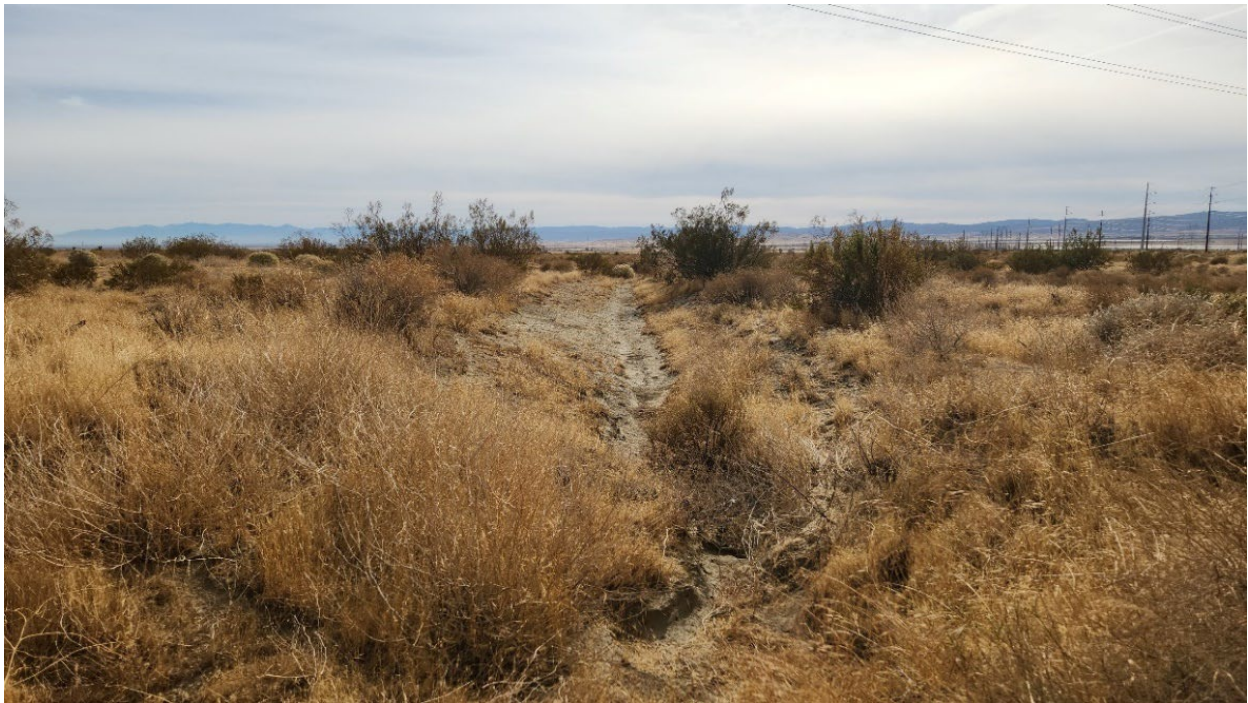
Photo Drainage 3-1. Looking southeast at Drainage 3 flow diversion Rosamond Boulevard.

Drainage 3 is classified as a roadside flow diversion on the south side of Rosamond Boulevard. This drainage has an approximate width of 55 inches, with a flow direction from north to south. Bordering vegetation primarily consists of cheesebush scrub and disturbed/developed communities with scattered in-channel desert grass (**Photo Drainage 3-1**). This drainage was dry during all site visits with no indication of running water or riparian vegetation. Drainage 3 is recommended as a state and federal non-jurisdictional feature as it is considered an artificial flow conveyance ditch which does not carry a relatively permanent flow of water and does not connect to any jurisdictional waters. However, LRWQCB has indicated that a natural or manmade geomorphological feature need only the ability to convey water to meet their interpretation of California “Waters of the State” for this area.

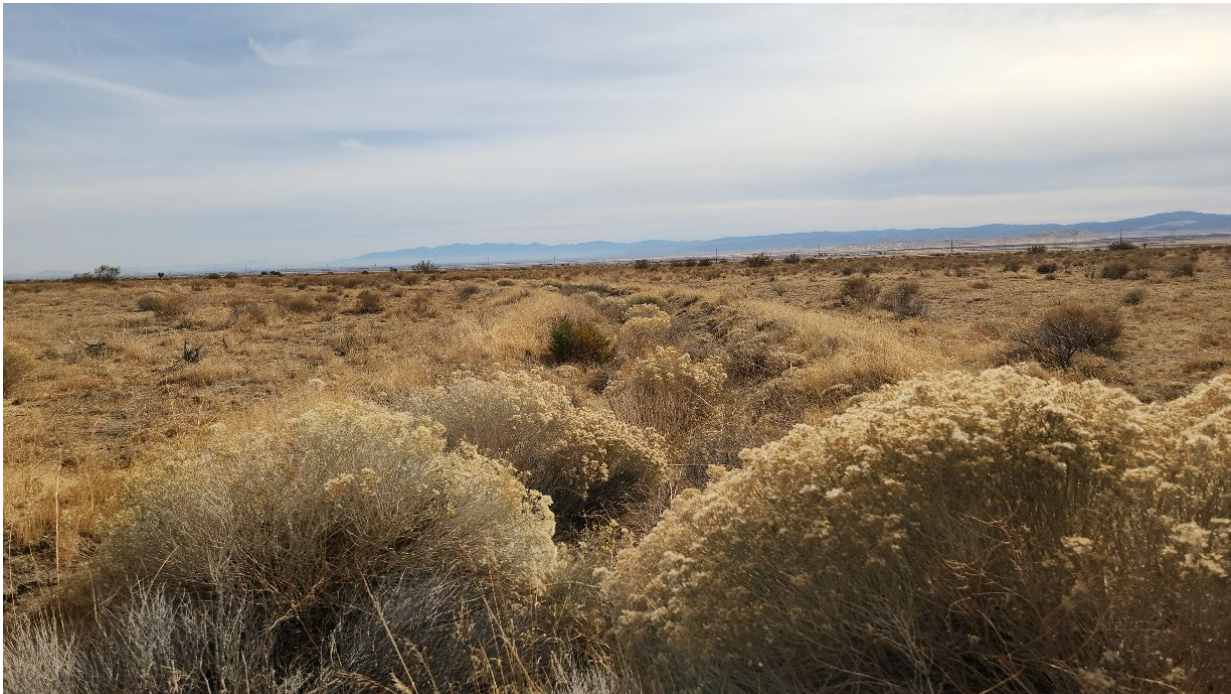
Photo Drainage 4-1. Looking southeast at Drainage 4 flow diversion from Rosamond Boulevard.

Drainage 4 is classified as an active roadside flow diversion on the south side of Rosamond boulevard. This drainage flows north to south and is characterized by a shallow depression in soil approximately 12 feet wide. The bordering and in channel vegetation primarily consists of cheesebush scrub and disturbed/developed communities (**Photo Drainage 4-1**). This drainage was dry during all site visits with no indication of running water or riparian vegetation. Drainage 4 is classified as a recommended state and federal non-jurisdictional feature as it is considered a flow conveyance which does not carry a relatively permanent flow of water and does not connect to any jurisdictional waters. However, LRWQCB has indicated that a natural or manmade geomorphological feature need only the ability to convey water to meet their interpretation of California “Waters of the State” for this area.

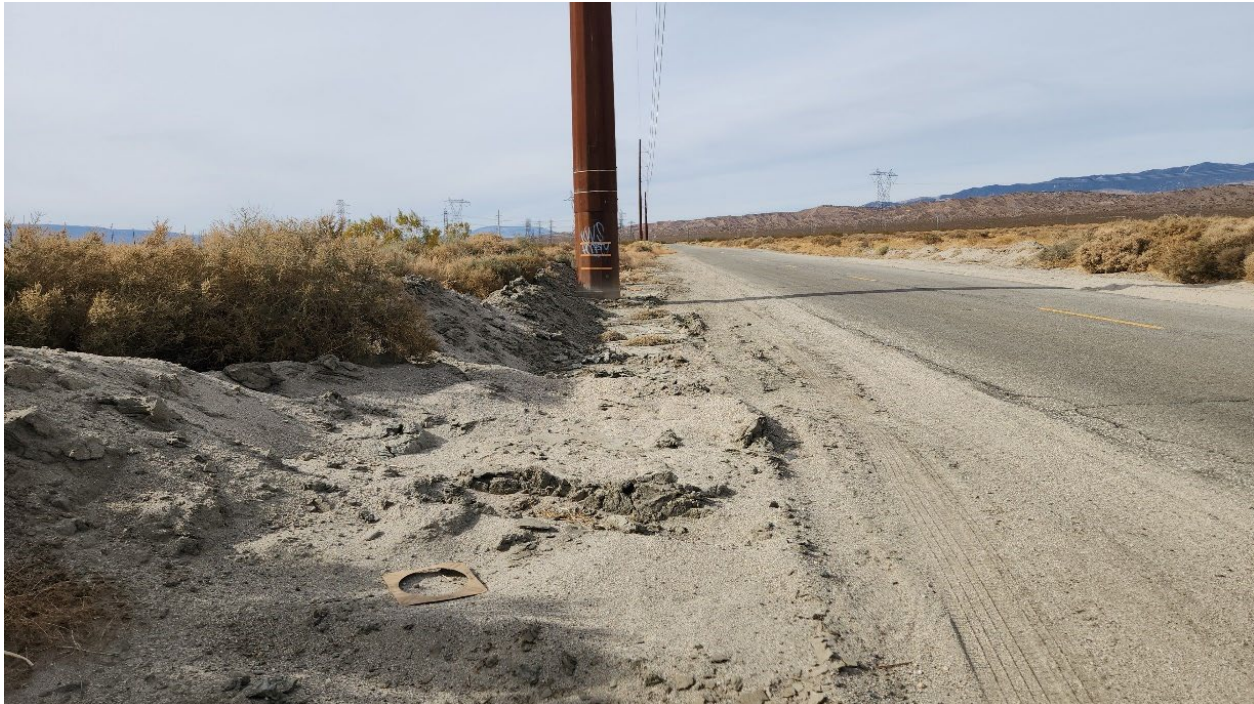
Photo Drainage 5a-1. Looking west at Drainage 5a, a roadside drainage ditch on the south edge of Rosamond Boulevard.

Drainage 5a is classified as an active roadside drainage ditch located along the south side of Rosamond Boulevard. No clear banks or vegetation were delineated in the field and the site was dry during all site visits (**Photo Drainage 5a-1**). Drainage 5a is classified as a recommended state and federal non-jurisdictional feature as it does not carry a relatively permanent flow of water, does not connect to any jurisdictional waters and has no evidence of riparian vegetation. However, LRWQCB has indicated that a natural or manmade geomorphological feature need only the ability to convey water to meet their interpretation of California “Waters of the State” for this area.

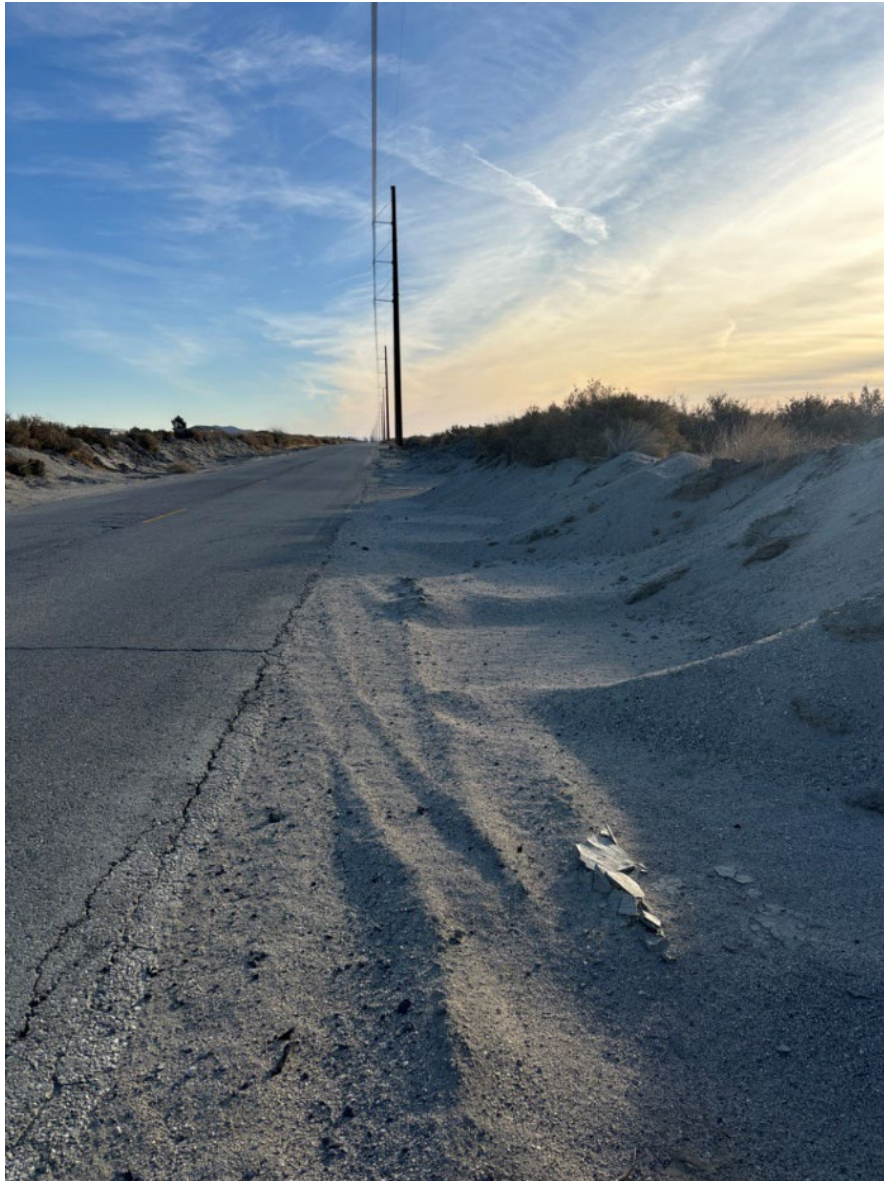
Photo Drainage 5b-1. Looking east at Drainage 5b, a roadside drainage ditch on the south side of Rosamond Boulevard.

Drainage 5b is an active roadside drainage ditch located along the south side of Rosamond Boulevard situated between Drainages 6 and 7. No clear banks were delineated in the field and the site was dry during all site visits (**Photo Drainage 5b-1**). Bordering vegetation on the south bank was dominated by allscale scrub and disturbed/developed communities. Drainage 5b is classified as a recommended state and federal non-jurisdictional feature as it does not carry a relatively permanent flow of water and has no indication of riparian vegetation or past flow. However, LRWQCB has indicated that a natural or manmade geomorphological feature need only the ability to convey water to meet their interpretation of California “Waters of the State” for this area.

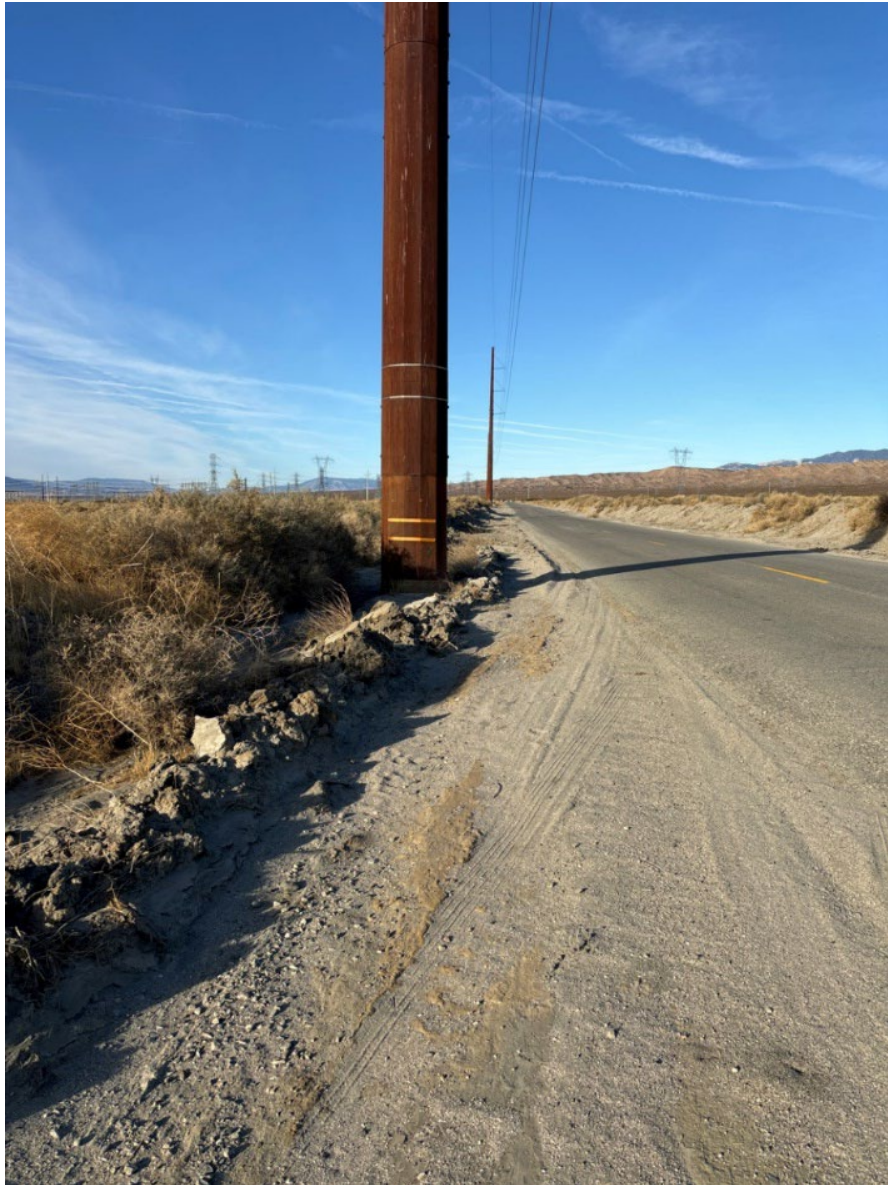
Photo Drainage 5c-1. Looking west at Drainage 5c, a roadside drainage ditch on the south side of Rosamond Boulevard.

Drainage 5c is an active roadside drainage ditch located along the south side of Rosamond Boulevard situated between Drainages 7 and 8. This drainage is characterized by a shallow depression in sediment and a vegetated south bank consisting of allscale scrub and disturbed/developed vegetation (**Photo Drainage 5c-1**). Drainage 5c is classified as a recommended state and federal non-jurisdictional feature as it does not carry a relatively permanent flow of water and has no indication of riparian vegetation or past flow. However, LRWQCB has indicated that a natural or manmade geomorphological feature need only the ability to convey water to meet their interpretation of California “Waters of the State” for this area.

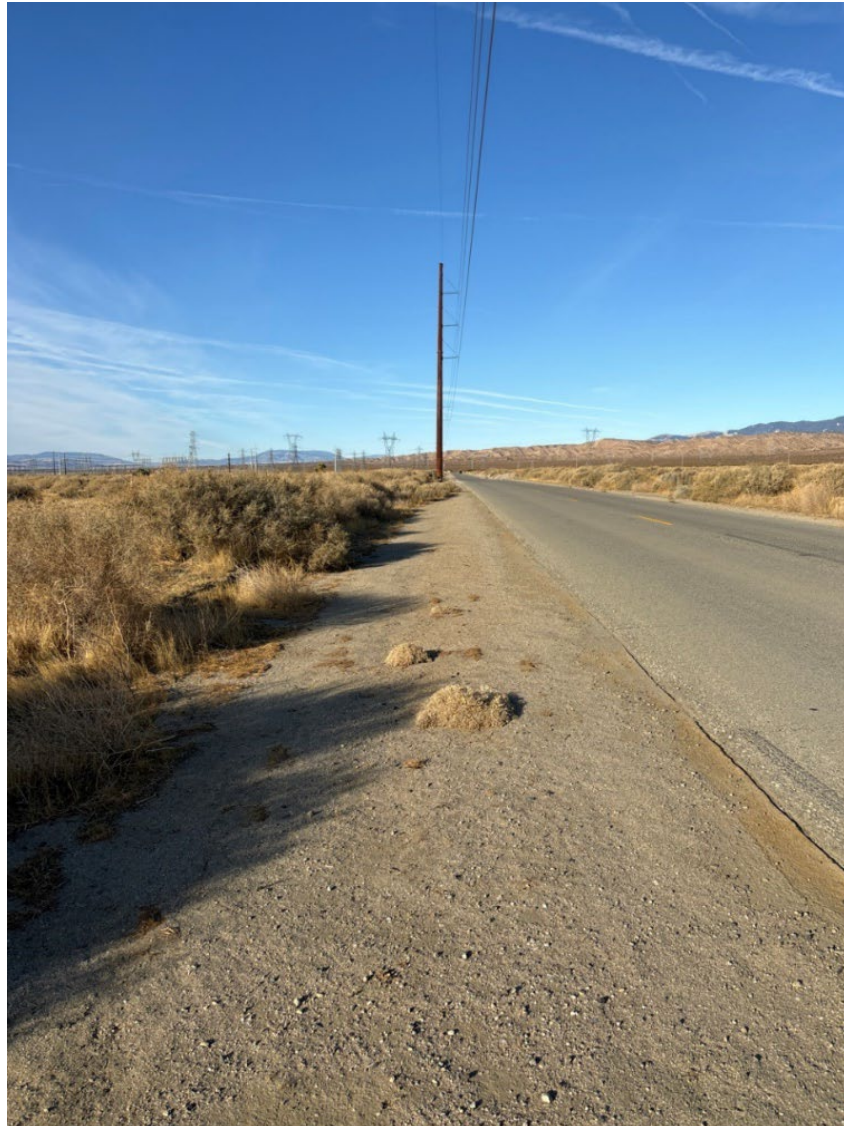
Photo Drainage 5d-1. Looking west at Drainage 5d, a roadside drainage ditch on the south side of Rosamond Boulevard.

Drainage 5d is an active roadside drainage ditch located along the south side of Rosamond Boulevard (**Photo Drainage 5d-1**). Bordering vegetation on the south bank was dominated by allscale scrub and disturbed/developed communities. No soil indicators or signs of erosion were delineated in the field for this feature. Drainage 5d is classified as a potential non-jurisdictional feature as it does not carry a relatively permanent flow of water and has no indication of riparian vegetation or past flow. However, LRWQCB has indicated that a natural or manmade geomorphological feature need only the ability to convey water to meet their interpretation of California “Waters of the State” for this area.

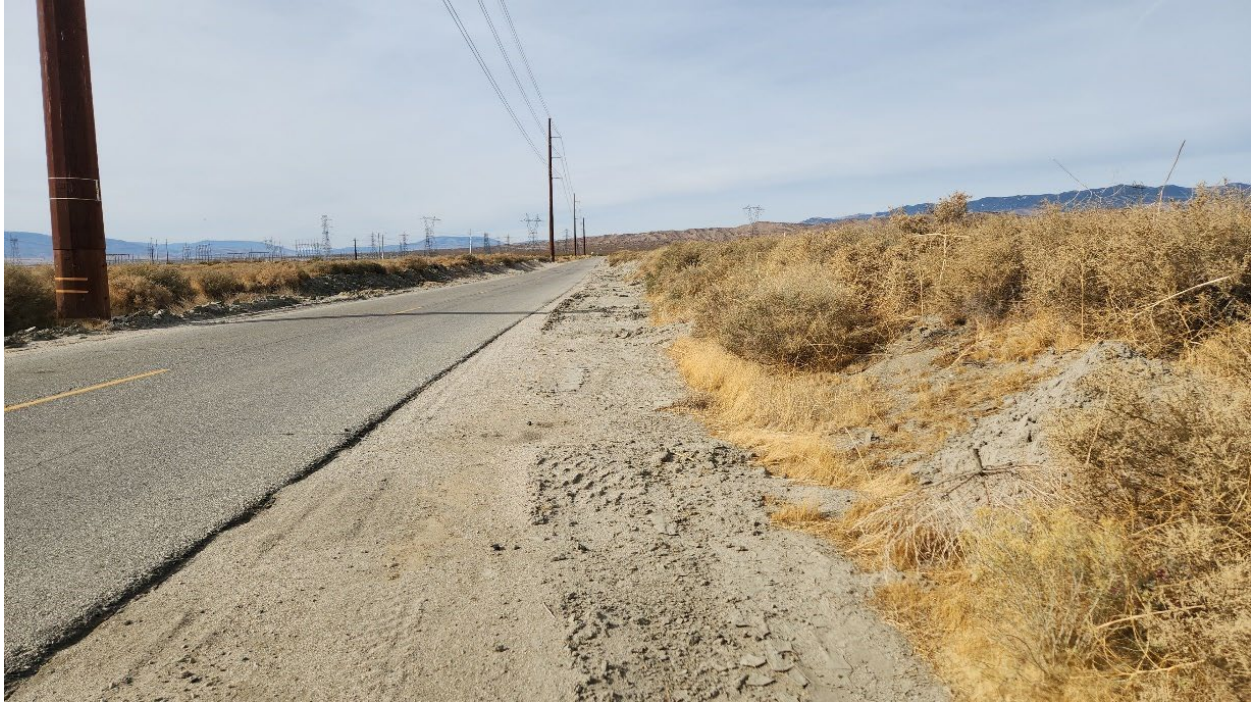
Photo Drainage 5e-1. Looking west at Drainage 5e, a roadside drainage ditch located along the north side of Rosamond Boulevard.

Drainage 5e is an active roadside drainage ditch located along the north side of Rosamond Boulevard across from Drainage 5c (**Photo Drainage 5e-1**). The northern bank of this feature is bordered predominantly by disturbed/developed vegetation community. Drainage 5e is classified as a recommended state and federal non-jurisdictional feature as it does not carry a relatively permanent flow of water and has no indication of riparian vegetation or past flow. However, LRWQCB has indicated that a natural or manmade geomorphological feature need only the ability to convey water to meet their interpretation of California “Waters of the State” for this area.

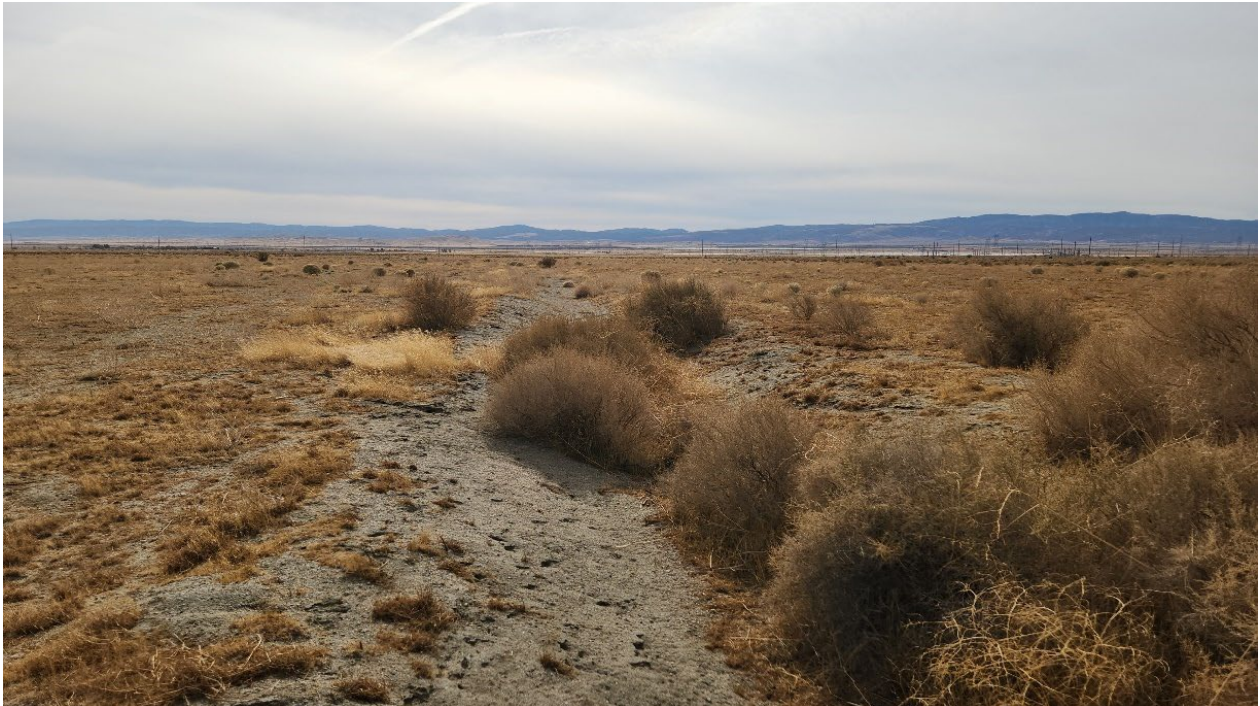
Photo Drainage 9-1. Looking south at Drainage 9 from Rosamond Boulevard.

Drainage 9 is an abandoned ephemeral swale on the south side of Rosamond Boulevard. This feature is south flowing and characterized by a shallow depression in soil with an approximate width of 9 feet (**Photo Drainage 9-1**). Bank and in-channel vegetation are predominantly allscale shrub and non-native grassland and forbes communities. Drainage 9 is classified as a recommended state and federal non-jurisdictional feature as it lacks riparian vegetation, does not carry a relatively permanent flow of water and is not connected to any jurisdictional waters. However, LRWQCB has indicated that a natural or manmade geomorphological feature need only the ability to convey water to meet their interpretation of California “Waters of the State” for this area.

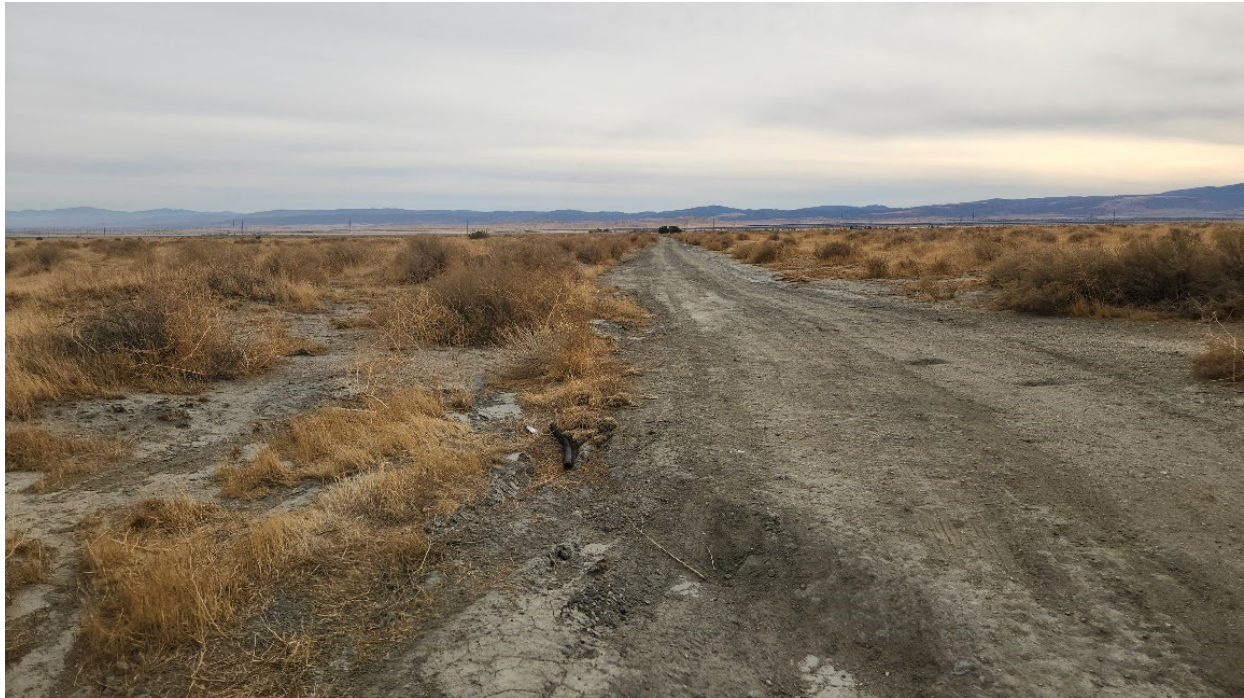
Photo Drainage 11a-1. Photo taken from the south side of Rosamond Boulevard looking south toward downstream of Drainage 11a on 155th Street.

Drainage 11a is classified as an active roadside drainage ditch along 155th Street W, near the intersection with the south side of Rosamond Boulevard. This feature is characterized by a slight depression in soil and has allscale scrub and disturbed/developed vegetation communities along its western bank (**Photo Drainage 11a-1**).

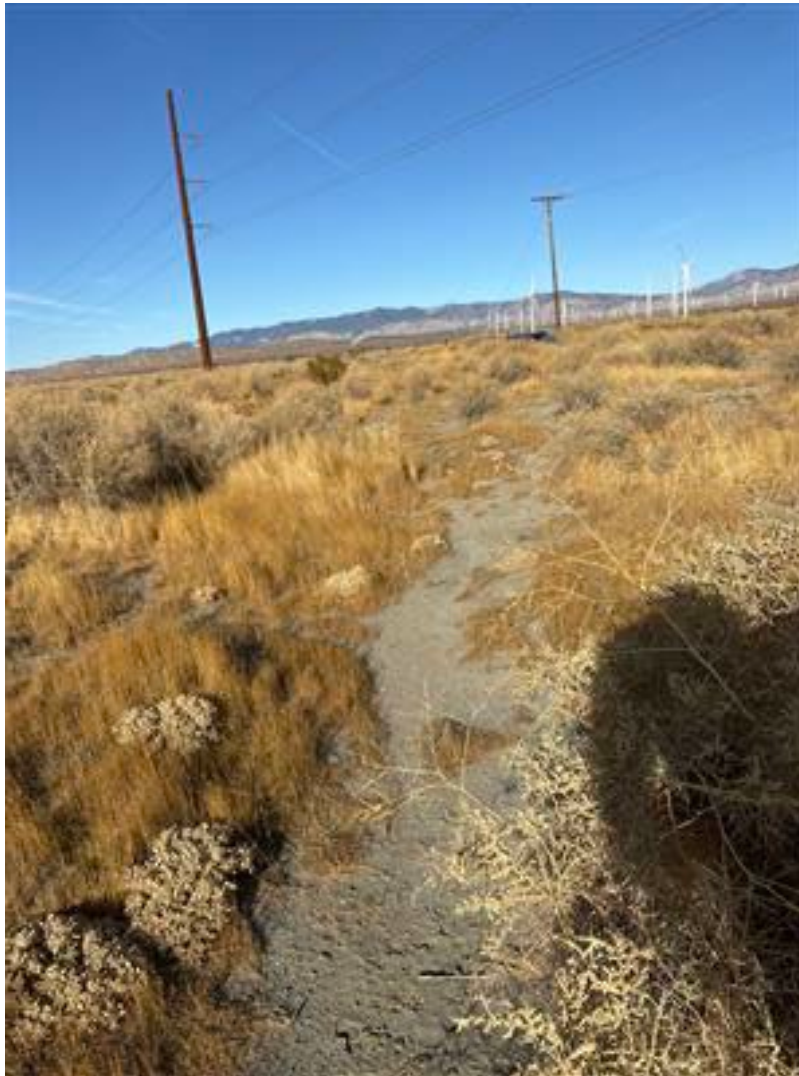
Photo Drainage 11b-1. Looking west at Drainage 11b on the south side of Rosamond Boulevard.

Drainage 11b is classified as an active upland swale located downstream of Drainage 11a, on the east side of 155th Street W near the intersection with Rosamond Boulevard. This drainage is characterized by a gap in vegetation approximately 4 feet wide, with bordering vegetation primarily consisting of desert grasses and allscale scrub (**Photo Drainage 11b-1**). Drainage 11b is classified as a recommended state and federal non-jurisdictional feature as it lacks riparian vegetation, does not carry a relatively permanent flow of water and is not connected to any jurisdictional waters. However, LRWQCB has indicated that a natural or manmade geomorphological feature need only the ability to convey water to meet their interpretation of California “Waters of the State” for this area.

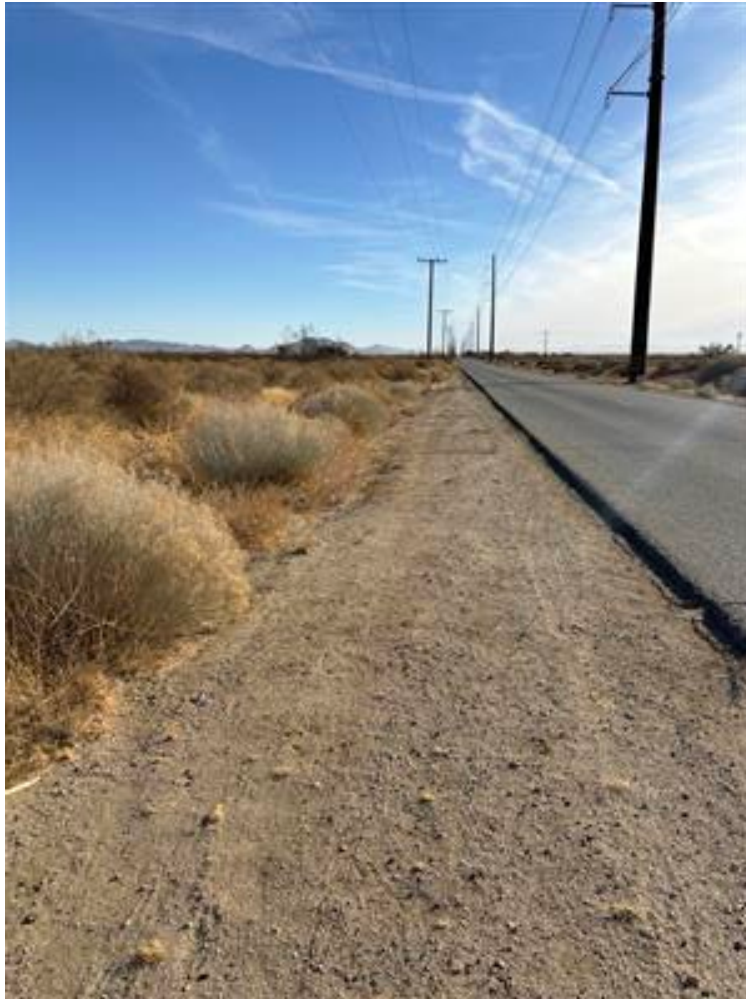
Photo Drainage 13-1. Looking east at Drainage 13, a roadside drainage ditch on the north side of Rosamond Boulevard.

Drainage 13 is classified as an active roadside drainage ditch located along the north side of Rosamond Boulevard. This feature is characterized by a disturbed/developed vegetation community (**Photo Drainage 13-1**). No evidence of erosion or soil indicators were delineated in the field for this feature. Drainage 13 is classified as a recommended state and federal non-jurisdictional feature as it lacks riparian vegetation, does not carry a relatively permanent flow of water and is not connected to any jurisdictional waters. However, LRWQCB has indicated that a natural or manmade geomorphological feature need only the ability to convey water to meet their interpretation of California “Waters of the State” for this area.

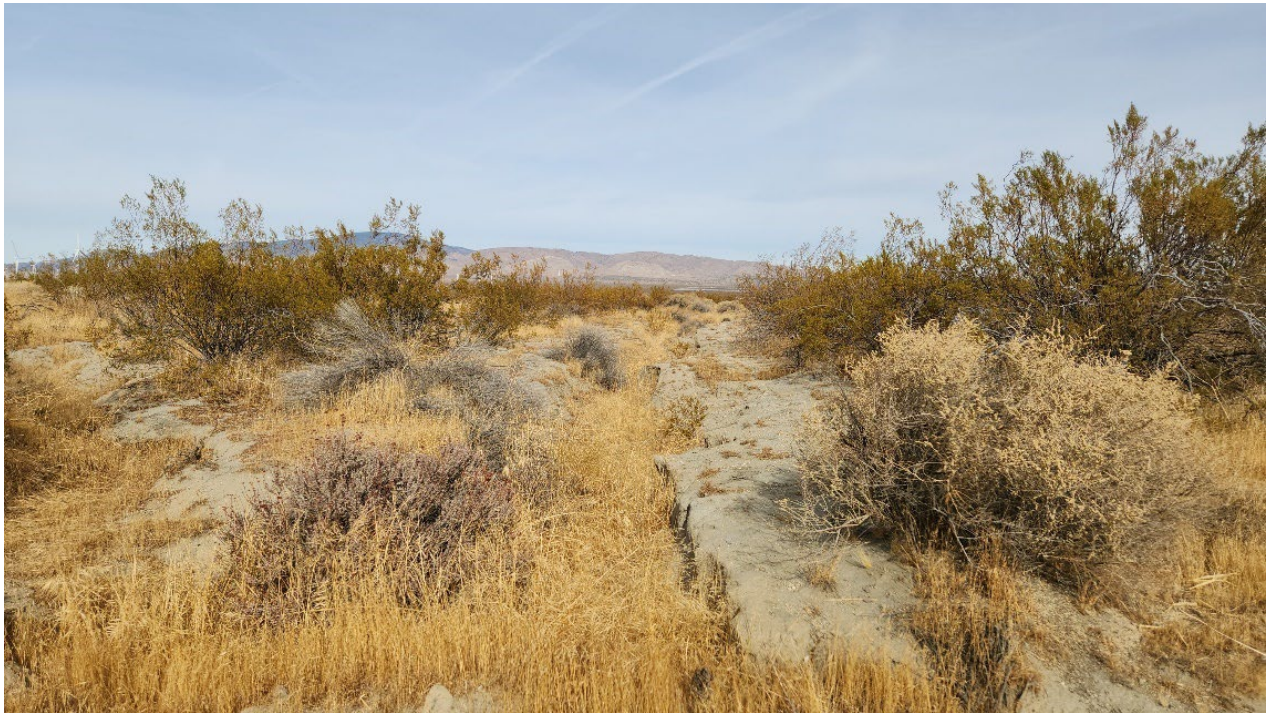
Photo Drainage 17-1. Looking north at Drainage 17 from Rosamond Boulevard toward 2nd Avenue.

Drainage 17 is classified as an active roadside swale located on the west side of 2nd Avenue near the intersection at Rosamond Boulevard. This feature flows north to south and has an approximate width of 68 inches (**Photo Drainage 17-1**). The bordering vegetation community is co-dominated by creosote bush scrub and disturbed/developed communities, with desert grass growing inside the channel. This feature was dry during all site visits with limited evidence of scouring approximately 10 inches deep. Drainage 17 is classified as a recommended state and federal non-jurisdictional feature as it lacks riparian vegetation, does not carry a relatively permanent flow of water and is not connected to any jurisdictional waters. However, LRWQCB has indicated that a natural or manmade geomorphological feature need only the ability to convey water to meet their interpretation of California “Waters of the State” for this area.

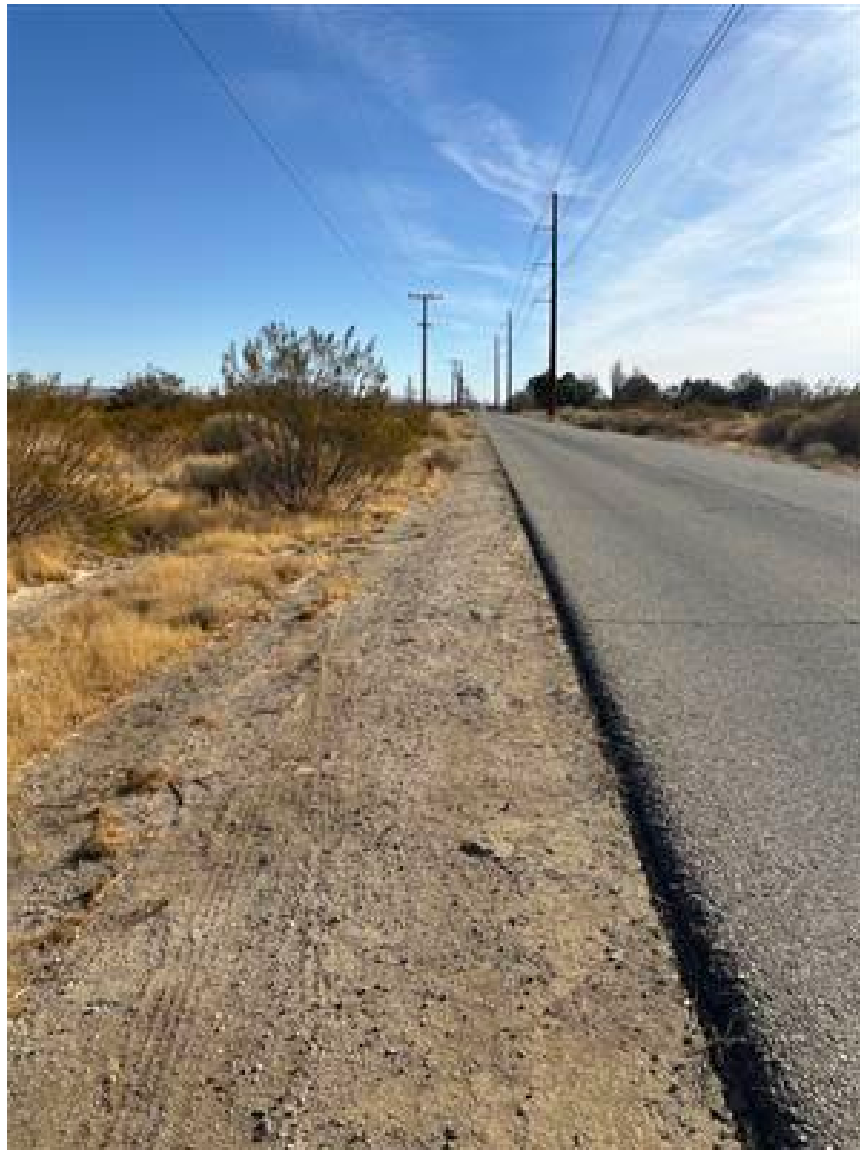
Photo Drainage 18a-1. Looking east at Drainage 18a, a roadside drainage ditch on the north side of Rosamond Boulevard.

Drainage 18a is classified as an active roadside drainage ditch located along the north side of Rosamond Boulevard east of 145th Street W. The northern edge of this feature is bordered by allscale scrub, creosote bushscrub and disturbed/developed vegetation communities (**Photo Drainage 18a-1**). This drainage was dry during all site visits with no indication of running water. Drainage 18a is classified as a potential non-jurisdictional feature as it is a roadside drainage ditch which does not carry a relatively permanent flow of water, and it does not connect to any jurisdictional waters. However, LRWQCB has indicated that a natural or manmade geomorphological feature need only the ability to convey water to meet their interpretation of California “Waters of the State” for this area.

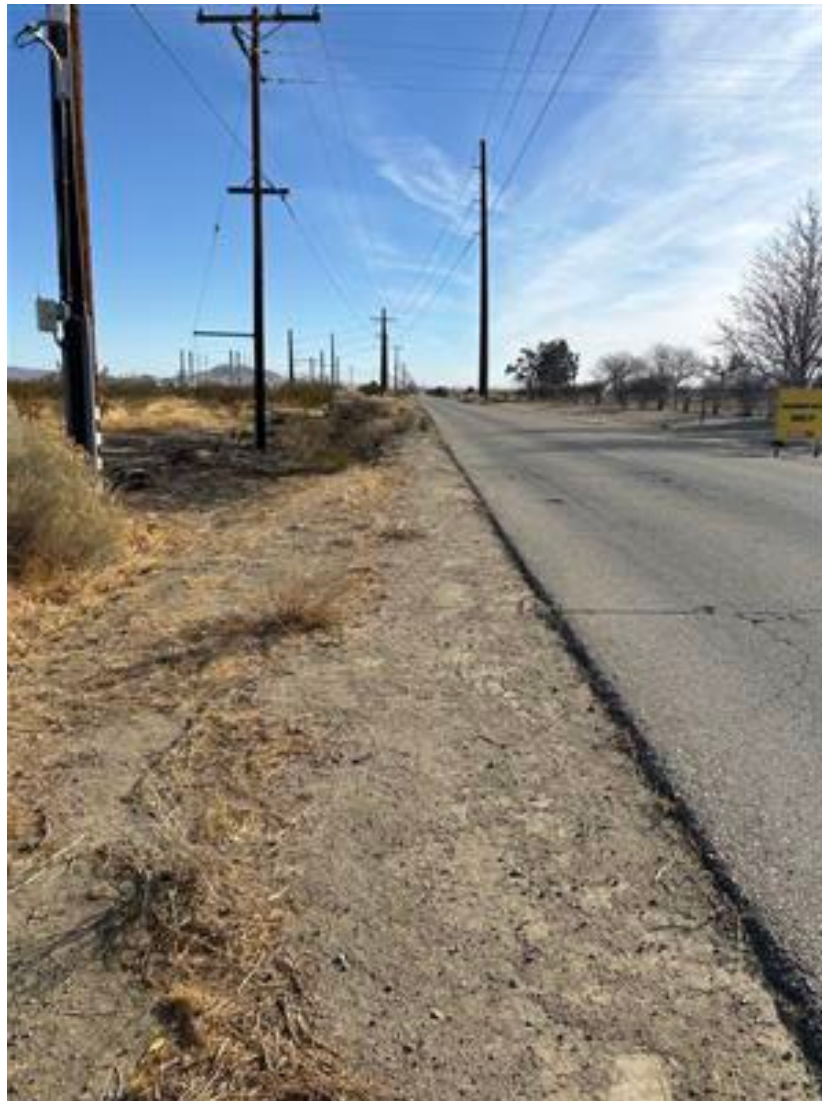
Photo Drainage 18b-1. Looking east at Drainage 18b, a roadside drainage ditch on the north side of Rosamond Boulevard.

Drainage 18b is classified as an active roadside drainage ditch located along the north side of Rosamond Boulevard, adjacent to Drainage 18a, west of 140th Street W. The northern edge of this feature is bordered by rubber rabbitbrush scrub and disturbed/developed vegetation communities (**Photo Drainage 18b-1**). This drainage was dry during all site visits with no indication of running water. Drainage 18b is classified as a recommended state and federal non-jurisdictional feature as it is a roadside drainage ditch which does not carry a relatively permanent flow of water, and it does not connect to any jurisdictional waters. However, LRWQCB has indicated that a natural or manmade geomorphological feature need only the ability to convey water to meet their interpretation of California “Waters of the State” for this area.

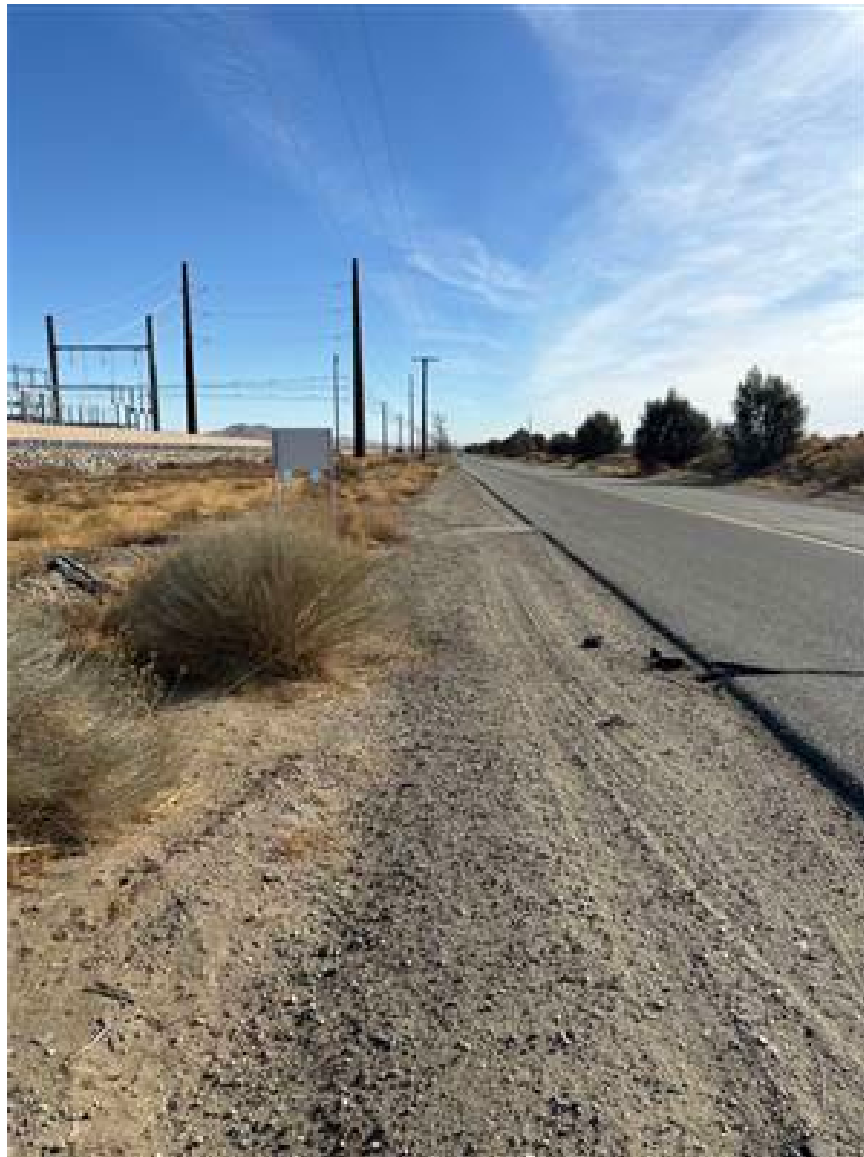
Photo Drainage 20a-1. Looking east at Drainage 20a, a roadside drainage ditch on the north side of Rosamond Boulevard.

Drainage 20a is classified as an active roadside drainage ditch along the north side of Rosamond Boulevard, located east of 140th Street W, near the Duke Energy North Rosamond Solar Site. The northern edge of this feature is bordered predominantly by disturbed/developed vegetation communities (**Photo Drainage 20a-1**). This drainage was dry during all site visits with no indication of running water. Drainage 20a is classified as a potential non-jurisdictional feature as it is a roadside drainage ditch which does not carry a relatively permanent flow of water, and it does not connect to any jurisdictional waters. However, LRWQCB has indicated that a natural or manmade geomorphological feature need only the ability to convey water to meet their interpretation of California “Waters of the State” for this area.

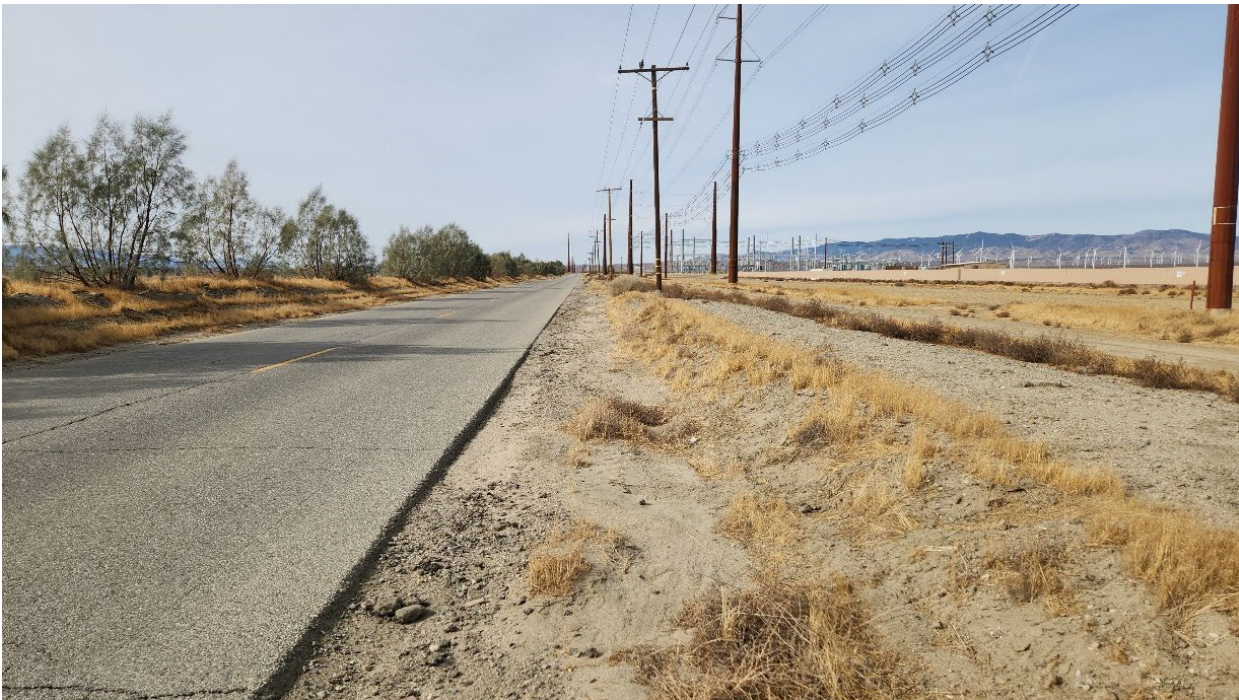
Photo Drainage 20b-1. Looking west at Drainage 20b. The photo depicts a roadside drainage ditch on the north side of Rosamond Boulevard surrounded by North Rosamond Solar facilities to the north and south.

Drainage 20b is classified as an active roadside drainage ditch along the north side of Rosamond Boulevard, located just east of Drainage 20a. The northern edge of this feature is bordered predominantly by disturbed/developed vegetation communities (**Photo Drainage 20b-1**). This drainage was dry during all site visits with no indication of running water. Drainage 20b is classified as a potential non-jurisdictional feature as it is a roadside drainage ditch which does not carry a relatively permanent flow of water, and it does not connect to any jurisdictional waters. However, Lahontan Regional Water Quality Control Board has indicated that a natural or manmade geomorphological feature need only the ability to convey water to meet their interpretation of California "Waters of the State" for this area.

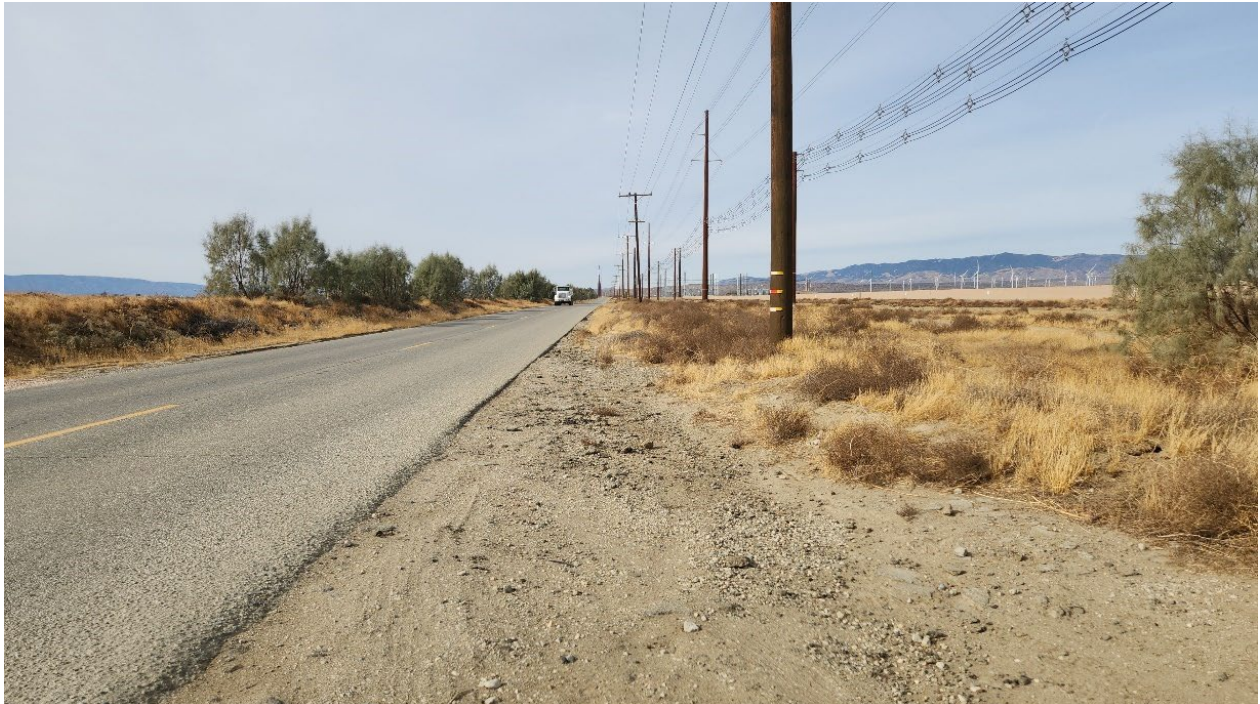
Photo Drainage 20c-1. Looking west at Drainage 20c. The photo depicts a roadside drainage ditch on the north side of Rosamond Boulevard. Photo taken at intersection with 135th Street W.

Drainage 20c is classified as an active roadside drainage ditch along the north side of Rosamond Boulevard, located near the 135th Street W intersection. This feature is predominantly bordered by disturbed/developed vegetation communities (**Photo Drainage 20c-1**). This drainage was dry during all site visits with no indication of running water. Drainage 20c is classified as a recommended state and federal non-jurisdictional feature as it is a roadside drainage ditch which does not carry a relatively permanent flow of water, and it does not connect to any jurisdictional waters. However, LRWQCB has indicated that a natural or manmade geomorphological feature need only the ability to convey water to meet their interpretation of California “Waters of the State” for this area.
