| DOCKETED | |
|---|--|
| Project Title: | Willow Rock Energy Storage Center |
| Document Title: | Willow Rock Jurisdictional Drainages Additional Information Text |

**Additional Information Related to DR128 -
Delineation of Jurisdictional Waters**
Willow Rock Energy Storage Center (21-AFC-02)

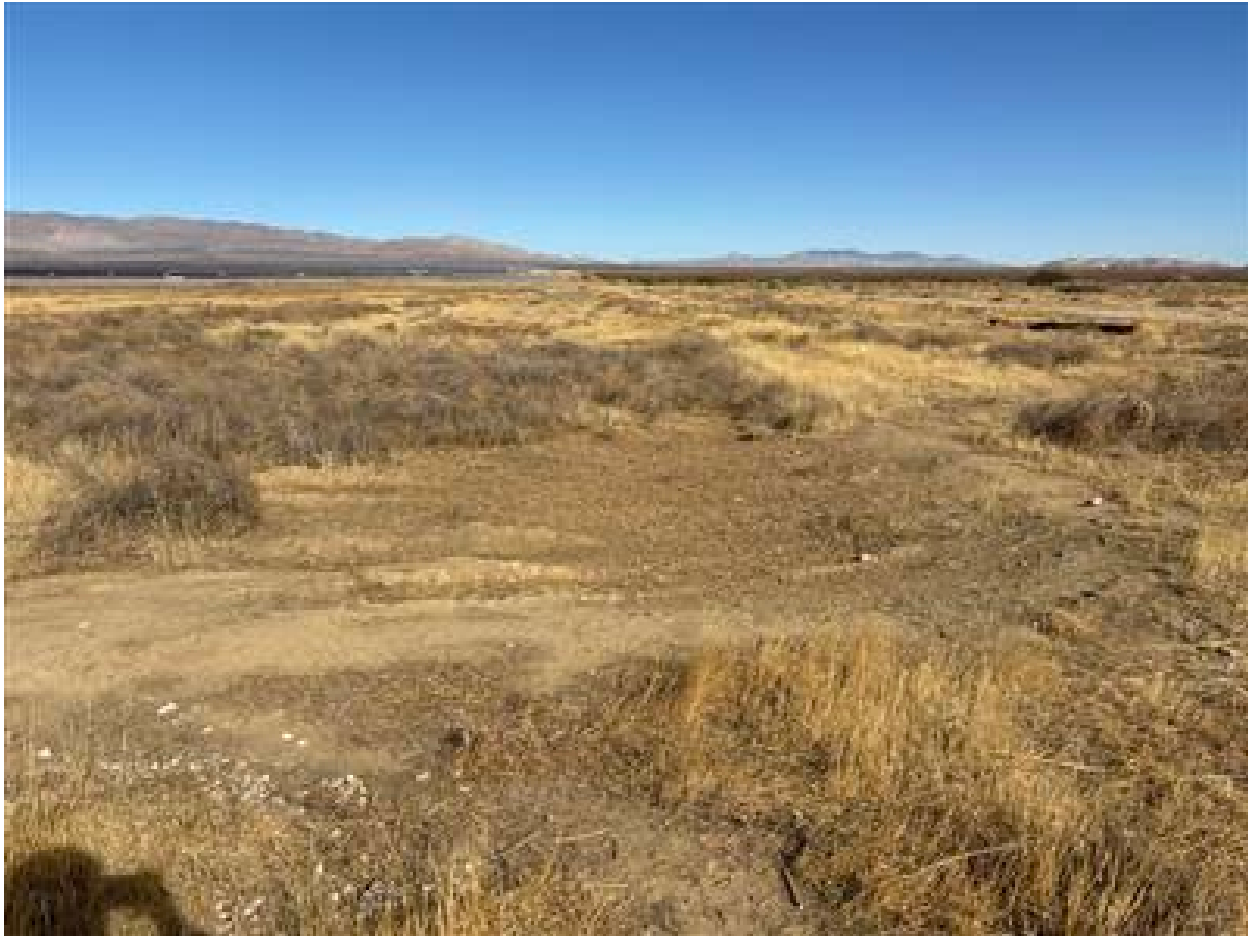
Photo Drainage 21a-1. Looking north at Drainage 21a from the north side of Rosamond Boulevard just west of 120th Street W intersection.

Drainage 21a is classified as an active detention basin swale located north-west of the Rosamond Boulevard and 120th Street W intersection. This feature is characterized by a gap in vegetation predominated by disturbed/developed communities (**Photo Drainage 21a-1**). This drainage was dry during all site visits with no indication of running water, or riparian vegetation. Drainage 21a is classified as a recommended state and federal non-jurisdictional feature as it does not carry a relatively permanent flow of water, and it does not connect to any jurisdictional waters. However, LRWQCB has indicated that a natural or manmade geomorphological feature need only the ability to convey water to meet their interpretation of California “Waters of the State” for this area.

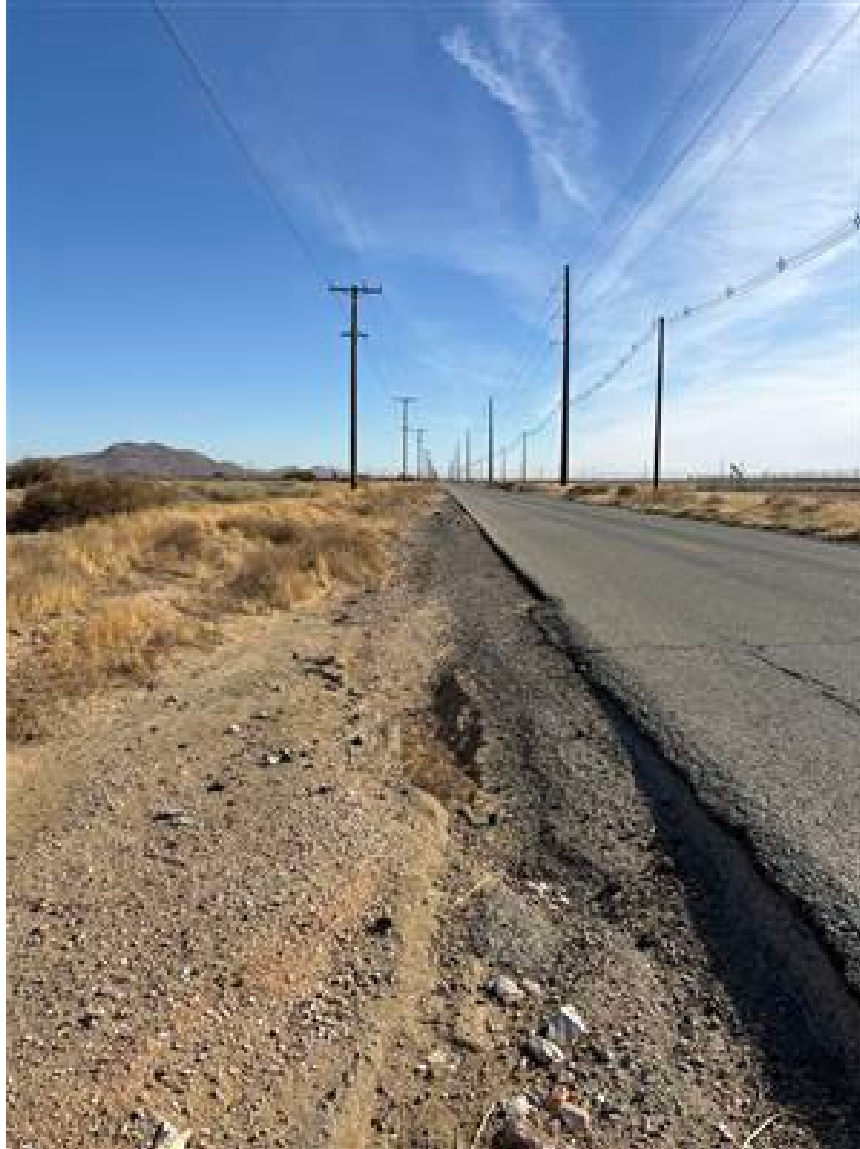
Photo Drainage 21b-1. Looking east at Drainage 21b along the north side of Rosamond Boulevard.

Drainage 21b is classified as an active roadside drainage ditch located along the east side of 120th Street W and the north side of Rosamond Boulevard. This feature is bordered by non-native grassland and forbes and disturbed/developed vegetation communities (**Photo Drainage 21b-1**). This drainage was dry during all site visits with no indication of running water, or riparian vegetation. Drainage 21b is classified as a recommended state and federal non-jurisdictional feature as it is a roadside drainage ditch which does not carry a relatively permanent flow of water and does not connect to any jurisdictional waters.

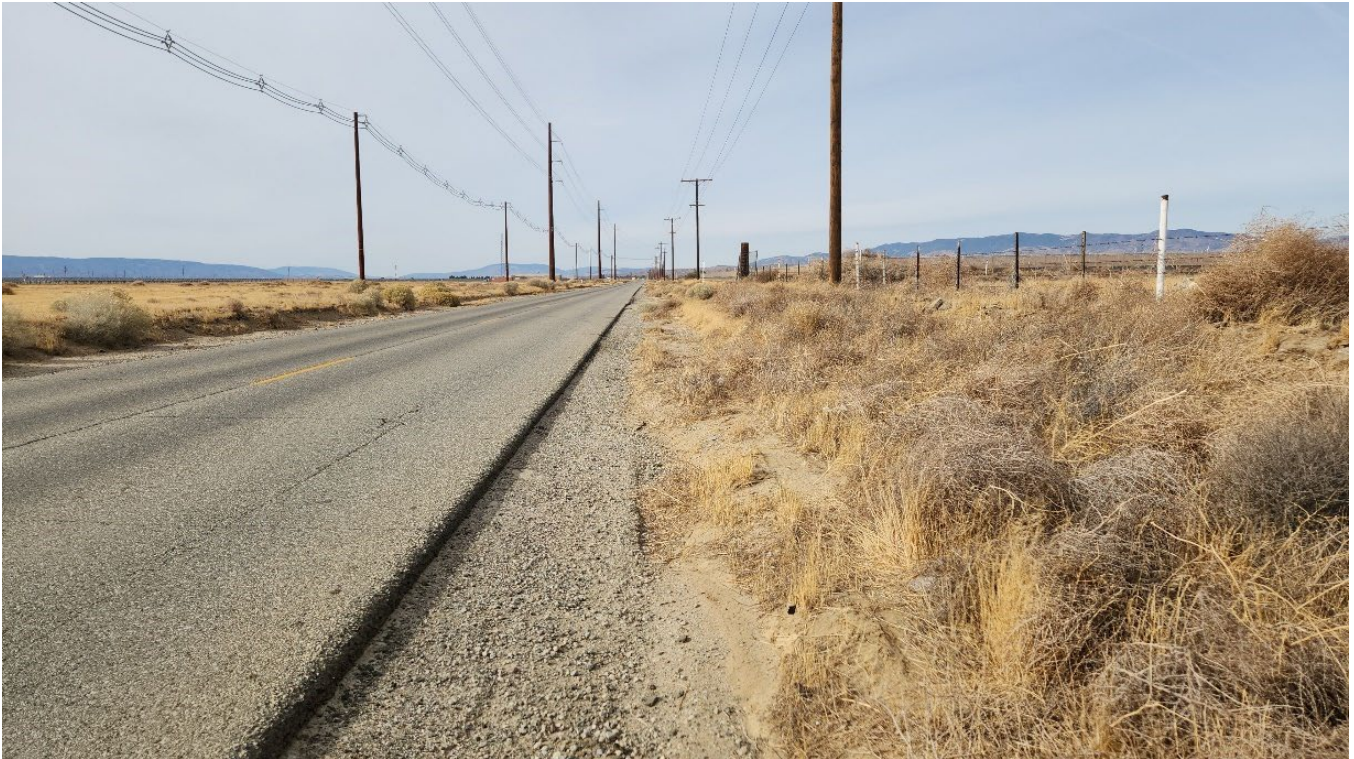
Photo Drainage 22a-1. Looking west at Drainage 22a, a roadside drainage ditch along the north side of Rosamond Boulevard.

Drainage 22a is classified as an active roadside drainage ditch located along the north side of Rosamond Boulevard west of 115th Street W. This feature is predominantly bordered by disturbed/developed vegetation communities (**Photo Drainage 22a-1**). This drainage was dry during all site visits with no indication of running water, or riparian vegetation. Drainage 22a is classified as a state and federal non-jurisdictional feature as it is a roadside drainage ditch which does not carry a relatively permanent flow of water and does not connect to any jurisdictional waters. However, LRWQCB has indicated that a natural or manmade geomorphological feature need only the ability to convey water to meet their interpretation of California “Waters of the State” for this area.

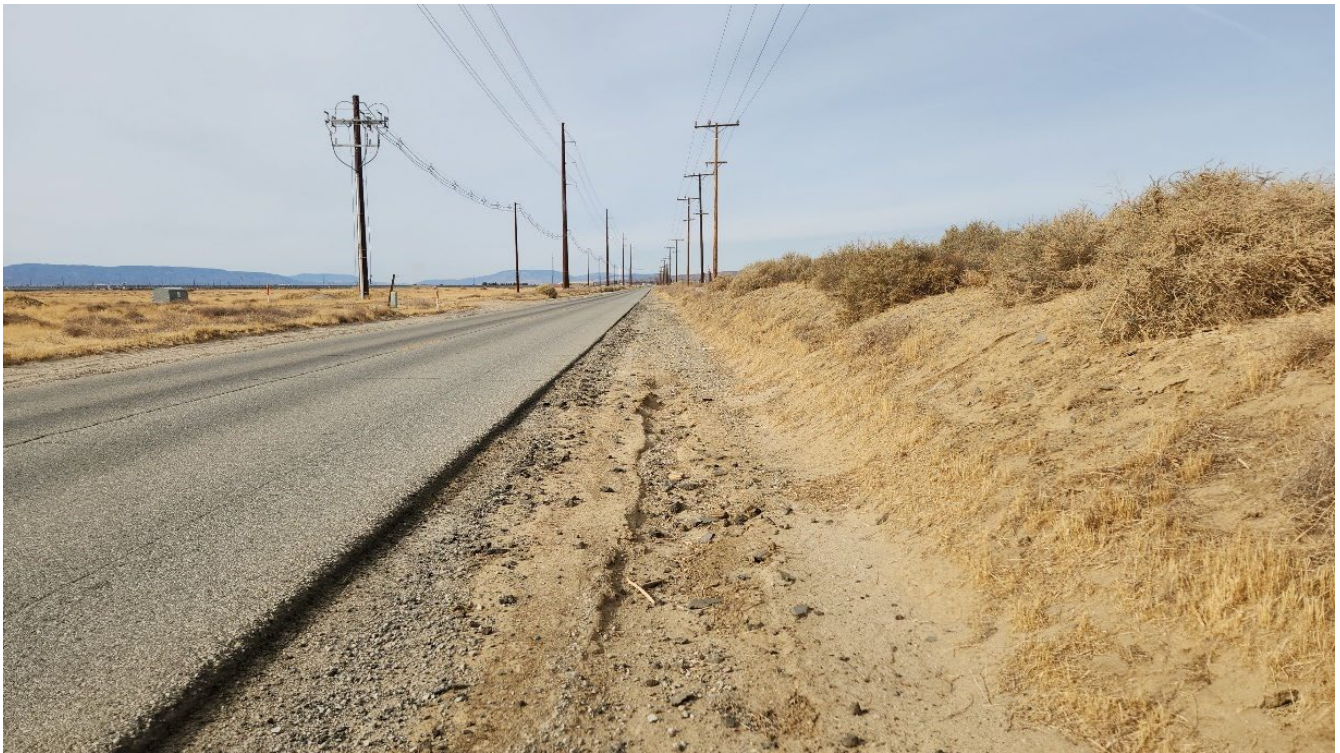
Photo Drainage 22b-1. Looking west at Drainage 22b, a roadside drainage ditch on the north side of Rosamond Boulevard.

Drainage 22b is classified as an active roadside drainage ditch along the north side of Rosamond Boulevard. East of 115th Street W. This feature is predominantly bordered by allscale scrub and disturbed/developed vegetation communities (**Photo Drainage 22b-1**). During all site visits, this feature was observed to be dry with no signs of flowing water or presence of riparian vegetation. Drainage 22b is classified as a potential non-jurisdictional feature as it is a roadside drainage ditch which does not carry a relatively permanent flow of water and does not connect to any jurisdictional waters. However, Lahontan Regional Water Quality Control Board has indicated that a natural or manmade geomorphological feature need only the ability to convey water to meet their interpretation of California “Waters of the State” for this area.

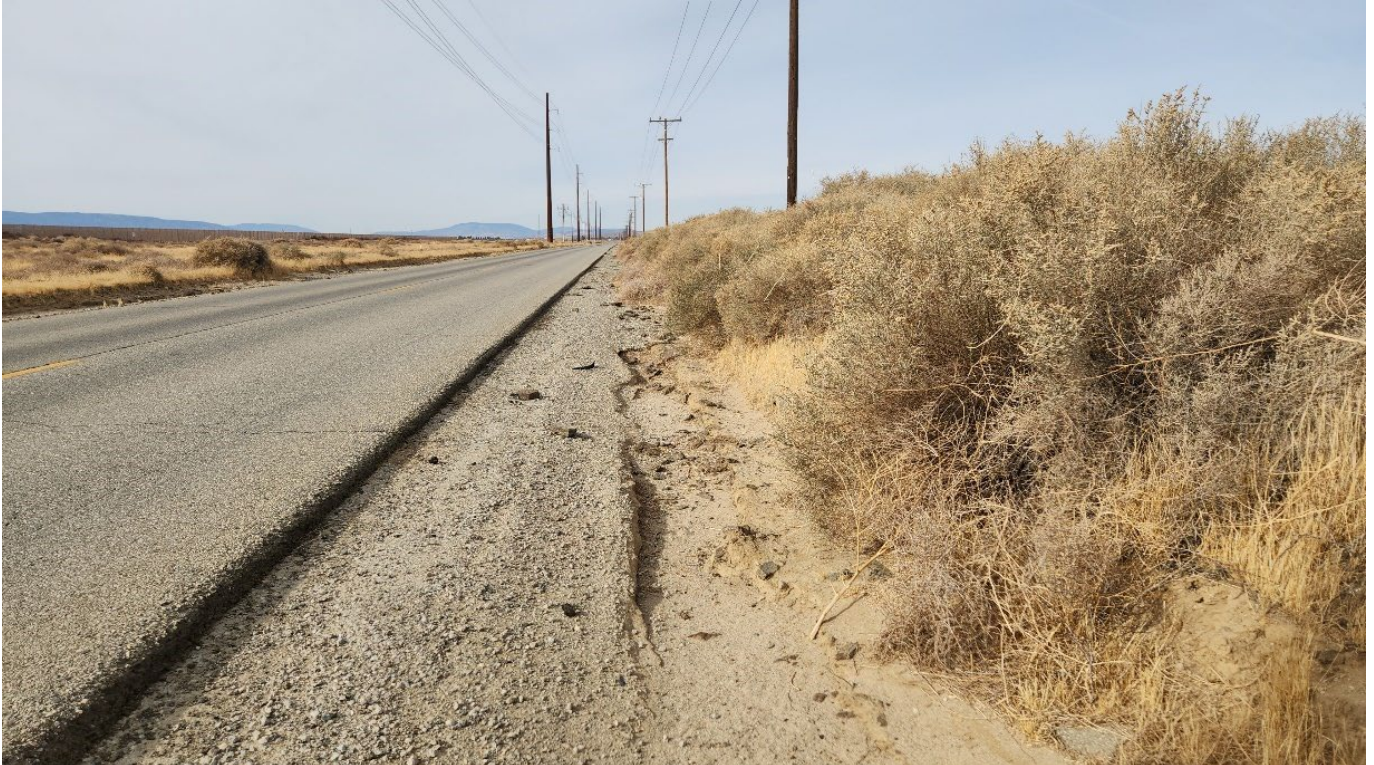
Photo Drainage 22c-1. Looking west at Drainage 22c, a roadside drainage ditch along the north side of Rosamond Boulevard.

Drainage 22c is classified as an active roadside drainage ditch located along the north side of Rosamond Boulevard. This feature is predominantly bordered by disturbed/developed vegetation communities (**Photo Drainage 22c-1**). During all site visits, this feature was observed to be dry with no signs of flowing water or presence of riparian vegetation. Drainage 22c is classified as a recommended state and federal non-jurisdictional feature as it is a roadside drainage ditch which does not carry a relatively permanent flow of water and does not connect to any jurisdictional waters.

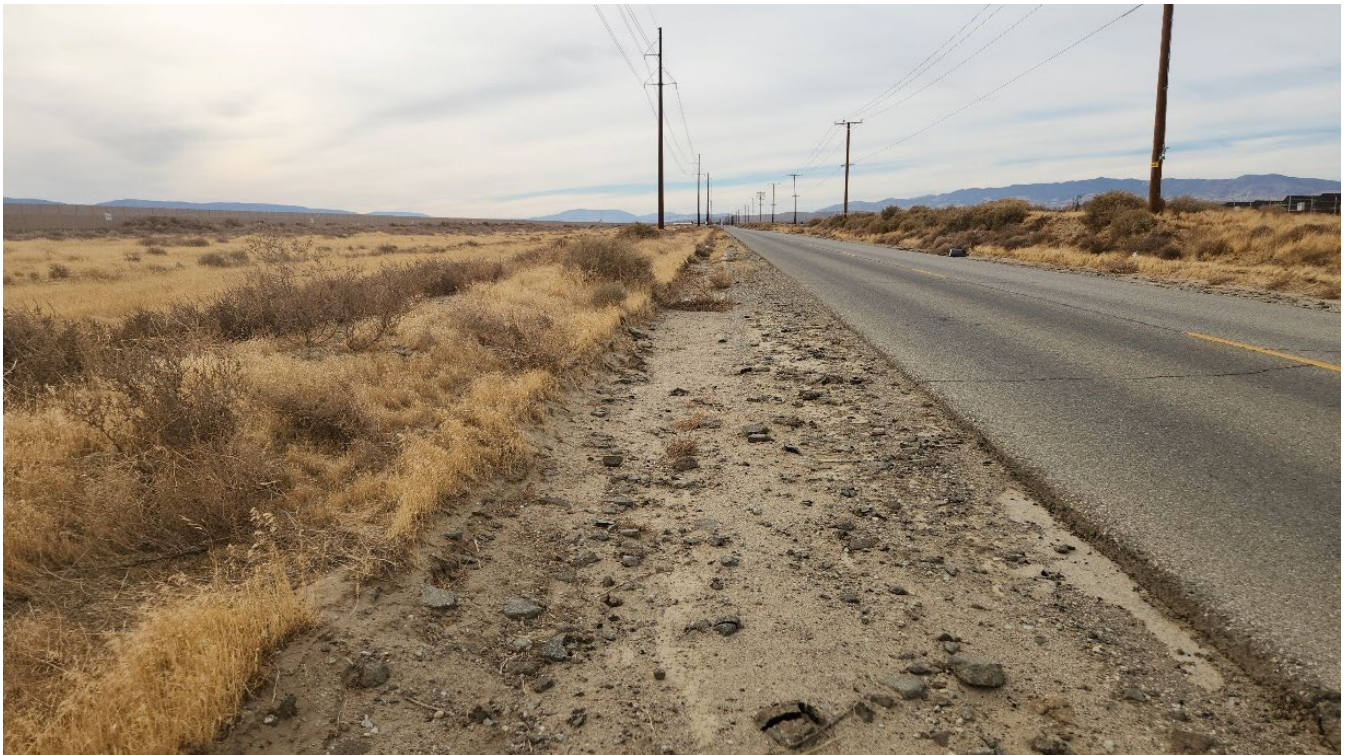
Photo Drainage 23a-1. Looking west at Drainage 23a, a roadside drainage ditch along the south side of Rosamond Boulevard. Photo taken near intersection of Rosamond Boulevard and 110th Street W.

Drainage 23a is classified as an active roadside drainage ditch located along the south side of Rosamond Boulevard, west of 110th Street W. This feature is predominantly bordered by disturbed/developed vegetation with no evidence of riparian communities (**Photo Drainage 23a-1**). Drainage 23a was dry during all site visits with minimal indication of flowing water. Drainage 23a is classified as a potential non-jurisdictional feature as it is a roadside drainage ditch which does not carry a relatively permanent flow of water and does not connect to any jurisdictional waters. However, Lahontan Regional Water Quality Control Board has indicated that a natural or manmade geomorphological feature need only the ability to convey water to meet their interpretation of California “Waters of the State” for this area.

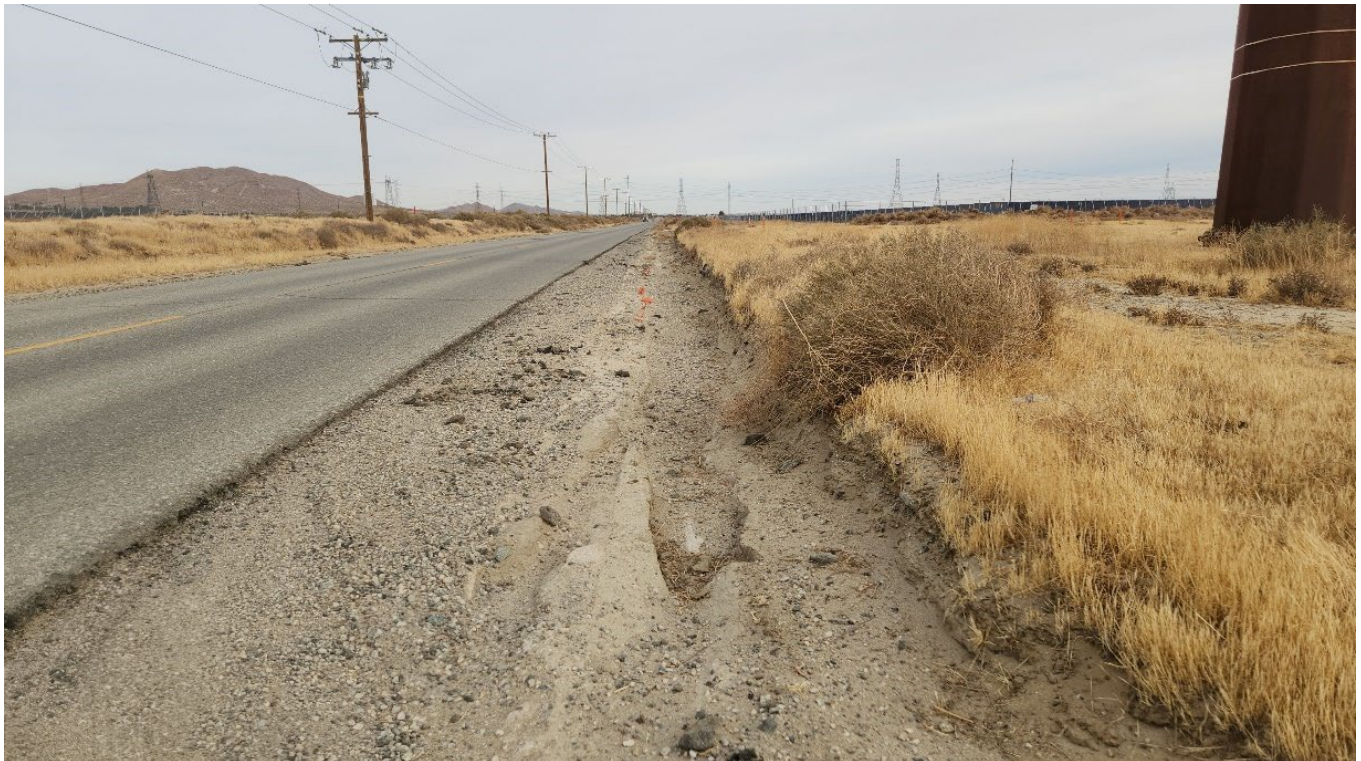
Photo Drainage 23b-1. Looking east at Drainage 23b, a roadside drainage ditch along the south side of Rosamond Boulevard.

Drainage 23b is classified as an active roadside drainage ditch located along the south side of Rosamond Boulevard, east of 110th Street W. This feature is predominantly bordered by disturbed/developed vegetation with no evidence of riparian communities (**Photo Drainage 23b-1**). Drainage 23b was dry during all site visits with minimal indication of flowing water. Drainage 23b is classified as a recommended state and federal non-jurisdictional feature as it is a roadside drainage ditch which does not carry a relatively permanent flow of water and does not connect to any jurisdictional waters. However, LRWQCB has indicated that a natural or manmade geomorphological feature need only the ability to convey water to meet their interpretation of California “Waters of the State” for this area.

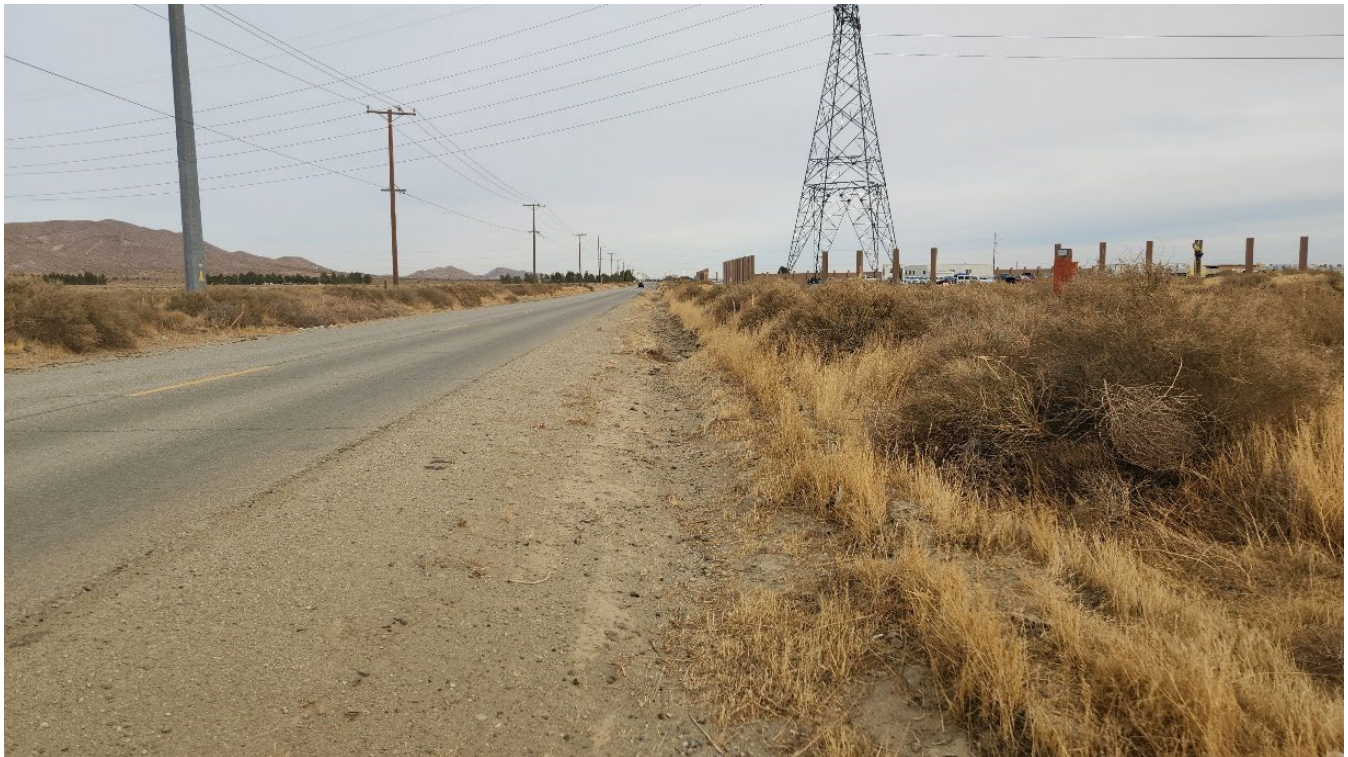
Photo Drainage 24-1. Looking East at Drainage 24, a roadside drainage ditch along the south side of Rosamond Boulevard.

Drainage 24 is classified as a roadside drainage ditch located along the south side of Rosamond Boulevard, east of Los Angeles DWP Easement Road. This feature is predominantly bordered by disturbed/developed vegetation with scattered allscale scrub and no evidence of riparian communities (**Photo Drainage 24-1**). Drainage 24 was dry during all site visits with minimal indication of flowing water. Drainage 24 is classified as a recommended state and federal non-jurisdictional feature as it is a roadside drainage ditch which does not carry a relatively permanent flow of water and does not connect to any jurisdictional waters. However, LRWQCB has indicated that a natural or manmade geomorphological feature need only the ability to convey water to meet their interpretation of California “Waters of the State” for this area.

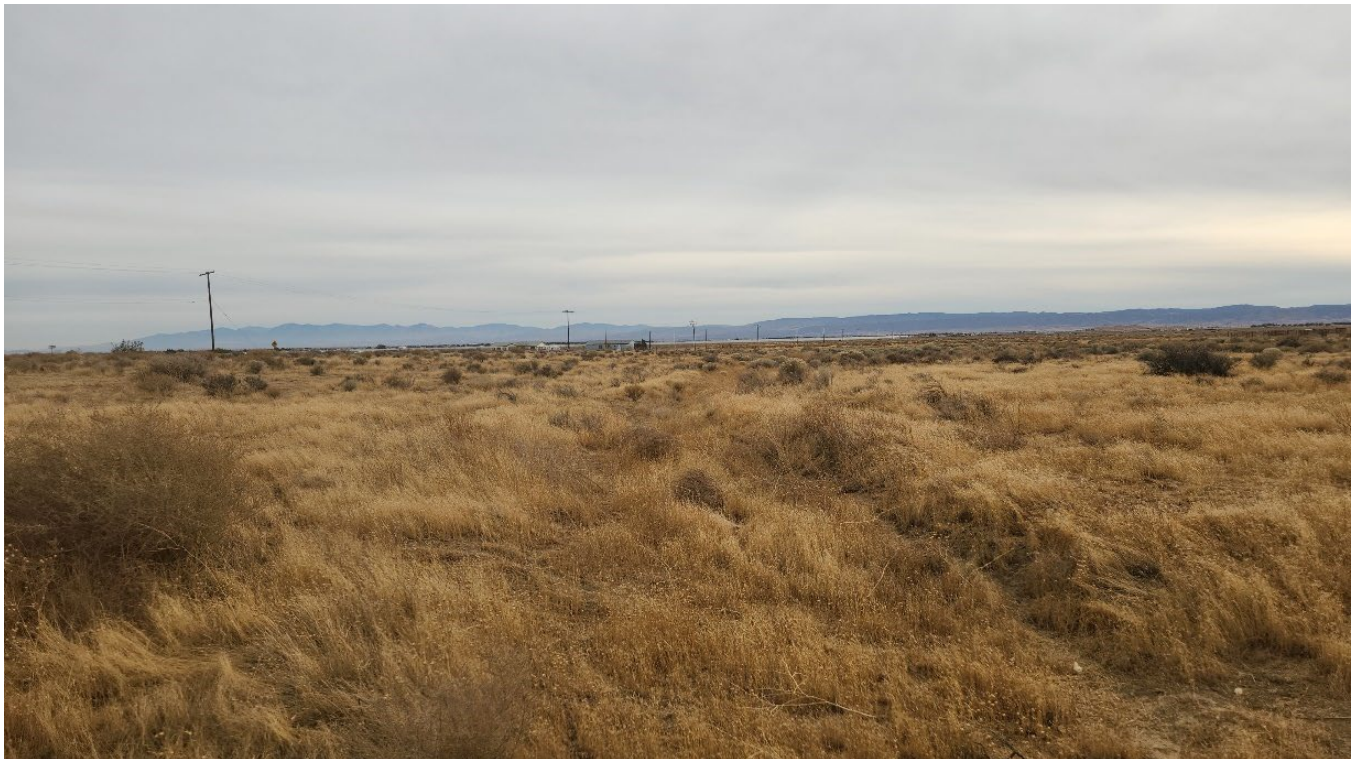
Photo Drainage 25-1. Looking northwest from the downstream portion of Drainage 25 toward the upstream near the south side of Rosamond Boulevard.

Drainage 25 is classified as an active ephemeral swale located on the south side of Rosamond Boulevard, west of 90th Street W. This feature flows north to south from its upstream at Rosamond Boulevard. The vegetation community observed at this feature consist of allscale scrub and disturbed/developed vegetation, with no evidence of riparian communities (**Photo Drainage 25-1**). Drainage 25 was dry during all site visits with minimal indication of flowing water. Drainage 25 is classified as a recommended state and federal non-jurisdictional feature as it does not carry a relatively permanent flow of water and does not connect to any jurisdictional waters. However, LRWQCB has indicated that a natural or manmade geomorphological feature need only the ability to convey water to meet their interpretation of California “Waters of the State” for this area.

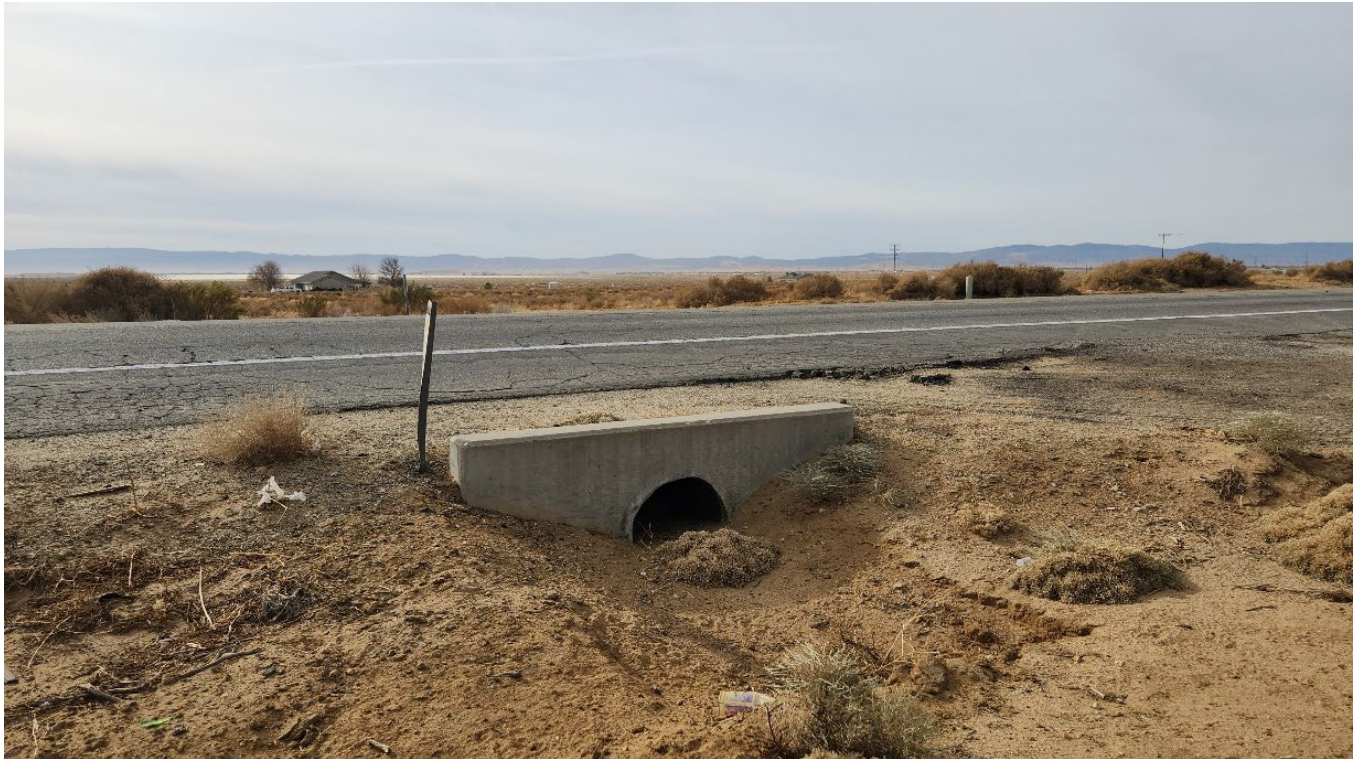
Photo Drainage 27-1. Looking south at Drainage 27, a culvert below Rosamond Boulevard just east of the intersection with 85th Street W.

Drainage 27 is an active underground culvert located beneath Rosamond Boulevard, east of 85th Street W. This feature flows north to south and is associated with predominantly disturbed/developed vegetation communities (**Photo Drainage 27-1**). Drainage 27 was dry during all site visits with minimal evidence of flowing water.

Drainage 27 is classified as a potential non-jurisdictional feature as it lacks riparian vegetation, does not carry a relatively permanent flow of water and does not connect to any jurisdictional waters. However, LRWQCB has indicated that a natural or manmade geomorphological feature need only the ability to convey water to meet their interpretation of California “Waters of the State” for this area.

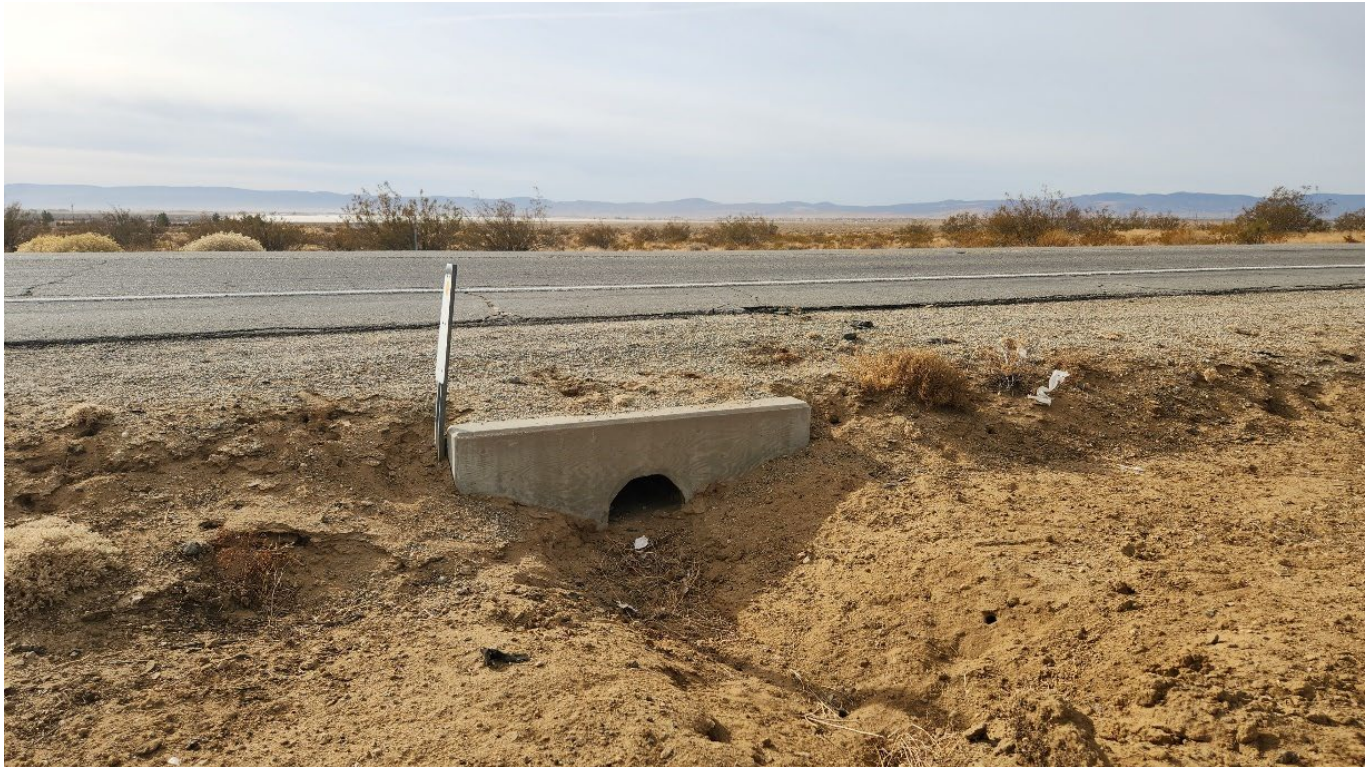
Photo Drainage 28-1. Looking south at Drainage 28, a culvert below Rosamond Boulevard just east of intersection with 83rd Street W.

Drainage 28 is an active underground culvert located beneath Rosamond Boulevard, east of 83rd Street. This feature flows north to south and is associated with predominantly disturbed/developed vegetation communities (**Photo Drainage 28-1**). Drainage 28 was dry during all site visits with minimal evidence of flowing water. Drainage 28 is classified as a recommended state and federal non-jurisdictional feature as it lacks riparian vegetation, does not carry a relatively permanent flow of water and does not connect to any jurisdictional waters. However, LRWQCB has indicated that a natural or manmade geomorphological feature need only the ability to convey water to meet their interpretation of California “Waters of the State” for this area.

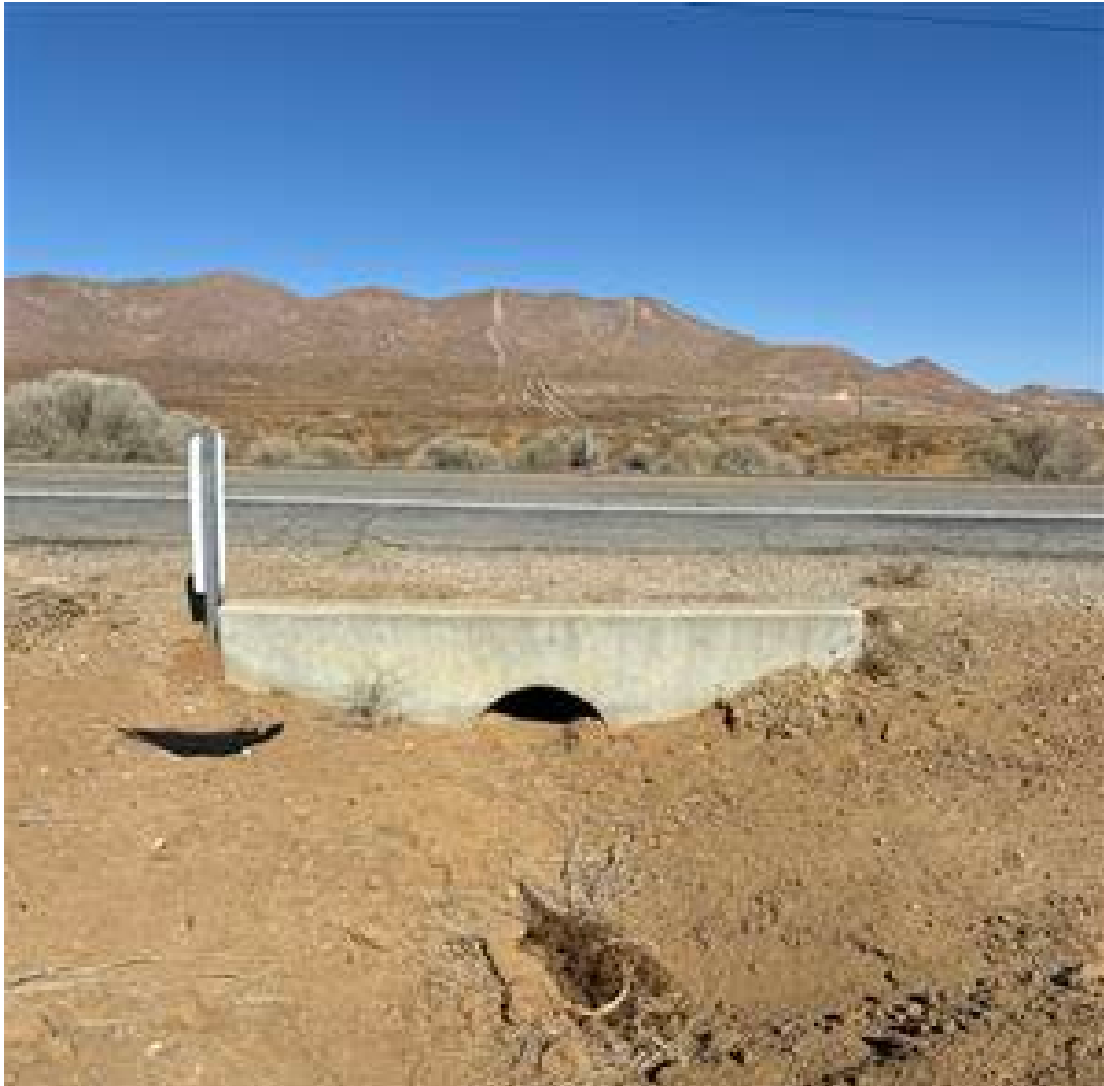
Photo Drainage 29-1. Looking north at Drainage 29 on the south side of Rosamond Boulevard pictured in the background.

Drainage 29 is an active underground culvert located beneath Rosamond Boulevard, west of 80th Street W. This feature flows north to south and is predominantly associated with rubber rabbitbrush scrub and disturbed/developed vegetation communities (**Photo Drainage 29-1**). Drainage 29 was dry during all site visits with no evidence of flowing water. Drainage 29 is classified as a recommended state and federal non-jurisdictional feature as it lacks riparian vegetation, does not carry a relatively permanent flow of water and does not connect to any jurisdictional waters. However, LRWQCB has indicated that a natural or manmade geomorphological feature need only the ability to convey water to meet their interpretation of California “Waters of the State” for this area.

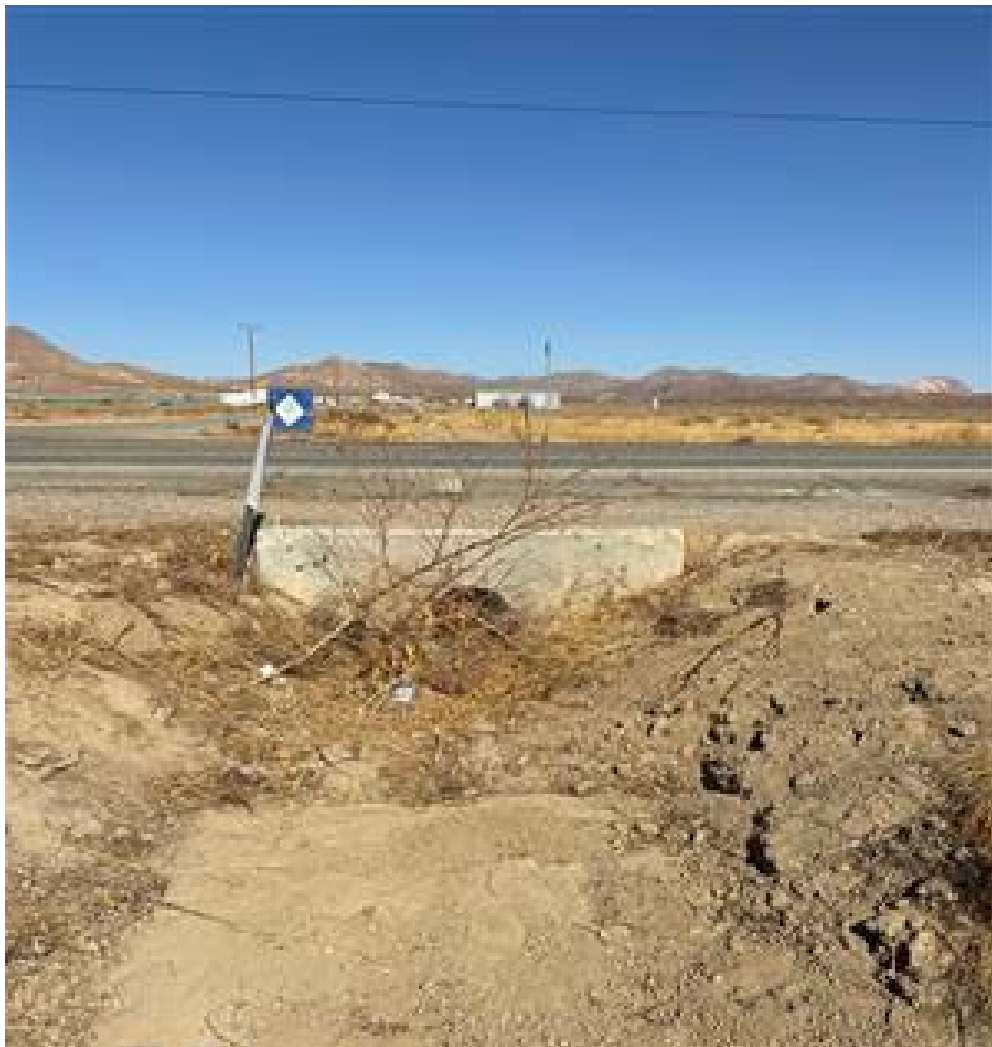
Photo Drainage 31-1. Looking north at Drainage 31 on the south side of Rosamond Boulevard pictured in the background.

Drainage 31 is classified as a dormant underground culvert located beneath Rosamond Boulevard, east of 70th Street W. This feature flows north to south from its upstream at the base of Horsethief Trail on the north side of Rosamond Boulevard and measured approximately 7 feet in width (**Photo Drainage 31-1**). Bordering vegetation is predominantly non-native grass and forbes, as well as disturbed/developed communities. Drainage 31 was dry during all site visits, with little indication of flowing water. Drainage 31 is classified as a recommended state and federal non-jurisdictional feature as it lacks riparian vegetation, does not carry a relatively permanent flow of water and does not connect to any jurisdictional waters. However, LRWQCB has indicated that a natural or manmade geomorphological feature need only the ability to convey water to meet their interpretation of California "Waters of the State" for this area.

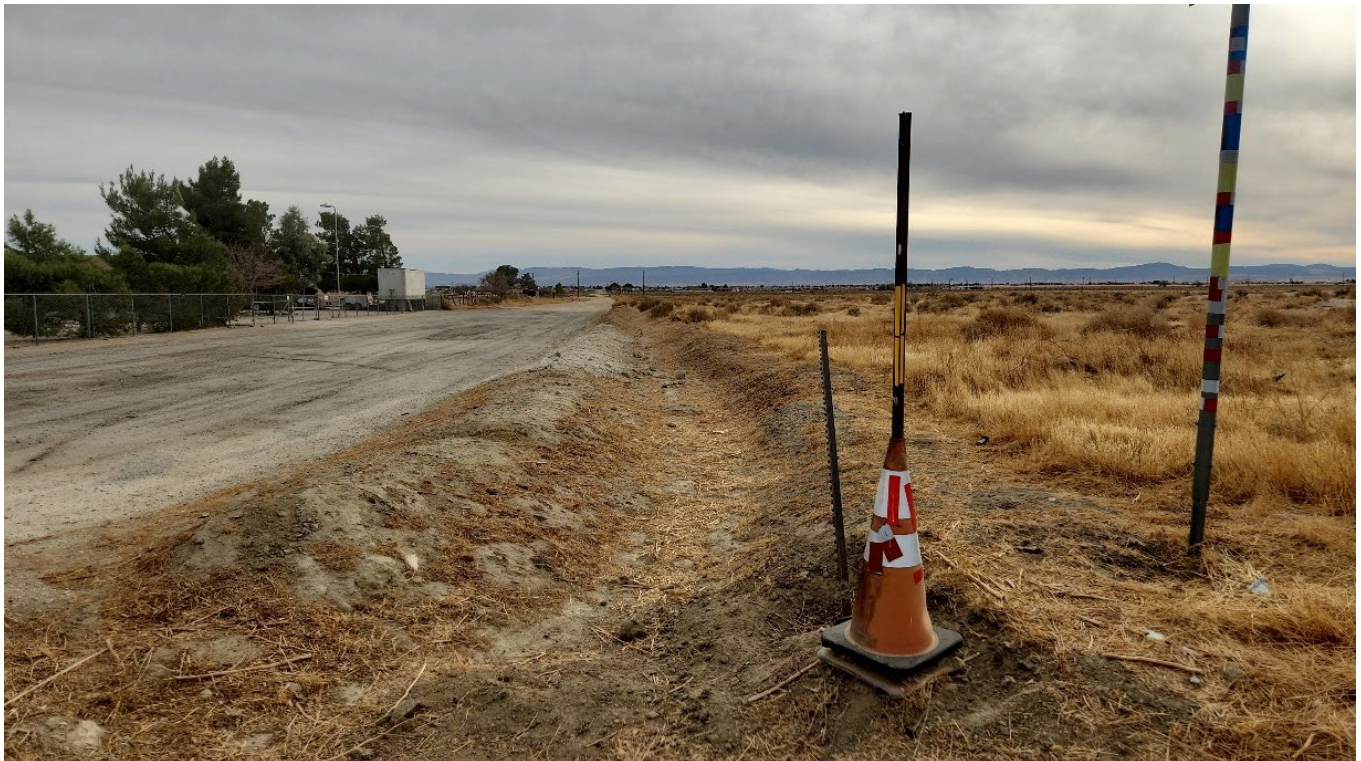
Photo Drainage 33-1. Looking south at upstream portion of Drainage 33, a roadside drainage ditch along the west side of 65th Street W. Depicted is an artificially created berm.

Drainage 33 is classified as an active roadside drainage ditch along the west side of 65th Street W. This feature flows north to south from the south side of Rosamond Boulevard and is characterized by an artificial berm along its west bank. Bordering vegetation is comprised predominantly of disturbed/developed communities (**Photo Drainage 33-1**). This feature was dry during all site visits, with no indication of flowing water. Drainage 33 is classified as a recommended state and federal non-jurisdictional feature as it lacks riparian vegetation, does not carry a relatively permanent flow of water and does not connect to any jurisdictional waters. However, LRWQCB has indicated that a natural or manmade geomorphological feature need only the ability to convey water to meet their interpretation of California “Waters of the State” for this area.

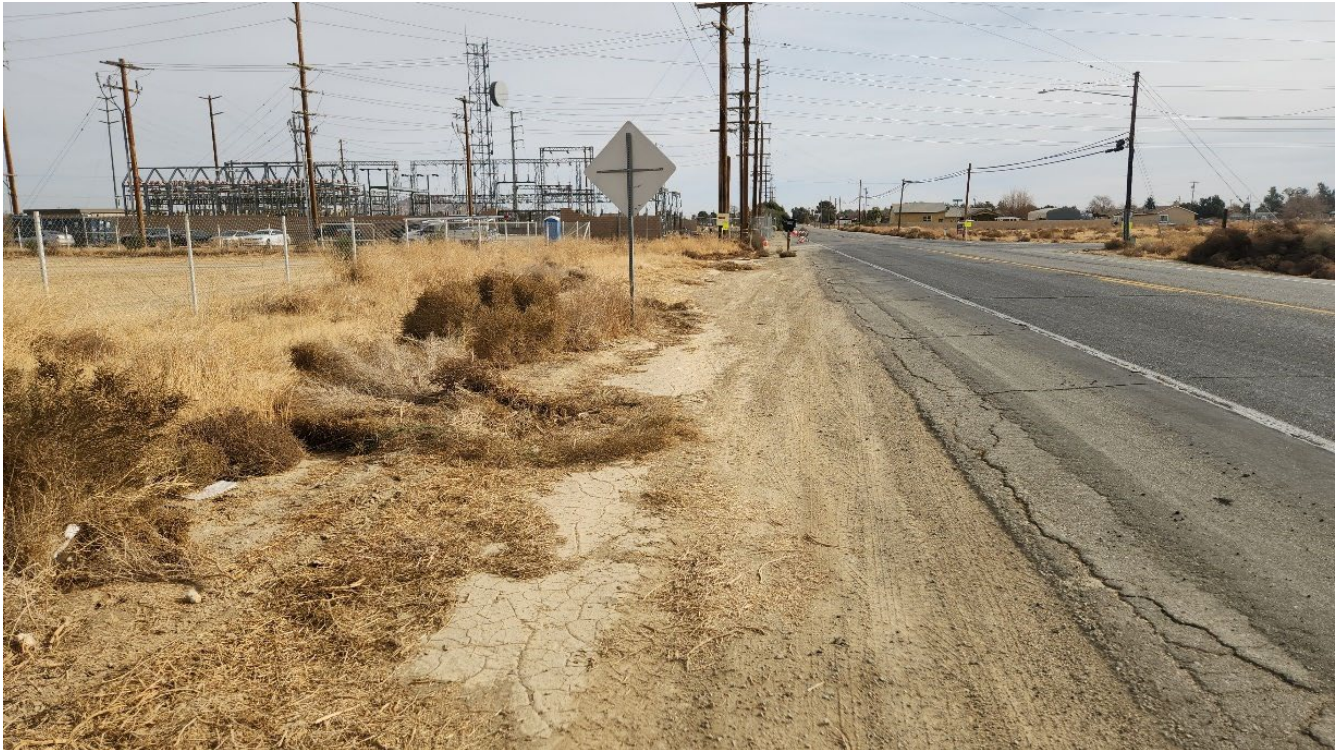
Photo Drainage 34-1. Looking east at Drainage 34, a roadside drainage ditch along the north side of Rosamond Boulevard toward the 60th Street W intersection.

Drainage 34 is classified as an active roadside drainage ditch along the north side of Rosamond Boulevard, west of the 60th Street W intersection. This feature is predominantly bordered by disturbed/developed vegetation communities (**Photo Drainage 34-1**). Drainage 34 was dry during all site visits with little indication of flowing water. Drainage 34 is classified as a recommended state and federal non-jurisdictional feature as it lacks riparian vegetation, does not carry a relatively permanent flow of water and does not connect to any jurisdictional waters. However, LRWQCB has indicated that a natural or manmade geomorphological feature need only the ability to convey water to meet their interpretation of California “Waters of the State” for this area.

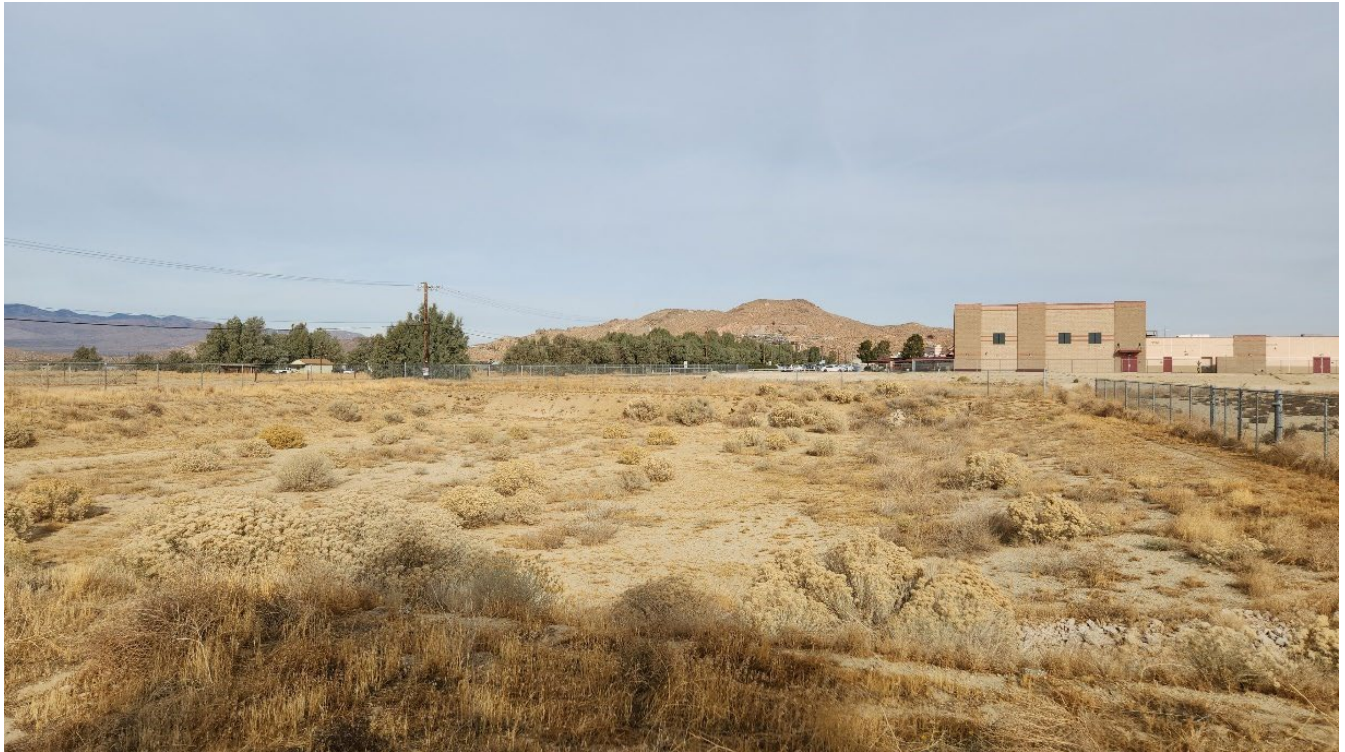
Photo Drainage 35-1. Looking northwest at Drainage 35. Photo was taken from the edge of the southeast portion from the north side of Rosamond Boulevard.

Drainage 35 is classified as an active detention basin located northeast of the Rosamond Boulevard and Tropic Road intersection. This feature is dominated by disturbed/developed vegetation communities (**Photo Drainage 35-1**). Drainage 35 was dry during all site visits with no indication of flowing water. Drainage 35 is classified as a recommended state and federal non-jurisdictional feature as it lacks riparian vegetation, does not carry a relatively permanent flow of water and does not connect to any jurisdictional waters. However, LRWQCB has indicated that a natural or manmade geomorphological feature need only the ability to convey water to meet their interpretation of California “Waters of the State” for this area.

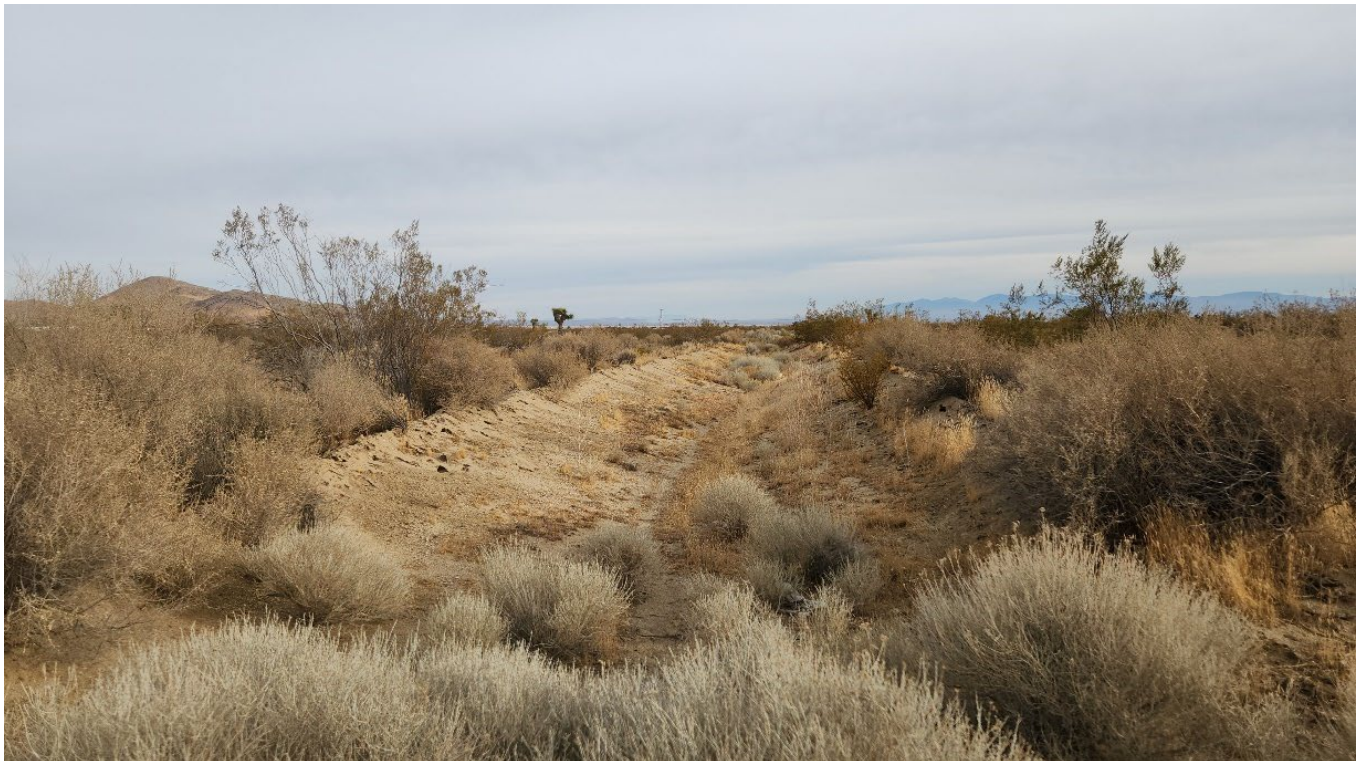
Photo Drainage 38-1. Looking North at the downstream portion of Drainage 38.

Drainage 38 is classified as an active artificial roadside flow diversion flowing south-east from Mojave Tropic Road. This feature is approximately 15 feet wide, with bordering vegetation comprised of allscale scrub and disturbed/developed communities (**Photo Drainage 38-1**). Drainage 38 was dry during all site visits with little indication of flowing water and is classified as a recommended state and federal non-jurisdictional feature as it is an artificial flow conveyance which lacks riparian vegetation, does not carry a relatively permanent flow of water and does not connect to any jurisdictional waters. However, LRWQCB has indicated that a natural or manmade geomorphological feature need only the ability to convey water to meet their interpretation of California “Waters of the State” for this area.
