| DOCKETED | |
|---|--|
| Project Title: | Willow Rock Energy Storage Center |
| Document Title: | Willow Rock Jurisdictional Drainages Additional Information Text |

**Additional Information Related to DR128 -
Delineation of Jurisdictional Waters**
Willow Rock Energy Storage Center (21-AFC-02)

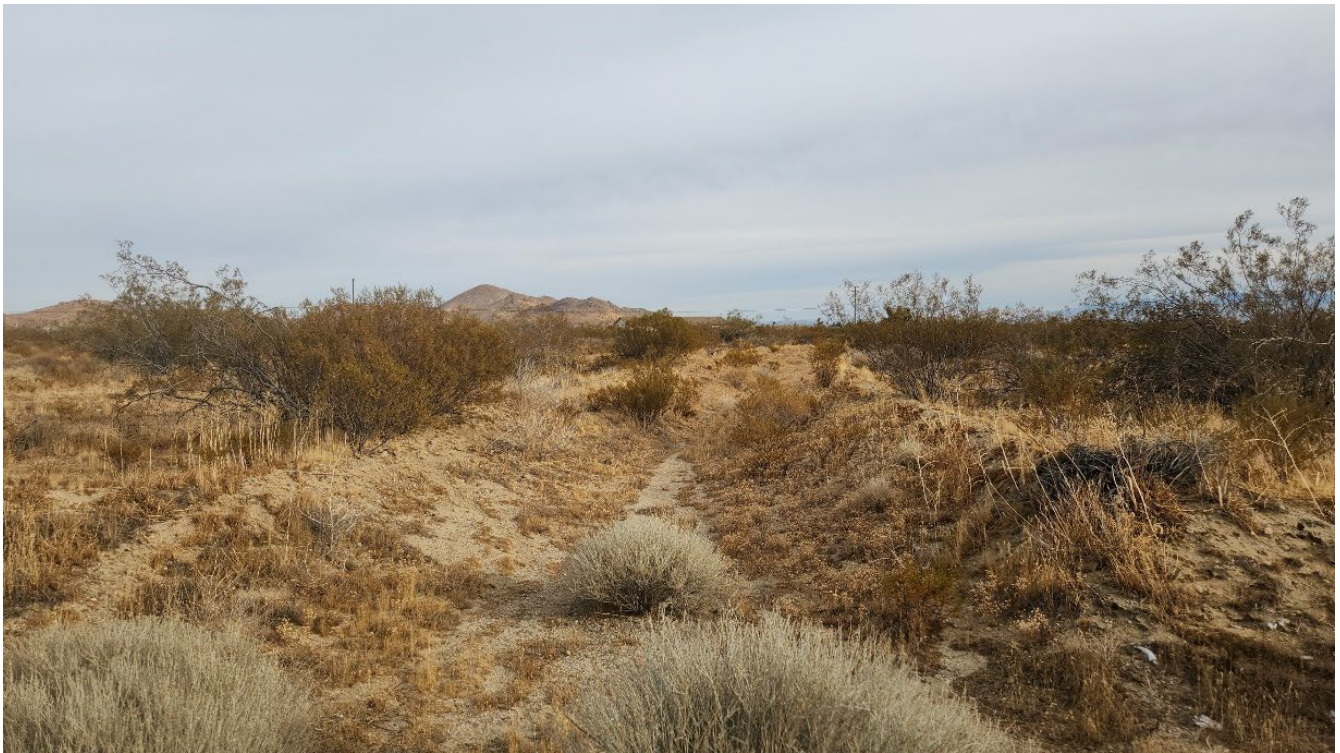
Photo Drainage 39-1. Looking northeast at the downstream portion of Drainage 39.

Drainage 39 is classified as an active artificial roadside flow diversion flowing south-east from Mojave Tropic Road. This feature is approximately 15 feet wide, with bordering vegetation comprised of creosote bush-white bursage scrub and disturbed/developed communities (**Photo Drainage 39-1**). Drainage 39 was dry during all site visits with little indication of flowing water. This Feature is classified as a recommended state and federal non-jurisdictional feature as it is an artificial flow conveyance that lacks riparian vegetation, does not carry a relatively permanent flow of water and does not connect to any jurisdictional waters. However, LRWQCB has indicated that a natural or manmade geomorphological feature need only the ability to convey water to meet their interpretation of California “Waters of the State” for this area.

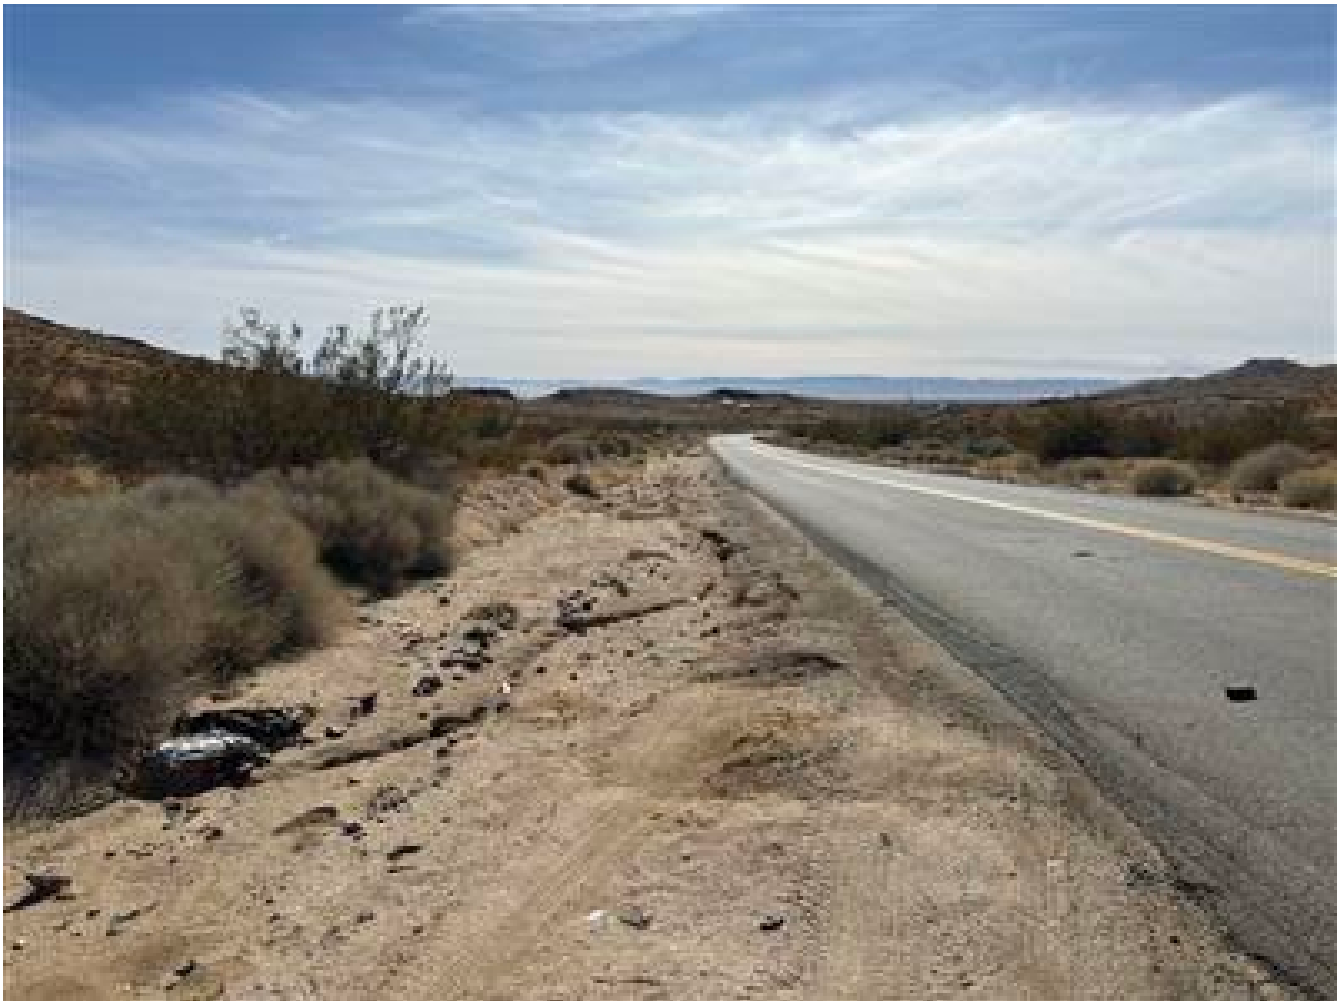
Photo Drainage 43a-1. Looking south at Drainage 43a.

Drainage 43a is an active roadside drainage ditch along the east side of Mojave Tropic Road, spanning across its intersection with Dawn Road. This feature has bordering vegetation comprised of creosote bush-white bursage scrub, allscale scrub and disturbed/developed communities (**Photo Drainage 43a-1**). Drainage 43a was dry during all site visits with little indication of flowing water. Drainage 43a is classified as a recommended state and federal non-jurisdictional feature as it lacks riparian vegetation, does not carry a relatively permanent flow of water and does not connect to any jurisdictional waters. However, LRWQCB has indicated that a natural or manmade geomorphological feature need only the ability to convey water to meet their interpretation of California “Waters of the State” for this area.

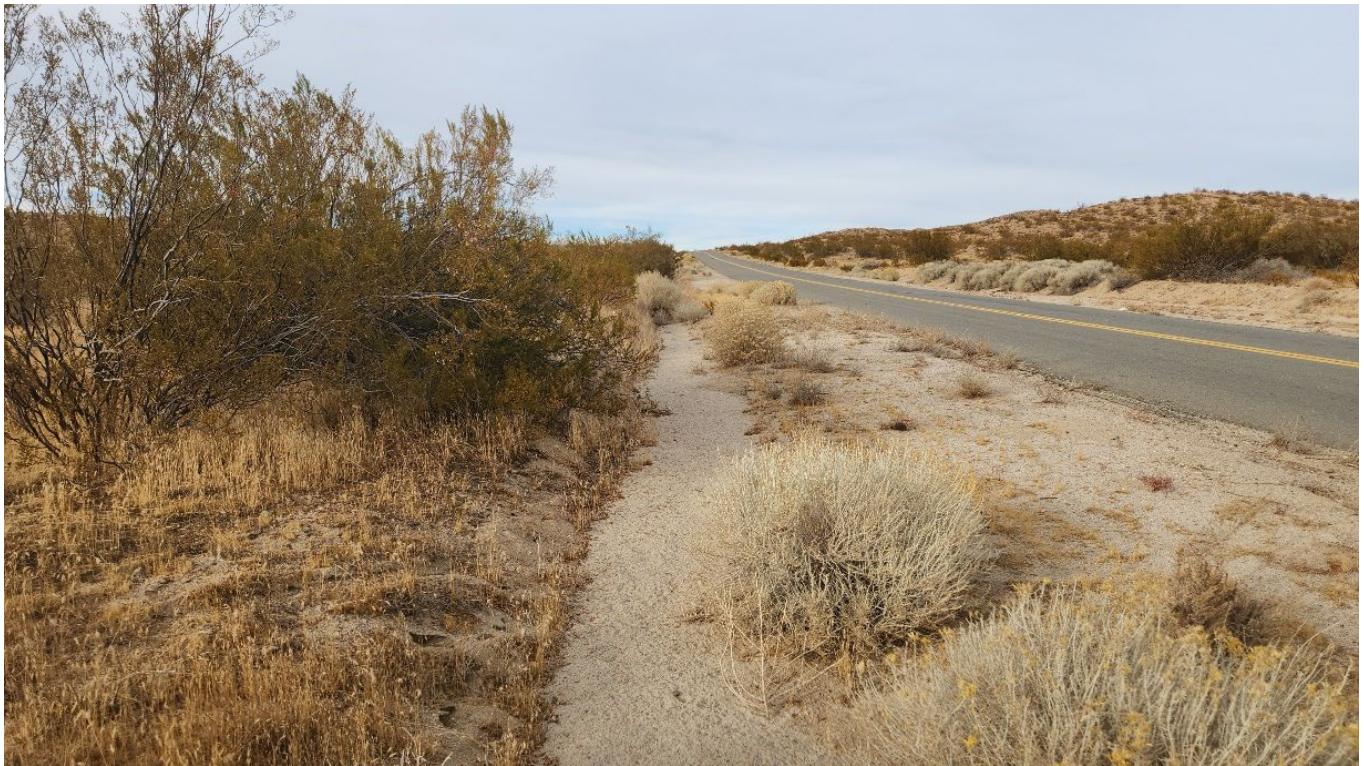
Photo Drainage 43b-1. Looking north at Drainage 43b, a roadside drainage ditch along the west side of Mojave Tropic Road.

Drainage 43b is classified as an active roadside drainage ditch located along the west side of Mojave Tropic Road, across from Drainage 43a. This feature is bordered predominantly by disturbed/developed vegetation with scattered creosote bush and white bursage shrubs (**Photo Drainage 43b-1**). Drainage 43b was dry during all site visits with little indication of flowing water. Drainage 43b is classified as a recommended state and federal non-jurisdictional feature as it lacks riparian vegetation, does not carry a relatively permanent flow of water and does not connect to any jurisdictional waters. However, LRWQCB has indicated that a natural or manmade geomorphological feature need only the ability to convey water to meet their interpretation of California “Waters of the State” for this area.

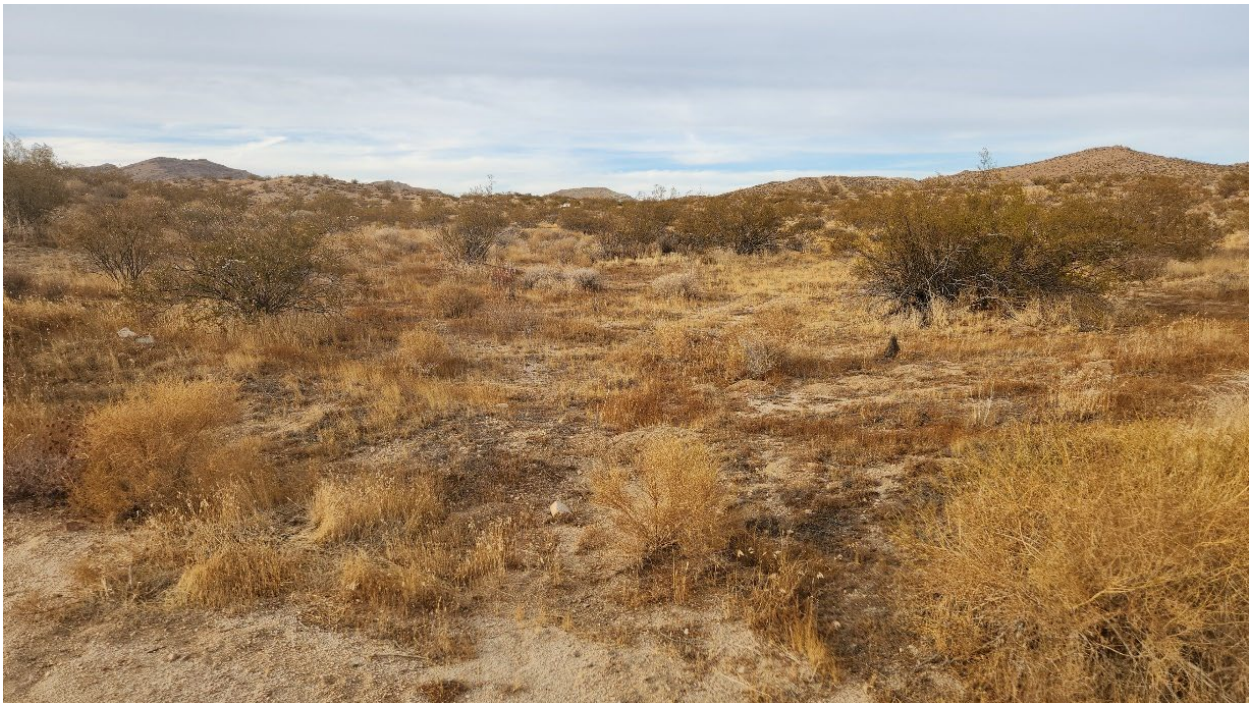
Photo Drainage 44a-1. Looking north from downstream of Drainage 44a on the north side of Dawn Road.

Drainage 44a is classified as an active ephemeral swale located on the north side of the western portion of Dawn Road, near Mojave Tropico Road. This feature has a flow direction of north to south and is dominated by creosote bush-white bursage scrub and disturbed/developed vegetation communities (**Photo Drainage 44a-1**). Drainage 44a was dry during all site visits with little indication of flowing water. Drainage 44a is classified as a recommended state and federal non-jurisdictional feature as it lacks riparian vegetation, does not carry a relatively permanent flow of water and does not connect to any jurisdictional waters. However, LRWQCB has indicated that a natural or manmade geomorphological feature need only the ability to convey water to meet their interpretation of California “Waters of the State” for this area.

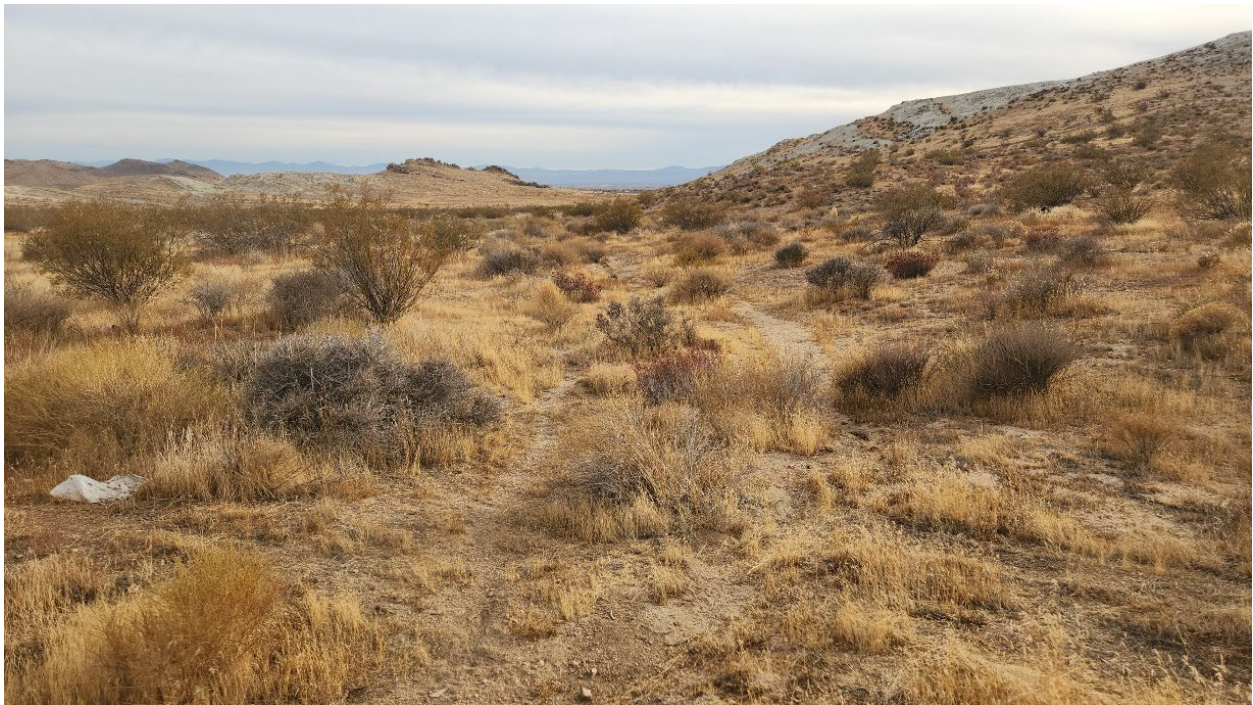
Photo Drainage 44b-1. Looking south from the upstream of Drainage 44b on the south side of Dawn Road.

Drainage 44b is classified as an active ephemeral swale located on the south side of the western portion of Dawn Road, across from Drainage 44a. This feature has a flow direction of north to south and a width of approximately 30 inches in some areas (**Photo Drainage 44b-1**). Drainage 44b is dominated by creosote bush-white bursage scrub and was dry during all site visits with little indication of flowing water. Drainage 44b is classified as a recommended state and federal non-jurisdictional feature as it lacks riparian vegetation, does not carry a relatively permanent flow of water and does not connect to any jurisdictional waters. However, LRWQCB has indicated that a natural or manmade geomorphological feature need only the ability to convey water to meet their interpretation of California “Waters of the State” for this area.

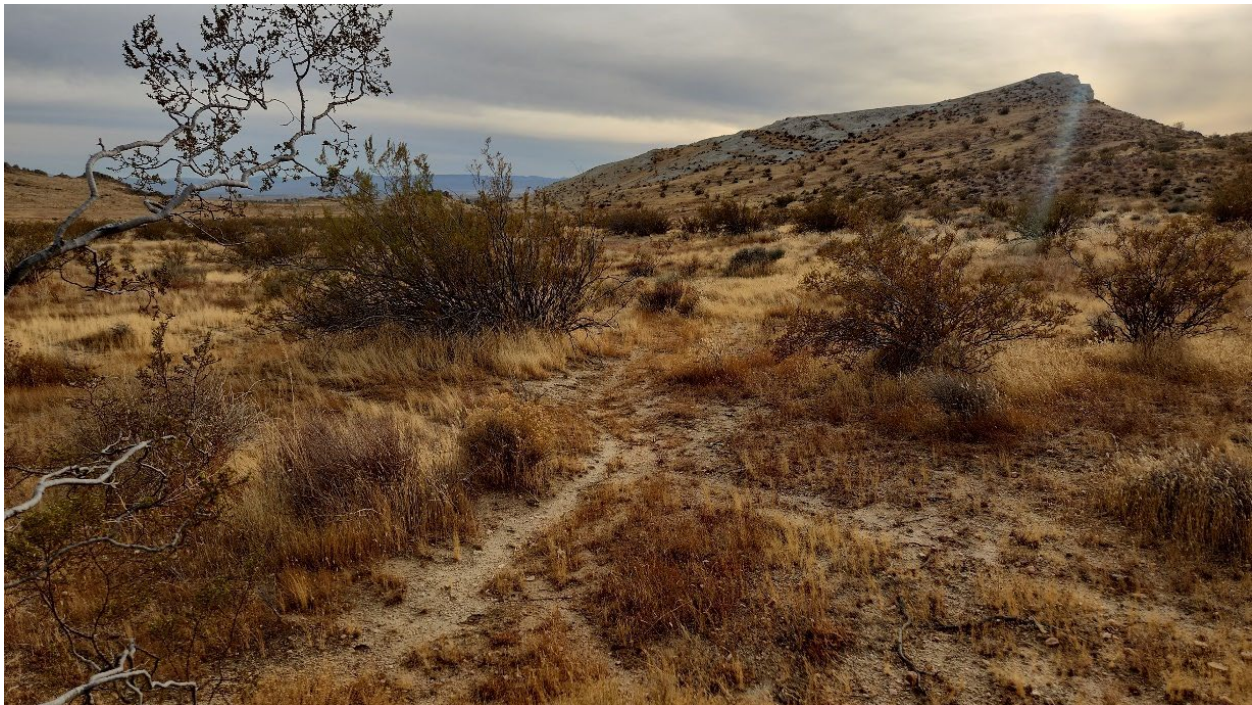
Photo Drainage 45-1. Looking southwest from upstream of Drainage 45 on the south side of Dawn Road.

Drainage 45 is classified as an active ephemeral swale located on the south side of the western portion of Dawn Road. This feature has a flow direction of north to south and is characterized by a gap in vegetation approximately 4 inches wide (**Photo Drainage 45-1**). Drainage 45 is dominated by creosote bush-white bursage scrub and was dry during all site visits with little indication of flowing water. Drainage 45 is classified as a potential non-jurisdictional feature as it lacks riparian vegetation, does not carry a relatively permanent flow of water and does not connect to any jurisdictional waters. However, the LRWQCB has indicated that a natural or manmade geomorphological feature need only the ability to convey water to meet their interpretation of California “Waters of the State” for this area.

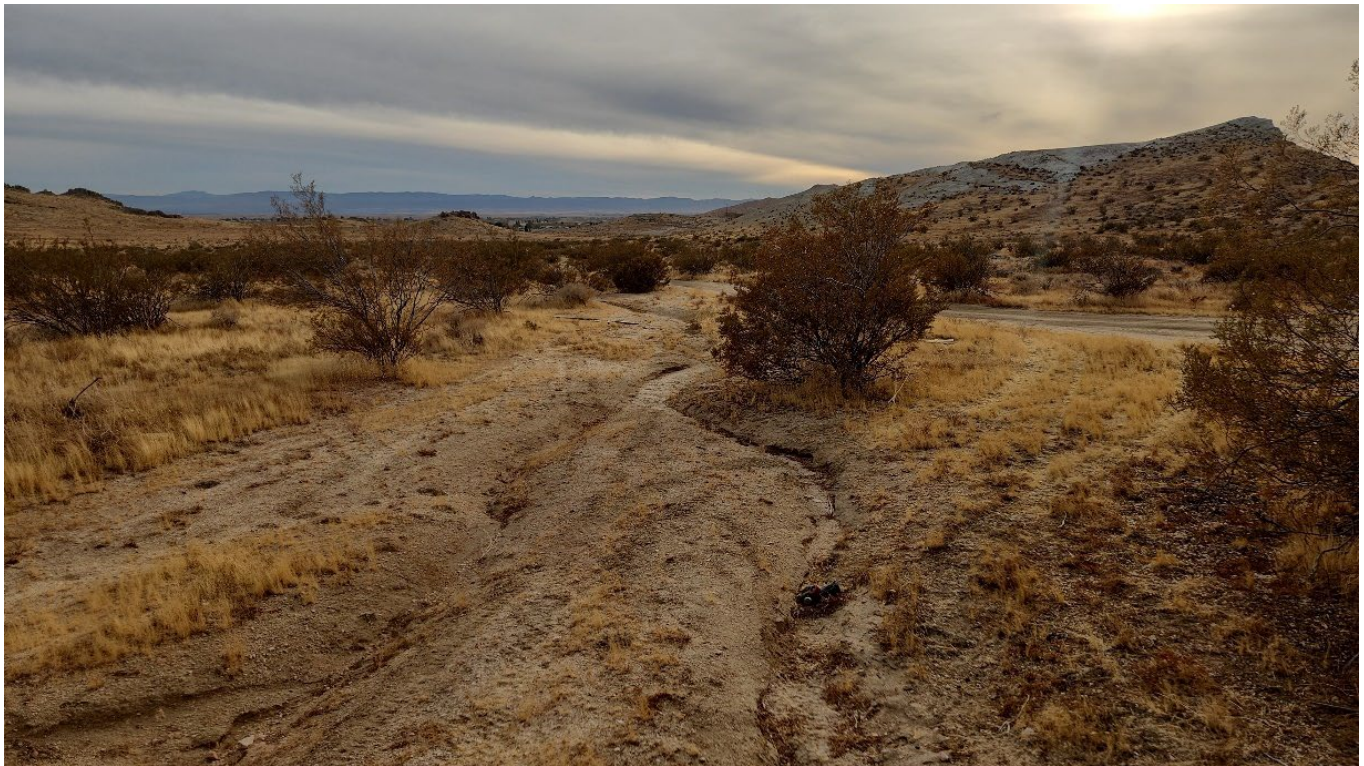
Photo Drainage 46-1. Looking southwest upstream of Drainage 46 on the south side of Dawn Road intersection with Budlong Avenue.

Drainage 46 is classified as an active ephemeral swale located on the south side of the western part of Dawn Road near its intersection with Budlong Avenue. This feature flows north to south and is characterized by a meandering channel approximately 17 inches wide (**Photo Drainage 46-1**). Bordering vegetation is dominated by disturbed/developed vegetation communities. This drainage was dry during all site visits with little indication of flowing water. Drainage 46 is classified as a recommended state and federal non-jurisdictional feature as it lacks riparian vegetation, does not carry a relatively permanent flow of water and does not connect to any jurisdictional waters. However, LRWQCB has indicated that a natural or manmade geomorphological feature need only the ability to convey water to meet their interpretation of California “Waters of the State” for this area.

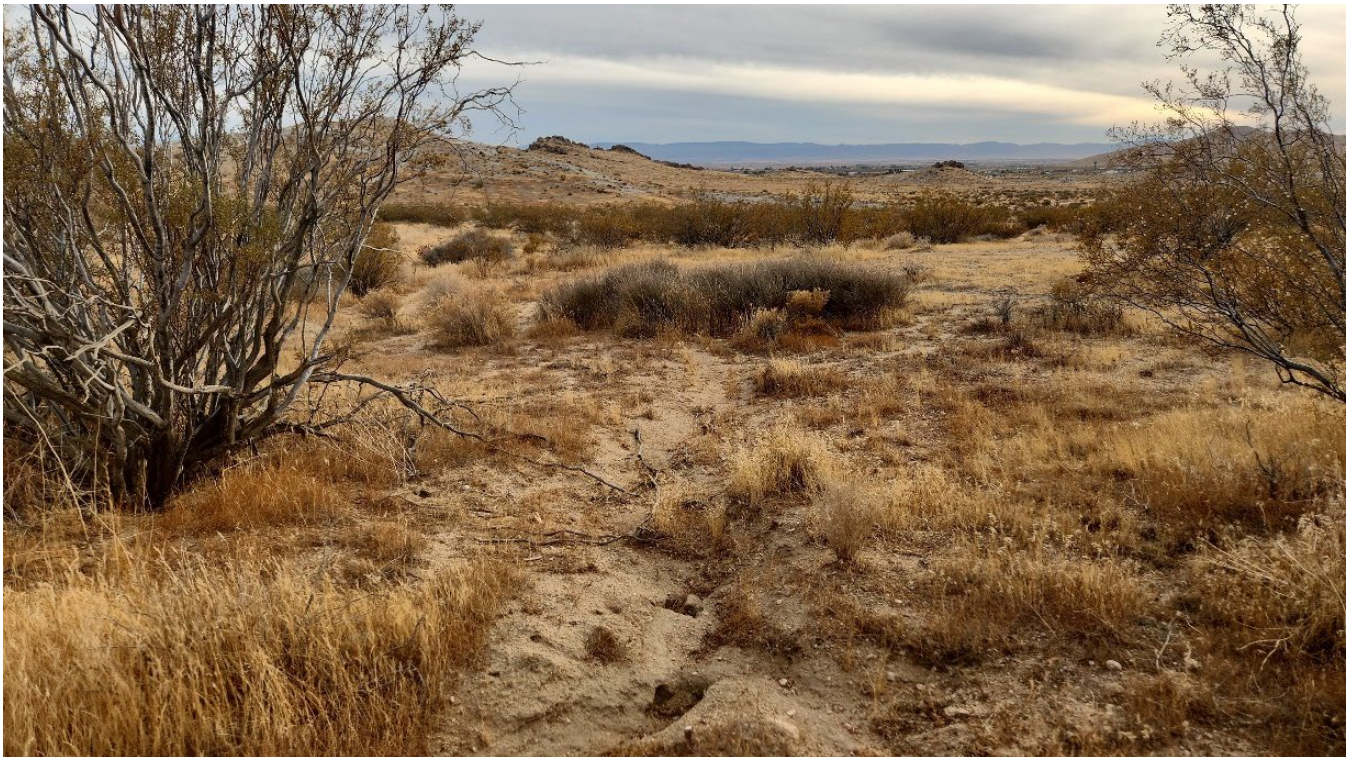
Photo Drainage 47-1. Looking south upstream of Drainage 47 on the south side of Dawn Road.

Drainage 47 is classified as an active ephemeral swale located on the south side of the western portion of Dawn Road. This feature flows north to south and is characterized by a gap in vegetation approximately 12 inches wide (**Photo Drainage 47-1**). Bordering vegetation is dominated by creosote bush-white bursage scrub and disturbed/developed vegetation communities. This feature was dry during all site visits with little indication of flowing water. Drainage 47 is classified as a potential non-jurisdictional feature as it lacks riparian vegetation, does not carry a relatively permanent flow of water and does not connect to any jurisdictional waters. However, LRWQCB has indicated that a natural or manmade geomorphological feature need only the ability to convey water to meet their interpretation of California “Waters of the State” for this area.

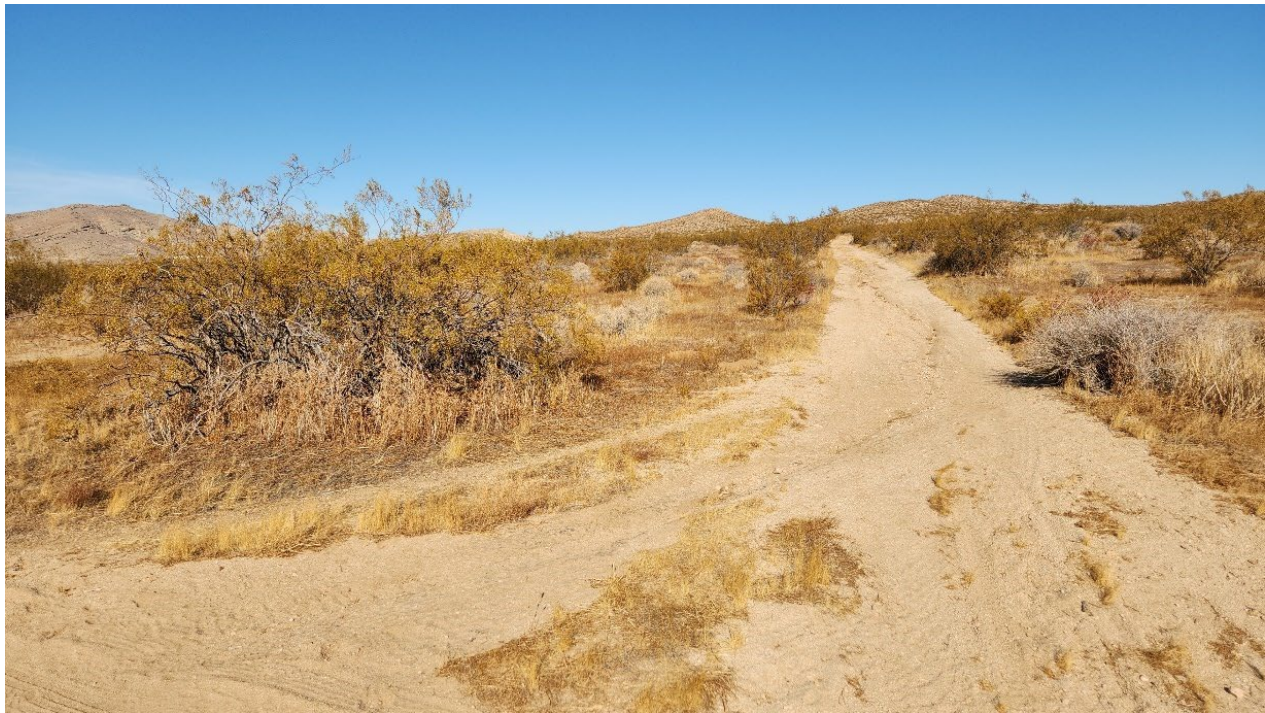
Photo Drainage 48-1. Looking west at Drainage 48, a roadside drainage ditch on an unnamed access road intersecting the north side of Dawn Road.

Drainage 48 is classified as an active roadside swale along the western side of an unnamed access road on the north side of Dawn Road. This feature flows north to south and is approximately 12 inches wide (**Photo Drainage 48-1**). Bordering vegetation include creosote bush-white bursage scrub and disturbed/developed vegetation communities. This feature was dry during all site visits with no indication of flowing water. Drainage 48 is classified as a recommended state and federal non-jurisdictional feature as it lacks riparian vegetation, does not carry a relatively permanent flow of water and does not connect to any jurisdictional waters. However, LRWQCB has indicated that a natural or manmade geomorphological feature need only the ability to convey water to meet their interpretation of California “Waters of the State” for this area.

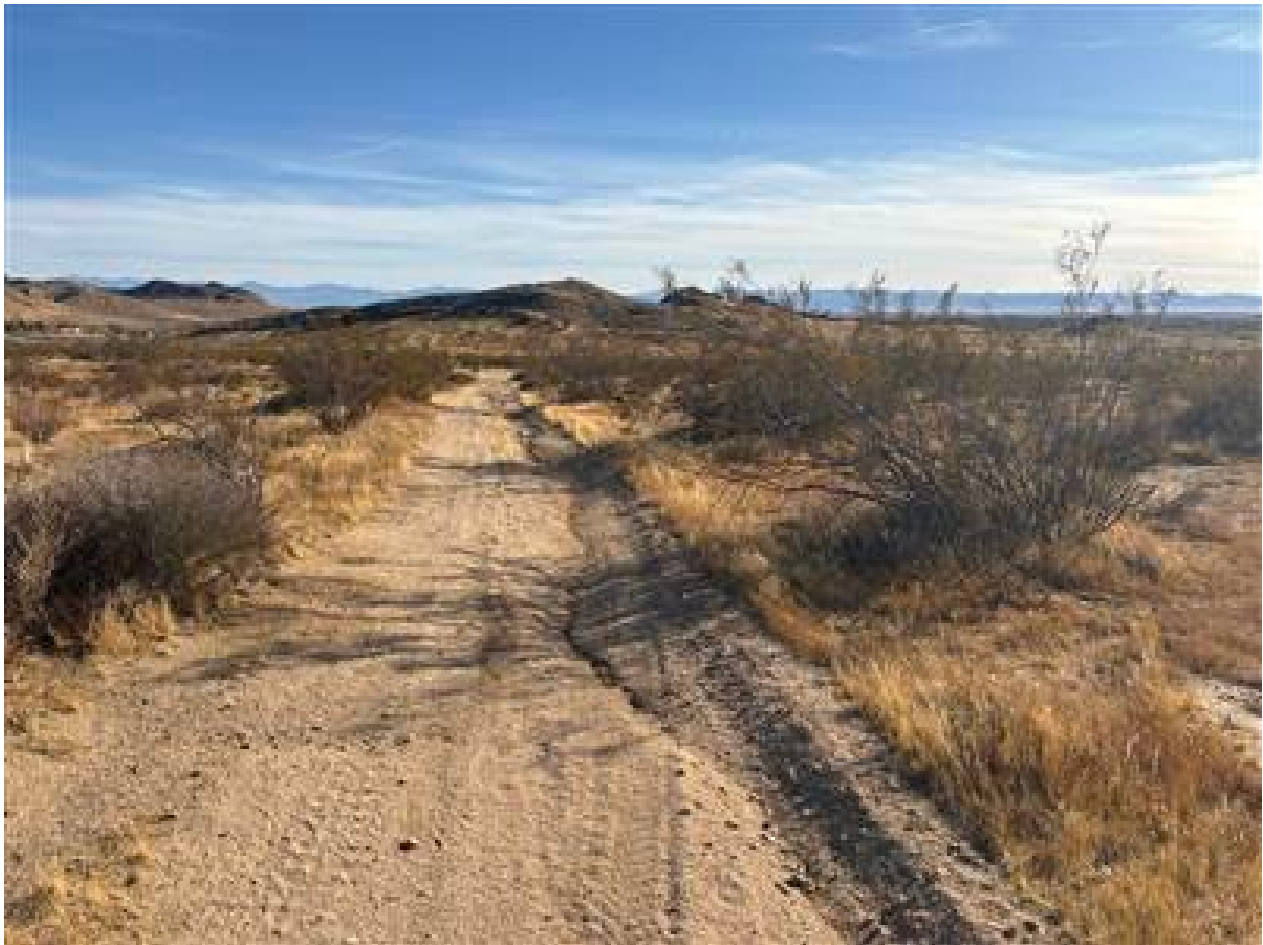
Photo Drainage 49-1. Looking northeast at Drainage 49 on the north side of Dawn Road.

Drainage 49 is classified as an active ephemeral swale located along the east side of an unnamed access road on the north side of Dawn Road. This feature flows north to south and is approximately 20 inches wide (**Photo Drainage 49-1**). Bordering vegetation include creosote bush-white bursage scrub and disturbed/developed vegetation communities. This feature was dry during all site visits with limited evidence of scouring. Drainage 49 is classified as a recommended state and federal non-jurisdictional feature as it lacks riparian vegetation, does not carry a relatively permanent flow of water and does not connect to any jurisdictional waters. However, LRWQCB has indicated that a natural or manmade geomorphological feature need only the ability to convey water to meet their interpretation of California “Waters of the State” for this area.

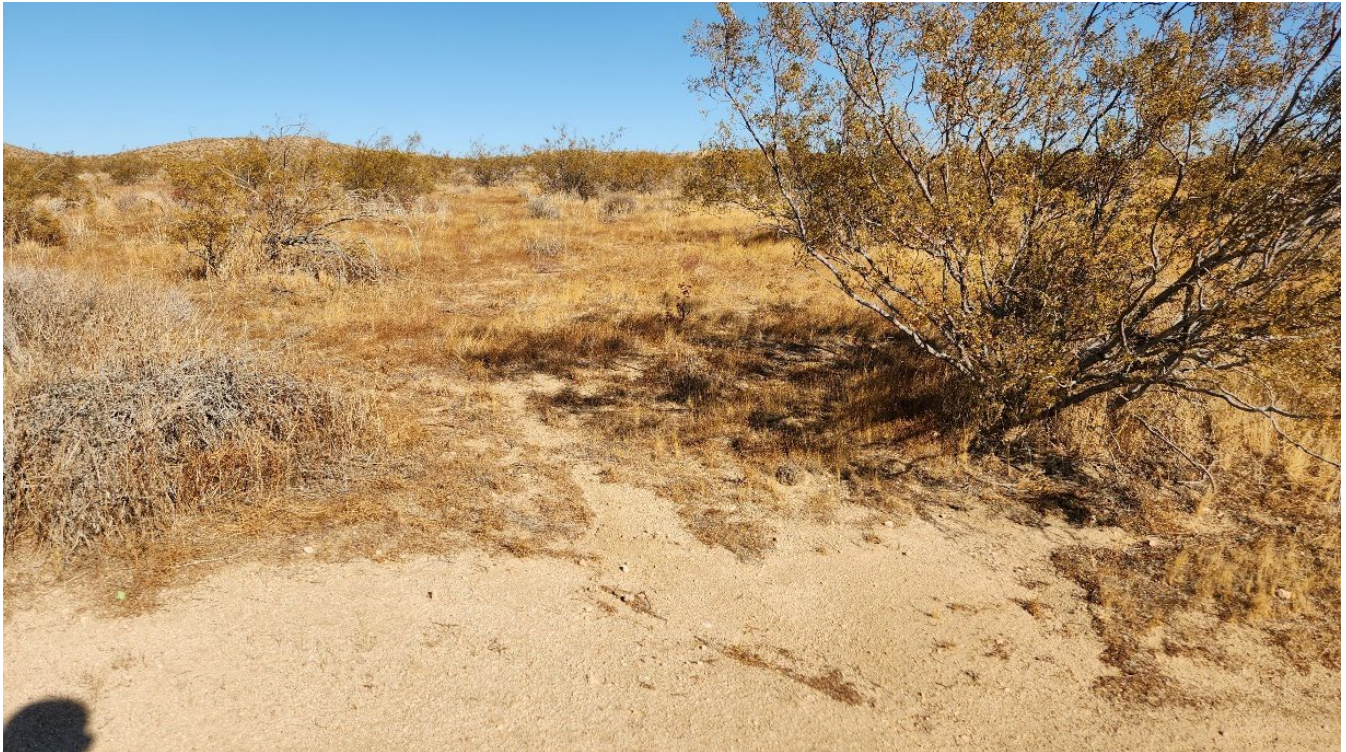
Drainage 50 is classified as an active ephemeral swale located predominantly on the south side of Dawn Road. This feature flows north to south and is bordered by creosote bush-white bursage scrub and disturbed/developed vegetation communities (**Photo Drainage 50-1**). This feature was dry during all site visits with no indication of flowing water. Drainage 50 is classified as a recommended state and federal non-jurisdictional feature as it lacks riparian vegetation, does not carry a relatively permanent flow of water and does not connect to any jurisdictional waters. However, LRWQCB has indicated that a natural or manmade geomorphological feature need only the ability to convey water to meet their interpretation of California “Waters of the State” for this area.

Photo Drainage 50-1. Looking north at upstream of Drainage 50 on the north side of Dawn Road.

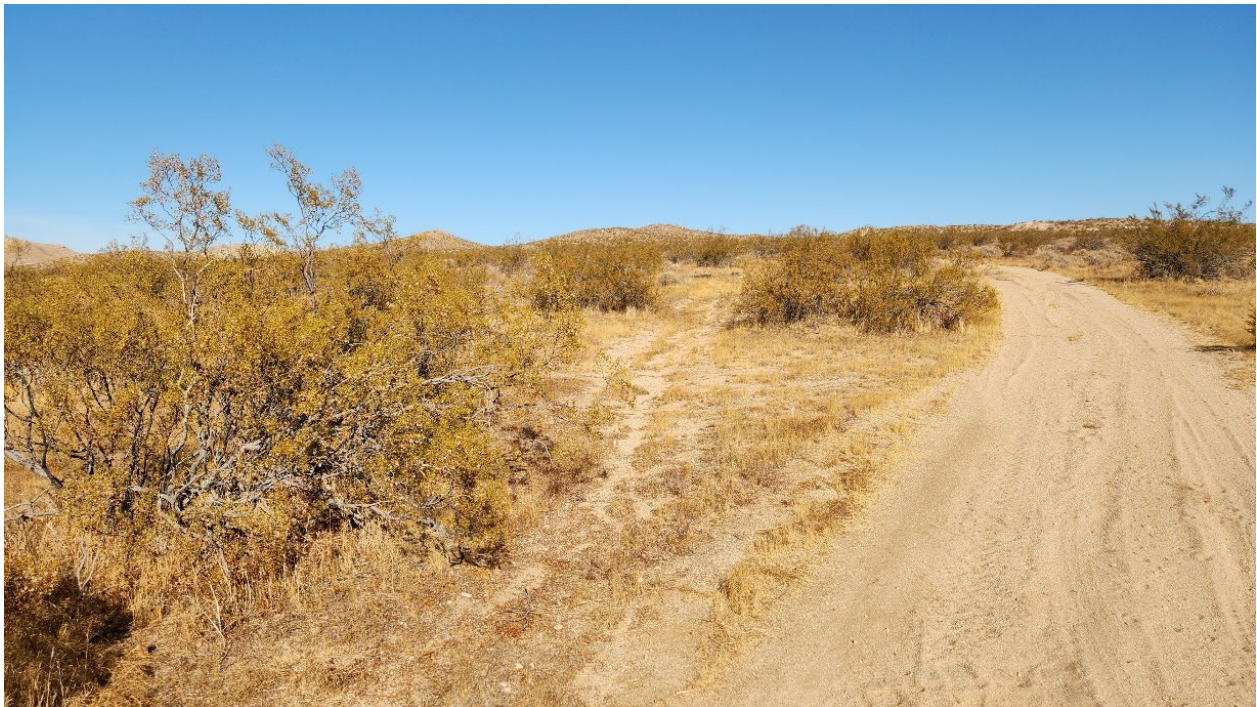
Drainage 51 is classified as an active ephemeral swale located across Dawn Road. This feature flows south from its upstream on the northern side of Dawn Road toward its downstream near Beaudette Road (**Photo Drainage 51-1**). Bordering vegetation consists of creosote bush-white bursage scrub and disturbed/developed vegetation communities. This feature was dry during all site visits, with little indication of flowing water. Drainage 51 is classified as a recommended state and federal non-jurisdictional feature as it lacks riparian vegetation, does not carry a relatively permanent flow of water and does not connect to any jurisdictional waters. However, LRWQCB has indicated that a natural or manmade geomorphological feature need only the ability to convey water to meet their interpretation of California “Waters of the State” for this area.

Photo Drainage 51-1. Looking north toward the upstream of Drainage 51 on the north side of Dawn Road. The feature runs parallel to an unnamed access road pictured on the right.

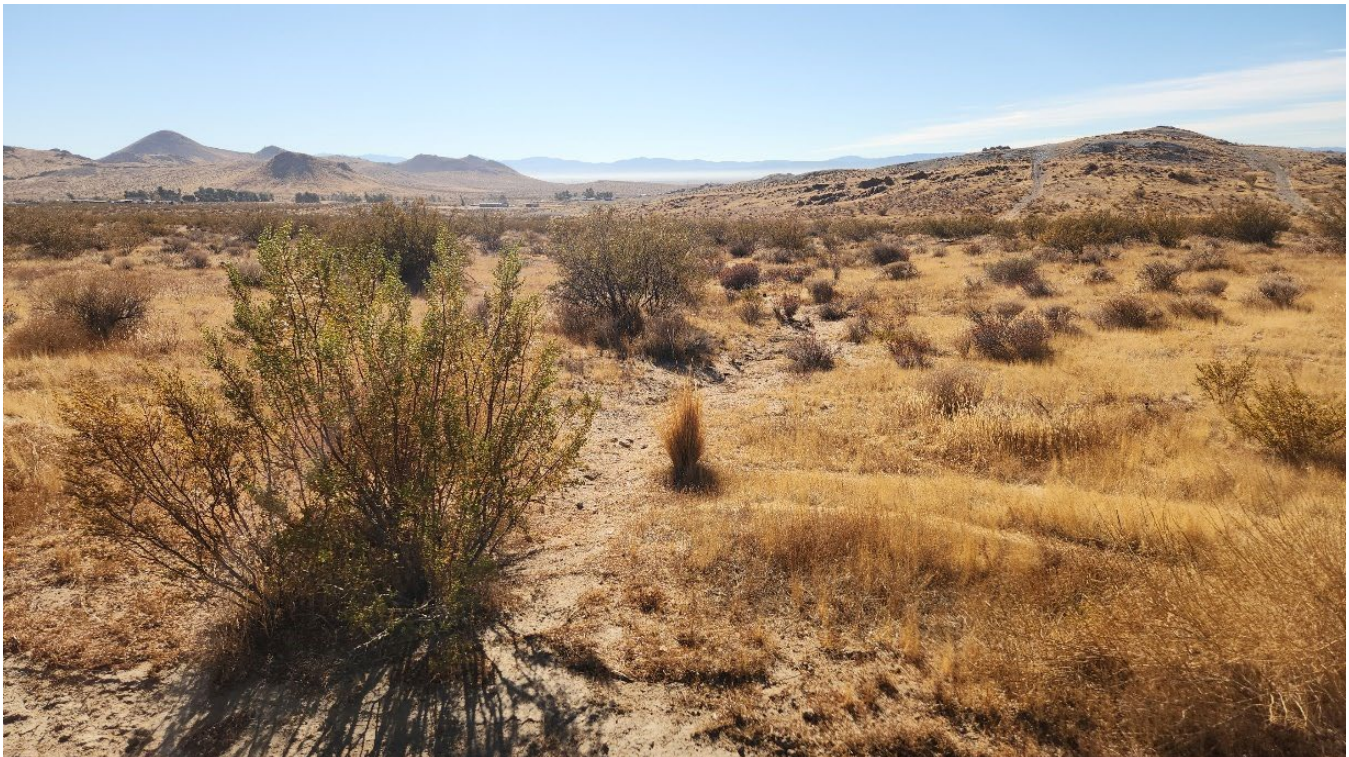
Drainage 52 is classified as an active ephemeral swale located on the south side of Dawn Road. This feature flows north to south and is characterized by a gap in vegetation with a bank width of approximately 6 inches (**Photo Drainage 52-1**). Bordering vegetation consists of creosote bush-white bursage scrub and disturbed/developed vegetation communities. This feature was dry during all site visits, with little indication of flowing water. Drainage 52 is classified as a state and federal non-jurisdictional feature as it lacks riparian vegetation, does not carry a relatively permanent flow of water and does not connect to any jurisdictional waters. However, LRWQCB has indicated that a natural or manmade geomorphological feature need only the ability to convey water to meet their interpretation of California “Waters of the State” for this area.

Photo Drainage 52-1. Looking south upstream of Drainage 52 from the south side of Dawn Road. Shallow depression can be seen between vegetation.

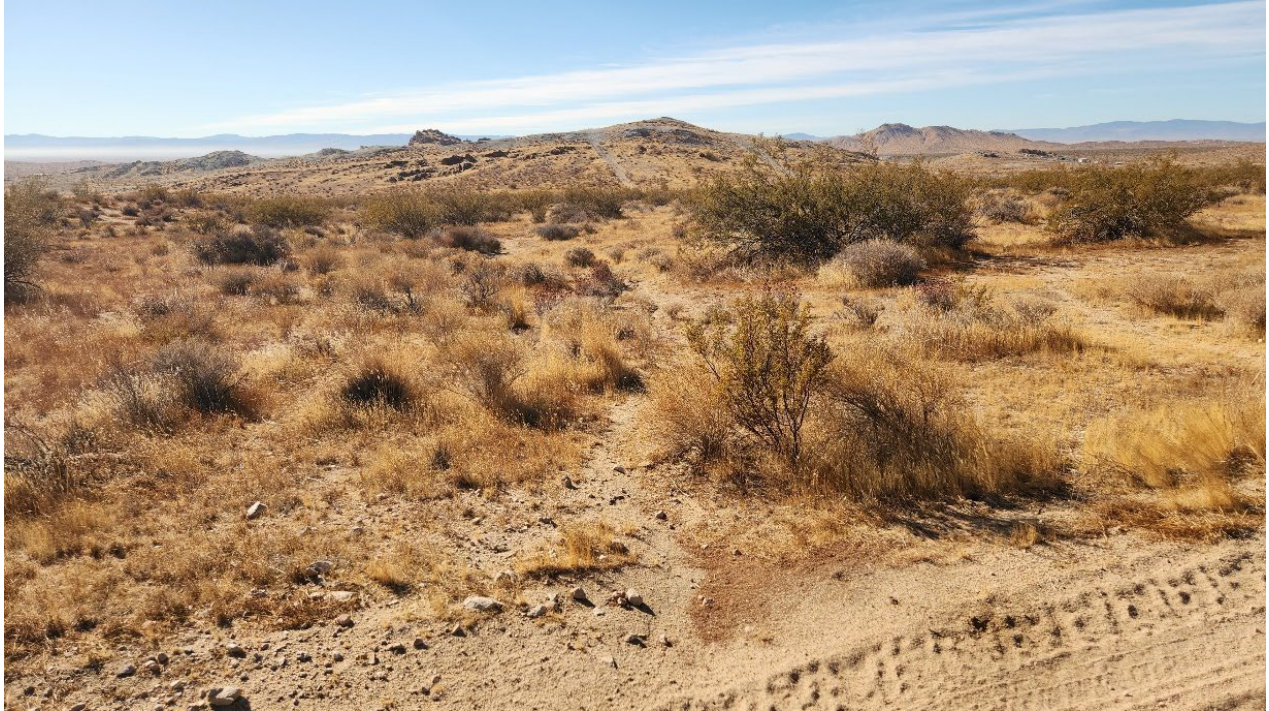
Drainage 53 is classified as an active ephemeral swale located on the south side of Dawn Road with a flow direction of north to south and a channel width of approximately 7 inches. This feature is characterized by a shallow depression in soil and a meandering gap in vegetation, with a bordering vegetation community comprised of creosote bush-white bursage scrub (**Photo Drainage 53-1**). This feature was dry during all site visits with little indication of flowing water. Drainage 53 is classified as a potential non-jurisdictional feature as it lacks riparian vegetation, does not carry a relatively permanent flow of water and does not connect to any jurisdictional waters.

Photo Drainage 53-1. Looking south/southwest at the upstream portion of Drainage 53 on the south side of Dawn Road.

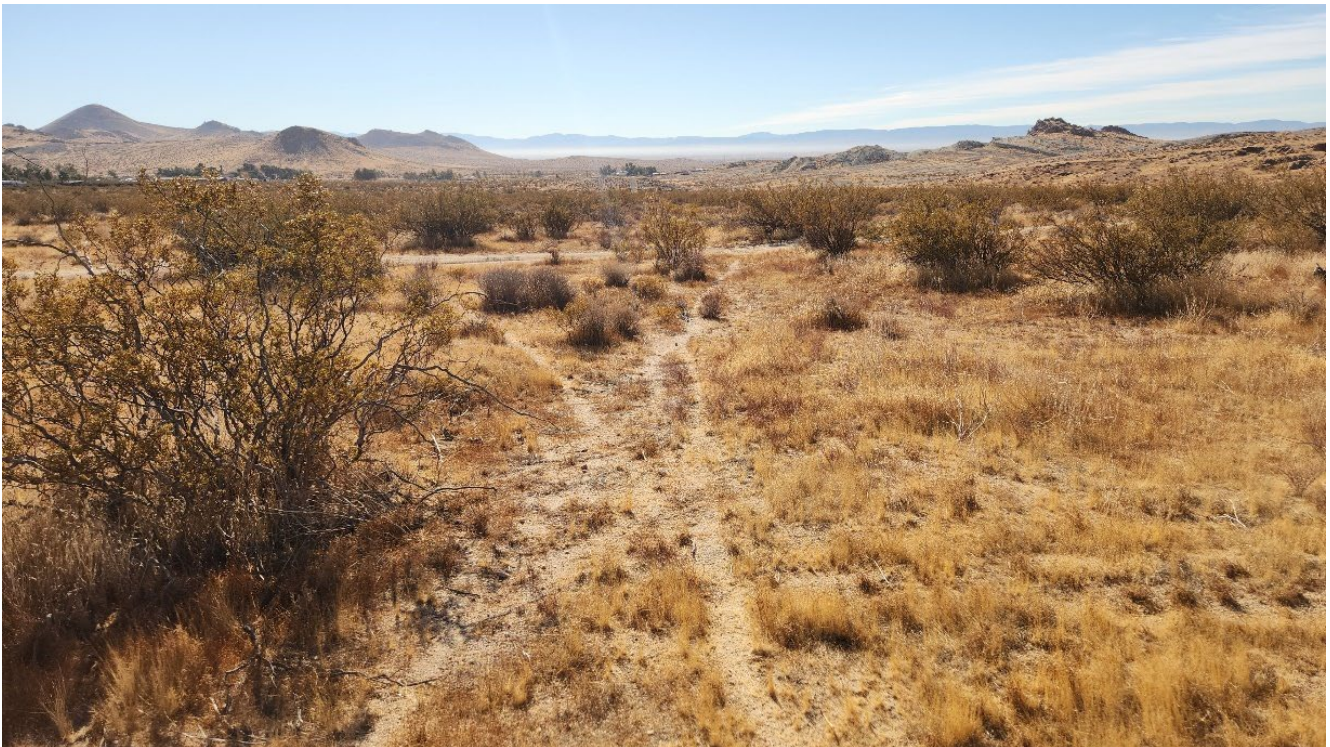
Drainage 54 is classified as an active ephemeral swale located on the south side of Dawn Road, west of the 40th Street W intersection. This feature flows north to south and is characterized by a braided gap in vegetation approximately 7 inches wide (**Photo Drainage 54-1**). Bordering vegetation includes creosote bush-white bursage scrub and disturbed/developed vegetation communities. Drainage 54 was dry during all site visits with little indication of flowing water. Drainage 54 is classified as a recommended state and federal non-jurisdictional feature as it lacks riparian vegetation, does not carry a relatively permanent flow of water and does not connect to any jurisdictional waters. However, LRWQCB has indicated that a natural or manmade geomorphological feature need only the ability to convey water to meet their interpretation of California “Waters of the State” for this area.

Photo Drainage 54-1. Looking south at Drainage 54 from the south side of Dawn Road, just west of the intersection with 40th Street West.

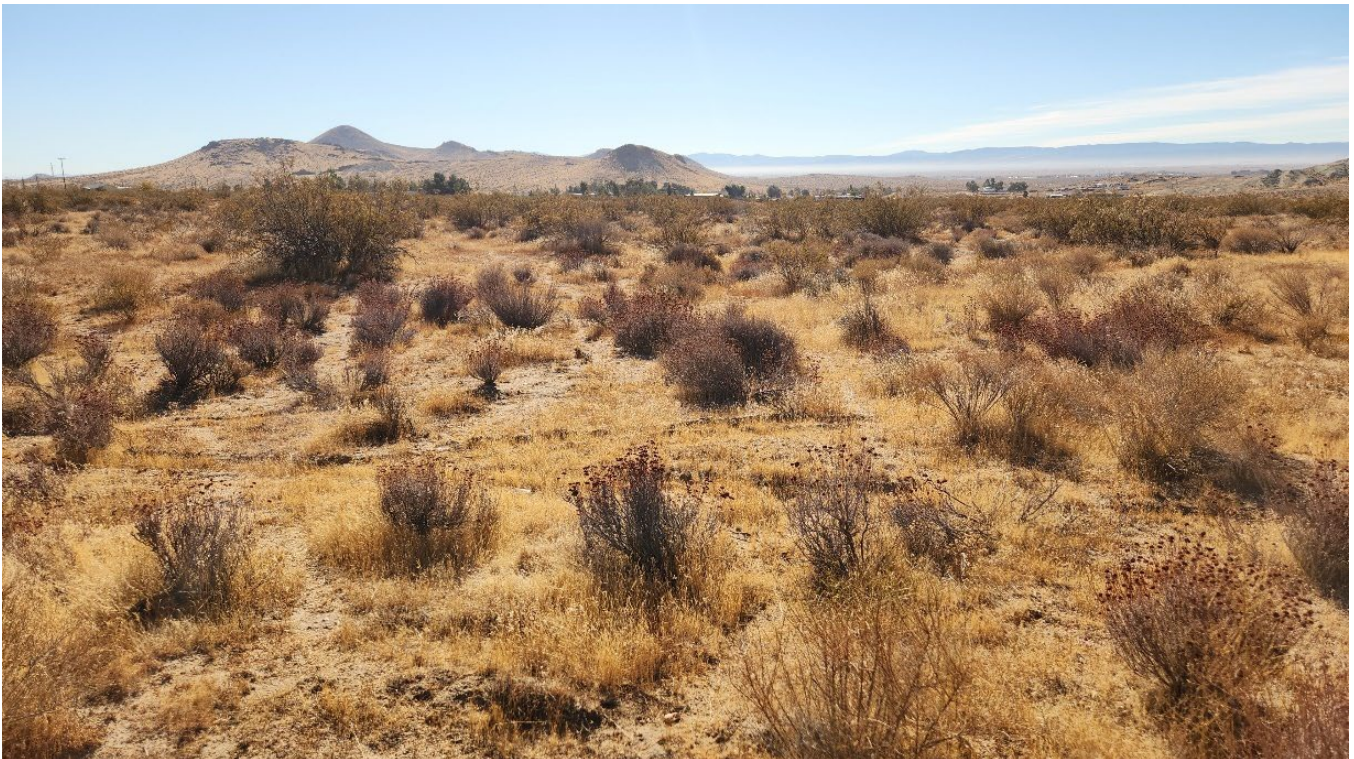
Drainage 55 is classified as an active ephemeral swale located on the south side of Dawn Road. This feature flows north to south and is characterized by a shallow depression in soil and a channel of approximately 20 inches (**Photo Drainage 55-1**). Bordering vegetation is dominated by creosote bush-white bursage scrub. This feature was dry during all site visits, with little indication of flowing water. Drainage 55 is classified as a recommended state and federal non-jurisdictional feature as it lacks riparian vegetation, does not carry a relatively permanent flow of water and does not connect to any jurisdictional waters. However, LRWQCB has indicated that a natural or manmade geomorphological feature need only the ability to convey water to meet their interpretation of California “Waters of the State” for this area.

Photo Drainage 55-1. Looking south at the upstream portion of Drainage 55 on the south side of Dawn Road.

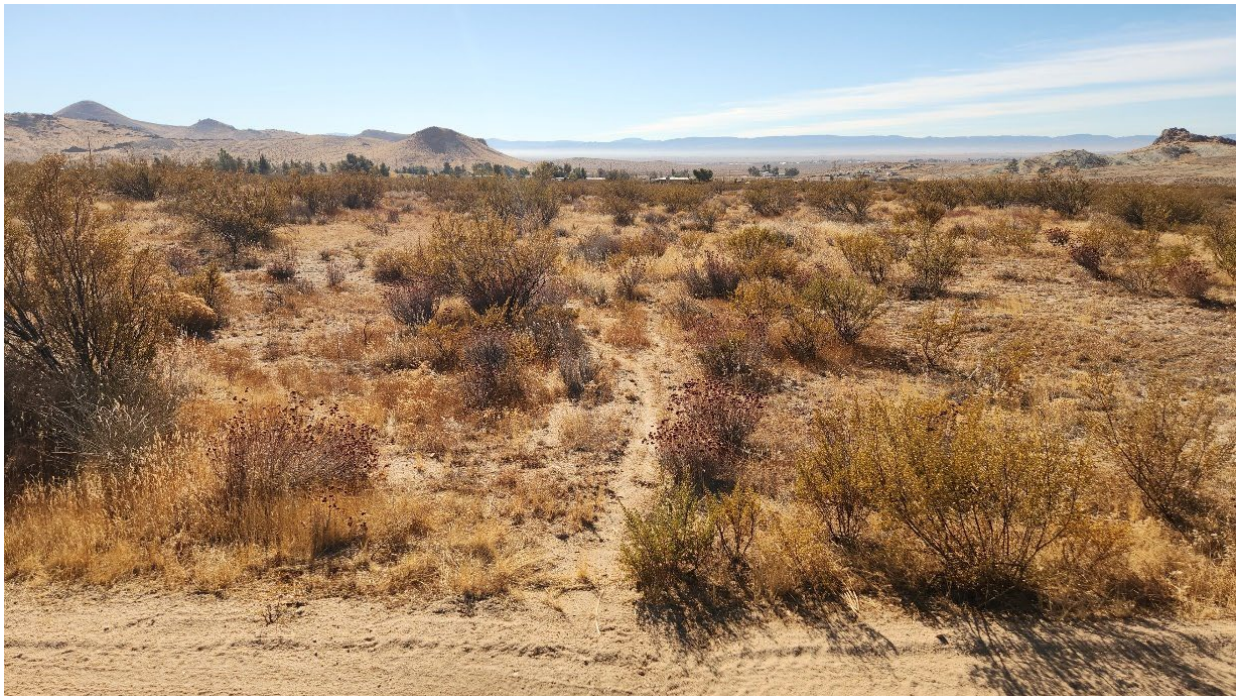
Drainage 56 is classified as an active ephemeral swale located on the south side of Dawn Road. This feature flows north to south and is characterized by a gap in vegetation approximately 8 inches wide (**Photo Drainage 56-1**). Bordering vegetation is predominantly creosote bush-white bursage scrub. This feature was dry during all site visits, with little indication of flowing water. Drainage 56 is classified as a recommended state and federal non-jurisdictional feature as it lacks riparian vegetation, does not carry a relatively permanent flow of water and does not connect to any jurisdictional waters. However, LRWQCB has indicated that a natural or manmade geomorphological feature need only the ability to convey water to meet their interpretation of California “Waters of the State” for this area.

Photo Drainage 56-1. Looking south upstream of Drainage 56 on the south side of Dawn Road. Shallow depression can be seen between vegetation.

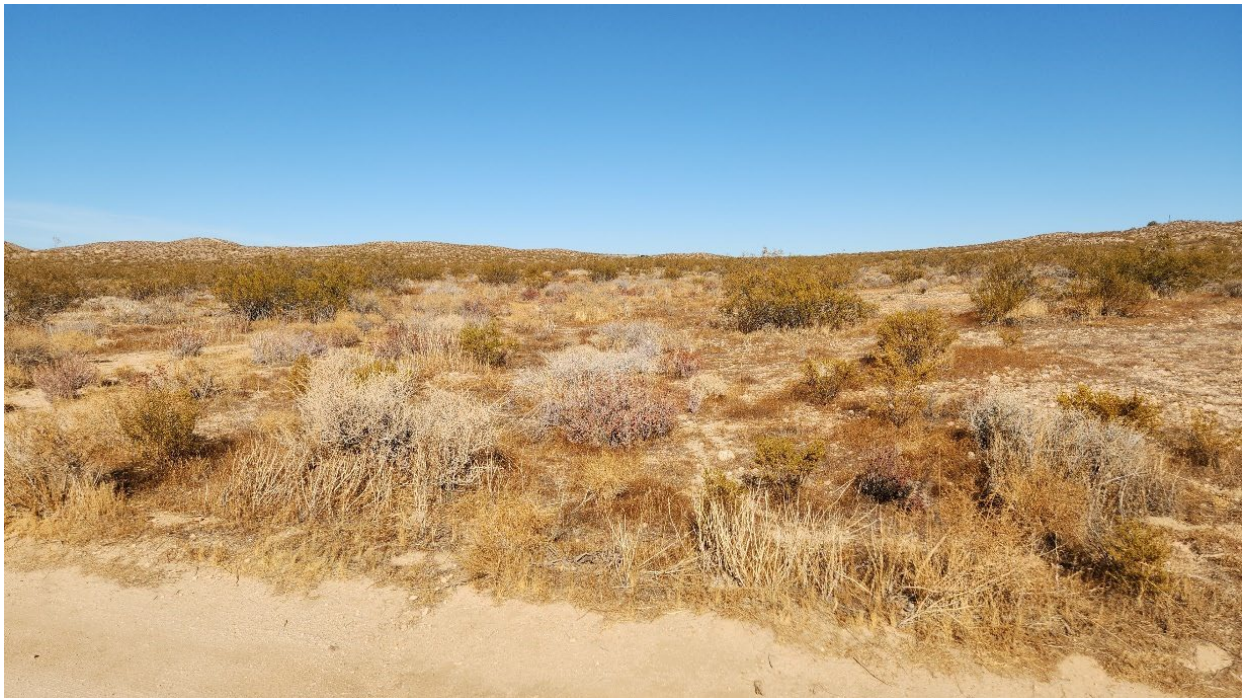
Drainage 58a is classified as an active ephemeral swale located on the north side of Dawn Road. This feature flows north to south toward Dawn Road and is characterized by a gap in vegetation approximately 45 inches wide (**Photo Drainage 58a-1**). Bordering vegetation includes creosote bush-white bursage scrub and disturbed/developed vegetation communities. Drainage 58a was dry during all site visits with little indication of flowing water. Drainage 58a is classified as a recommended state and federal non-jurisdictional feature as it lacks riparian vegetation, does not carry a relatively permanent flow of water and does not connect to any jurisdictional waters. However, LRWQCB has indicated that a natural or manmade geomorphological feature need only the ability to convey water to meet their interpretation of California “Waters of the State” for this area.

Photo Drainage 58a-1. Looking north at the downstream portion of Drainage 58a on the north side of Dawn Road.
