| DOCKETED | |
|---|--|
| Project Title: | Willow Rock Energy Storage Center |
| Document Title: | Willow Rock Jurisdictional Drainages Additional Information Text |

**Additional Information Related to DR128 -
Delineation of Jurisdictional Waters**
Willow Rock Energy Storage Center (21-AFC-02)

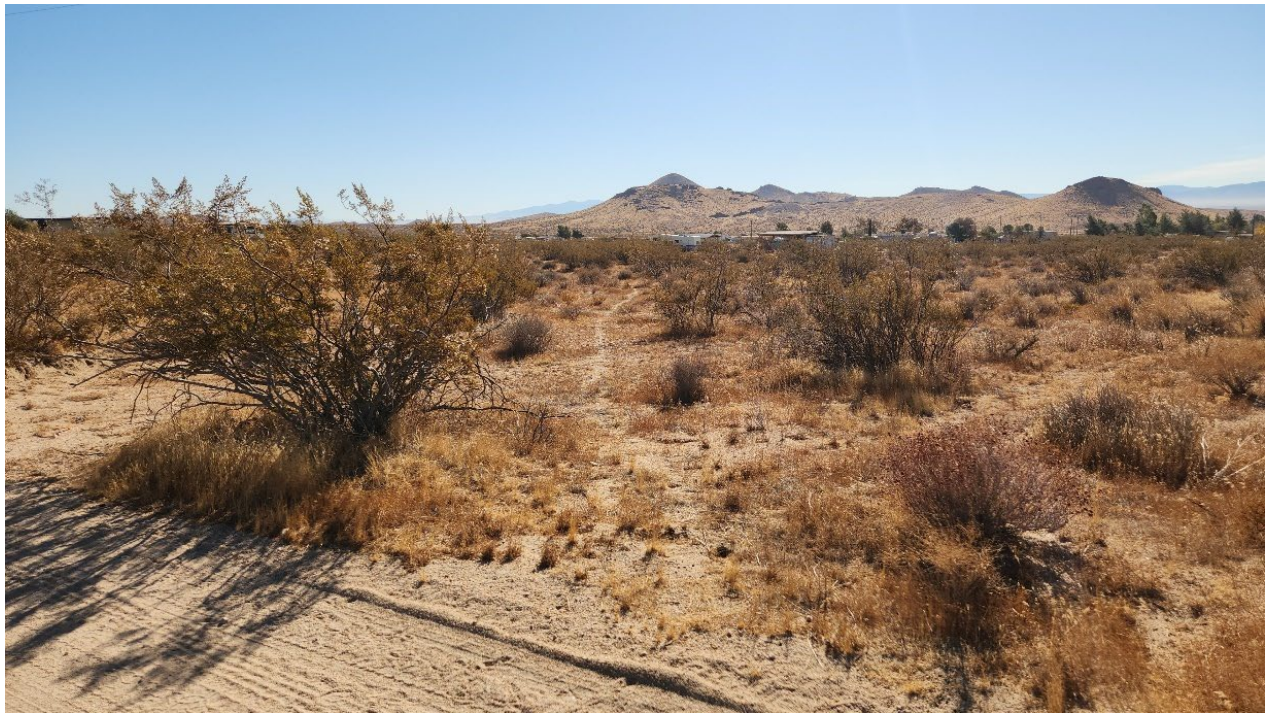
Drainage 58b is classified as an active ephemeral swale located on the south side of Dawn Road, across from Drainage 58a. This feature flows north to south and is characterized by gap in vegetation approximately 8 inches in width (**Photo Drainage 58b-1**). Bordering vegetation includes creosote bush-white bursage scrub and disturbed/developed vegetation communities. This feature was dry during all site visits with little indication of flowing water. Drainage 58b is classified as a recommended state and federal non-jurisdictional feature as it lacks riparian vegetation, does not carry a relatively permanent flow of water and does not connect to any jurisdictional waters. However, LRWQCB has indicated that a natural or manmade geomorphological feature need only the ability to convey water to meet their interpretation of California “Waters of the State” for this area.

Photo Drainage 58b-1. Looking southeast at the upstream portion of Drainage 58b on the south side of Dawn Road.

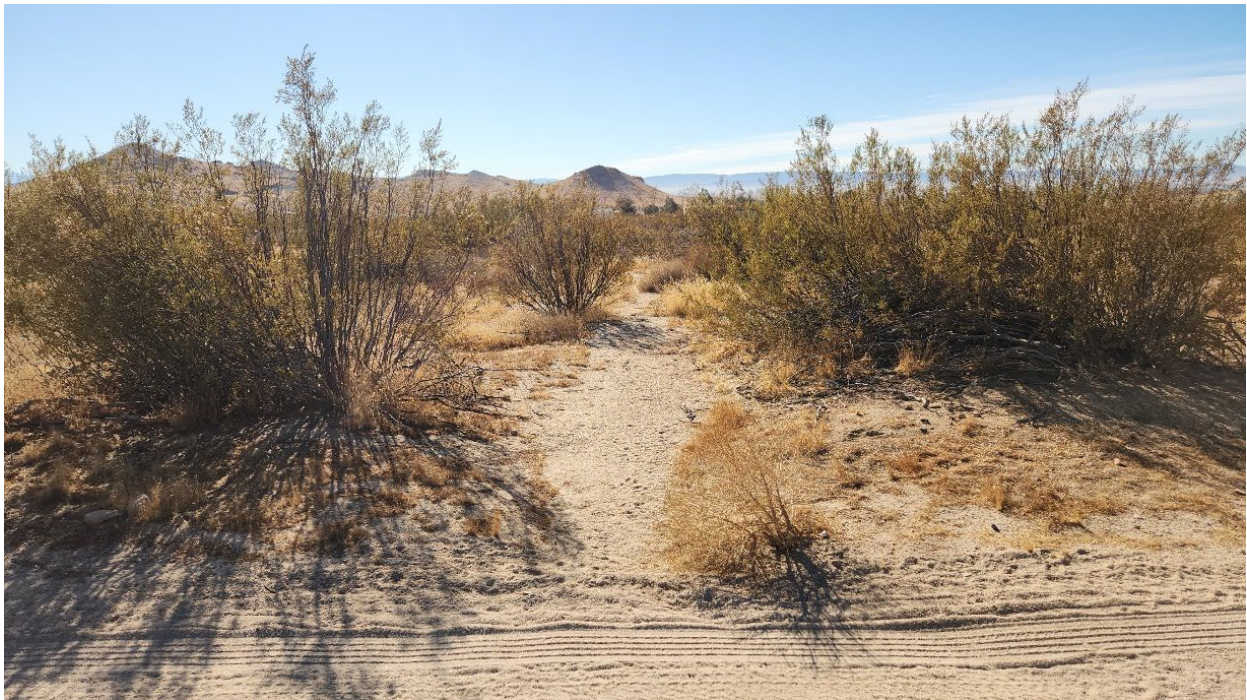
Drainage 59 is classified as an active ephemeral swale located on the south side of Dawn Road, near a residential area. This feature flows north to south and is characterized by a gap in vegetation approximately 10 inches in width (**Photo Drainage 59-1**). Bordering vegetation includes creosote bush-white bursage scrub and disturbed/developed vegetation communities. This feature was dry during all site visits with little indication of flowing water. Drainage 59 is classified as a potential non-jurisdictional feature as it lacks riparian vegetation, does not carry a relatively permanent flow of water and does not connect to any jurisdictional waters. However, LRWQCB has indicated that a natural or manmade geomorphological feature need only the ability to convey water to meet their interpretation of California “Waters of the State” for this area.

Photo Drainage 59-1. Looking south at the upstream portion of Drainage 59 on the south side of Dawn Road.

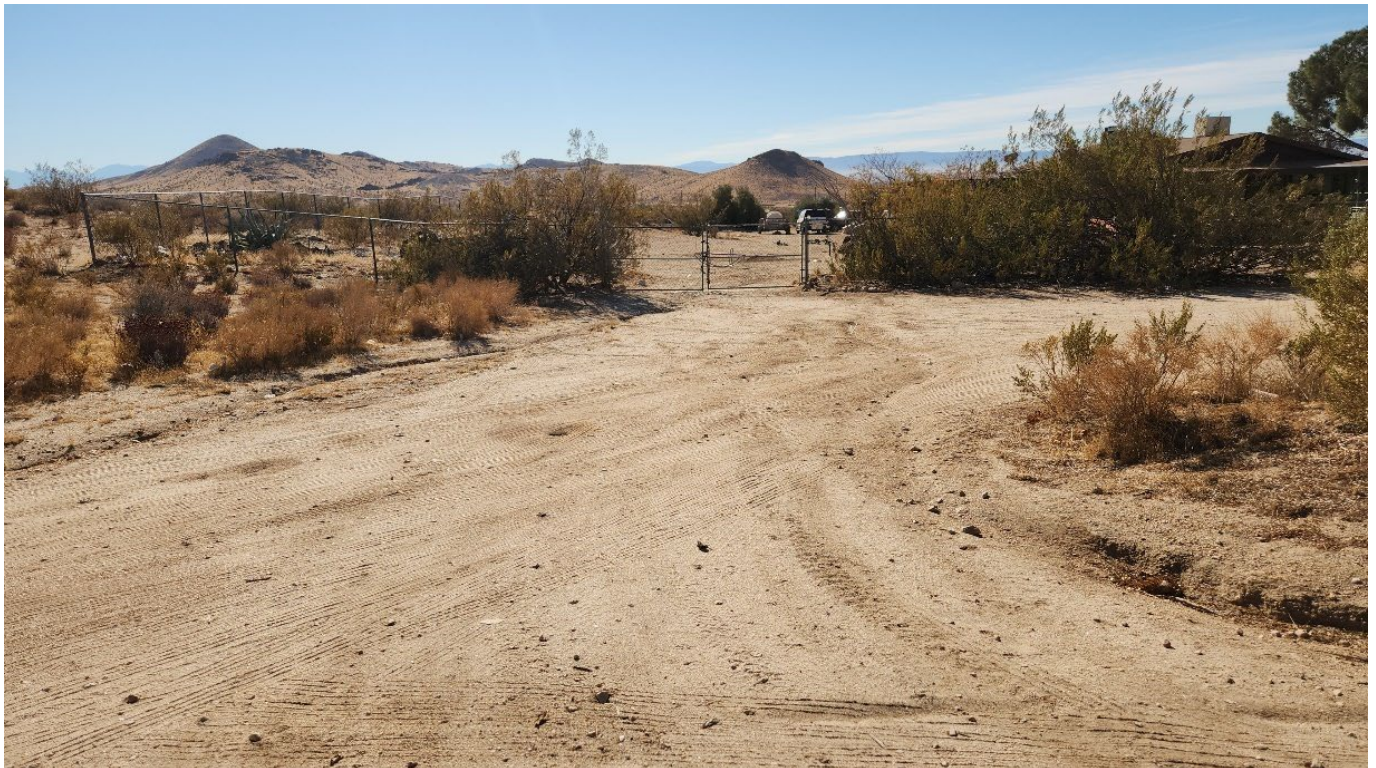
Drainage 60 is classified as an active ephemeral swale located on the south side of Dawn Road, at the base of a residential driveway. This feature flows north to south and is characterized by a slight depression in soil (**Photo Drainage 60-1**). Bordering vegetation is dominated by disturbed/developed vegetation communities. This feature was dry during all site visits with little indication of flowing water. Drainage 60 is classified as a recommended state and federal non-jurisdictional feature as it lacks riparian vegetation, does not carry a relatively permanent flow of water and does not connect to any jurisdictional waters. However, the LRWQCB has indicated that a natural or manmade geomorphological feature need only the ability to convey water to meet their interpretation of California “Waters of the State” for this area.

Photo Drainage 60-1. Looking southeast at Drainage 60 from the south side of Dawn Road toward a residence.

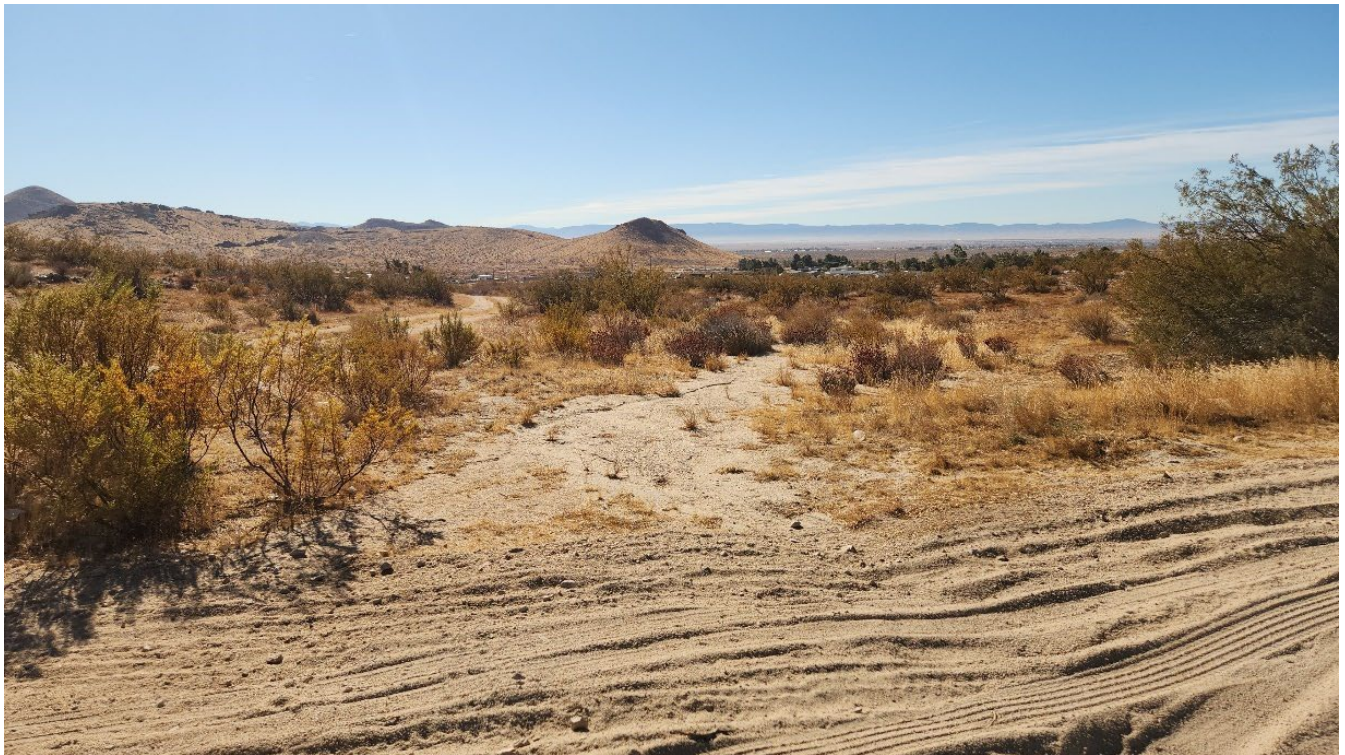
Drainage 61 is classified as an active ephemeral swale located on the south side of Dawn Road, in a residential area. This feature flows north to south and is characterized by a slight depression in soil with a channel width of approximately 10 inches (**Photo Drainage 61-1**). Bordering vegetation is dominated by creosote bush-white bursage scrub. This feature was dry during all site visits with little indication of flowing water. Drainage 61 is classified as a recommended state non-jurisdictional feature as it lacks riparian vegetation, does not carry a relatively permanent flow of water and does not connect to any jurisdictional waters. However, LRWQCB has indicated that a natural or manmade geomorphological feature need only the ability to convey water to meet their interpretation of California “Waters of the State” for this area.

Photo Drainage 61-1. Looking south at the upstream portion of Drainage 61 from the south side of Dawn Road.

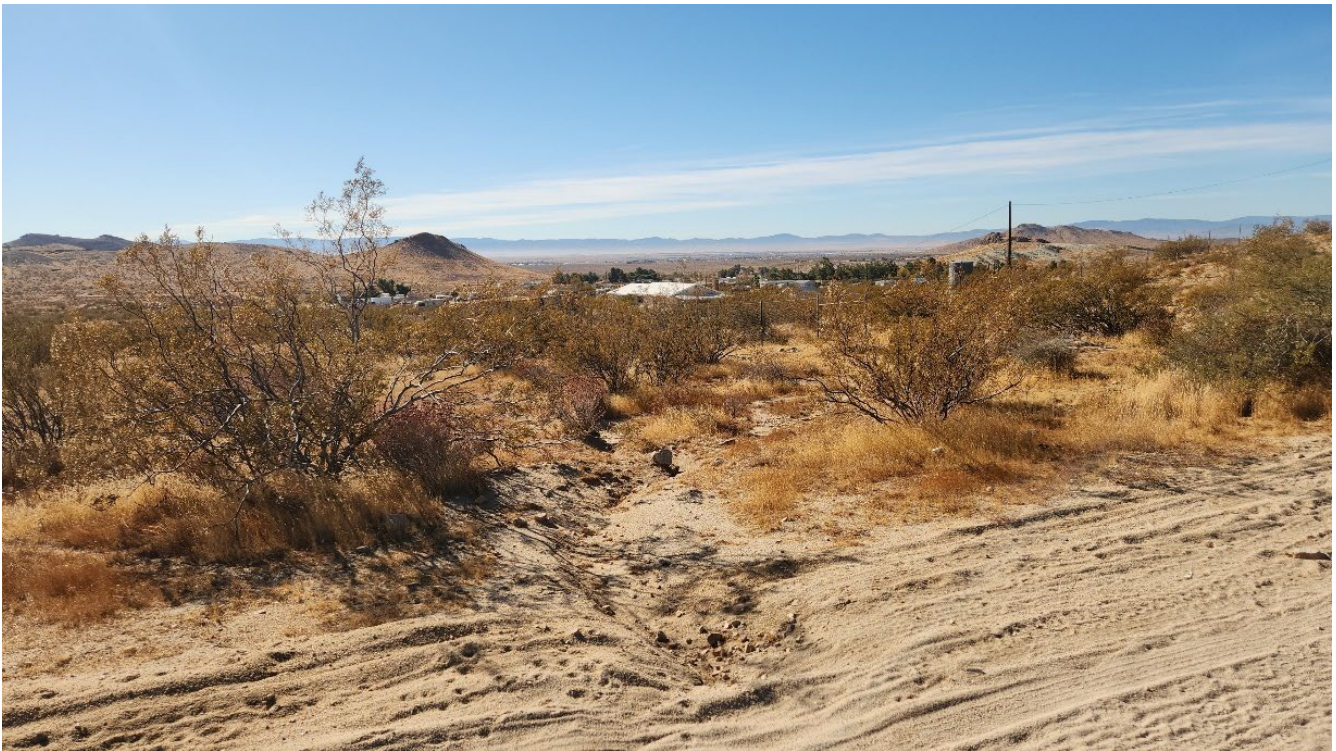
Drainage 62 is classified as an active ephemeral swale located on the south side of Dawn Road, in a residential area. This feature flows north to south and is characterized by a slight depression in soil with a channel width of approximately 7 inches (**Photo Drainage 62-1**). Bordering vegetation is dominated by creosote bush-white bursage scrub. This feature was dry during all site visits with little indication of flowing water. Drainage 62 is classified as a recommended state and federal non-jurisdictional feature as it lacks riparian vegetation, does not carry a relatively permanent flow of water and does not connect to any jurisdictional waters. However, Lahontan Regional Water Quality Control Board has indicated that a natural or manmade geomorphological feature need only the ability to convey water to meet their interpretation of California “Waters of the State” for this area.

Photo Drainage 62-1. Looking southwest at the upstream portion of Drainage 62 from the south side of Dawn Road. Shallow depression can be seen in soil between vegetation.

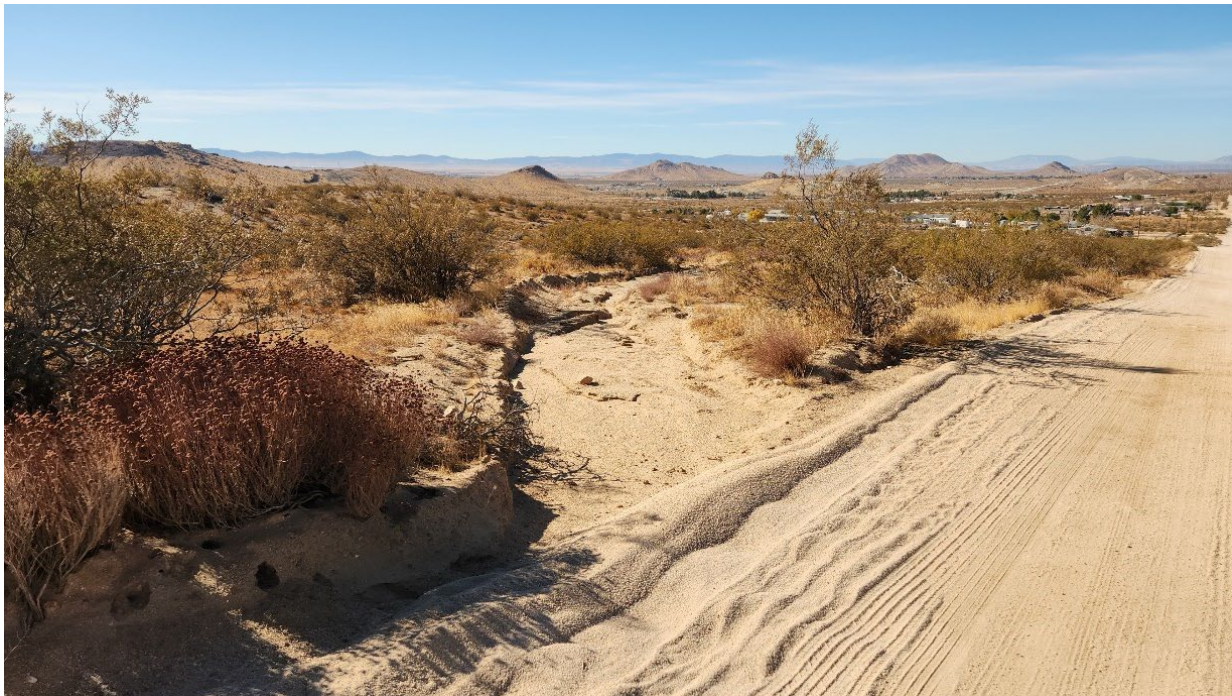
Drainage 64a is classified as an artificial roadside flow diversion located on the south side of central Dawn Road. This feature flows south-west where it combines with Drainages 64c and 64b, and has a channel width of approximately 4 feet (**Photo Drainage 64a-1**). Bordering vegetation is dominated by creosote bush-white bursage scrub. This feature was dry during all site visits with little indication of flowing water or riparian vegetation. Drainage 64a is classified as a recommended state and federal non-jurisdictional feature as it is an artificial flow conveyance for Dawn Road which does not carry a relatively permanent flow of water and does not connect to any jurisdictional waters. However, LRWQCB has indicated that a natural or manmade geomorphological feature need only the ability to convey water to meet their interpretation of California “Waters of the State” for this area.

Photo Drainage 64a-1. Looking south at the eastern upstream end of Drainage 64a from the south side of Dawn Road. Flow direction from east to west. Soil scouring can be seen along banks.

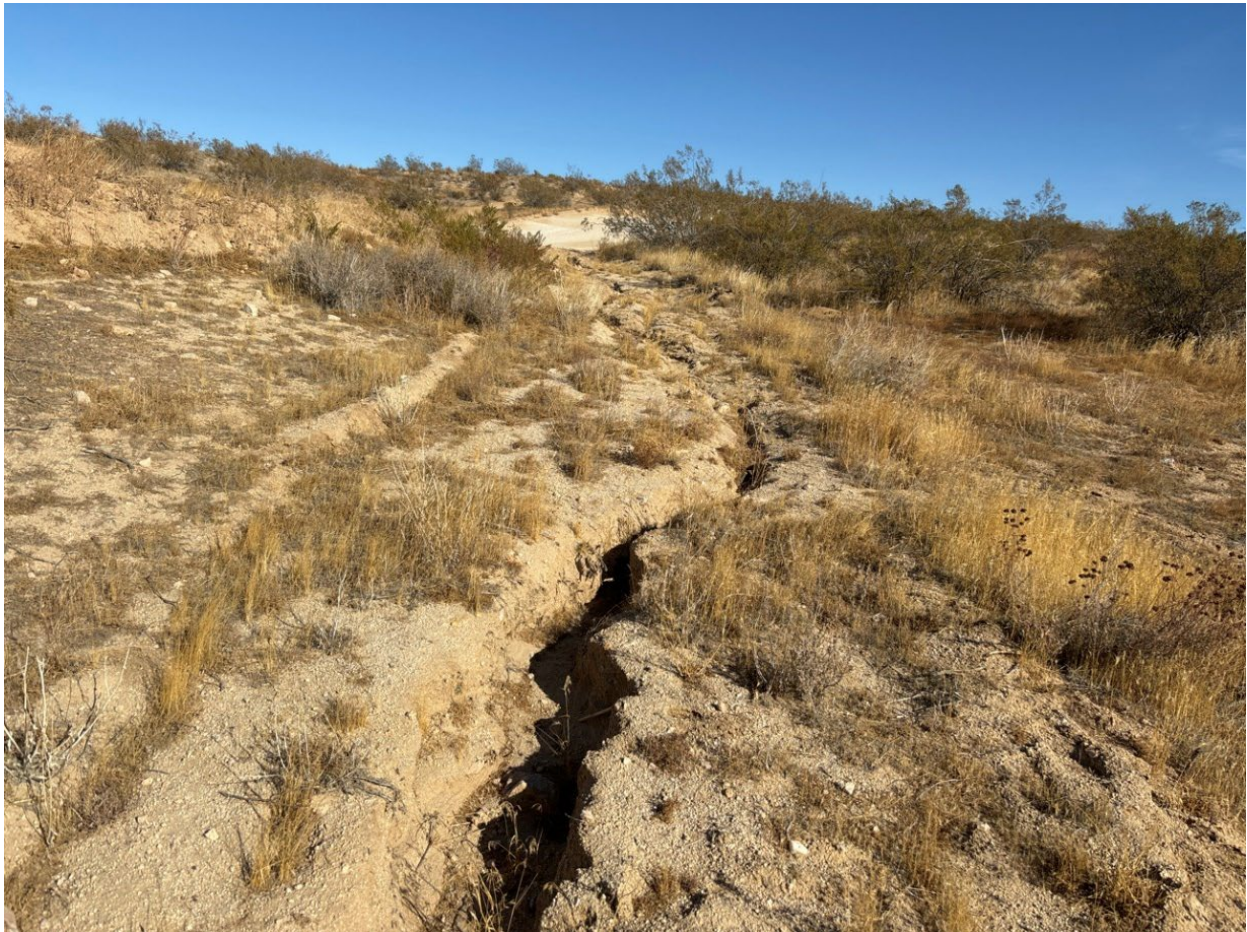
Drainage 64b is classified as an artificial roadside flow diversion located on the south side of central Dawn Road. This feature flows south-west where it combines with Drainages 64a and has a maximum channel width of approximately 16 inches and maximum depth of 10 inches (**Photo Drainage 64b-1**). Bordering vegetation is dominated by creosote bush-white bursage scrub. This feature was dry during all site visits with limited evidence of downstream scouring. Drainage 64b is classified as a recommended state and federal non-jurisdictional feature as it is an artificial flow conveyance for Dawn Road which does not carry a relatively permanent flow of water and does not connect to any jurisdictional waters. However, LRWQCB has indicated that a natural or manmade geomorphological feature need only the ability to convey water to meet their interpretation of California "Waters of the State" for this area.

Photo Drainage 64b-1. Looking northeast at the downstream portion of drainage 64b facing Dawn Road.

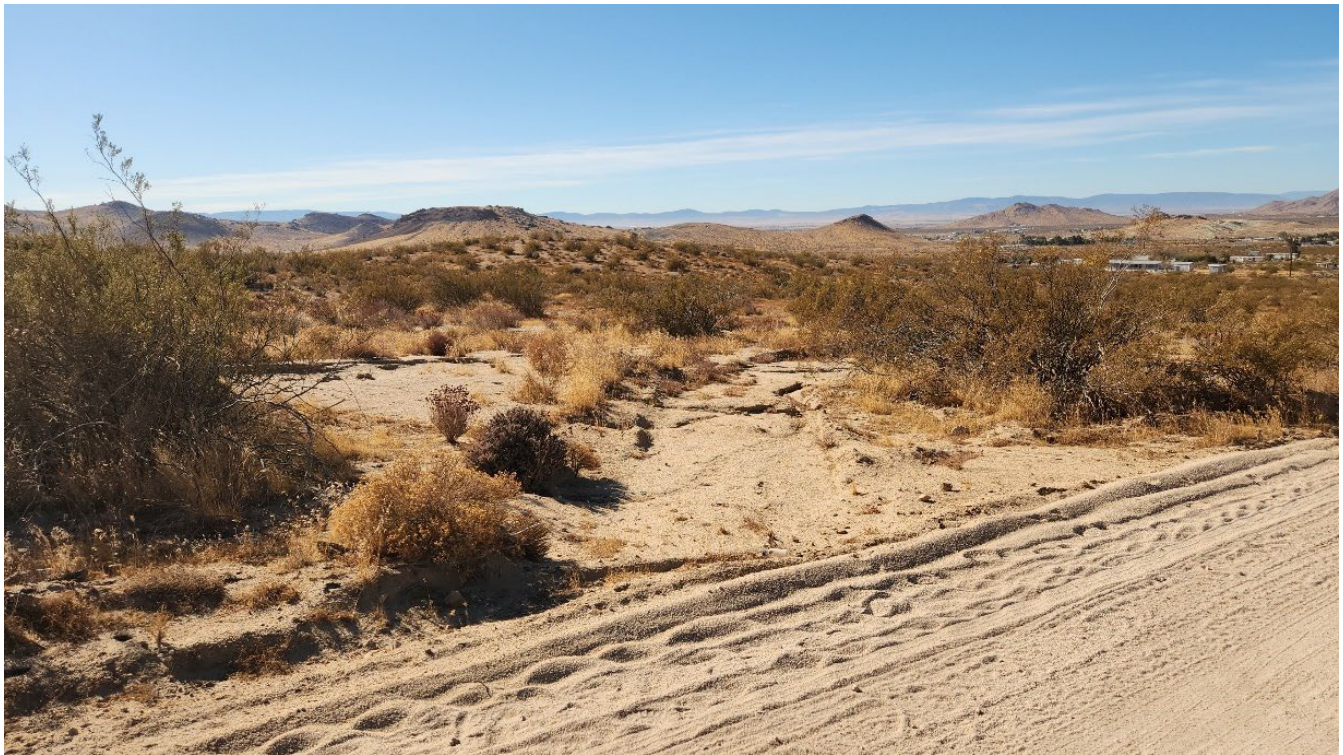
Drainage 64c is classified as an artificial roadside flow diversion located on the south side of central Dawn Road, situated between the upstream of Drainage 64a and Drainage 64b. This feature flows south-west where it combines with Drainages 64a and has a channel width of approximately 72 inches (**Photo Drainage 64c-1**). Bordering vegetation is dominated by creosote bush-white bursage scrub. This feature was dry during all site visits and is classified as a potential non-jurisdictional feature as it is an artificial flow conveyance for Dawn Road which does not carry a relatively permanent flow of water and does not connect to any jurisdictional waters. However, LRWQCB has indicated that a natural or manmade geomorphological feature need only the ability to convey water to meet their interpretation of California “Waters of the State” for this area.

Photo Drainage 64c-1. Looking southwest at the upstream portion of Drainage 64c from the south side of Dawn Road. Flow direction southwest toward the upstream portion of Drainage 64a.

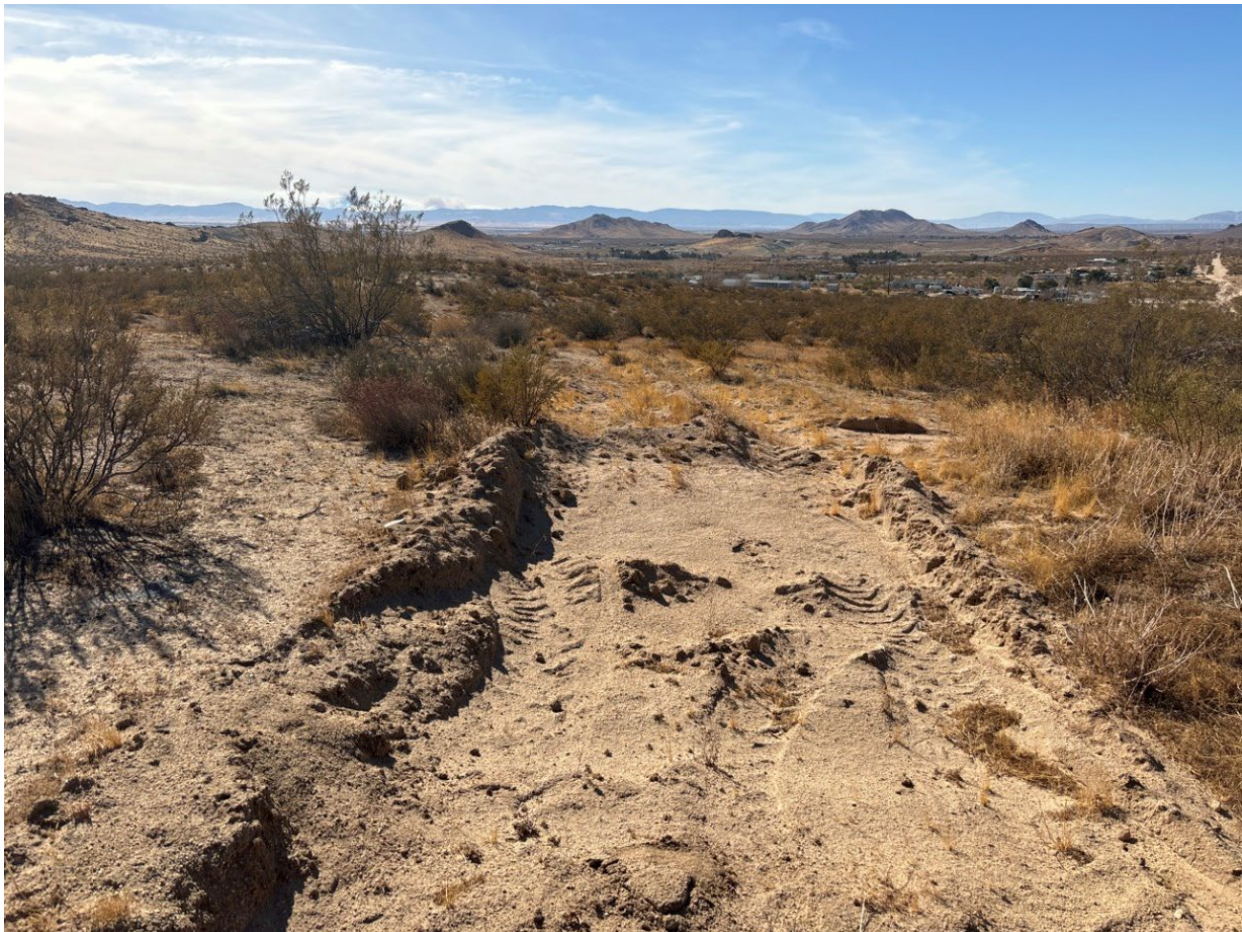
Drainage 64d is classified as an artificial roadside flow diversion located on the south side of central Dawn Road, east of the upstream of Drainage 64a. This feature flows south-west and has a channel width of approximately 86 inches (**Photo Drainage 64d-1**). Bordering vegetation is dominated by creosote bush-white bursage scrub. This feature was dry during all site visits and is classified as a recommended state and federal non-jurisdictional feature as it is an artificial flow conveyance for Dawn Road which does not carry a relatively permanent flow of water and does not connect to any jurisdictional waters. However, LRWQCB has indicated that a natural or manmade geomorphological feature need only the ability to convey water to meet their interpretation of California "Waters of the State" for this area.

Photo Drainage 64d-1. Looking southwest at the upstream portion of Drainage 64d on the south side of Dawn Road.

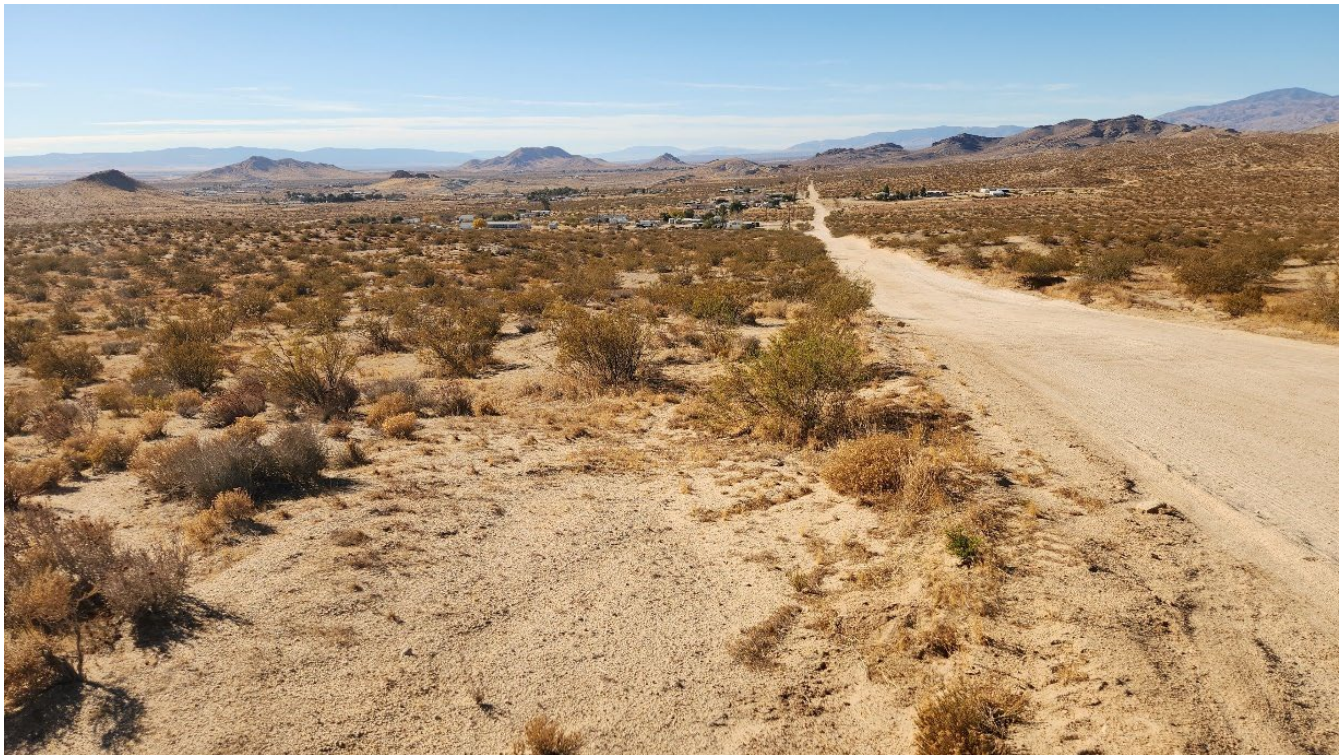
Drainage 64e is classified as an artificial roadside flow diversion located on the south side of central Dawn Road. This feature flows south-west and is characterized by a slight depression in sediment with no clear banks (**Photo Drainage 64e-1**). Bordering vegetation is dominated by creosote bush-white bursage scrub. This feature was dry during all site visits and is classified as a recommended state and federal non-jurisdictional feature as it is an artificial flow conveyance for Dawn Road which does not carry a relatively permanent flow of water and does not connect to any jurisdictional waters. However, LRWQCB has indicated that a natural or manmade geomorphological feature need only the ability to convey water to meet their interpretation of California “Waters of the State” for this area.

Photo Drainage 64e-1. Looking west toward the upstream portion of Drainage 64e on the south side of Dawn Road pictured on the right.

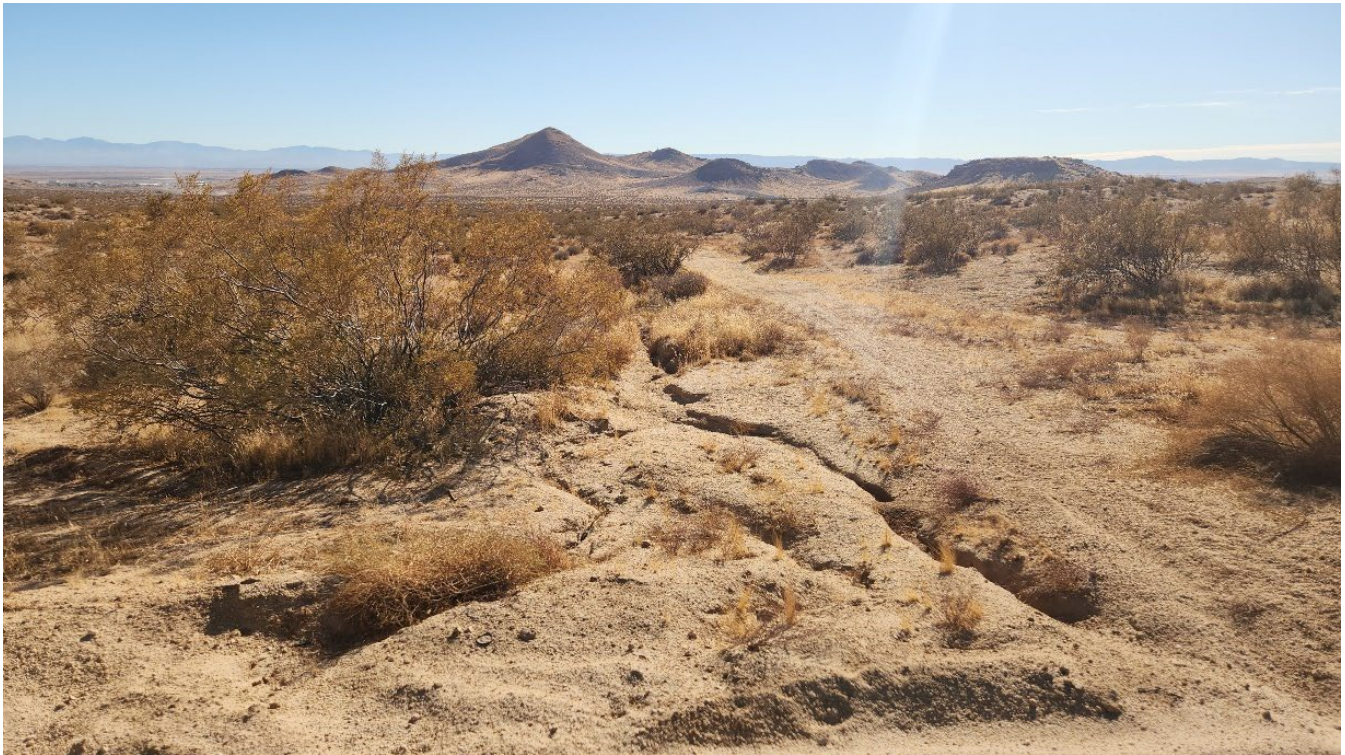
Drainage 65a is classified as an active ephemeral swale located on the south side of the central part of Dawn Road. This feature has two upstreams at Dawn Road, which converge at the southern downstream portion. Drainage 65a showed signs of scouring and has a channel width of approximately 18 inches (**Photo Drainage 65a-1**). Bordering vegetation is dominated by creosote bush-white bursage scrub and disturbed/developed communities. This feature was dry during all site visits with limited evidence of scouring indicating historical flow. Drainage 65a is classified as a potential non-jurisdictional feature as it lacks riparian vegetation, does not carry a relatively permanent flow of water and does not connect to any jurisdictional waters. However, LRWQCB has indicated that a natural or manmade geomorphological feature need only the ability to convey water to meet their interpretation of California “Waters of the State” for this area.

Photo Drainage 65a-1. Looking south at the upstream portion of Drainage 65a running parallel to unnamed access road on the south side of Dawn Road. Soil scouring can be seen.

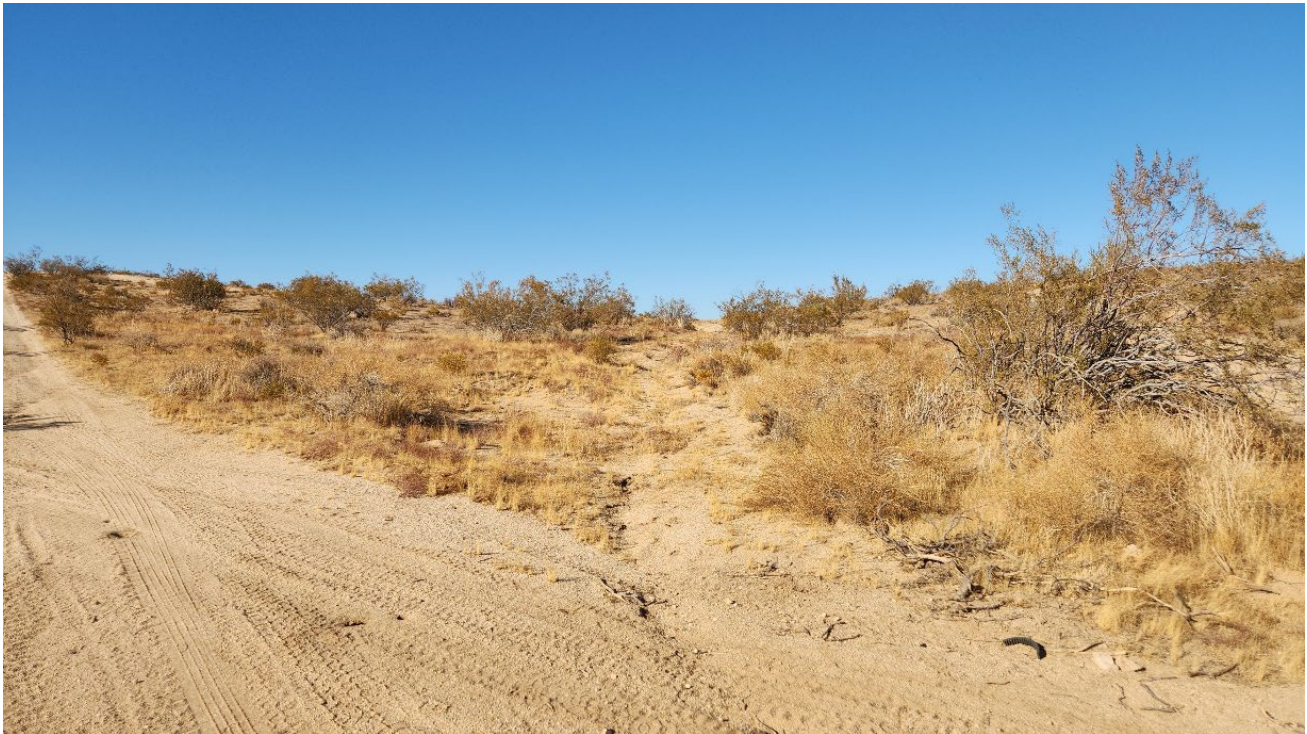
Drainage 65b is classified as an active ephemeral swale located on the north side of central Dawn Road, across from Drainage 65a. This feature flows south toward its downstream at Dawn Road and is characterized by a shallow depression in sediment with an approximate channel width of 32 inches (**Photo Drainage 65b-1**). Bordering vegetation is dominated by creosote bush-white bursage scrub. This feature was dry during all site visits, with little indication of flowing water. Drainage 65b is classified as a recommended state and federal non-jurisdictional feature as it does lack riparian vegetation, does not carry a relatively permanent flow of water and does not connect to any jurisdictional waters. However, LRWQCB has indicated that a natural or manmade geomorphological feature need only the ability to convey water to meet their interpretation of California "Waters of the State" for this area.

Photo Drainage 65b-1. Looking northwest at the upstream portion of Drainage 65b on the north side of Dawn Road.

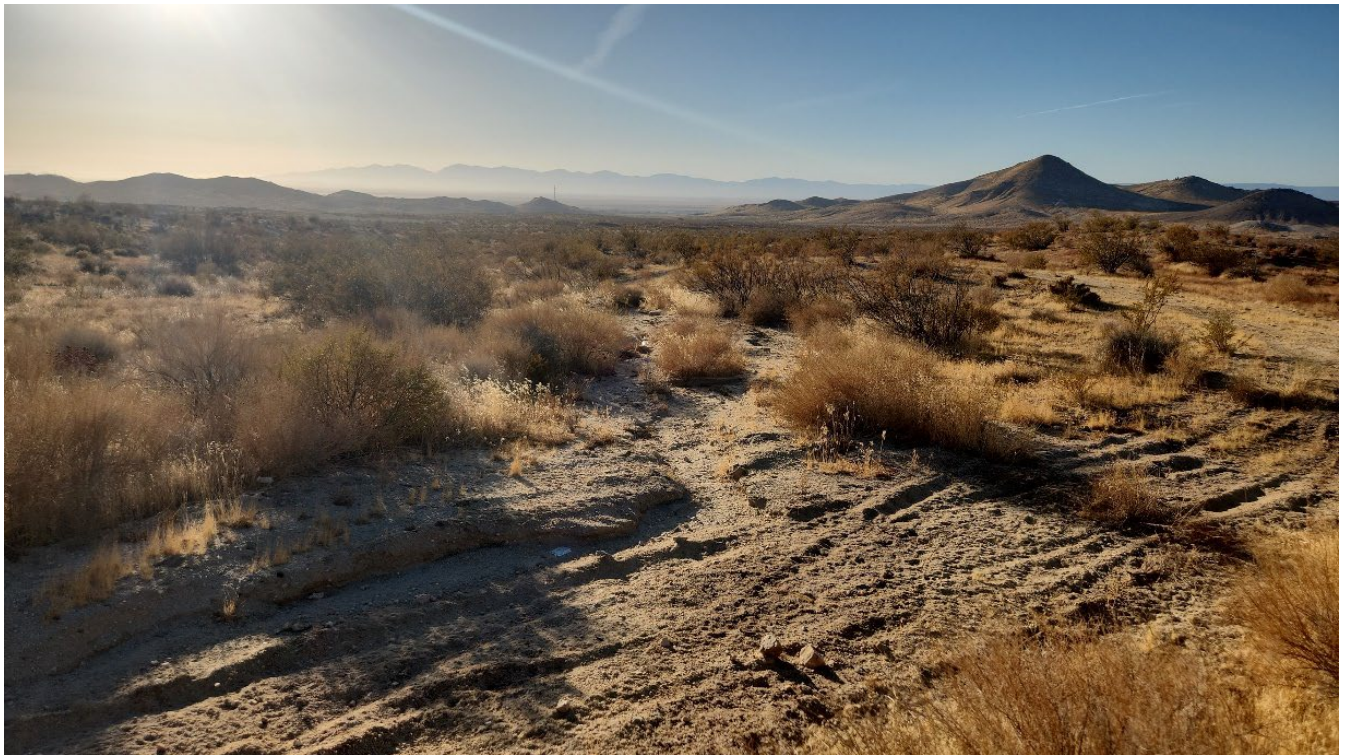
Drainage 66 is classified as an active ephemeral swale located on the south side of central Dawn Road. This feature flows south-east from its upstream at Dawn Road and is characterized by a meandering gap in vegetation of approximately 6 inches (**Photo Drainage 66-1**). Bordering vegetation is dominated by creosote bush-white bursage scrub. This feature was dry during all site visits and is classified as a recommended state and federal non-jurisdictional feature as it does lacks riparian vegetation, does not carry a relatively permanent flow of water and does not connect to any jurisdictional waters. However, LRWQCB has indicated that a natural or manmade geomorphological feature need only the ability to convey water to meet their interpretation of California “Waters of the State” for this area.

Photo Drainage 66-1. Looking south/southeast at the upstream portion of Drainage 66 on the south side of Dawn Road.

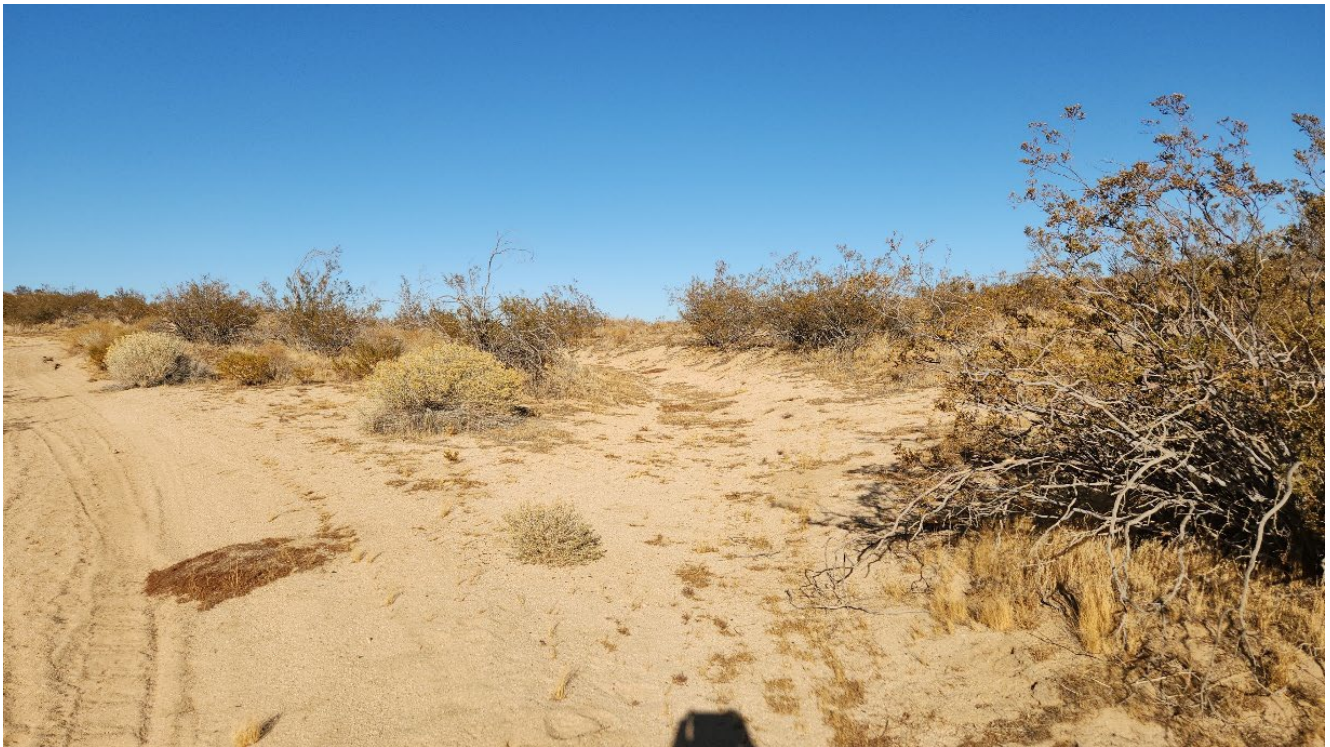
Drainage 69 is classified as an active ephemeral swale located on the north side of the eastern portion of Dawn Road. This feature flows north to south and is characterized by a shallow depression in sediment with a channel width of approximately 10 feet (**Photo Drainage 69-1**). Bordering vegetation is dominated by creosote bush-white bursage scrub and disturbed/developed communities. This feature was dry during all site visits with little indication of flowing water. Drainage 69 is classified as a recommended state and federal non-jurisdictional feature as it does lack riparian vegetation, does not carry a relatively permanent flow of water and does not connect to any jurisdictional waters. However, LRWQCB has indicated that a natural or manmade geomorphological feature need only the ability to convey water to meet their interpretation of California “Waters of the State” for this area.

Photo Drainage 69-1. Looking northeast at the downstream portion of Drainage 69 on the north side of Dawn Road. Shallow depression in soil can be seen between vegetation.

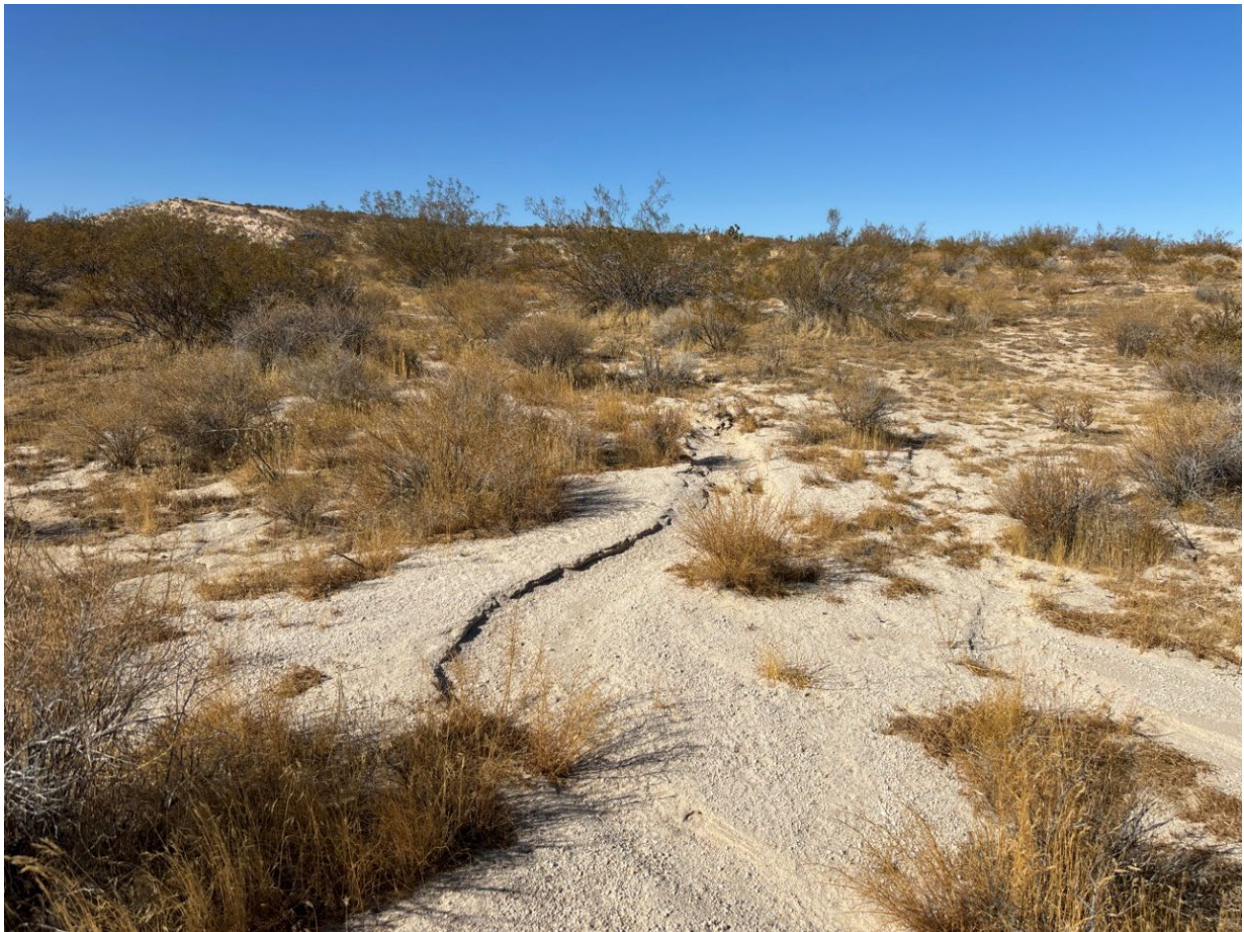
Drainage 70 is classified as an active ephemeral swale located southeast of the eastern Dawn Road intersection with an unnamed access road. This feature flows southeast and is characterized by a meandering channel approximately 15 inches wide (**Photo Drainage 70-1**). Bordering vegetation is predominantly creosote bush-white bursage scrub, with no indication of riparian vegetation. This feature was dry during all site visits, and had limited evidence of scouring on its west bank. Drainage 70. is classified as a recommended state and federal non-jurisdictional feature as it does not carry a relatively permanent flow of water and does not connect to any jurisdictional waters. However, LRWQCB has indicated that a natural or manmade geomorphological feature need only the ability to convey water to meet their interpretation of California “Waters of the State” for this area.

Photo Drainage 70-1. Looking northwest downstream portion of Drainage 70 towards Desert Highland Parkway.

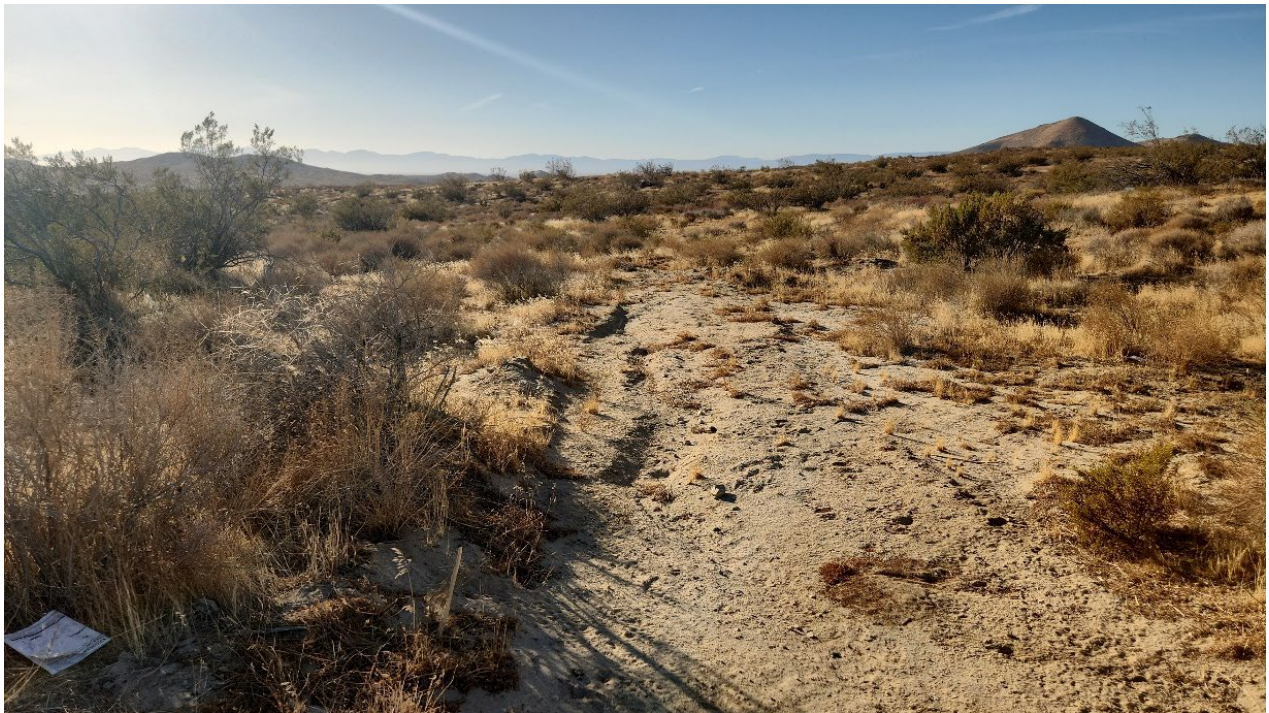
Photo Drainage 72-1. Looking south at the upstream portion of Drainage 72 on the south side of Dawn Road.

Drainage 72 is classified as an active ephemeral swale located on the south side of the eastern part of Dawn Road near Aerospace Highway. This feature has a channel width of approximately 86 inches at its upstream at Dawn Road, however the channel becomes less defined toward the southern downstream portion (**Photo Drainage 72-1**). Bordering vegetation includes creosote bush-white bursage scrub, with no indication of riparian vegetation. This feature was dry during all site visits and is classified as a recommended state and federal non-jurisdictional feature as it does not carry a relatively permanent flow of water and does not connect to any jurisdictional waters. However, LRWQCB has indicated that a natural or manmade geomorphological feature need only the ability to convey water to meet their interpretation of California “Waters of the State” for this area.
