| Project Title: | Commercial and Industrial Fans & Blowers |
| Document Title: | Daikin Applied Comments on Packaged Rooftops |

Daikin Applied Comments: Commercial and Industrial Fans and Blowers (CIFB)

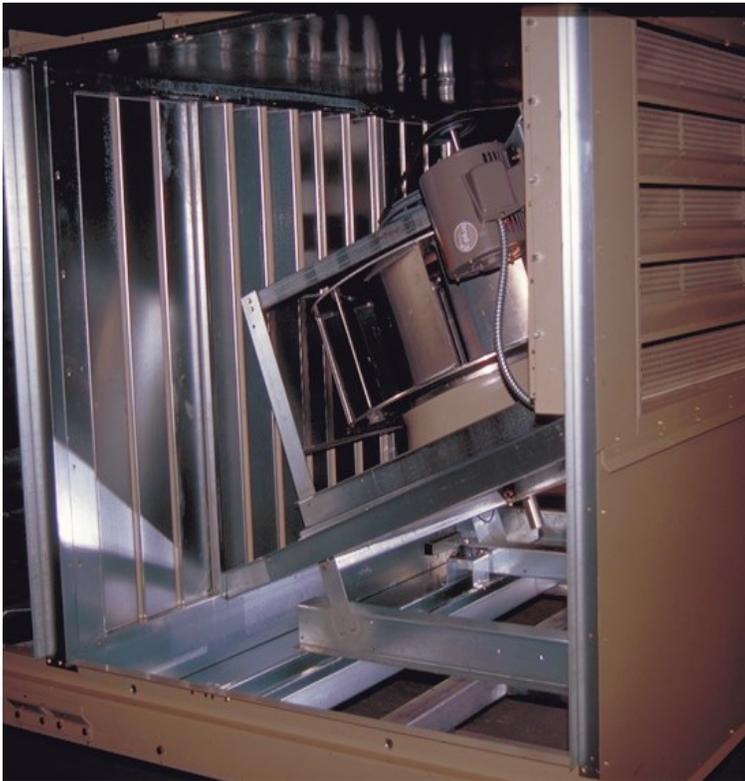
This following photo shows the especially space constrained, return fan option with bottom or back return and back exhaust. Note the following.

- These plenum fans need clearances of 0.5 – 1.0 fan diameters from cabinetry or efficiency suffers. Insufficient clearance may cause a larger fan with better FEI to consume more energy than a smaller fan with lesser FEI.
- Air must discharge in 2 opposite, return or exhaust directions. An unhooded, centrifugal airfoil fan is the most efficient choice.
- There is no extra room between [the left hand, return dampers and the right hand exhaust dampers] or [the drives and the top of the unit.]
