CALICO SOLAR POWER PROJECT

DPW CONCERNS REGARDING:

Supplemental Staff Assessment, Part II
September 13, 2010

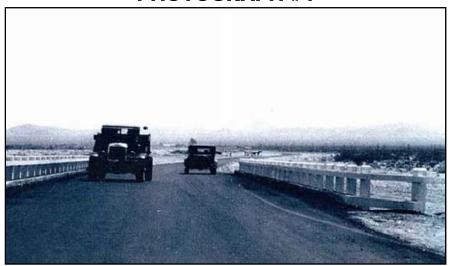
PHOTOGRAPH #1

Typical Existing Above Grade View of NTH/Route 66 Bridge

Note: The visual prominence of the original wood railings/guardrails and the wood curbs with scuppers. The original bridges clearly read as wood timber trestle structures, as opposed to the current condition of the vast majority of existing bridges.

NOTE: See Figures #1 and #2 Below

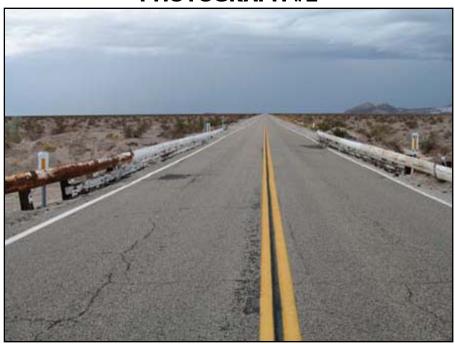
PHOTOGRAPH #2

Typical Existing Above Grade View of NTH/Route 66 Bridge

Note: How the original wood railings have been removed, the original wood posts reduced in height, and how the wood curbs with scuppers have been modified. In effect, this bridge no longer reads clearly as an historic timber trestle structure. Rather, it reads as a highly modified bridge lacking historic integrity.
